National Park Service
Cultural Landscapes Inventory
2016

Johnstown Flood NMem Landscape
Johnstown Flood National Memorial

Inventory Unit Summary & Site Plan

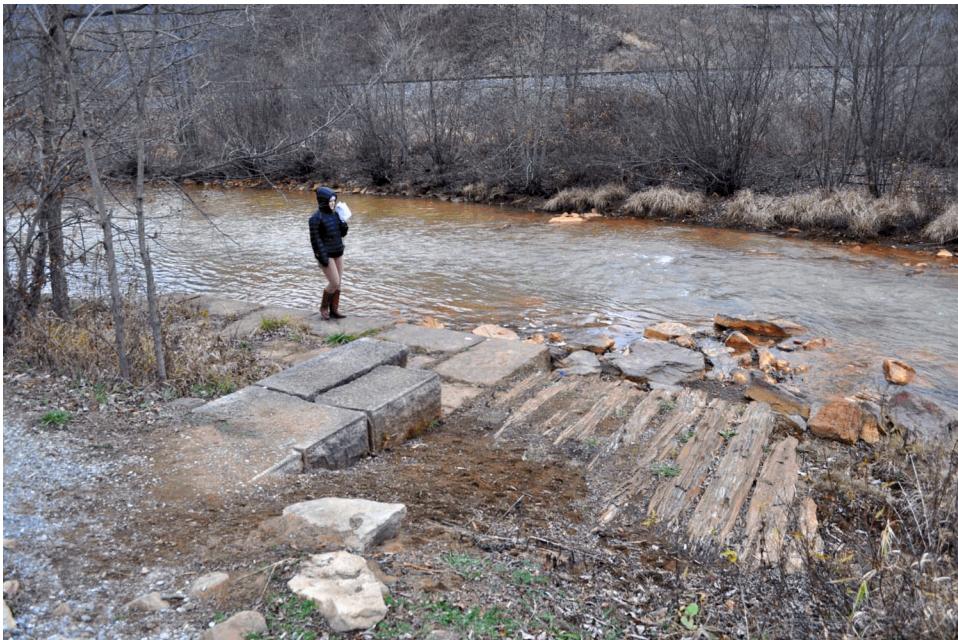
Overall, the Johnstown Flood National Memorial landscape is in "fair" condition, primarily because of the reestablishment of trees in the lakebed since the late 1980s and early 1990s. The bed of Lake Conemaugh and the remnants of the South Fork Dam are a destination for visitors to witness and reflect on the cause of the devastating Johnstown Flood of May 31, 1889. The portion of the lake's former shoreline lying within the park boundary is a critical component of the park's interpretive program, but it has become increasingly obscured by vegetation. If left to continue, it will be increasingly difficult for visitors to visualize the size of Lake Conemaugh, understand the volume of water that poured through the dam's breach, and recognize the physical relationship between the dam, lake, and club buildings. The park is currently exploring vegetation management alternatives in the lakebed that balance cultural resource goals with natural resource regulations and practices. In addition, recent (2012-13) condition assessments evaluated the dam spillway as "good," dam abutments and carriage road trace as "fair," and the sluice culvert and valve control tower ruins as "poor."

Figure 24. View looking north at the remnants of the sluice culvert and valve control tower foundation. (OCLP 2014, DSC_0145)
