REVEGETATION AT CRATER LAKE

NATIONAL PARK:

A PROGRESS REPORT

FOR 1979

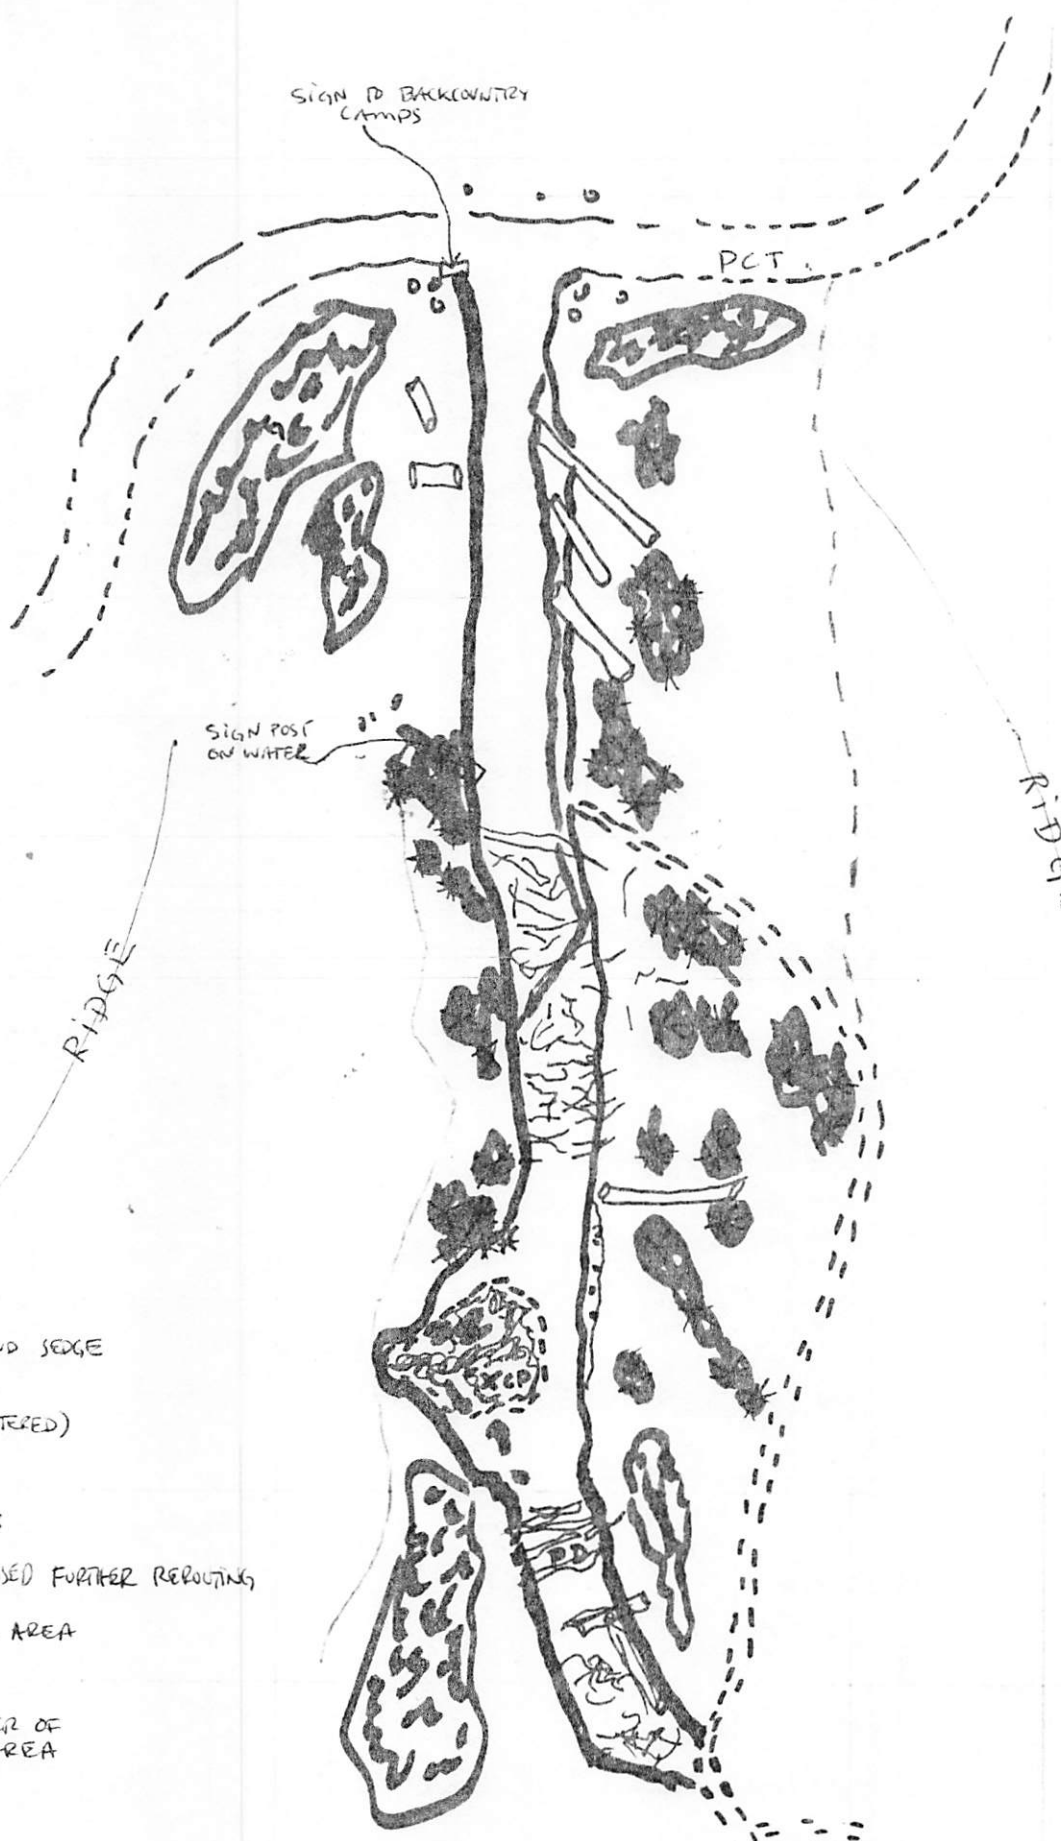
LIGHTNING STRIKES BACKCOUNTRY CAMP AREA

This site is located in the SW $\frac{1}{4}$ , NW $\frac{1}{4}$  of Sec. 25, T 30S, R 5E and is found approximately .8 miles from Rim Drive. As it appears now, Lightning Spring Camp is perhaps one of the most accessible overnight backcountry camps in the park. As such it has for some time received much use and, as a result, it has suffered from human impact. Nevertheless, the area will continue to be used and measures have already been initiated to accomodate further use without further destruction.

The area presented impacted begins at the PCT and continues down toward the new backcountry sites. About 200 meters from the PCT there is a large area where much camping once took place and where a pump-house once stood. This is the site where the greatest denudation has occurred. It is open but now lacks any natural cover such as woodrush and sedge. Furthermore, it lies only a few feet from Lightning Spring.

The present soil conditions of the site appear to be the limiting factor for revegetation. Soil compaction is extensive preventing seeds from germinating properly or grasses from sending out root systems. Some erosion has begun to occur close to the PCT junction and a small gully has been forming.

Already some work has been initiated to rehabilitate the site. It includes: 1) rerouting trail, 2) construction of backcountry sites, 3) closing of lower rehab. area with debris and "reseeding" signs, and 4) tilling of the most impacted area where the pumphouse once was.

Further rehabilitation procedures for the following summers should include: 1) totally closing off the old trail to camp area and further rerouting trail to camps (as shown on map), 2) tilling all that trail completely after observing revegetation effects from 1979 tilling project, 3) conducting a simple soil nutrient analysis to determine need for fertilizer, 4) careful monitoring of tilled sites noting rehabilitation.
