Mission San Juan De Capistrano, Convent  
Berg's Mill-Graf Road  
Berg's Mill Community  
San Antonio  
Bexar County  
Texas

HABS No. TX-321 B

MISSION SAN JUAN DE CAPISTRANO,  
CONVENT

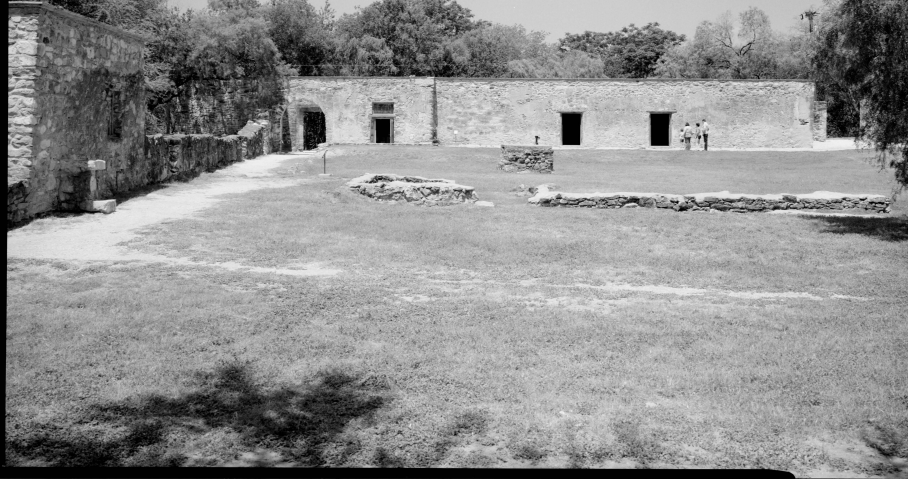
HABS No. TX-321 B-1

TX-321 B-1 GENERAL VIEW AND FRONT ELEVATION, LOOKING WEST

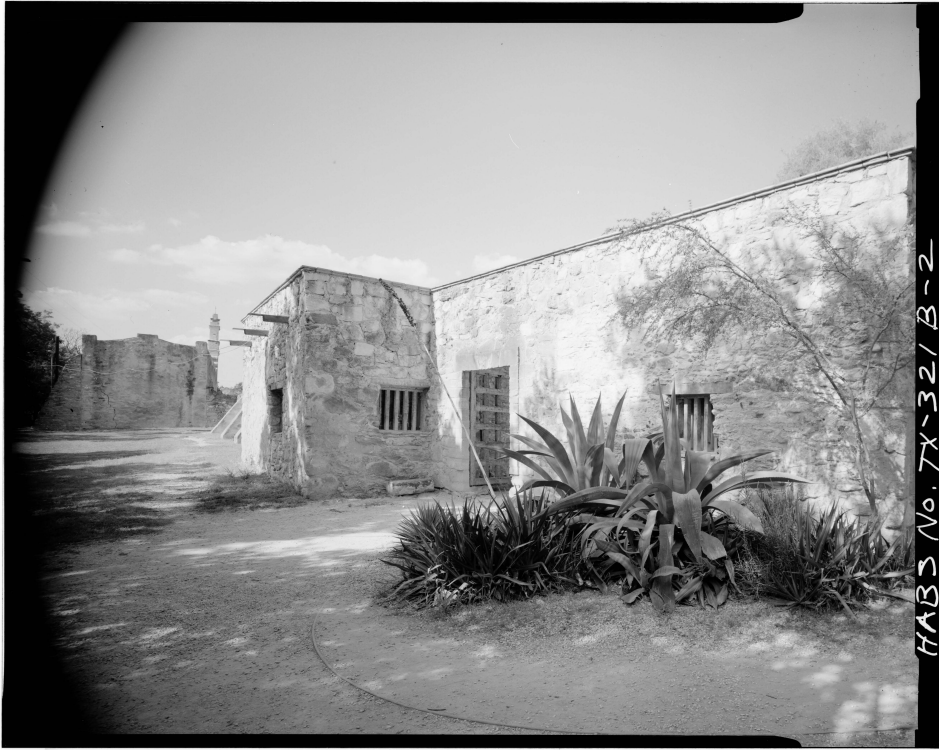
HABS No. 7X-321 B-2

TX-321 B-2 WEST (REAR) ELEVATION, LOOKING NORTHEAST
