# Coastal Hazards & Sea-Level Rise Asset Vulnerability Assessment for San Juan Island National Historical Park & Ebey's Landing National Historical Reserve

## *Summary of Results*

NPS 438/199213, NPS 484/199213, March 2026

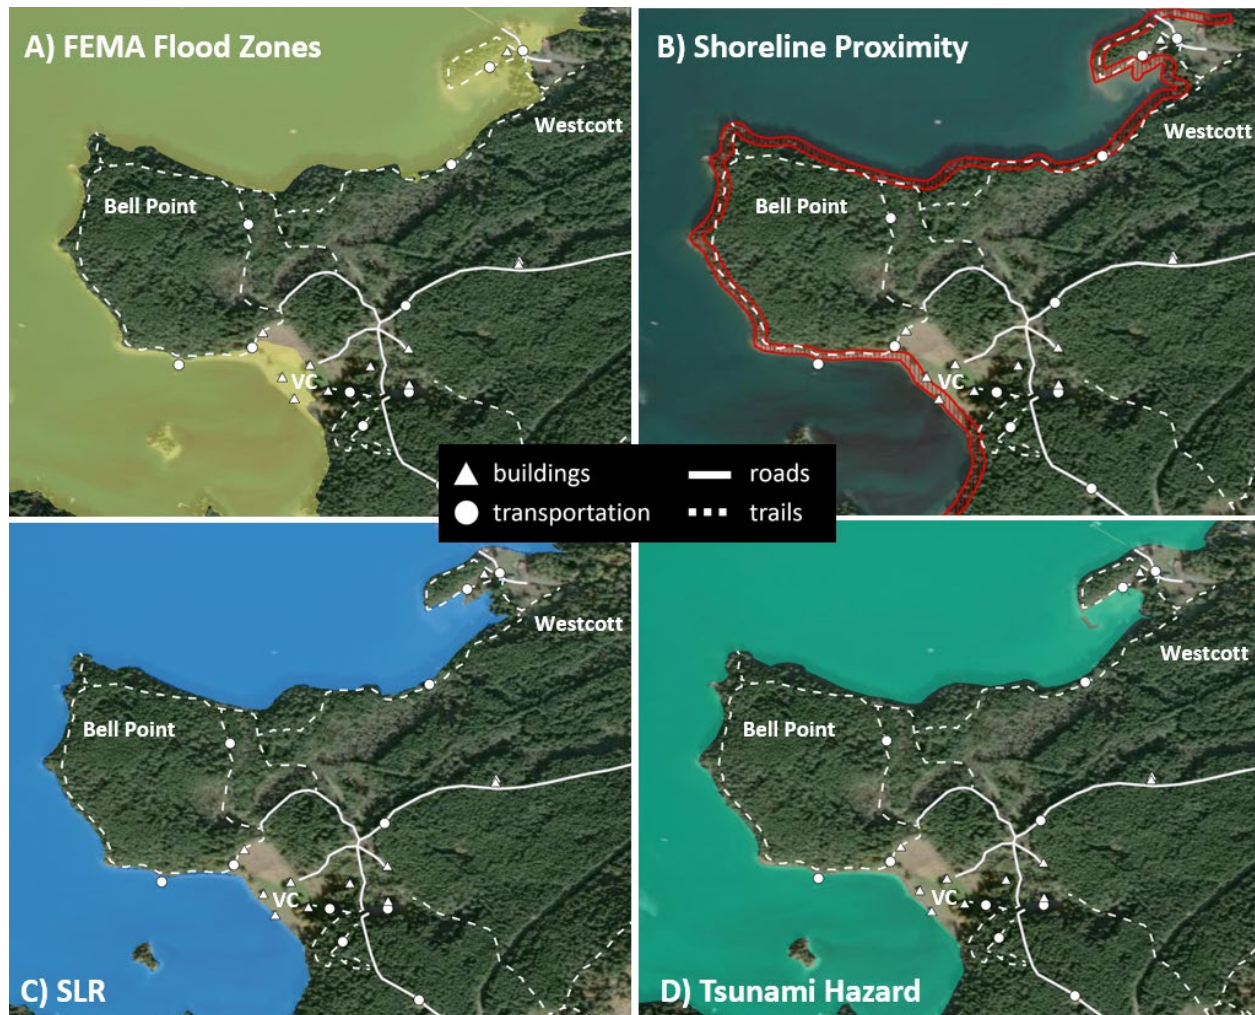
**Figure 1.** SAJH exposure hazard data in the English Camp: A) FEMA flood zones (AE zone shown as yellow shading), B) shoreline proximity (red striped), C) SLR (NOAA 1 ft shown as light blue shading and NPS 0.52 ft as dark blue), D) tsunami hazard (green shading). General areas in the English Camp are labeled. Background is 2021 ESRI world imagery.

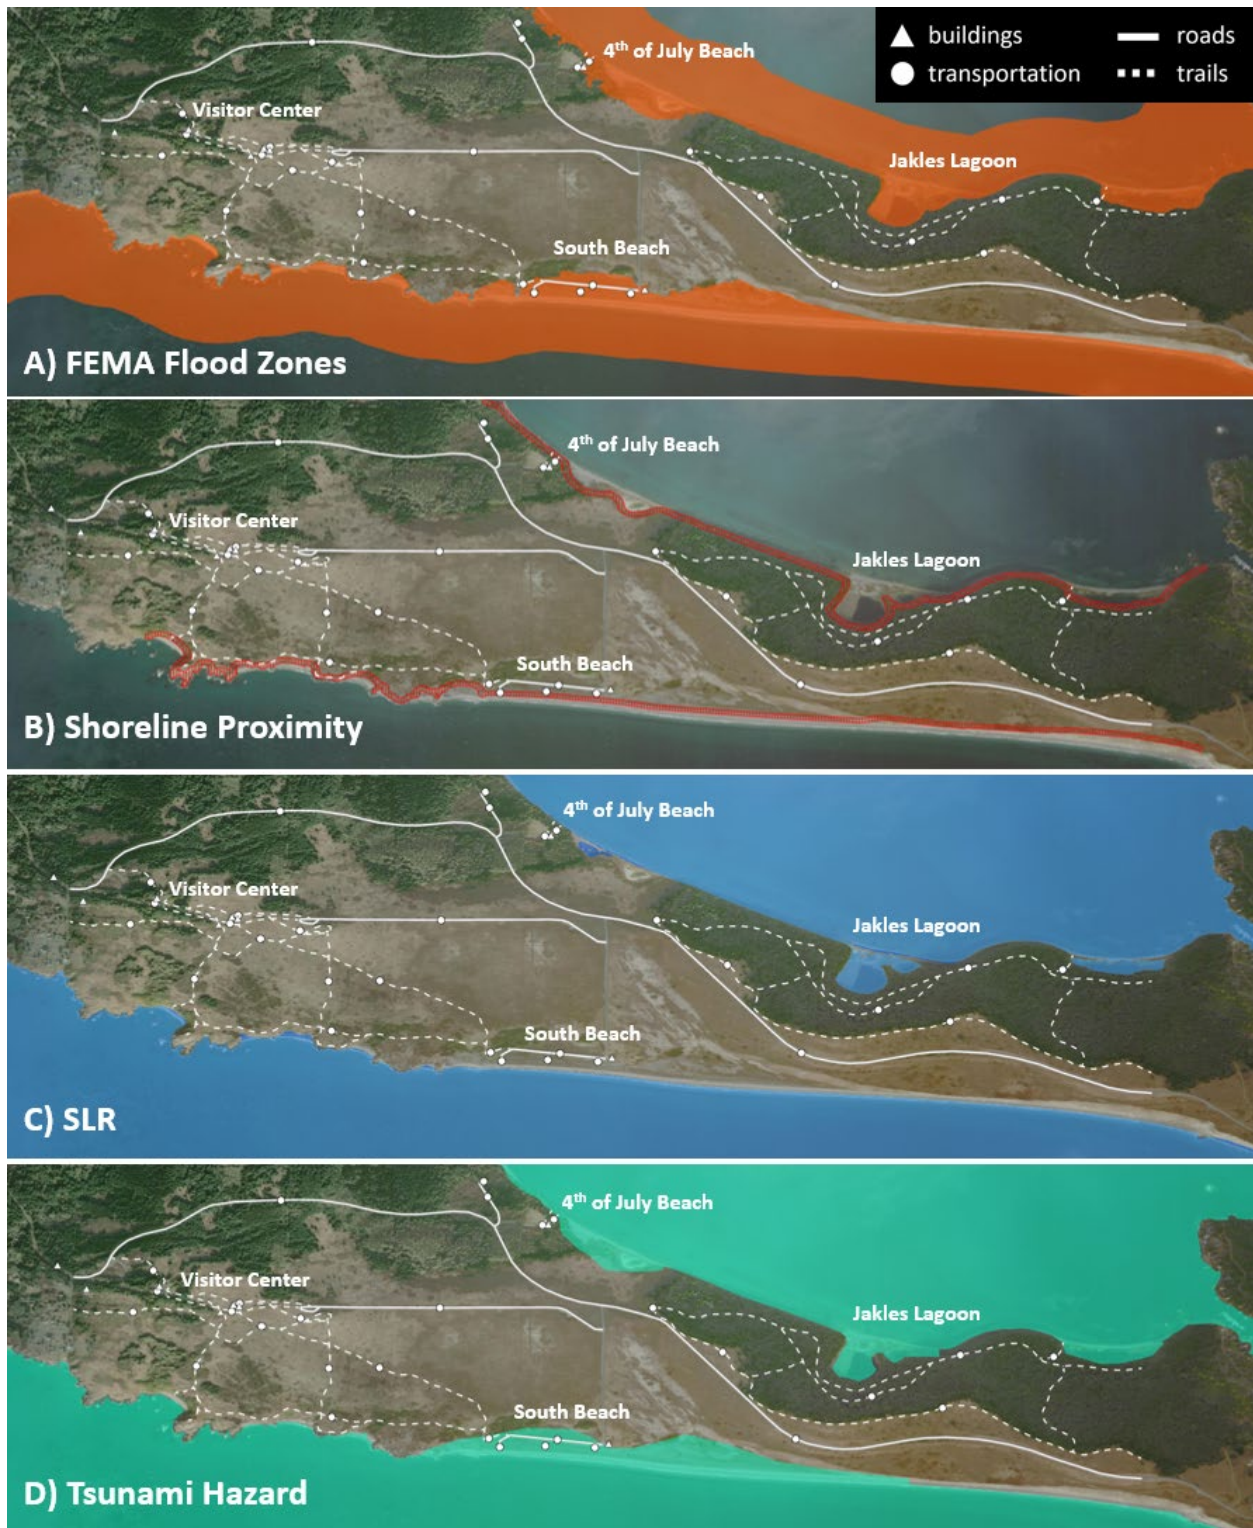
**Figure 2.** SAJH exposure hazard data in the American Camp: A) FEMA flood zones (VE zone shown as orange shading), B) shoreline proximity (red striped), C) SLR (NOAA 1 ft shown as light blue shading and NPS 0.52 ft as dark blue), D) tsunami hazard (green shading). General areas in the American Camp are labeled. Background is 2021 ESRI world imagery.

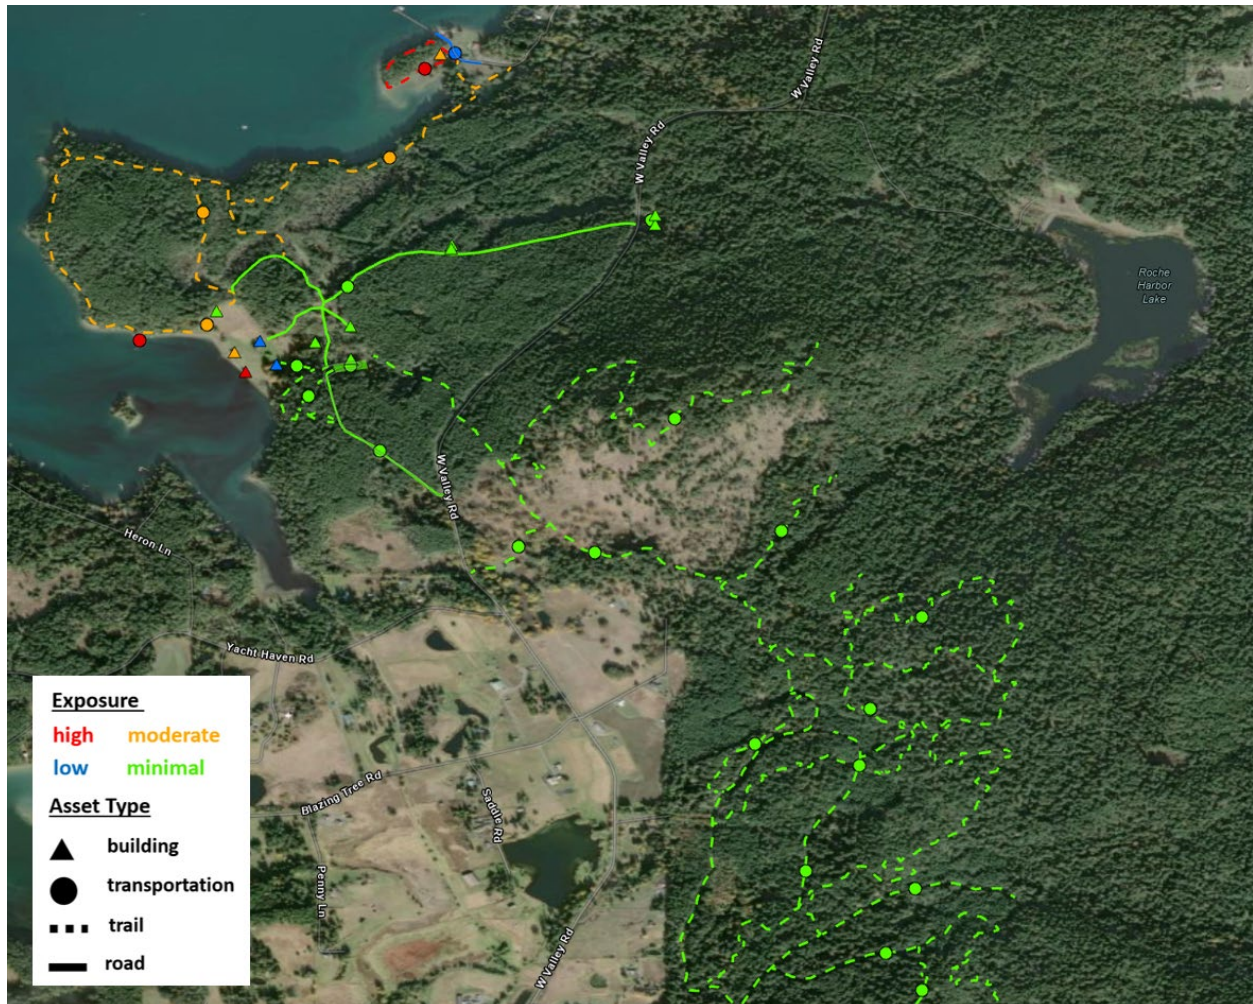
Twelve (16%) assets analyzed at SAJH have high exposure to the coastal hazards evaluated (Table 2). Transportation assets make up the majority of the high exposure assets across the park. Three assets are within all evaluated exposure zones: Blockhouse, EC Trails – Westcott Loop, and Dinghy Dock. Five assets (7%) evaluated at SAJH have moderate exposure and four (5%) have low exposure. Almost three-quarters (72%) of assets have minimal exposure, a result of the park’s higher elevation leading to lower exposure overall to coastal flooding and SLR (Figures 3-4).

**Figure 3.** SAJH exposure results for the English Camp. Background is 2024 ESRI world imagery.

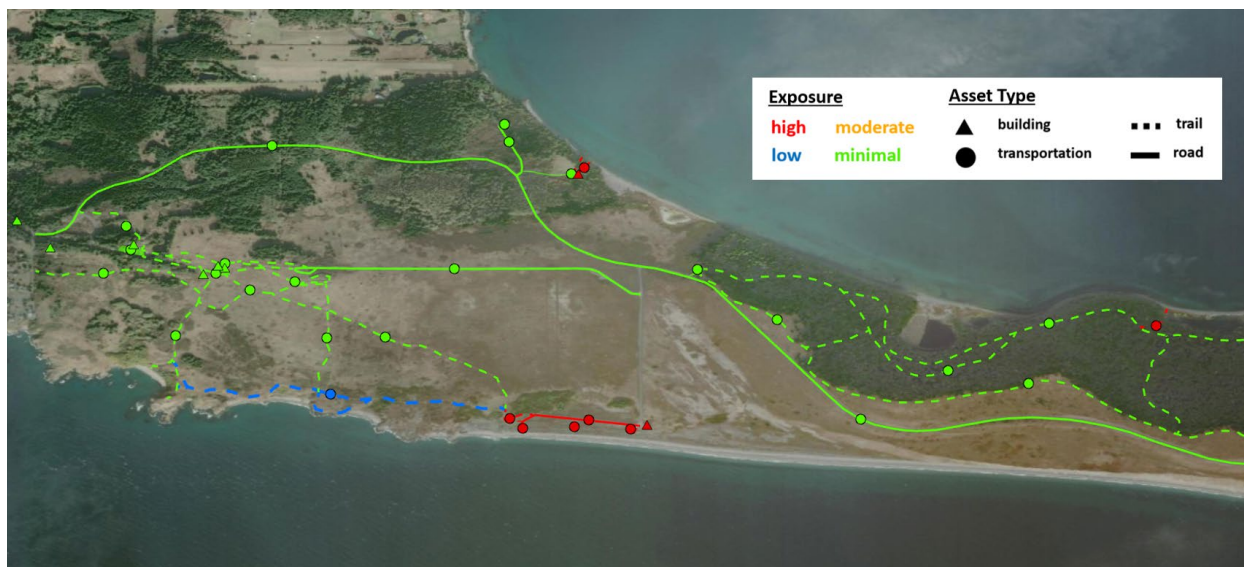
**Figure 4.** SAJH exposure results for the American Camp. Background is 2024 ESRI world imagery.

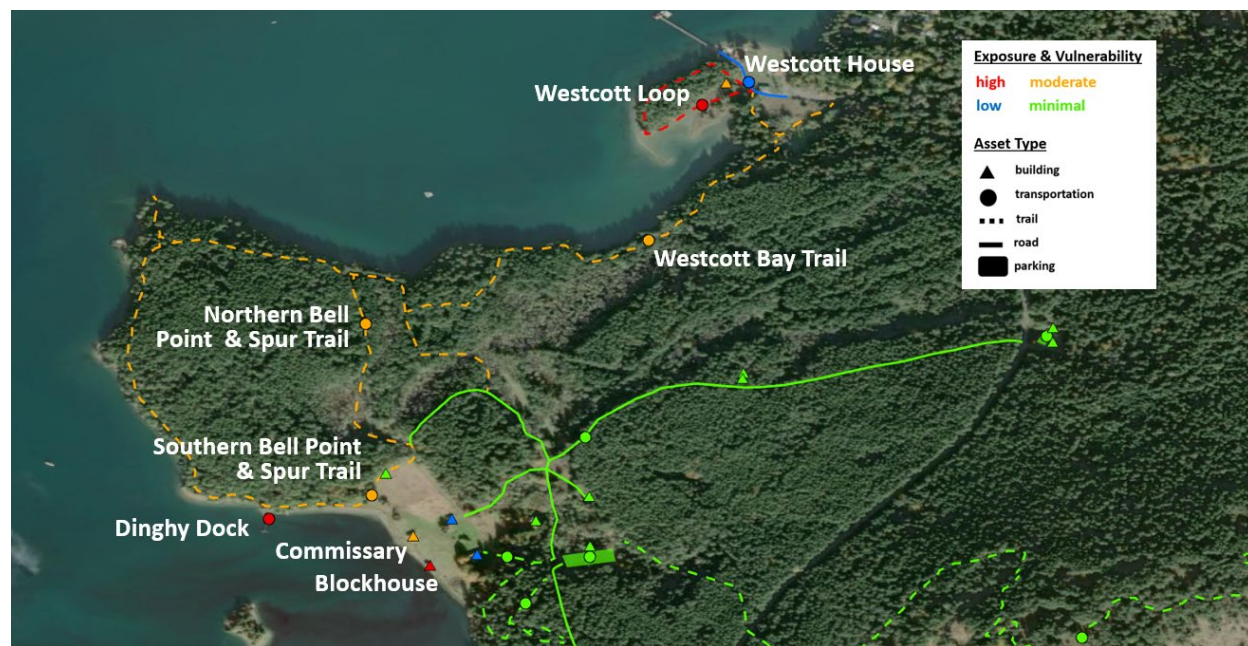
The vulnerability results at SAJH are identical to the exposure results, as the majority of assets evaluated for sensitivity were scored as moderate (Table 4, and Figures 5-6). This lack of variability in sensitivity means that the vulnerability of assets at SAJH is primarily controlled by exposure. The Blockhouse and EC Trails – Westcott Loop have both high exposure and high sensitivity (Figure 5). South Beach Parking and the Blockhouse have both high vulnerability and a high asset priority index (API  $\geq 70$ , as reported in FMSS).

**Figure 5.** SAJH exposure and vulnerability results for the English Camp. Only high or moderate assets are labeled. Background is 2024 ESRI world imagery.

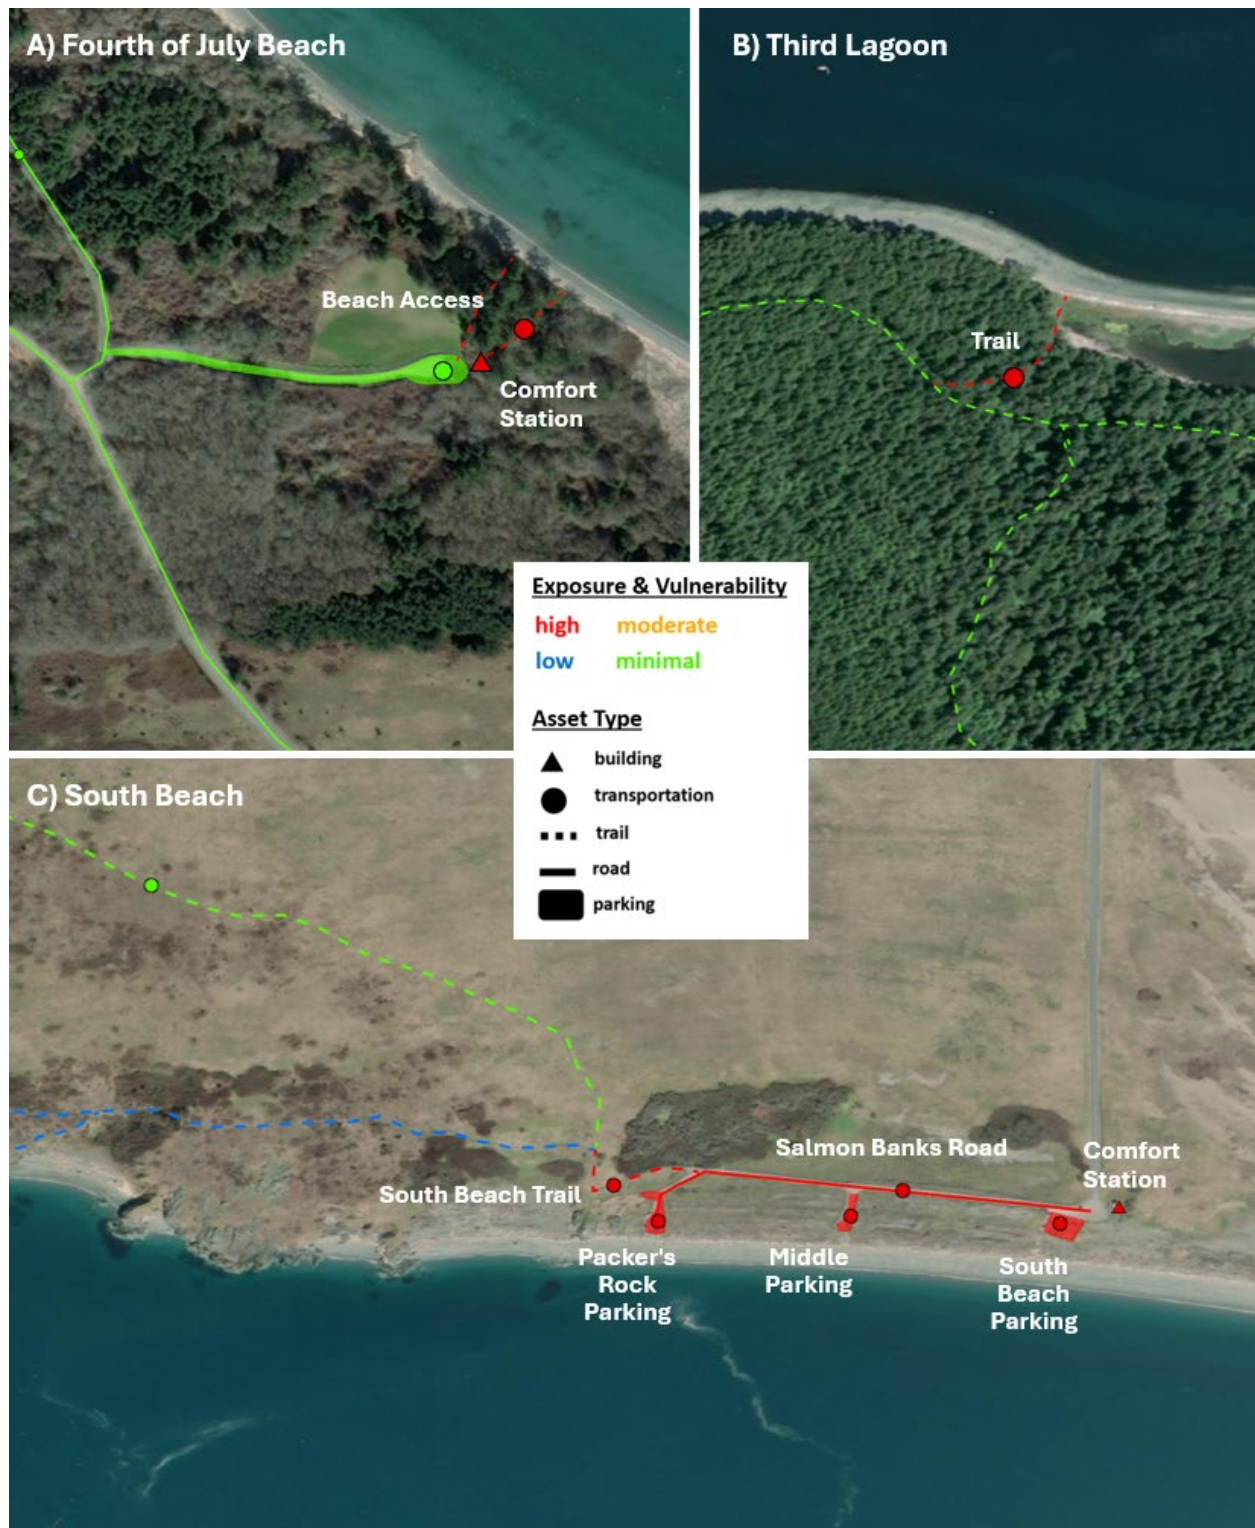
**Figure 6.** SAJH exposure and vulnerability results for the A) Fourth of July Beach, B) Third Lagoon, and C) South Beach areas of the American Camp. Only high assets are labeled. Background is 2024 ESRI world imagery.

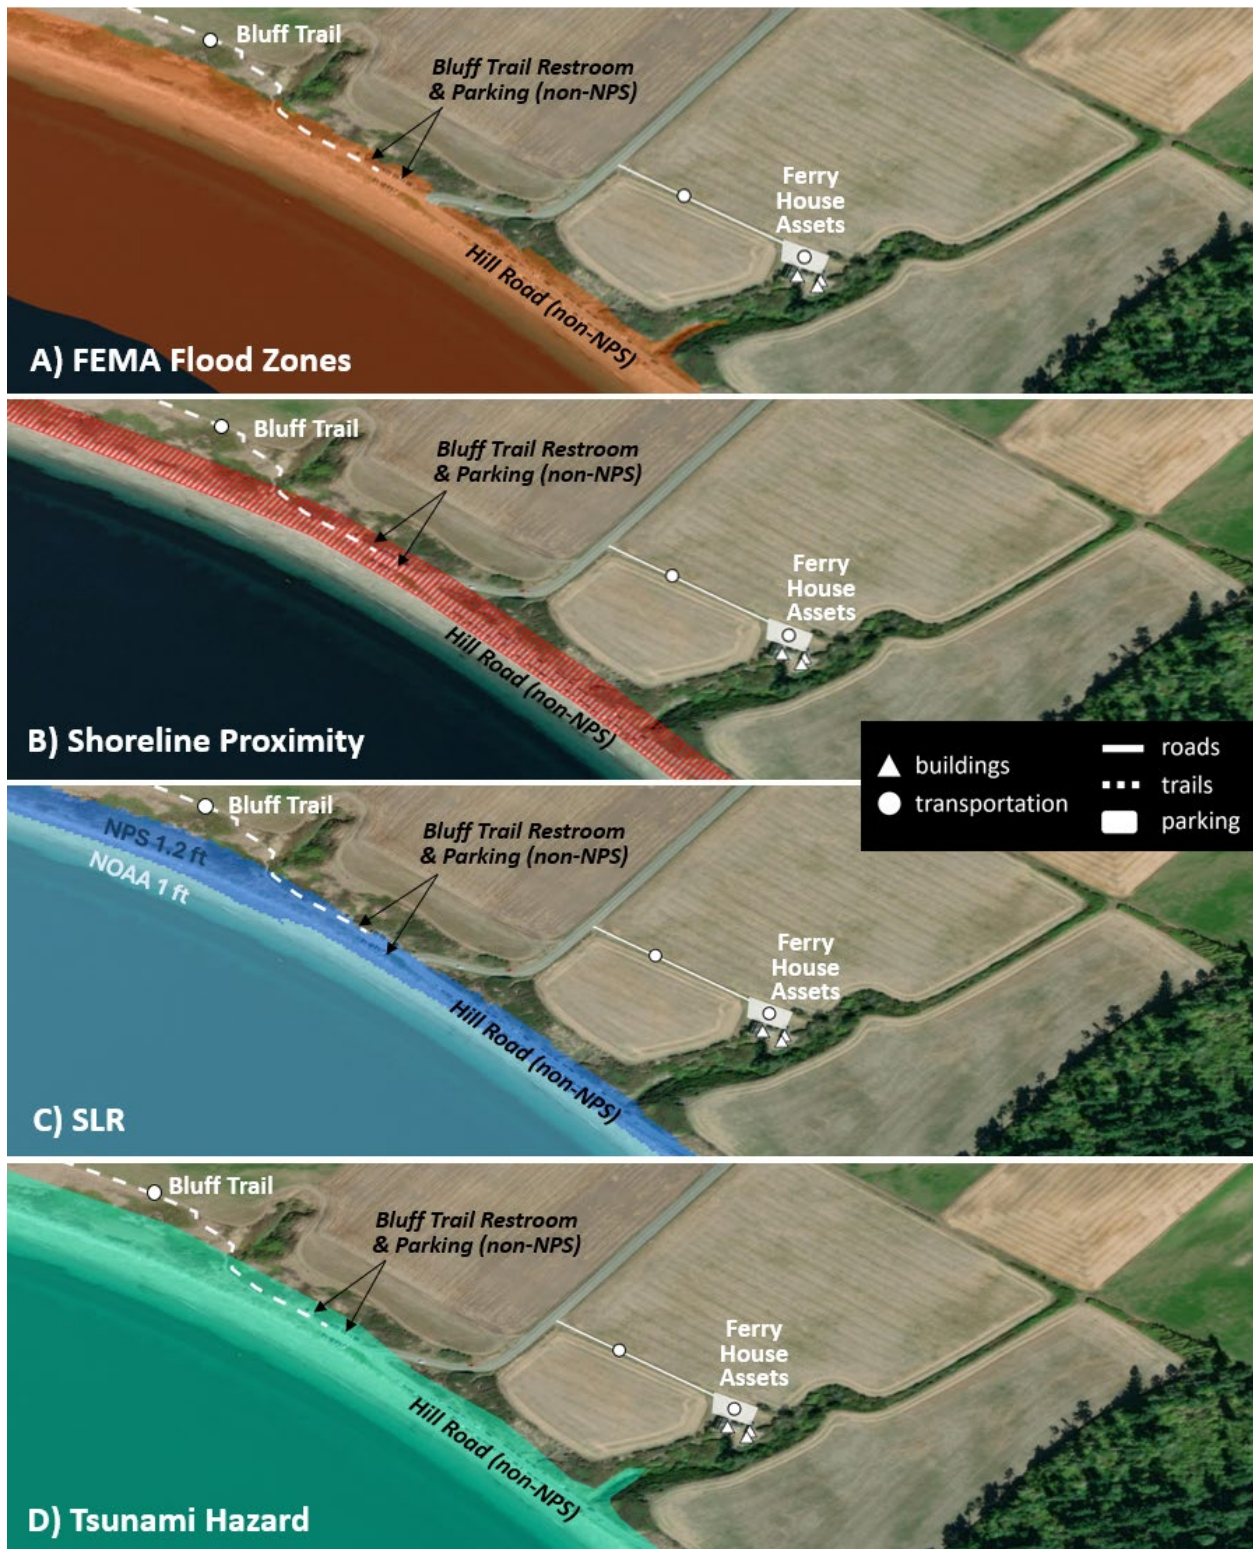
The Bluff Trail and Ferry House areas of EBLA are the closest to the island shoreline and evaluated coastal hazard zones. Although the assets in these areas have minimal vulnerability using this VA protocol, approximately 300 feet of the Bluff Trail (near the parking lot) is highly exposed to coastal hazards (in the FEMA VE, shoreline proximity, SLR, and tsunami zones; Figure 8). However, most of the trail (over 97% by length) is outside of all hazard zones. The Ferry House is another significant asset to EBLA, and sits only a few feet from a small creek, and approximately 500 feet from the island shoreline. While the evaluated coastal hazard zones do not extend to this building, there is the possibility of flooding from this creek during heavy precipitation events, which is not reflected in the available FEMA maps.

There are also several non-NPS assets in this area that are highly exposed to coastal hazards, including the Bluff Trail Parking Lot and Restroom, as well as portions of Hill Road (Figure 8). While these assets are not listed in FMSS or maintained by NPS, they provide access and/or support to numerous EBLA resources, and therefore their exposure should be considered in future planning efforts.

**Figure 8.** Exposure hazard data for the Bluff Trail and Ferry House areas of EBLA: A) FEMA flood zones (VE zone shown as orange shading), B) shoreline proximity (red striped), C) SLR (NOAA 1 ft shown as light blue shading and NPS 1.2 ft as dark blue), D) tsunami hazard (green shading). Background is 2021 ESRI world imagery.
