# President William Jefferson Clinton Birthplace Home

## Cultural Landscape Report

## **Cultural Landscape Report Environmental Assessment**

April 2014

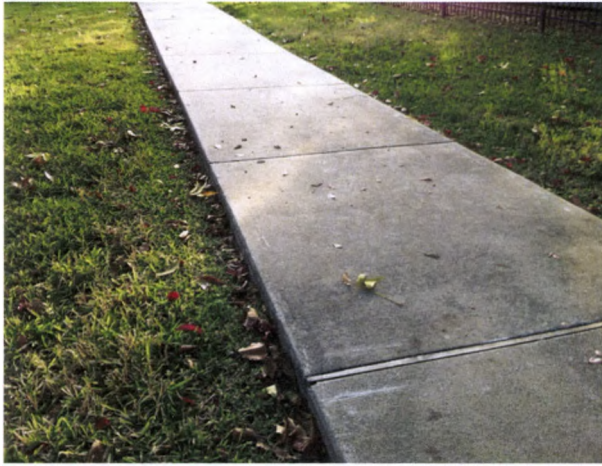
**FIGURE 69.** Looking east along the concrete walk running between the Cassidy House and the visitor center. Note the lowered lawn surface abutting the walk. Photograph by Oculus, October 16, 2012.

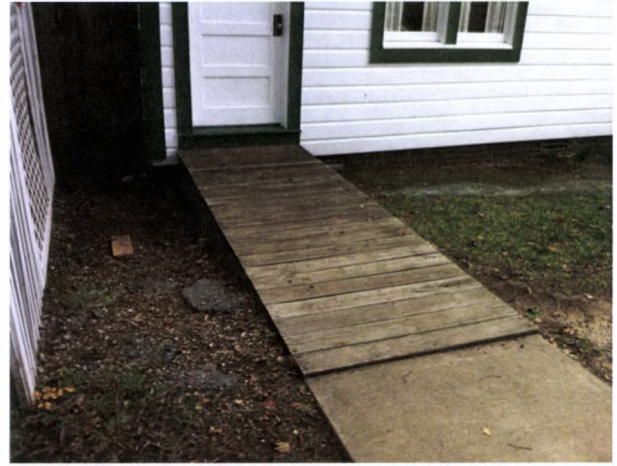
**Ramp to Side Door/Kitchen.** This ramp (Figure 71) is of 5/4-inch by 6-inch planks on a structure of 2x nominal lumber. It is approximately 12 to 14 inches in height at the point where it connects to the house. The ramp is four feet wide and 11 feet 6 inches in length. Height at its low end is one inch above the concrete walk. The door to which it leads is approximately 6 inches above the surface of the ramp. The ramp lacks a landing and handrails. It is nearly level. The condition of the ramp is good.

**FIGURE 71.** View south of the ramp to the side door, the gate to the rear utility yard, and one of two lattice screens. Note remnant asphalt. Photograph by Oculus, October 16, 2012.

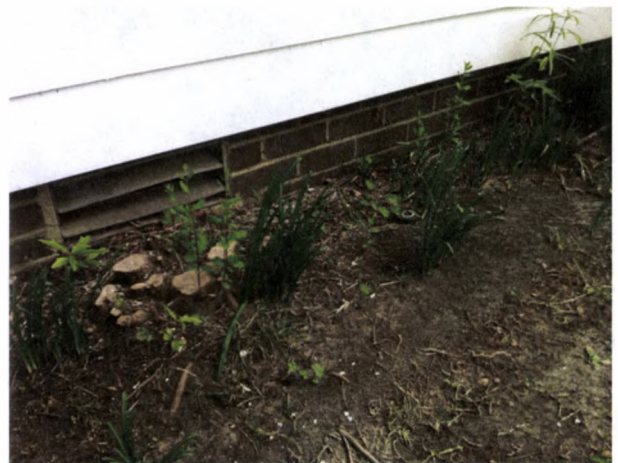
**FIGURE 79.** View southwest of perennials planted along the foundation at the north wall of the Cassidy House. Note the stump in front of the crawlspace vent. Photograph by Oculus, October 16, 2012.

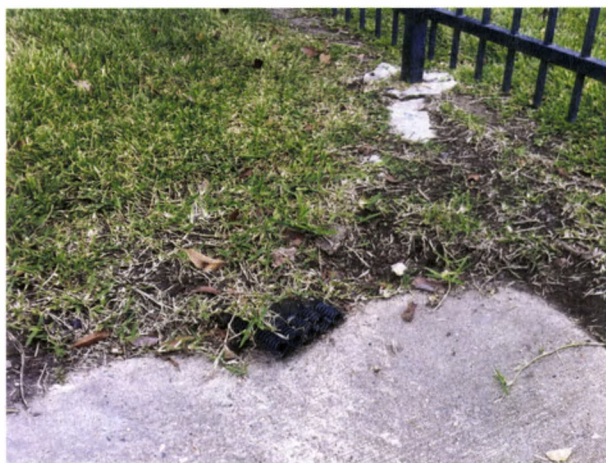
**FIGURE 97.** This exposed drainage piping is at the top of a concrete flume that drains to the sidewalk on South Hervey Street looking east. Photograph by Oculus, October 16, 2012.

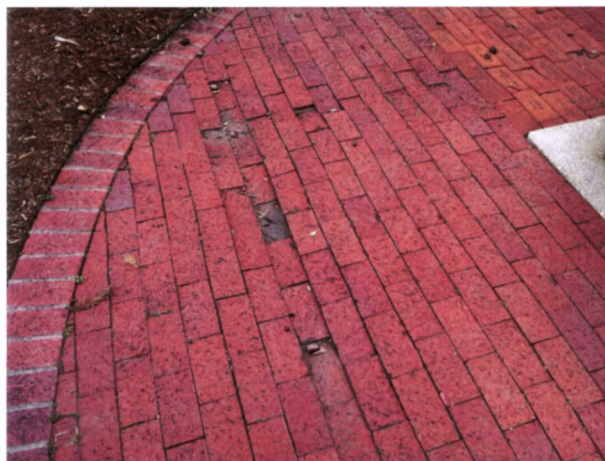
**FIGURE 124.** View toward the east of uneven brick at the north terrace. Photograph by Oculus, October 16, 2012.

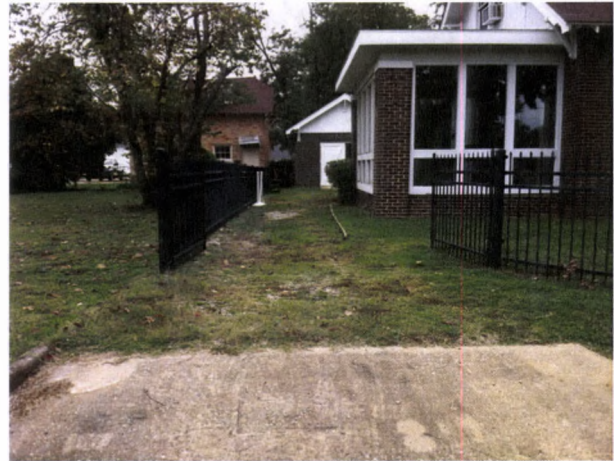
**FIGURE 172.** View south of the driveway leading south from West Division Street, running alongside the visitor center. Note the uneven grass-covered pedestrian access route to the accessible entrance of the visitor center. Photograph by Oculus, October 16, 2012.

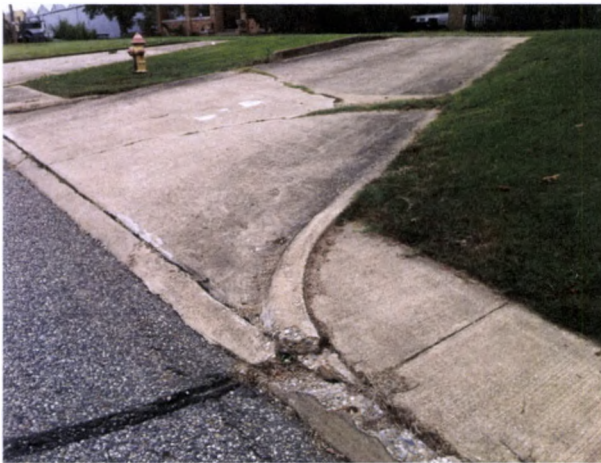
**FIGURE 175.** Looking northeast at a detail of the concrete apron connecting West Division Street and the visitor center driveway. Note the deterioration of concrete. Photograph by Oculus, October 16, 2012.

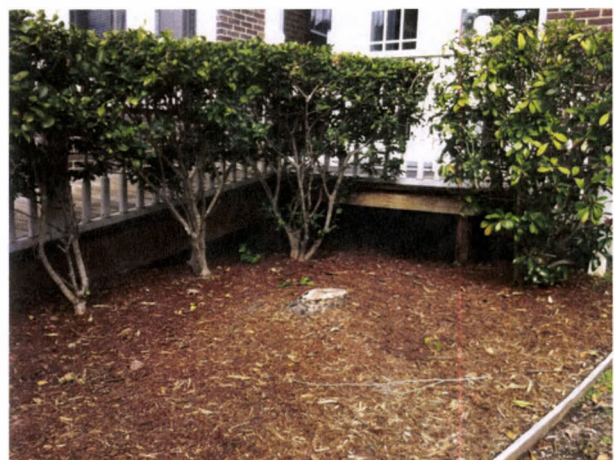
**FIGURE 185.** View northwest showing the planting bed at the rear deck of the visitor center building. Note the tree stump at the center. Photograph by Oculus, October 16, 2012.
