CRM

VOLUME 15 • NO. 6
1 9 9 2

Cultural Resources Management
Information for
Parks, Federal Agencies,
Indian Tribes, States,
Local Governments and the
Private Sector

Workshop in Historic Structures

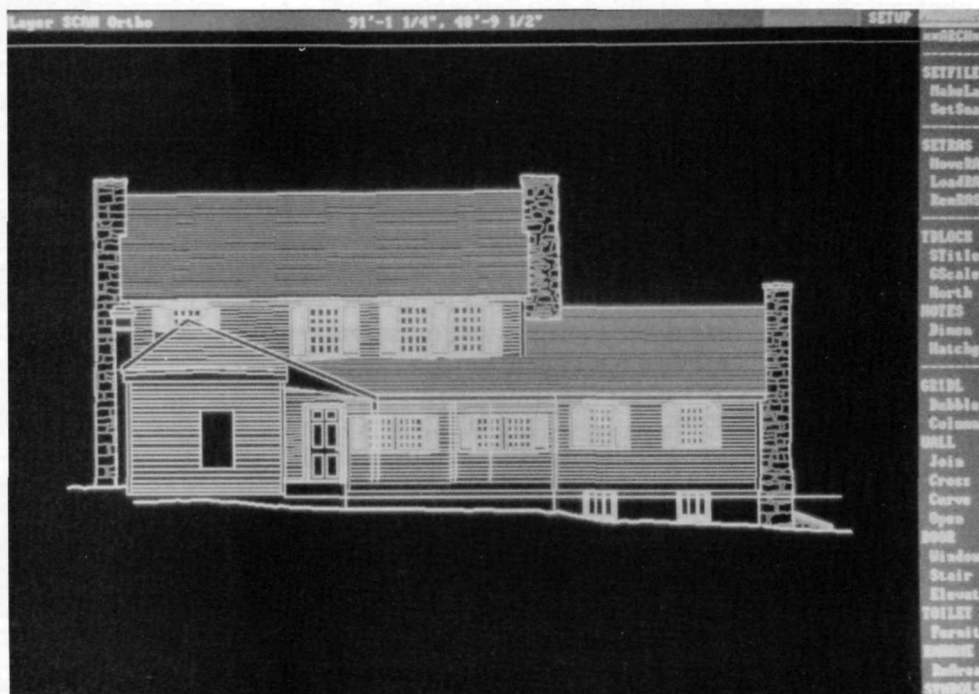
After the new lines are added to the drawing with aid of the scanned photo and AutoCAD, the north elevation of White Haven gives the appearance of the home before the 1940 demolition of the addition.

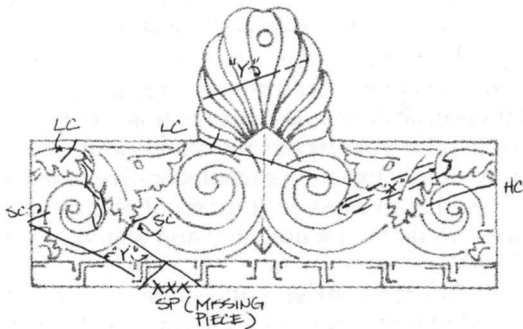
* STONE IS IN BAD SHAPE - LOTS OF CRACKS

* CRACKS ARE PACKED WITH DIRT #

* POSSIBLE FRACTURE - TIP "SHELL" SEEMS READY TO DETACH & FALL! - WATCH

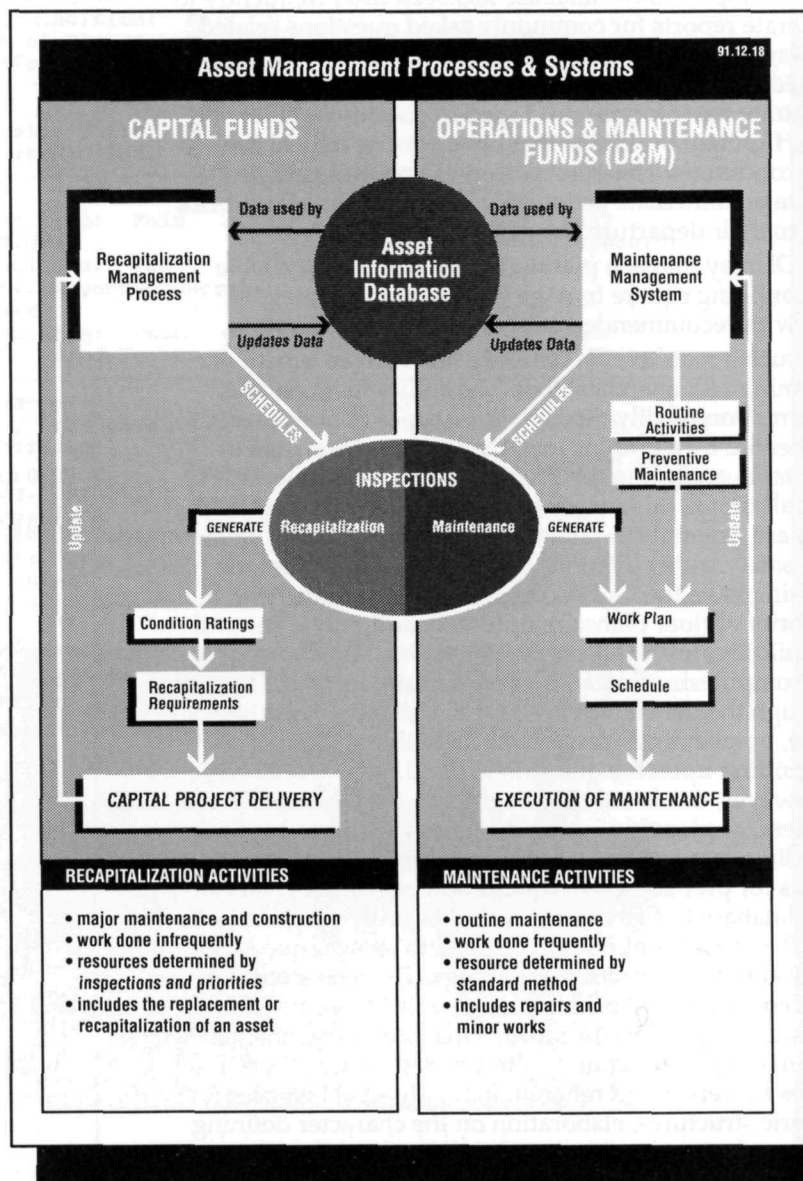
Figure 1.

Asset Management Process				
Recapitalization Management Process				
Asset Condition Rating				
Ratings	Criteria			
	Health & Safety	Risk to Asset	Level of Service	Urgency
Good	Normal Risk	Normal O&M Procedures	Normal Operation	6 Years +
Fair	Slight Increase in Risk	Minor Deterioration	Reduced Operation	3-5 Years
Poor	Significant Risk	Significant Deterioration	Restricted Operation	1-2 Years
Closure	High Risk	Major Deterioration	Non-Operational	Immediate Action Req'd

In concert with rating the condition of the asset, the inspector is asked to forecast the amount and timing (year) of capital funds needed for remedial action required due to the condition of the asset. Using these primary pieces of information, CPS can more accurately prioritize and plan for its capital requirements at all levels of the organization. The field level can identify what funds are required for specific action, regional offices can use site reports to prepare regional roll-ups to aid in the allocation process, and headquarters can use national reports to justify programwide resource requirements. It must be emphasized that many factors are taken into account prior to making capital asset investment decisions. RMP addresses one of the factors by providing a valuable tool which concisely and consistently indicates condition and technical requirements.

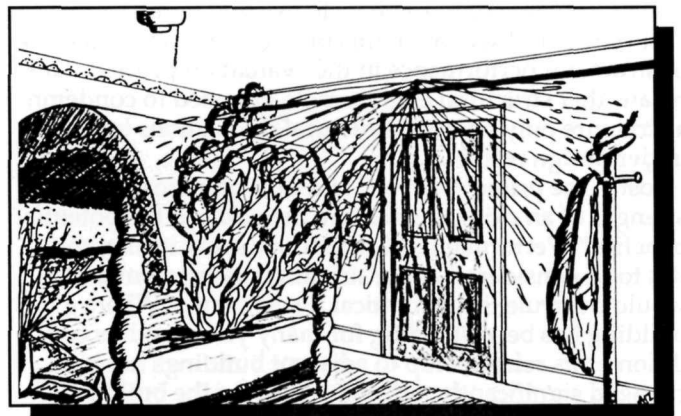
Guest room protection using sidewall residential sprinkler supplied by plastic pipe concealed in a boxed-in cornice. Maramede Inn, Middletown, MD.

Excerpt from Table 1, Safety Parameter 5, Automatic Sprinklers, showing the points granted for partial to total sprinkler installations.

The scoring is done on worksheets which define 11 safety parameters. These parameters measure the extent to which various building features contribute to the protection of life and property. They range from construction and finish, through exit arrangements and distances to

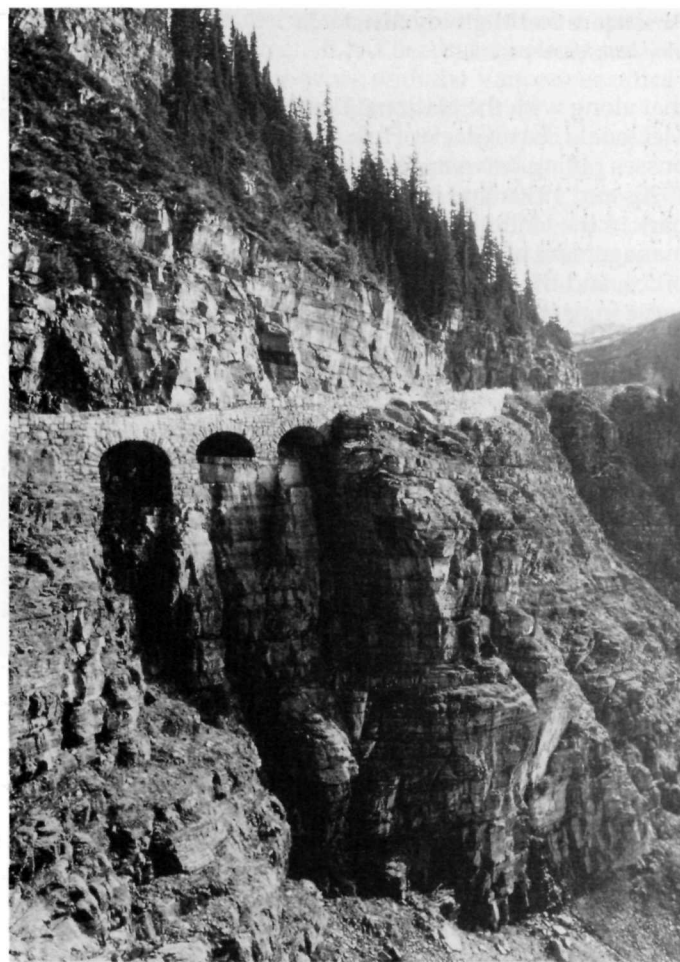
Triple Arches.

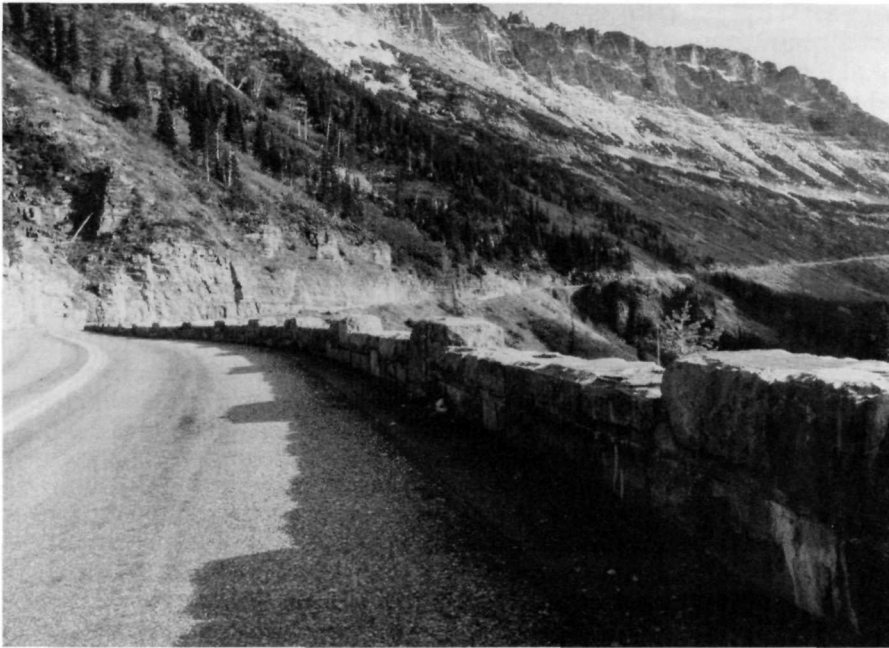
Typical masonry guardwall.

Second, Federal Highways agreed to determine through computer modeling the height of a new concrete reinforced guardwall that will be acceptable in resisting impact and breaching. If that modeling suggests that a lower height is acceptable, that type of reinforced wall will be crash tested. For both conditions the issues are

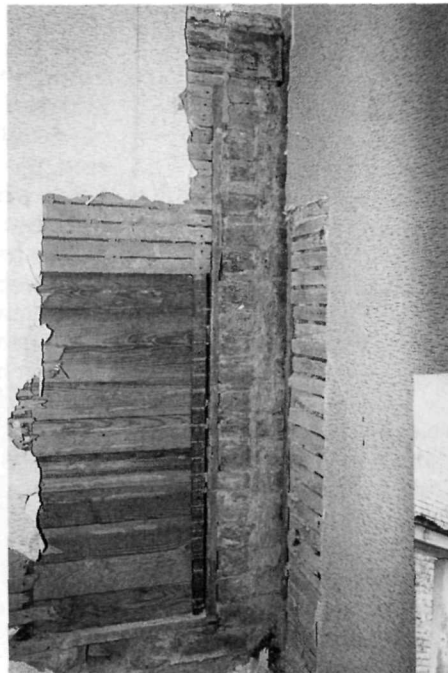
Mumma Farm House, Antietam National Battlefield, MD. The braced frame of the structure was discovered while siding repairs were underway. Drawings and photographs were made to document the framing system before the siding was replaced.

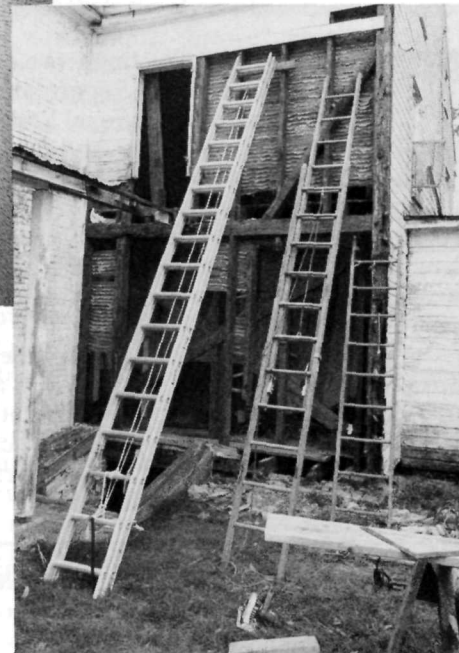
Mumma Farm House, Antietam National Battlefield, MD. A former window location was discovered during the removal of interior plaster. This feature should be recorded prior to the replastering of the wall surface. Photos by Thomas Vitanza, Williamsport Preservation Training Center, National Park Service, 1992.

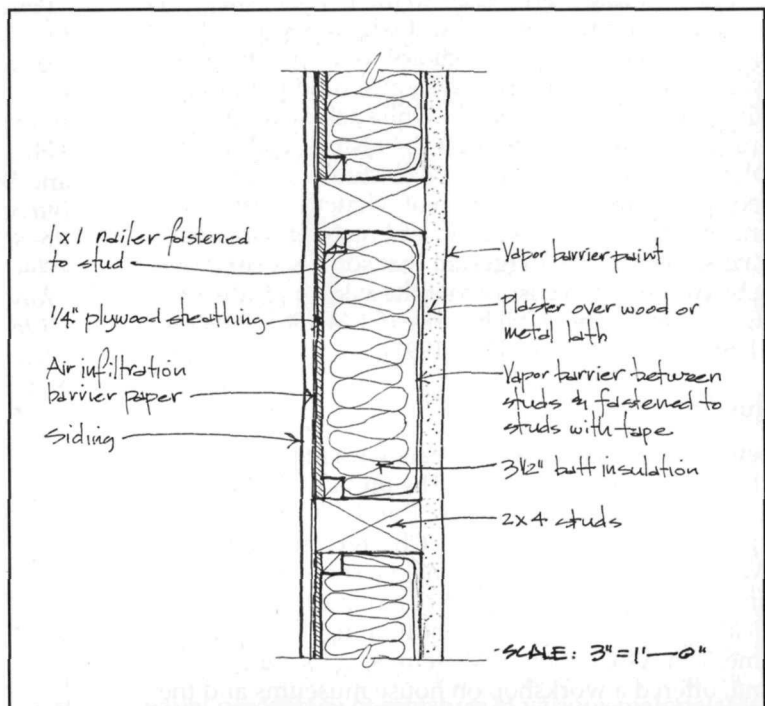
Figure 1. Typical perimeter wall plan section of the Lincoln Home after 1988 restoration work. Note that the vapor barrier is discontinuous at the studs. Field note drawing by the author.

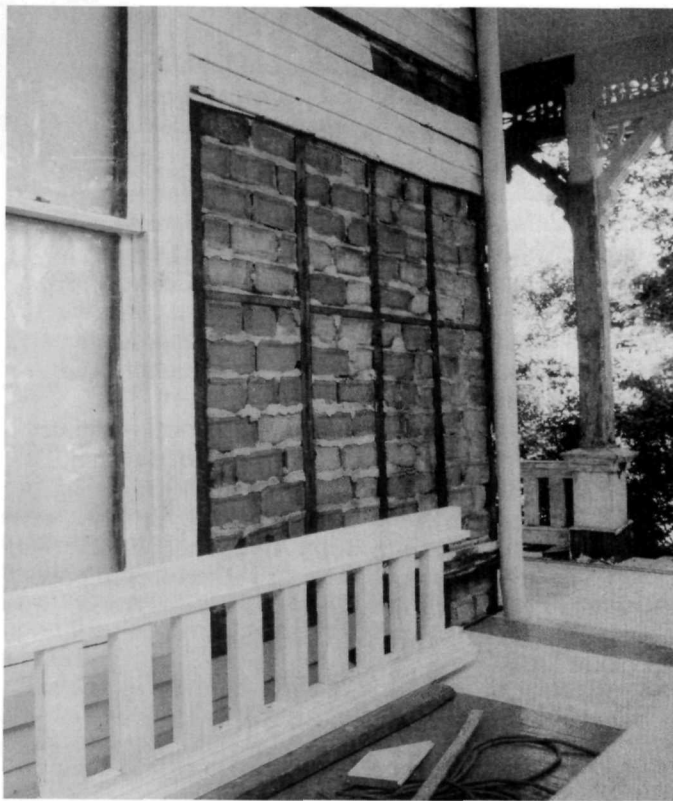
Figure 2. Cavity wall brick infill or "nogging" on the Truman home. This unique element would be sacrificed if insulation were to be installed. Photo by the author.

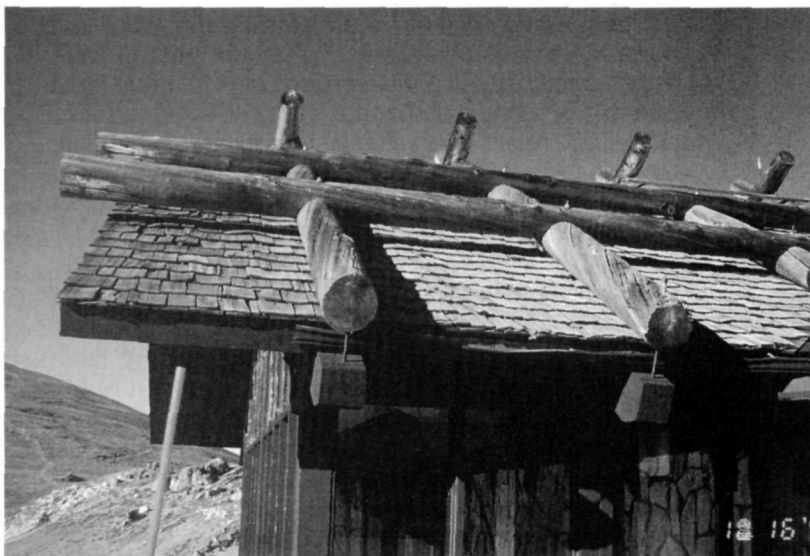
Figure 1 The log snow guards on the Rocky Mountain National Park visitors' center allow snow to accumulate without introducing further stresses to the roof system.

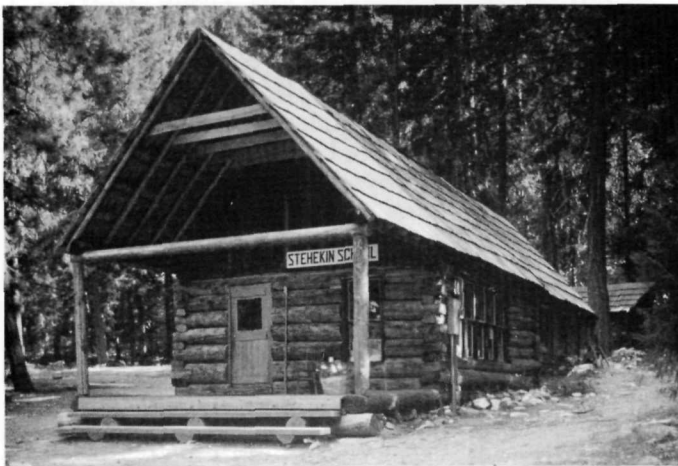
Figure 2 In the North Cascades, a distinct style of cabin has evolved that allows both light and people to enter a snow bound building.

With snow periodically and unpredictably breaking loose and falling from the building roof and walls, pedestrians entering and leaving the facility may be in some peril. Standard gutters, snow-guards, and diverters that offer effective protection on the low-sloped roofs of the dry snow regions are unable to withstand the force of the heavy wet snow accumulation on the steeper roofs; furthermore, these details can also contribute to unwelcome ice damming problems during the spring thaw. In deep-snow areas, moving the building entrances to the gable ends is an adaptation that addresses these hazards. Icicle formation and snow corning are two additional problems that are commonly encountered. Where 24-hour period snowfalls are high or drifting snows are the norm, outward-opening doors are impractical, even on public buildings (figure 2).

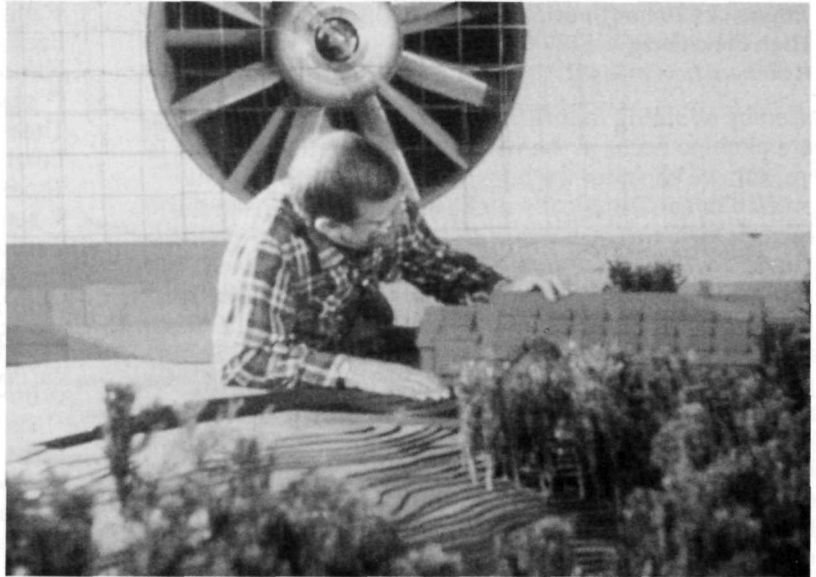
Figure 3. Wind tunnel testing can be useful in predicting the behavior of snow around a building.

Actively melting snow from the roof is a strategy that has been attempted on some contemporary structures. Such solutions are a conscious attempt to improve on the melting that is frequently observed on uninsulated older structures that have some heat during the colder months. For such systems to be practical and effective in areas of extremely high snow accumulation, snow build-up on the roof cannot be allowed. Extremely high calorie inputs are required to melt the denser snow and ice at the bottom of a typical snow pack and in these situations, the lag in melting the accumulation from the roof could leave it overloaded after an unanticipated blizzard. Another complication is that if the roof surface is not heated perfectly evenly, the denser ice at the bottom of the stack will bridge over the heated spot, creating an air gap and greatly increasing the time required to reduce the snow load on the roof structure. In areas of high

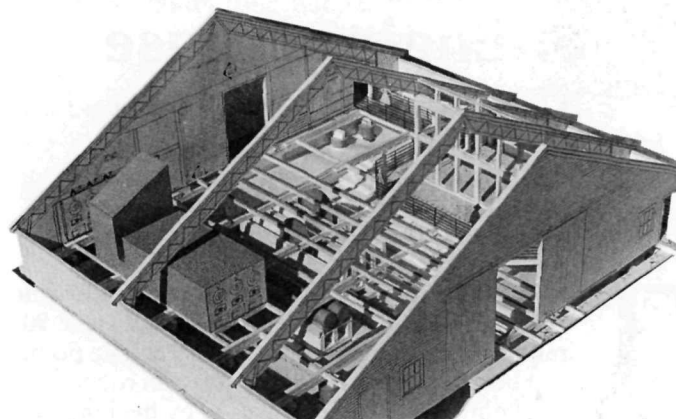
As the design progressed, a scale model of the entire shelter was necessary to help clarify the sheer complexity of the project. Once the shelter model was complete, a replica of the steam engine exhibit was placed inside so its impact could be better evaluated. This three-dimensional representation proved essential in communicating

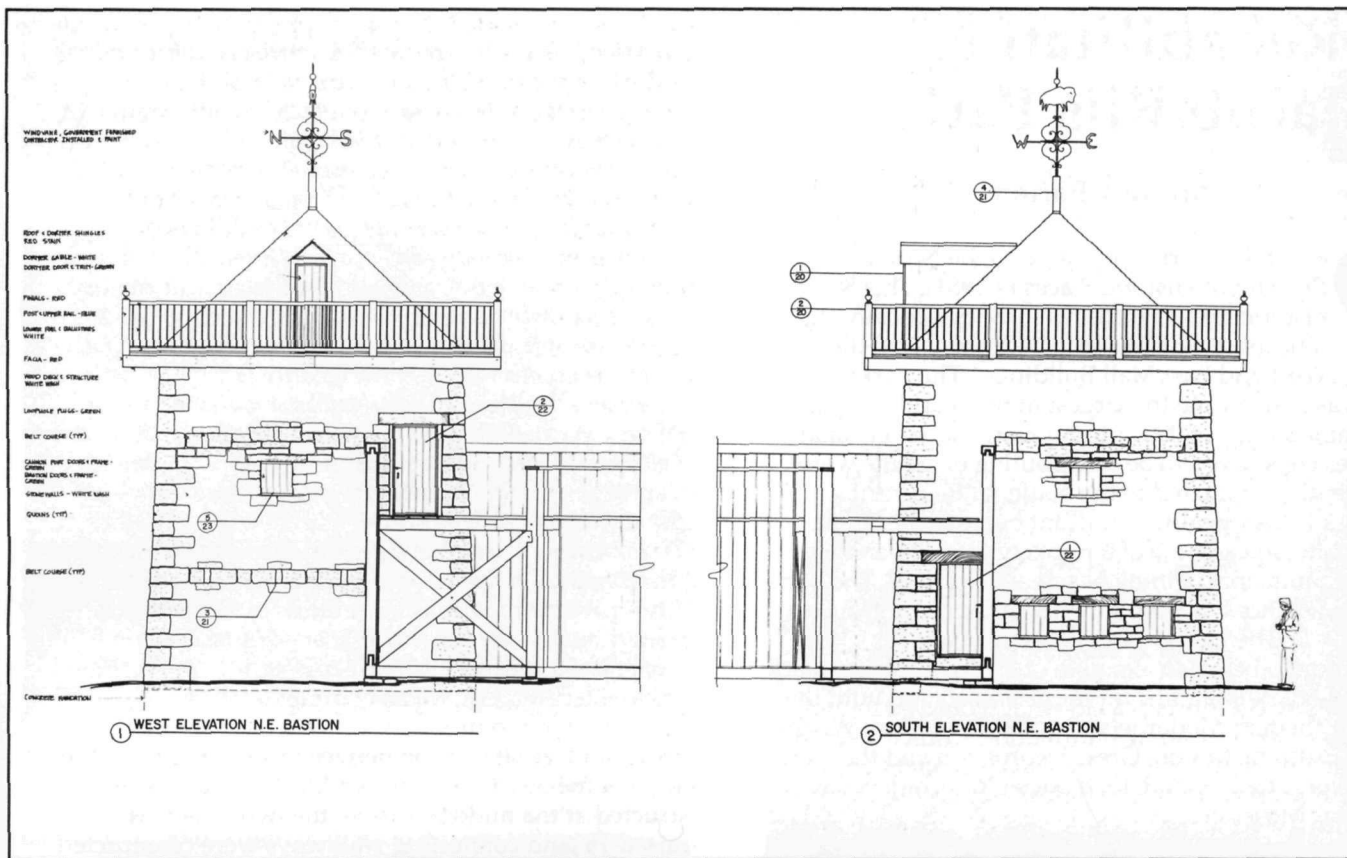
Northeast Bastion, west and south elevations. Drawing by Richard Cronenberger, Rocky Mountain Region, National Park Service.

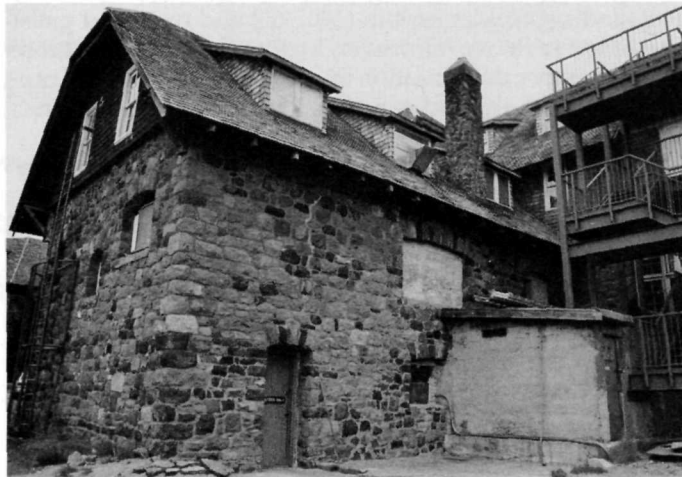
Crater Lake Lodge, kitchen wing.

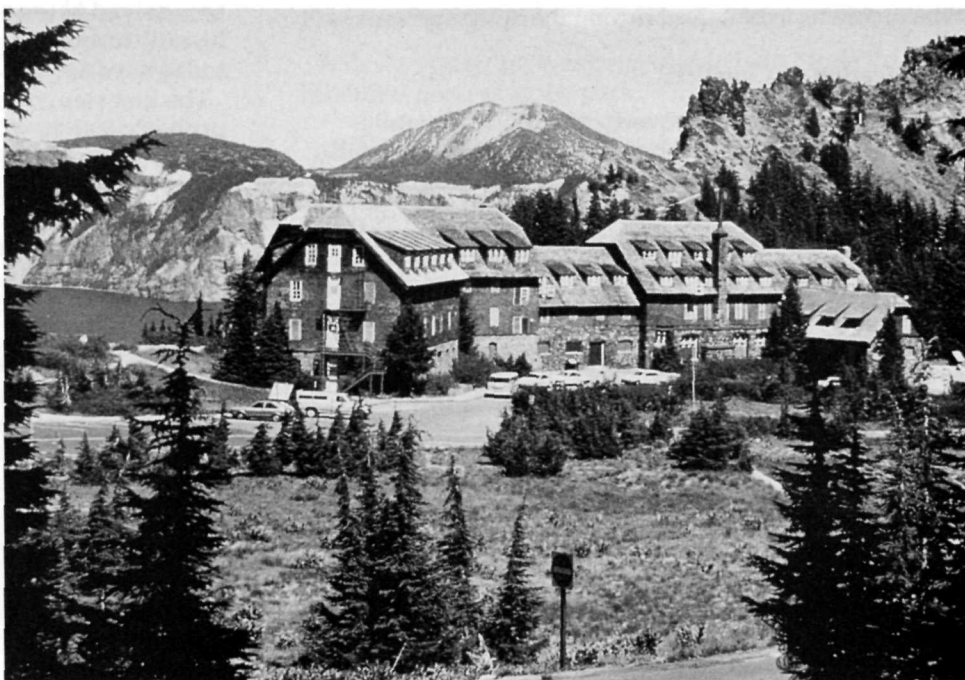
Crater Lake Lodge, built beginning in 1909, seen from the southwest in 1990.

Original construction simply underestimated the design snow loads—which can amount to 350 pounds per square foot (up to 60' of snow can be encountered per season)—and used techniques and materials common at much lower elevations. Weather conditions at the altitude of the lodge are brutal. The lime based mortar employed 80 years ago did not stand up well and had become friable and was falling out of the walls. The double hung sash could not keep out blowing snow. Floors sagged. Gaps had grown to nearly 3" between partition walls at upper floors where they intersected deformed exterior walls. Some rafters, and dormer headers, were cracked and, even with subsequent shoring, were bowed under snow loads.

The great hall wing, at the center of the older portion of the building had to be entirely rebuilt. Structurally, it was most deteriorated being held together by 1950s cables and shoring. It was also very crucial to the lateral stability of adjacent wings. A full basement was constructed before the wing was rebuilt to provide a connection between the dining wing and annex basements. The wing was originally under designed. Therefore, 24" steel beams replaced 14" wooden first floor beams, 18" steel replaced 10" second floor joists, and 7 x 9 glulams replaced 2 x 6 rafters. In addition, the stone walls of the lower floor became stone veneered cast-in-place reinforced concrete walls. The external appearance, however, duplicated the original great hall wing.

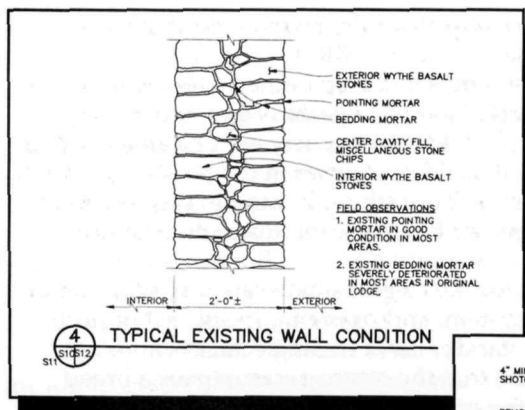
The lobby wing also had only a crawl space. Installing a basement under it required shoring the entire wing to excavate and pour new concrete walls. This was partially facilitated while the adjacent Great Hall wing was removed and its basement built concurrently. The new basements and the deepening of existing basements to create additional head room provided space for service and utility equipment and plumbing and mechanical runs where none had existed.

Two techniques were employed for stabilizing un-reinforced stone masonry walls of the lodge (see details). The stone appearance was sacrificed where the interior would not be seen by visitors. A 4" reinforced application of shotcrete anchored to the interior side of the repointed stone wall provided the necessary reinforcement. Where both interior and the exterior stone surfaces of walls would be seen, the exterior was thoroughly repointed, then the inner wythe was dismantled. A reinforced shotcrete core was built and the inner wythe, after stone trimming, was then relayed. All 700 perimeter feet of the building's stone walls were underpinned with a 5' spread footing, after initial masonry stabilization. This was done in nominal 6' increments involving excavation, compacting soils, forming and pouring reinforced concrete, waterproofing, and backfilling. Throughout the building undersized floor members were replaced with larger ones or 'sisters' installed to enhance the strength of the floor diaphragms.

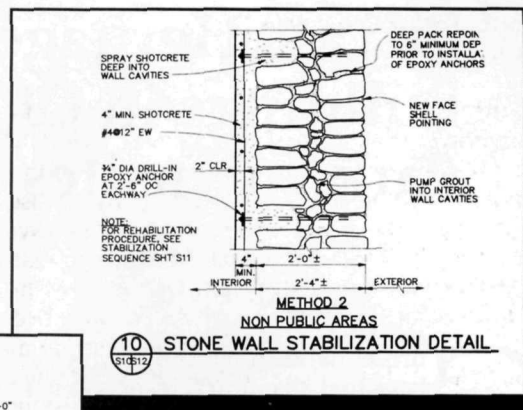
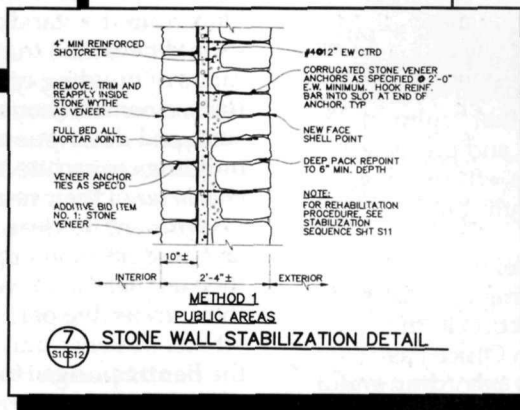
Technical details showing two methods for stabilizing unreinforced stone masonry bearing walls.

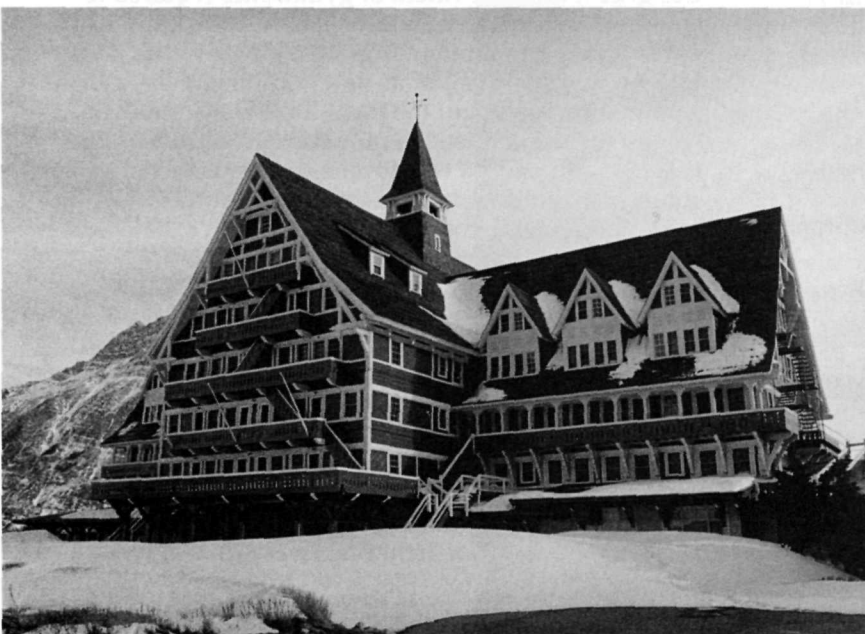
The Prince of Wales Hotel, built in 1926 as part of the Great Northern Railroad's chain of resort hotels. Photo: E. Mills

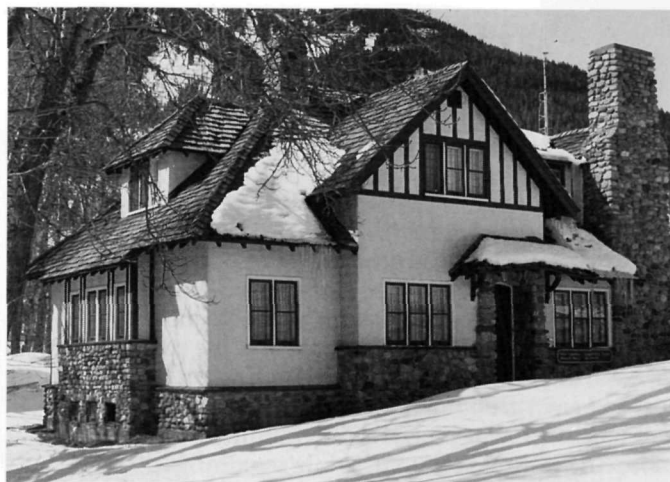
The Royal Canadian Mounted Police headquarters in Waterton Lakes, designed by chief national park architect W.D. Cromarty and built in 1927-28. This was one of several public buildings that anchored the "Tudor Rustic" architectural theme in the townsite.

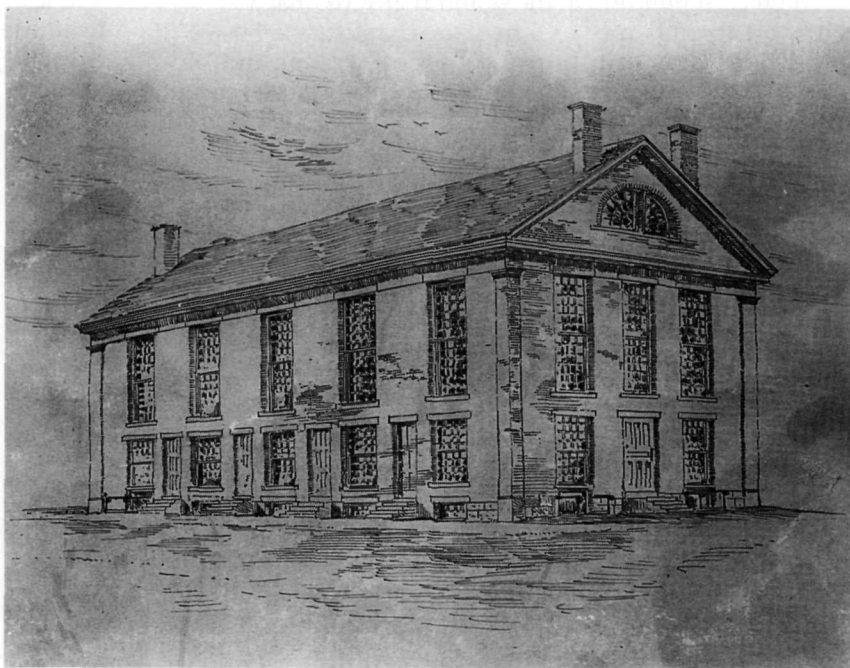
Figure 1. Conjecture drawing (1894) of the original Town House as constructed in 1830. Drawing by F.W. Stickney, architect.

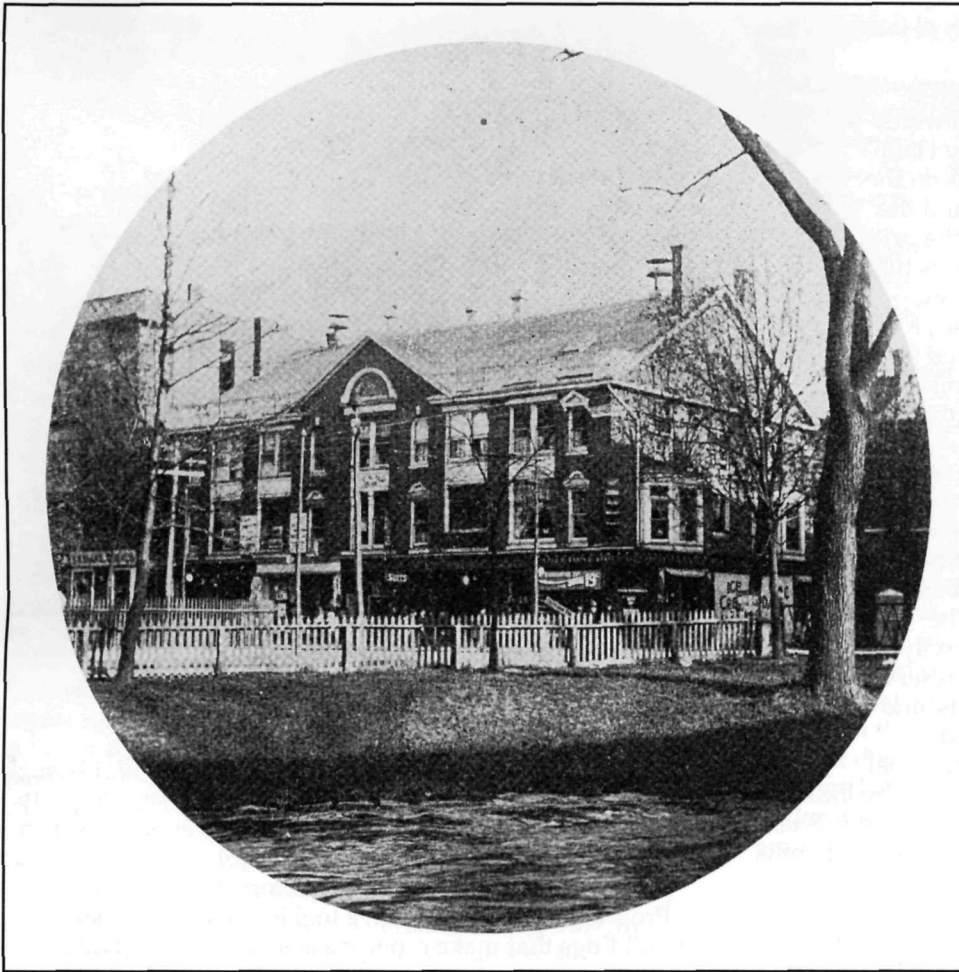
Figure 2. Ca. 1896-1900 photo showing the Old City Hall after the 1896 remodeling.

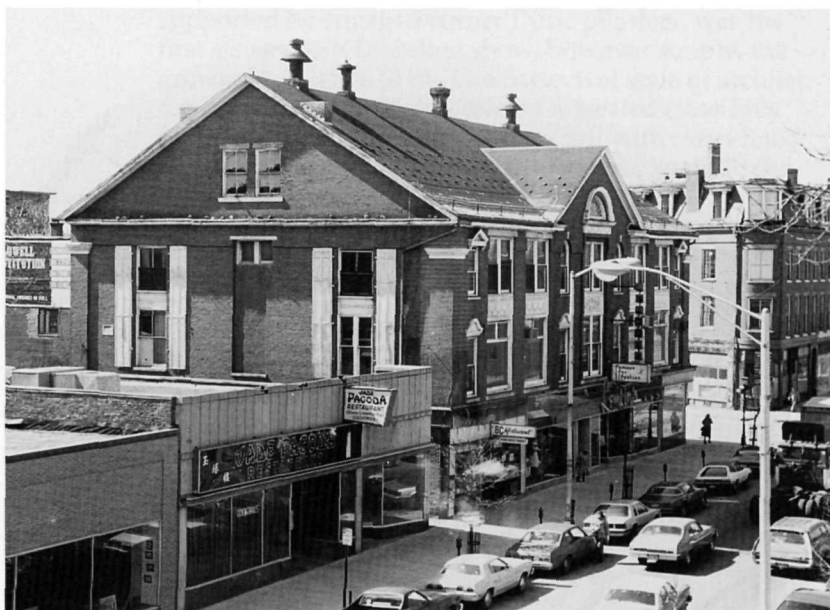
Figure 3. Old City Hall prior to rehabilitation. Photo by Harlan D. Unrau, National Park Service, 1979.
