Cultural Resource Protection and Emergency Preparedness

Information for parks, federal agencies, Indian tribes, states, local governments, and the private sector that promotes and maintains high standards for preserving and managing cultural resources

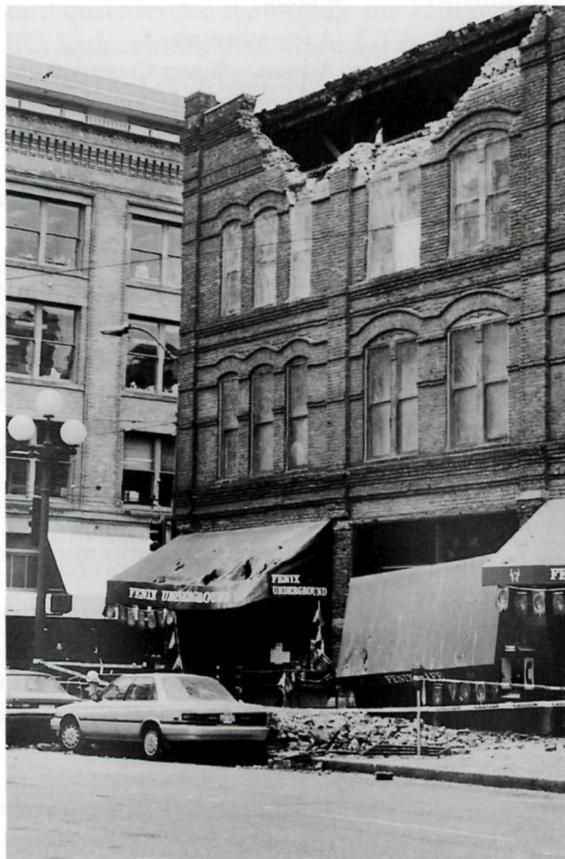
Cadillac Hotel, Seattle, Washington, March 1, 2001. The Cadillac Hotel is the most controversial building damaged in the Nisqually earthquake. Photo by the author.

Seattle's vital Pioneer Square Historic District, where the greatest dollar value damage was experienced, but the best assistance programs are available, several buildings are in jeopardy as a result of opportunistic interests looking for a higher use, among them the venerable Cadillac Hotel.

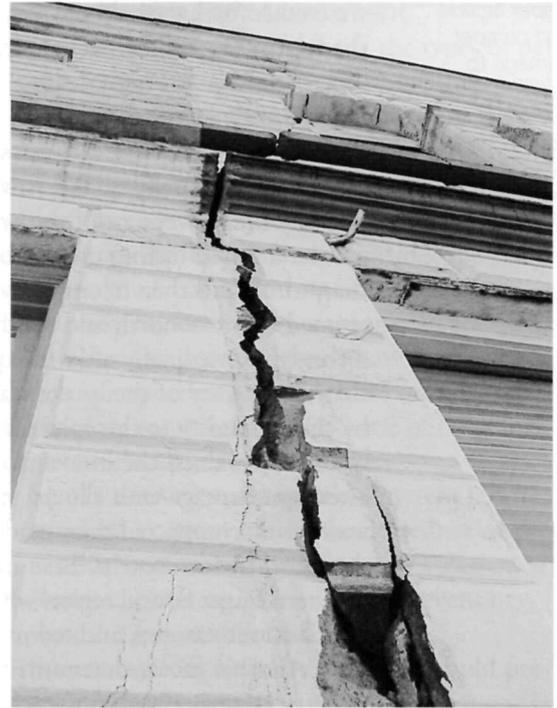
Vertical crack in façade pilaster on the Aberdeen Post Office building. Artifacts field photo.

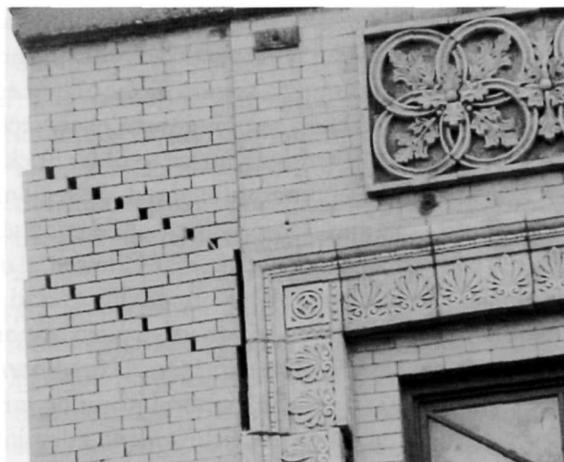
Another factor that contributed to historic structure damage was construction type. Unreinforced brick buildings (c.1875-1900) fared the worst, with stone masonry (c.1875-1920) and concrete (c. 1905-1950) following. Wood frame and timber buildings typically were not seriously damaged even in the areas of most severe shaking. The most troubling pattern of destruction was between dissimilar building materials on composite structures. Many commercial buildings with wood or timber framing and brick veneer lost entire exterior walls and parapets as the sharp jolt early in the quake sheared the attachments between materials and the following rolling motion tipped the outer wall away. Similar damage occurred on bridges where steel and concrete connect, on reinforced concrete frame buildings with stone or brick cladding, and on hundreds of wood frame houses where brick chimneys fell away.

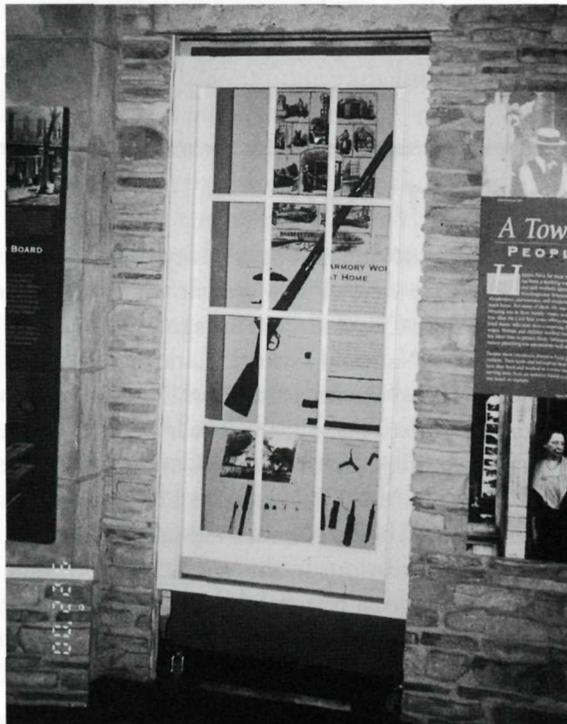
Museum exhibit case ready to be wheeled from building after removal of decorative base plate. Photo by the author.

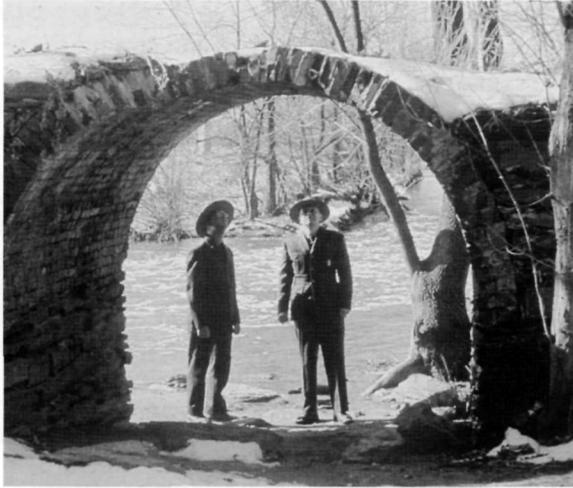
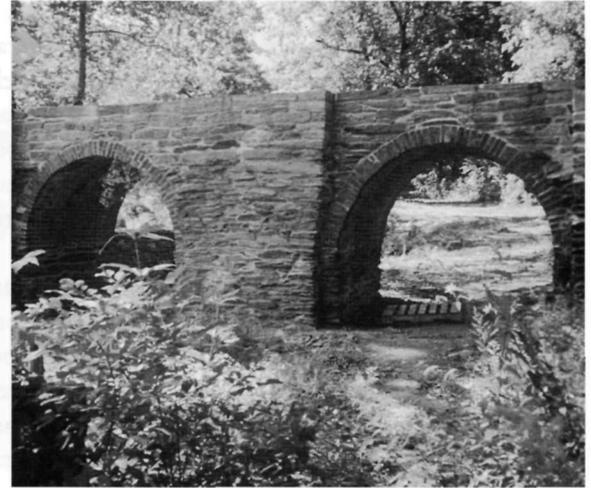
Left, Virginius Island water intake arch in jeopardy of collapse after losing its structural load, photo courtesy NPS. Right, same arch following stabilization work completed during 1996 flood recovery program, photo by the author.

During the 19th century, a series of water intake channels was instrumental in directing water from the Shenandoah River into tunnels leading to the small factories on Virginius Island. Prior to the 1996 floods, the water intake arches were close to collapsing, the tunnels had been completely filled with silt and other flood debris, and the foundations of historic mill buildings had deteriorated to the point where their total loss had become a realistic possibility. The funding provided by Congress following the 1996 floods made it possible to reopen the tunnels and stabilize the arches and foundations. These steps have ensured that the water distribution system will be visible to the public and incorporated into the park's interpretive programs for decades to come.

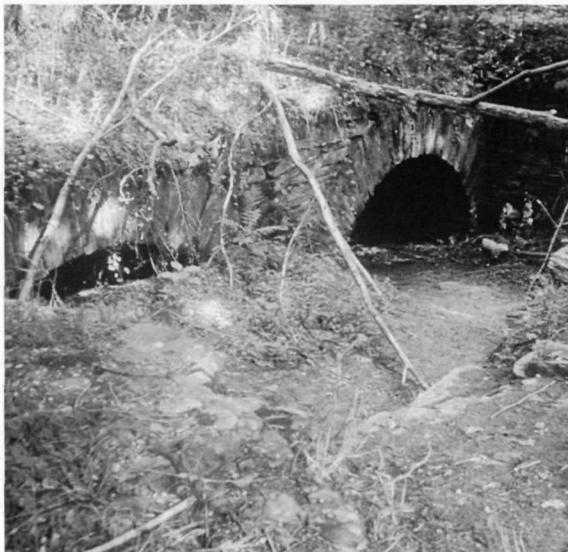
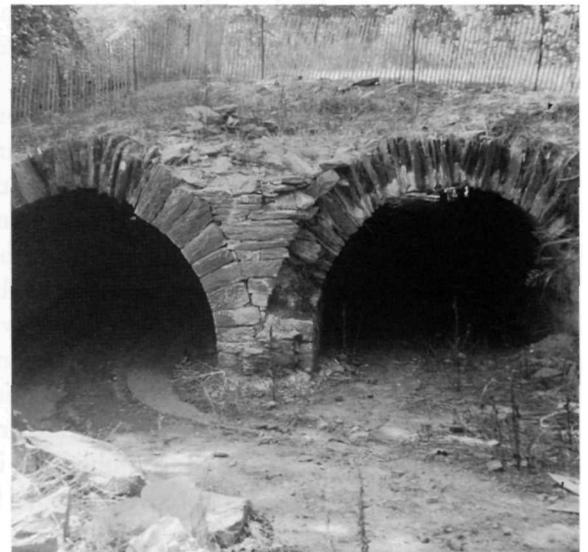
Left, water tunnels on Virginius Island nearly filled with flood debris, photo courtesy NPS. Right, same tunnels with debris removed as part of the 1996 flood recovery program, photo by the author.

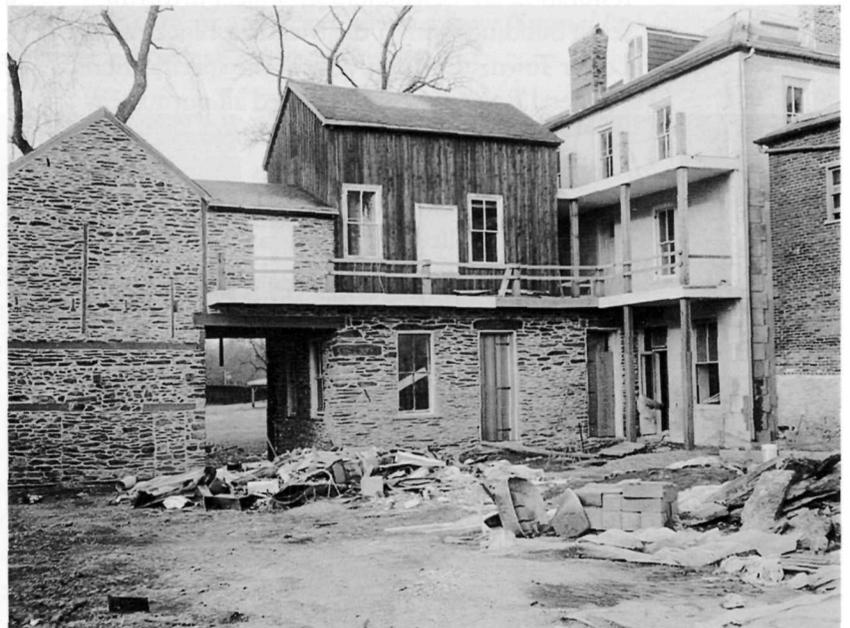
East elevation of buildings 32 and 33A following the January 1996 flood, looking west. Site debris was deposited as the water receded. The trees behind the buildings were lost.

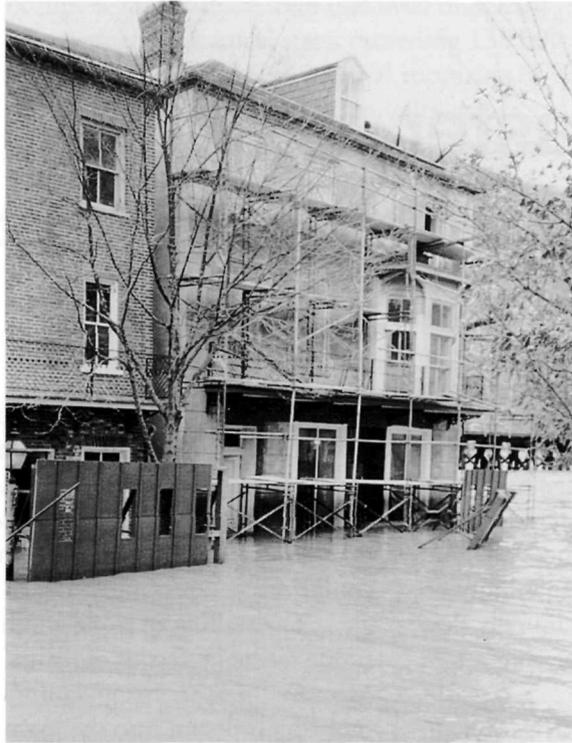
Close-up of buildings 33 and 34 during the January 1996 flood, looking southwest along Shenandoah Street.

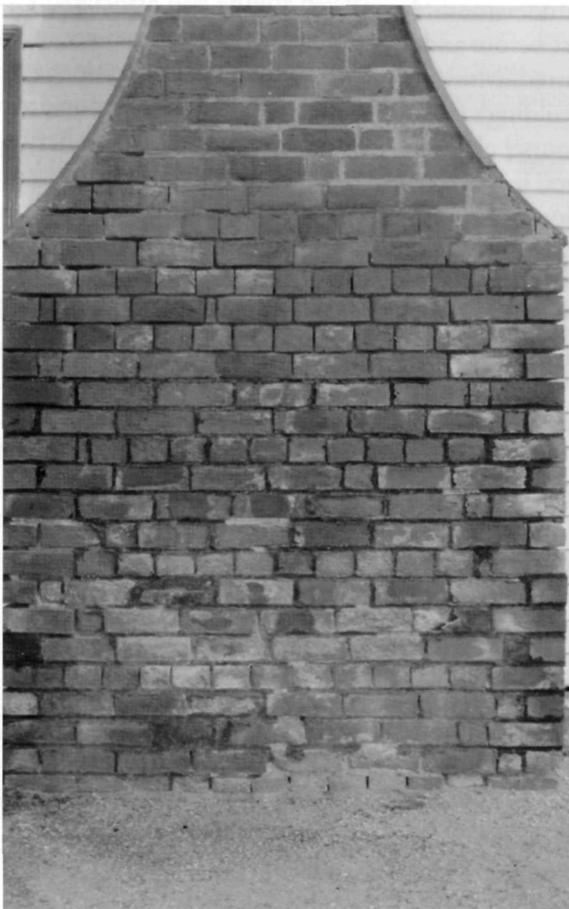
Rising damp and salt attack, chimney of cook house, Murray Downs Homestead, Swan Hill, NSW. Note the salt efflorescence at the bottom and the extent of the mortar loss. Photo by the author.

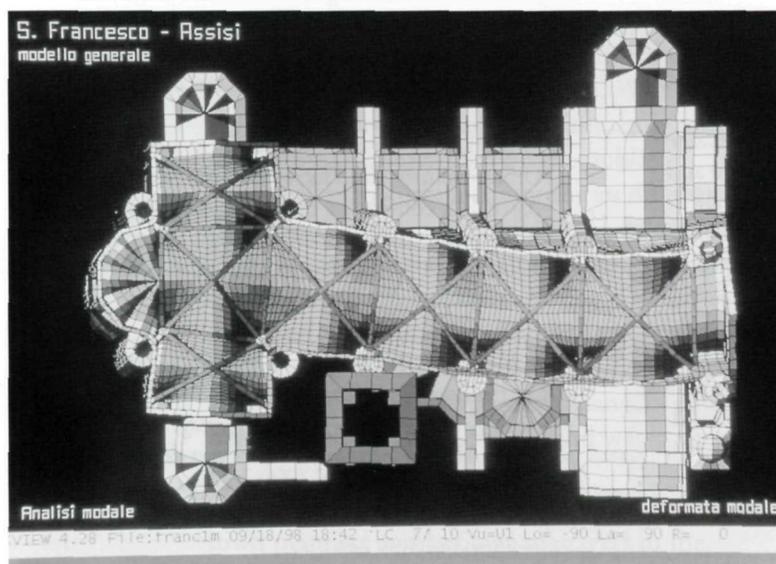
One of the modes of vibration of the global model.

clearly shows that high tensile stress is produced in the ribs and the curvature is reduced even in static conditions under the effect of dead loads. A preliminary step-by-step analysis with horizontal statically equivalent forces shows that when seismic forces reach approximately 0.18g, cracks and permanent deformation occurs, and that with forces between 0.25 and 0.30g the vault may collapse. These values of the seismic forces are comparable with the values induced by the earthquakes of September 1997. The values also explain the great damage everywhere and how the vaults near the façade and near the transept, which received the additional stress, collapsed.

The model of a central module of the nave, without the fill refers to the deformed shape of the vaults, as it has been surveyed; however, it neglects the stress accumulated as a consequence of deformations. This approximation is partially justified by the presence of the cracks, but it would be impossible to evaluate this stress reliably. A first elastic analysis shows that stresses are significantly reduced after the removal of the fill. Considering horizontal statically equivalent forces, a second step-by-step analysis shows that great deformation develops when the horizontal seismic force on the vaults reaches approximately 0.4g (compared to 0.18g with fill). Collapse occurs between 0.6 and 0.7g (instead of 0.25g to 0.3g with fill). This improvement, however, is not sufficient to deal with the maximum expected earthquake.

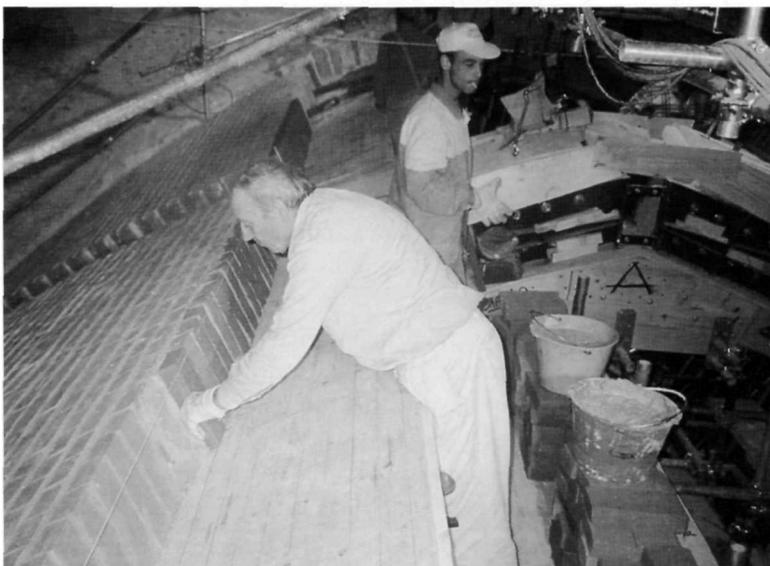
The reconstruction of the vault.

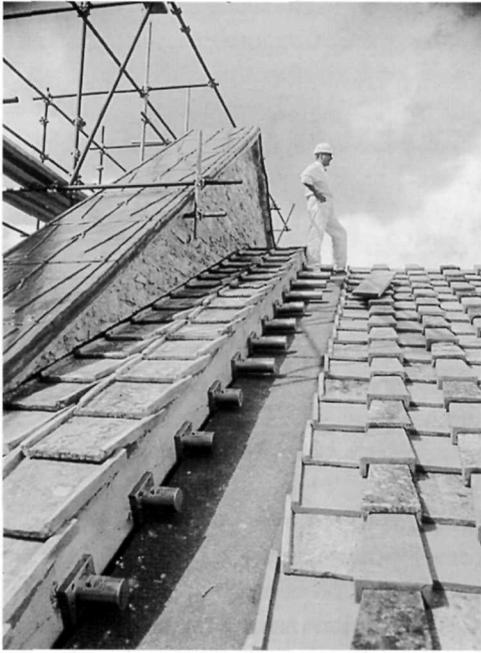
The cylinders that contain the special anchorages connecting the tympanum and the roof.

steel trussed beam has been placed over the cornice of the walls inside the basilica (immediately below the stained glass windows), to stiffen and strengthen the walls covered with Giotto's frescoes. The connection between this beam, which runs along the perimeter, and the walls has been created with special viscous devices which allow relative displacements due to thermal effects, but become rigid under dynamic

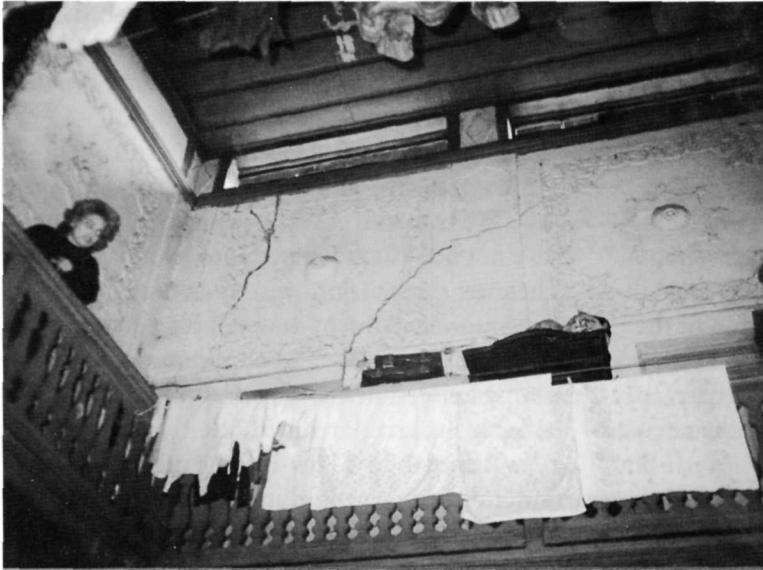
Tbilisi, Georgia, earthquake damage. Photo by the author.

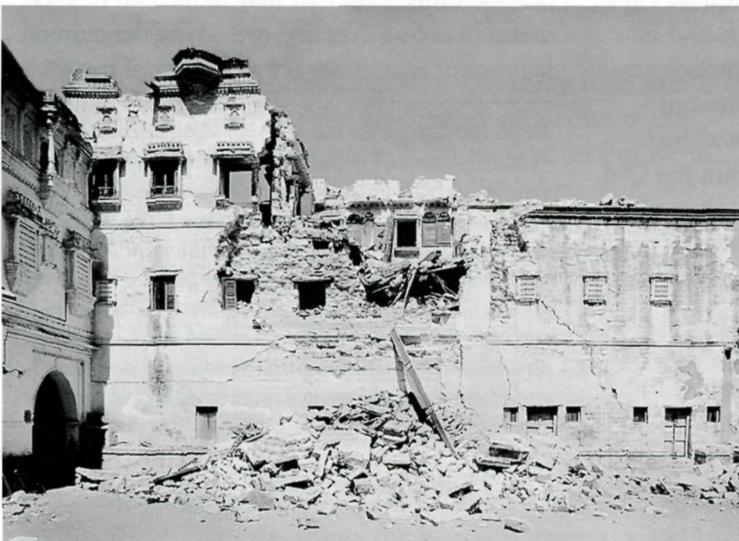
*City Palace,
Bhuj, India.*

fact that they remained full of the art and culture of the region, nowadays they are not under any heritage protection and often they are not maintained. Now, the earthquake has turned many of these former palaces into ruins.

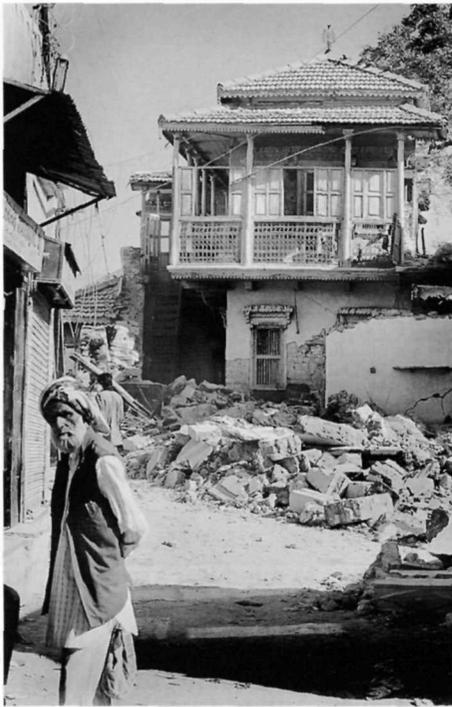
Surviving house, Anjar, India.
