National Park Service
Cultural Landscapes Inventory
2010

Erbie Area
Buffalo National River

Inventory Unit Summary & Site Plan

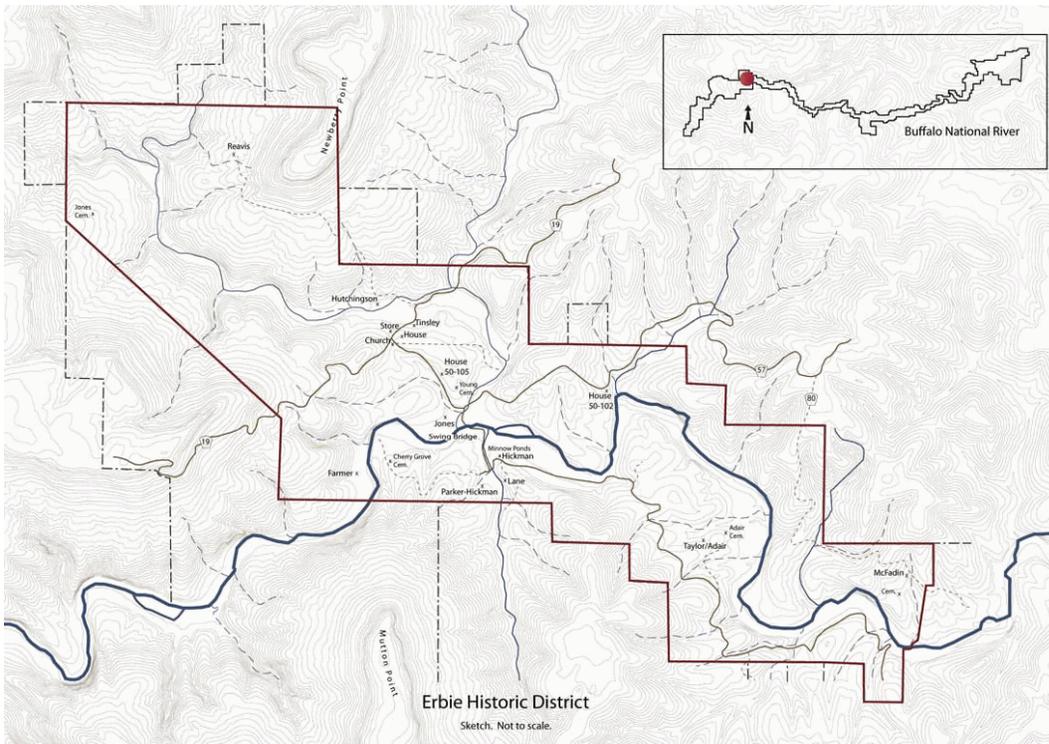
Map of the Erbie Historic District with approximate locations of contributing sites (NPS, 2010).

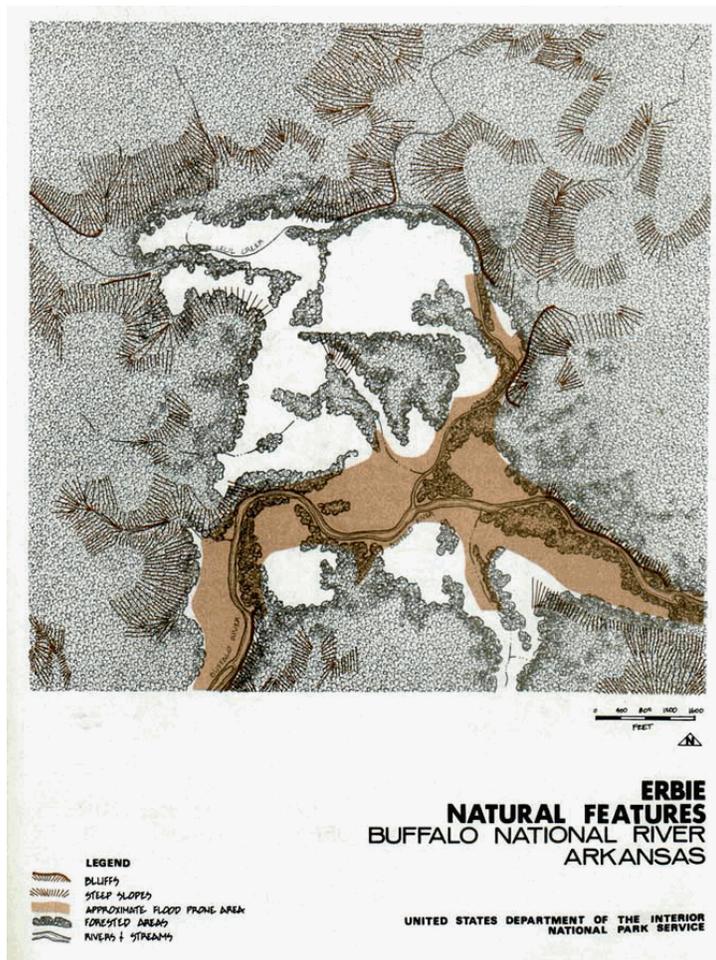
Map illustrating the natural features of the district. From the 1986 Erbie Cultural Landscape Report (NPS, 1986).

The Buffalo River cuts through the hills of the Boston Mountains creating valleys and narrow gorges. These valleys provided a most prosperous setting to early settlers who wished to succeed under a subsistence agricultural lifestyle. The river in flood proved a hazard to the inhabitants but also a boon to their way of life.

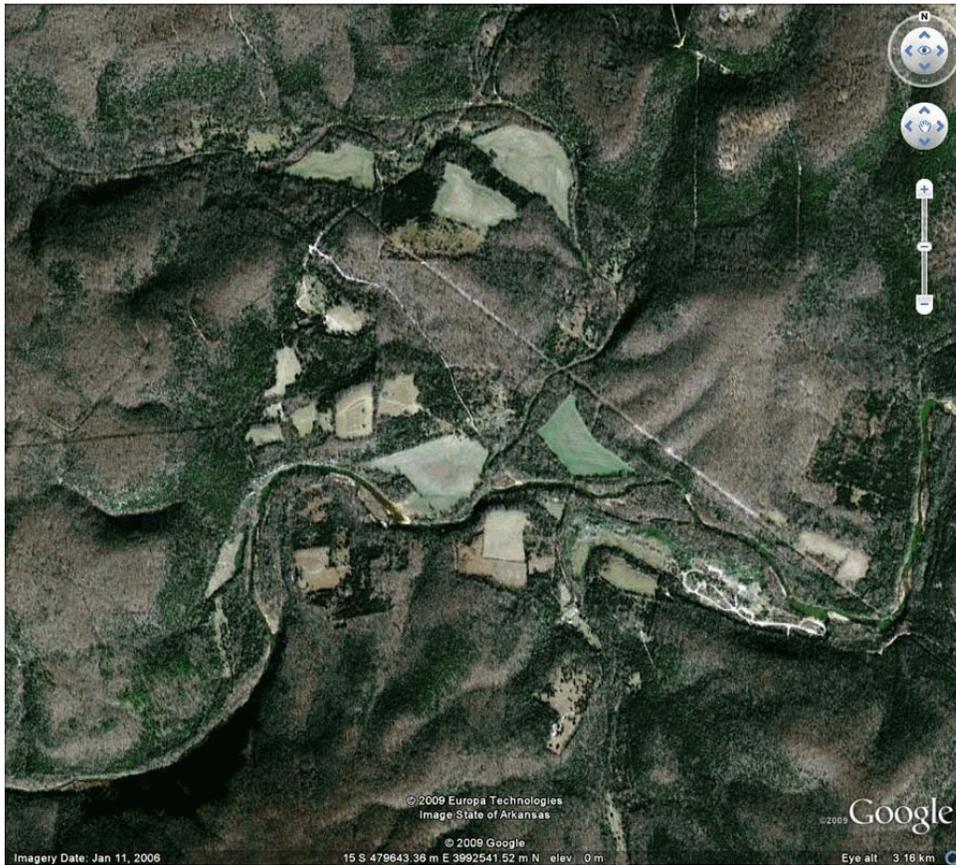
Google Earth image showing the fields in the Erbie Historic District (Google Earth, 2010).

From the 1840s to 1978 agriculture was the predominant land use in the Erbie area. Due to the isolation and difficulty of transport, subsistence farming was the primary endeavor of the farmers of the valley. The Buffalo bottom land could easily support a family while it was much more difficult to focus on a single cash crop which would not have succeeded under the physical and economic conditions of the area (Pitcaithley 1976, 126). As a result, farmers grew a diversity of crops such as wheat, corn, cotton, potatoes, tobacco, and rice. A diversity of livestock was also kept and remnant fencing makes former pasture land evident to this day. Agriculture has ceased in the area with the exception of the leased fields which continue to be used primarily for hay production. This continued use maintains the spatial conditions of several of the historic fields, thus contributing to the integrity of the site.

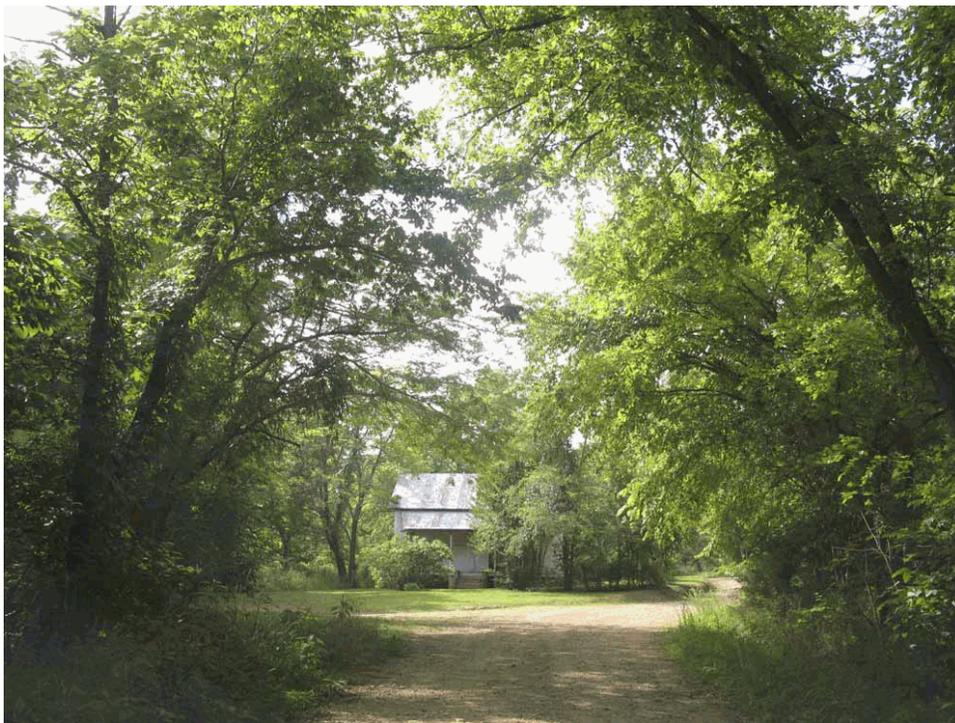
Rulus Jones Farm House viewed from the road (NPS, 2009).

The Jones House is a one-and-a-half story, frame dwelling built in 1922. The house has a stone foundation, a gable roof of corrugated metal panels, a central interior brick chimney, and an exterior of weatherboard siding. On the main (south) elevation is a $\frac{3}{4}$ width shed roof porch with original turned wood posts. The porch is supported by tapered poured concrete piers. The porch has a wood floor. Leading to the porch are poured concrete steps framed with an uncut stone wall capped with concrete. The porch has an original tongue-and-groove ceiling. Entrances and windows in the dwelling are boarded up with wood panels to prevent vandalism. The house originally had two entrances on the main facade. One has been enclosed with weatherboard siding. Second story windows in the side gable are paired one-over-one wood sash designs. The dwelling has an original rear T-wing with a central interior brick chimney, stone foundation and an exterior of weatherboard siding. On both the east and west elevations of the wing are original shed roof porches with turned wood posts. The east porch has two entrances. A portion of the west porch has been enclosed. The east porch has a poured concrete floor and the west porch has a wood floor supported by concrete piers. A window in the gable field of the wing has a four-over-four wood sash window. Adjacent to the east porch is a stone well.

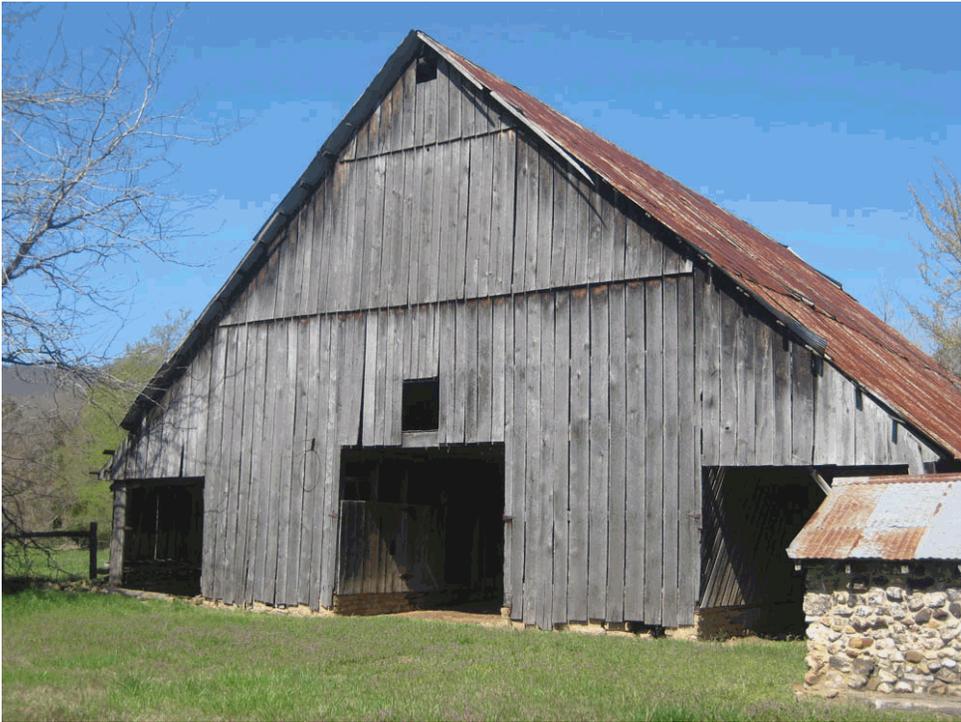
Rulus Jones Barn (NPS, 2009).

West of the dwelling is a large frame barn built ca. 1913. A dirt road extends in front of the dwelling and leads to the barn and associated fields. The barn has a stone foundation, a vertical board exterior, and a gable corrugated metal roof. The barn has a central drive-thru bay shed roof wings on either side. The central bay is divided into stock pens and cribs. Interior steps lead to the loft area. There is some use of diagonal board on the interior of the barn. The pens have triangular cutout openings that access feed bins. A fence line runs behind the barn's west wall and large fields that are still in use are located to the south and west of the barn.

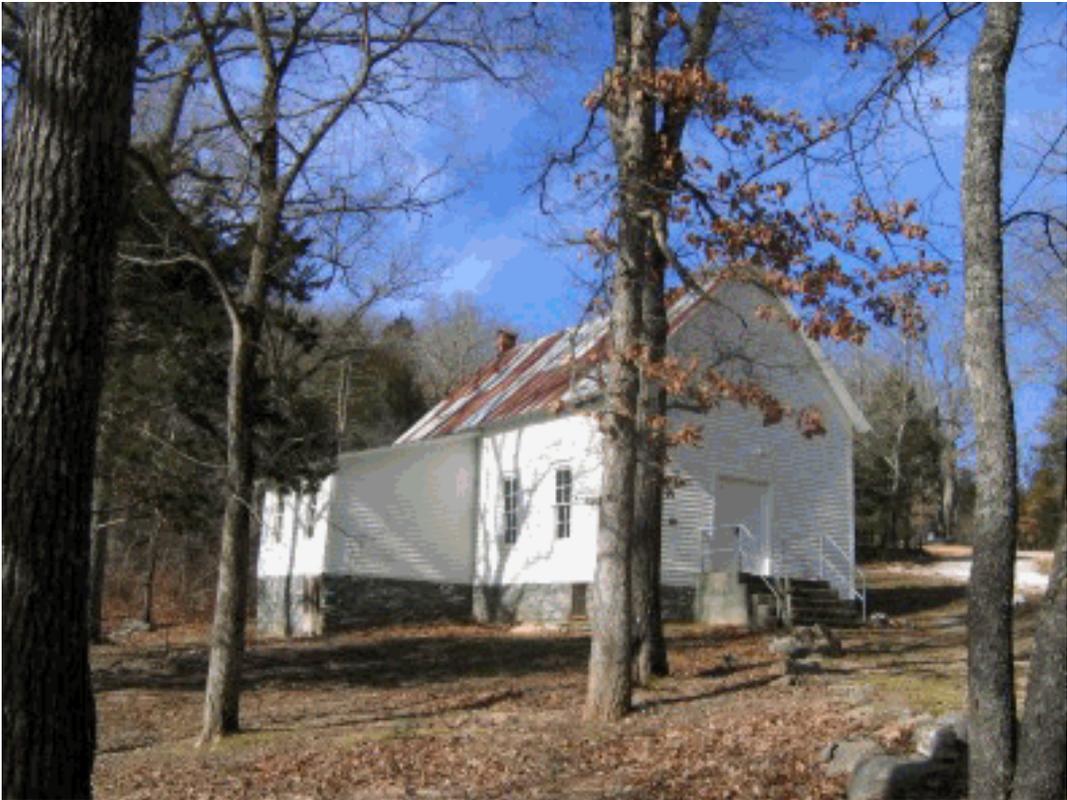
Erbie Church (NPS, 2009).

Erbie Church is a one-story, gable-front, frame building constructed ca. 1900. The church has a stone foundation, a corrugated metal gable roof, an interior brick chimney, and an exterior of weatherboard siding. On the main (east) façade is the main entrance, which has paired ca. 1960 diamond light glass and wood doors. Concrete block steps lead to the entrance and have metal railings. Above the entrance is a wooden sign that reads "Erbie Church." Above the sign is a simple metal light fixture. On the south elevation is a small shed roof wing built ca. 1930. This wing has exposed roof rafters and at the basement level has a vertical board entrance. The church has original four-over-four wood sash windows that appear on the side elevations. There is no fenestration on the rear elevation.

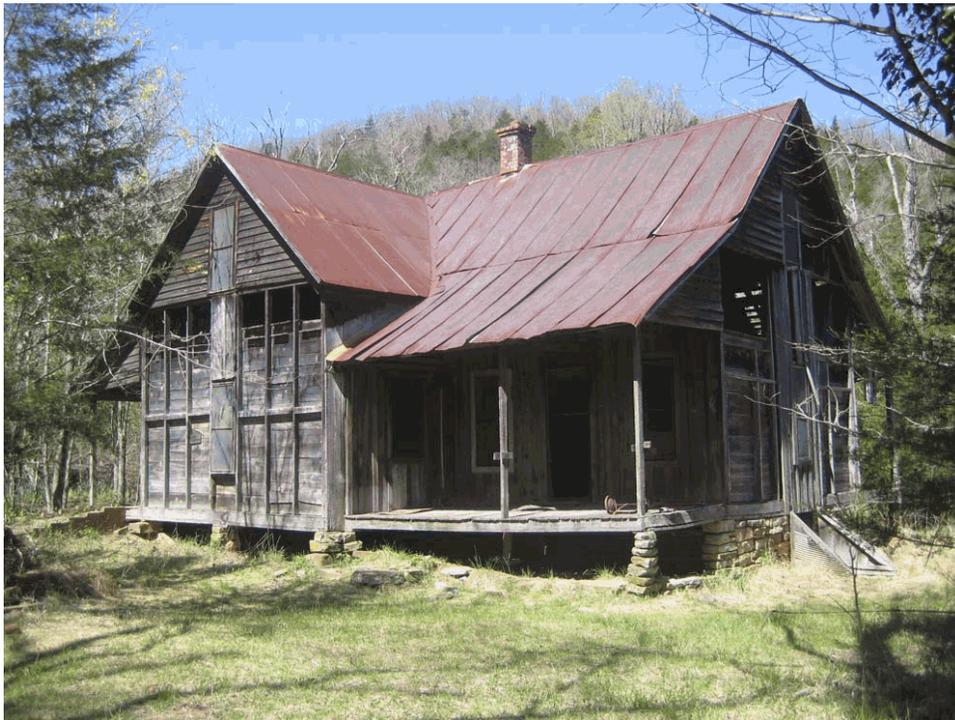
Farmer Farm House (NPS, 2009).

The main Farmer House is a one-and-a-half story, frame dwelling built ca. 1905. It has a stone pier foundation, a gable corrugated metal panel roof, a central interior brick chimney, and a board and batten exterior. On the main (west) facade is a full-width shed roof porch with chamfered wood posts. The porch has a wood floor and a rock pier foundation. There are two entrances on the main facade. One is missing a door and the western most entrance has a paneled wood door that is in ruins. This entrance has a metal mesh screen over it. On the north side of the porch two large stones and one small stone serve as steps leading to the ground. The south side of the porch has a poured concrete ramp that is lined with brick. At the north end of the porch is an electrical outlet. There is weatherboard siding in the gable fields of the house. There is no extant siding on the north or east elevations. The house has an original rear T-wing with shed roof porches on both the north and south elevations. The porches have sawn wood posts and rock pier foundations. The ceiling of the north porch has caved in. Window openings in the dwelling are rectangular in shape and are covered with metal wire mesh screens. The rear T-wing has a continuous dry stack stone foundation and beneath it is a root cellar. An entrance to the cellar is at the rear (east) elevation. A vertical board wood door remains partially attached at the entrance. The cellar entrance is framed in and supported by stone and had an angled cellar door. Hinges remaining demonstrate this. The cellar has a dirt floor.

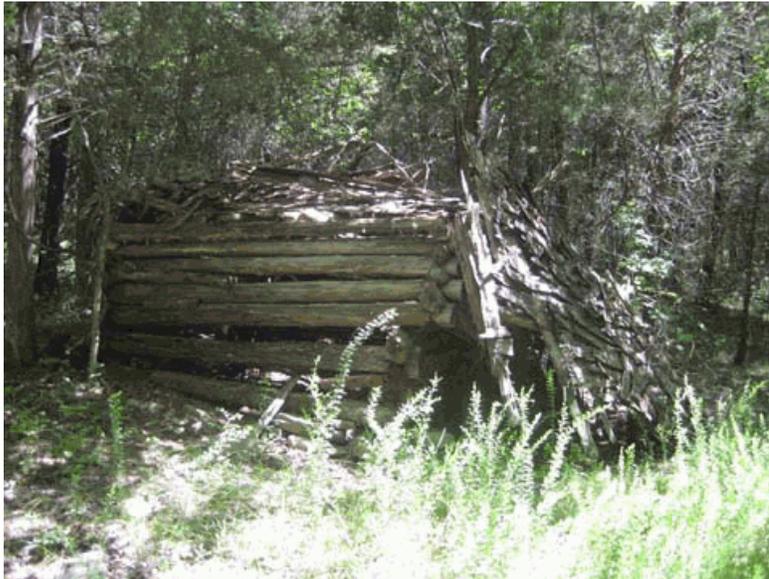
Shake Roof Cabin (NPS, 2009).

The building sits in a wooded area off of an NPS hiking trail. A small footpath leads to the building from the trail. An NPS boundary marker lies about twenty-five feet to the north of the building. Despite its poor condition, the Shake Roof Cabin adds to the overall setting of the Erbie Rural Historic District. Its construction of "recycled" logs reflects a common practice of reusing materials from older dwellings, and its shake roof is an example of local building traditions and craftsmanship.

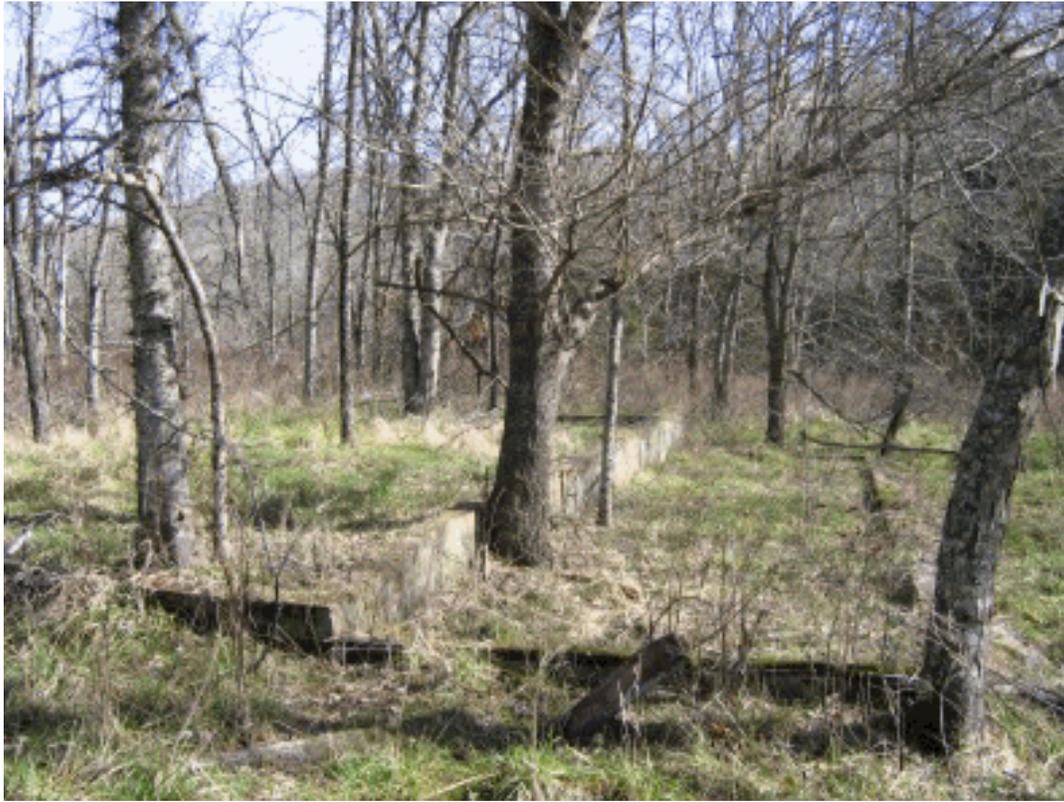
Tinsley Barn foundation (NPS, 2009).

At this site are the concrete foundations of an early twentieth century barn and milkhouse. The barn foundations are of concrete and measure 53' x 41'. Approximately 100 feet southwest of the barn foundation is the foundation of the milkhouse. This foundation is of concrete block with rock infill and is around three feet in height. The foundation is long and narrow and has concrete ramps on both the north and south sides, and pairs of concrete steps appear on the east end of the foundation. Remnants of a wooden fence line run behind (east) the milkhouse to the barn site. East of the barn site by approximately twenty feet is the poured concrete foundation of another outbuilding, possibly a smokehouse. Fence remnants border this foundation. There is a scattering of stone throughout the area. Remnants of a rock wall are south of the foundations along a narrow stream.
