# Restoration of Mined Lands in Kantishna

**Glen Creek is one of the mined sites in Kantishna undergoing large-scale restoration, in order to help restore function and structure to damaged stream and floodplain ecosystems.**

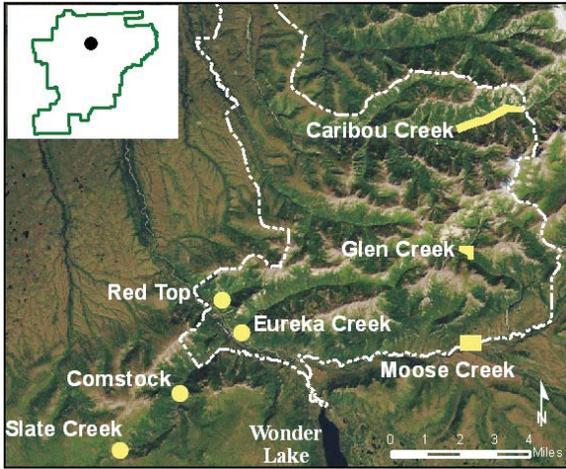
NPS has active restoration plans for the mined lands in the Kantishna Mining District (white outline) that are marked in yellow.

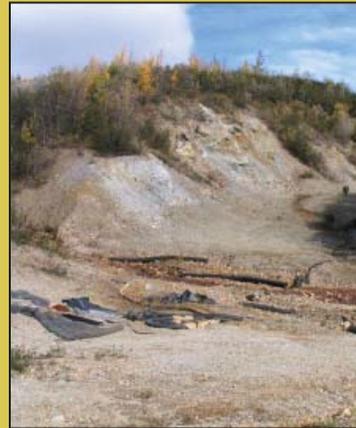
Caribou Creek has the most extensive placer mining-related damage of any drainage in Denali (361 acres comprising 13.1 miles of aquatic and riparian habitat). Portions were dredged in the 1930s, and then aggressively reworked with heavy equipment in the 1970s and 1980s. Stream banks are devoid of vegetation and rows of tailing piles are evident (see aerial photo). Plans for 2010 include widening and smoothing the upper portion of the disturbed floodplain (last mined in the mid-1980s), creating a relief channel for flood events, and reinforcing some previously restored curves in the main channel.

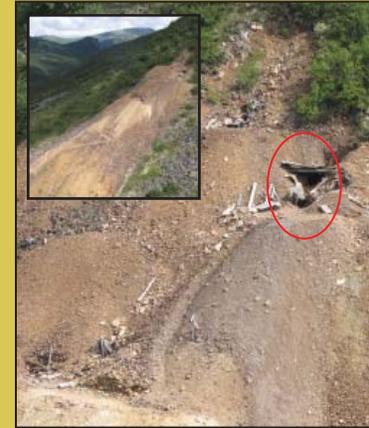
Slate Creek, a tributary of Eldorado Creek, has several adjacent abandoned lode claims including a semi-open pit style mine that was intermittently active from 1910 to 1983. This site consists of exposed mine walls that are leaching acidic minerals (see photo); 245 linear meters (~800 linear feet) of tailings piles; and an acidic stream section. Despite limestone buffer methods used beginning in 1998, acid mine drainage continues, and portions of the site remain barren. One recent in-stream pH measurement was extremely acidic (pH of 2.8). Plans for restoration in 2010 and/or 2011 include capping mineralized outcrops, backfilling the open pit, grading the tailings piles, and relocating and re-enforcing the stream channel.

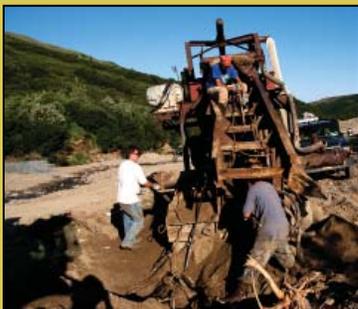
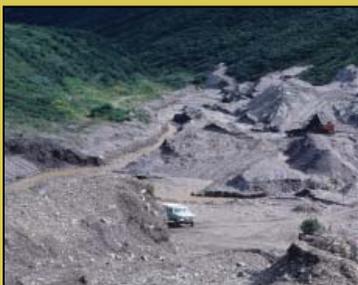
Glen Creek was mined intermittently from its original gold placer claim staking in the early 1900s through 1985. The property is the site of abandoned mining debris (see upper photo), substantial soil contamination, and extensive mining-related impacts. A contractor worked from June to September 2009 to (1) remove buildings, mining equipment, and other debris, (2) characterize and excavate contaminated soils, (3) level tailings piles (see lower photo) and rebuild portions of the Glen Creek floodplain, and (4) revegetate disturbed areas.
