# Spanning the Gap

## Restoration at Millbrook Village: the Garis House

By Ken Sandri

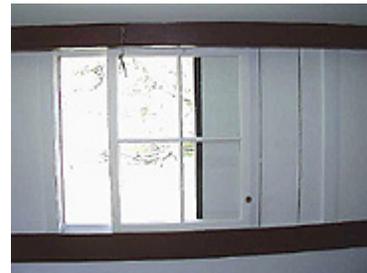
Sliding window in the kitchen addition, as restored.

Garis House also presents an item of particular architectural interest, a kitchen addition which is a rare surviving example of a framing method called *plank construction*. Built in the 1860s, this supposedly temporary structure survived substantial alteration over the years, and is now restored to its original appearance.

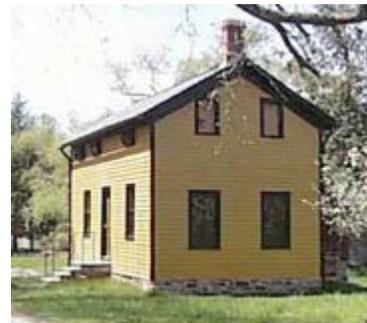
The northeast side of Garis House after restoration.

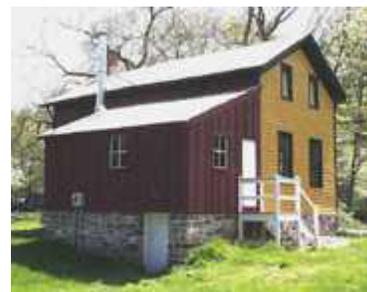
The southwest side of Garis House after restoration,

showing kitchen addition in back.
