# Big Rivers Monitoring within Dinosaur National Monument

*A summary of monitoring results to detect change in channel condition*

Natural Resource Report NPS/NCPN/NRR—2018/1635

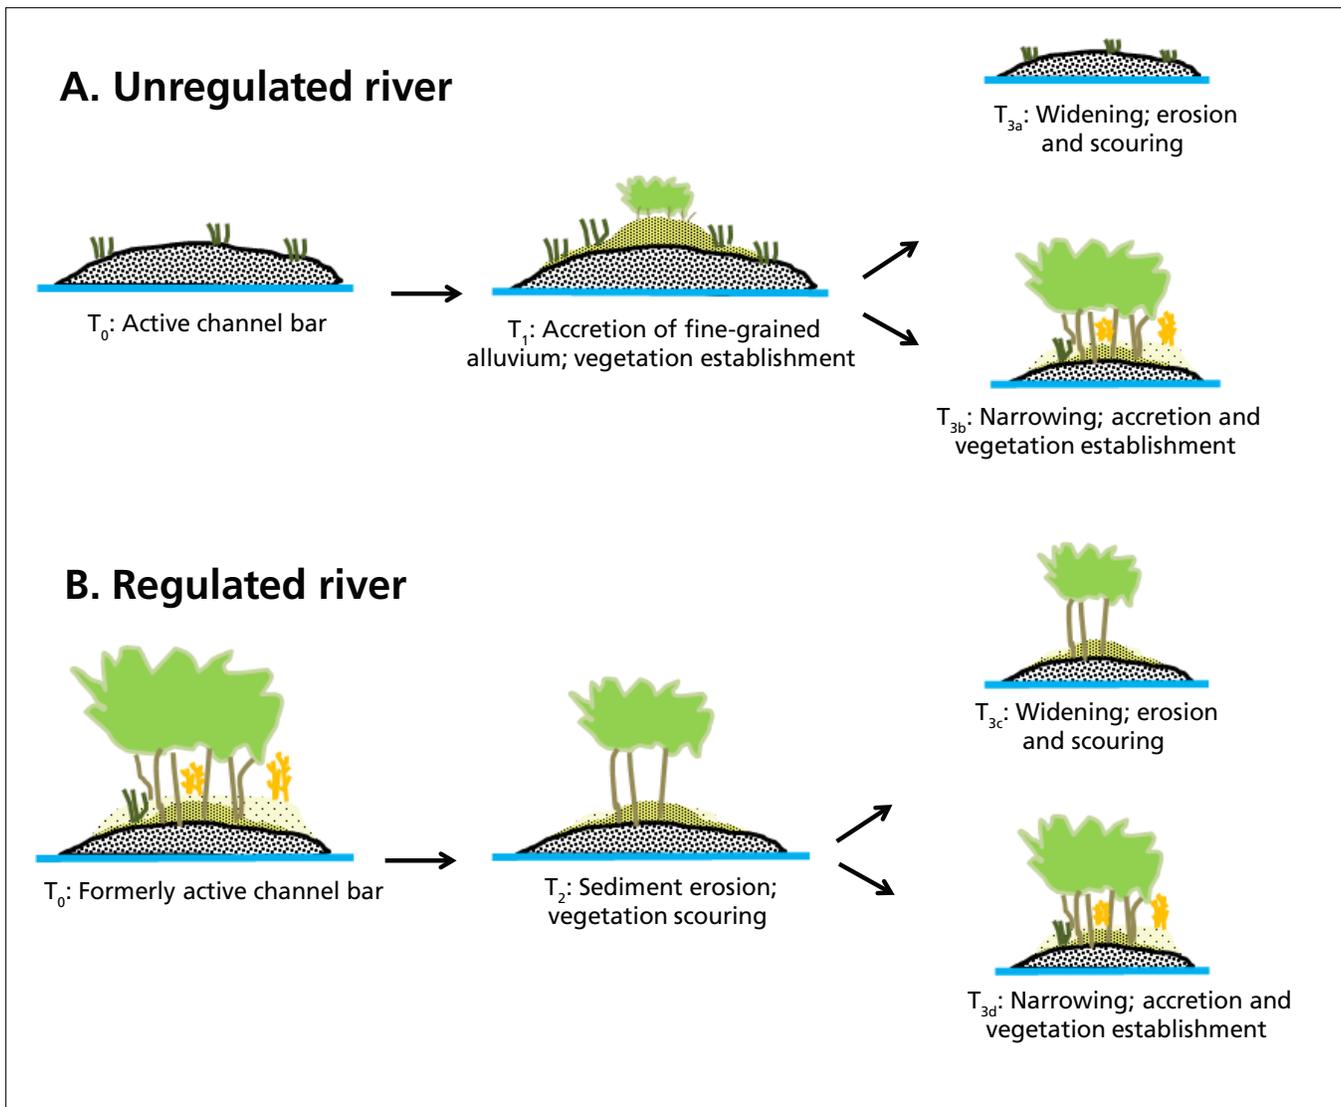
Figure 1-1. A conceptual model illustrating differences in channel and vegetation conditions along an (A) unregulated and (B) regulated river. Because of high flow variability, relatively unregulated rivers, like the Yampa, feature extensive, active bar forms with little or no perennial vegetation at any given time (A,  $T_0$ ). Following temporary flow reductions, such features may accumulate fine sediments that can become colonized by vegetation (A,  $T_1$ ). Return to normal flow variability restores active-channel features by eroding sediments and scouring/inundating vegetation (A,  $T_{3a}$ ). Persistent flow reductions lead to narrowing with continued sediment accretion and vegetation establishment (A,  $T_{3b}$ ). Formerly active bar forms along regulated rivers exhibit some degree of narrowing in the form of fine sediment accretion and encroachment by perennial vegetation (B,  $T_0$ ). Following unusually large or long-duration floods, temporary channel widening may occur as sediments and vegetation are removed (B,  $T_2$ ). Sustained increases in the magnitude, frequency, and duration of high flows would result in permanent widening (B,  $T_{3c}$ ), whereas return to regulated conditions would lead to narrowing (B,  $T_{3d}$ ).

A conceptual model (Figure 1-1) helps illustrate the differences in channel and vegetation conditions along a relatively unregulated river versus a regulated river. Because of their relatively high flow variability, largely unvegetated, active-channel bedforms are prominent bottomland features along large, unregulated regional rivers. These surfaces are sensitive to temporary accumulation of fine sediments and colonization by vegetation during temporary reductions in flow, such as might result from short-term drought. A return to more typical flow variability would be expected to erode fine sediments, scour vegetation, and restore the pattern and extent of active-channel features. Persistent reductions in flow, such as those that would result from long-term drought conditions and/or human-caused flow depletions, would lead to progressive channel narrowing as active-channel features converted to vegetated floodplain (Figure 1-1A).

Along regulated rivers, formerly active-channel features are transformed to some extent by narrowing, depending upon the degree of flow regulation. In such cases, changes in channel condition are likely to involve temporary widening from removal of sediments and vegetation during rare, large floods. With a return to regulated conditions, post-flood narrowing would occur: the channel could widen or narrow incrementally with sustained increases or decreases in flow variability away from baseline flow conditions (Figure 1-1B).

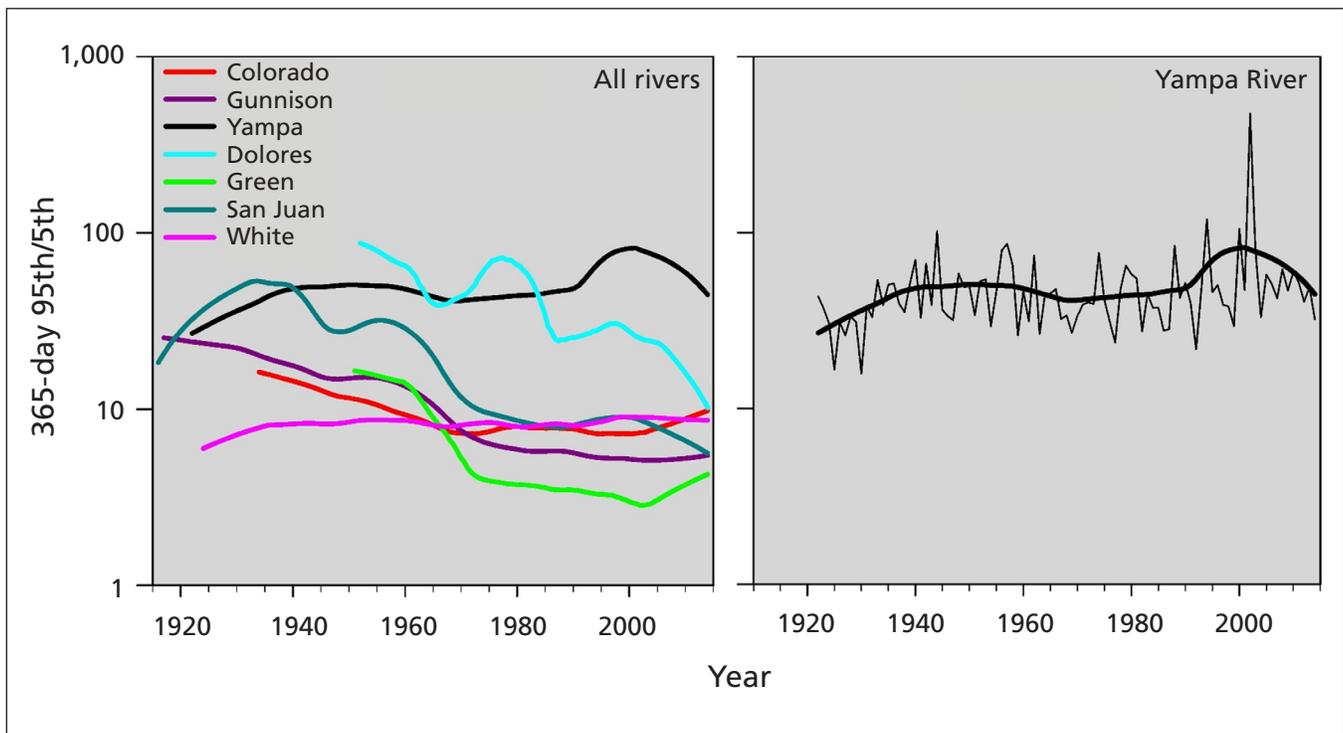
Figure 2-1. A comparison of historical flow variability for seven rivers within the Colorado River basin, including the Green and Yampa rivers. Flow variability is represented as the ratio of the annual 95<sup>th</sup> percent exceedance flow (low) divided by the 5<sup>th</sup> percent exceedance flow (high). Flow variability has declined over time on all rivers except for the White and Yampa rivers (left panel). The annual hydrograph is over-plotted on the flow variability curve for the Yampa River (right panel).

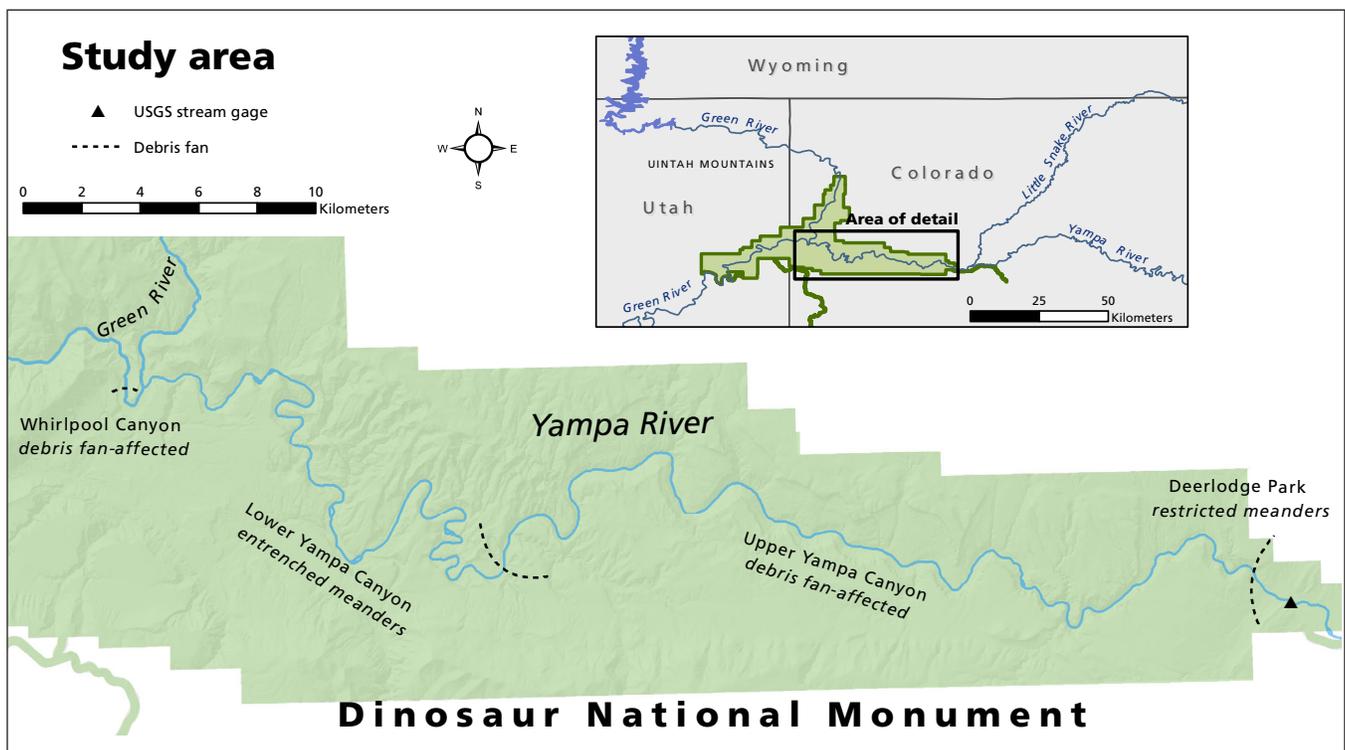
Figure 2-2. The Yampa River study area within Dinosaur National Monument. Three distinct channel types occur within the study area, including restricted meanders in Deerlodge Park, debris fan-affected in the upper Yampa Canyon, and entrenched meanders in lower Yampa Canyon. The occurrence of the three channel types is controlled by bedrock geology at river level (see text).

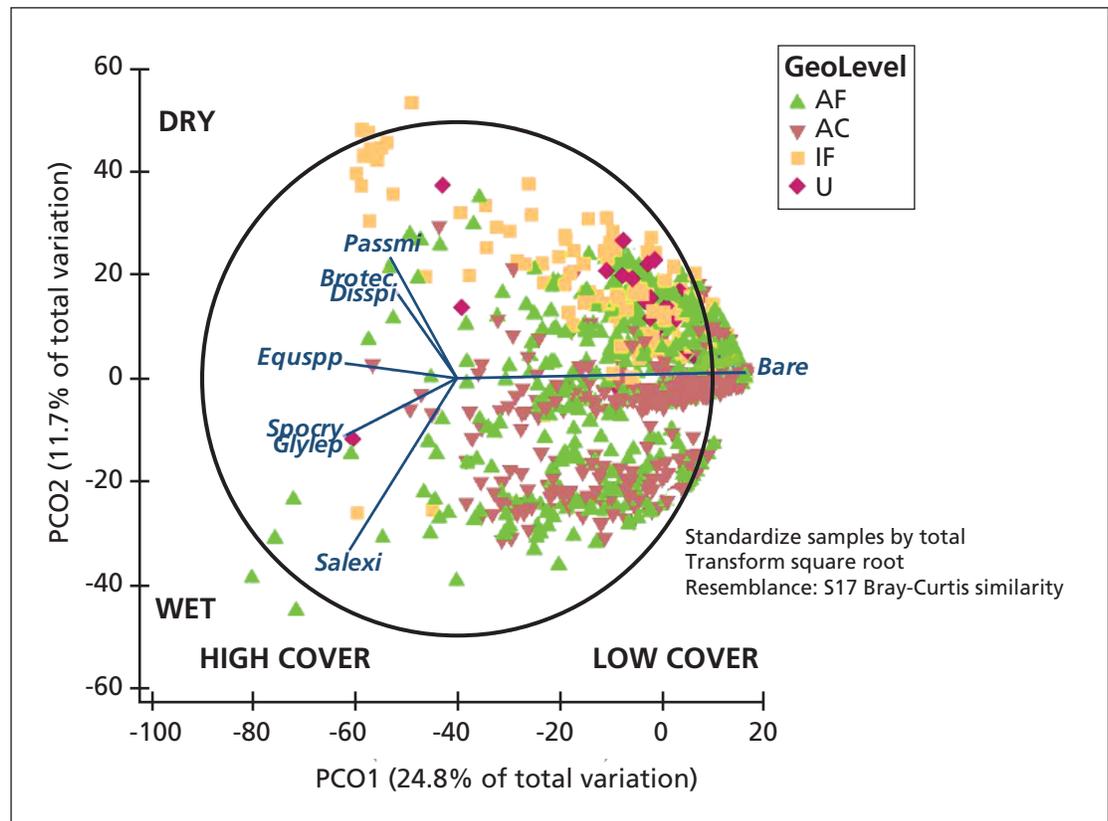
Figure 2-3. Principal coordinates ordination (PCO) of species and samples from 1,462 quadrats and relevés sampled along the Yampa River in Dinosaur National Monument. A total of 798 quadrats were bare of vegetation but were included in the ordination as a pseudospecies. The ordination showed clear gradients structuring plant-species composition on four geomorphic surfaces: active channel (AC), active floodplain (AF), inactive floodplain (IF), and upland (U). The cover gradient along the first axis was likely a combination of frequency and intensity of fluvial disturbance for active-channel and active-floodplain plots and moisture limitations for inactive-floodplain and upland plots. Species codes: Bare=Bare pseudospecies; Brotec=Bromus tectorum; Disspi=Distichlis spicata; Equspp=Equisetum species; Glylep=Glycyrrhiza lepidota; Passmi=Pascopyrum smithii; Salexi=Salix exigua; Spocry= Sporobolus cryptandrus.

This hallmark was reflected in the ordination (see large number of active-channel and active-floodplain plots with low to no cover, Figure 2-3). The ordination showed clear gradients structuring plant species composition on four geomorphic surfaces: active channel, active floodplain, inactive floodplain, and upland. The cover gradient along the first axis was likely a combination of frequency and intensity of fluvial disturbance for active-channel and active-floodplain plots and moisture limitations for inactive-floodplain and upland plots.

Results of the first PCO analysis demonstrated clear gradients, separating vegetated quadrats on the left side of the ordination from largely bare quadrats on the right. The second axis represents a moisture gradient, where largely active-floodplain quadrats dominated by sandbar willow (*Salix exigua*),

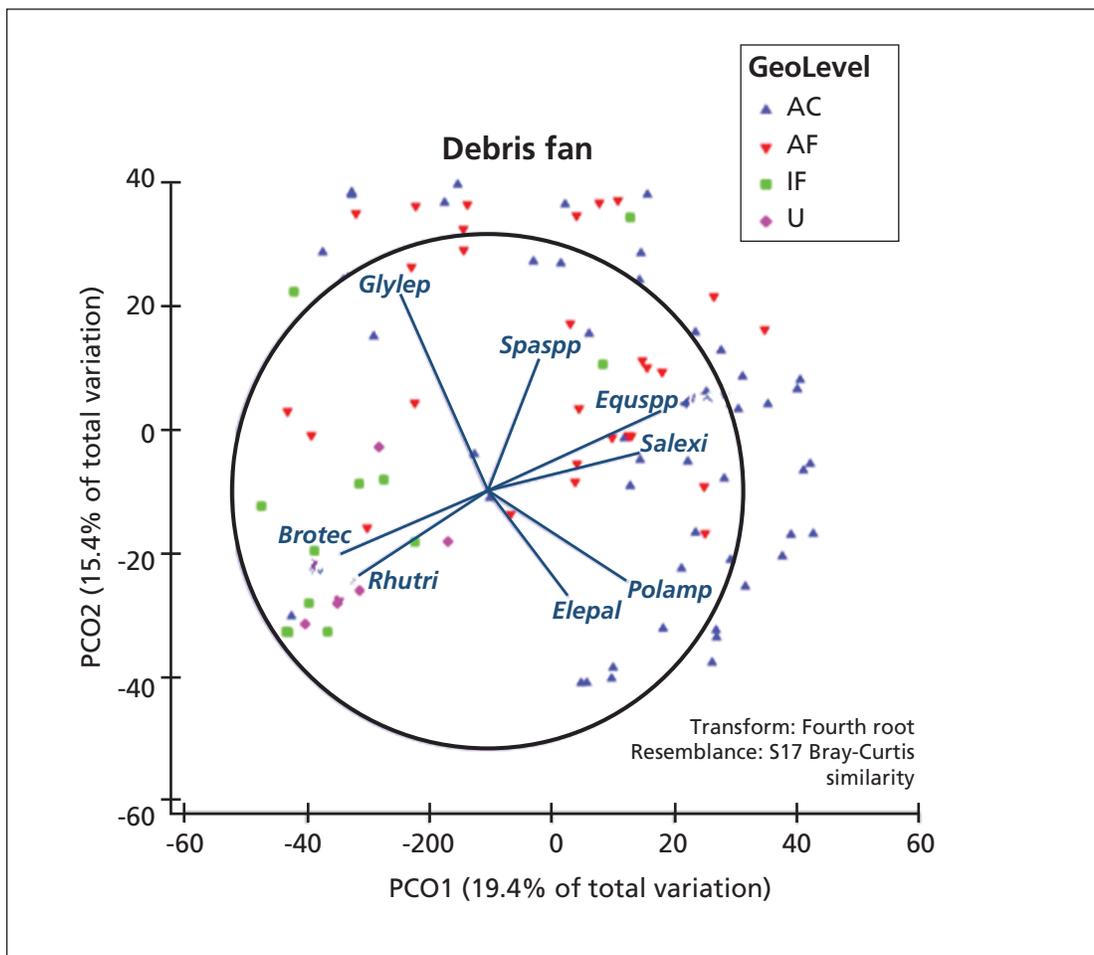
Figure 2-6. Principal coordinates ordination (PCO) of vegetation quadrats showing relationships of geomorphic surface and vectors of important species within the debris fan-affected channel type. Geomorphic surface abbreviations: AC=active channel; AF=active floodplain; IF=inactive floodplain; and U=upland. Species codes: *Brottec*=*Bromus tectorum*; *Elepal*= *Eleocharis palustris*; *Equspp*=*Equisetum* species; *Glylep*=*Glycyrrhiza lepidota*; *Polamp*= *Polygonum amphibium*; *Rhutri*= *Rhus trilobata*; *Salexi*=*Salix exigua*; *Spaspp*=*Spartina* species.

Ordination results for the debris fan-affected channel type were similar to those from the entrenched-meander channel type. The first ordination axis predominantly represented a moisture gradient and the second axis represented a disturbance/inundation duration gradient (see Figure 2-6). In this ordination, most of the upland and inactive floodplain quadrats clustered on the lower left side of the ordination and aligned with species vectors for cheatgrass (*Bromus tectorum*) and skunkbush sumac (*Rhus trilobata*). The upper right side of ordination space was largely a mix of active-floodplain and active-channel quadrats, with quadrats dominated by wild licorice, prairie cordgrass, horsetail species, and sandbar willow. As in the entrenched-meander channel type, this group of species was associated with finer-textured deposits in the active channel and on active-floodplain surfaces. Finally, in the lower right quadrat of the ordination space, spike rush, along with water knotweed (*Polygonum amphibium*), was primarily associated with frequently inundated active-channel deposits.

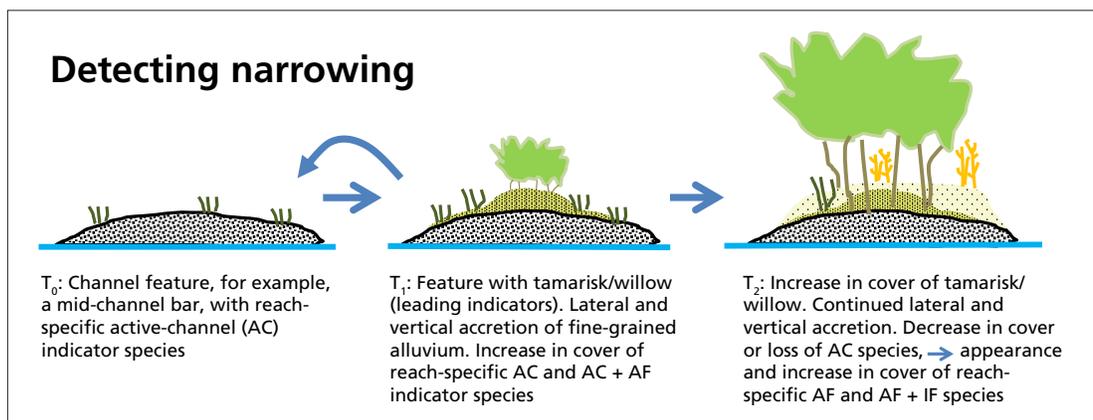
Figure 2-7. A conceptual model of how narrowing on an active-channel feature along a largely unregulated river could be detected using reach- and geomorphic surface-specific indicator species.  $T_0$  represents initial conditions on a channel-bar feature with reach-specific, active-channel indicator species. At  $T_1$ , floodplain construction and channel-narrowing are indicated by accretion of sediments and increases in the cover of active-channel species as well as the appearance of new active-channel and/or active-floodplain species. Flow variability over time may return the channel feature to initial conditions, or persistent reductions in flow variability may lead to progressive narrowing, as indicated by continued sediment accretion, increased vegetation cover, loss of typical active-channel species, and the appearance of new active and inactive floodplain species ( $T_2$ ).

ences in species composition and cover of riparian vegetation among channel types and across geomorphic surfaces within channel types. This work showed that by using indicator species specific to channel type and geomorphic surface, we should be able to detect geomorphic surface state changes quickly and accurately and, thus, track changes in channel condition and channel narrowing (see Figure 2-7).

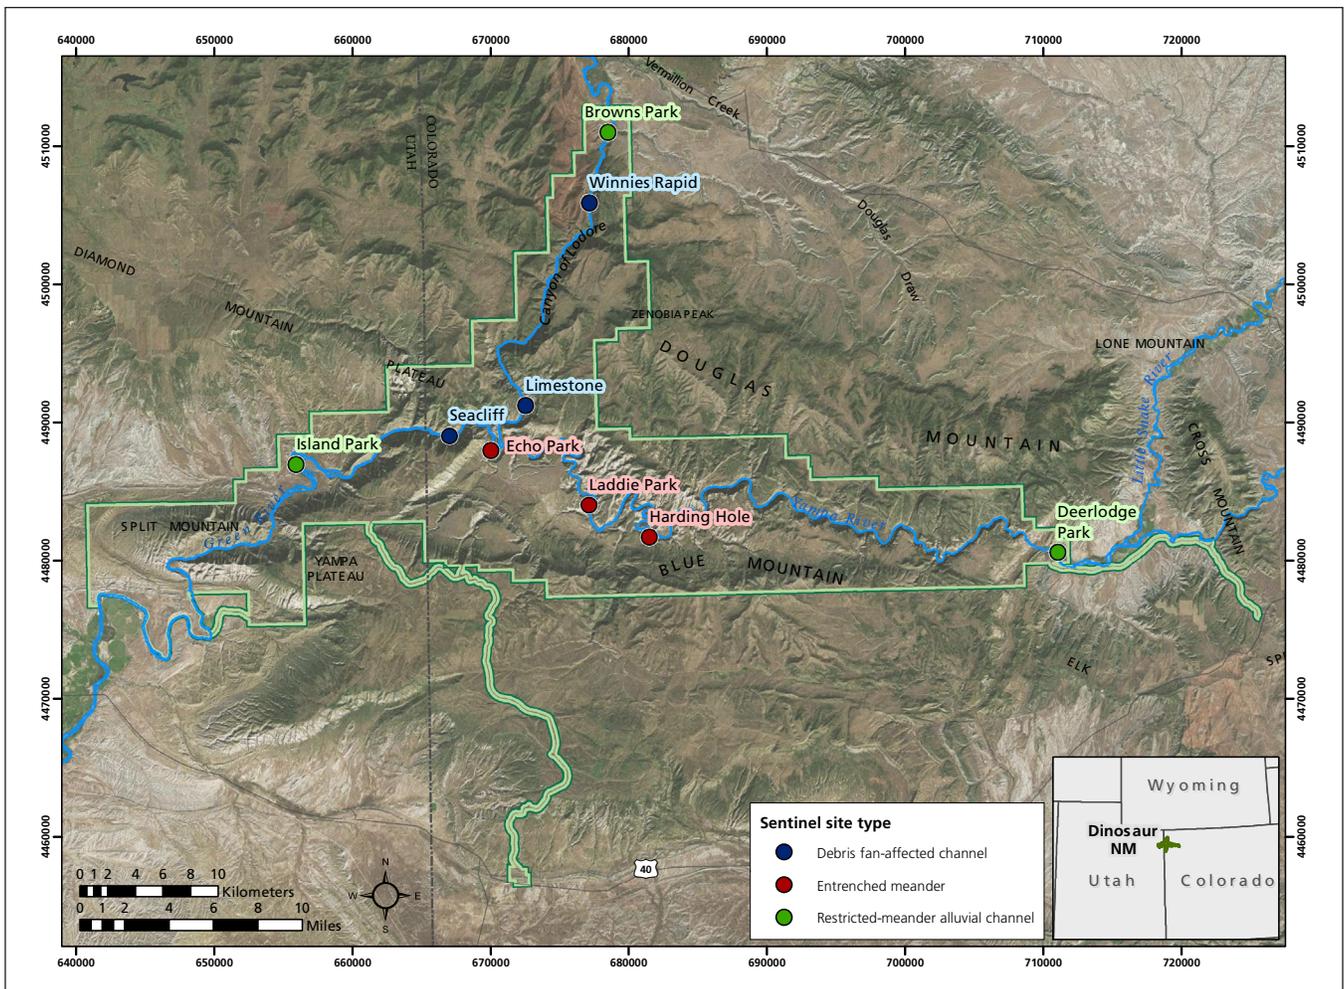
Figure 3-1. The location of nine sentinel monitoring sites within Dinosaur National Monument. These sites represent all of the channel forms found along the Yampa and Green rivers within Dinosaur National Monument.

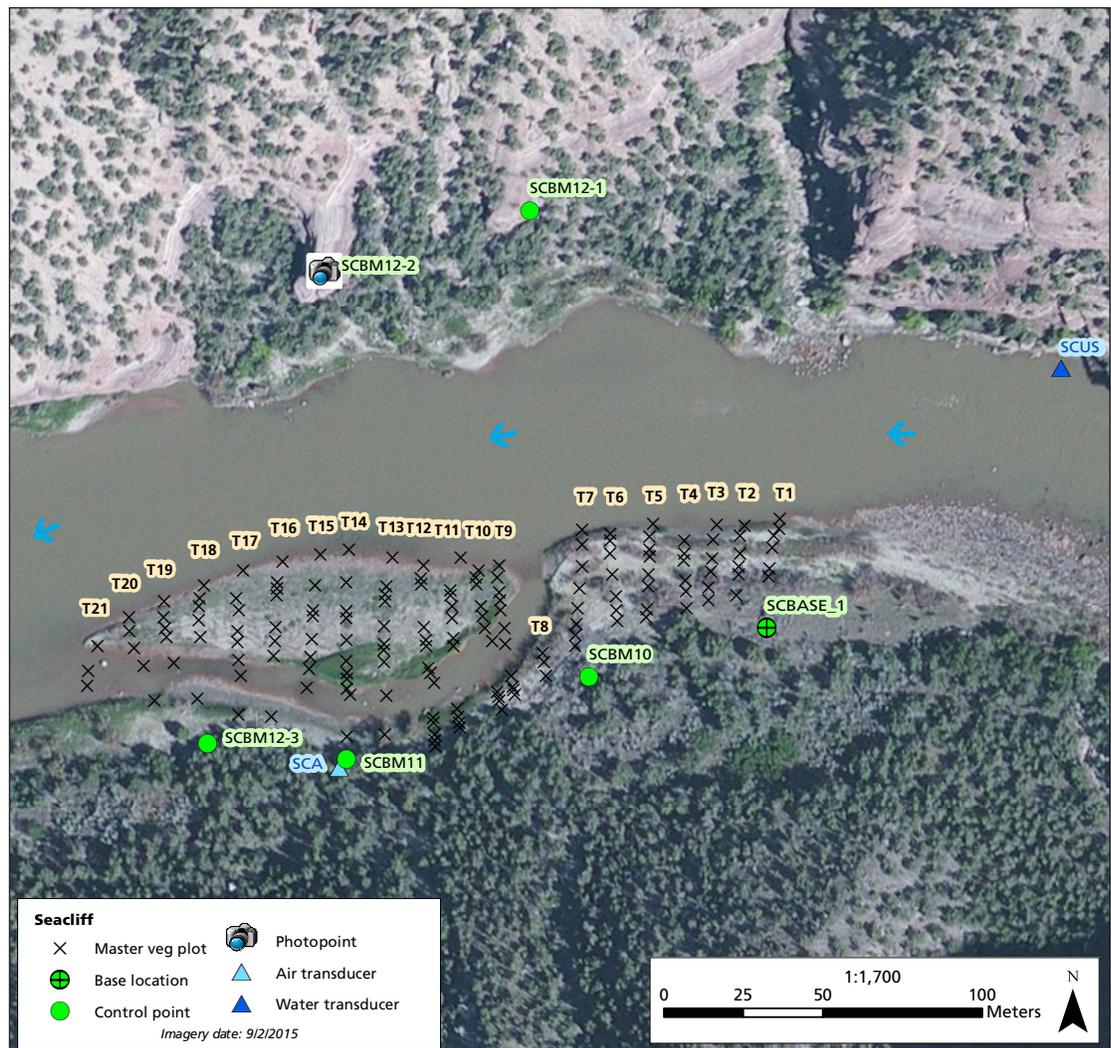
Figure 3-2. Seacliff sentinel site showing plot locations, benchmarks for surveying, air and water transducers, and overview photo locations. The downstream water transducer is not shown, as it is located 200 meters downstream. Depicting its location would have altered the scale of the graphic.

Sentinel sites are designed to be monitored every 1–3 years, with relatively high-intensity data collected at each site. Monitoring at these sites includes repeat measurements of hydrology, geomorphology, sedimentary structure of the geomorphic feature being monitored (facies mapping), vegetation, and repeat photos (Figure 3-2). In this report, we

present the results from data collected from 2010 to 2014 at two sentinel sites: Deerlodge Park, in the restricted-meander alluvial channel type of the Yampa River; and Seacliff, in the debris fan-dominated channel type of Whirlpool Canyon on the Green River (see Figure 3-2).

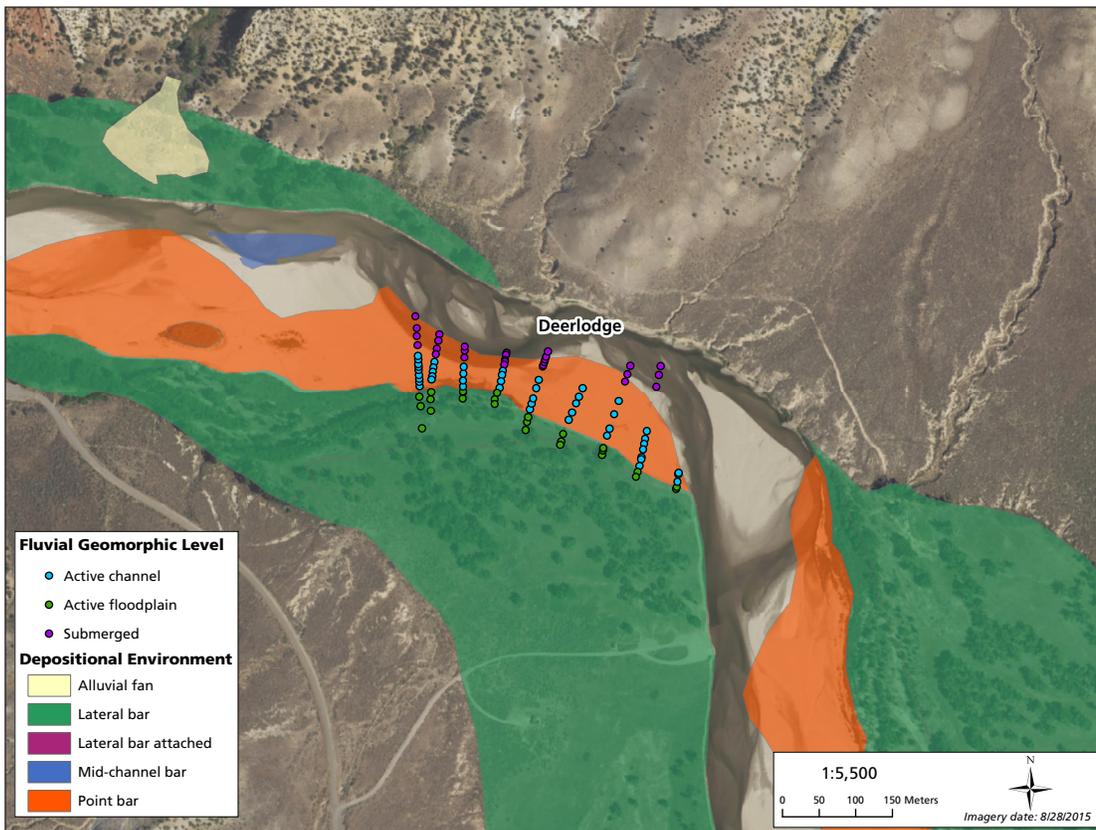
Figure 3-3. Sentinel monitoring at Deerlodge Park, showing depositional environments as identified in the geomorphic mapping of the Yampa River. The distribution of vegetation-sampling quadrats, placed as transects across active-channel and active-floodplain surfaces at the site, is also shown.

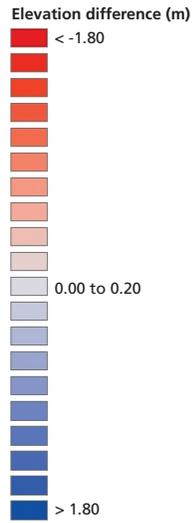
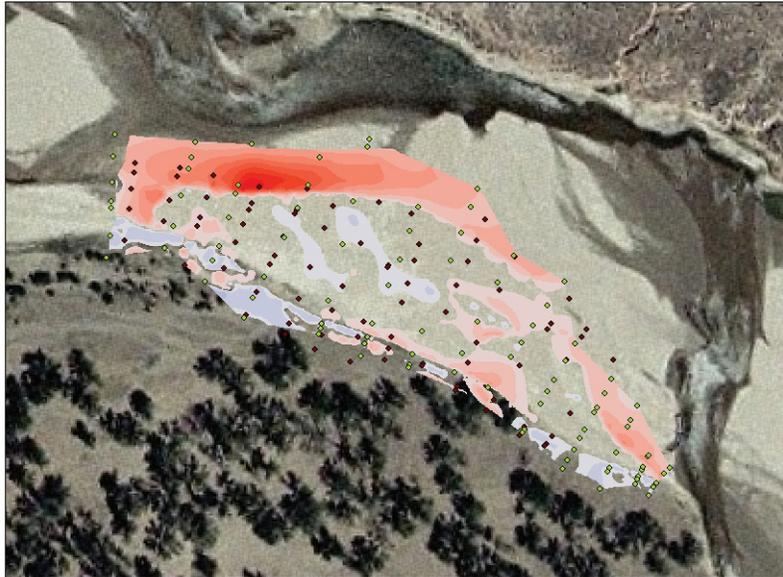
Figure 3-4. Planview of the Deerlodge Park sentinel site, depicting spatial areas of erosion (red shading) and deposition (blue shading) between 2011 and 2012. The figure was thresholded to only show differences greater than 10 centimeters. Figure shows erosion at the downstream end of the site. Flow is from right to left in the image.

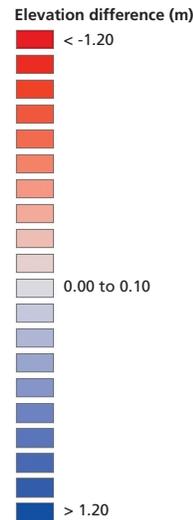
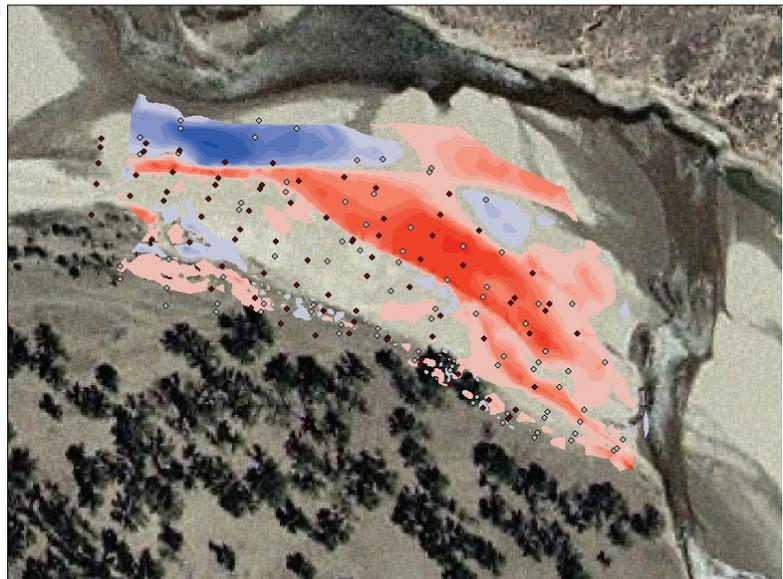
### Deerlodge Geomorphic Change Detection, 2013 vs 2012

Figure 3-5. Planview of the Deerlodge Park sentinel site, depicting spatial areas of erosion (red shading) and deposition (blue shading) between 2012 and 2013. The figure was thresholded to only show differences greater than 10 centimeters. Figure shows erosion at the center and right side (upstream) and deposition at the downstream end of the site. Flow is from right to left in the image.

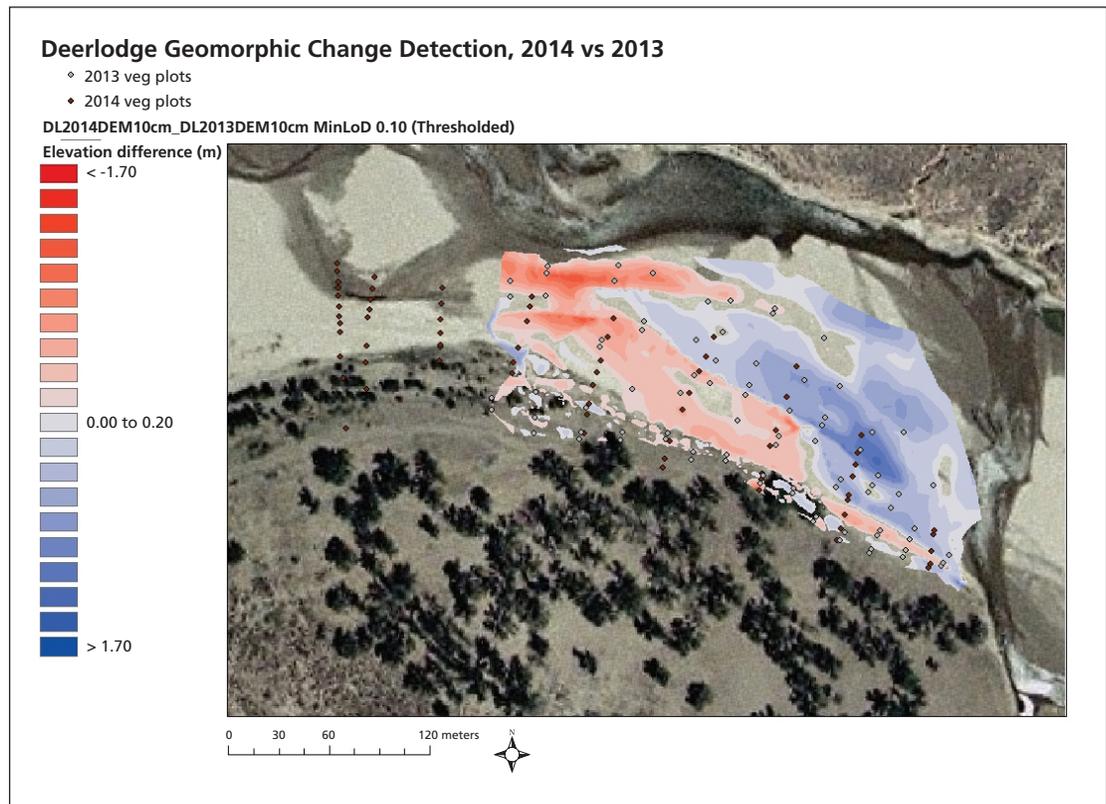
Figure 3-6. Planview of the Deerlodge Park sentinel site, depicting spatial areas of erosion (red shading) and deposition (blue shading) between 2013 and 2014. The figure was thresholded to only show differences that are greater than 10 centimeters. Figure shows deposition at the center and right side (upstream) and erosion at the downstream end and left side of the site. Flow is from right to left in the image.

At Deerlodge Park, there is one large sand facies (Figure 3-14) that was mapped consistently between 2013 and 2014. Grain-size distributions were very similar in this facies between 2013 and 2014 (Figure 3-15). In 2013, the observer noted a pebbly-gravel facies on the river right side of the sand facies, while in 2014 the observer detected a much smaller sandy-cobble facies in the same general area (Figure 3-14). The decrease in size of this facies may have been due to deposition in this area between 2013 and 2014 (see Figure 3-6).

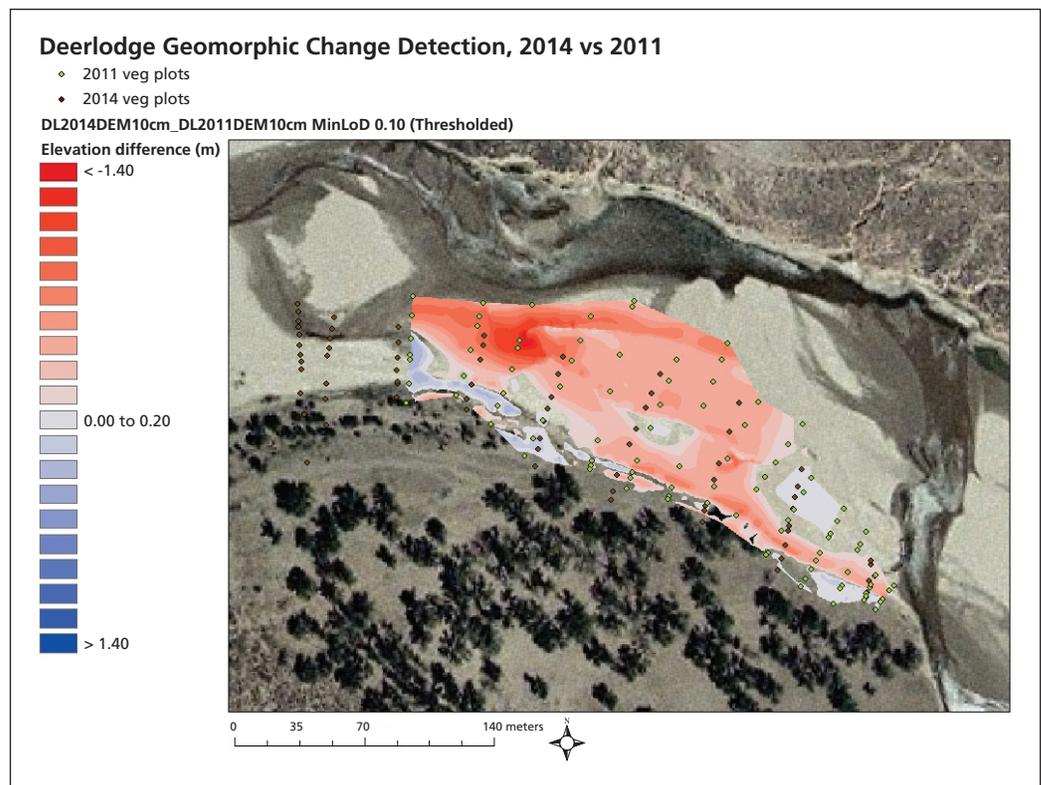
Figure 3-7. Planview of the Deerlodge Park sentinel site, depicting spatial areas of erosion (red shading) and deposition (blue shading) between 2011 and 2014. The figure was thresholded to only show differences greater than 10 centimeters. Figure shows general erosion of the site. Flow is from right to left in the image.

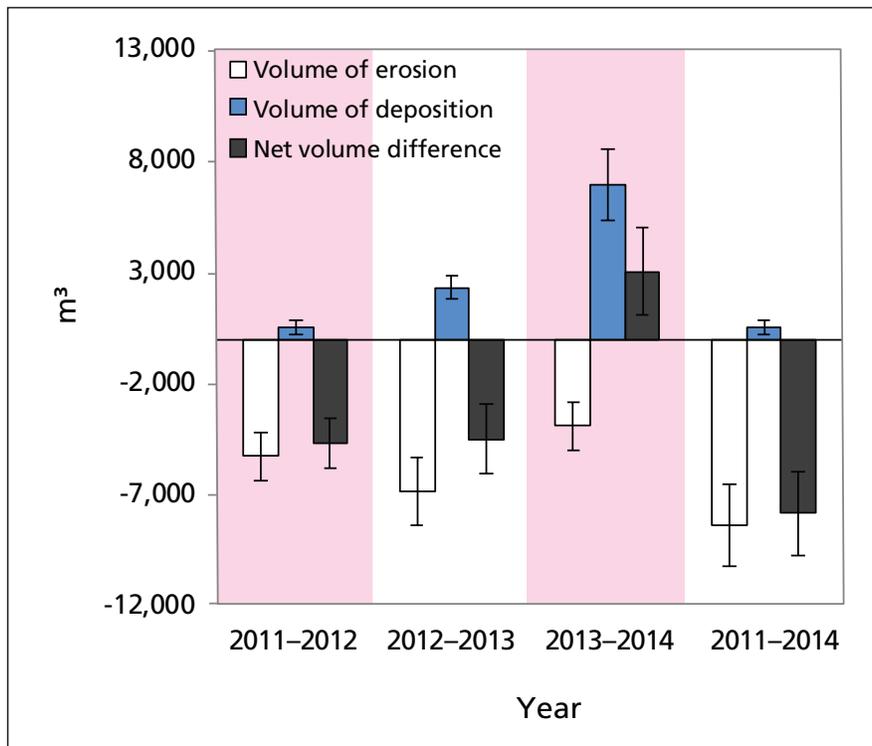
Figure 3-8. Total volume of erosion, deposition, and net volume difference at the Deerlodge Park sentinel site, 2011–2014.

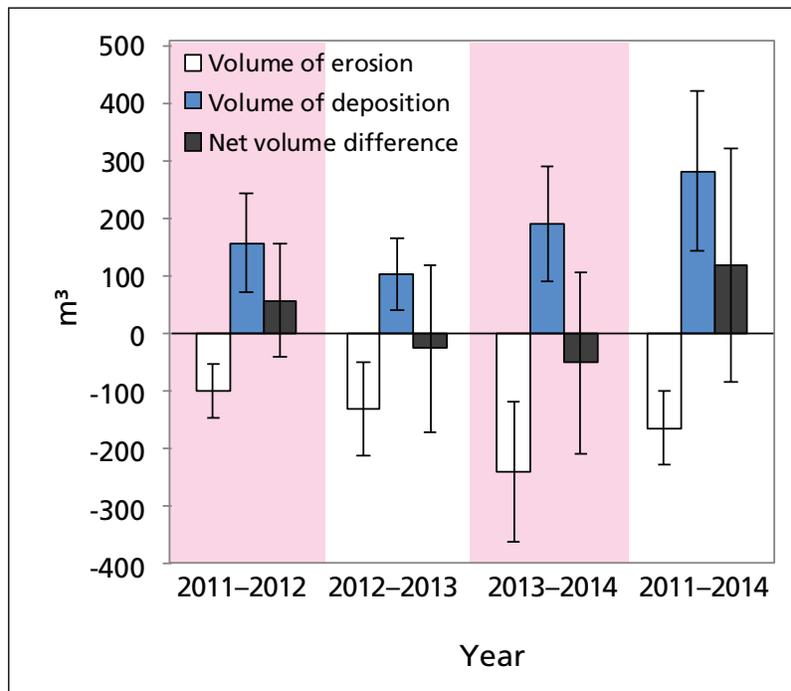
Figure 3-9. Total volume of erosion, deposition, and net volume difference at the Seacliff sentinel site, 2011–2014.

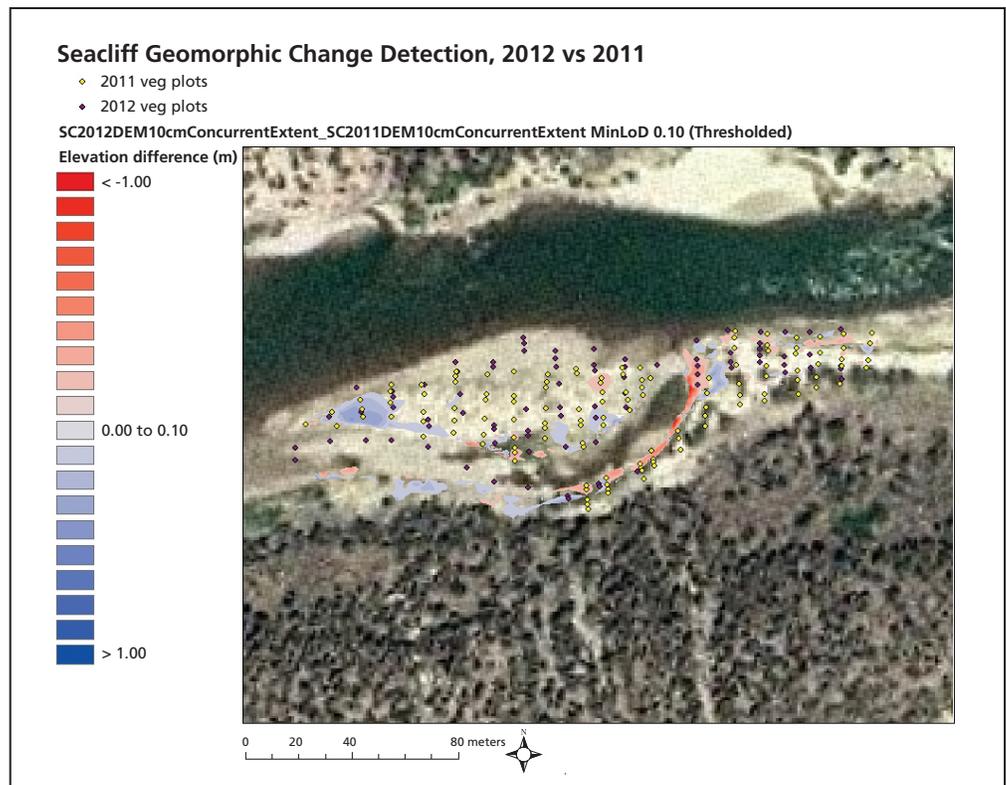
Figure 3-10. Planview of the Seacliff sentinel site, depicting spatial areas of erosion (red shading) and deposition (blue shading) between 2011 and 2012. The figure was thresholded to only show differences greater than 10 centimeters. Figure shows little change other than some deposition at the downstream end of the site. Flow is from right to left in the image.

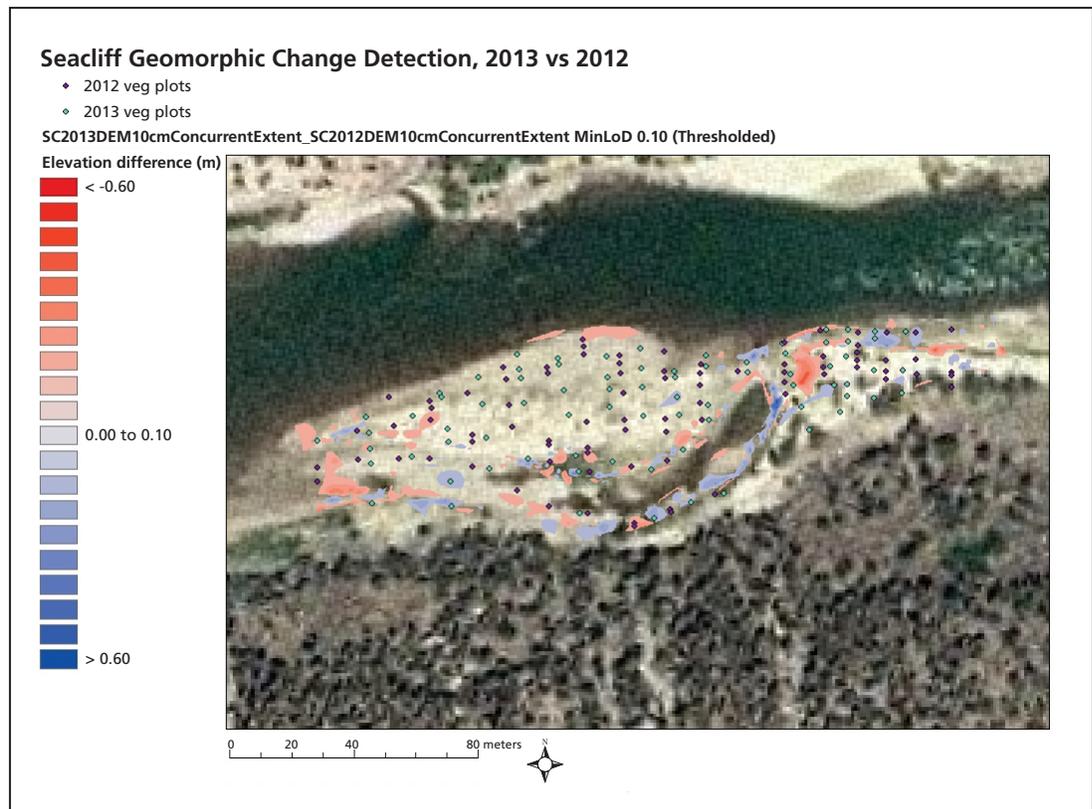
Figure 3-11. Planview of the Seacliff sentinel site, depicting spatial areas of erosion (red shading) and deposition (blue shading) between 2012 and 2013. The figure was thresholded to only show differences greater than 10 centimeters. Figure shows little change between the two sample periods. Flow is from right to left in the image.

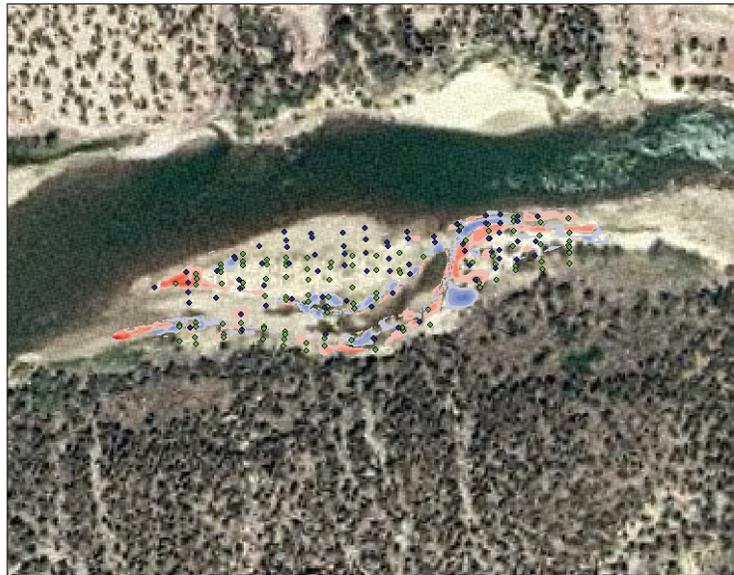
### Seacliff Geomorphic Change Detection, 2014 vs 2013

Figure 3-12. Planview of the Seacliff sentinel site, depicting spatial areas of erosion (red shading) and deposition (blue shading) between 2013 and 2014. The figure was thresholded to only show differences greater than 10 centimeters. Figure shows some erosion at the downstream end of the site with erosion and deposition at the upstream end. Flow is from right to left in the image.

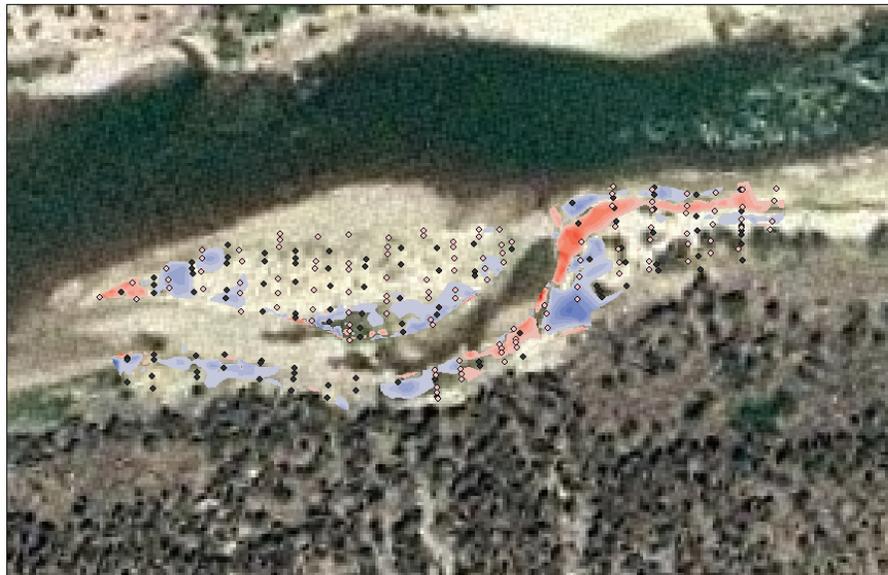
Figure 3-13. Planview of the Seacliff sentinel site, depicting spatial areas of erosion (red shading) and deposition (blue shading) between 2011 and 2014. The figure was thresholded to only show differences greater than 10 centimeters. Figure shows some deposition on the sandcaps in the center of the site and mixed deposition and erosion at the downstream and upstream ends. Flow is from right to left in the image.

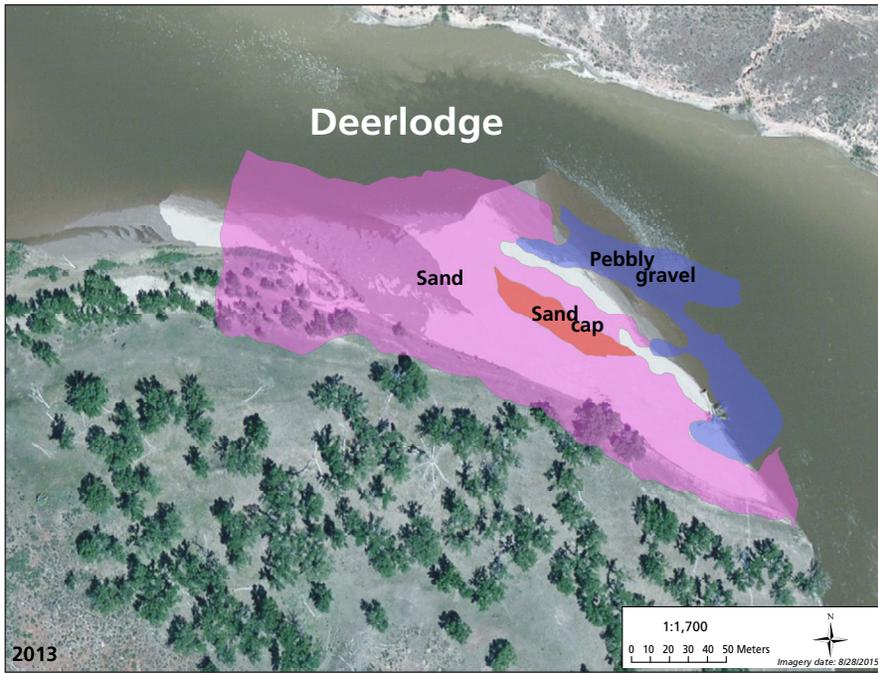
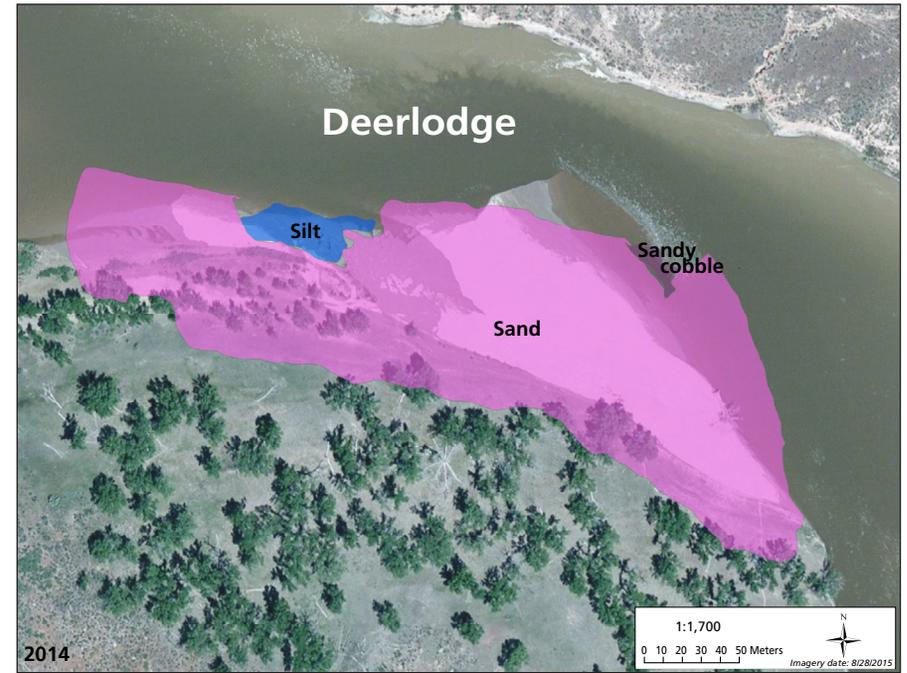
Figure 3-14. Facies mapping from the Deerlodge Park sentinel site, 2013 and 2014. Figure shows a large, stable sand facies with changing facies on the river-right side of the sand facies, dependent on flows. Facies mapping is designed to detect state changes. Small size changes in individual facies can be the result of different observers. Flow is from right to left in the image; river-right is toward the top of the image.

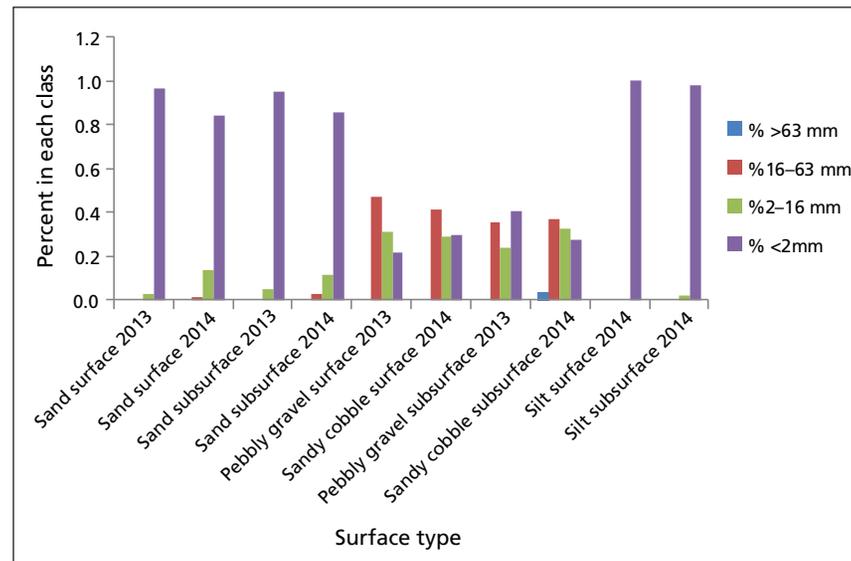
Figure 3-15. Surface and subsurface grain-size distributions from the facies at the Deerlodge Park sentinel site in 2013 and 2014.

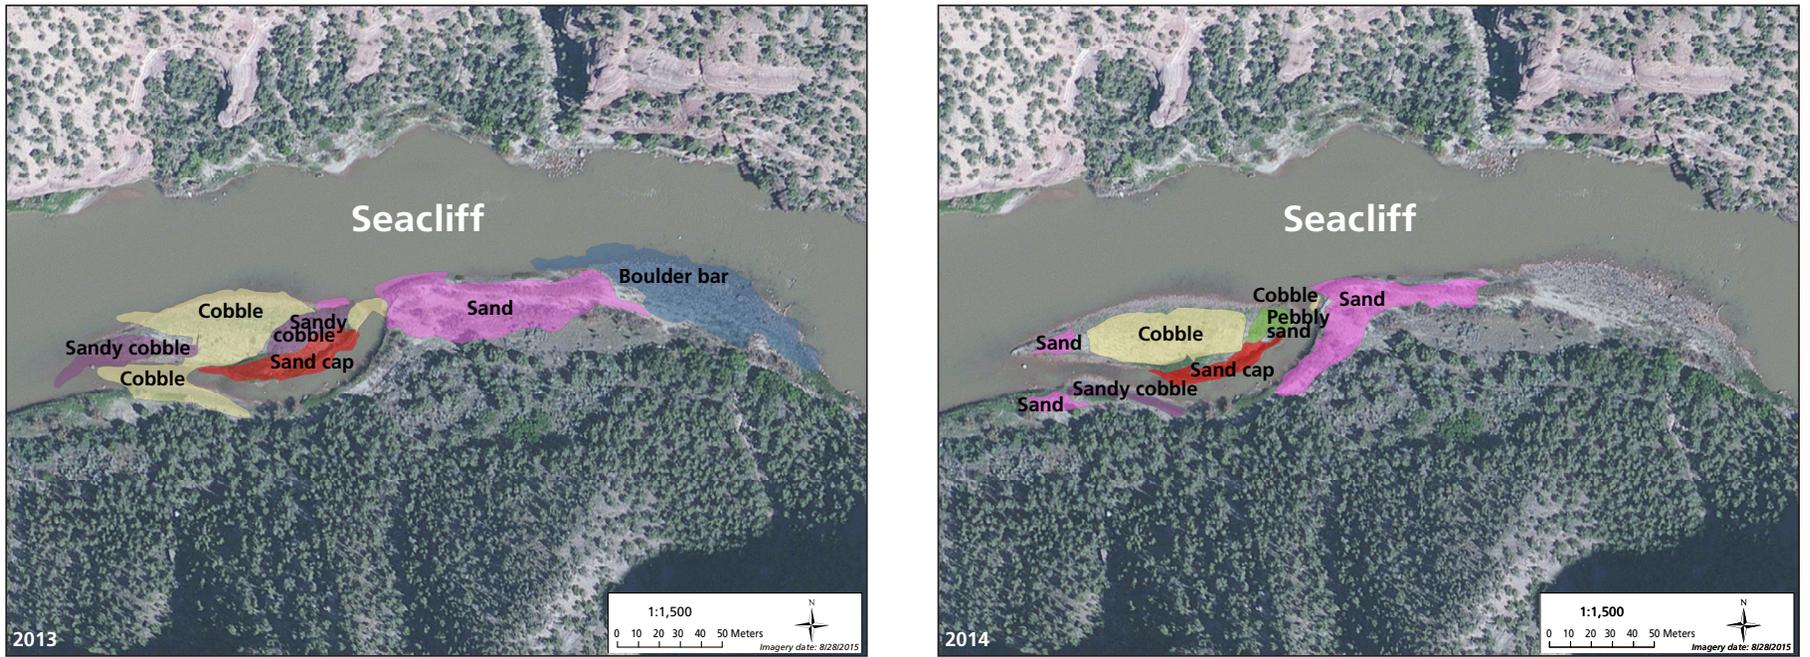
Figure 3-16. Facies mapping from the Seacliff sentinel site. Figure shows a largely stable site from 2013 to 2014. Facies mapping is designed to detect state changes. Small size changes in individual facies can be the result of different observers. Flow is from right to left in the image.
