# Big Rivers Monitoring within Dinosaur National Monument

*A summary of monitoring results to detect change in channel condition*

Natural Resource Report NPS/NCPN/NRR—2018/1635

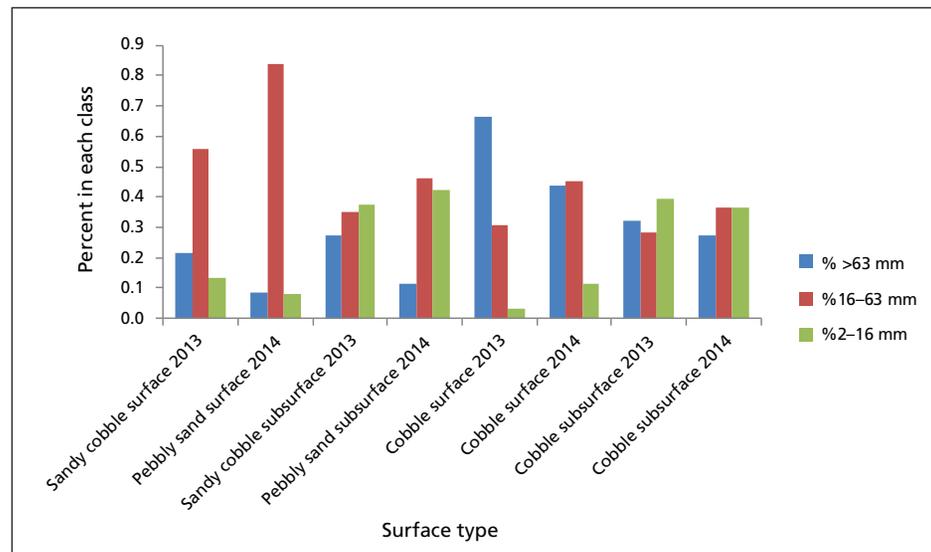
Figure 3-17. Surface and subsurface grain-size distributions from the facies at Seacliff sentinel site in 2013 and 2014.

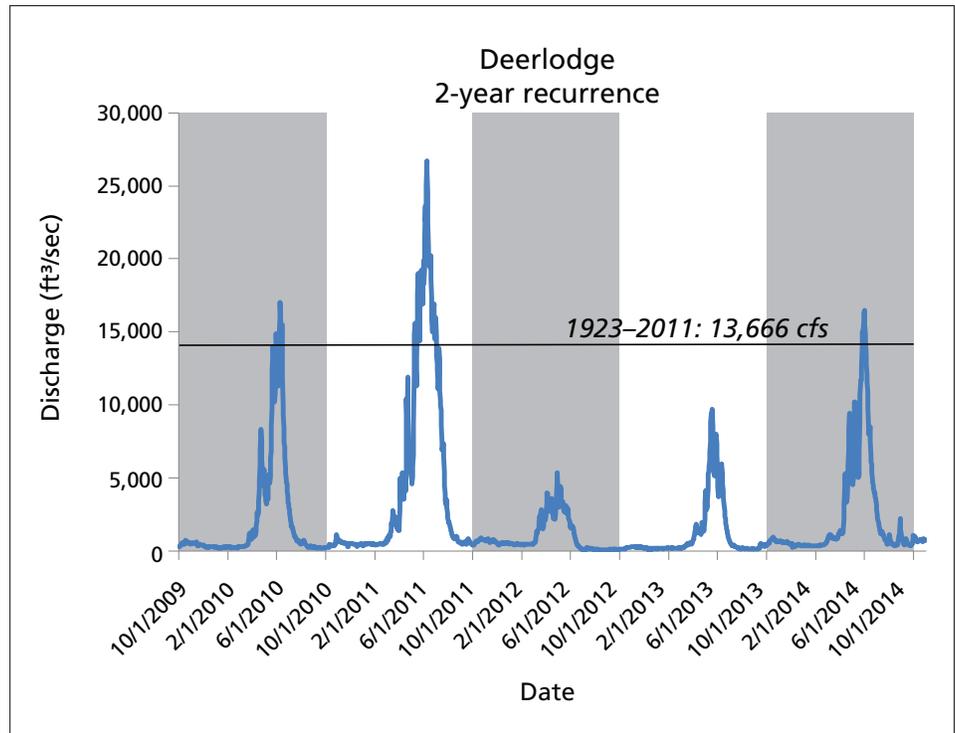
Figure 3-18. Hydrograph of Yampa River discharge at Deerlodge Park featuring peak flows from 2010 to 2014. The average two-year recurrence flow calculated for the period 1923–2011 (Manners et al. 2014) is indicated. This is the discharge considered necessary to inundate the active floodplain. We present discharge in cubic feet per second here to be consistent with reported gage information.

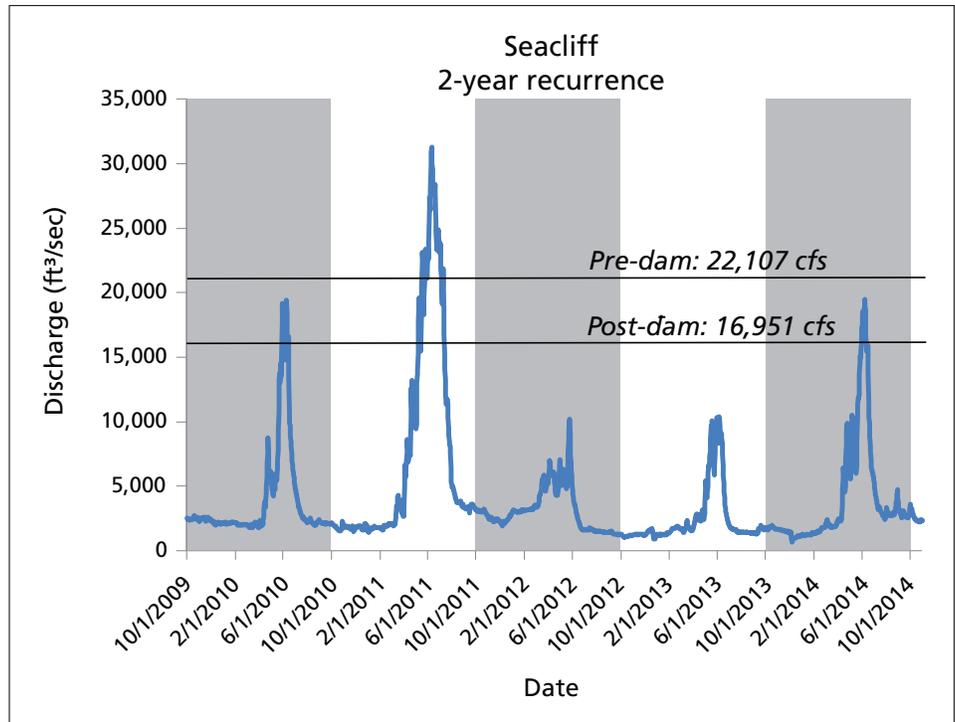
Figure 3-19. Hydrograph of Green River discharge at Jensen, UT, featuring peak flows from 2010 to 2014. The average two-year recurrence flow calculated for the pre- and post-dam periods (Grams and Schmidt 2002) is indicated. This is the discharge considered necessary to inundate the active floodplain. We present discharge in cubic feet per second here to be consistent with reported gage information.

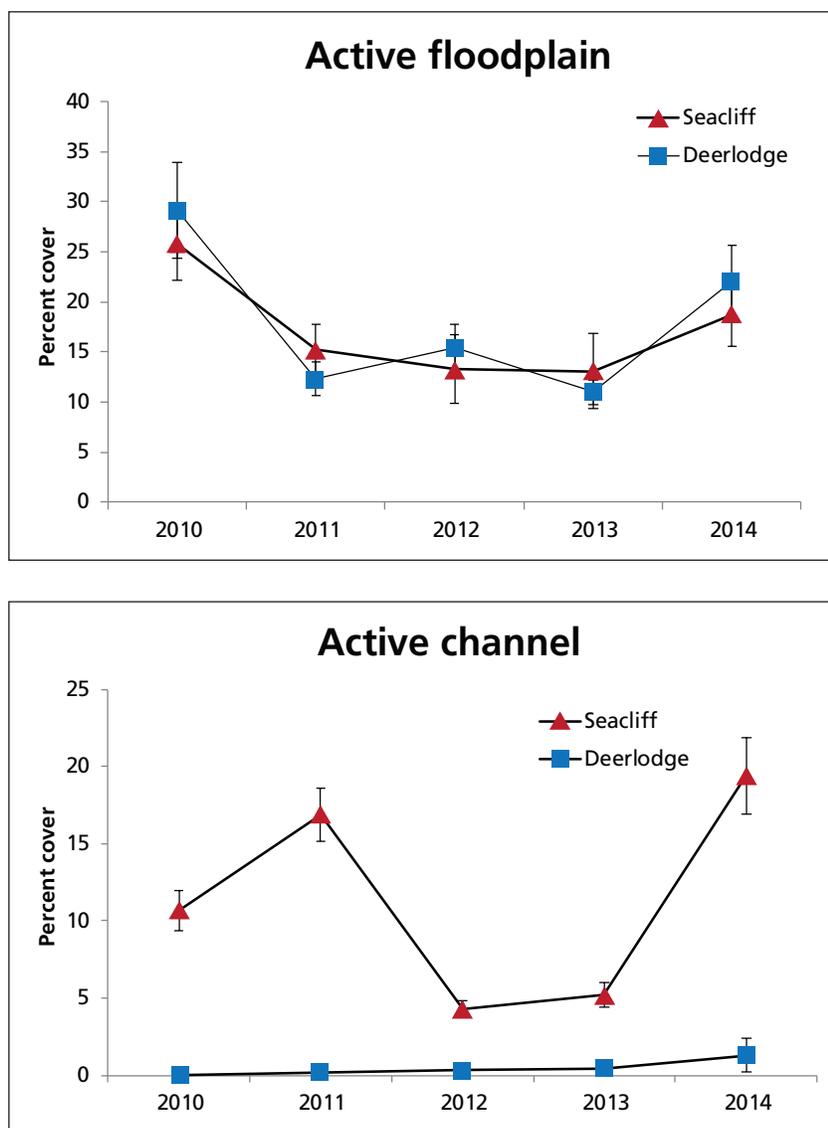
Figure 3-20. Percent cover of vegetation on active-channel and active-floodplain surfaces for the Seacliff and Deerlodge Park sentinel sites, as measured in the field in 2010–2014. Sampling dates in all years are late summer, July–September, post-snowmelt flood.

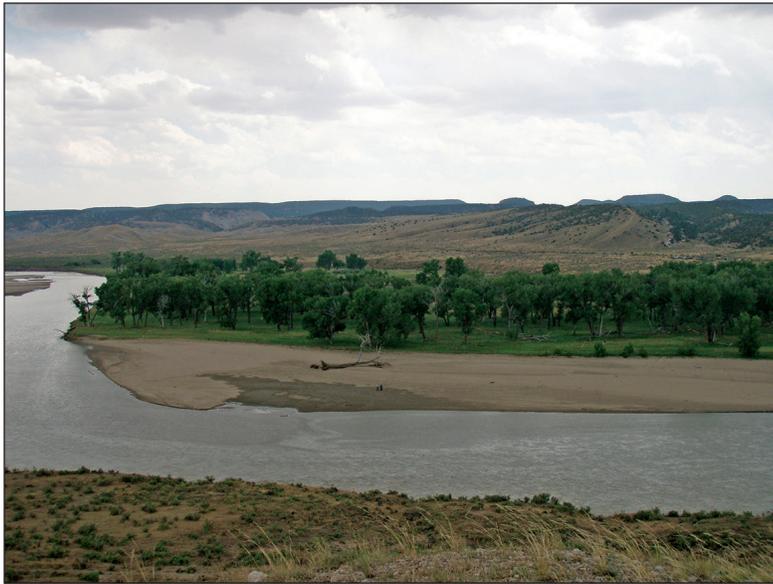
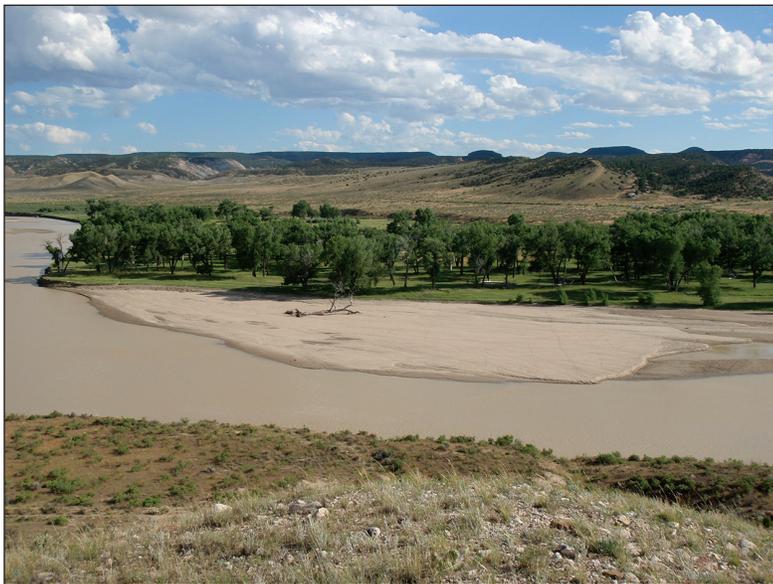
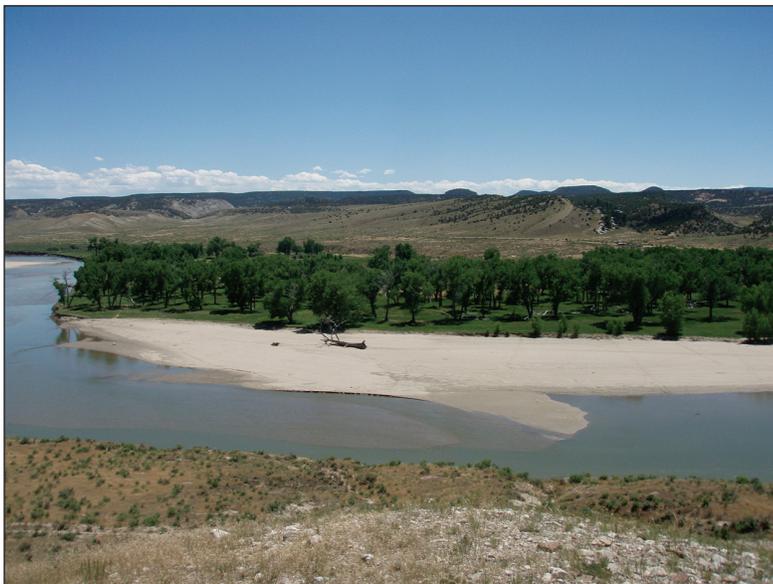
Figure 3-21. Reference photos of Deerlodge Park from river-right to river-left: (A) July 15, 2014, at 1,290 cfs, (B) July 21, 2015, at 809 cfs, and (C) July 13, 2016, at 896 cfs. Reference photos were not established until 2014. These photos show the large amount of deposition that occurs in restricted-meander channel types. Note the deposition of sand on the downstream edge from 2014 to 2015 and again from 2015 to 2016. Also note the change in orientation of the large cottonwood tree from 2015 to 2016. Flow is from left to right in the images.

One or more photopoints have been established for each of the sentinel sites. The purpose of these photos is to document long-term, broad-scale changes in the geomorphic condition of the sentinel site. Such photos have been very effective at interpreting long-term changes in vegetation and channel condition in the Grand Canyon (Webb 1996; Webb et al. 2011). Figures 3-21 and 3-22 are examples of the reference photos established for the Deerlodge Park and Seacliff sentinel sites.

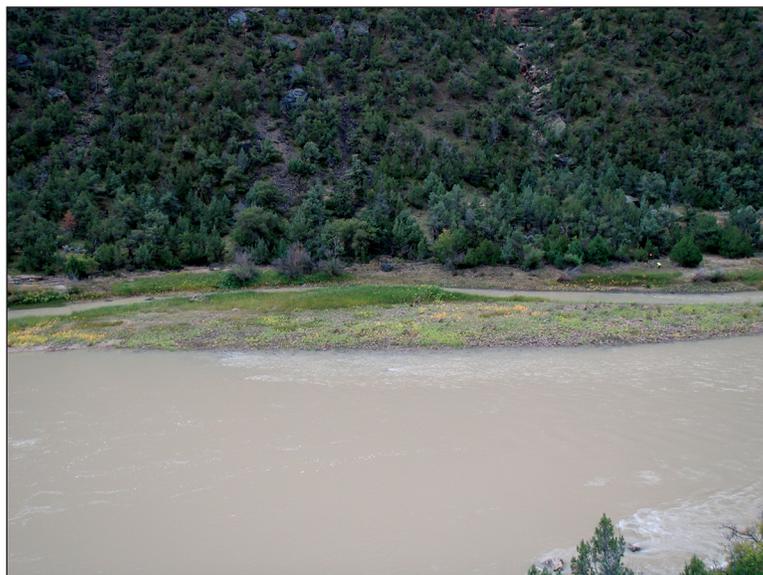
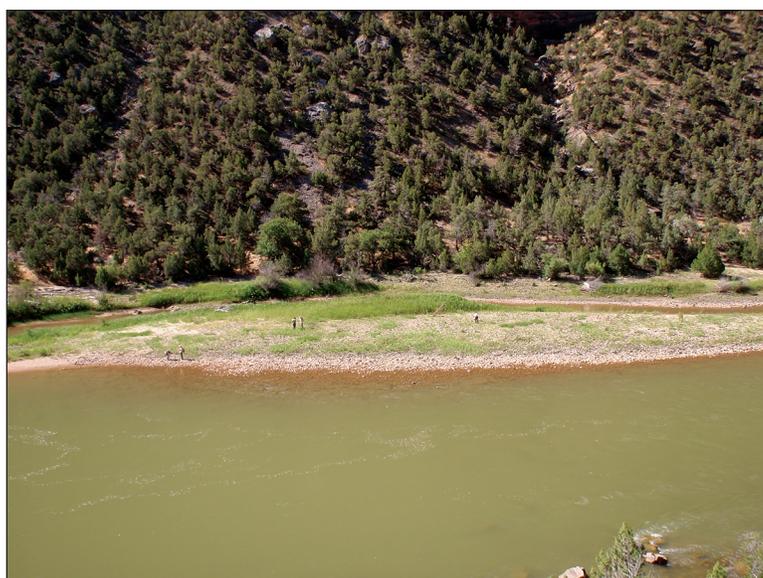
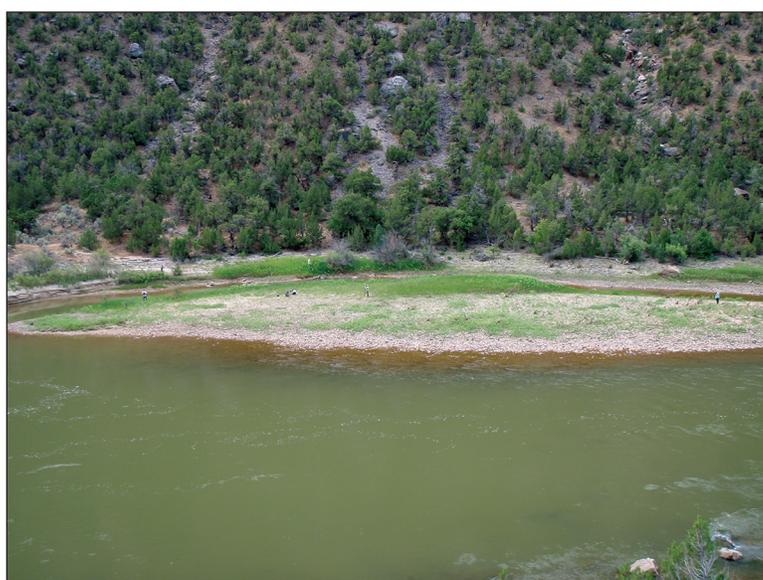
Figure 3-22. Reference photos of Seacliff: (A) September 29, 2014, at 3,010 cfs, (B) August 2, 2015, at 2,300 cfs, and (C) July 31, 2016, at 2,170 cfs. To be effective, photo matches must be relocated and reframed with high precision to the founding photo and be of similar quality and ideally taken with the same camera, lens, and focal length.

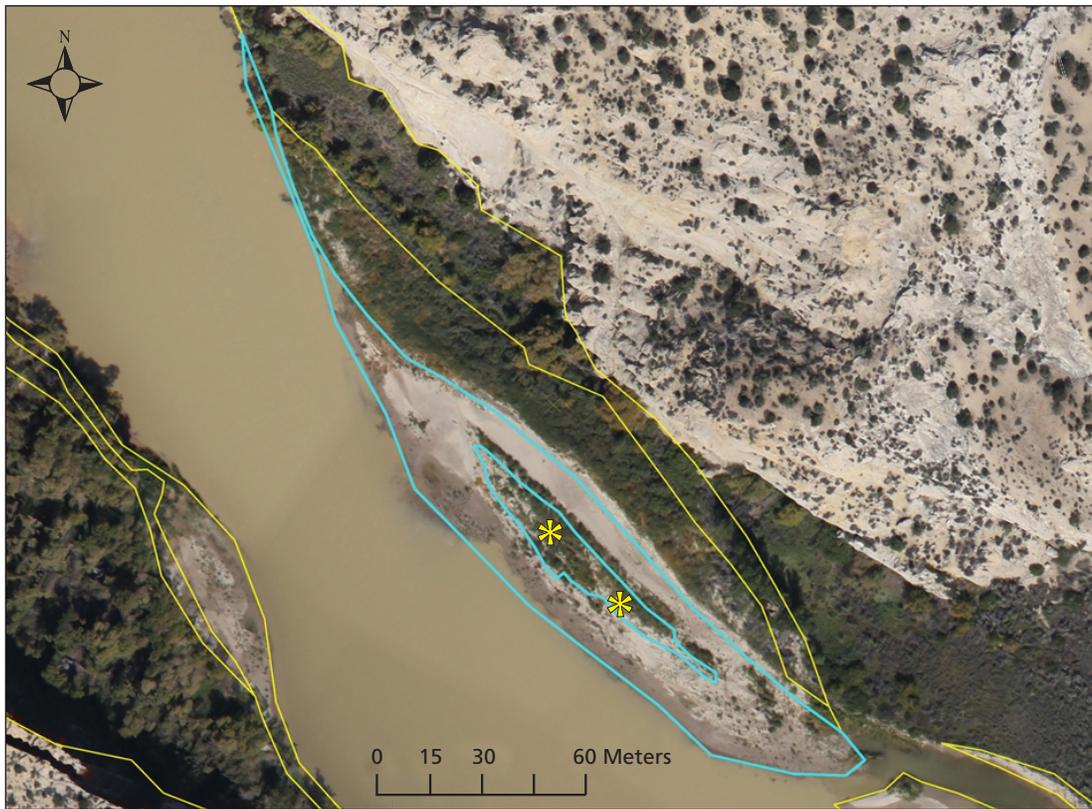
Figure 3-23. A lateral bar located just downstream of the Deerlodge Park USGS gage. The blue polygon delineates the active-channel surface. Yellow polygons are other geomorphic surfaces (active floodplain, inactive floodplain, or uplands) not included in the rapido assessment. At the center of the bar is a vegetated sandcap, which corresponds in elevation and total vegetation cover with an active-floodplain surface. The yellow asterisks mark locations of the quickplots sampled on the sandcap.
