FORT VANCOUVER EXCAVATIONS - V

Flagstaff and Belfry

United States Department of the Interior

October 1973

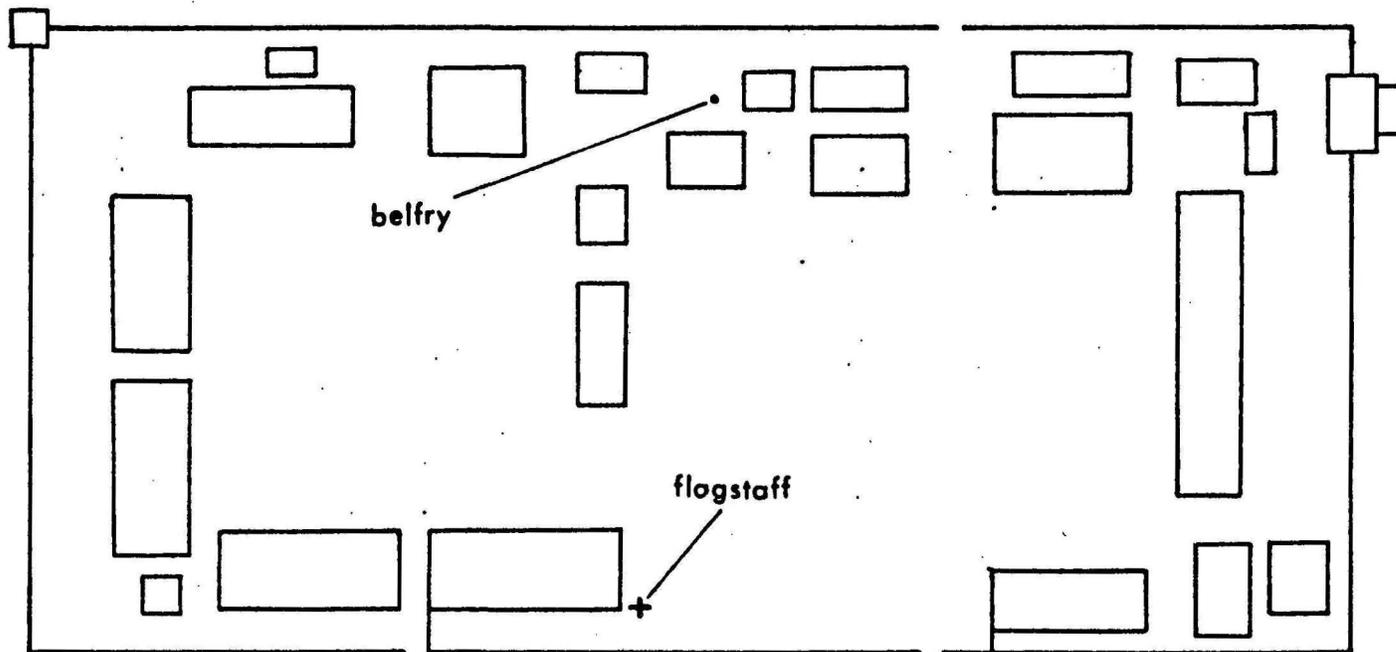
Fig. 1 - Archeological locations of the Flagstaff and Belfry in relation to major buildings of 1845 as plotted by Lt. M. Vavasour of the Royal Engineers (redrawn from Hussey 1972:Pl. VII).

Subsurface remains of the Flagstaff were found immediately east of the 1845 period Fur Store (Fig. 1). Distance from the center of the Store's southeastern corner footing to the center of the staff was 9 ft. east and one ft. north. This location was about 22 ft. north of the centerline of the 1845 period Stockade trench, and less than 9 ft. east of the actual east wall of the Fur Store.

Remains of the Belfry were found in the north central sector of the Fort. By reference to a map of past explorations (Caywood 1955: sheet 8 of map 2), we determined this location to be about 32.5 ft. south of the northern Stockade, about 18 ft. north of the New Office north wall, and about 15 ft. west of the presumed west wall of the Jail (Fig. 1).

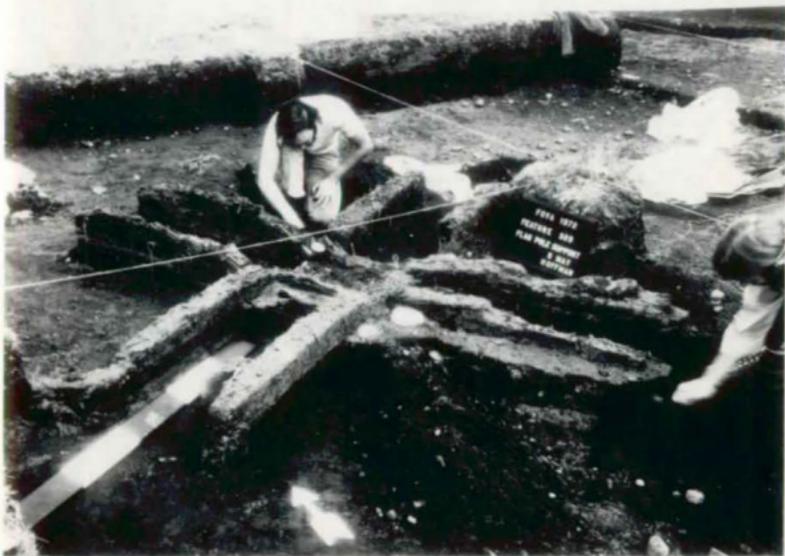
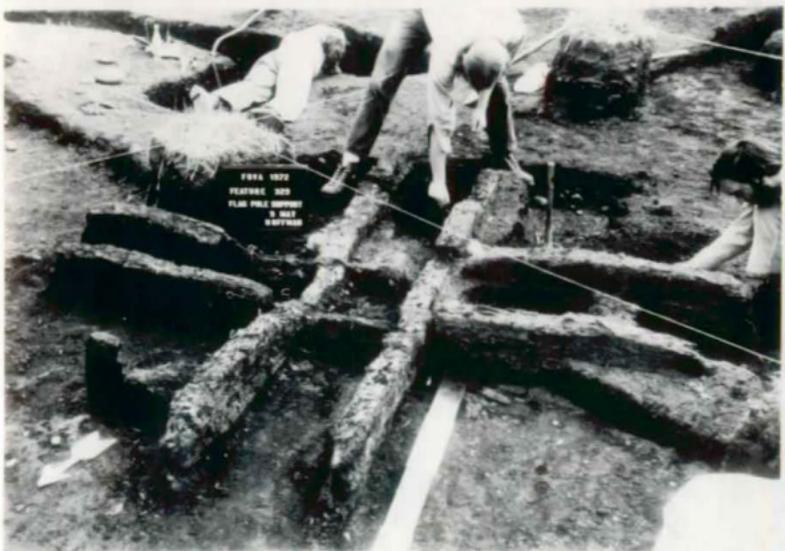
Fig. 2 - Crossed timbers of Flagstaff support.

a - Excavating timbers from HBC matrix  
(FOVA neg. 069.51-72/14)

b - View of rectangular collar at center  
of crossed timbers (FOVA neg. 069.51-72/13)

Remains consisted of 4 wooden timbers laid horizontally and notched to intersect each other. These were set slightly under the top of the HBC surface (Fig. 2). Field records indicate that the old surface was a compacted level immediately below modern sod. Tops of the timbers were slightly deeper than the tops of other HBC features in the immediate area. Center of the crossed timbers formed a rectangle that contained a cast and fragments of the wooden staff butt. Under the timbers and surrounding the butt remains was a large hole originally dug to set the butt (Fig. 3).

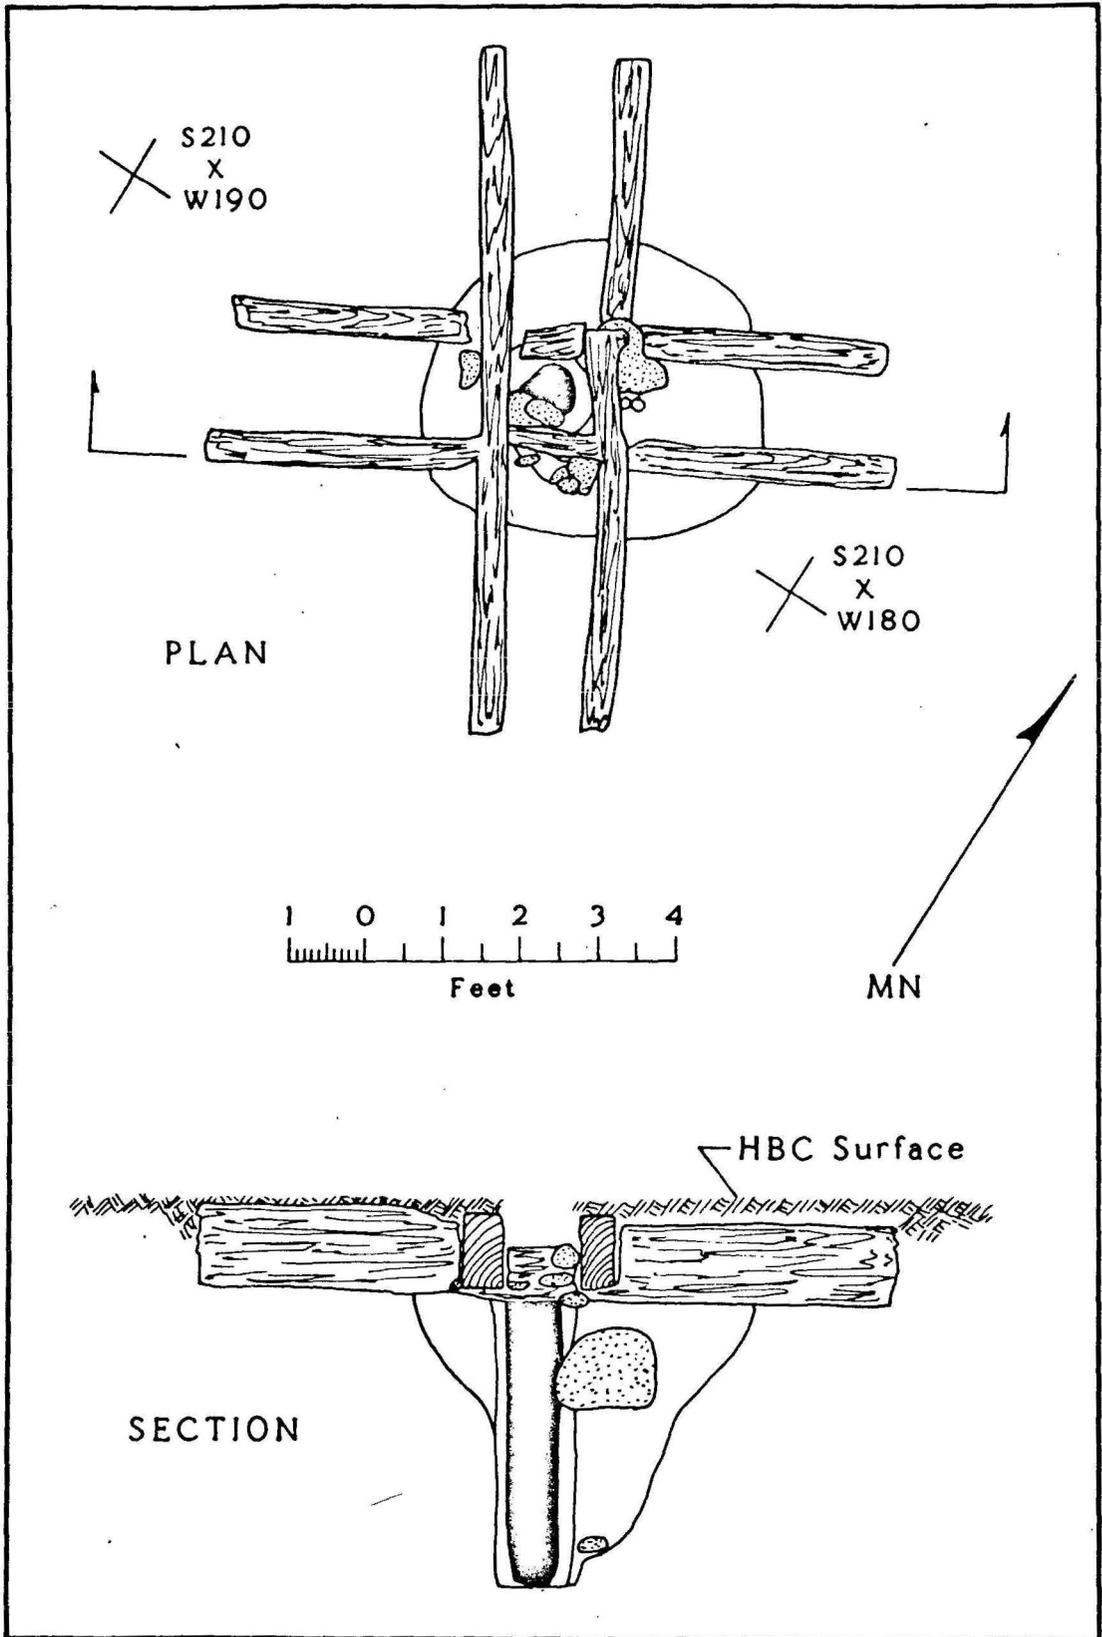
Fig. 3 - Archeological plan and section of Flagstaff remains.

Intersection of the timbers formed a rectangular area that varied from 0.95 to 1.20 ft. on a side. This area formed the supportive collar for the Flagstaff. Remains of the wooden butt were badly rotted; however, a well-preserved cast of the butt indicated the original diameter to have been one ft. Evidence of the cast and butt fragments were found within the collar but they extended only 3.55 ft. below the timbers (Fig. 3).

The hole dug to set the butt had an oval plan 3.7 to 4.3 ft. in diameter and an irregular section. Part of the hole fill consisted of large stones used to brace the butt. We were unable to find evidence of the HBC excavation opened for the setting of the timbers. While several small posts and stakes were found in the vicinity of the Flagstaff remains, we could not conclusively identify them as auxiliary supports.

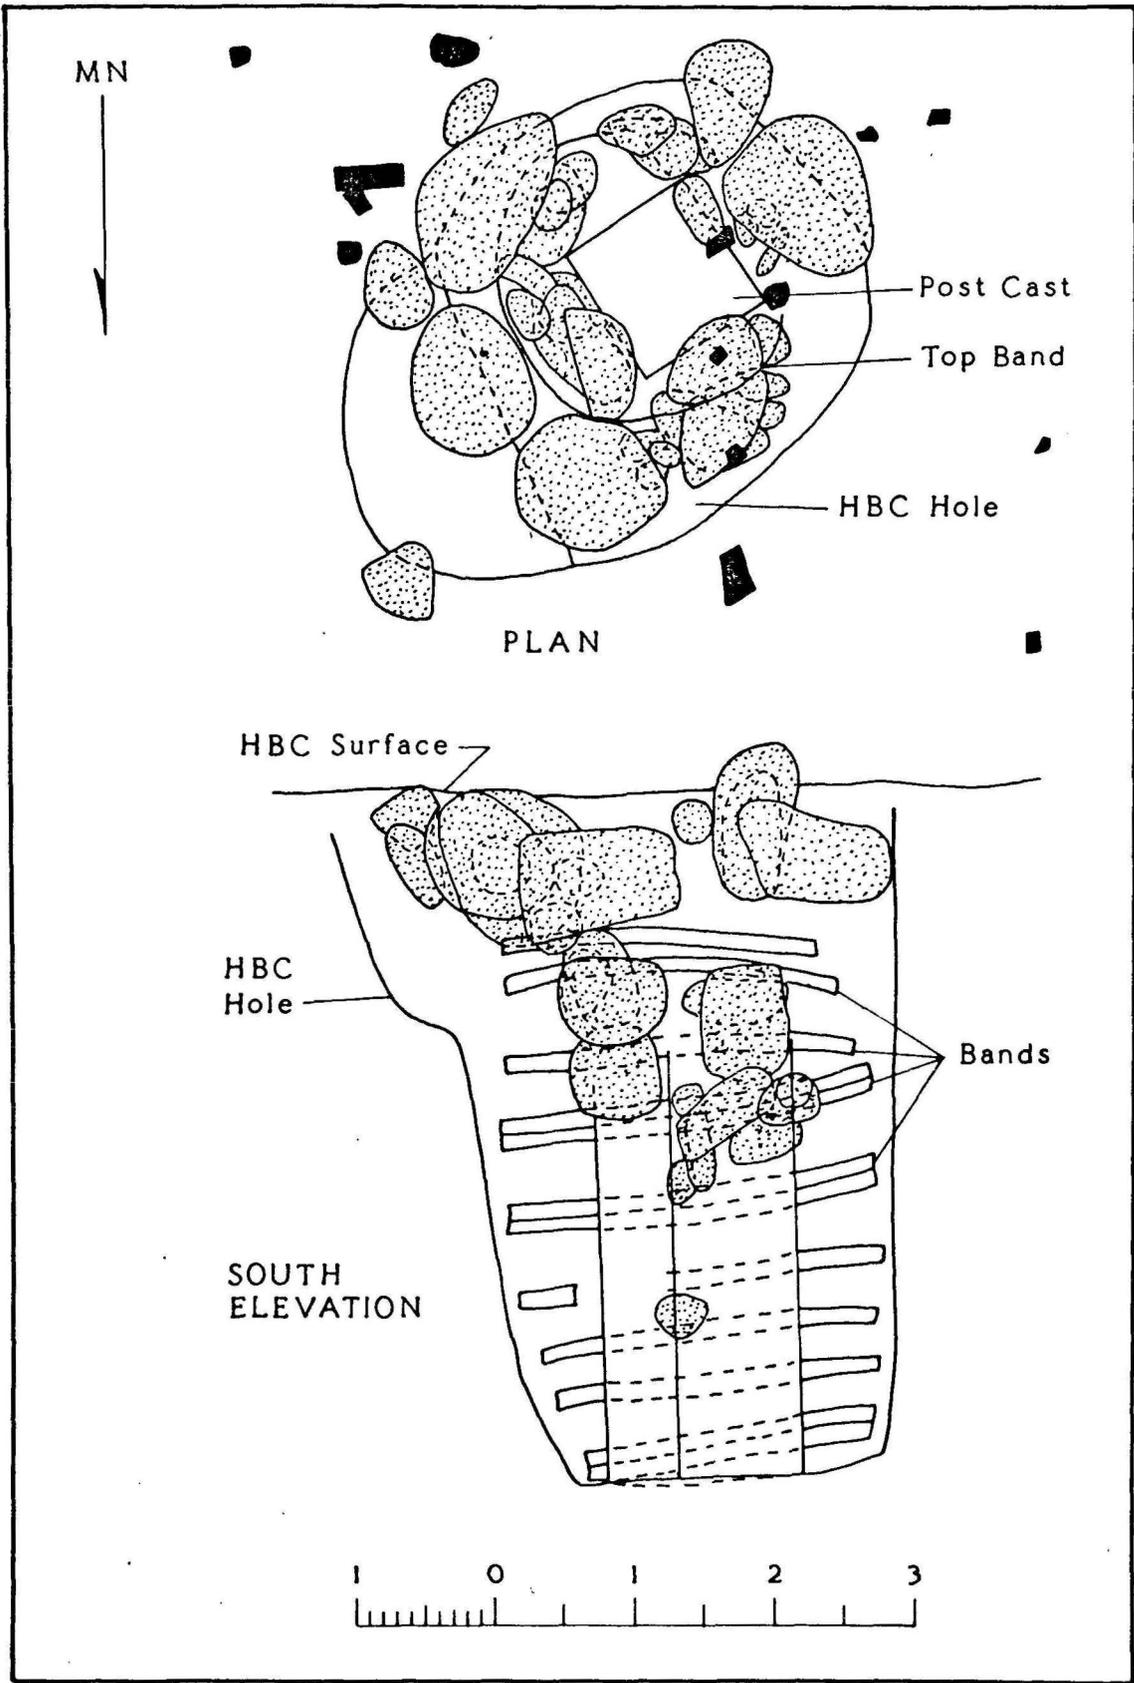
Fig. 5 - Archeological plan and section of Belfry remains.

Base of the Belfry consisted of an iron-hooped wooden barrel set 4.80 to 4.95 ft. below the HBC surface (Fig. 5). Top of the barrel was ringed with large, rounded stones which were partially exposed at the HBC surface (Fig. 7a). The only remnant wood of the barrel was found adhering to a series of iron hoops that remained in place after rotting of the barrel. However, partial stave casts were found in the earthen matrix. Within the barrel was the vertical cast of a one-ft. square wooden timber that was the butt of the bell mast (Fig. 7b). The butt had been packed in the barrel with black silty clay and, in its upper portions, large rounded stones (Fig. 5). In addition to the archeologically

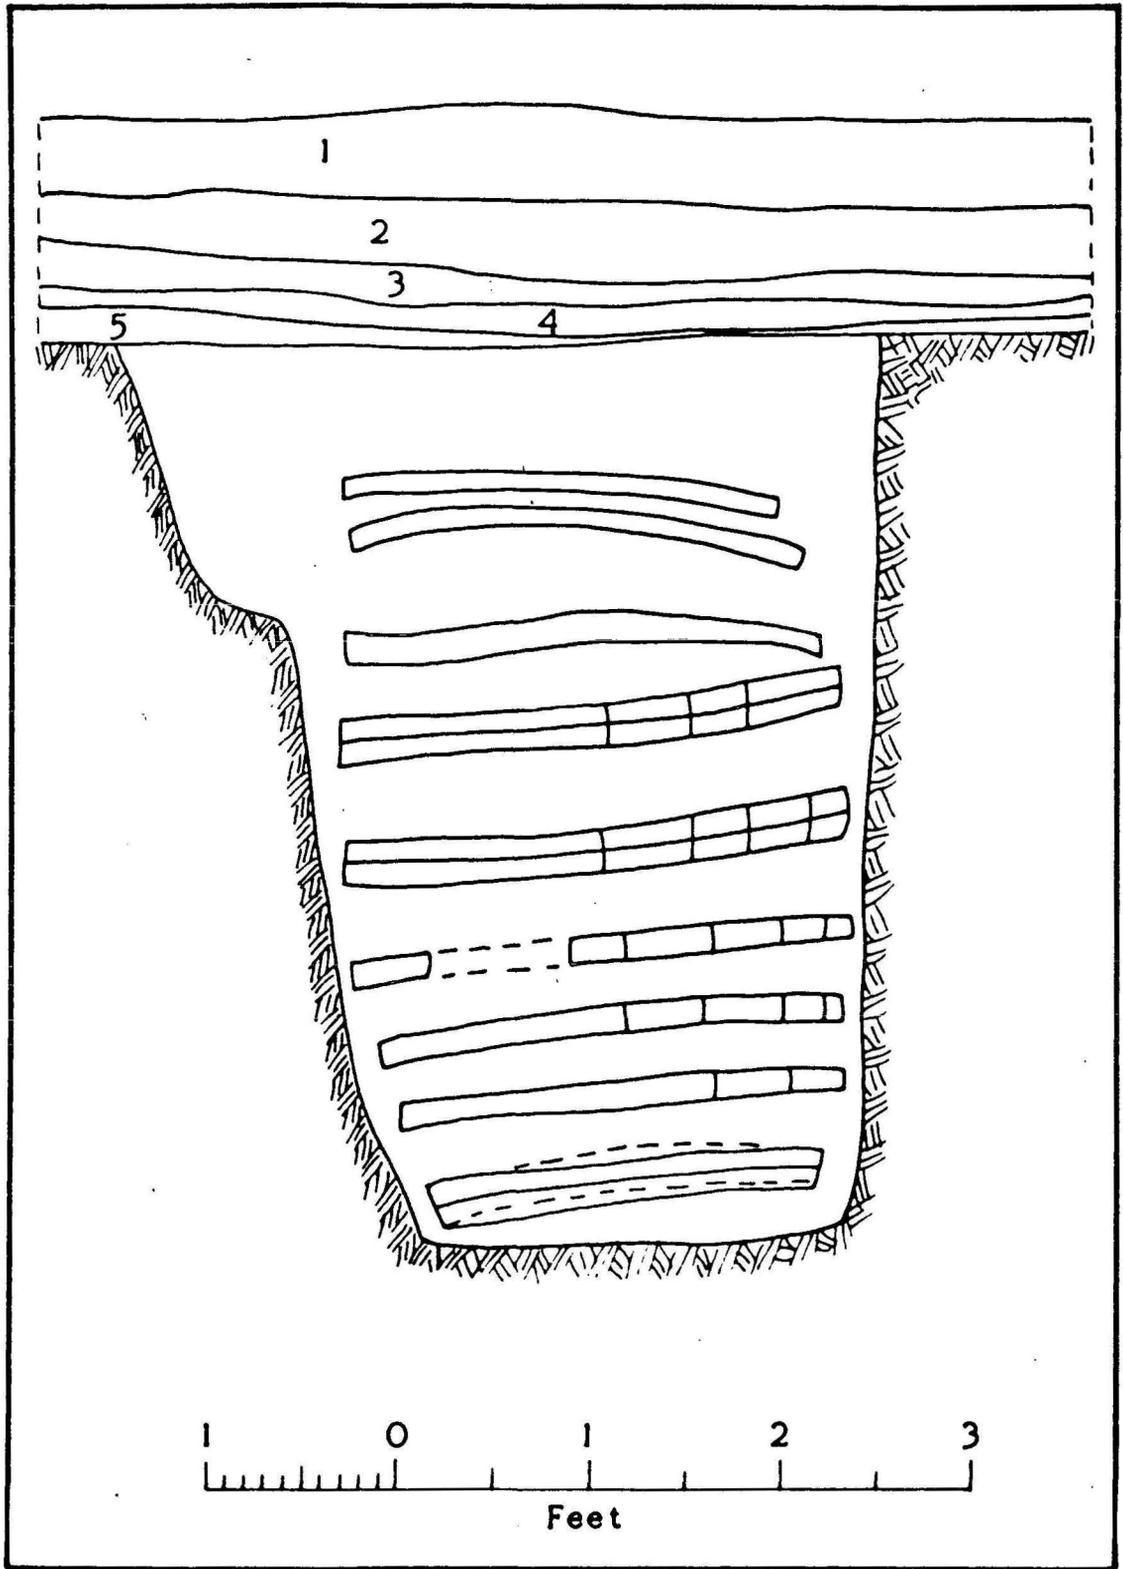
Fig. 6 - Soil stratigraphy and hoop positions of the Belfry base.

Several 10-ft. square units were opened in this general area before finding the Belfry location. These exploratory efforts revealed modern U.S. Army trash, a short section of railroad spur, scattered and mixed HBC trash, and outlines of past explorations. Fortunately, the subsurface remains of the Belfry were undisturbed by modern intrusions, and soil stratigraphy was quite clear (Fig. 6).

The first layer over the Belfry base was a mixture of gravelly, silty clay 0.35 to 0.45 ft. thick. Top of this modern layer was the grass-covered surface of 1973. The second layer consisted of fine and coarse sands 0.2 to 0.4 ft. thick slightly mixed with clay at its upper portion. This appeared to be deliberate fill from USA activities of 1918-19. The third layer was a moist band of silty clay mixed with small amounts of gravel. It was 0.10 to 0.25 ft. thick and represented deposition from a late 19th Century river flood. The fourth layer, the main HBC cultural deposit, was 0.05 to 0.20 ft. thick. It consisted of moist, brown silty clay mixed with buff pea gravels and HBC specimens. Since this layer was sealed by a historically known flood, we assume the top of layer 4 to be the last HBC occupation surface. The fifth layer was a moist mixture of brown and buff silty clay with gravel no more than 0.2 ft. thick. It appeared to be a combination of general HBC deposit and fill from the excavation prepared for the Belfry base. In turn, the base was set into the culturally sterile buff gravels of the floodplain (Fig. 6).

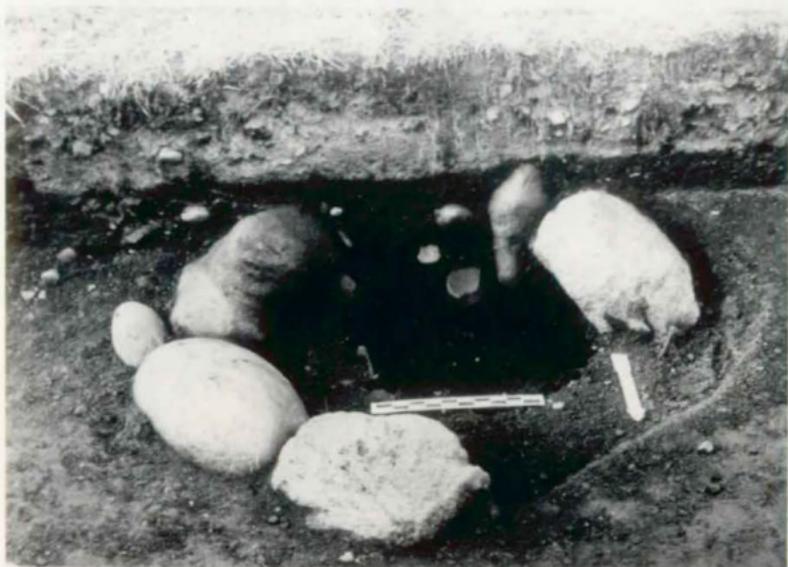
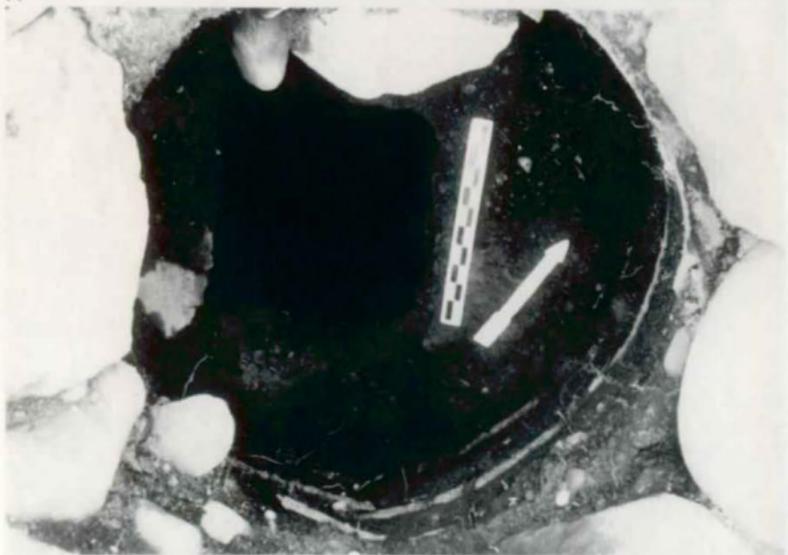
Fig. 7 - Belfry remains.

a - Stone ring outlining mouth of barrel  
(FOVA neg. 069.51-73/6)

b - Interior of barrel showing hoops and  
cast of bell mast (FOVA neg. 069.51-73/13)

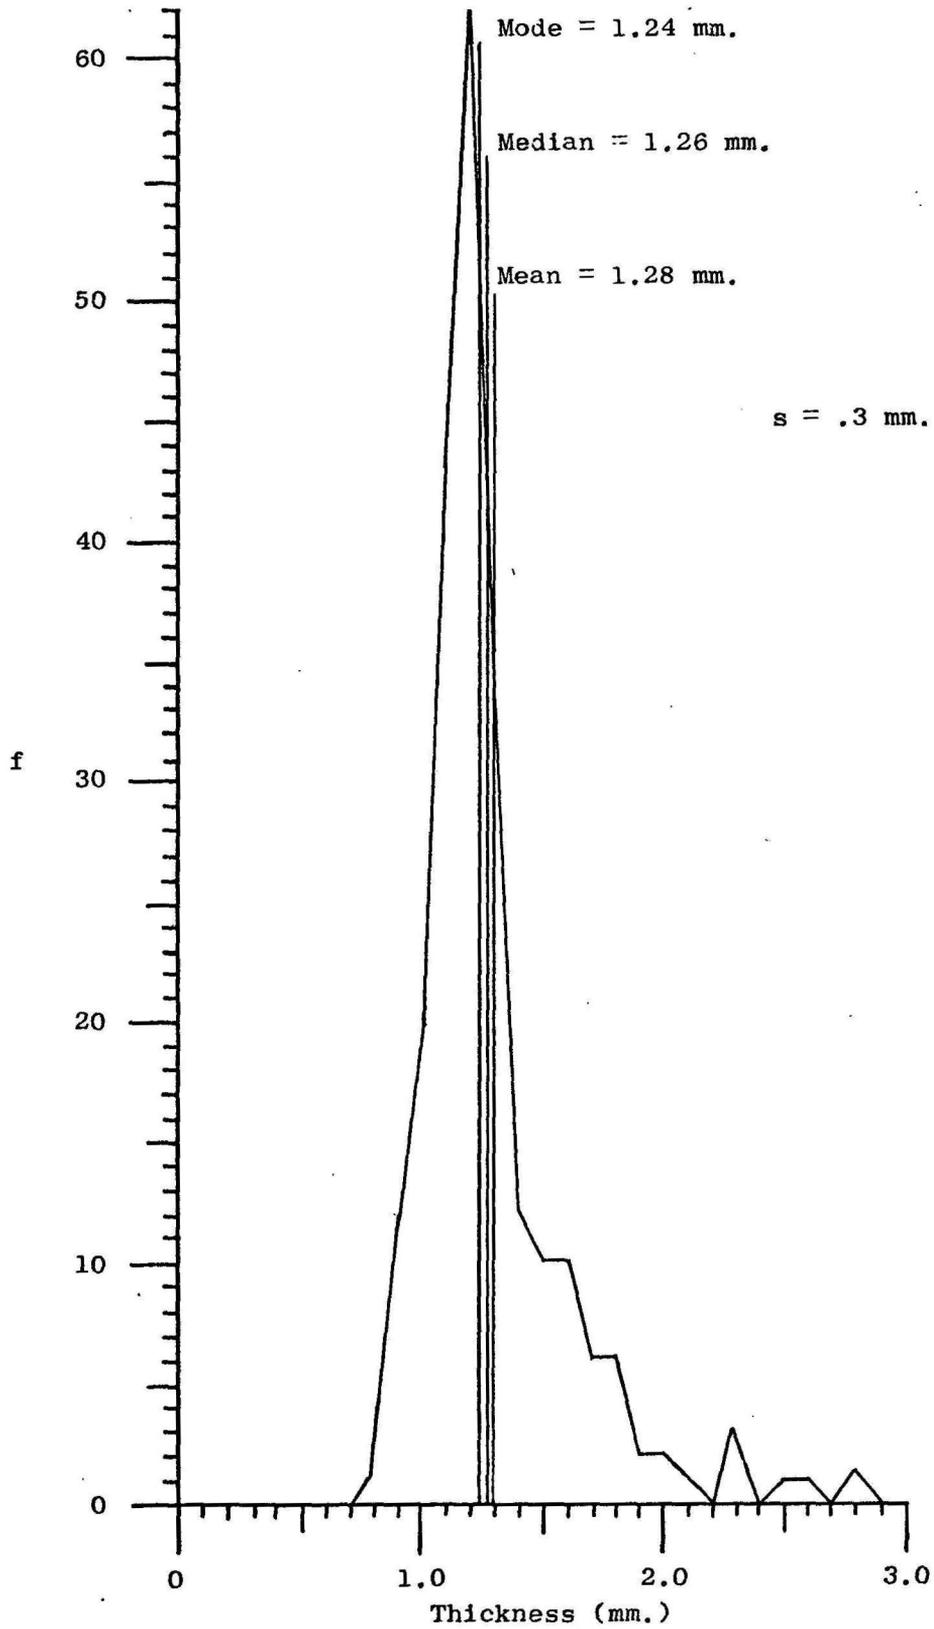
Fig. 8 - Frequency of window glass thickness for the area of the Belfry (N=225).

As with previous reports, the only attribute of window glass found to be significant was thickness, and the frequency distribution for the Belfry area (Fig. 7) was similar to that of the Chief Factor's House. This glass probably came from the New Office.

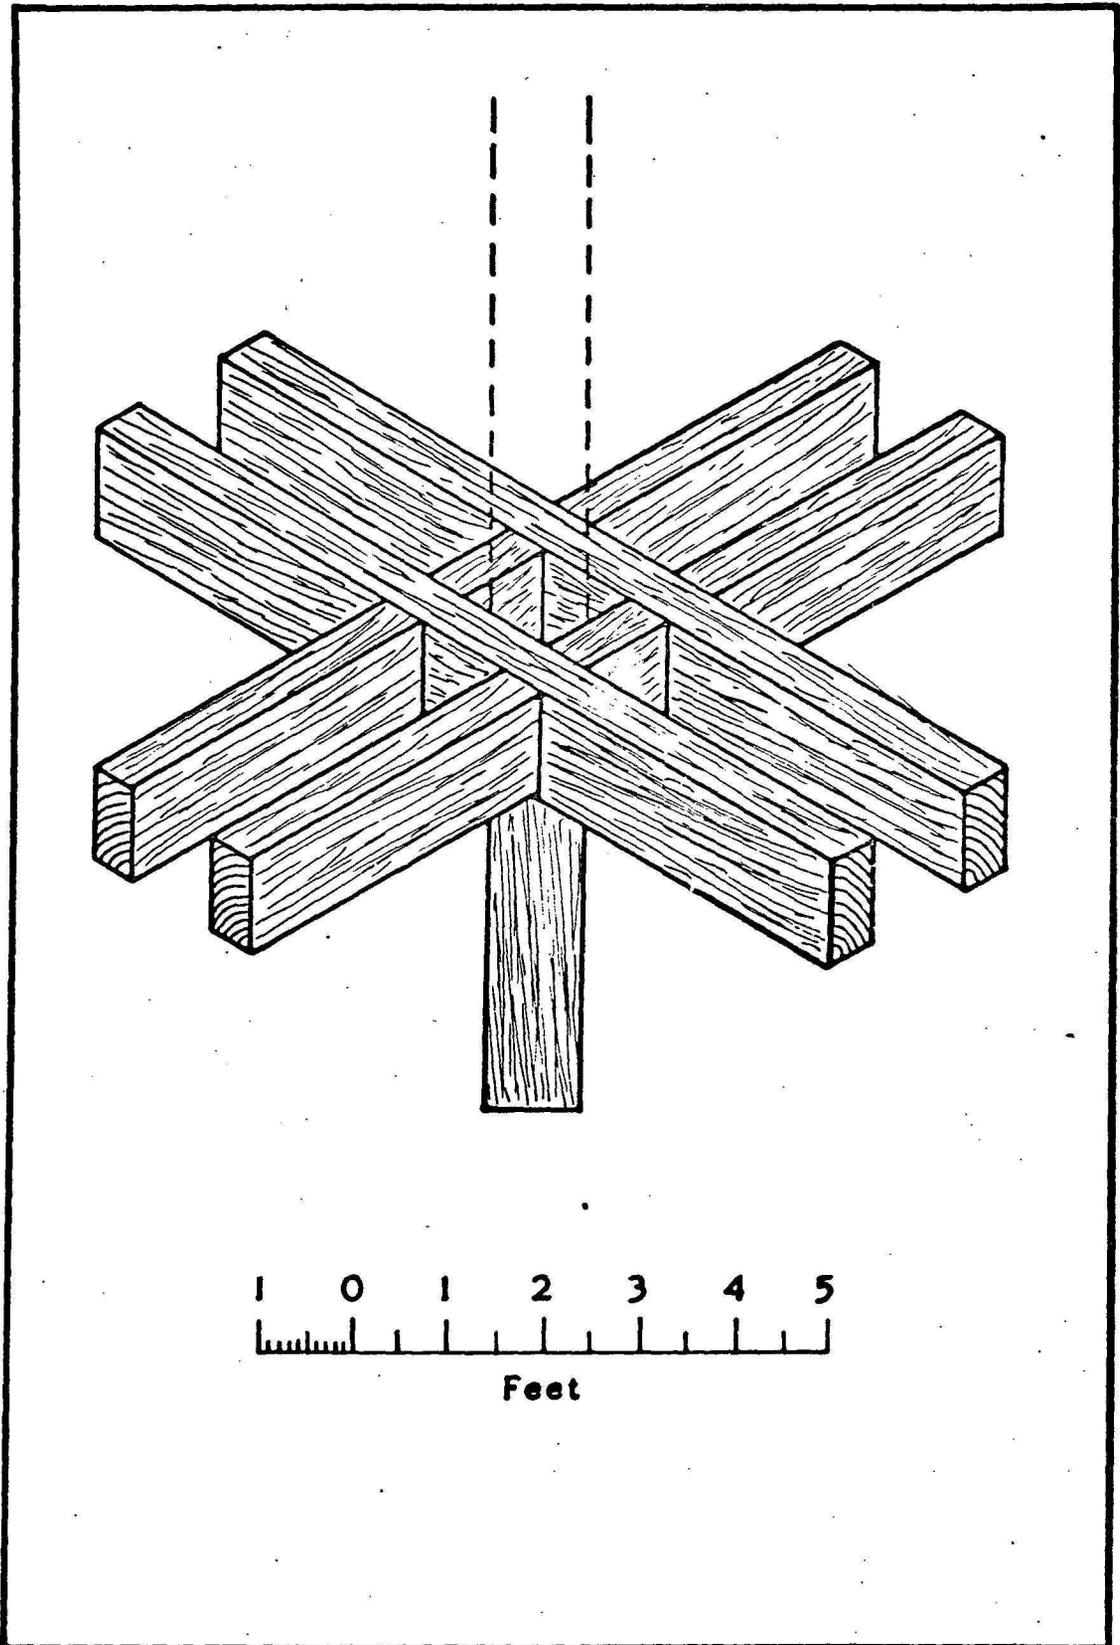
Fig. 9 - Inferred construction of Flagstaff support.

The archeological evidence of the Flagstaff is subsumed in the schematic drawing of Fig. 9. With the staff butt packed in rock, it is possible that the subsurface crossed timbers were sufficient support for a single wooden pole 103 ft. long. While this length is not extraordinary for local Douglas fir trees, the butt diameter is. If the Flagstaff was a single tree, its butt must have been extensively trimmed to obtain the even diameter of one ft.

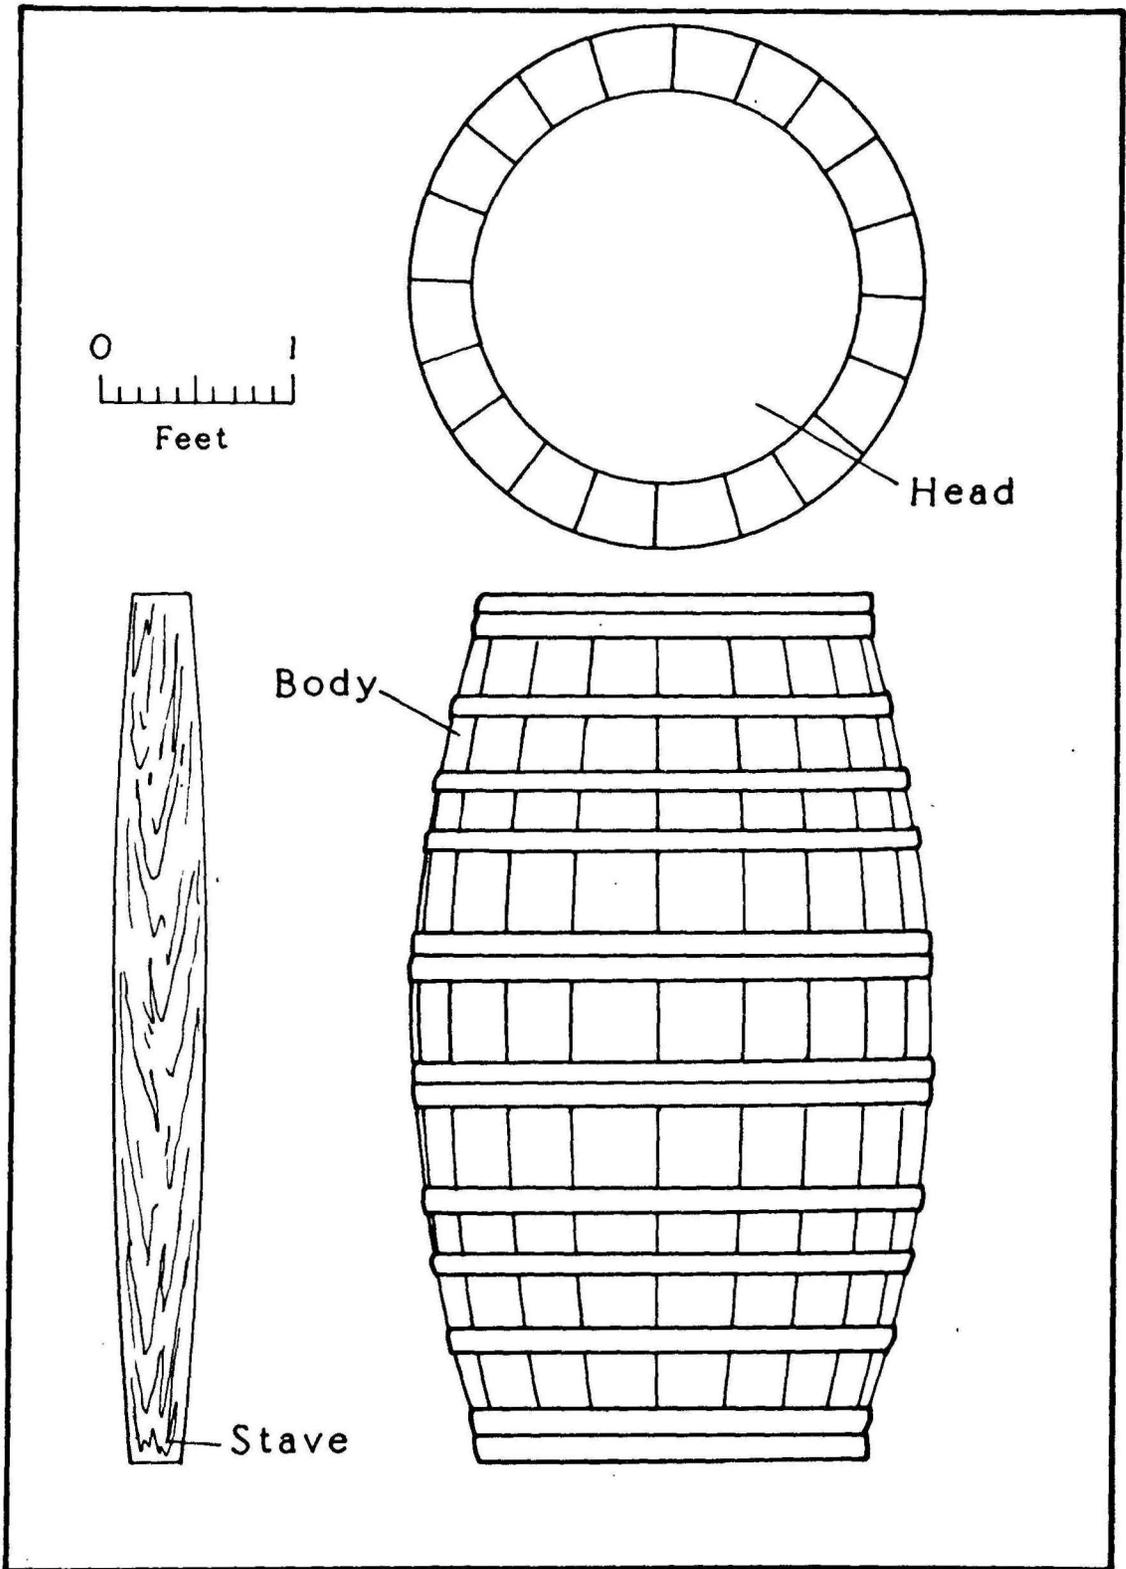
Fig. 10 - Inferred appearance of the salt barrel used for the Belfry base.

a 50 ft. pole into "a large cask of salt." A reconstructed view of this cask appears as Fig. 10, and if it was indeed a cask for salt, then its reconstructed volume indicates that it was a 1/2 avoirdupois ton salt cask (i.e. 1120 avoirdupois lbs. of salt) which would have held an equivalent of 138.5 imperial gallons (based upon 1 imperial gallon = 8.08 avoirdupois lbs. of salt; British). Since salt was commonly sold by the avoirdupois hundred-weight (i.e. 112 avoirdupois lbs.; British), this 1/2-ton cask would have contained an even 10 avoirdupois cwt. of salt.

As depicted in Fig. 10, the cask consisted of 20 staves (oak?) held together by 14 iron bands. Each band was made from strap iron measuring 1 3/8 inches in width and ca. 1/8 inch in thickness, and each was formed from a single piece of strap iron bent in a circle, overlapped and joined with a single rivet. Apparently, the inner bands were held in place without the use of fasteners, but the method of attaching the end bands could not be determined due to the loss of these bands through corrosion.

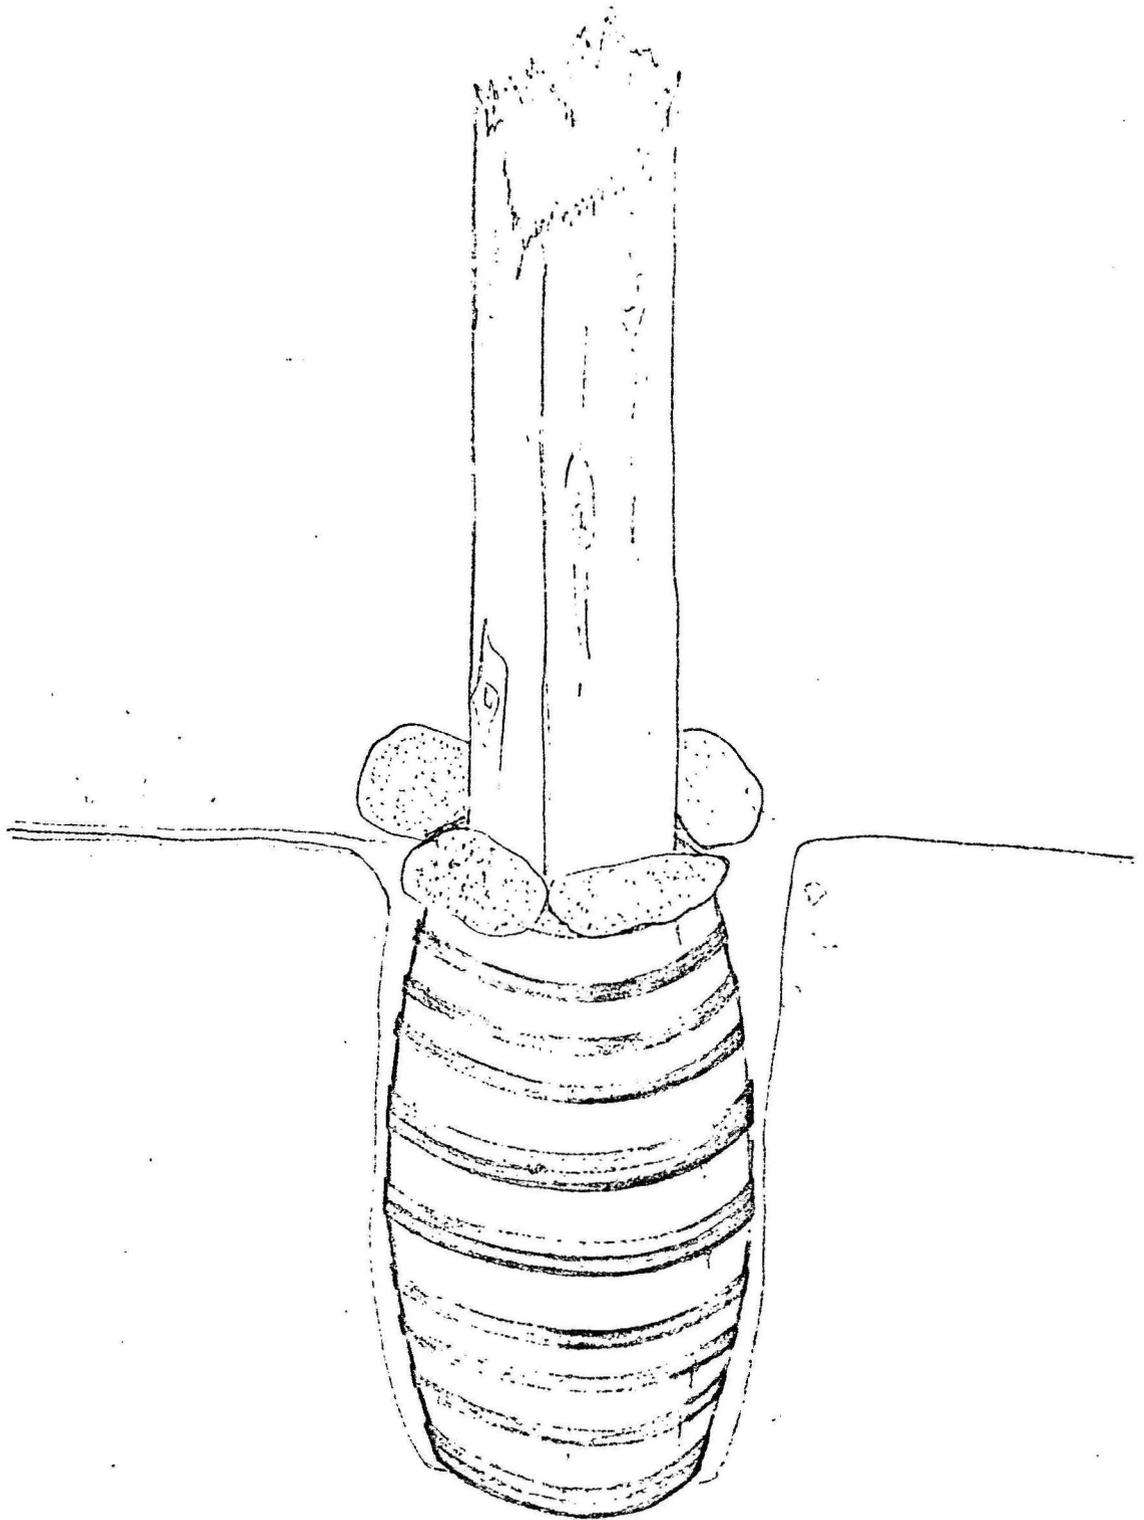
Fig. 11 - Inferred construction of Belfry base.

barrel or cask buried in the ground. The barrel was 4.5 ft. high and 2.65 ft. in diameter at its girth. The heads were 2 ft. in diameter and the circumference of the girth was about 8.32 ft. These measurements indicate that the barrel had a salt capacity of 1/2 avoirdupois ton. As discussed in Chapter III, this capacity is better expressed as 10 avoirdupois cwt. of salt.

While the archeological evidence was fragmentary, we believe the barrel consisted of 20 wooden staves, each 4.5 ft. long. Assuming symmetry of the staves, they were about 0.416 ft. or 5 inches wide at their girths and about 0.312 ft. or 3 3/4 inches wide at their ends. Thickness could not be determined. Twelve metal bands or hoops were found in situ, although only 8 could be collected due to fragmentation. Each hoop was made of 1/8 inch stock, cut 1 3/8 inches wide, and joined at the ends by a single rivet. The archeological evidence indicates that the barrel heads were hooped by double bands and the barrel girth held by 2 sets of double bands. Intervening hoops were single bands. Thus, the barrel was originally hooped with 14 bands (Fig. 10). Apparently, the bands were held by pressure alone; we have no clear evidence for other means of attachment.
