**CULTURAL LANDSCAPE REPORT:
LAKE MCDONALD LODGE HISTORIC DISTRICT,
GLACIER NATIONAL PARK, MONTANA**

**Cultural Landscape Report:
Lake McDonald Lodge Historic District,
Glacier National Park, Montana**

February 2006

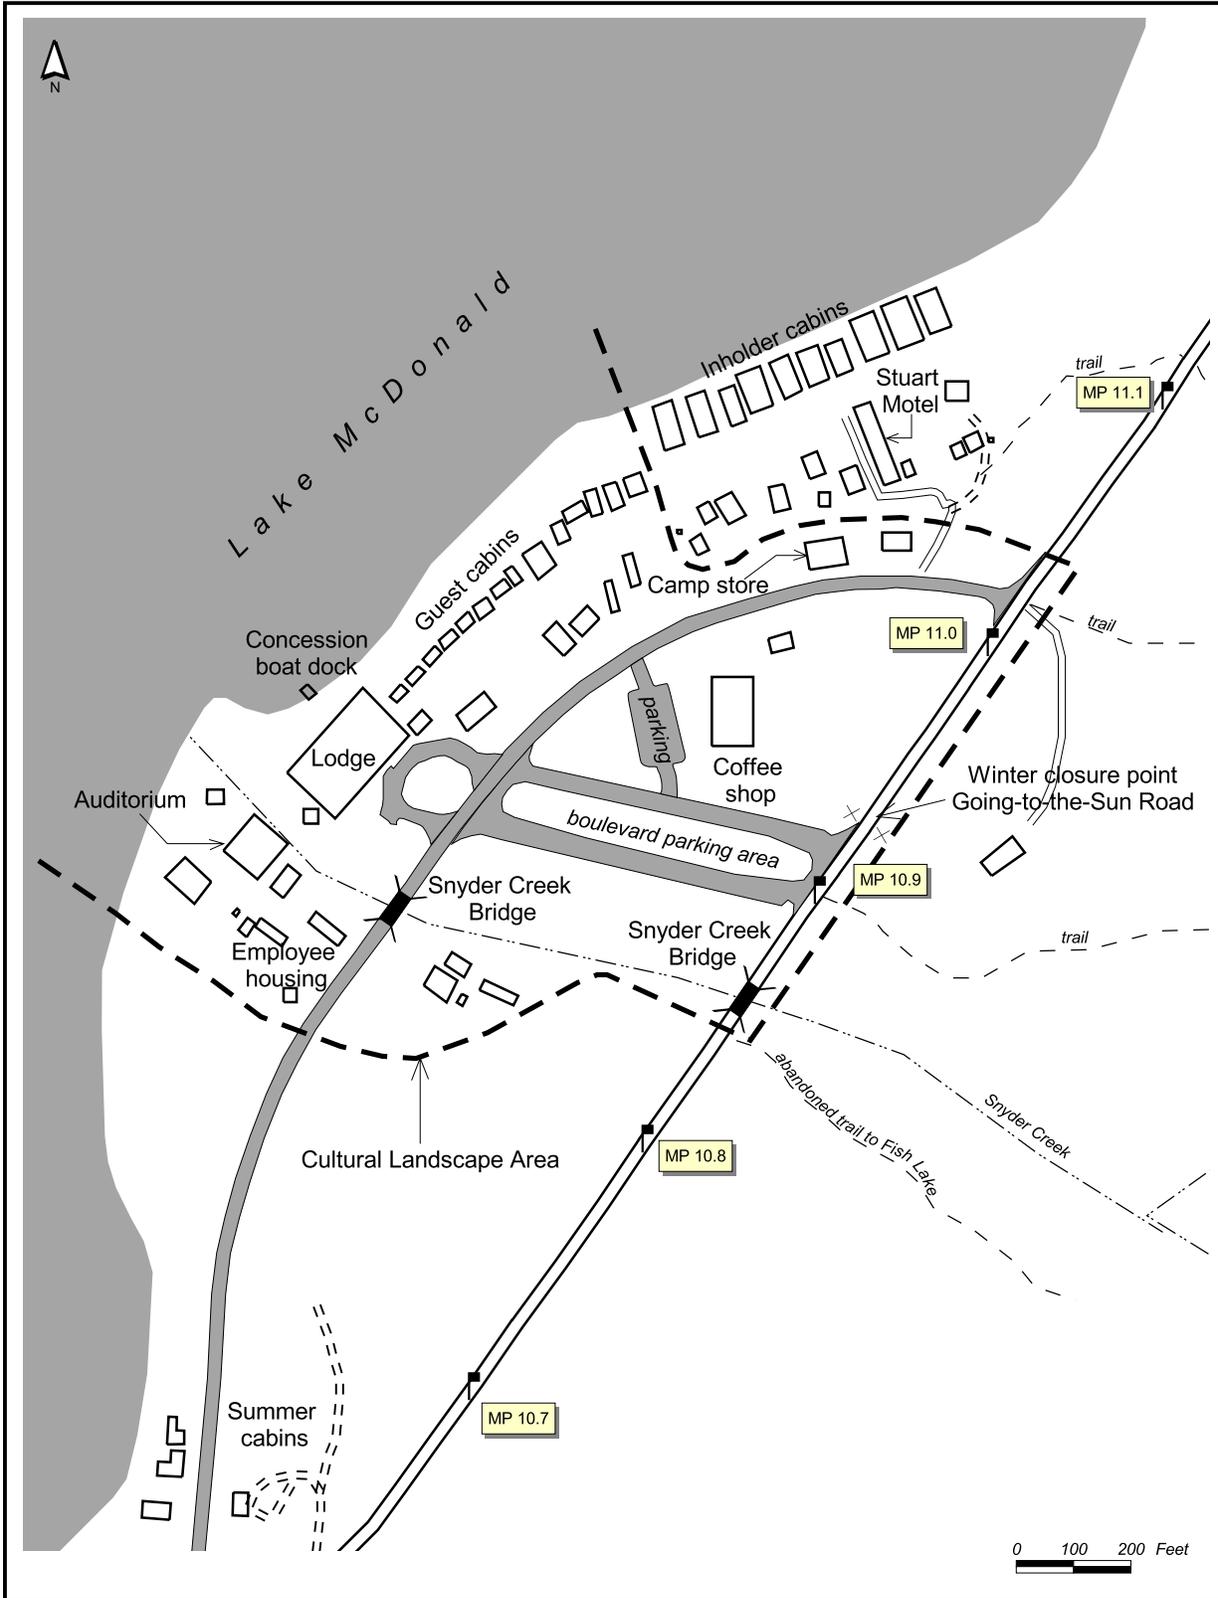
Figure 2. Sketch map showing boundaries of the Lake McDonald Lodge cultural landscape area.

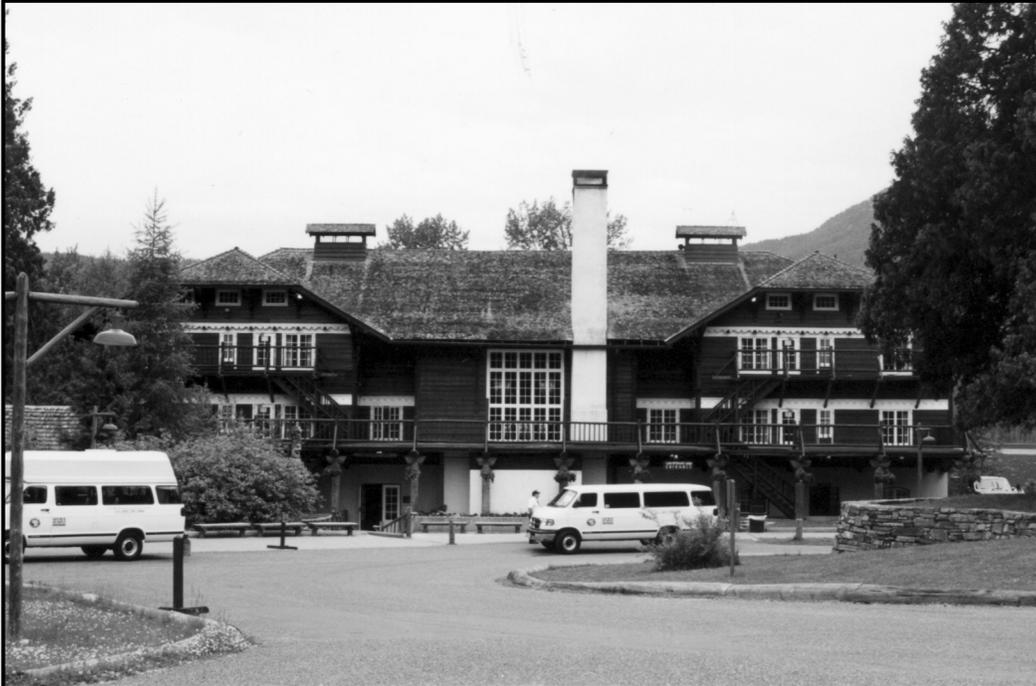
Figure 3. Lake McDonald Lodge, 2001 photo.

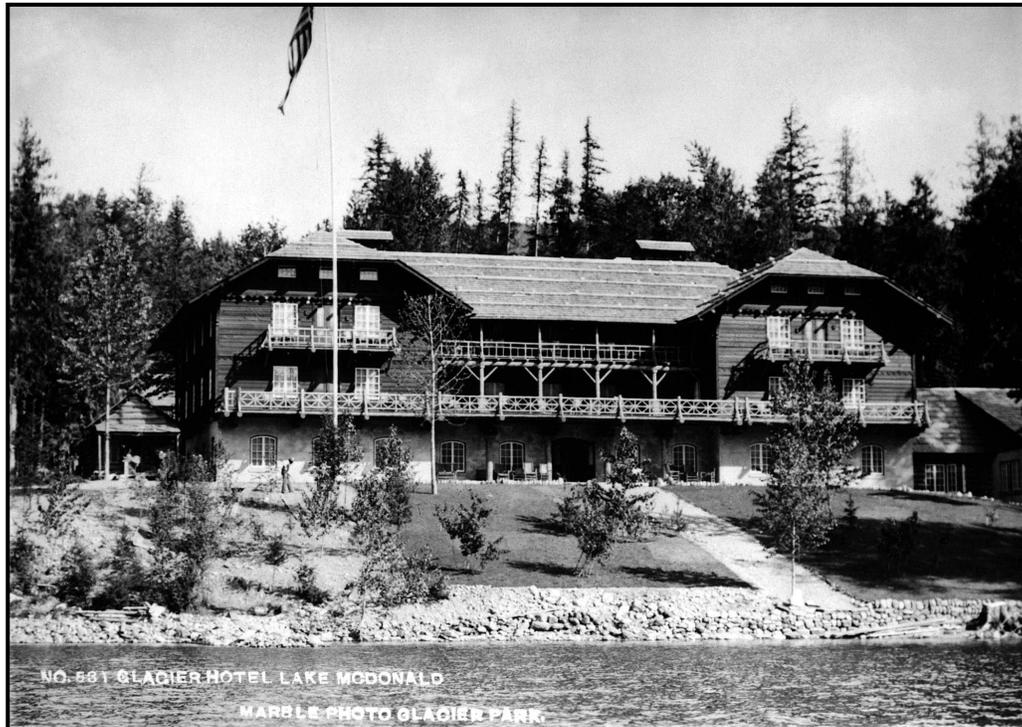
Figure 4. Lewis Glacier Hotel (Lake McDonald Lodge), ca. 1920.
Photo by R. E. Marble, GNPA #2981.

Lewis enlisted Cutter and Malmgram, a large Spokane, Washington architectural firm, for the design of a hotel that could be considered “something worthy of the park”.¹⁴ The construction feat required the freighting of fixtures, furnishings, and other materials across the ice of Lake McDonald during the winter months and by boat in the spring. The three-story hotel, which featured steam heat, electric lighting and running water, contained 64 guest rooms (the adjacent cabins provided 20 additional rooms). There was an elegant lobby on the first floor as well as eight 2-room suites. The dining room, attached to the southwest side of the lodge, was housed in a 1910 log building¹⁵ and a kitchen was attached to the rear of the dining room sometime after the hotel was built. Guests arrived at the hotel by boat, climbing a long set of steps that led from the dock, under the lakeside balcony to the entrance. No expense was spared in providing visitors with first-class accommodations and ambiance, although Lewis also made sure that his long-time friends and acquaintances from the Flathead Valley were made welcome in the grand

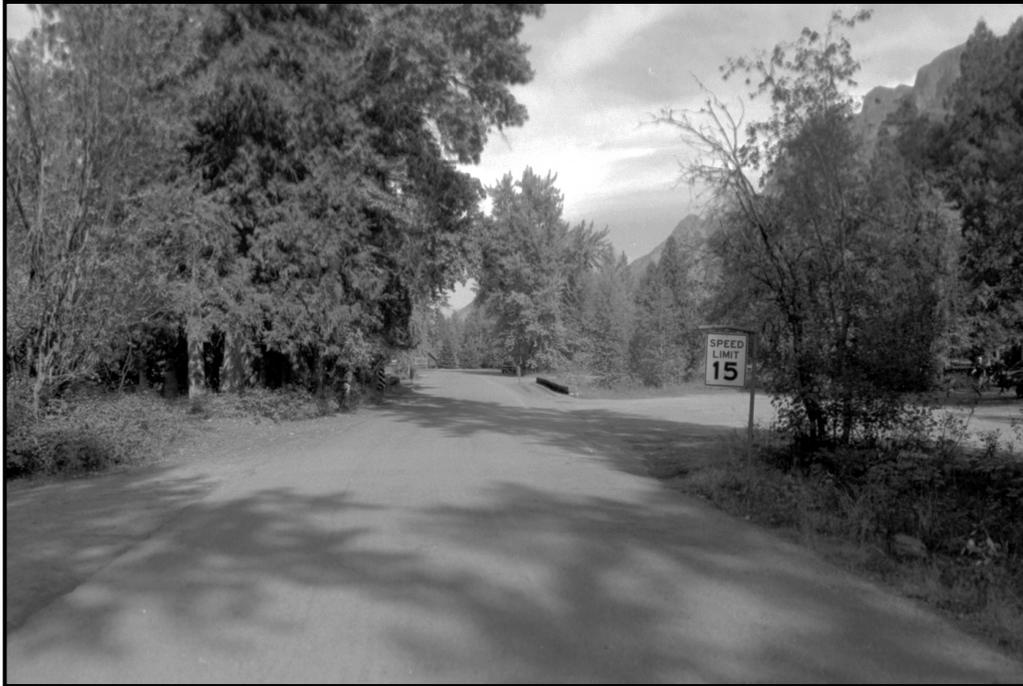
Figure 9. Northward view of the current secondary access lane to Lake McDonald Lodge, a former alignment of the Sun Road. 2000 photo.

In 1936 -37 a turnabout for vehicles and flagstone steps were also added to what had been the rear entrance of the hotel.²⁶ At about the same time the alignment of Going-to-the-Sun Road was altered and the new roadway by-passed the hotel property. The original alignment remained as an inside access road, while a parking lot and new entry road into the hotel complex, built in a cul-de-sac arrangement, was added between the turnabout and the new Roadway. The new entry road/parking area featured a central boulevard, with angle parking adjacent to both of the travel lanes. The new road system in the Lake McDonald Hotel complex was constructed by William and Douglas in Kalispell. Construction began on August 27th of 1936 and rough grading of the surfaces was completed by the fall. The project was completed on June 15th, 1937 in time for the opening of the Park that year.²⁷

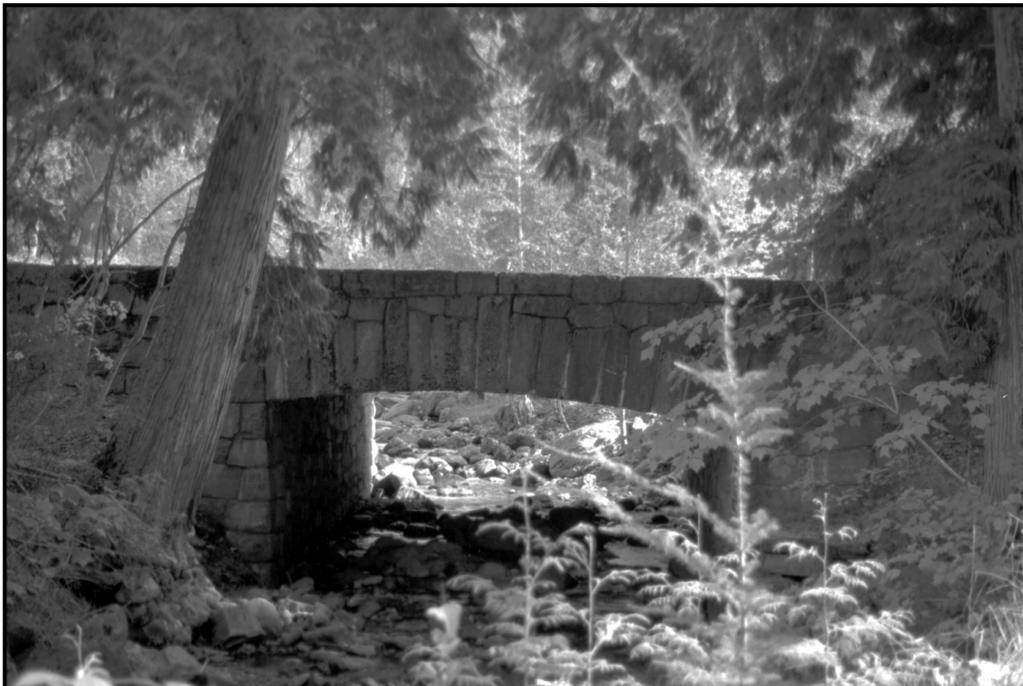
Figure 10. Highway bridge across Snyder Creek, near Lake McDonald Lodge. 2000 photo.

On August 27th, 1936, two beautifully crafted stone bridges spanning Snyder Creek were completed, one on the new Going-to-the-Sun Road alignment and one near the Lodge, close to the laundry. The bridges were designed by W.K. Trippit of Whitefish, Montana, and constructed using both skilled and unskilled laborers from the Flathead Valley through the National Re-employment Service.²⁸

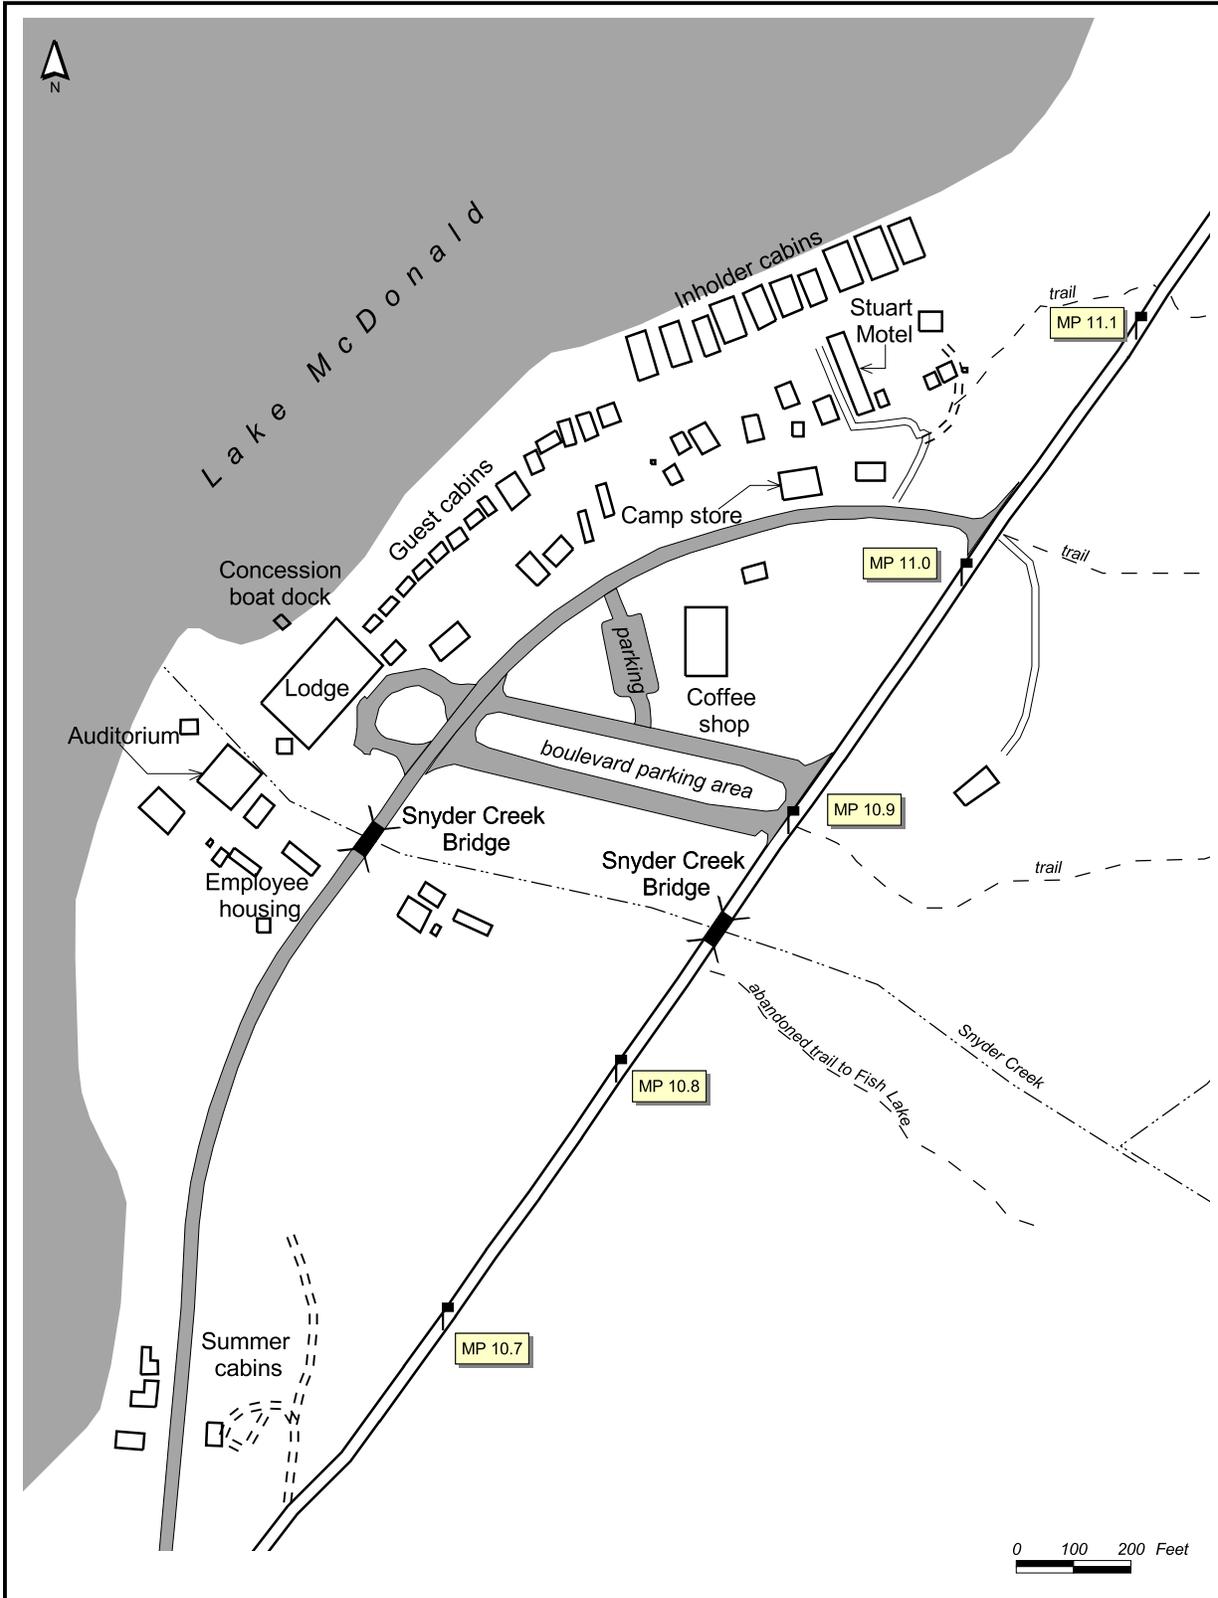
Figure 12. Sketch map of the Lake McDonald Lodge area, 2002. Note the "boulevard" parking area added in 1936-1937, tying the lodge building to the relocated roadway.

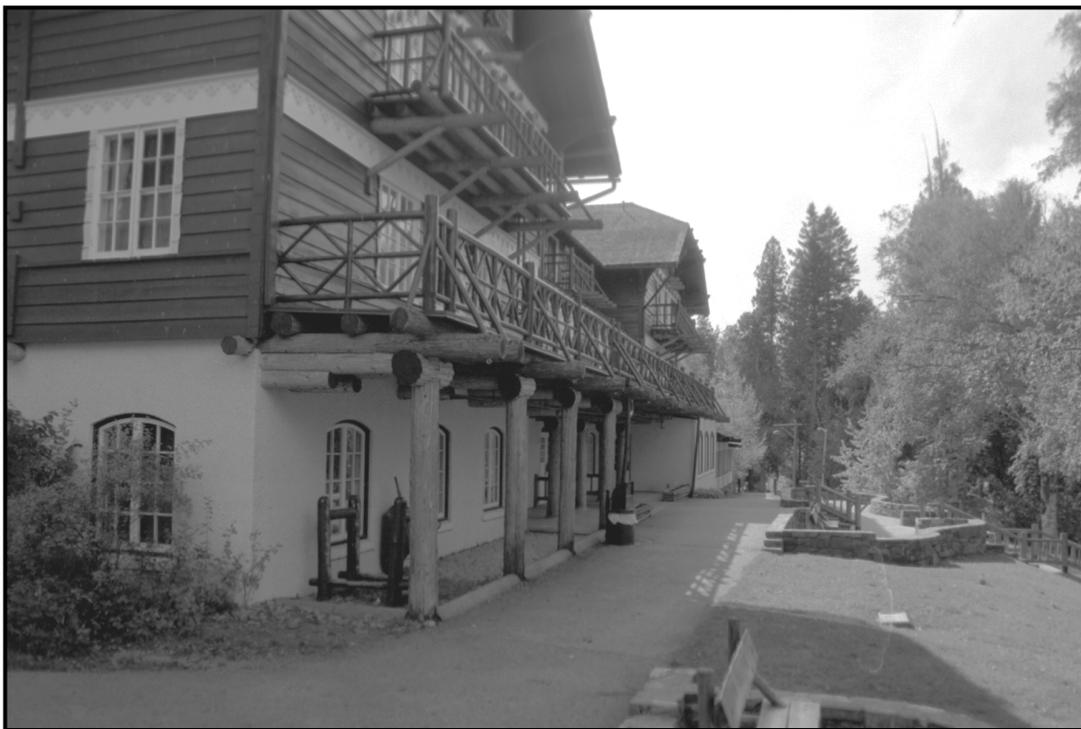
Figure 16. Lakeside facade of Lake McDonald Lodge, showing the revamped footpaths and exterior features added in 1989. 2000 photo.

Ownership of Glacier Park Incorporated was transferred in 1981 to a predecessor of Viad Corporation, the current concessionaire. In 1988-89, the Park Service undertook a \$1.2 million renovation of Lake McDonald Lodge, restoring the lobby to its original flavor and general historic configuration. A totem pole was erected near the lodges' vehicle-side entrance, commemorating a similar pole that once stood by the lakeside façade. Other improvements included the restoration of the lobby fireplace, an upgrade to the lounge and the replacement of the 1950s era dining room and lounge windows. The dining room fireplace which had been destroyed in the 1964 flood was restored. The turnabout at the front of the Lodge was also modified, as was the landscaping surrounding the Lodge building.

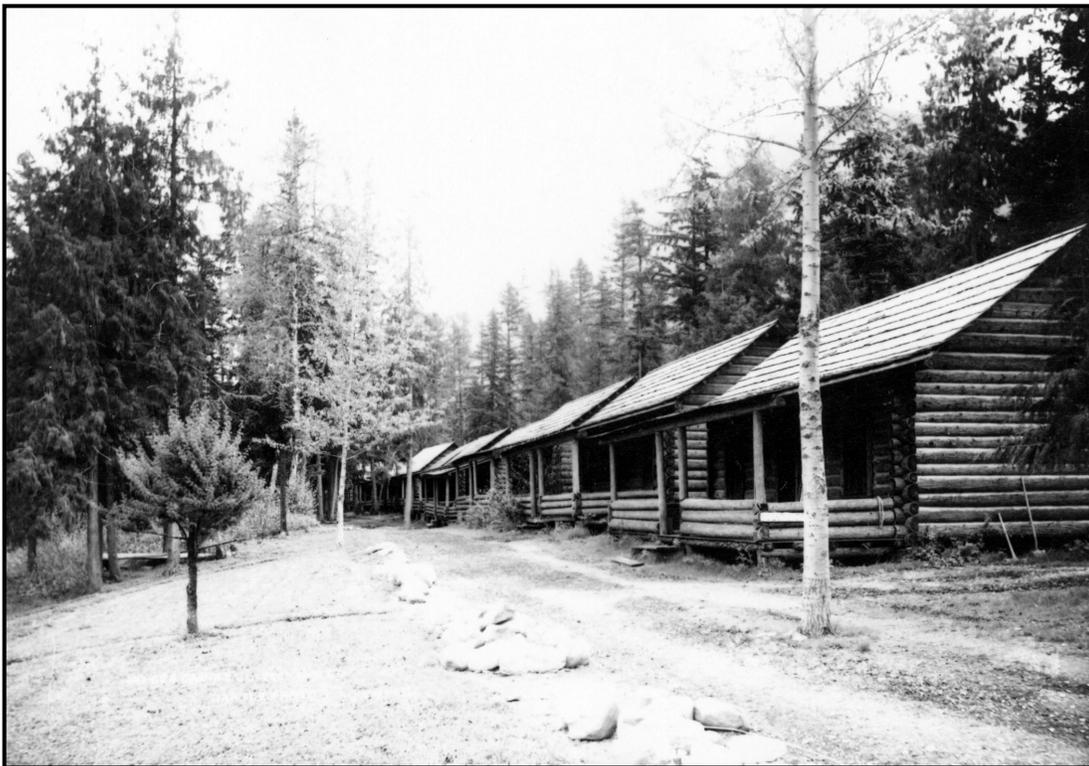
Figure 17. Circa 1914 view of the Row of Guest Cabins, Lake McDonald Hotel
R.E. Marble photograph. Glacier National Park Archives.

The buildings constructed at Lake McDonald Lodge during the first decade of the twentieth century reflected a landscape pattern that was probably very common for lakeshore resorts of the time, and was also seen elsewhere along the lake – most notably at the Kelly's Camp development about a mile away. The primary buildings intended for guest use were arranged in a relatively orderly row along the lakeshore, but were higher than and set back from the water. Relatively little development took place between the buildings and lakeshore. From the lake or the shore, buildings were visible but not intrusive, and at best an incomplete view of the lake was possible from the buildings.

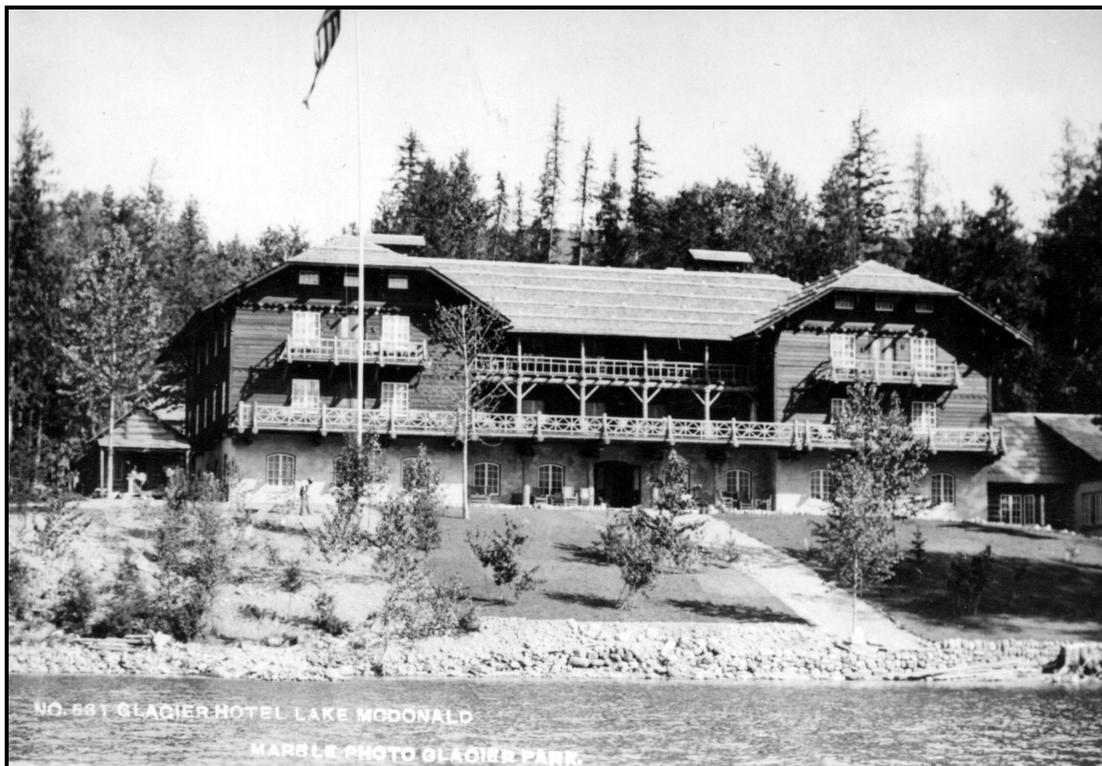
Figure 18. Circa 1920 view of the Lakeshore Lawn in front of Lake McDonald Hotel. R.E. Marble photograph. Glacier National Park Archives.

One major exception to this characteristic occurred in front of the main hotel building itself. There, vegetation was cleared and the land contour smoothed to create a grassy “front yard” for the development’s primary public areas. This allowed unfettered views of the lake from the hotel (and vice-versa), and helped visually define the hotel as the focal point of the overall property. This was important for the development as a whole, since guests at the time arrived via a boat dock on the shore near the front of the main building. Even here, though, the level of landscaping was relatively minimal, consisting of a planted lawn and delineated pathways between dock and hotel. A second formalized path along the “lake” side of the buildings connected the main hotel structure with the cabins.

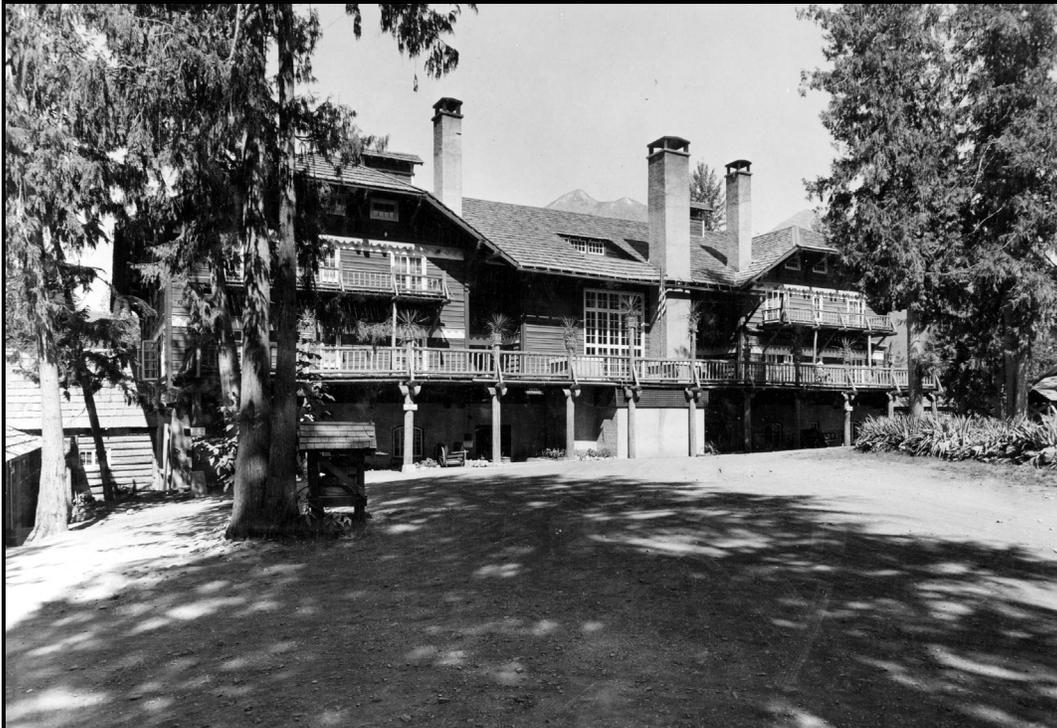
Figure 21. 1936 view of the circular entrance drive at Lake McDonald Hotel. T.J. Hileman photograph. Glacier National Park Archives.

The arrival of the automobile, however, caused far more dramatic changes within the “land” side of the lodge property. The new road entered the lodge area from the southwest, crossing Snyder Creek and accessing a small, unpaved loop driveway that accessed the hotel’s rear (southeastern) entrance. It then traveled easterly towards the rear of the property’s cleared pasture area before angling northward to exit the site. This route provided the “land” side of the hotel with its first major, well-defined circulation pattern – one that also characterized and defined the entry and exit experiences for virtually all of the lodge’s guests.

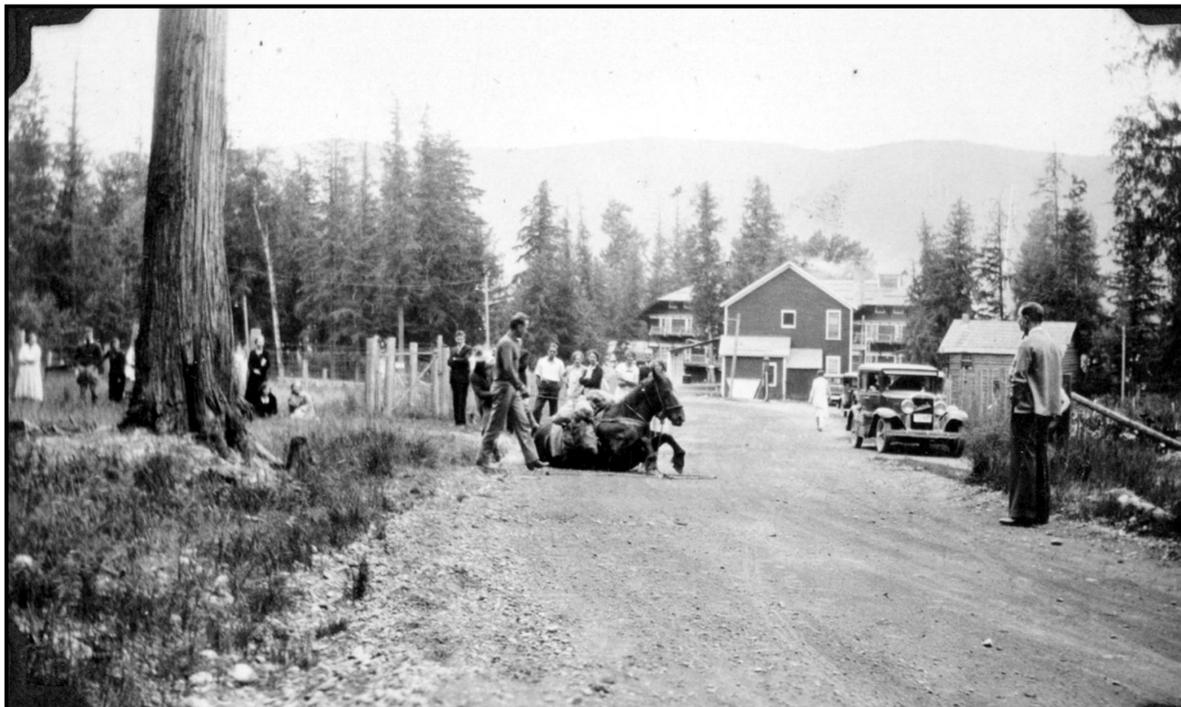
Figure 22. The arrival of the automobile created a haphazard, mixed-use development area along the “Land” side of the Lake McDonald Hotel. 1931 view. Glacier National Park Archives.

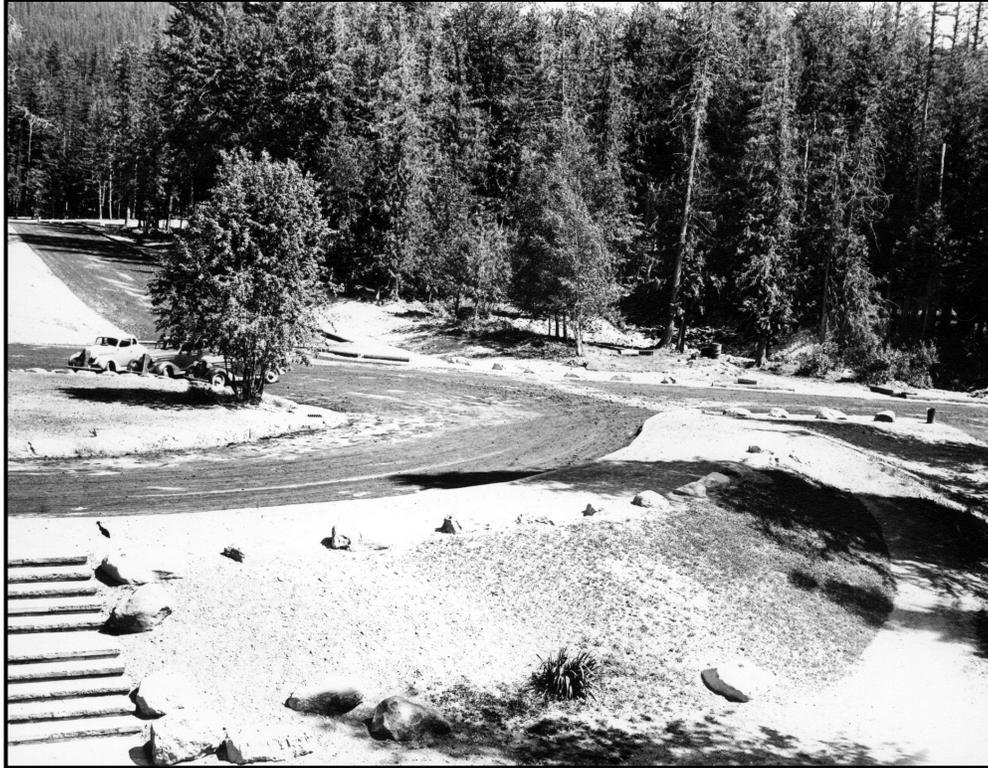
Figure 24. View of the 1937 entry boulevard and raised loop driveway, soon after completion. Glacier National Park Archives.

The completion of the Going-to-the-Sun Road brought about a tremendous increase in the amount of automobile traffic through the Lake McDonald Lodge area. The increased traffic at the lodge served to point out the inadequacy of the roadway and parking network at the property, and the Park Service quickly planned a series of road improvements to help rectify the situation. The work was completed by 1937, and resulted in a new alignment of the Sun Road that bypassed the immediate lodge area completely. The realigned road was joined to the hotel area by a large “boulevard” roadway and parking area, and the loop roadway at the hotel’s southern entrance was paved and elevated to match the entry boulevard.

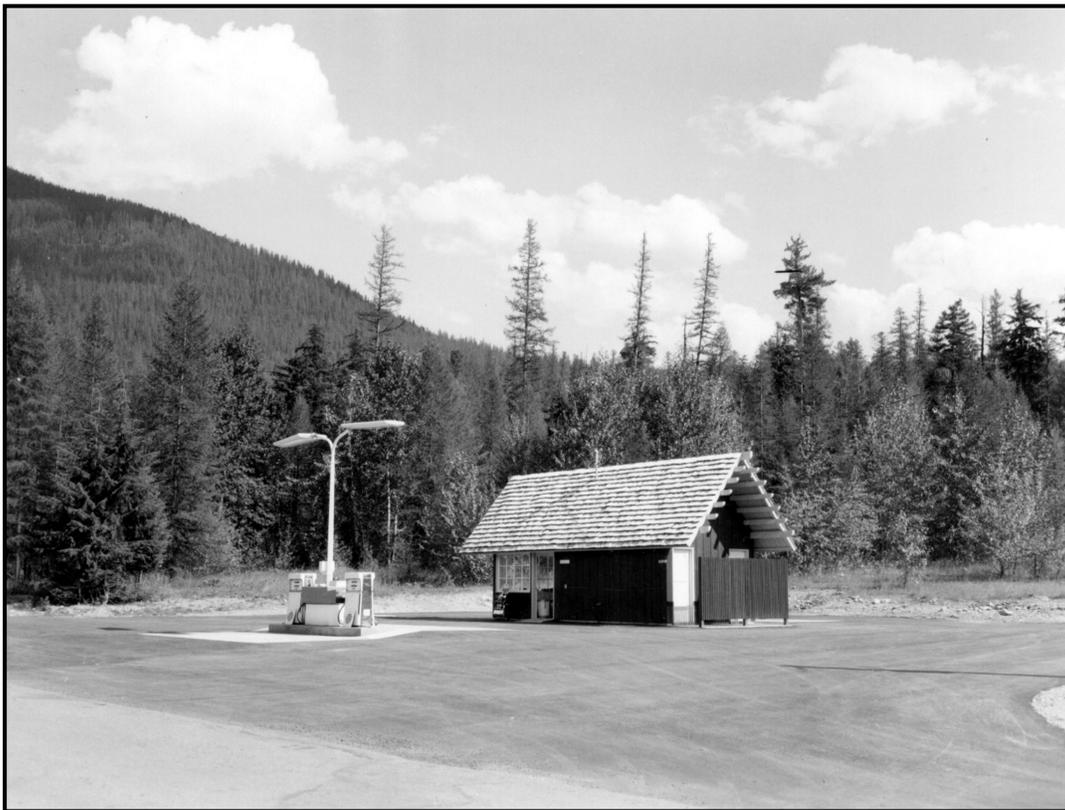
Figure 28. Lake McDonald service station, 1962. Glacier National Park Archives.

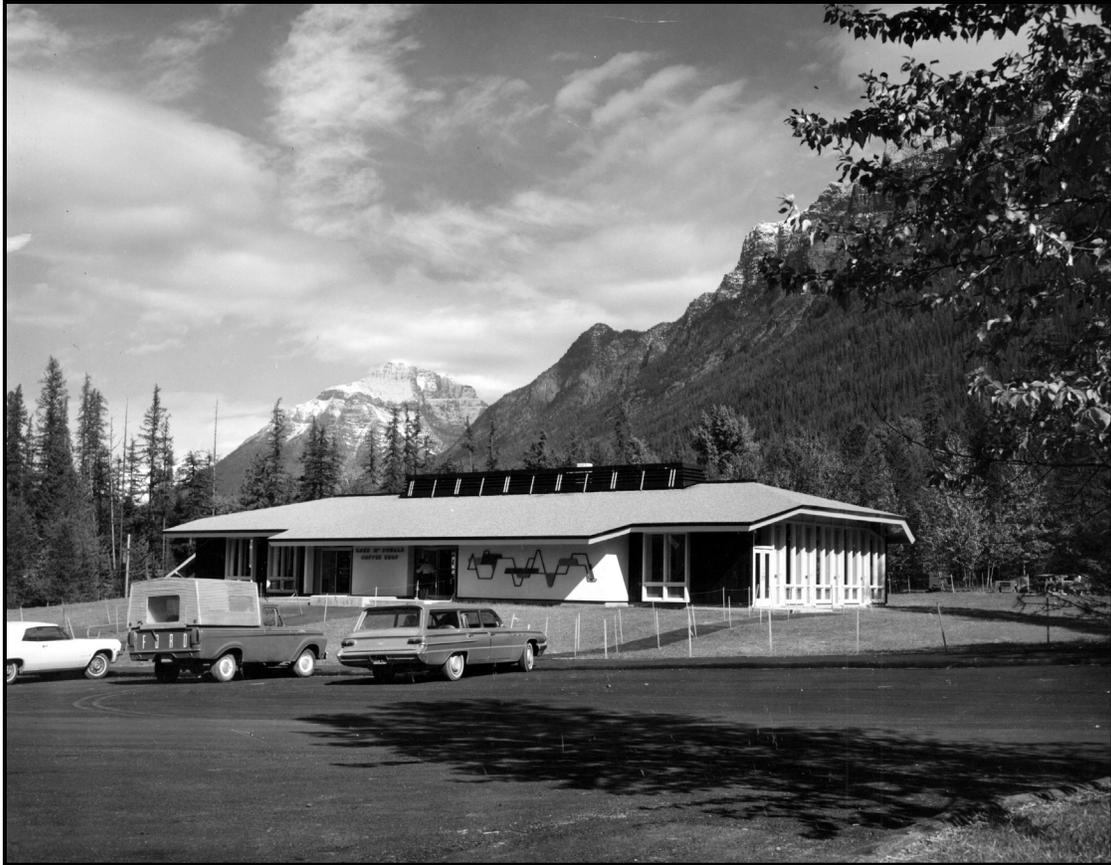
Figure 29. View of the new Lake McDonald coffee shop building, soon after its 1965 completion. Glacier National Park Archives.

Probably in response to the flood damage of 1964, a new coffee shop building and associated parking lot were constructed at Lake McDonald the following year, on a prominent location near the east end of the complex.³⁷ In contrast to the earlier buildings at the site, the coffee shop displayed contemporary architectural lines that, to some eyes, contrasted to its environment. In about 1968, 10 cabins from the Swiftcurrent auto camp were moved to Lake McDonald and in combination with new structural elements were used to create 5 employee dormitory facilities.³⁸ A fire truck garage near the campstore became part of the property in 1975, the result of federal acquisition of a former inholder parcel.³⁹ In ca. 1980, the post office was moved from the camp store to the gas station building, across the street. The gas station's pumps and underground tanks were removed in the fall of 1996, but the building continues to house the Lake McDonald post office as well as public restrooms.⁴⁰

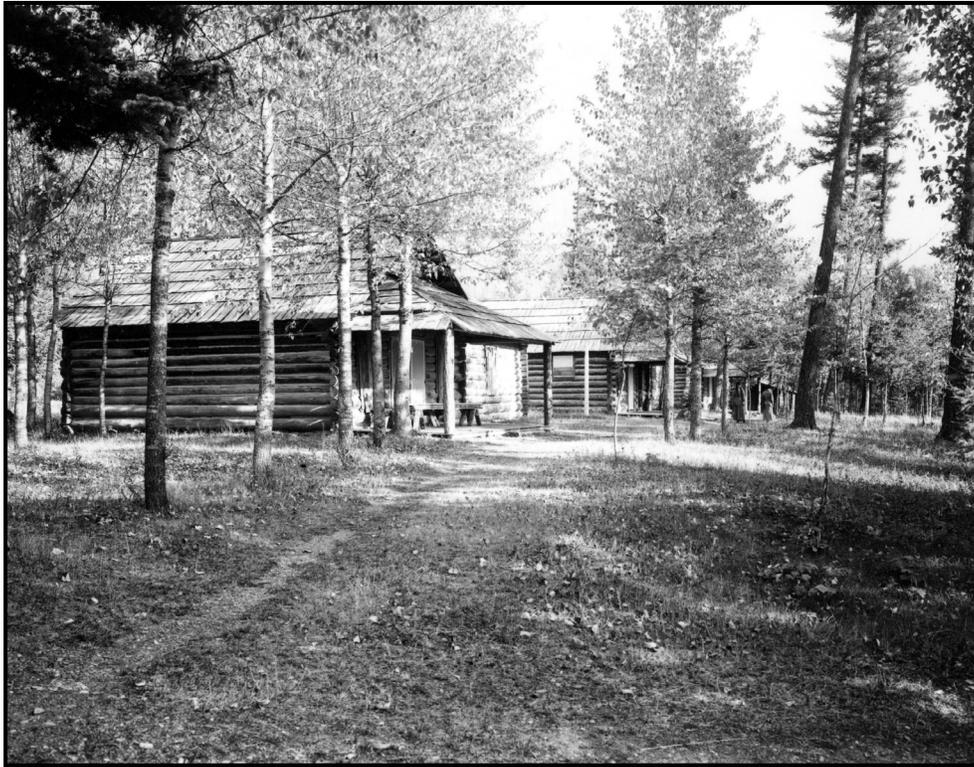
Figure 31. 1914 view of the north end of the guest cabin row.
R.E. Marble photograph. Glacier National Park Archives.

Most of these characteristics date from the early years of lodging development at Lake McDonald, and reflect the wilderness hotel atmosphere that was once characteristic of the entire Lake McDonald development. More than any other part of the Lake McDonald complex, this

area continues to reflect much of the early overall atmosphere of the hotel property. The row of historic buildings and the quiet, simple pathway in front of the cabins are particularly reflective of this atmosphere.

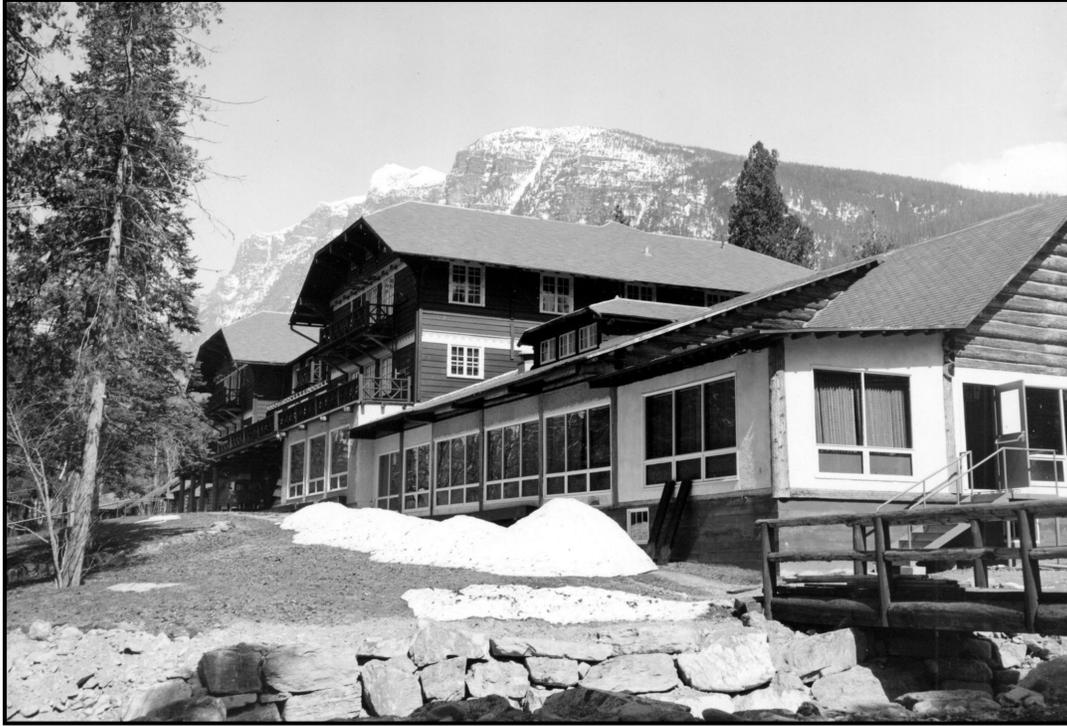
Figure 32. 1972 view of Lake McDonald Lodge and its lakeside lawn. Note the pattern of curved rocks, remaining from the original path to the lakeshore. Glacier National Park Archives.

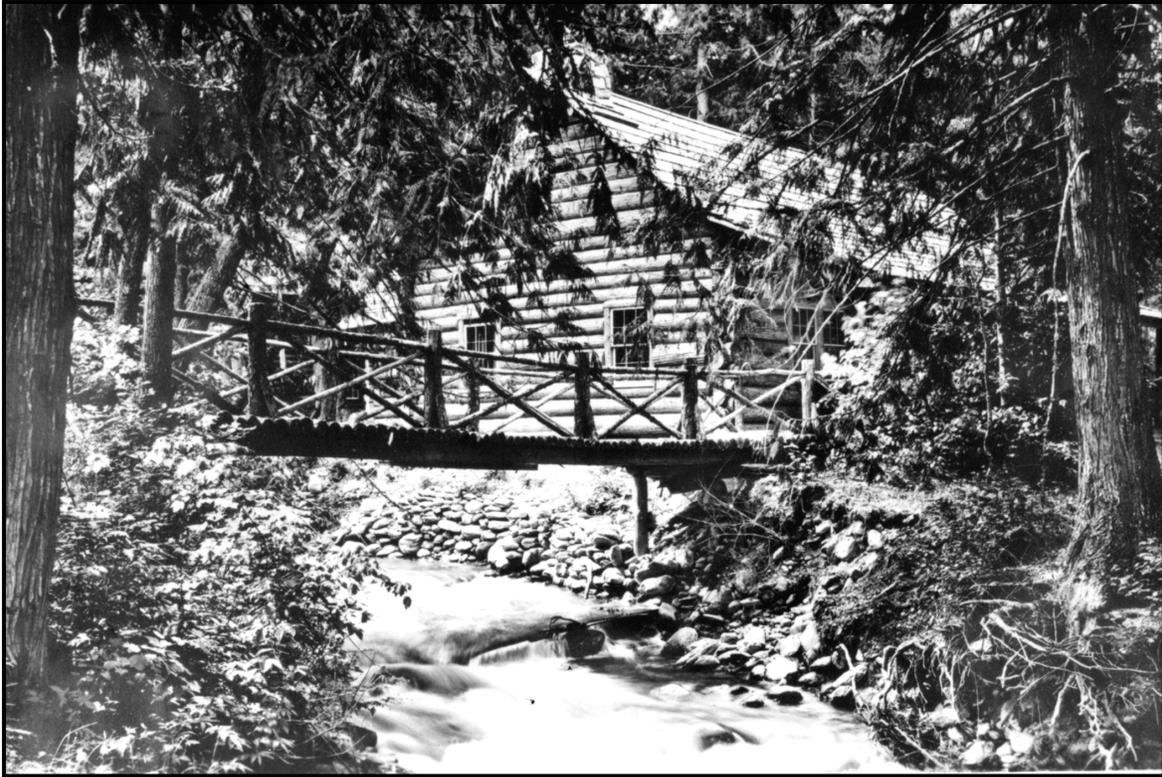
Figure 33. Snyder Creek footbridge and soda fountain building, 1930s.
Glacier National Park Archives.

Unique among the landscape areas of the lodge property, a portion of this area is actually less developed now than it was in the early twentieth century. A small manmade pond or pool once existed between the soda fountain building and the lake, although details of its design are not known.

As in the historic period, visitor use in the area today is largely limited to the small parcel of land in front of the auditorium building, an area where flooding and other changes have removed much of what historic setting there may have been. In overall appearance, though, the area remains one of rustic buildings placed unobtrusively in an unchanged natural landscape. This has been diluted in recent years only by the increased presence of motor vehicles in the area.

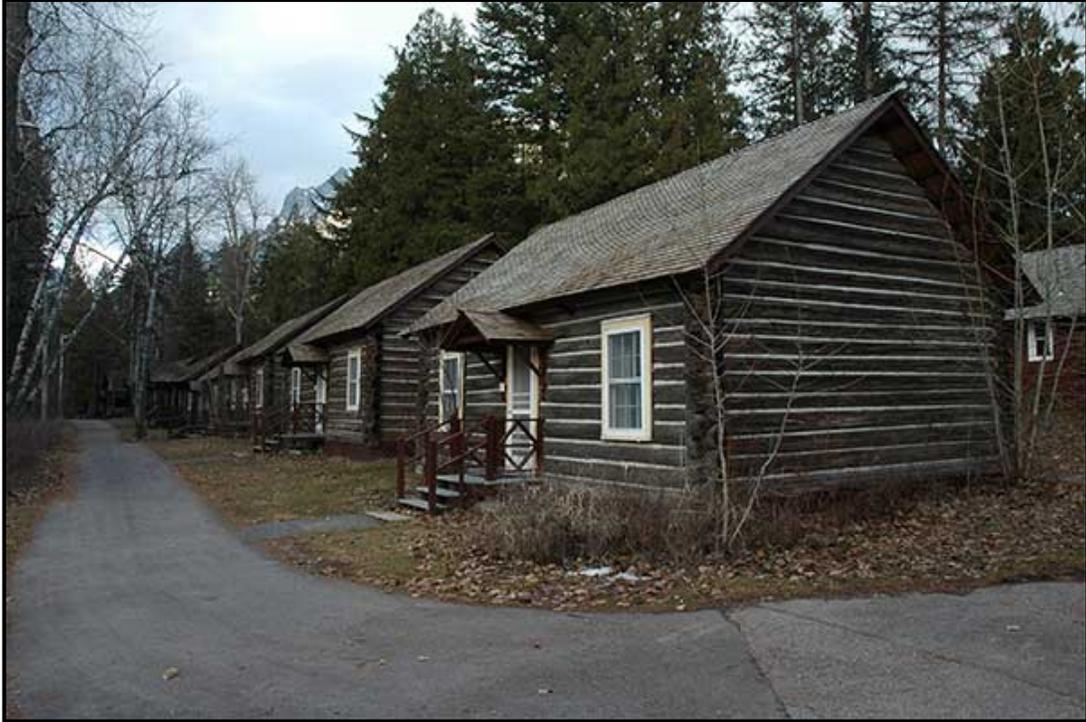
Figure 34. Lakeside views of the row of guest cabins at Lake McDonald. 2005 photos.

With the exception of the area of modern landscaping immediately in front of the hotel building, the lakeside area continues to strongly evoke the landscape of the Lewis Glacier Hotel era. All but one of the buildings in the area date from that period and are of a compatible design. Similarly, non-building development in the area remains limited, and the primary manmade landscape element – the footpath – retains its historic character despite modern surfacing. The natural vegetation that existed here during the historic era continues to thrive.

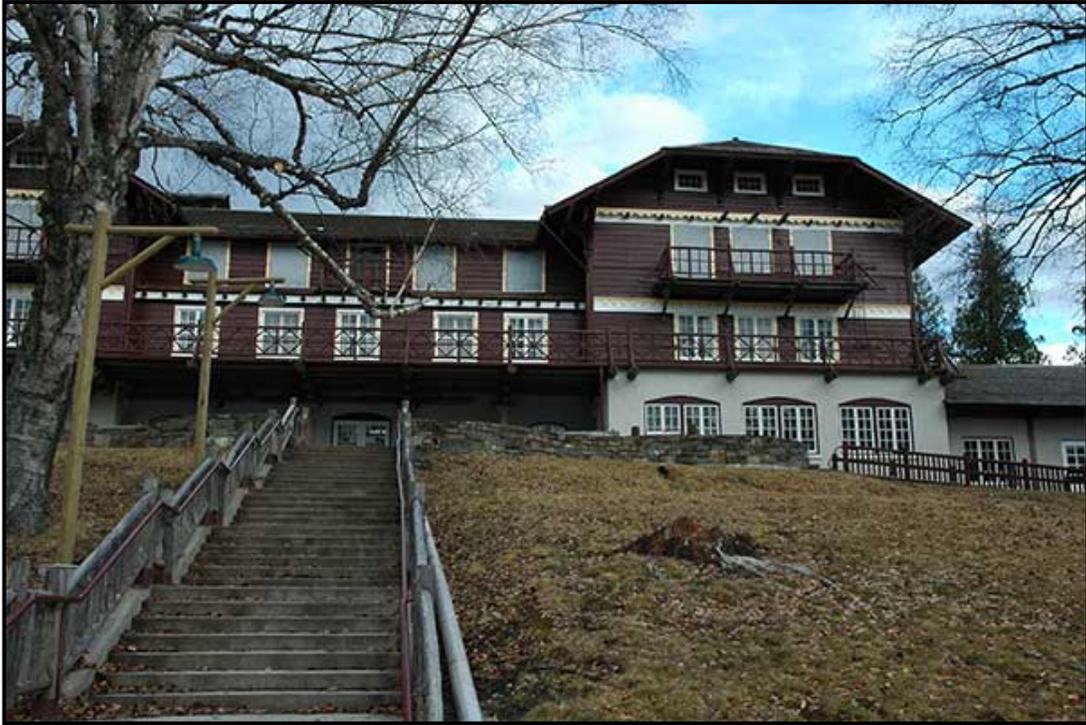
Figure 35. The landscaped area connecting the lakeshore and hotel. 2005 photos.

The cleared, landscaped area between the hotel building and lakeshore continues in its historic role as a visual portal between the lake and the lodge facility. However, the recent landscape additions – hard-surfaced pathways, stone walls, benches, and other elements – are not compatible with the area’s historic landscaping or design philosophy.

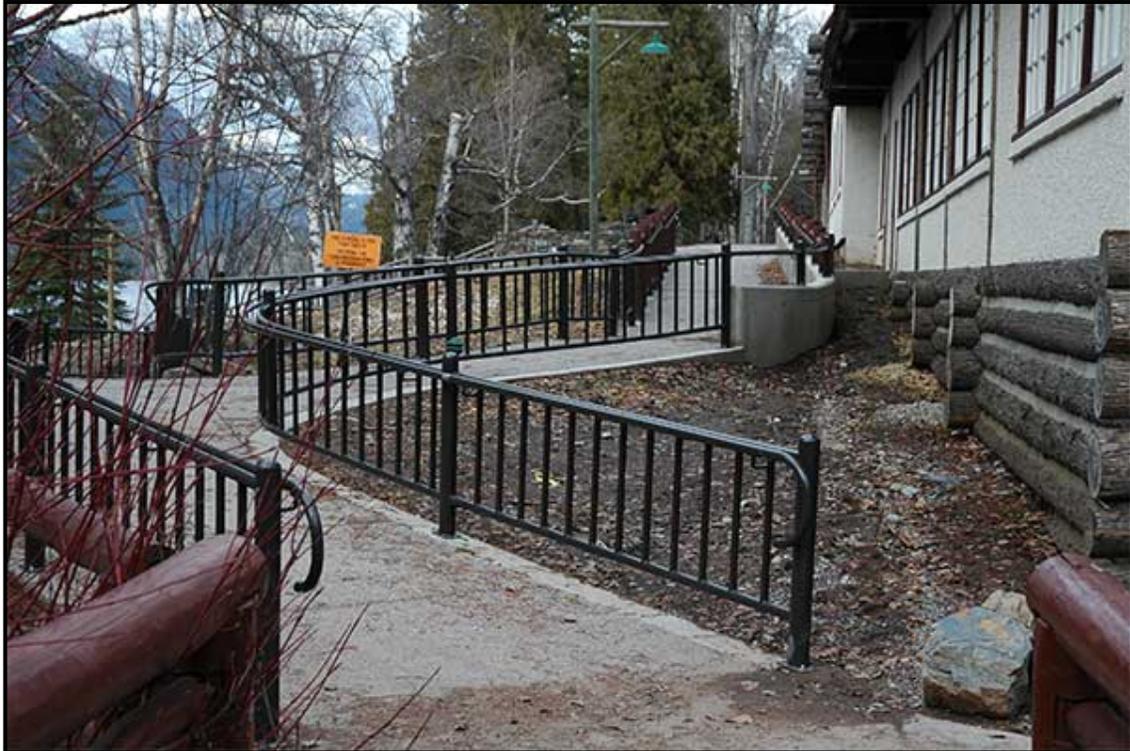
Figure 36. Visually-prominent modern landscaping in front of the hotel building. 2005 photo.

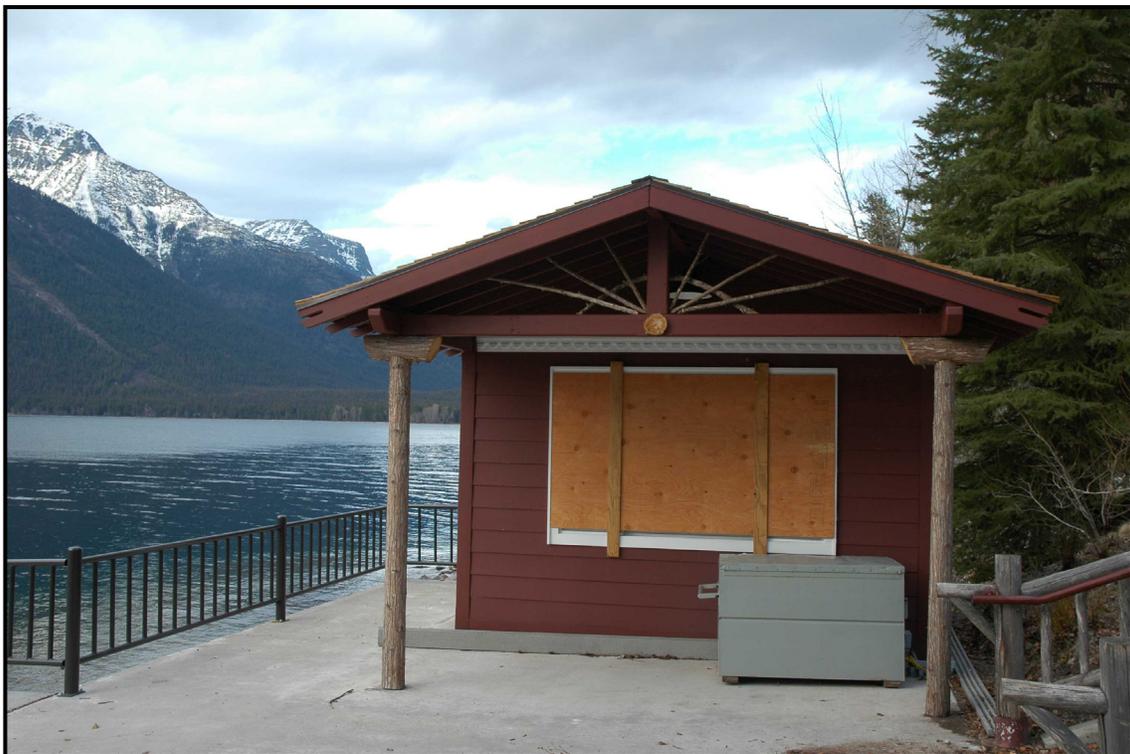
Figure 37. The modern boat dock in front of the hotel building. 2005 photos.
