**CULTURAL LANDSCAPE REPORT:
LAKE MCDONALD LODGE HISTORIC DISTRICT,
GLACIER NATIONAL PARK, MONTANA**

**Cultural Landscape Report:
Lake McDonald Lodge Historic District,
Glacier National Park, Montana**

February 2006

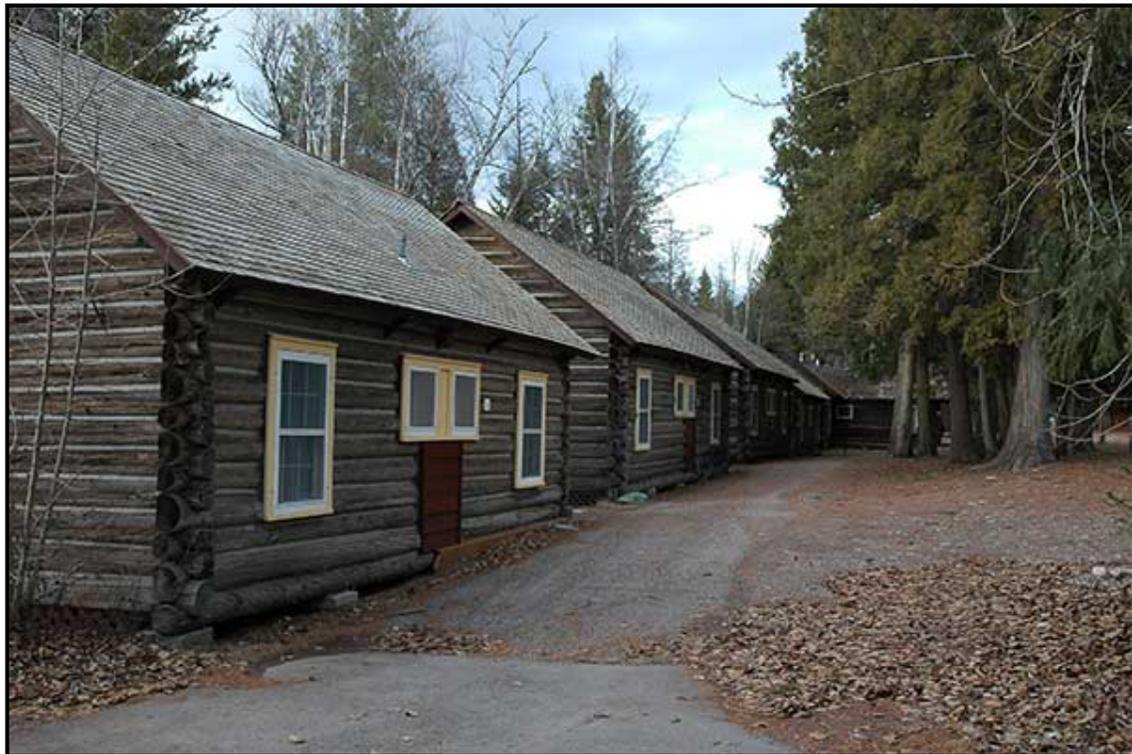
Figure 38. Access lane at the rear of the cabins. 2005 photos.

Along with the Lakeside area, this portion of the Lake McDonald Lodge property continues to reflect the general landscape appearance of the Lewis Glacier Hotel era. However, a series of both historic and modern changes to the area and its surroundings make it somewhat less representative of the pre-1932 period at the hotel. The most significant of these changes include the paving of the cabin access lane that runs through the area, the transformation of the former agricultural pasture to the east to a mowed lawn, and the addition of several recent buildings to the area and its viewshed, and the removal of a number of older buildings.

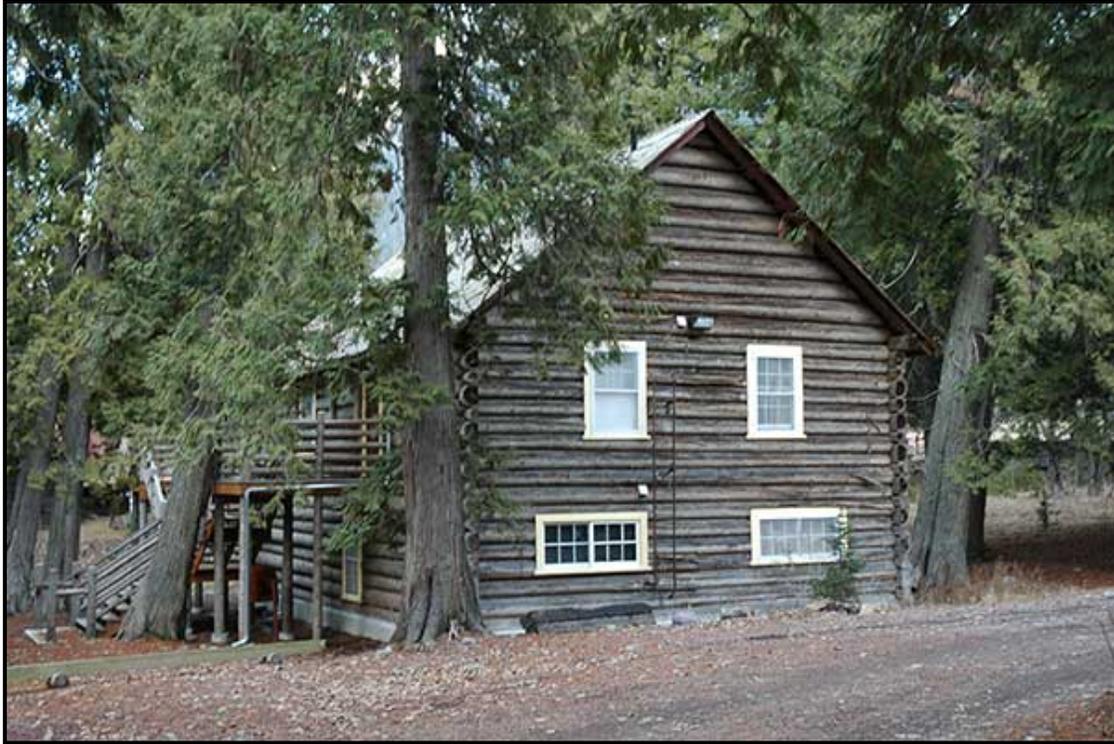
Figure 39. Employee dormitory buildings, south of Snyder Creek. 2005 photo.

Except for the area near the auditorium/soda fountain building, this portion of the lodge property has always hosted a series of support buildings not intended to be a direct part of the visitor experience. The presence of a number of historic buildings in this area, combined with the lack of planned, visitor-oriented development, has left the area with a general appearance still reminiscent of the Lewis Glacier Hotel era, but almost inadvertently so. The undeveloped, forested setting of most of the buildings in the area is little-changed from that era.

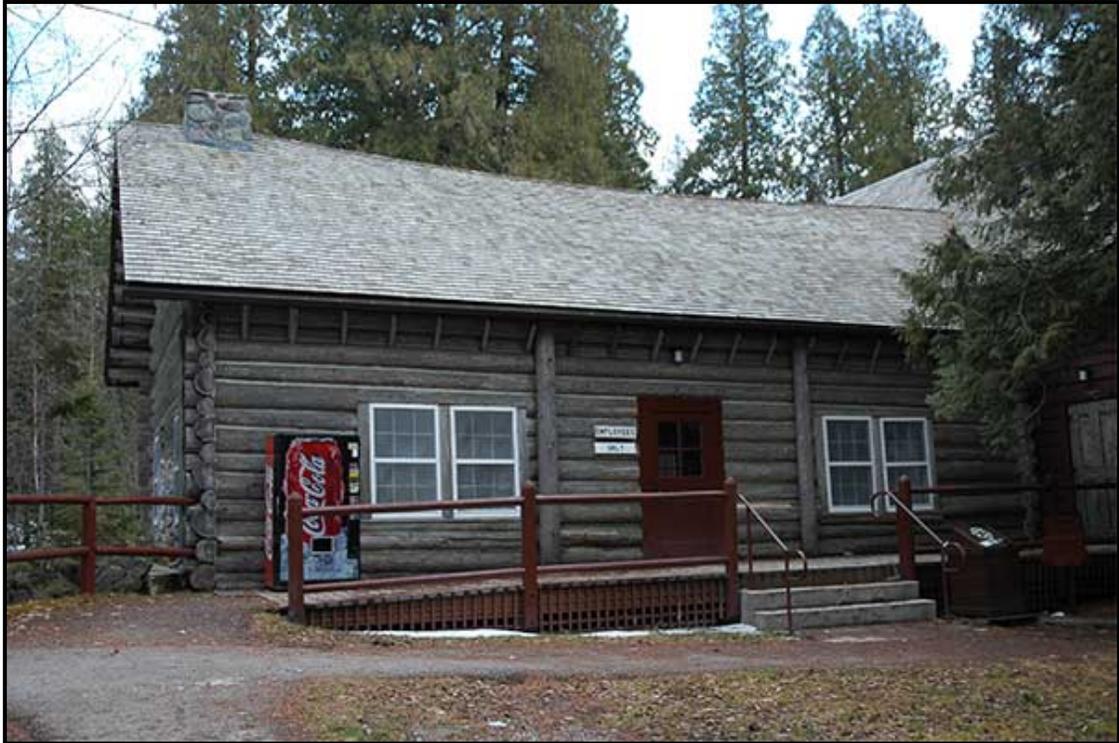
Figure 40. Area in front of the soda fountain/auditorium building. 2005 photo.

In contrast, the portion of this area between the auditorium and the lakeshore was more heavily vegetated and completely developed in the Lewis era than it is today. While some features have been removed and modern ones added, recurrent flooding of Snyder Creek in the area has also played a role.

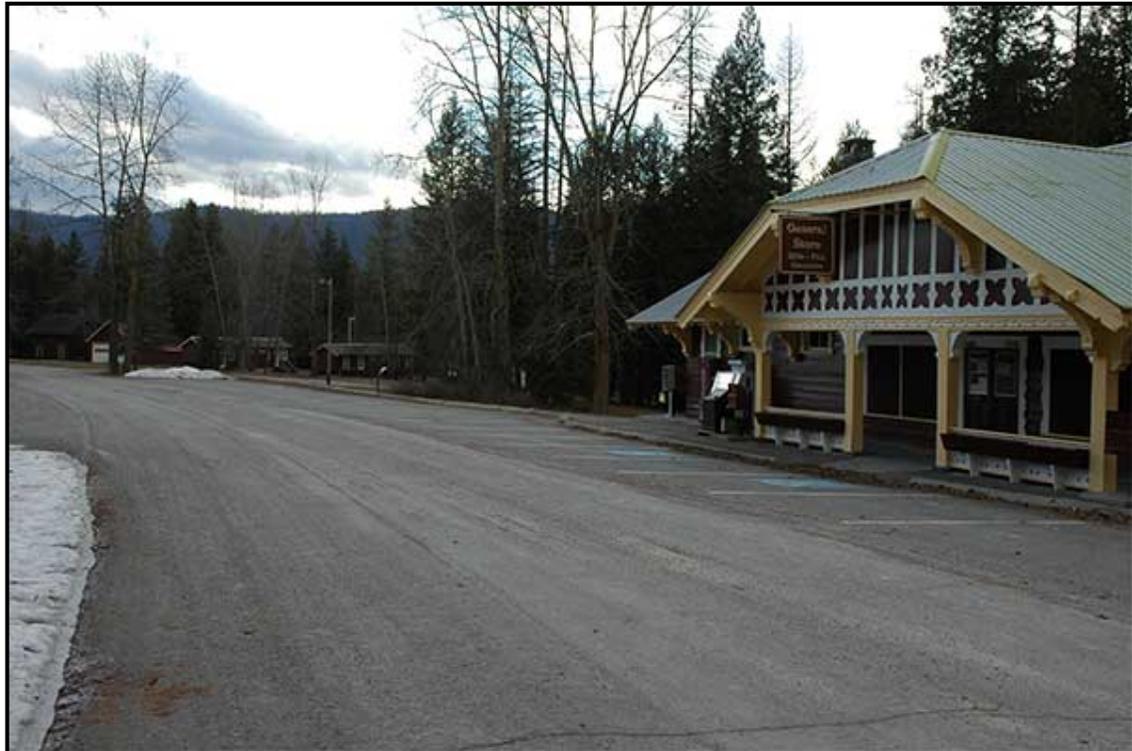
Figure 41. The general store and north hotel access road. 2005 photos.

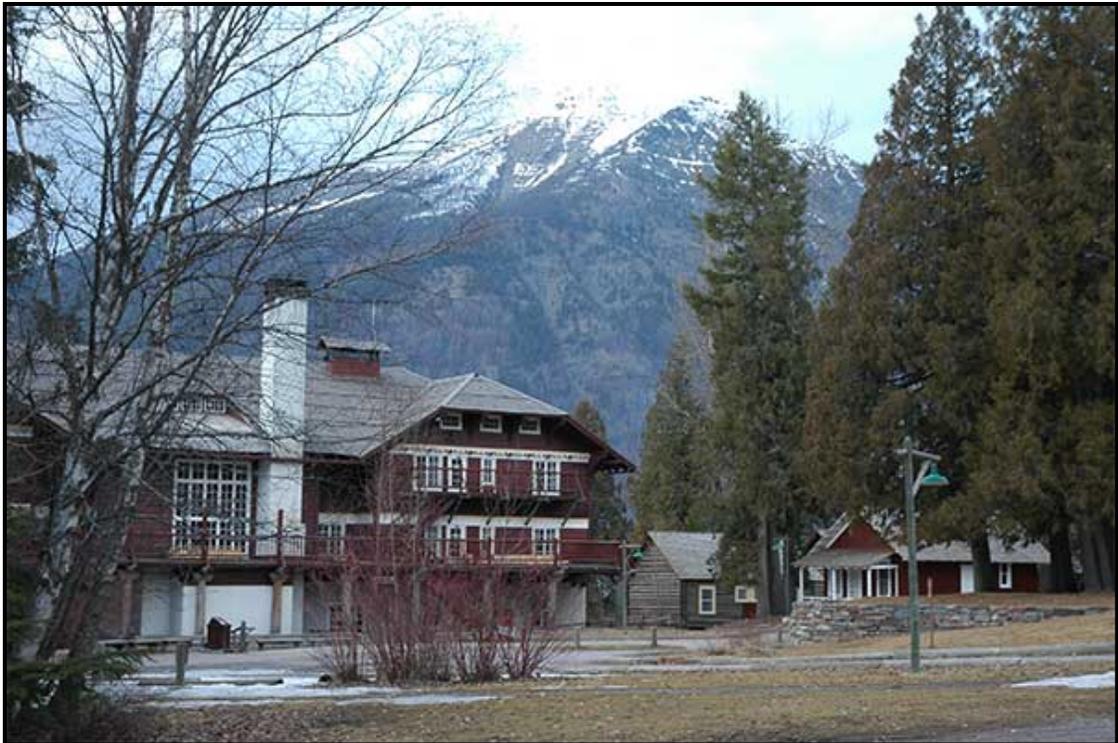
Figure 43. Vehicle entry drive at the hotel building. 2005 photos.
