FORT JAY BARRACKS

Governors Island National Monument
New York, New York

Paint Sampling Report: Doorways and Windows

Barbara A. Yocum, Architectural Conservator
Historic Architecture Program
Northeast Region, National Park Service
Lowell, Massachusetts

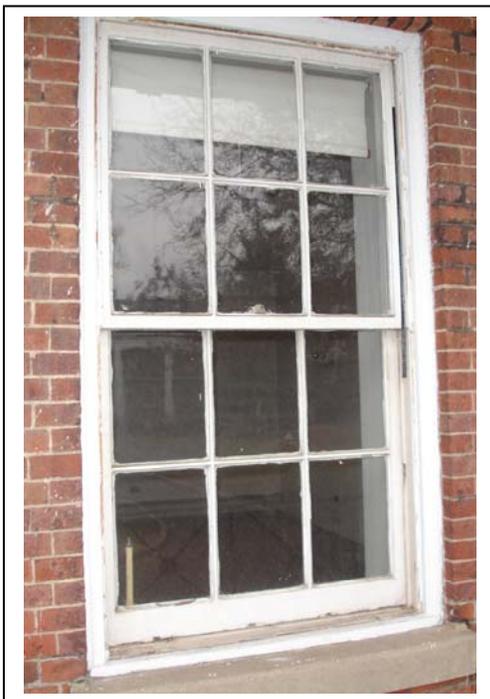
The exterior doorways and windows of the four barracks buildings at Fort Jay are painted in a uniform paint scheme of white and black. White paint finishes the casings of the doorways, windows, and the window sashes; the doors are painted black. This color scheme is found on both the courtyard side and the opposite ditch side of the buildings.

Exterior doorway in the east elevation of the west barrack (above).

Regarding the contractor's recommendations for interior painting of the barracks, I concur with using an EGGSHELL finish for the walls and a FLAT/MATT finish for the ceilings. A GLOSS finish should be used for both interior and exterior woodwork trim, doors, and window sashes.

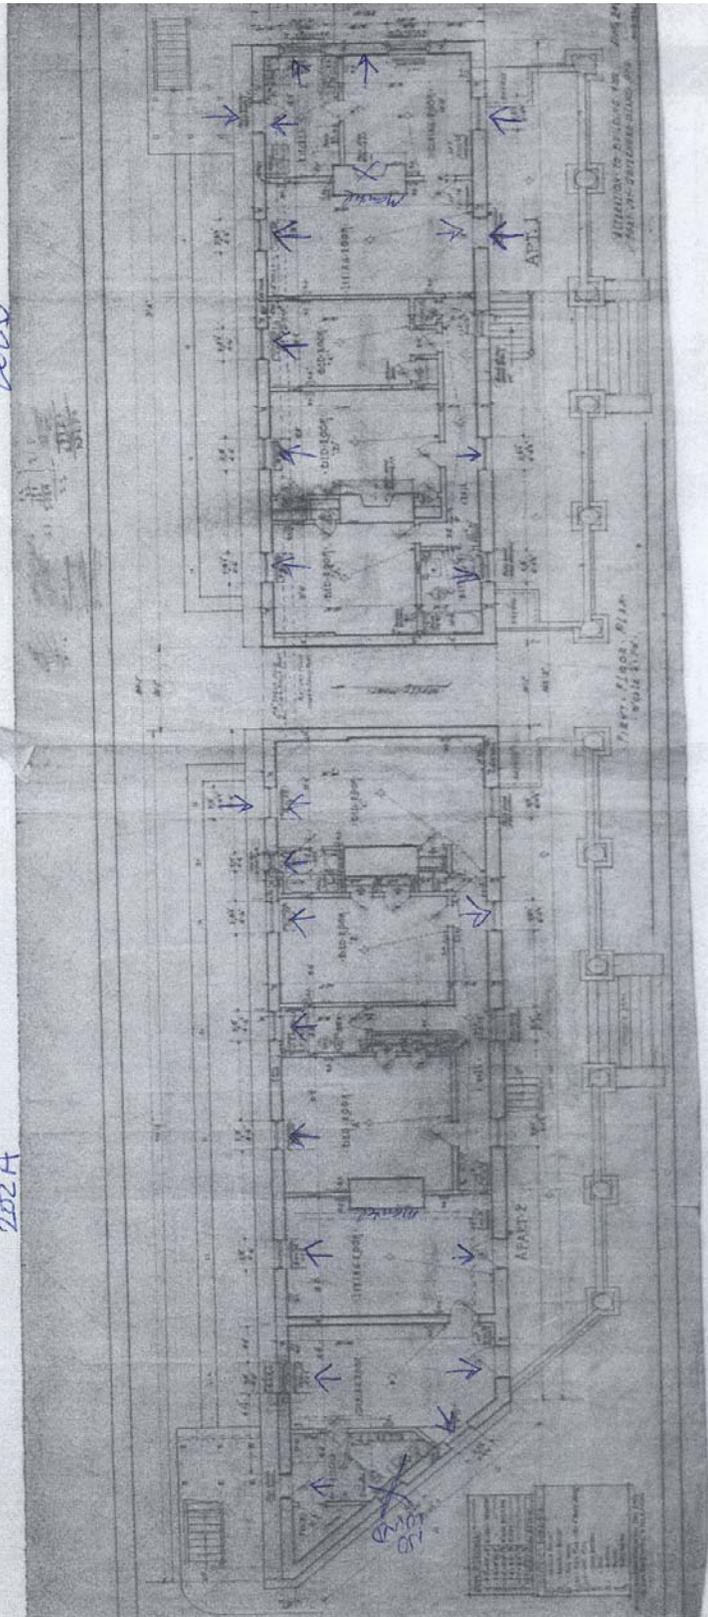
BUDG 202
2ND FLR
1934

knife, placed in coin envelopes, and assigned temporary numbers. Sample locations were recorded on the envelopes and keyed to 1930s floor plans of each building (see Appendix B). Existing paint schemes were documented in written notes and selected digital photographs. The samples were deposited in the paint archives of the Historic Architecture Program in Lowell, Massachusetts. No comprehensive analysis was carried out at this time.
