A REPORT ON ARCHEOLOGICAL INVESTIGATIONS WITHIN THE GRAND PORTAGE DEPOT (21CK6), GRAND PORTAGE NATIONAL MONUMENT, MINNESOTA: THE KITCHEN DRAINAGE PROJECT

VERGIL E. NOBLE

United States Department of the Interior
National Park Service
Midwest Archeological Center
Lincoln, Nebraska

1990

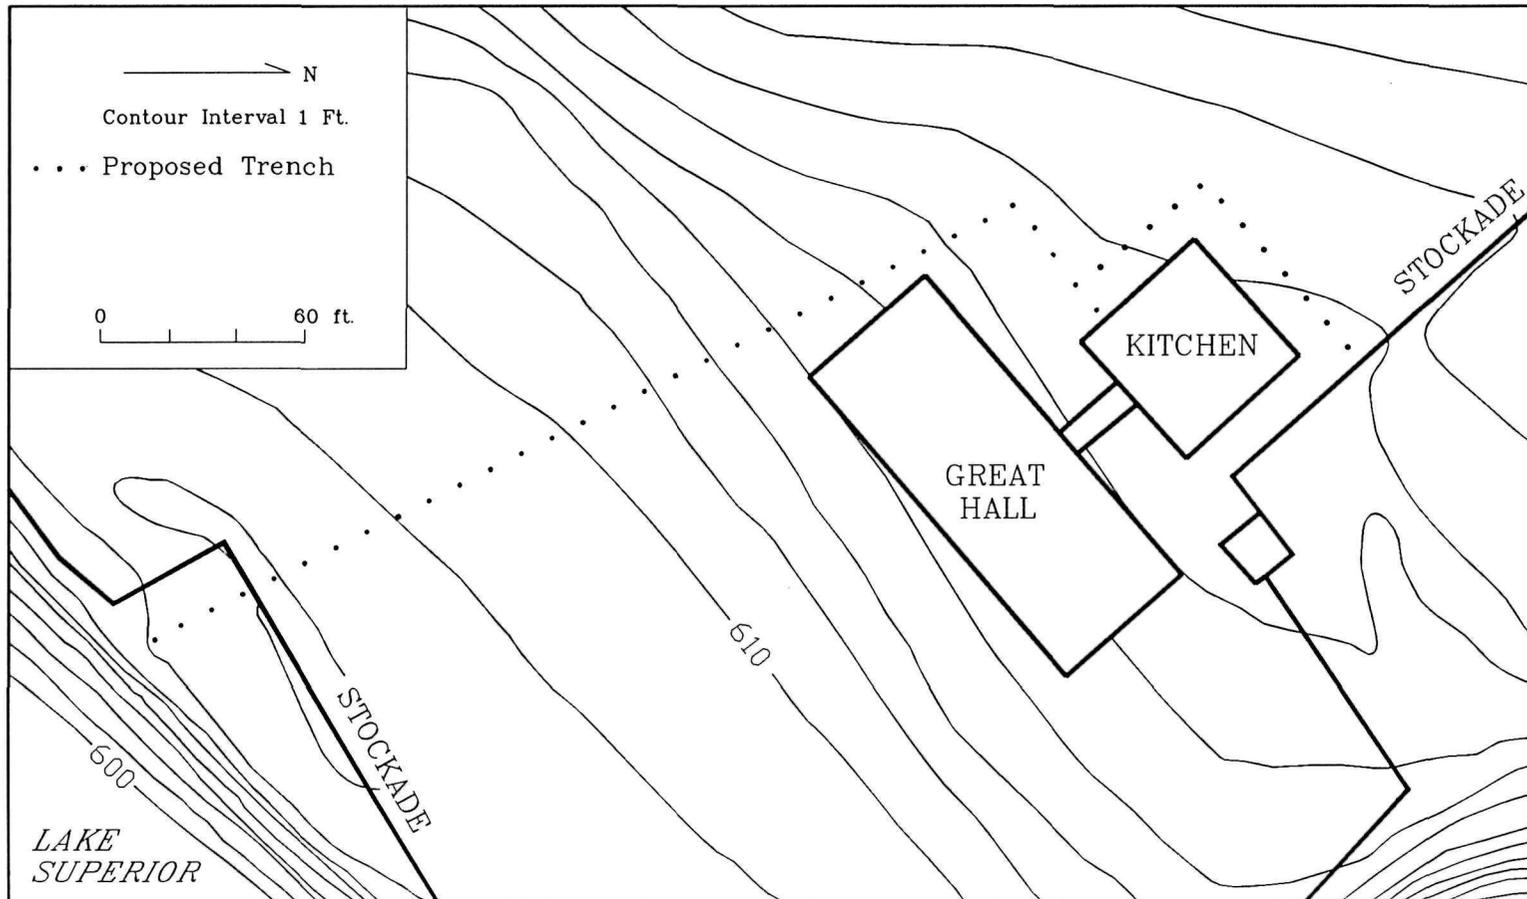
Figure 2. Plan of the proposed drainage system at Grand Portage.

age system that they hoped would improve drainage about the Kitchen and convey excess water to the lake (Figure 2). The proposed system entailed installation of an interceptor drain on two sides of the kitchen. Perforated pipe bedded in gravels, which in turn would be encapsulated in a filter fabric, would be buried on the north and west sides of the structure. That line would continue past the Great Hall toward Lake Superior, effectively intercepting ground water near that structure, as well. Down-slope from the Great Hall, however, the pipeline would be solid. Furthermore, in order to limit the amount of new ground disturbance, that segment of the alignment was to follow an existing drainage line that was installed in 1975 as part of a sump pump system. It also was believed that an earlier drain (circa 1940) had run through this general area soon after initial reconstruction of the Great Hall.

In addition to the interceptor drain, the new drainage system was designed to connect with existing sump pumps beneath the two reconstructed buildings. Short leaders of solid pipe would convey collected water from beneath the buildings to the installed line and thence to the lakeshore outlet. Thus, any water that might not be intercepted by the drain field could still be removed from the buildings by pumping it out.

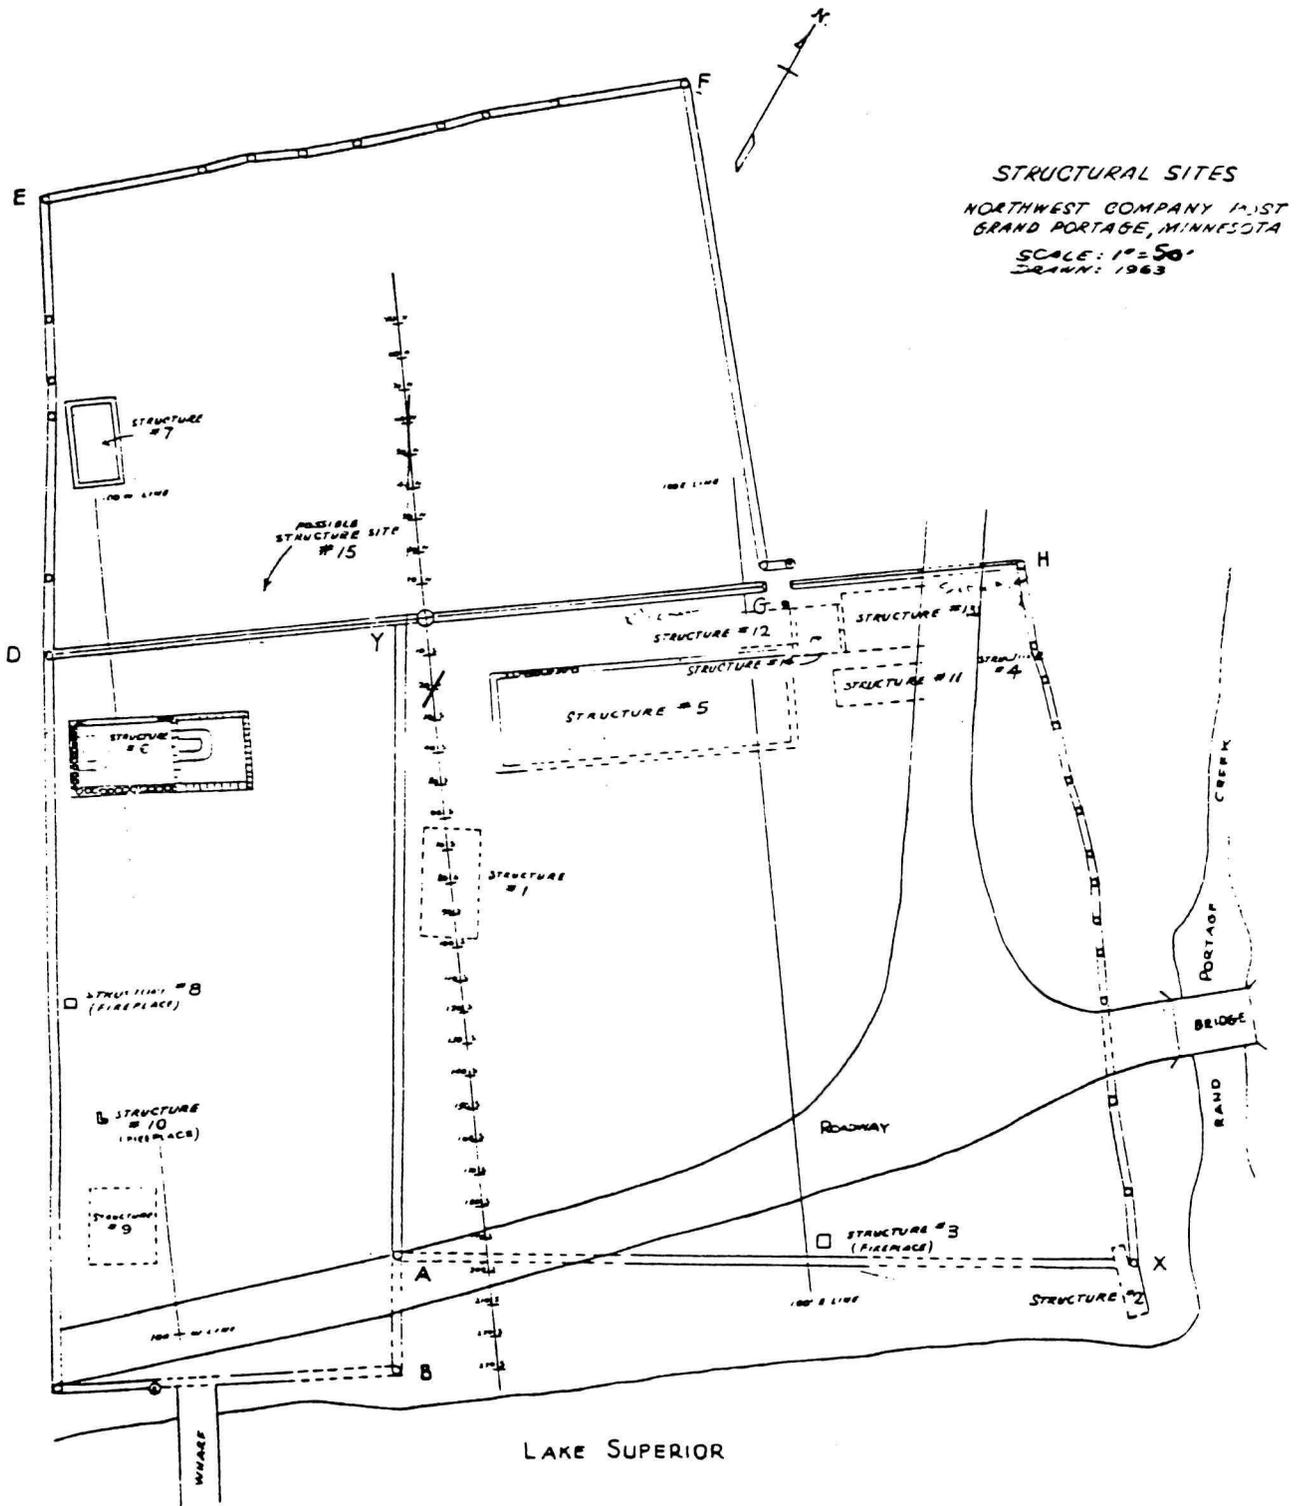
Figure 3. Location of Structure 1 relative to the Great Hall (Structure 5) and grid baseline (Woolworth 1963:Map 11).

It is known that the 1936 archeological project encountered the remains of a rectangular structure a short distance southwest from the Great Hall (Figure 3). The small building, which measured 18 ft x 30 ft, is alternately called "Structure 1" or "Feature 12" in various documents on the site (Woolworth 1963:76-78; Woolworth and Woolworth 1982:225-226, Inventory Form 12). Built of upright posts set in the ground, the structure was sited approximately 6 ft east of an interior palisade line connecting Corner A and Corner Y of the Depot. The structure also appeared to parallel that palisade wall. Records indicate that much of Structure 1 was exposed and excavated in 1936, but it is not clear how much of the feature remains undisturbed (Figure 4).

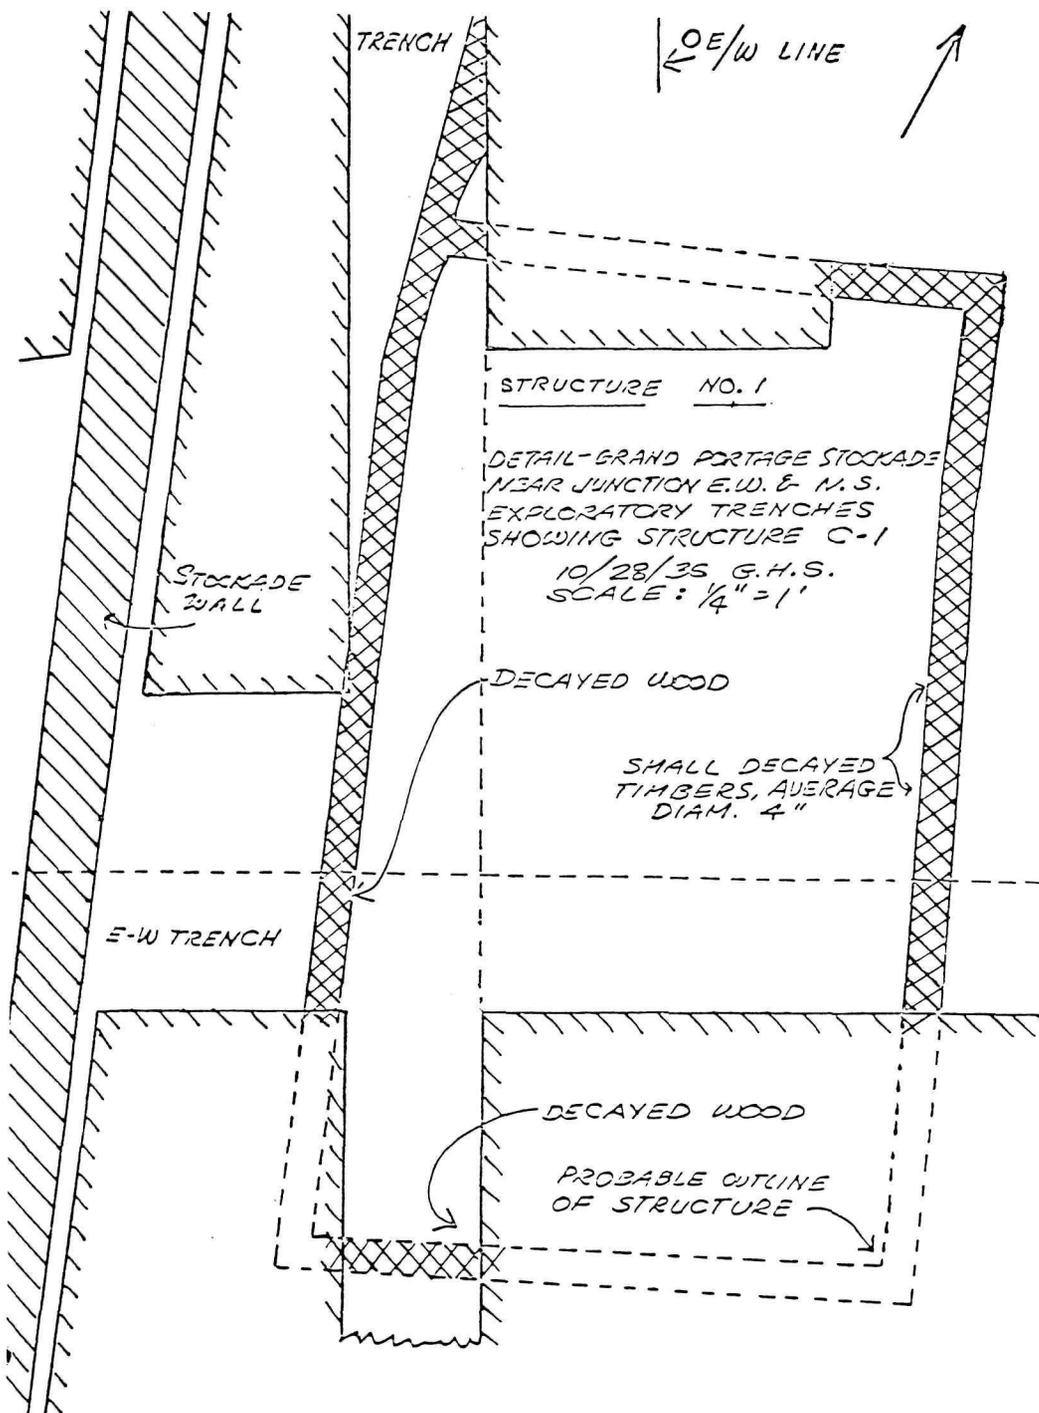
Figure 4. Detail of Structure 1 area based on 1936 excavation records (Woolworth 1963:Map 1b).

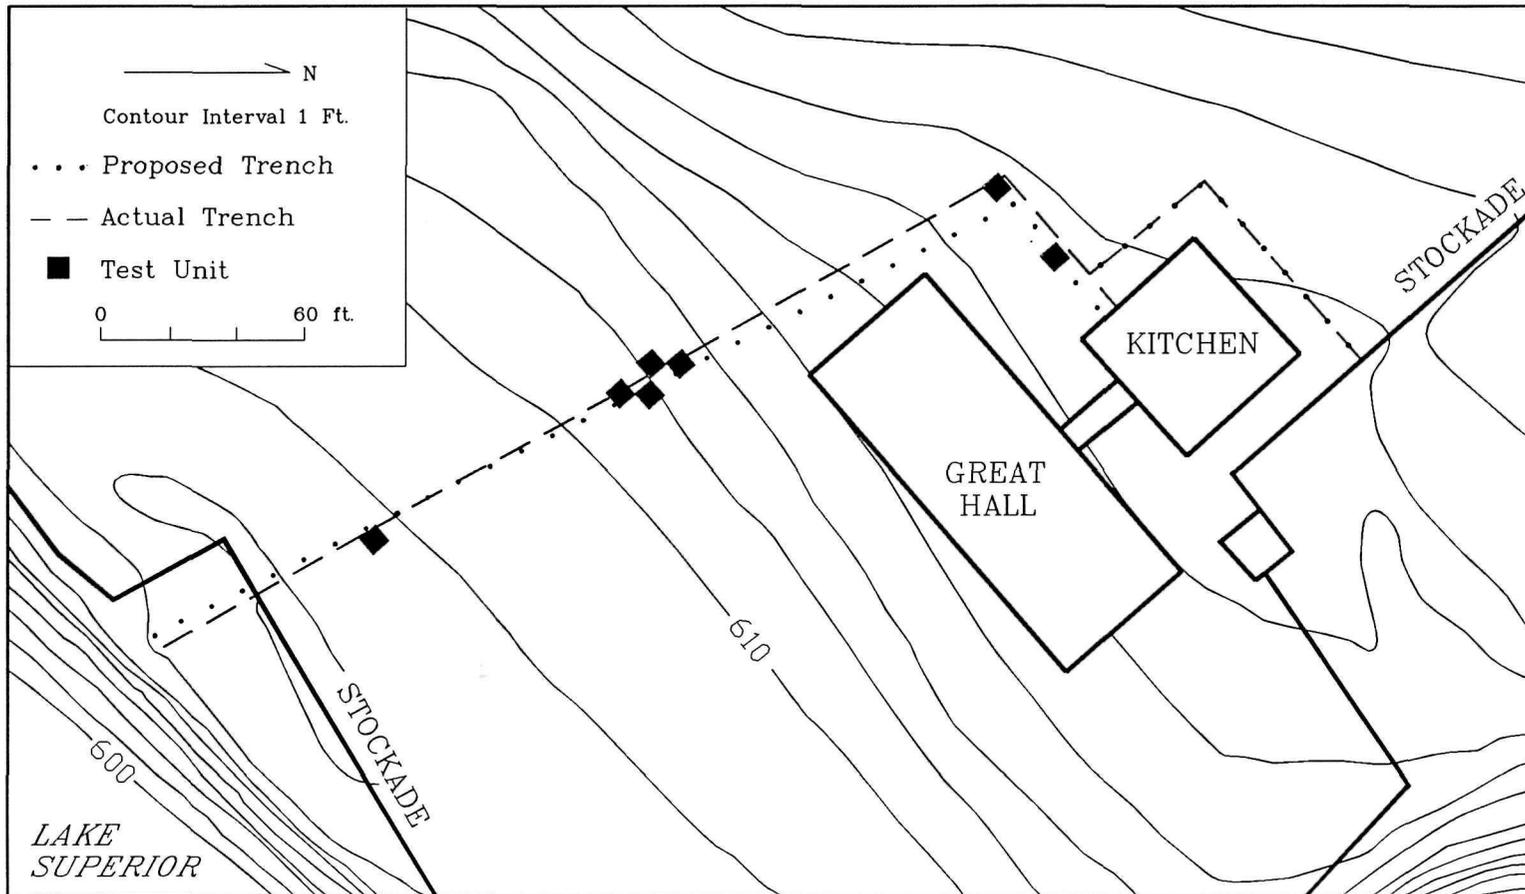
Figure 5. Actual trench placement and locations of 1989 test excavations.

During the two-week field project, seven test units were excavated within the Depot (Figure 5). Four of those, however, fell upon the area where Structure 1 was believed to have been located and partially excavated in 1936. Since little or nothing of real consequence was found in the 1989 excavations, it should not be necessary to dwell upon their contents in any detail. Rather, they will be discussed in more general terms with respect to the three areas represented: the Structure 1 area, the palisade area, and the Kitchen/Great Hall area.

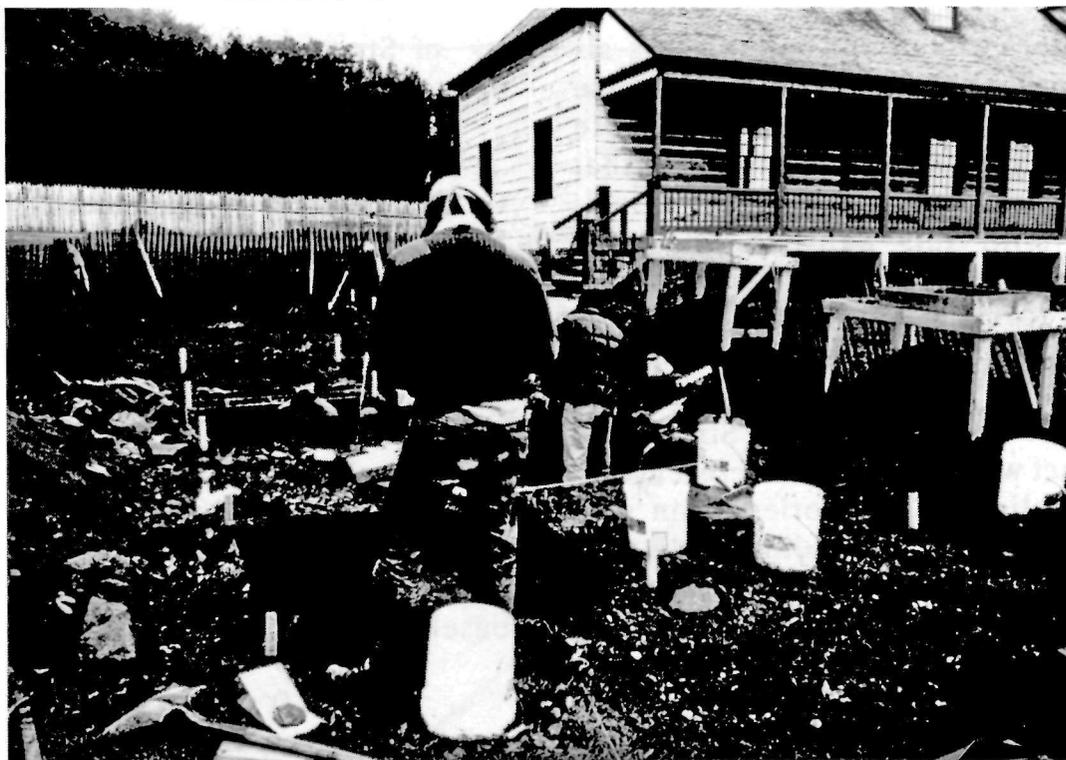
Figure 6. Testing the Structure 1 Area.

Four 5 ft x 5 ft test units were excavated in the vicinity of Structure 1: S25/W5, S30/W10, S35/W5, S40/W10. Together, the four units formed a checkerboard pattern that enabled the investigators to examine, in effect, a 10 ft x 20 ft area (Figure 6). That was deemed sufficient to sample the direct impact zone of the drain installation and large enough to encounter any remains of Structure 1 that might survive in its path.

It was found, however, that the area already was badly disturbed, and no evidence of the feature was discerned in the soils. The most obvious disturbance was a north-south trending trench that proved to contain the existing 1975 drainage line. The edge of the trench could be seen passing through the foot-thick fill layer immediately below the thin sod layer, indicating that it was of more recent origin. At the top, the trench

appeared to be nearly 5 ft wide, narrowing to approximately 3 ft at its base. The four-inch diameter, solid PVC pipe was set at 3.5 ft below the ground surface.

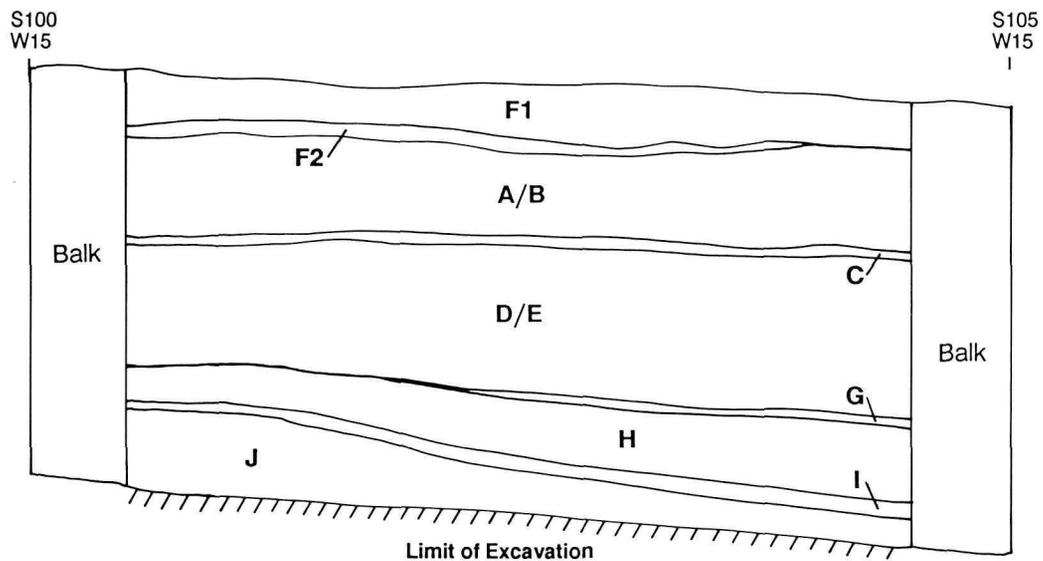
- A** Brown Sandy Loam with Small Particles of Yellowish Brown Coarse Sand
- B** Yellowish Brown Coarse Sand
- C** Thin Lens of Black Sand
- D** Brown Loamy Sand with Large Patches of Yellowish Brown Sand and Sparse Pea Gravels
- E** Homogeneous Brown Loamy Sand
- F** Homogeneous Yellowish Brown Coarse Sand with Streaks of Gray Sand
F1 - Overburden, Clay Silt
F2 - Overburden, Red Clay and Pea Gravel
- G** Thin Layer of Fine Gravels
- H** Homogeneous Yellowish Brown Coarse Sand
- I** Pea Gravels and Black (Iron-Rich) Sand
- J** Homogeneous Yellowish Brown Coarse Sand

Figure 7. East Profile, Test Unit S105/W20.

The most remarkable aspect of unit S105/W20 was its column of soil strata. Inspection of the east unit profile showed that each layer slopes downward gently toward the lakeshore and consists of well-sorted sands and gravels (Figure 7). The north profile, on the other hand, exhibits essentially level bedding of the soil layers. The configuration and content of those deposits, therefore, both point toward the conclusion that the column represents a natural beach sequence built up over the course of time.

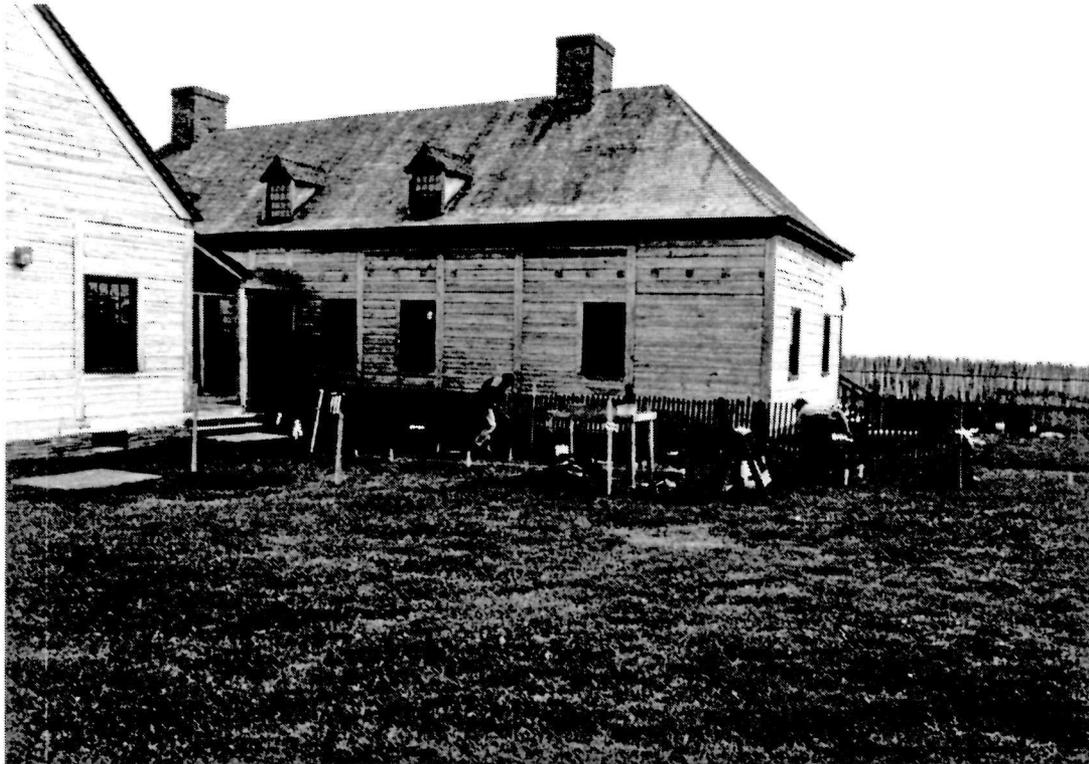
Figure 8. Excavations begin at the Kitchen/Great Hall Area.

The 1989 investigations within the Depot at Grand Portage included the excavation of two test units between the reconstructed Great Hall and Kitchen on a rather level bench that may represent an old beach ridge. It was in this area that a section of drain conduit would be run west from the Kitchen before turning south toward the lake. Since no previous investigations had been carried out in that particular area, the two 5 ft x 5 ft units sought to determine whether any significant archeological deposits might lie in the proposed path (Figure 8).

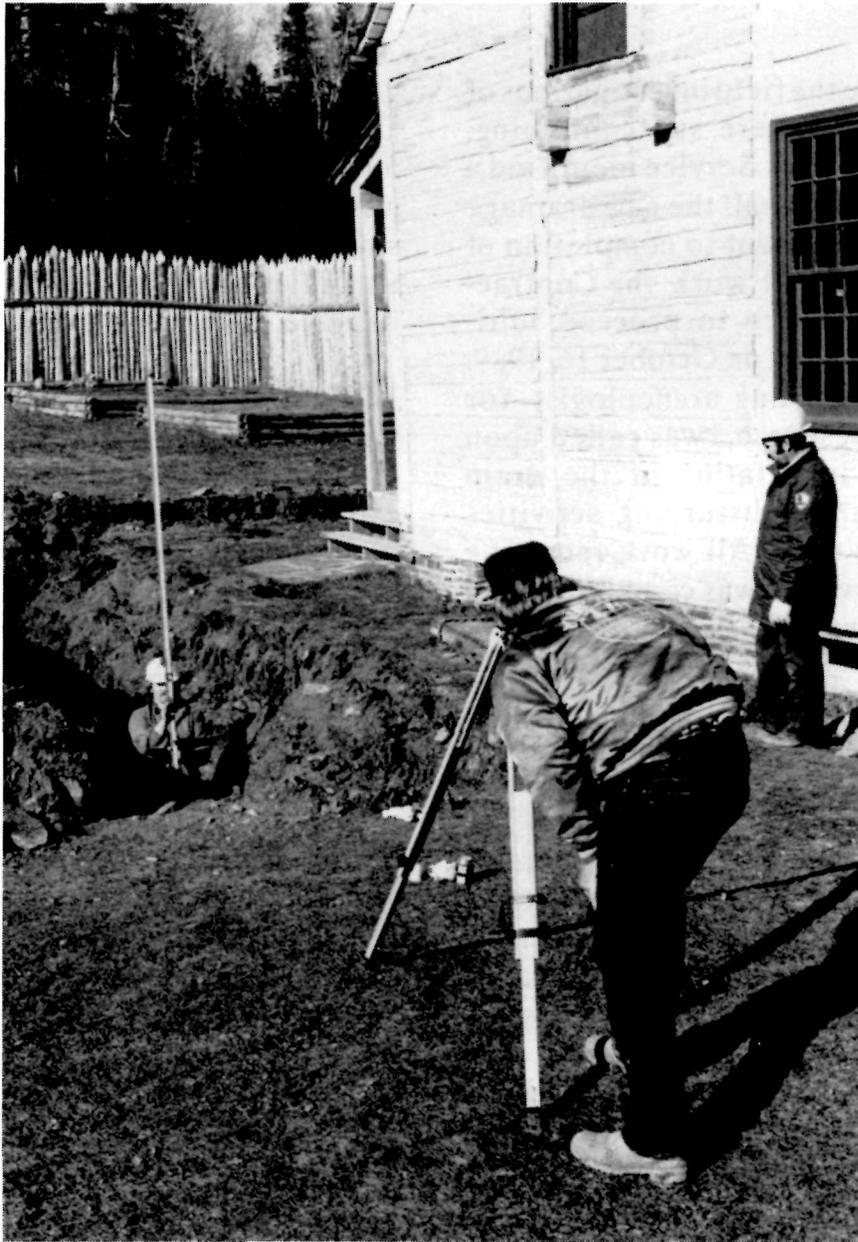
Figure 9. Workers check grade of trench near the Kitchen.
