HAMPTON MANSION

ADDENDUM
HISTORIC STRUCTURE REPORT
ARCHITECTURAL DATA SECTION
HAMPTON MANSION
HAMPTON NATIONAL HISTORIC SITE
TOWSON, MARYLAND

Prepared by
Anthony O. James
and
Penelope Hartshorne Batcheler

DENVER SERVICE CENTER
MID-ATLANTIC/NORTH ATLANTIC TEAM
BRANCH OF HISTORIC PRESERVATION
NATIONAL PARK SERVICE
UNITED STATES DEPARTMENT OF THE INTERIOR
DENVER, COLORADO

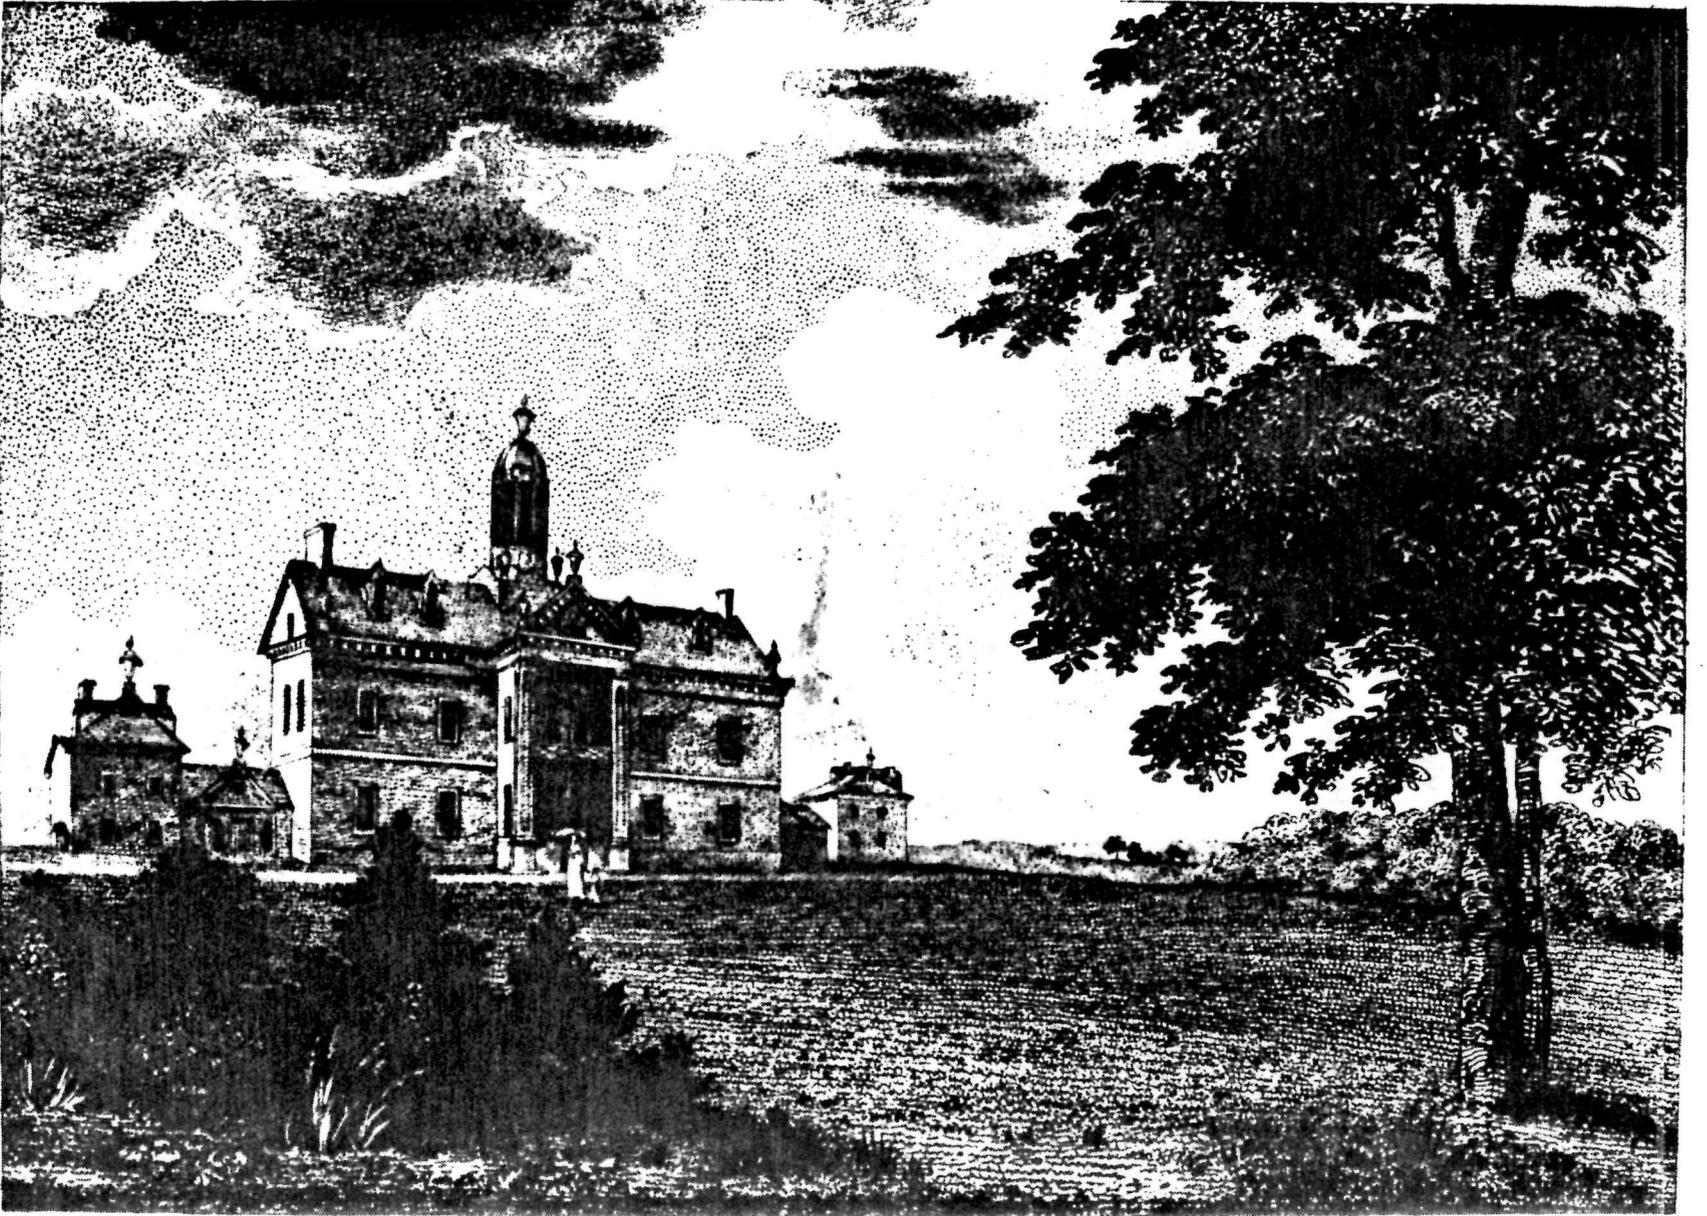
ILLUSTRATION 1: North Facade

1808 (published date; perhaps drawn as early as 1802). Engraving by William Russell Birch. Copy located at Historical Society of Pennsylvania.

The most important piece of information which might be garnered from the view is whether or not the shutters were in existence at that time. All of the shutters referred to in the accounts of the original construction are described as "inside shutters."⁵ Presently we cannot be sure when the exterior shutters were first hung. We do know that they were in place by 1838, the date of Illustration 3.

Birch is known to abbreviate and simplify the detail of his presentations, explaining the incorrect number of windows on the gable end of the main house. It is even more understandable, therefore, that he did not attempt to show the stucco penciling which we believe to have been present.

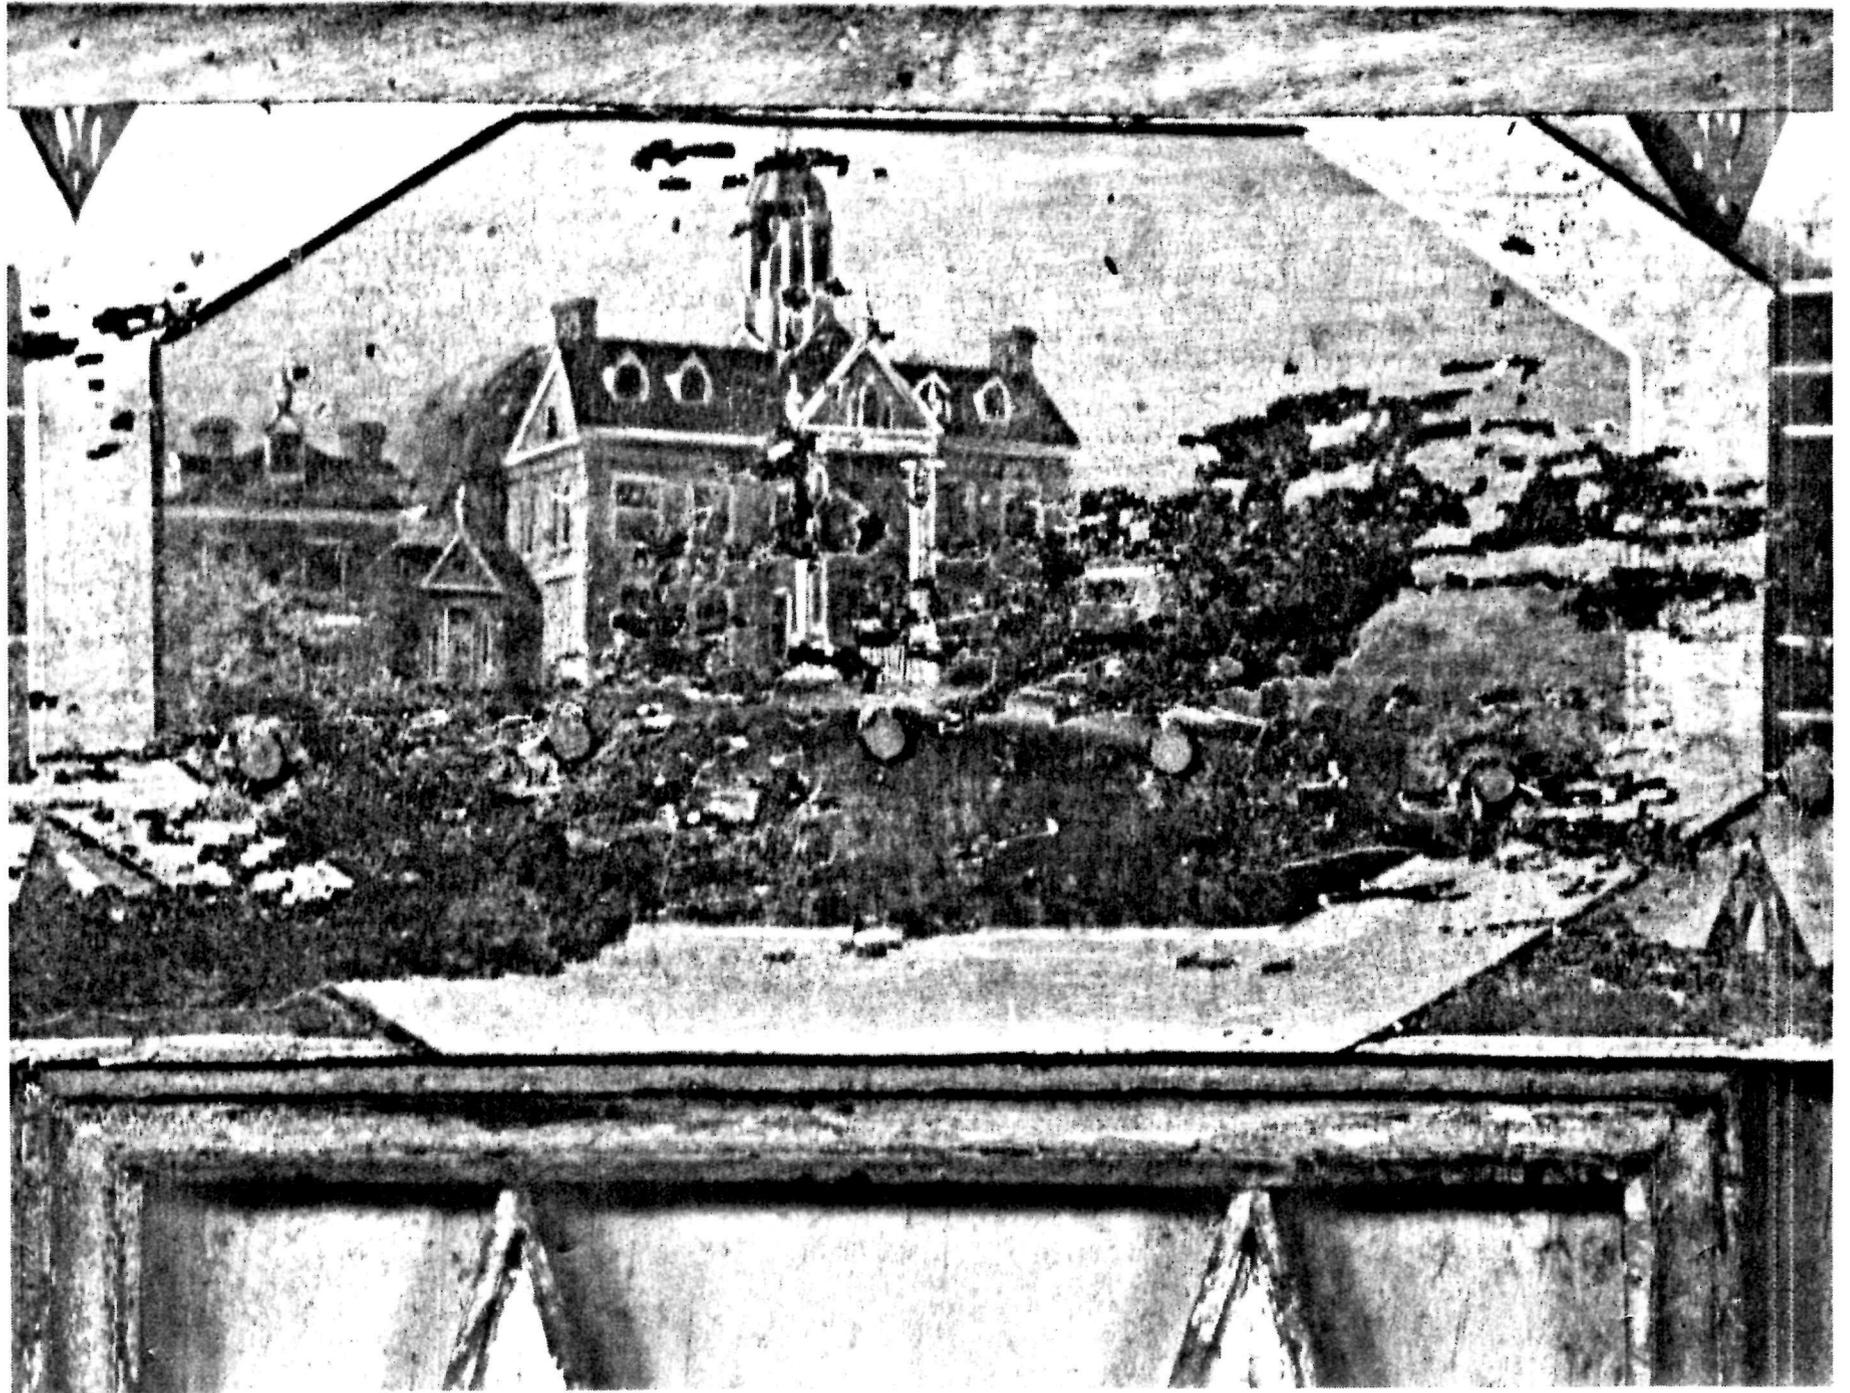
ILLUSTRATION 2: Hampton mansion
1800-10 Painting on crest rail of a Sheraton style chair in the collection of Hampton National Historic Site, donated by John Ridgely III.

We cannot determine whether the view exhibits the north or south facade. Indications exist of a wrought iron railing on the portico stairs. The ochre color of the stucco is clearly indicated by the painting and the chimneys on the main block and wings are painted red indicating exposed brick.

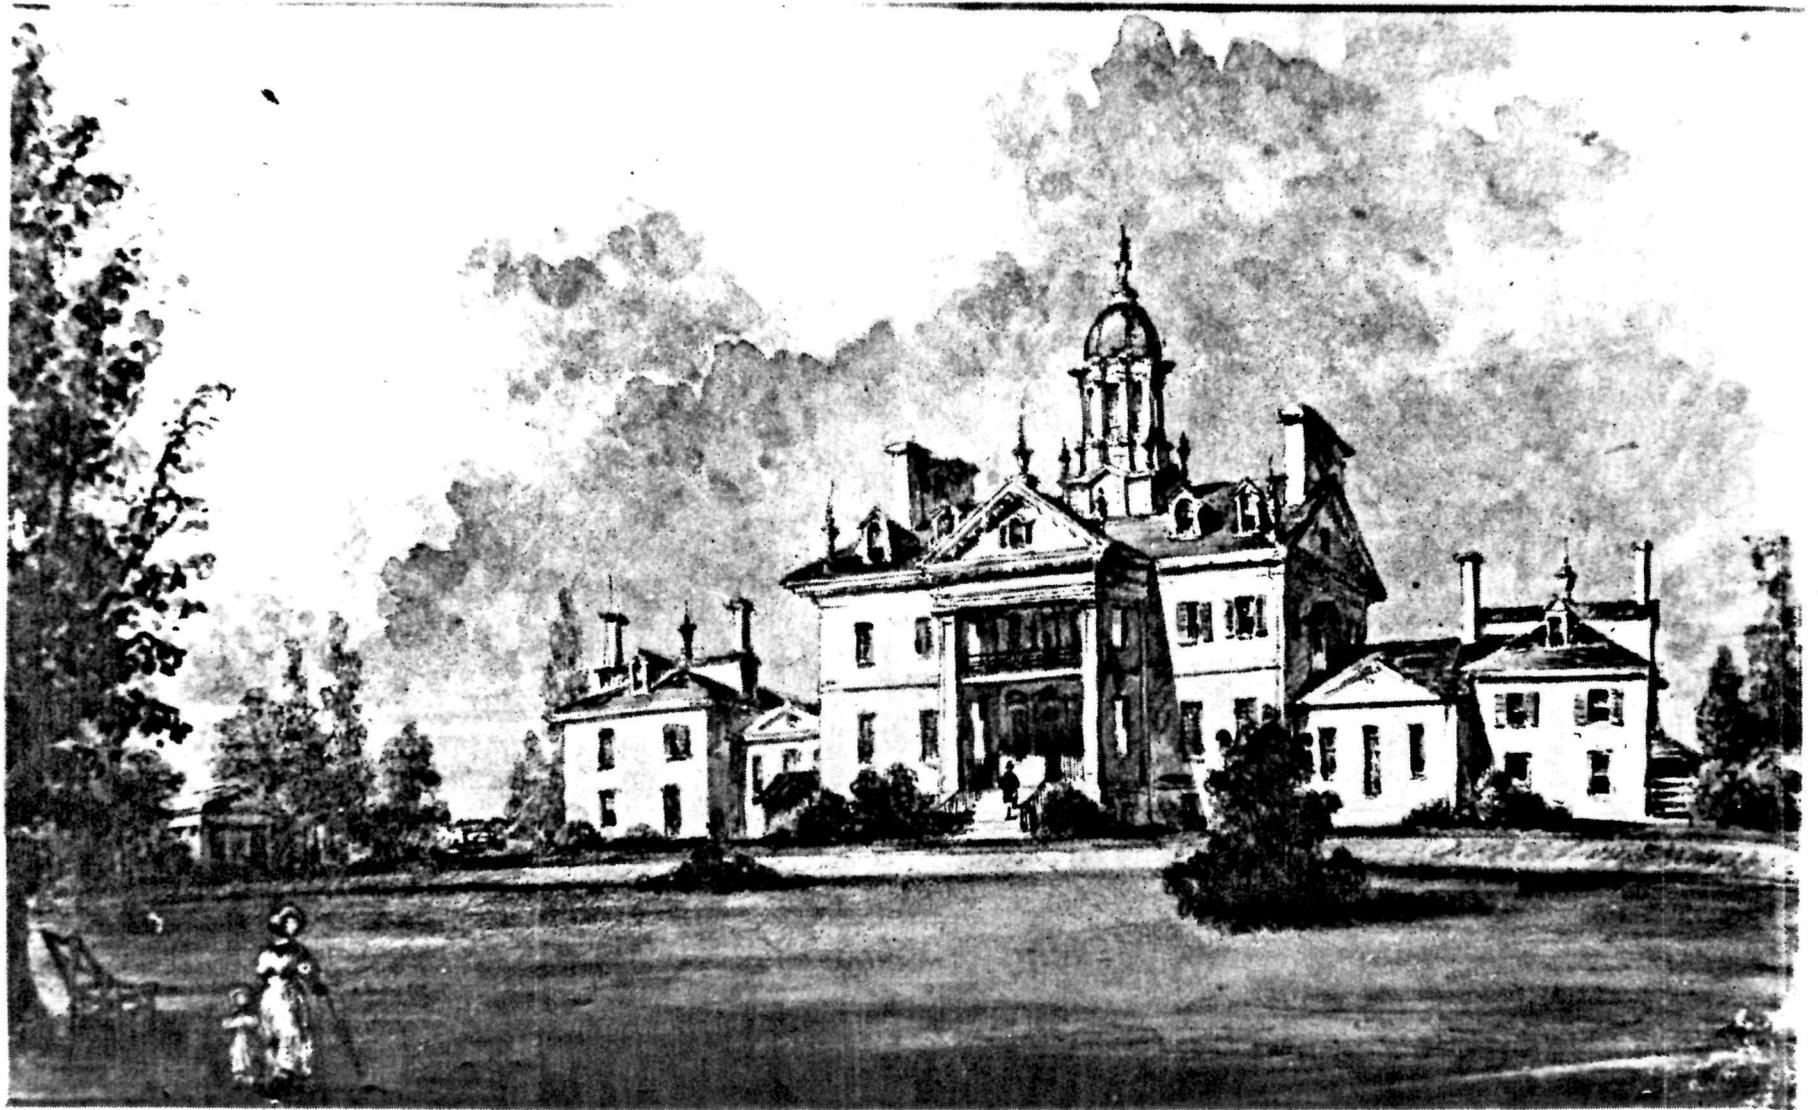
ILLUSTRATION 3: South Facade 1838
(dated on watercolor)
Watercolor by Robert Cary Long, Jr.
Collection of John Campbell White
Copy negative H-PHP-2-6

From this watercolor view we know that the east hyphen had been extended by 1838, and the building stucco layer was overall light colored (the rendering is not detailed enough to show the ashlar pattern penciling known to have been used prior to the extension of the east hyphen.) The view shows shutters were fitted to eight windows, four on either side of the portico, on the main block, and to the second floor windows of the wings. Other shutters may have been in place elsewhere, particularly on the gable ends on the main block; but they are not clearly visible here. Another feature which was not shown in the Birch view 30 years earlier is the long shed built against the east wall of the east wing, apparently a woodshed. This structure stood until the time the National Park Service took over the property. Note what apparently is an awning over the south entrance of the west hyphen. Also appearing in this view is the orangery, which must have been built recently.⁶ There are still practically no trees close to the mansion.

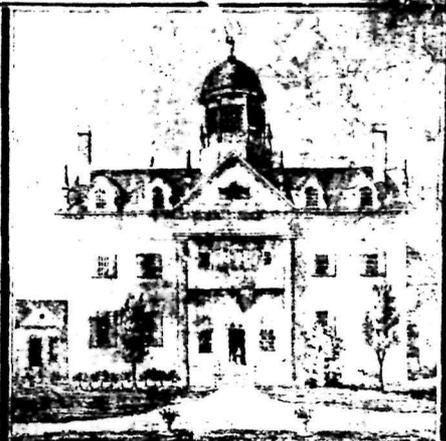
ILLUSTRATION 4: South Facade
1857 (published date of Baltimore City and County map for which this view is a border illustration)
Lithograph by Robert Taylor
Collection of Maryland Historical Society

This simplified view is probably a version of the lithograph for which "R. Taylor, surveyor" was paid \$5 by the Ridgelys in 1856.⁷ It shows shutters on the eight nonportico windows of the south facade of the main block, as well as ones on the second floor door of the portico. This first floor door is open and shows no shutters, although they easily could have existed since the view is basically very sketchy. No shutters show on the portico windows.

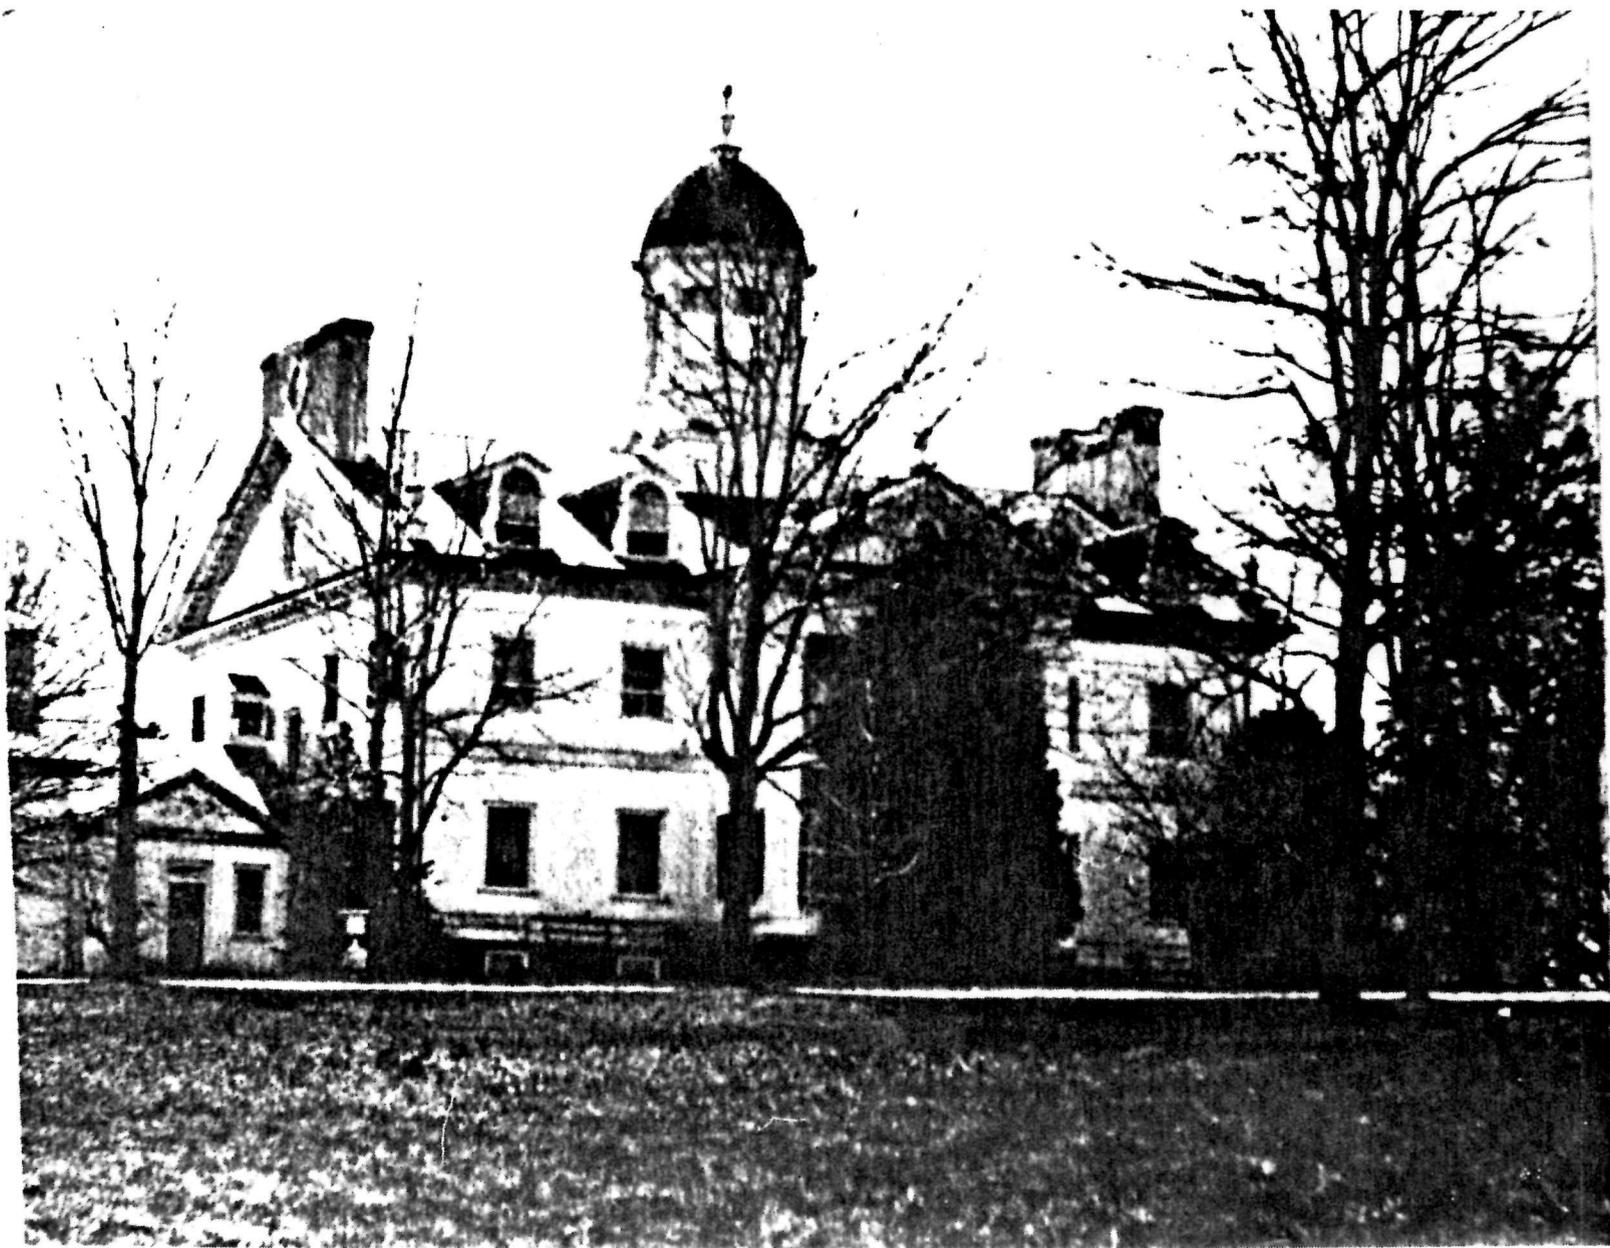
ILLUSTRATION 5: North Facade

Grouped in a family photograph album with portraits taken in the 1860s, this view of the north facade may have been one of the photographs for which the Bendwin Brothers were paid \$10 in 1862.⁸ As the earliest known photograph of Hampton, this view shows the north portico before the installation in 1867 of the marble steps. Unfortunately most of the north portico is obscured by a huge cedar tree.

Note that this is the earliest view of the Victorian two color stucco (dark base, light upper walls). Indeed the belt course between the first and second floors seems to be a shade darker than the surrounding walls.

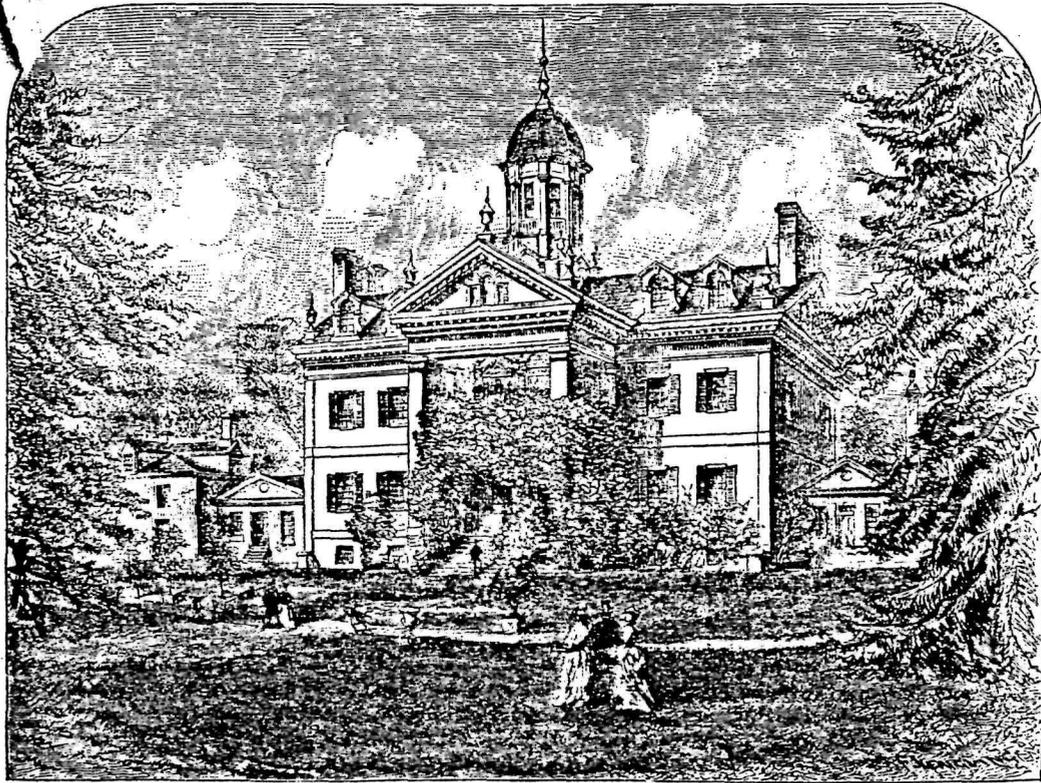
Although the text of the article states that this view is from the north, it is our conclusion that the view is instead from the southeast, for the following reasons: shutters are shown (shutters as shown here are not found on the north facade); the north portico was never overgrown with a Wisteria vine (such a vine never appears in other views of the north facade); the sun is shining on the facade; there is no carriage drive shown; and there is a walk below the house, with urns and orange trees in boxes, as shown in later views of the south facade.

Artistic license has been taken to the extent of not including the east hyphen addition. Shutters are shown on the same eight windows on the south side of the main block as in the earlier views, Illustrations 3 and 4. Shutters either no longer existed on the second floor of the west wing or they were closed. It is difficult to tell whether or not there were shutters on the portico windows. An interesting addition is the chimney pot on the east hyphen chimney. The Wisteria vine which covered the south portico until 1950 is shown here well established.

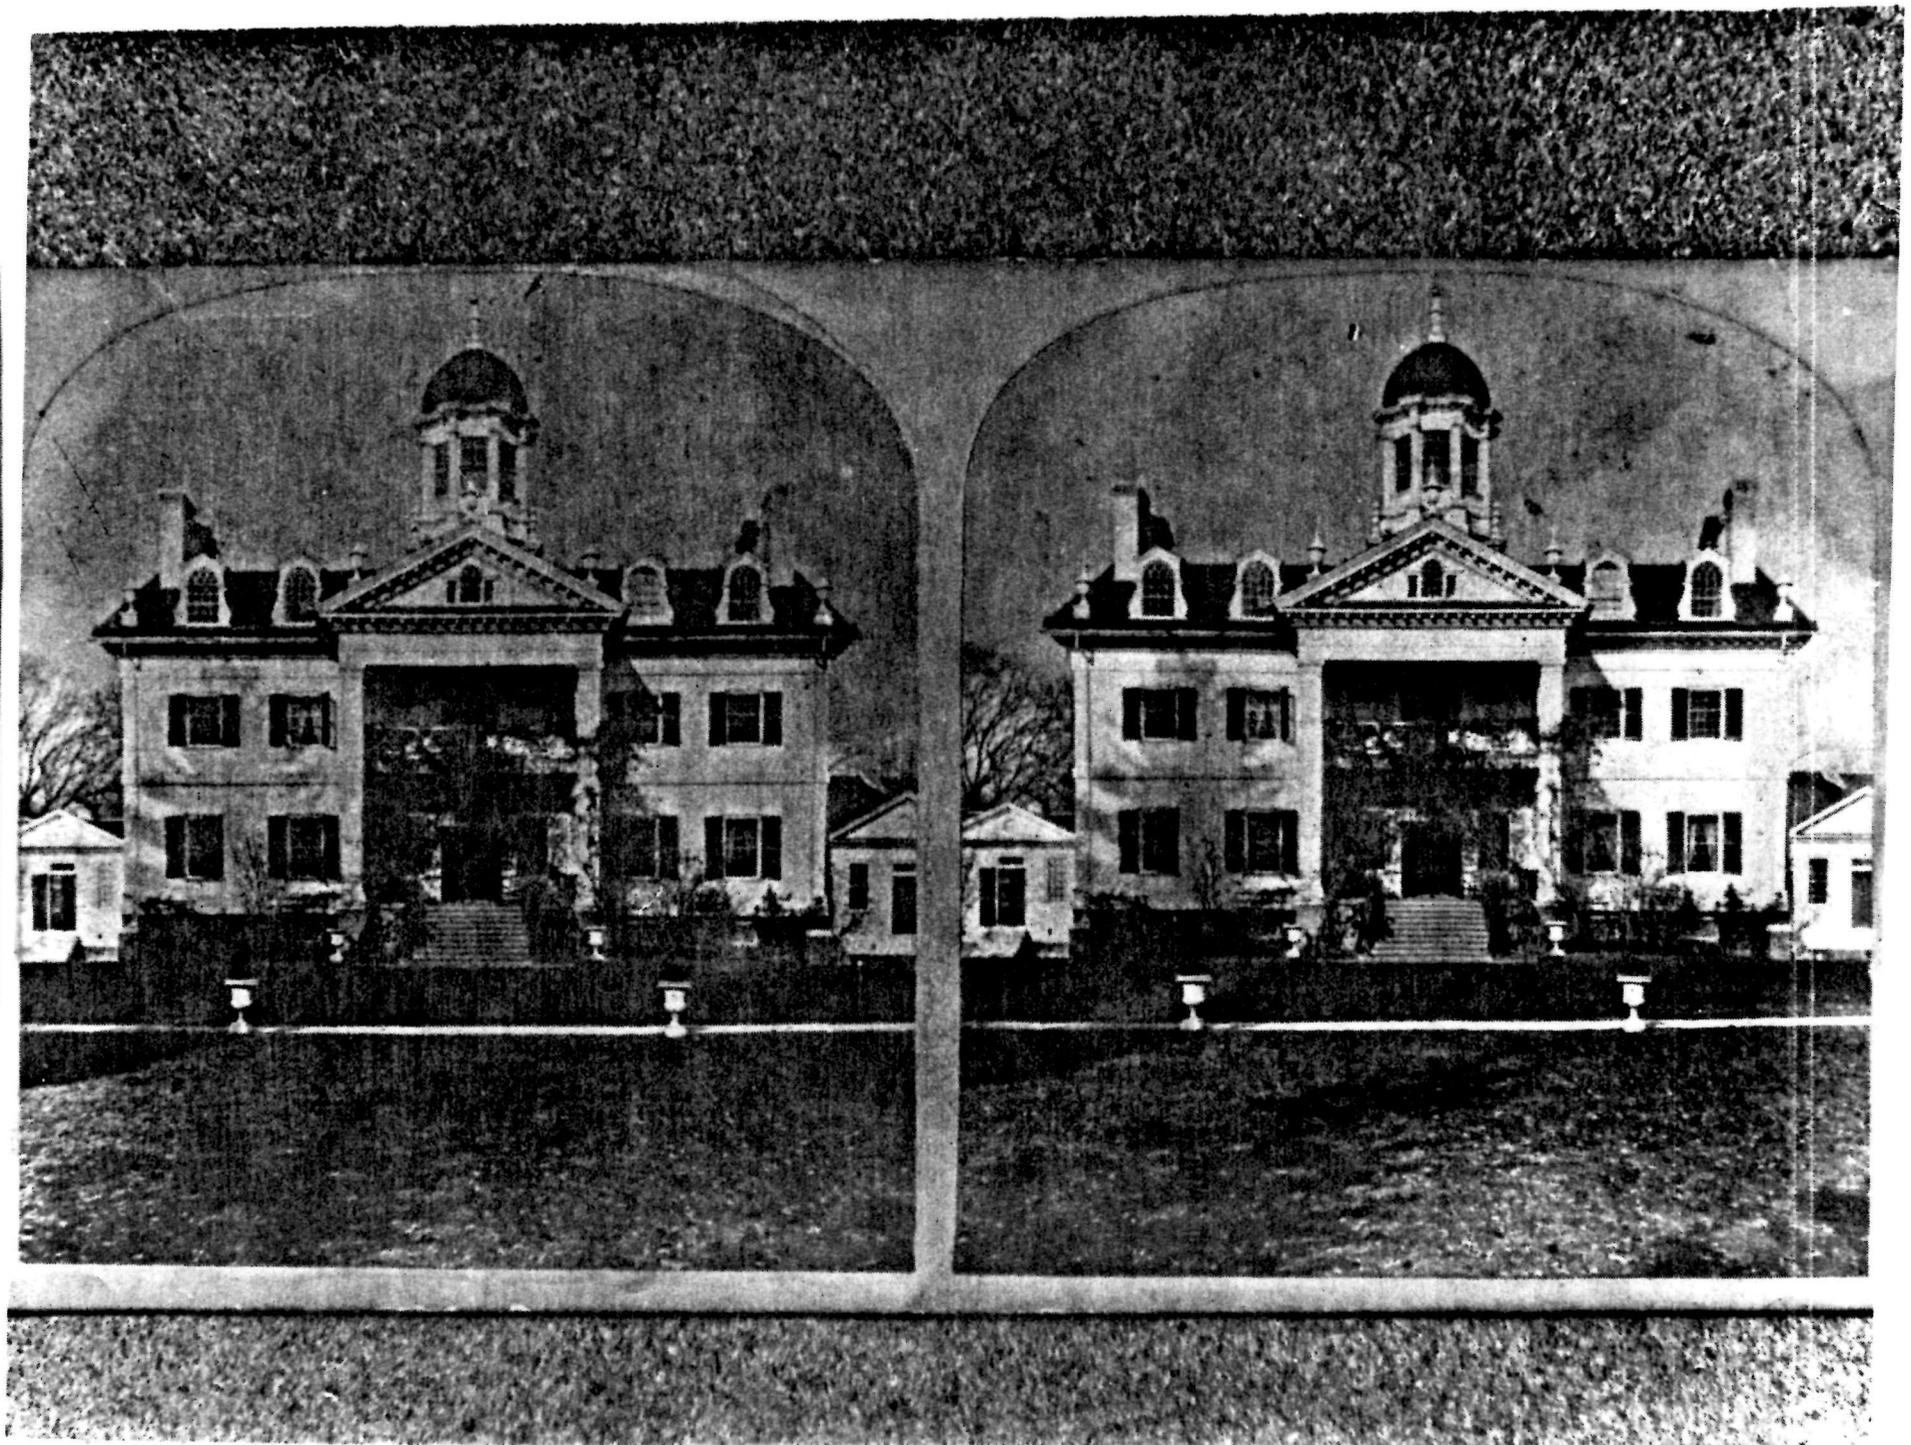
ILLUSTRATION 7: South Facade
Mid-1870s?

It should be noted that the catch basins, except for the marble cap stones, were apparently painted the same dark color as the base of the house.

Noted also that the ball surmounting the cupola finial is gilded. On July 6, 1841, James Shanessy was paid for "Guilding [sic] ball 5.00" (see Snell, HSR, p. 84).

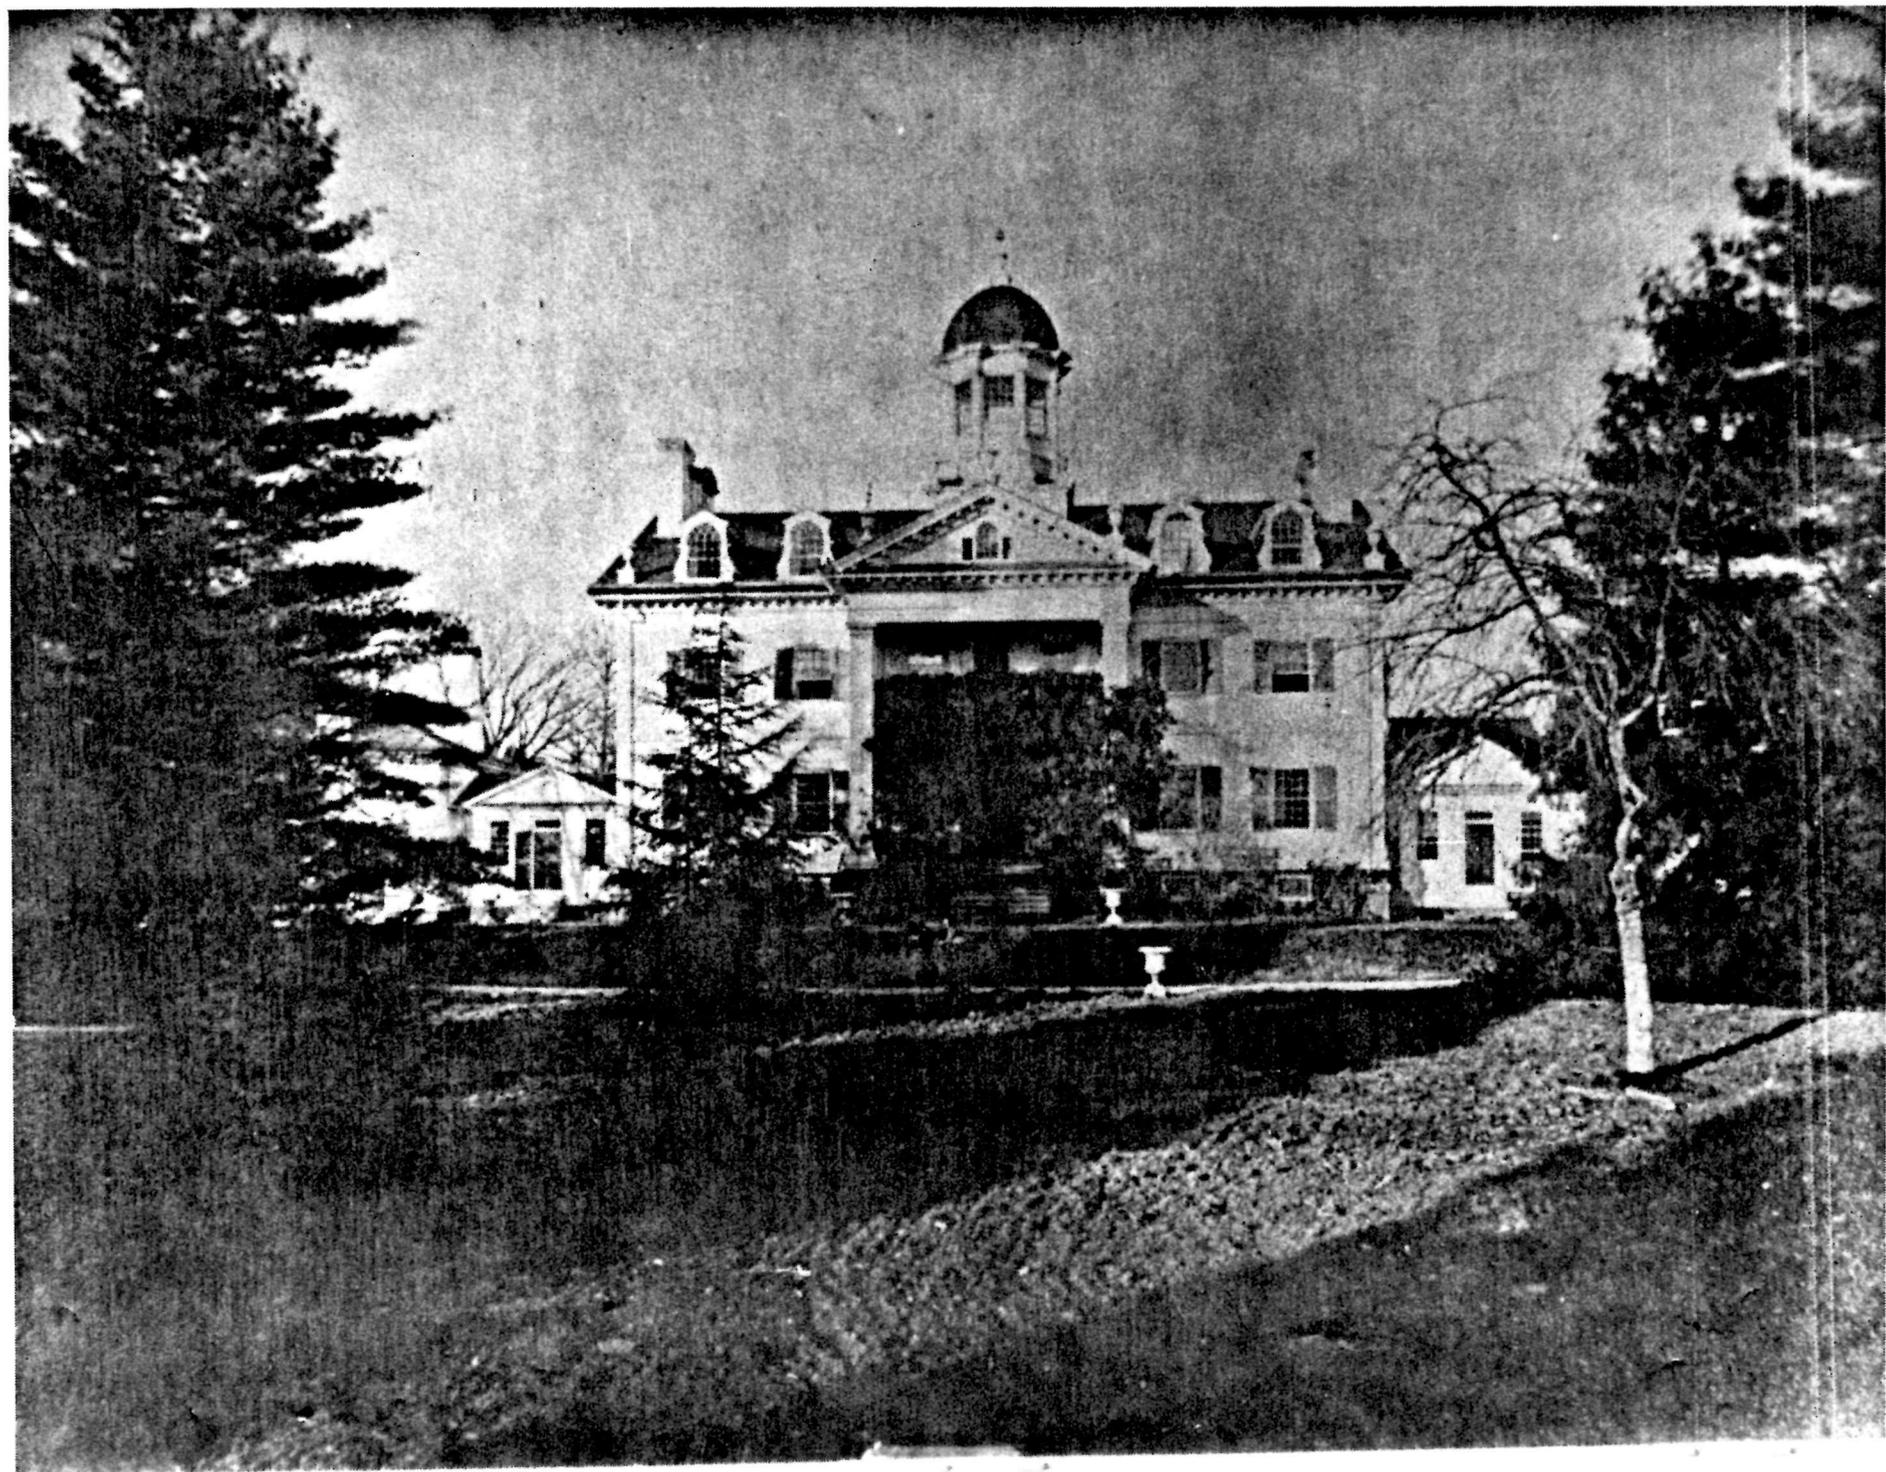
ILLUSTRATION 8: South Facade

Taken from practically the same spot as the previous photograph (Illustration 7) this view shows an evergreen planted in front of the house. Since the trees here are leafless the earliest it could have been taken would have been the winter of 1877-78 (assuming the tree was planted in the fall of 1877 as noted under the previous illustration). It could have been taken no later than the winter of 1880-81 since the first chimney cap was installed the following spring.¹² In the original print white joints are visible on the dark stucco house base. Note the plowed lawn, which may have been prepared to take sod in early spring.

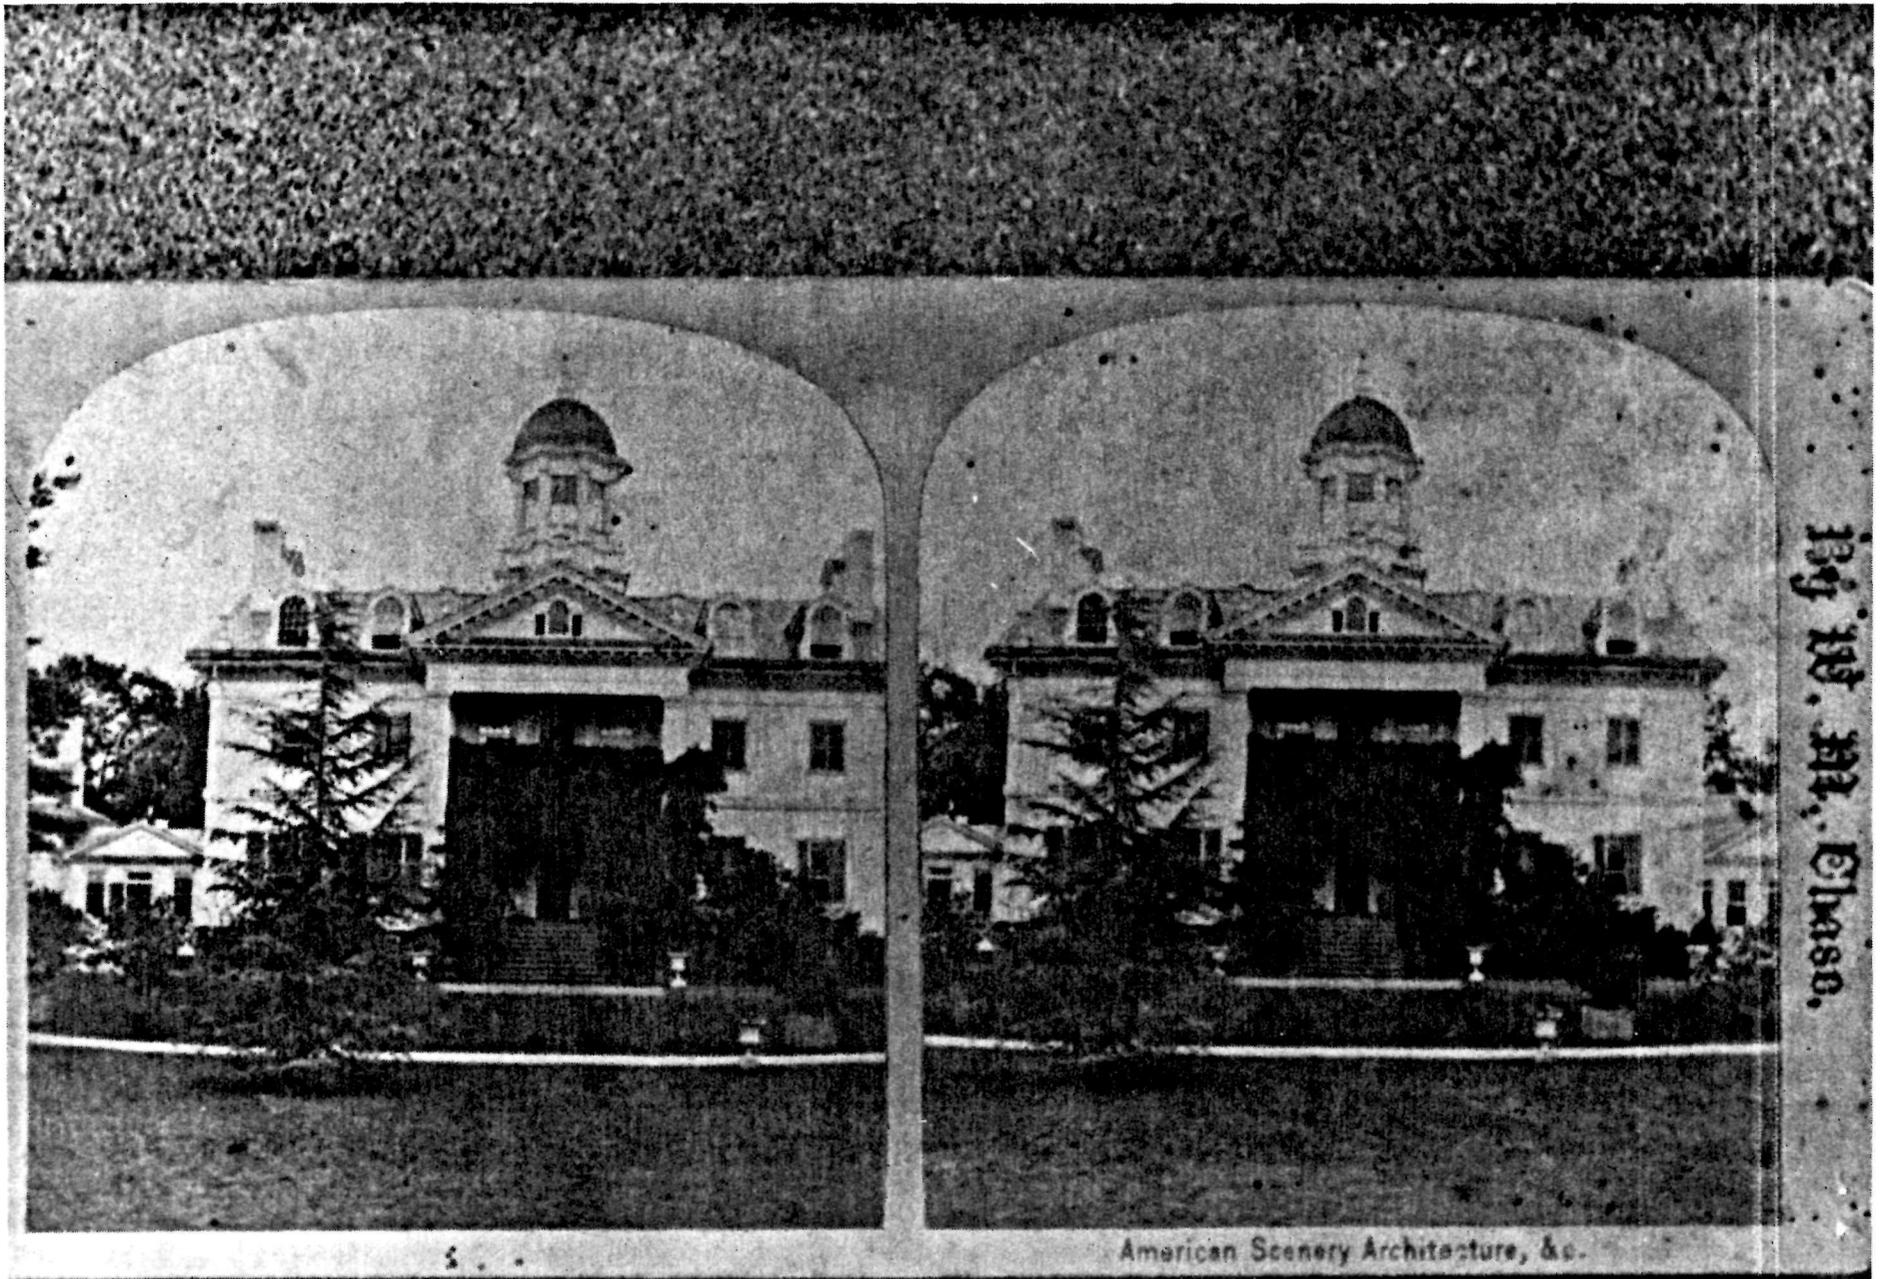
The garden furniture and the tree boxes shown here were painted with contrasting colors in 1881.¹³ These were apparently wood boxes, unlike the later cast iron and slate boxes (see Illustration 20).

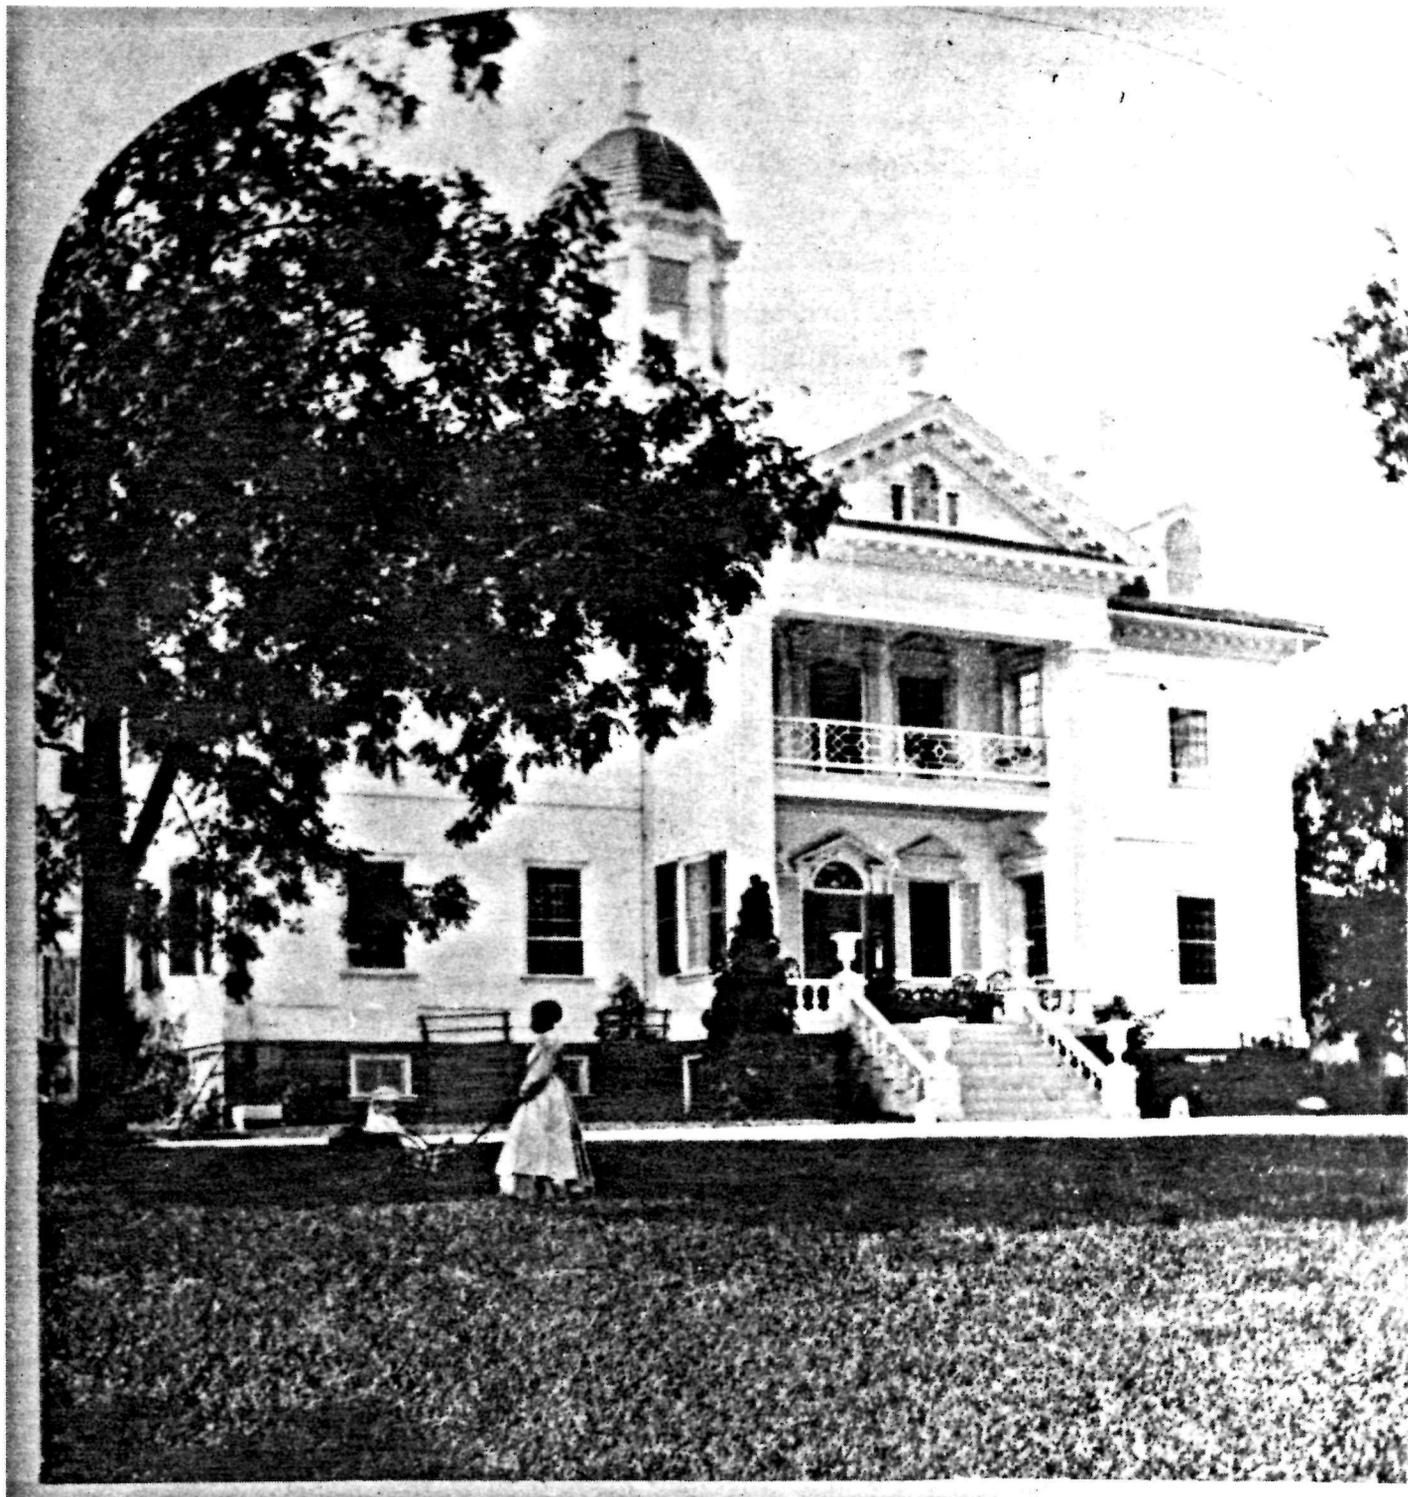
ILLUSTRATION 10: North Facade
Circa 1880-81?

The Ridgely accounts include the bills for work done in August 1880, when, after "repairing plaster & woodwork of exterior of Hampton House . . . the entire walls, woodwork &c of same" were painted, at a total cost of \$1,476.¹⁴ The base appears freshly penciled. There is a bill from Emmart & Quartley dated January 12, 1881, "to pointing plaster base of house to represent stone."¹⁵
