HAMPTON MANSION

ADDENDUM
HISTORIC STRUCTURE REPORT
ARCHITECTURAL DATA SECTION
HAMPTON MANSION
HAMPTON NATIONAL HISTORIC SITE
TOWSON, MARYLAND

Prepared by
Anthony O. James
and
Penelope Hartshorne Batcheler

DENVER SERVICE CENTER
MID-ATLANTIC/NORTH ATLANTIC TEAM
BRANCH OF HISTORIC PRESERVATION
NATIONAL PARK SERVICE
UNITED STATES DEPARTMENT OF THE INTERIOR
DENVER, COLORADO

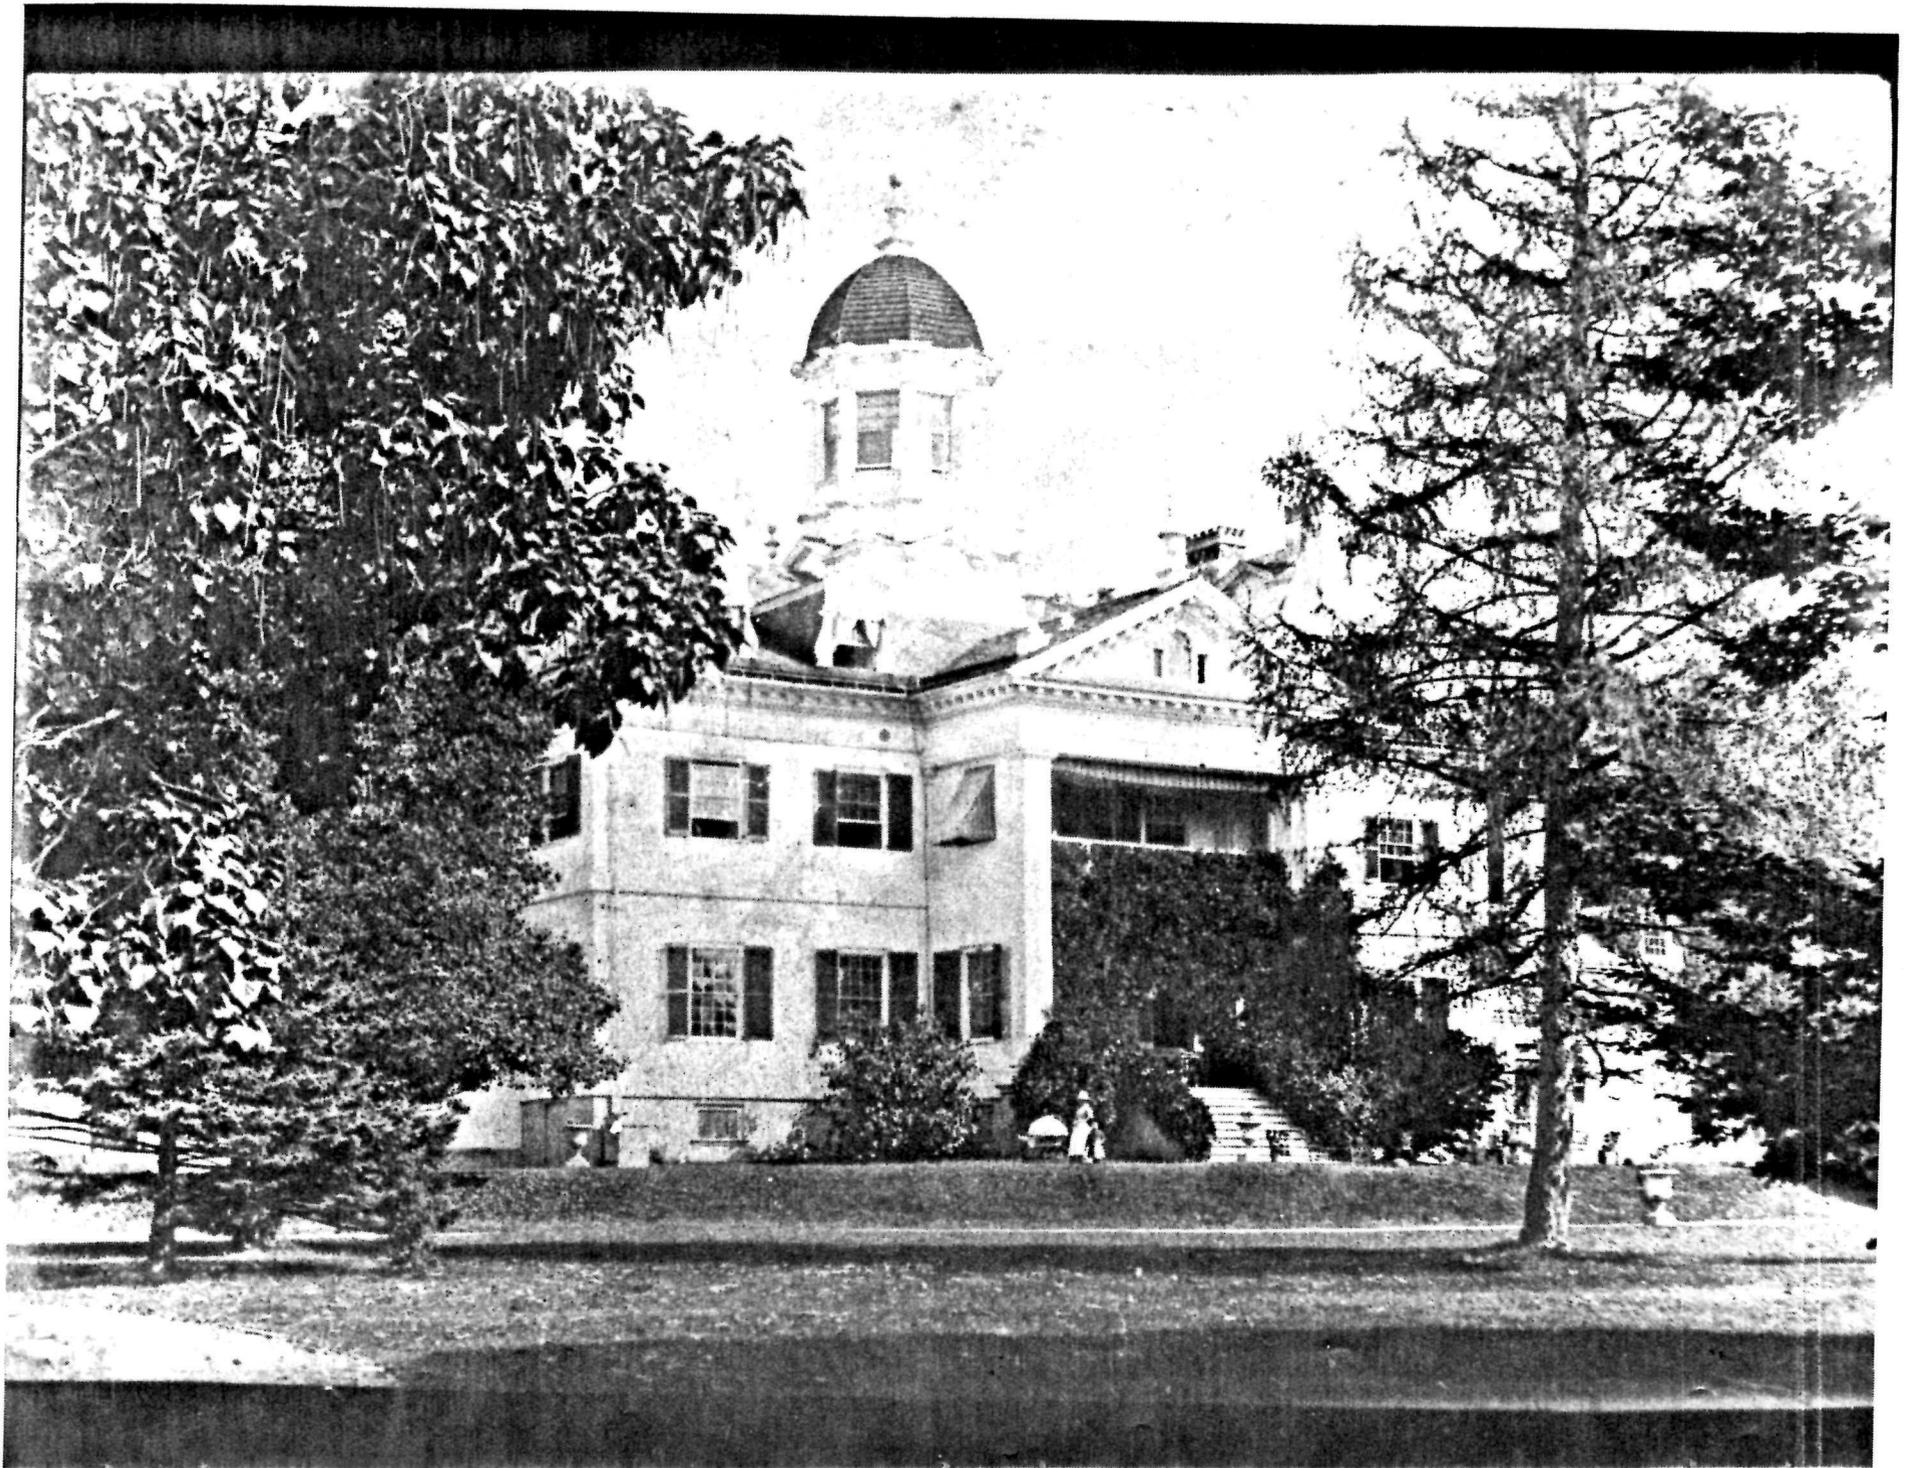
ILLUSTRATION 12: South Façade
1887
Photograph by Julian White
Collection of Hampton National Historic Site
Copy negative H-PHP-1-15

This is the first view of Hampton showing an awning across the second floor of the portico, and on the dormers. Note window shades in the cupola. This is also the first view showing the castellated chimney caps.

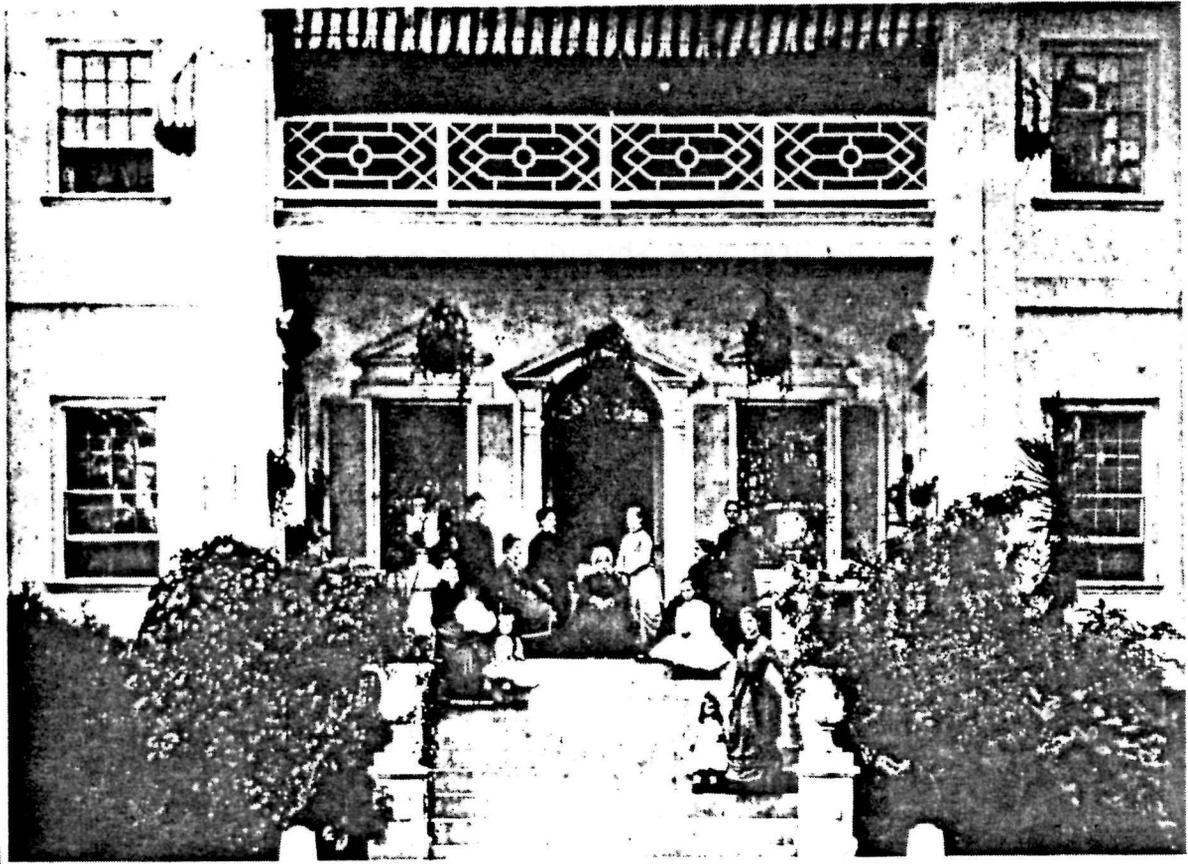
ILLUSTRATION 13: North Portico

The awnings shown in this view are very similar to those of Illustration 12. For this reason and the dress styles, it is suggested that this view dates from c. 1887.

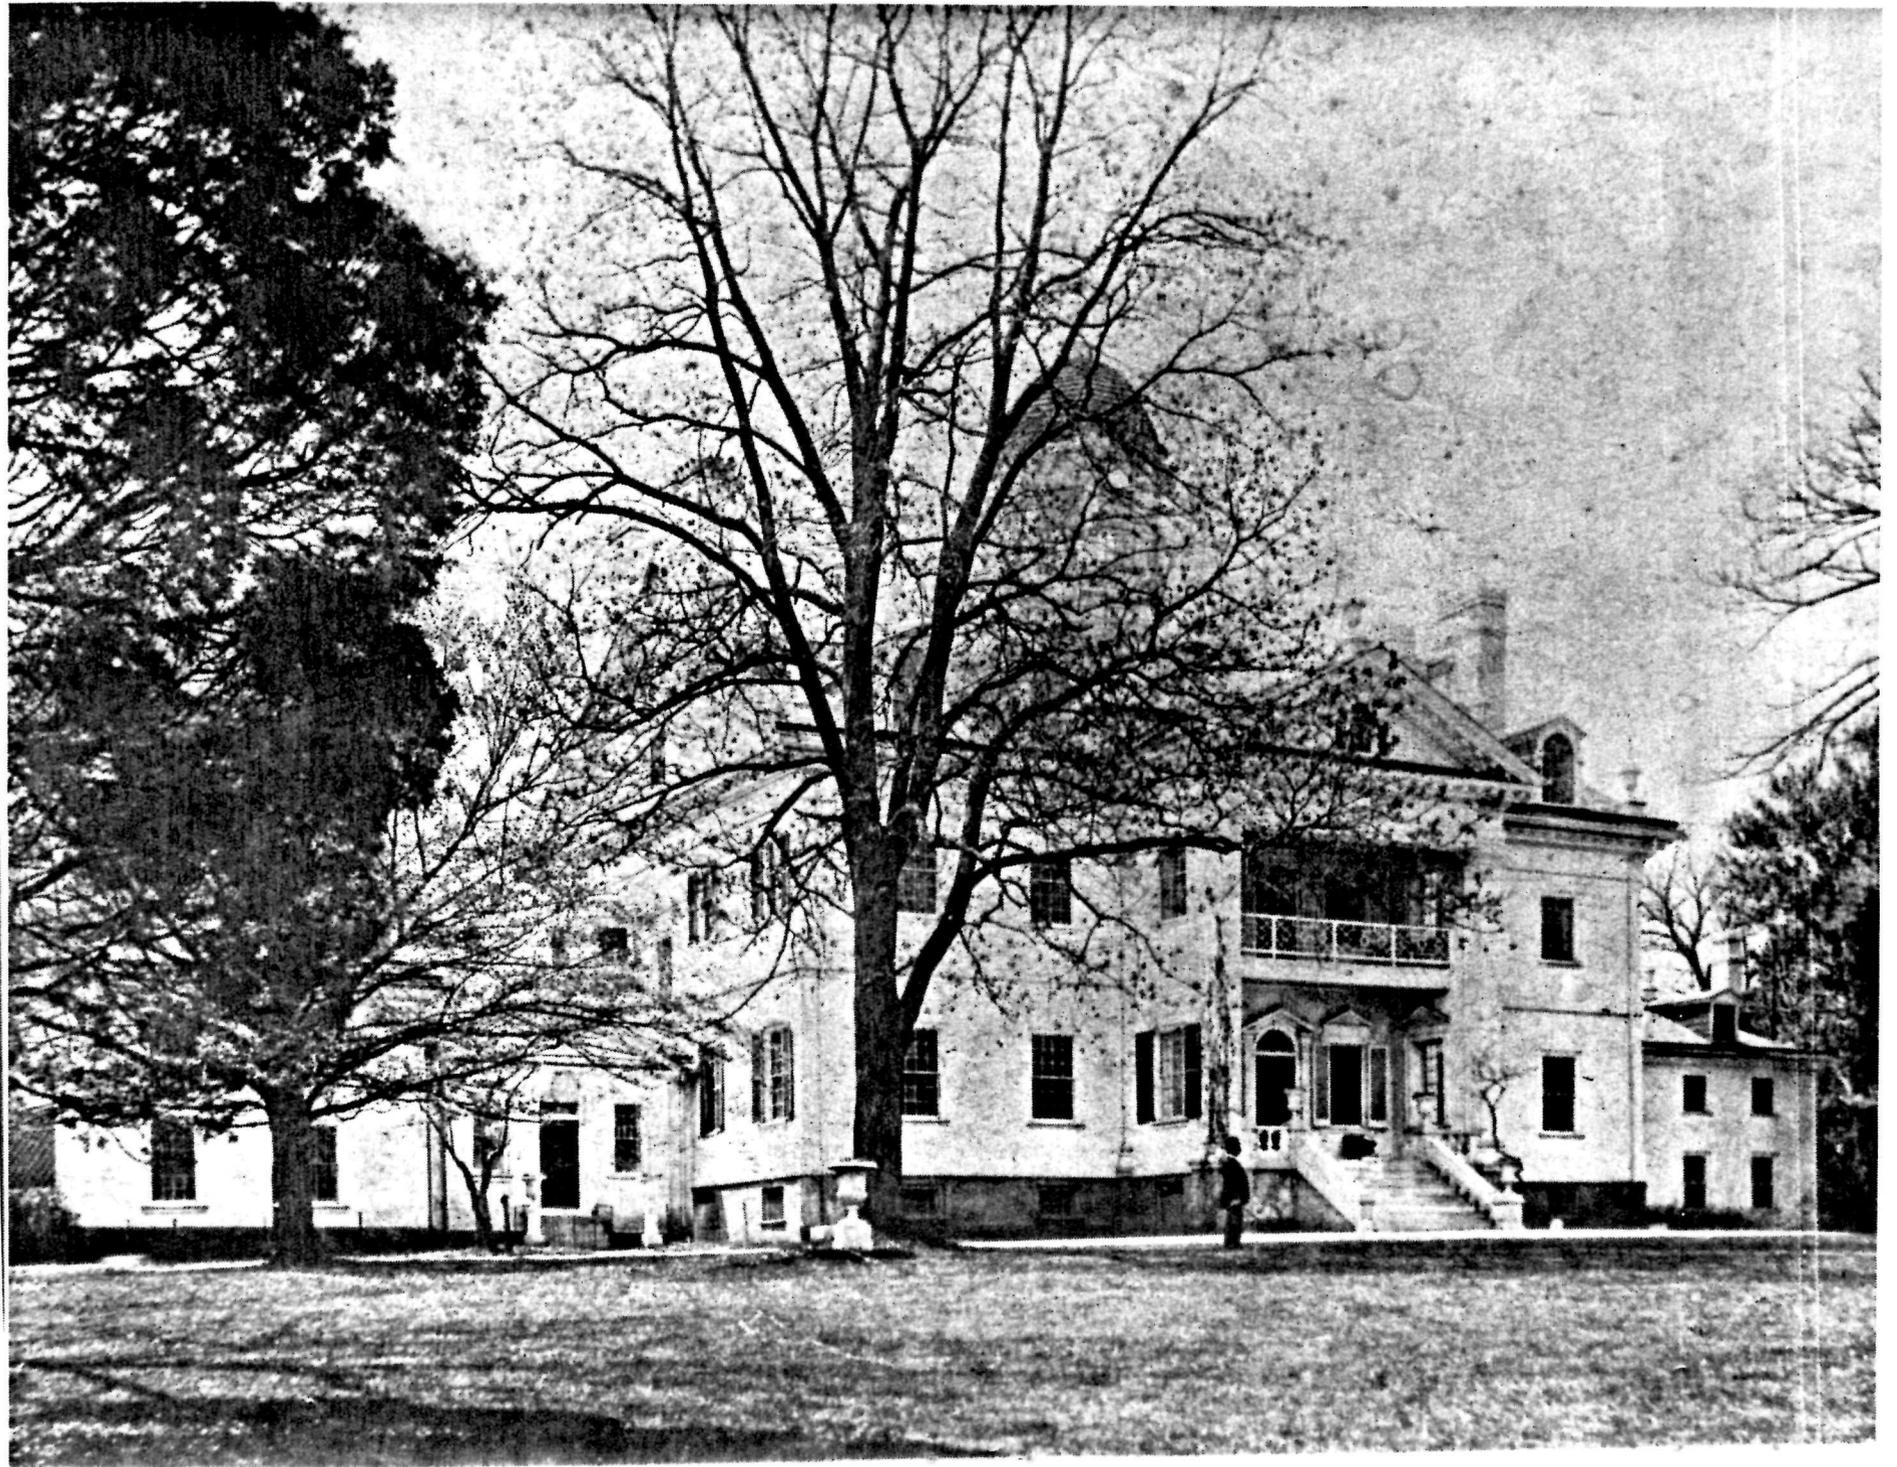
ILLUSTRATION 14: North Facade
Turn-of-the-Century
Photograph by W. C. Russell
John Ridgely Collection, Hampton National Historic Site
Copy negative H-PHP-3-4

Standing on the lawn in front of the north facade in this springtime view is Colored Brian, a black servant who served as a sort of major domo at Hampton for many years.¹⁷

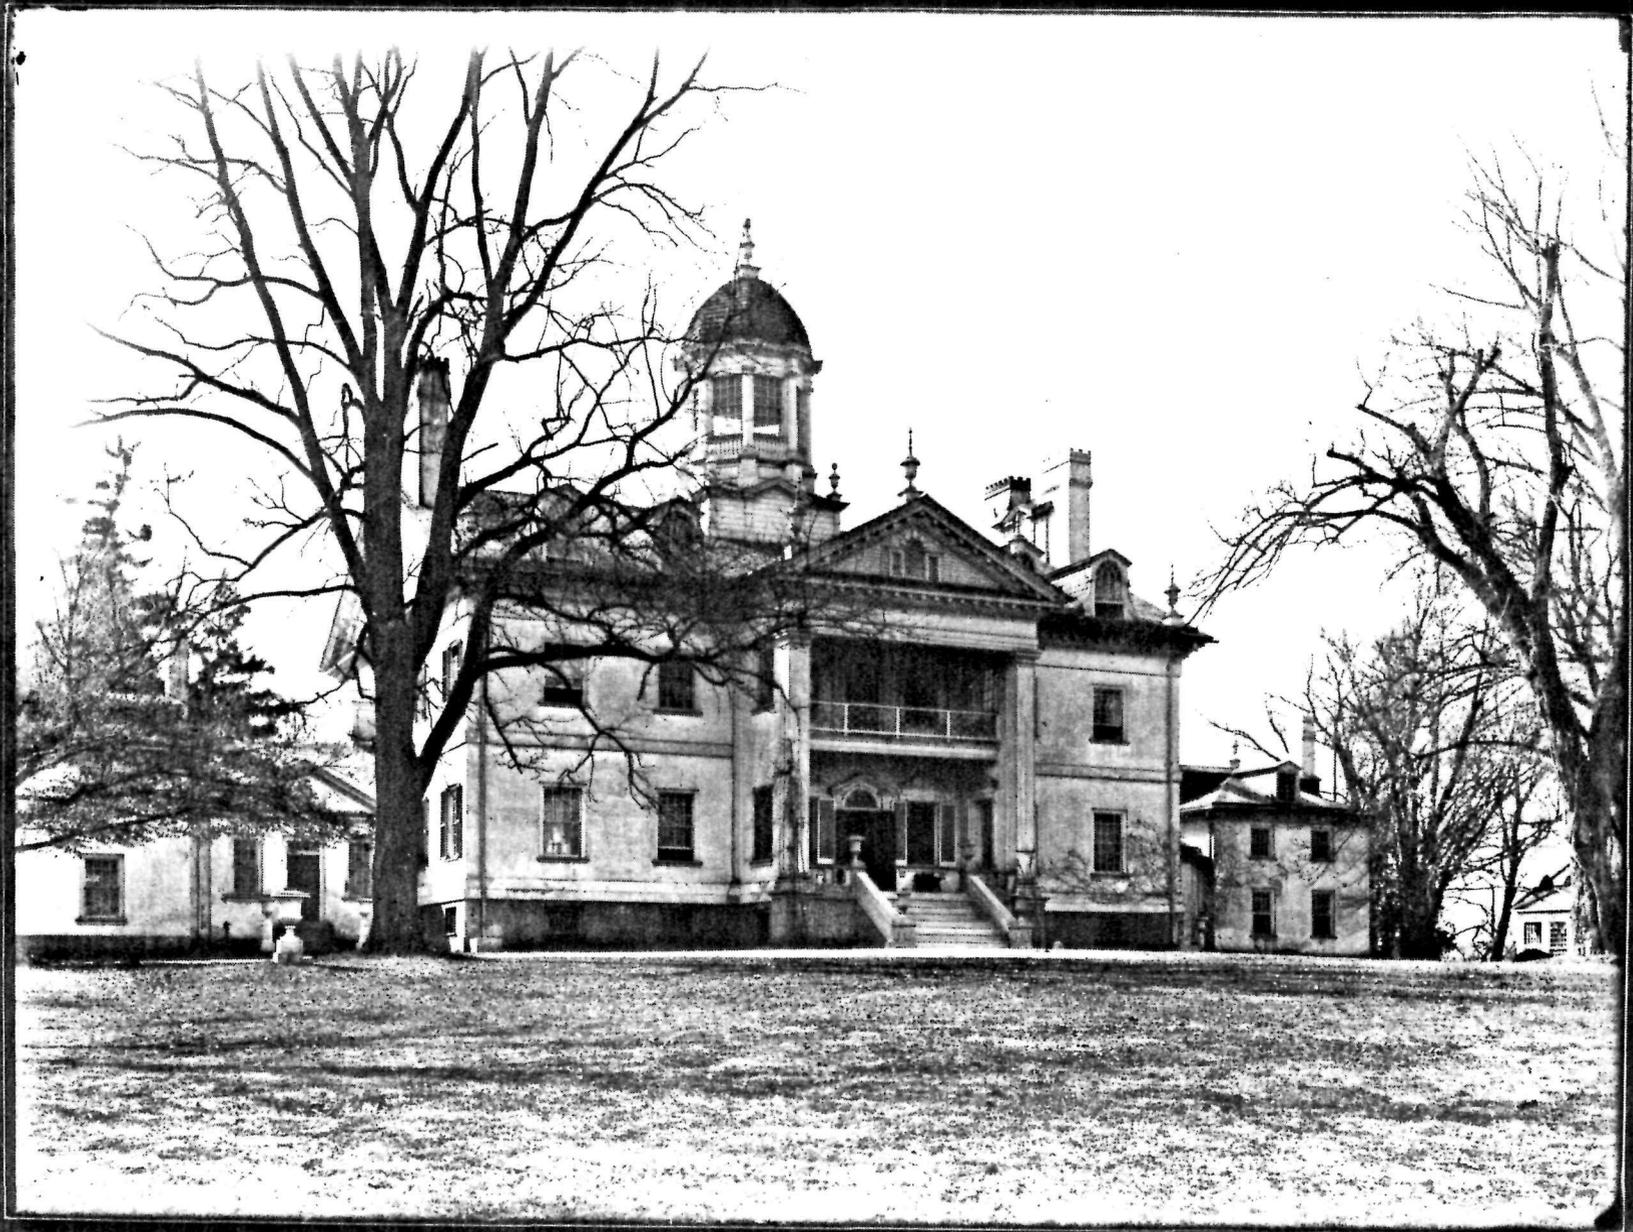
ILLUSTRATION 15: North Facade
1908

In the John Ridgely collection at Hampton are a number of glass-plate negatives four of which (Illustrations 15-18) are stamped and dated "J. E. H. Post/1908." This precise dating allows us to say that the castellated chimney caps, appearing on all chimneys in these views, were the earlier type, and that the antefix decorated caps (see in Illustrations 22-24) were a later replacement.

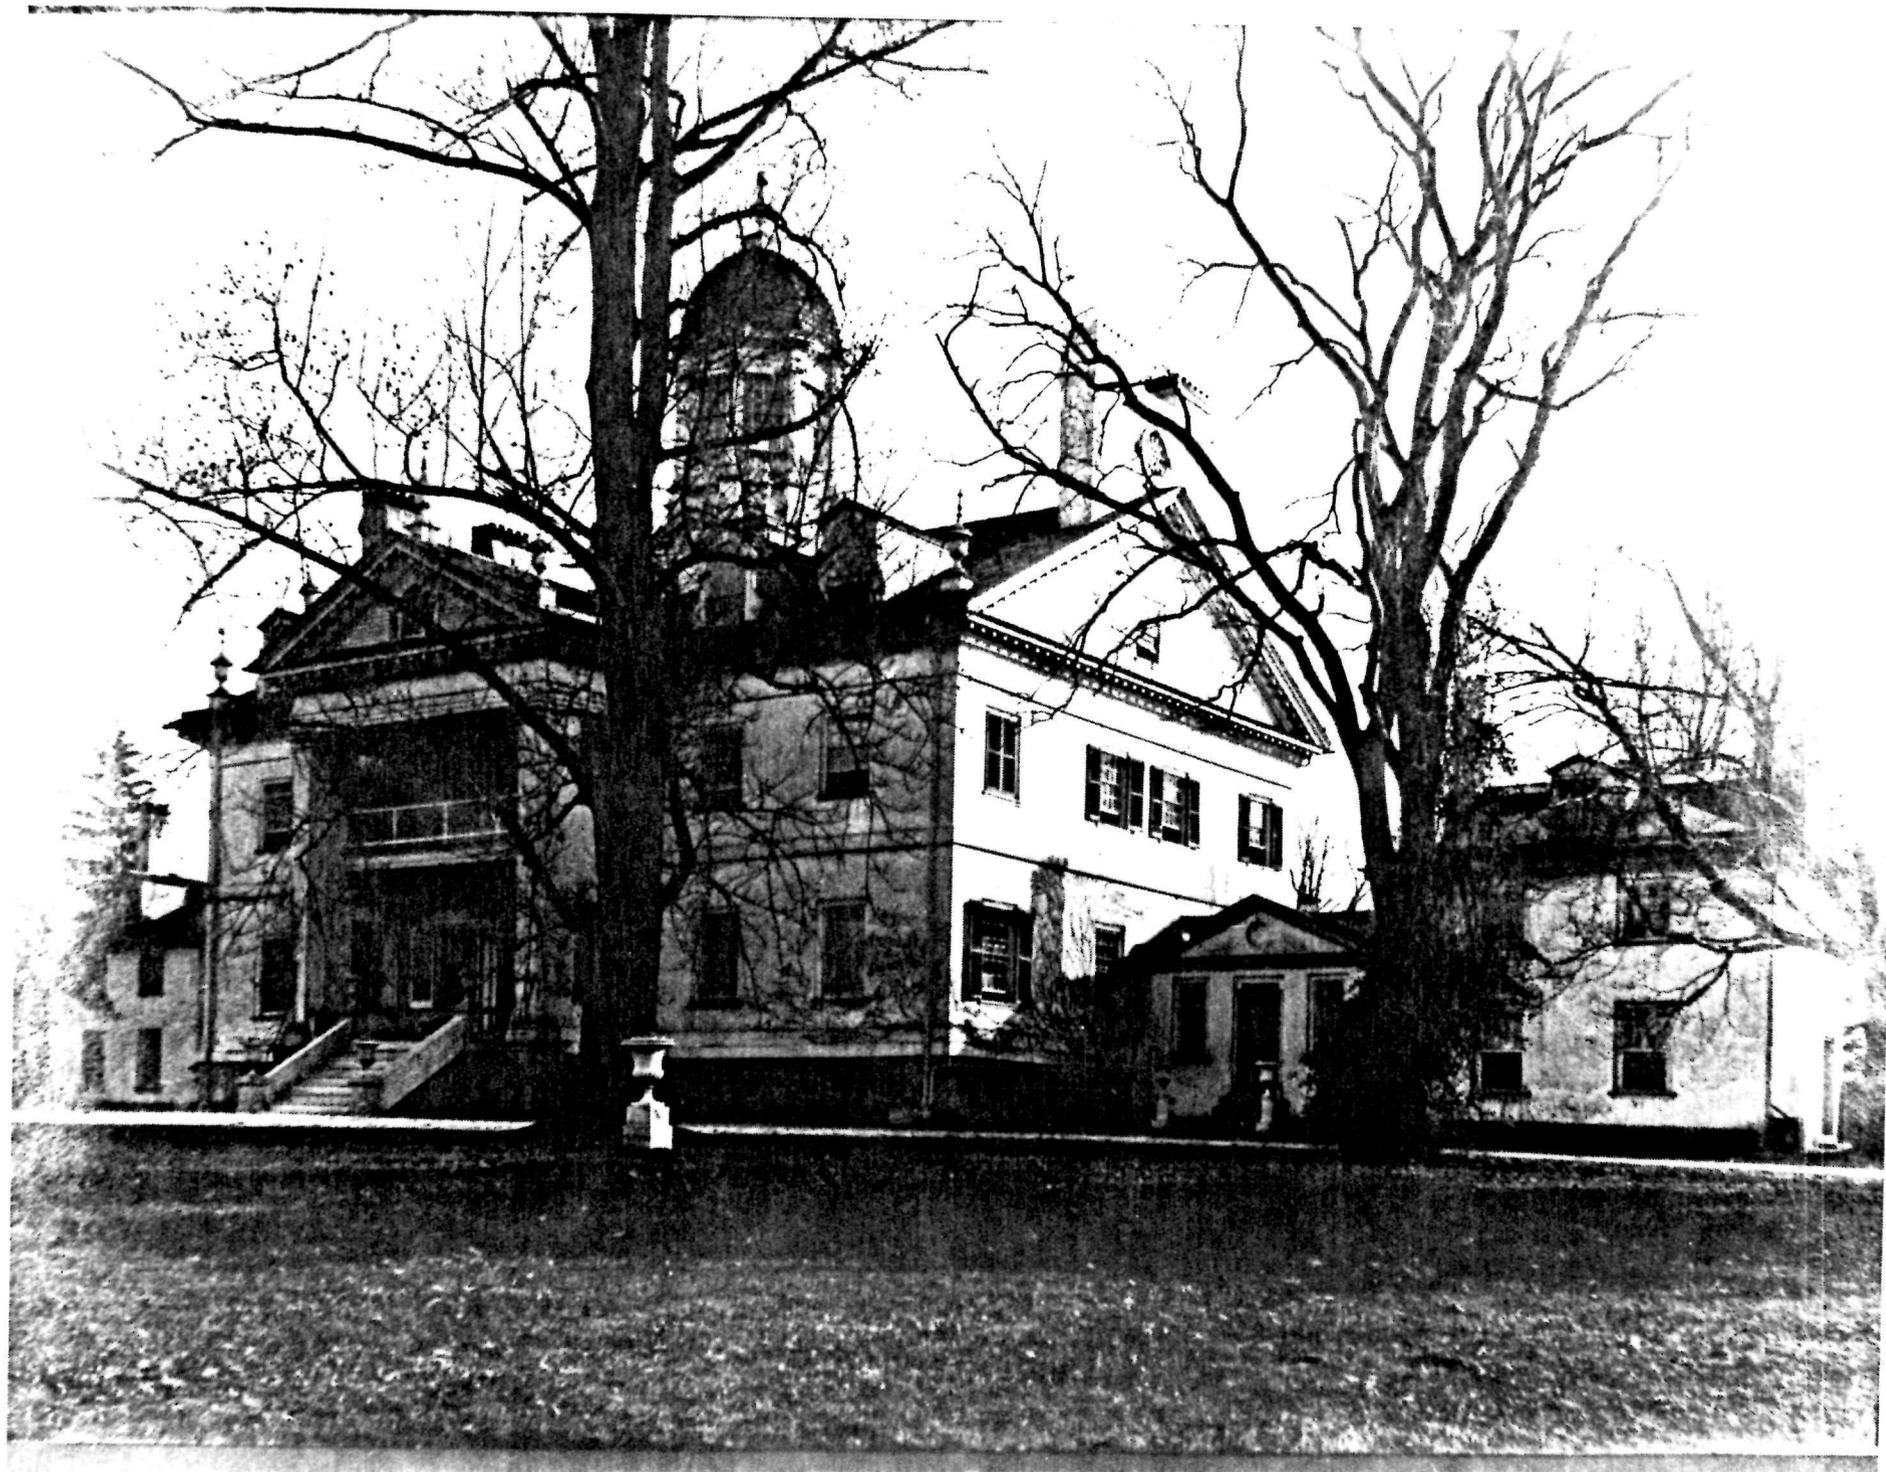
ILLUSTRATION 16: North Facade
1908

By referring to this view and Illustration 18, it is possible to see that the chimney caps on the chimneys of the main block differ on the east and west ends. The east chimneys have five castellations in the long direction while the west chimneys have six. This is apparently due to a difference in the dimension of the chimneys, although the caps may have been installed at different dates, since the original documentary reference mentions only one cap and since the east caps were replaced later.

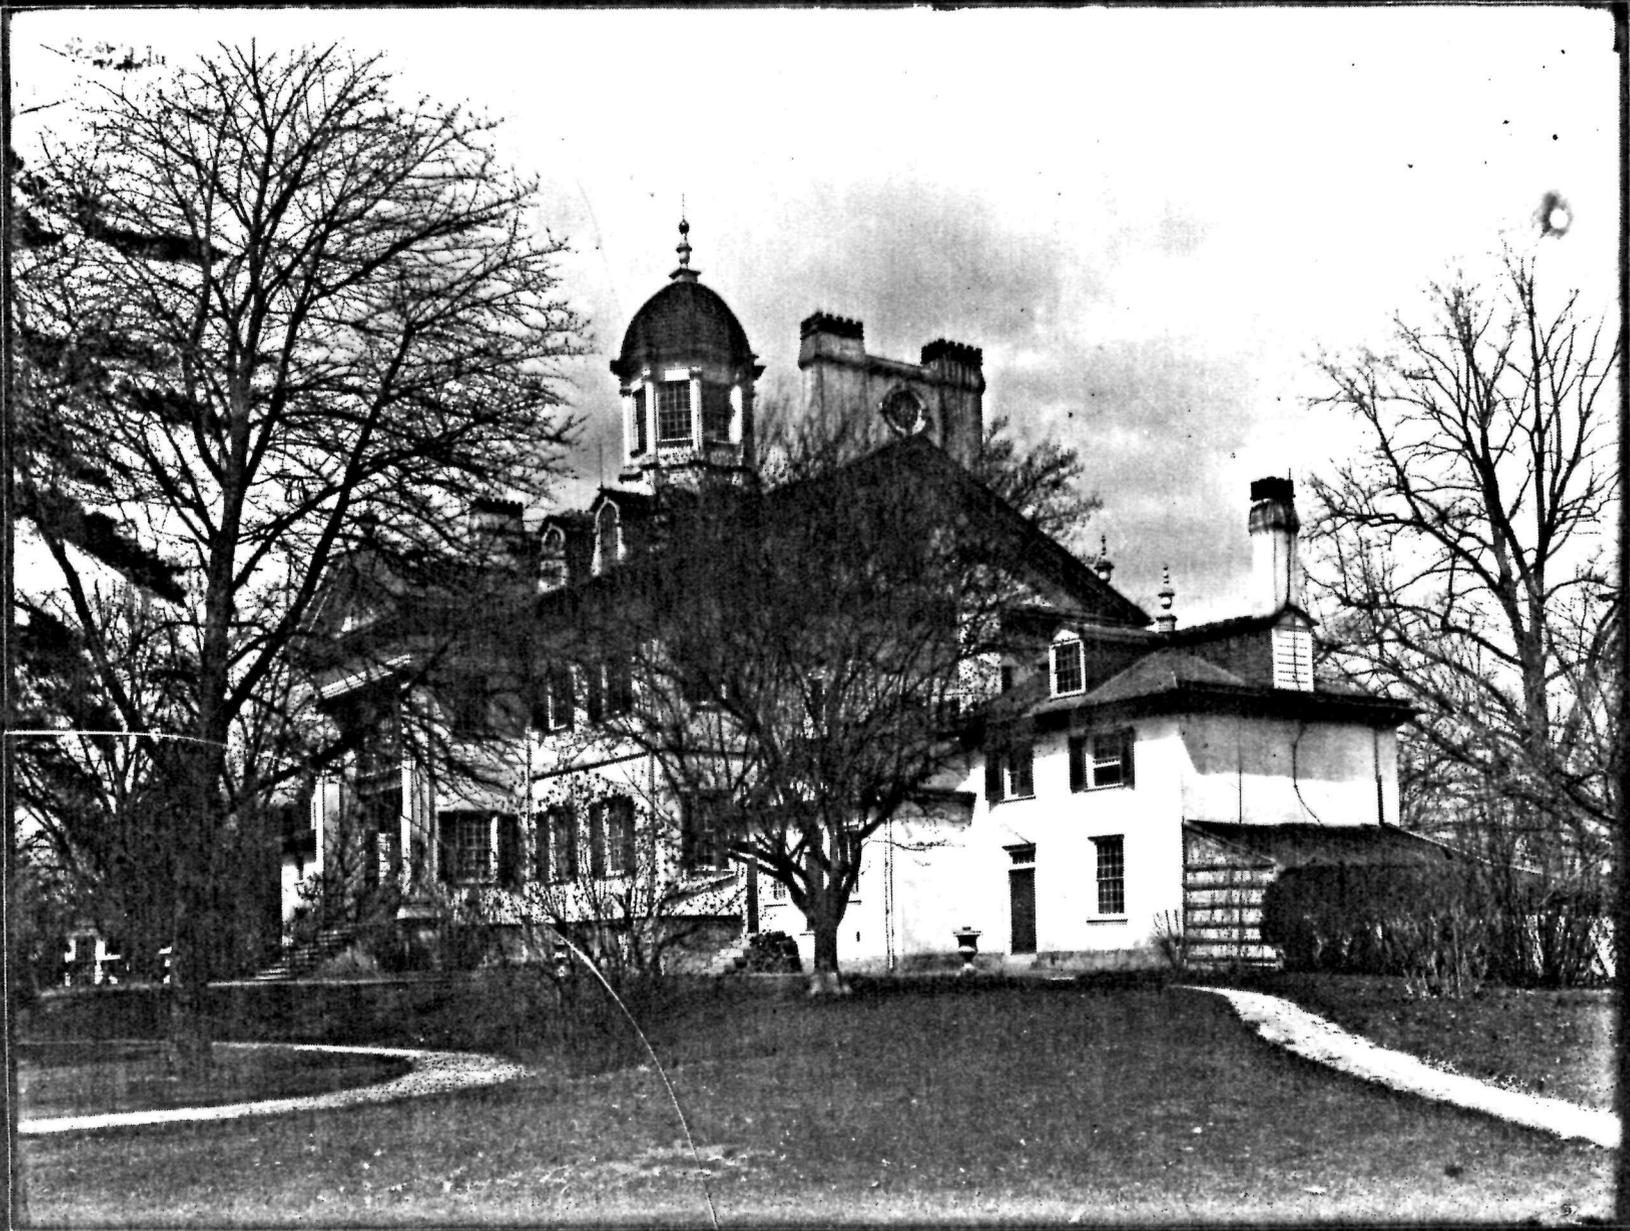
ILLUSTRATION 18: South Facade
1908

Note that the base stucco has been clearly brought out over the cheeks of the south steps by this time. From physical evidence it is believed the stone cheeks were originally exposed.

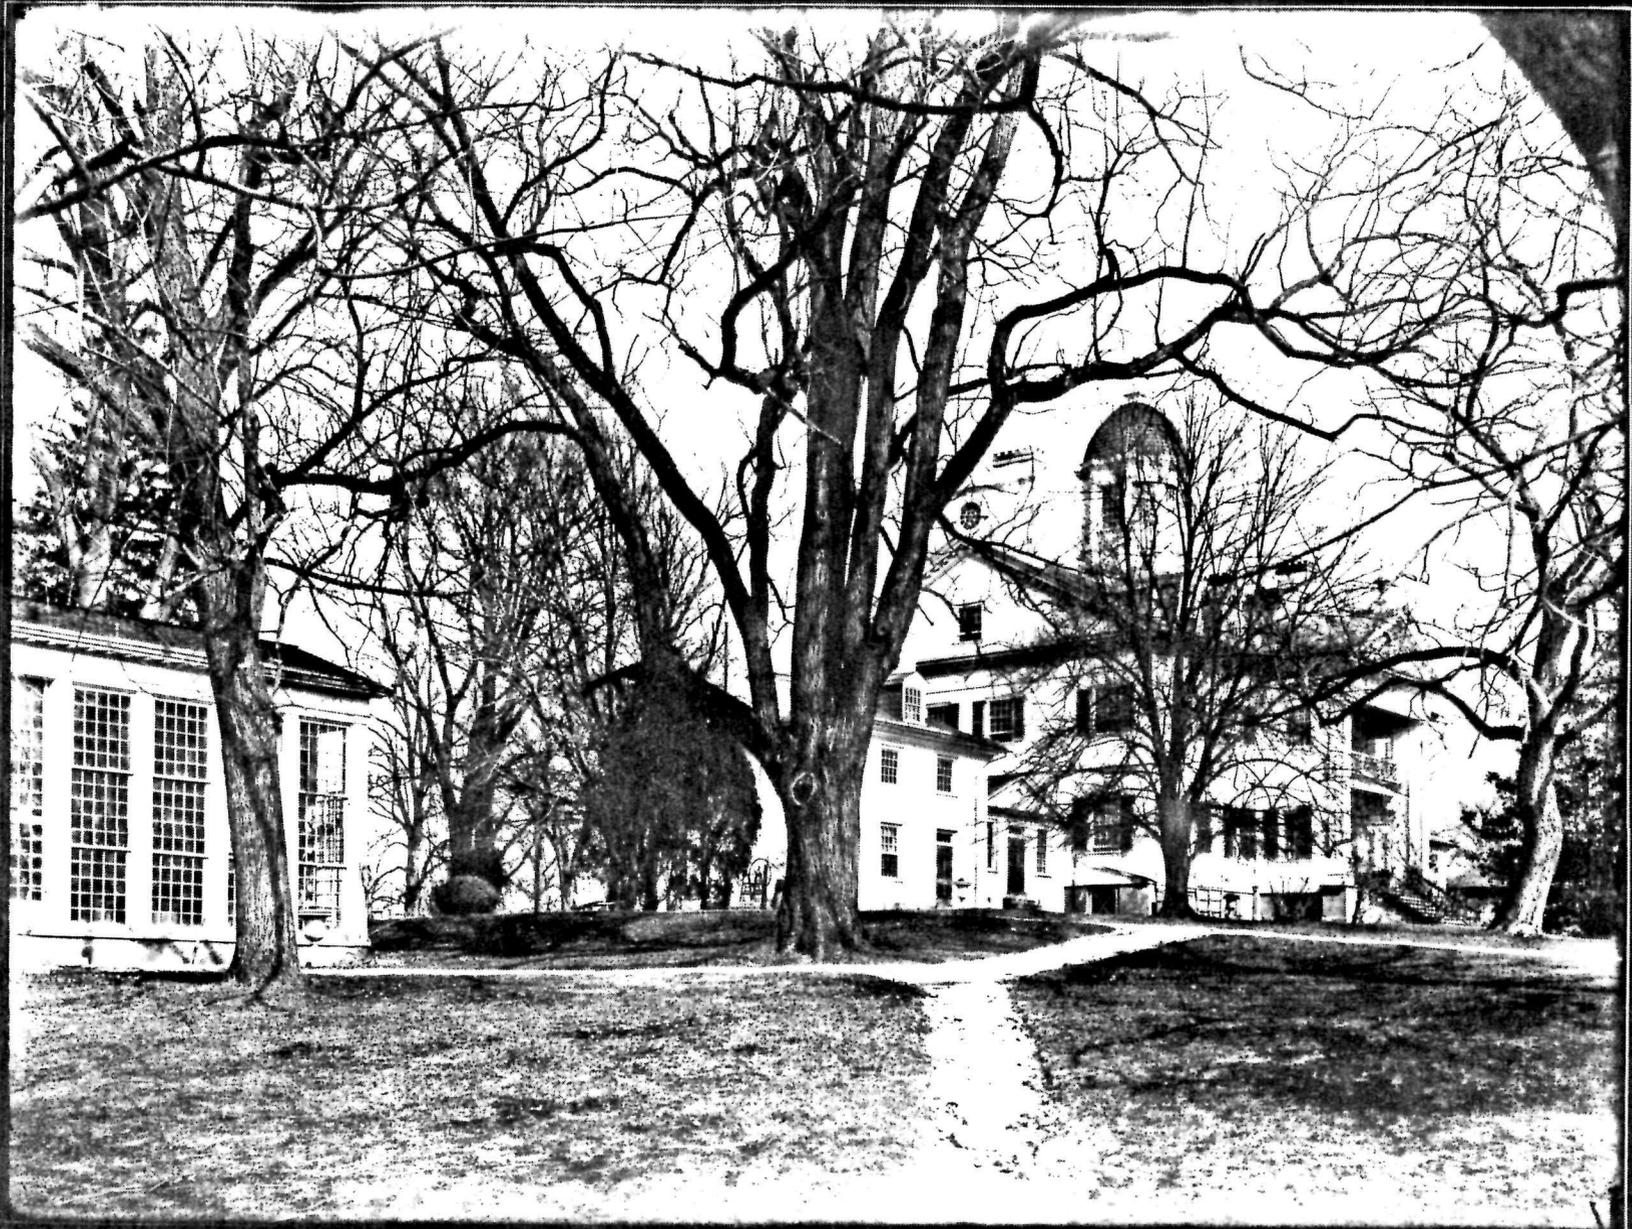
ILLUSTRATION 19: South Facade

Note also a mechanism which stands atop the west cistern cover, said by John Ridgely to be a pump for filling a tank in the west wing attic.

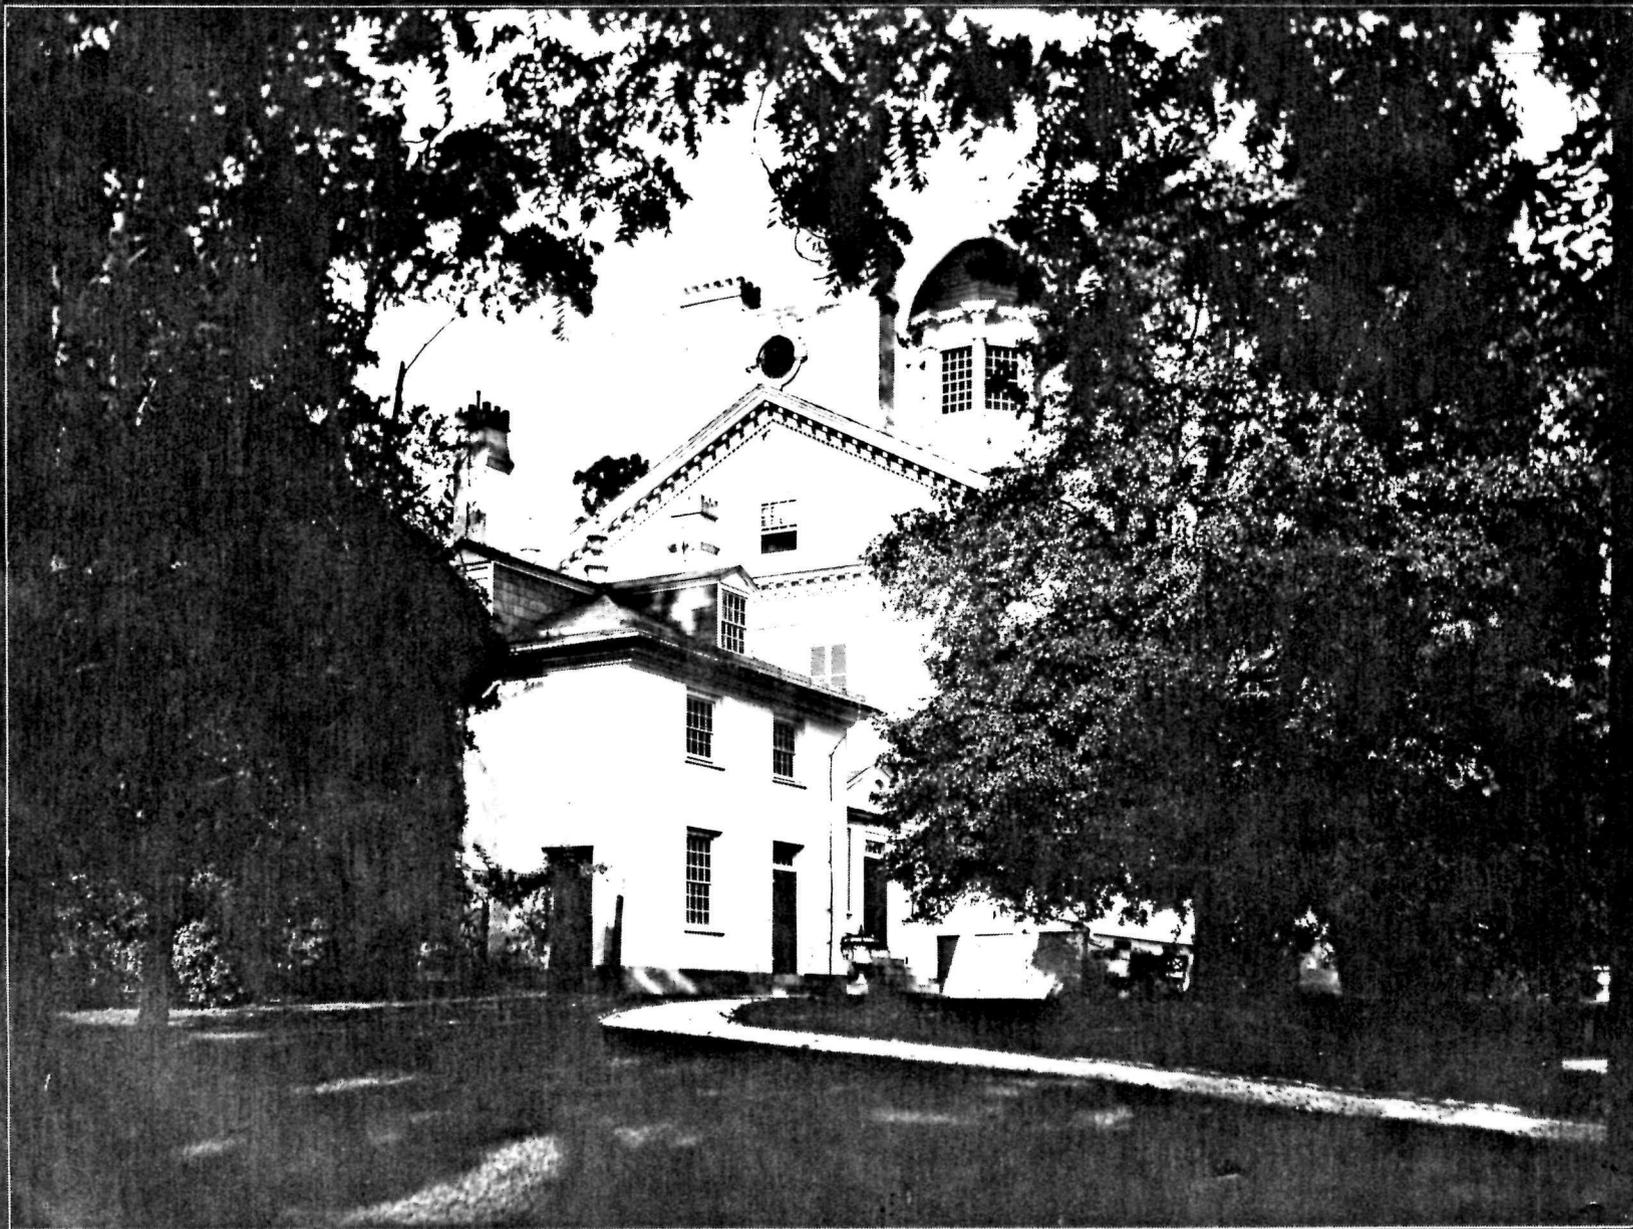
ILLUSTRATION 20: South Facade
Early 20th Century
Photograph by an unknown photographer, glass-plate negative
John Ridgely Collection, Hampton National Historic Site

The west wing of the mansion is the subject of this summertime view from the southwest. The treatment of the dark base of the wing is easily visible here. Shutters appear on the south doors of the wings and the hyphen, but not on the west door of the wing. Also of note here is the large wheel outside the west door of the wing, apparently a device to pump water to a storage tank in the west wing attic. There is a wire fence south of the cistern.

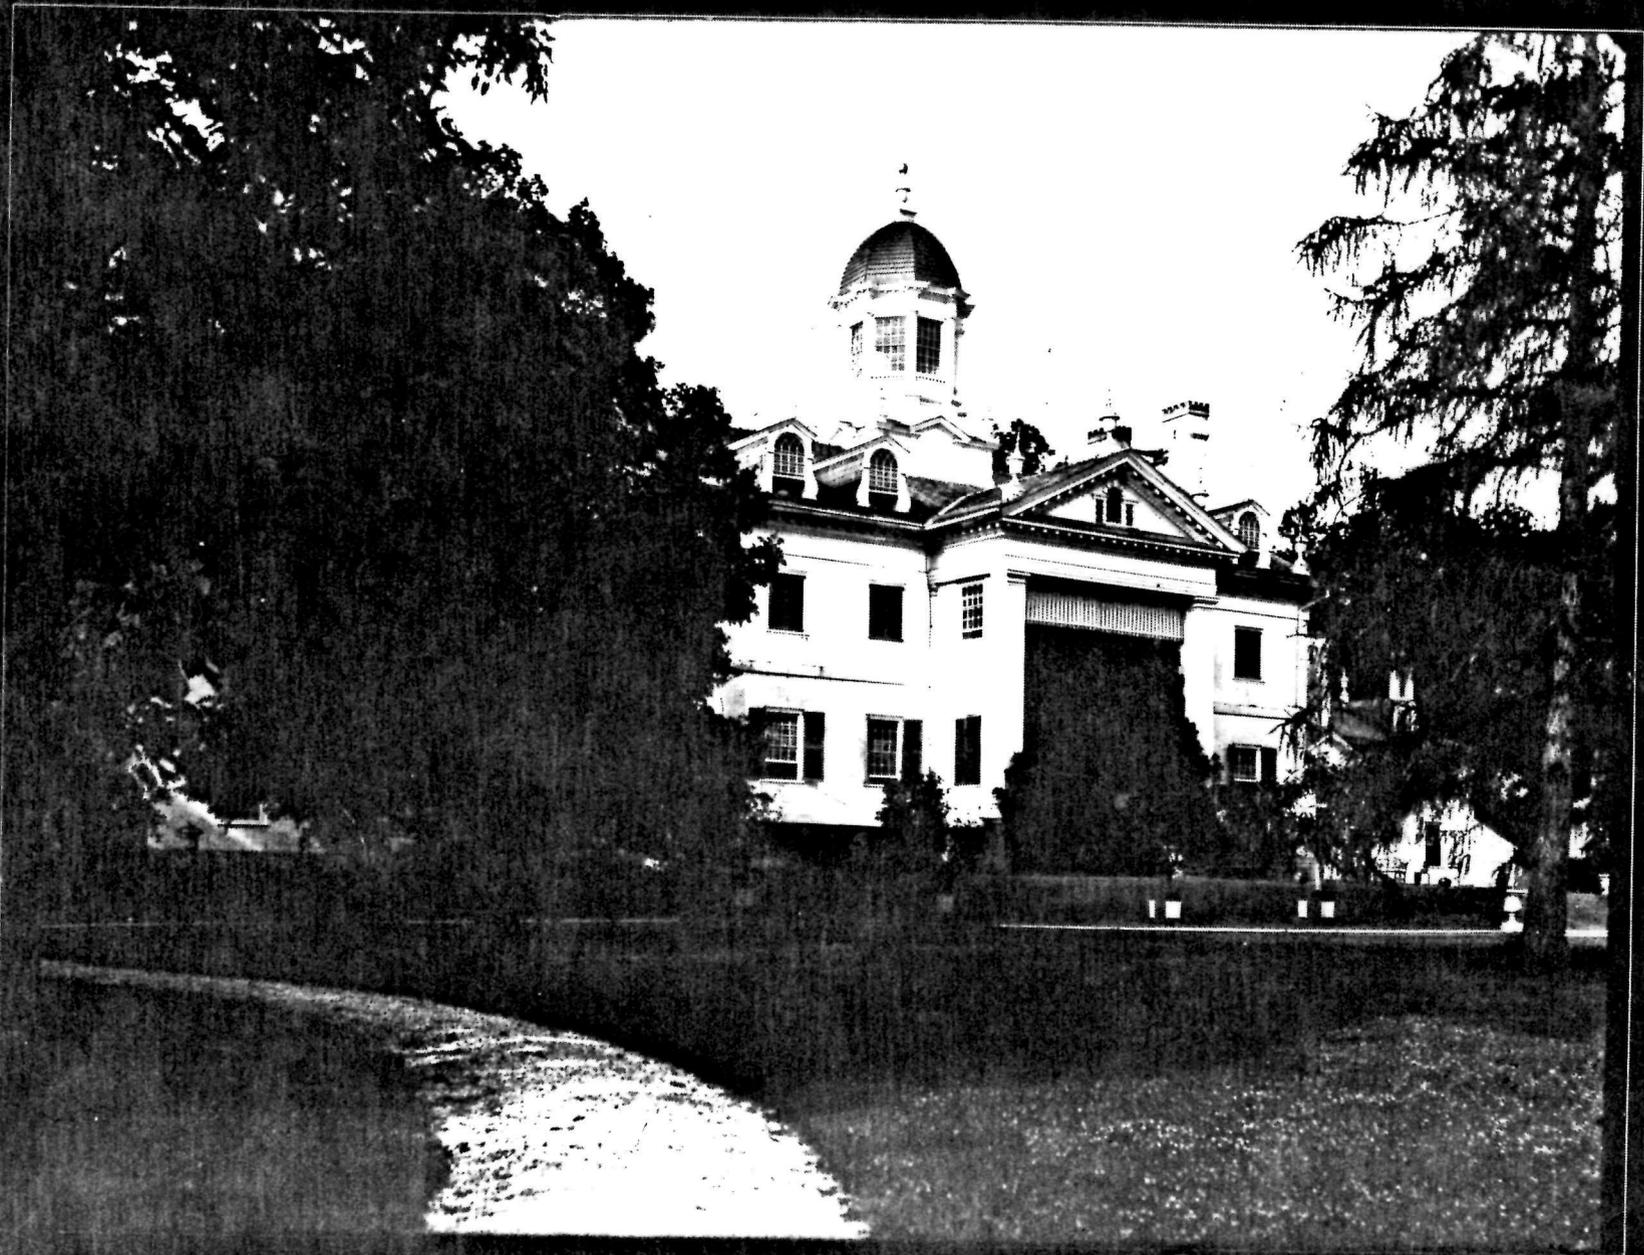
ILLUSTRATION 21: South Facade

This photograph of the south facade was apparently taken at the same time as the previous (Illustration 20). This view shows the cast iron and slate tree boxes for the first time. Note the awning on the second floor of the portico. The awnings on the dormers and the second floor portico side windows which were visible in the 1887 photograph (Illustration 13) have been removed.

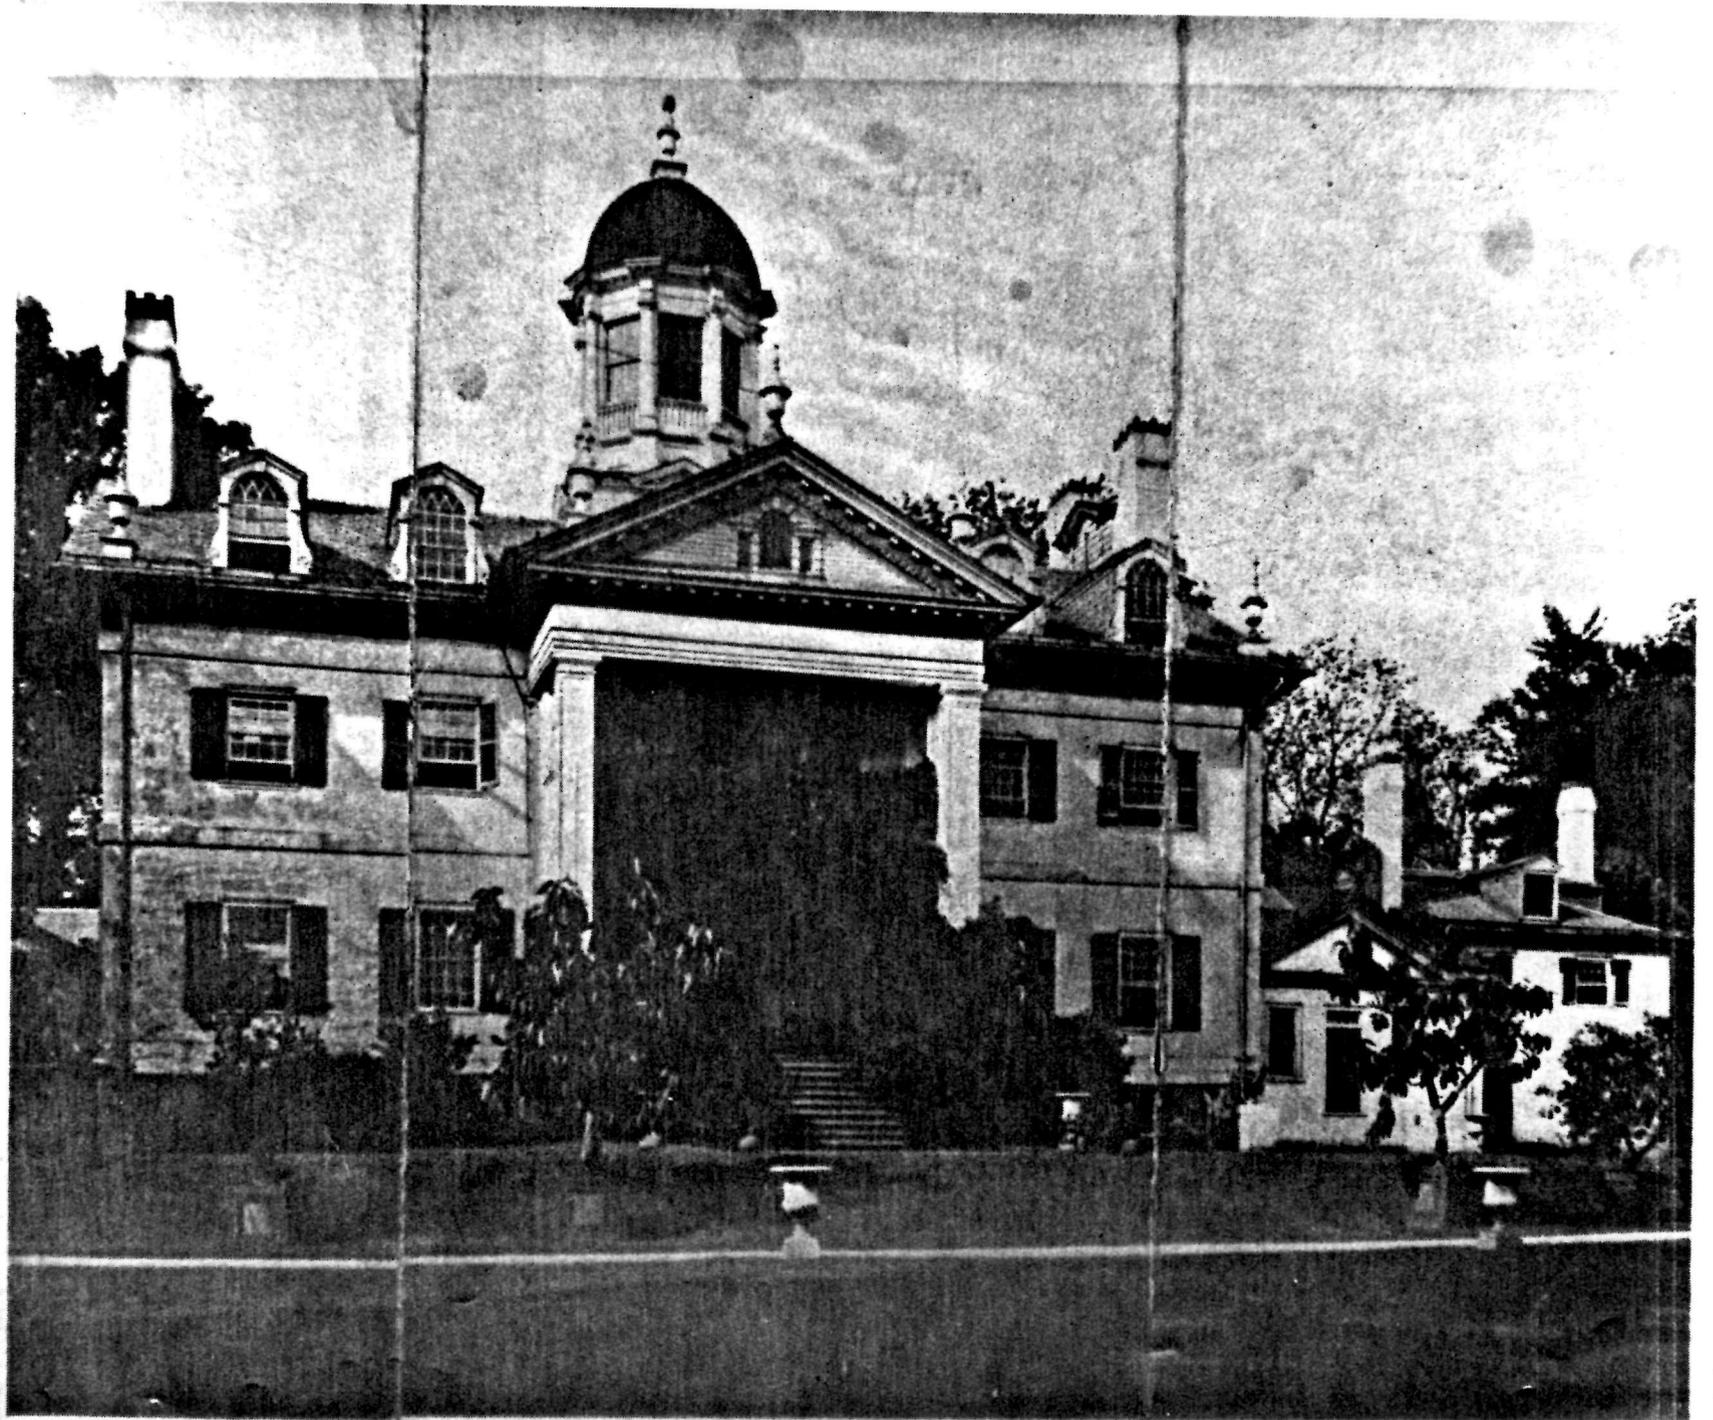
ILLUSTRATION 22: South Facade
1910s?
Photograph by Mattie Edwards Hewitt
Collection of Hampton National Historic Site
Copy negative H-PHP-2-18

This summertime view of the south facade is printed in half-tone on slick paper, as though it was an illustration for a publication. Citrus trees are still set out in tree boxes (the organery did not burn until 1926). Of most interest here are the antefix decorated chimney caps of the east wing and the east side of the main block, new sometime after 1908. Shutters still show on the second floor of the east wing. A photographic print of this view in the Maryland Historical Society is marked on the back "Photographs From/Mattie Edwards Hewitt, 536 Fifth Ave, New York."
