HAMPTON MANSION

ADDENDUM
HISTORIC STRUCTURE REPORT
ARCHITECTURAL DATA SECTION
HAMPTON MANSION
HAMPTON NATIONAL HISTORIC SITE
TOWSON, MARYLAND

Prepared by
Anthony O. James
and
Penelope Hartshorne Batcheler

DENVER SERVICE CENTER
MID-ATLANTIC/NORTH ATLANTIC TEAM
BRANCH OF HISTORIC PRESERVATION
NATIONAL PARK SERVICE
UNITED STATES DEPARTMENT OF THE INTERIOR
DENVER, COLORADO

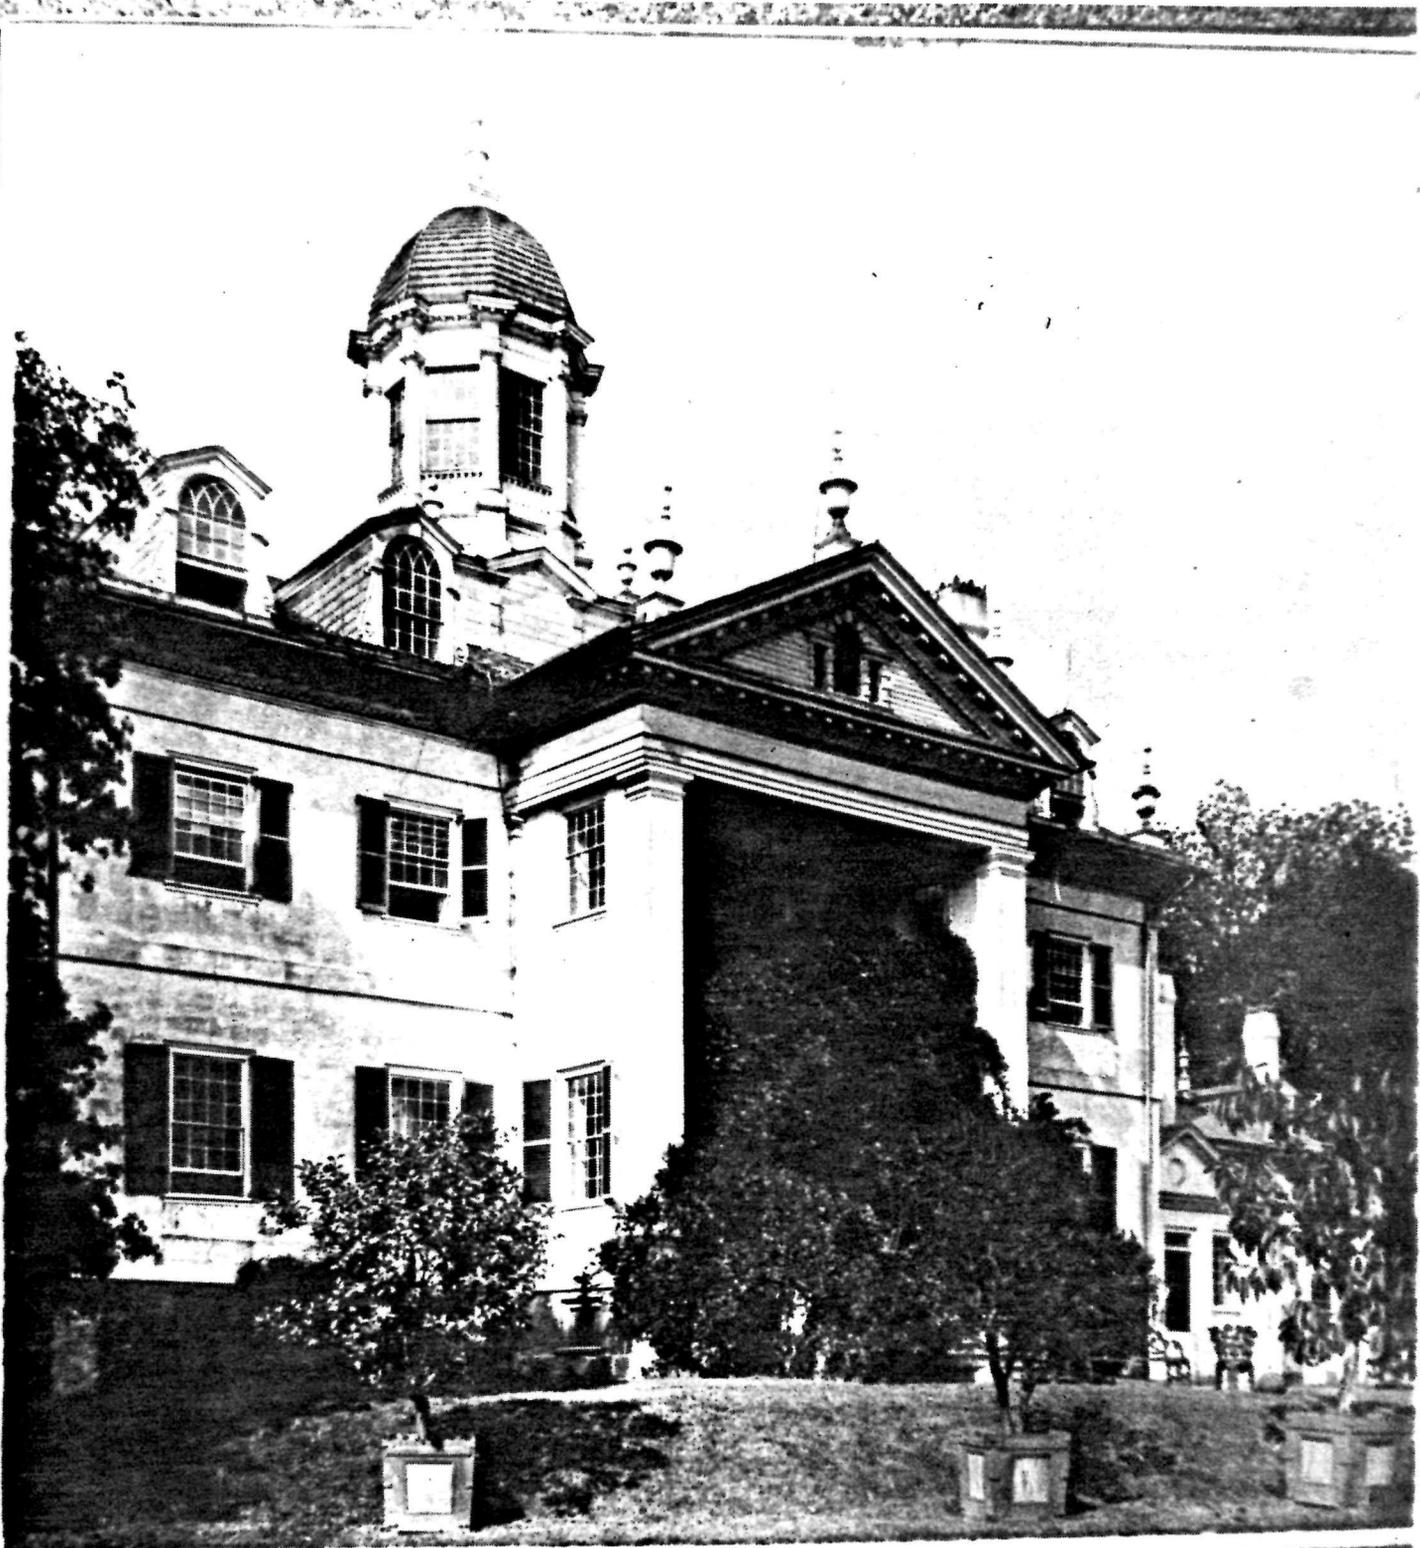
ILLUSTRATION 23: South Facade
1910s?

Taken probably at the same time as the previous view (Illustration 22), this photograph of the south facade shows the tree boxes and the shutters positioned exactly as they were in that view. Numerous cracks appear in the stucco. The new antefix decorated chimney caps are visible. On the back of the copy of this photograph in the Maryland Historical Society is marked "Photographs from/M. E. Hewitt Studio/536 Fifth Avenue, New York."

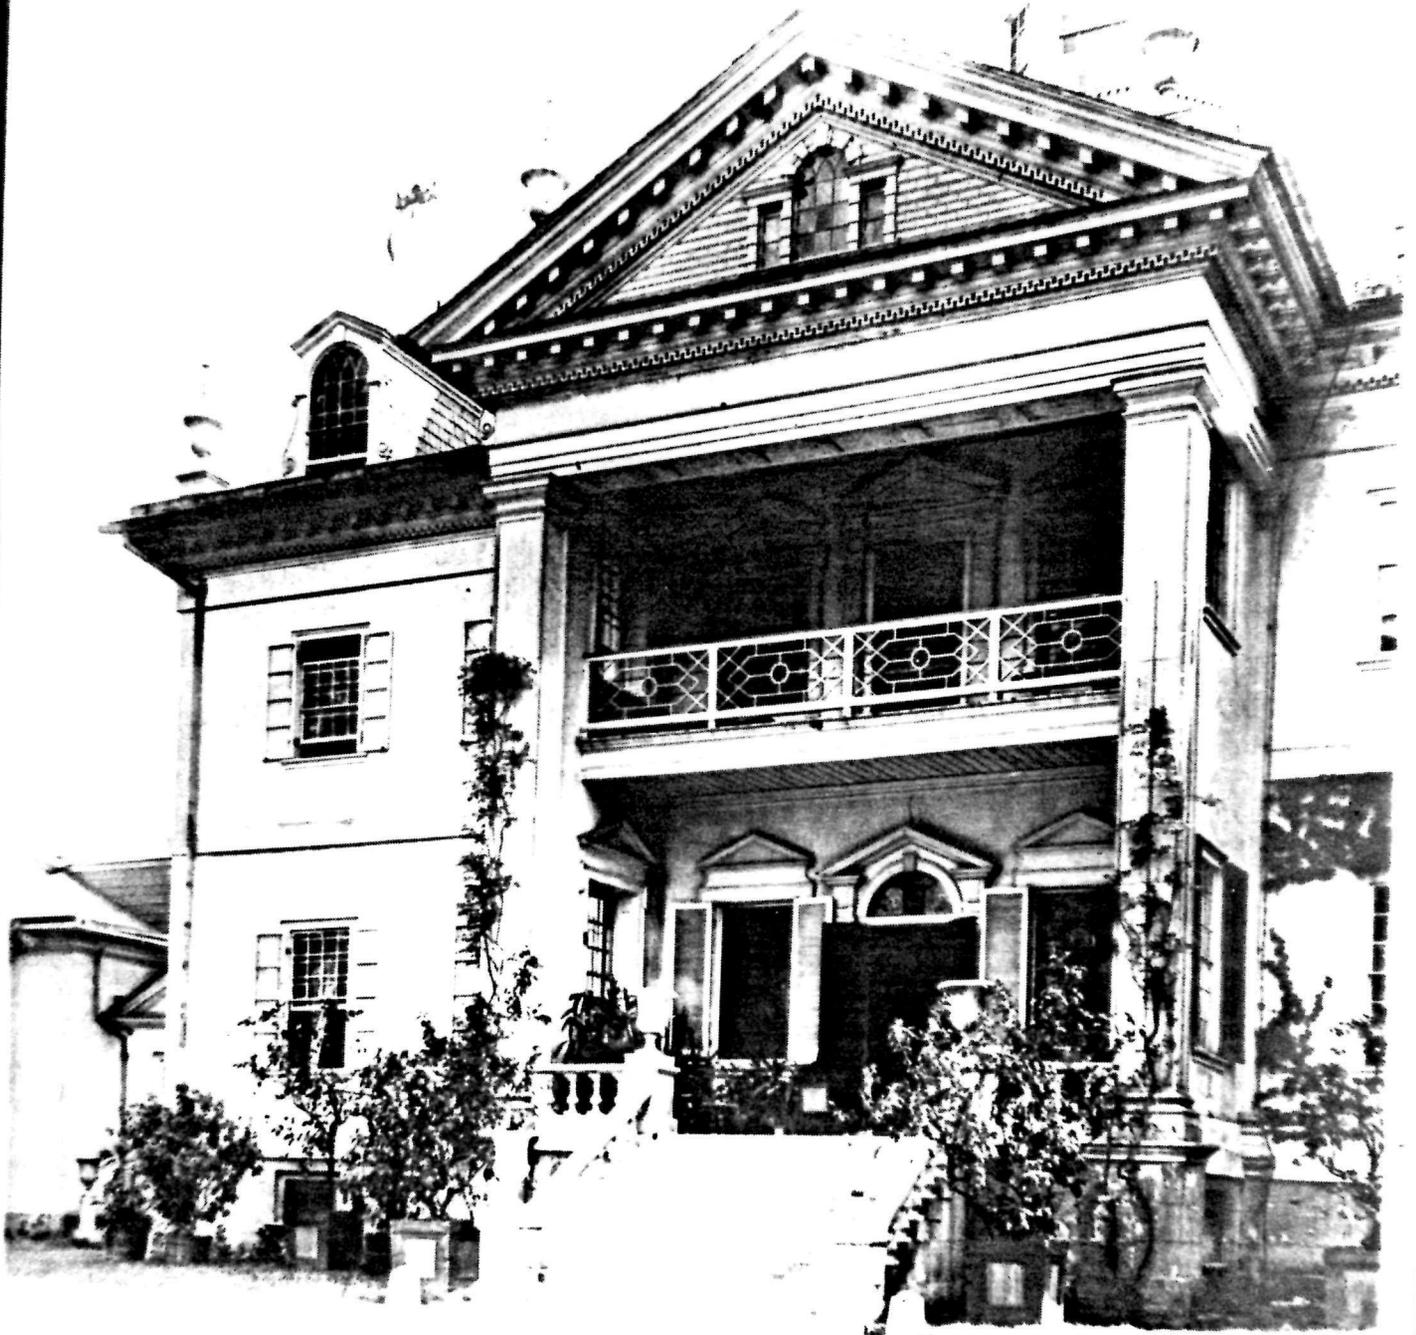
ILLUSTRATION 24: North Facade
1910s?
Photograph by Mattie Edward Hewitt
Collection of Hampton National Historic Site
Copy negative H-PHP-1-11

This view of the north facade was taken at the same time as the previous photograph (Illustration 23). It shows antefix decorated chimney caps and, for the first time, glass shutters (storm windows) on the four windows of the main block which are east of the portico. Various trees, shrubs, and ferns are set out in boxes and tubs along the house. The copy of this photograph in the Maryland Historical Society is marked on the back "Photograph from/the Johnston-Hewitt Studio/536 Fifth Ave. New York."

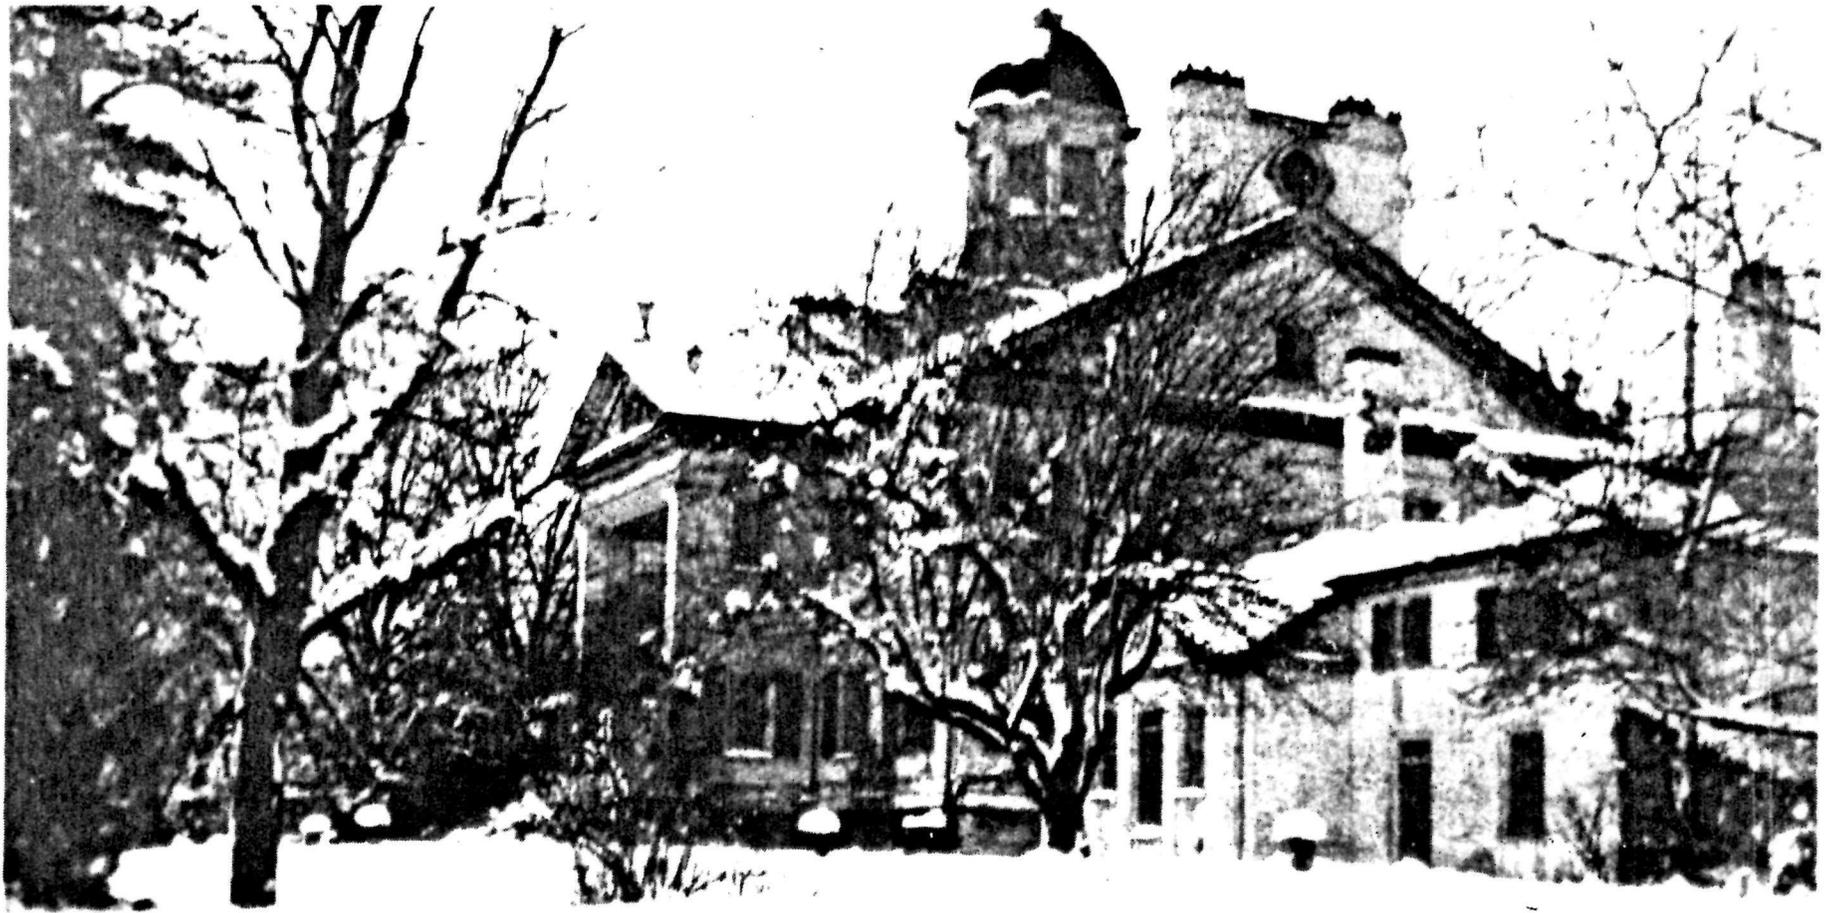
ILLUSTRATION 25: South Facade

This dated and annotated photograph shows the mansion from the southeast with "26-1/2 inches snow" on the ground. On the reverse side of the print in the John Ridgely collection are sketches of the chimney caps. This view shows that the antefix decorated chimney caps had already deteriorated badly and would soon need to be removed. Shutters show on the second floor of the east wing. The shed on the east side of the east wing just shows.

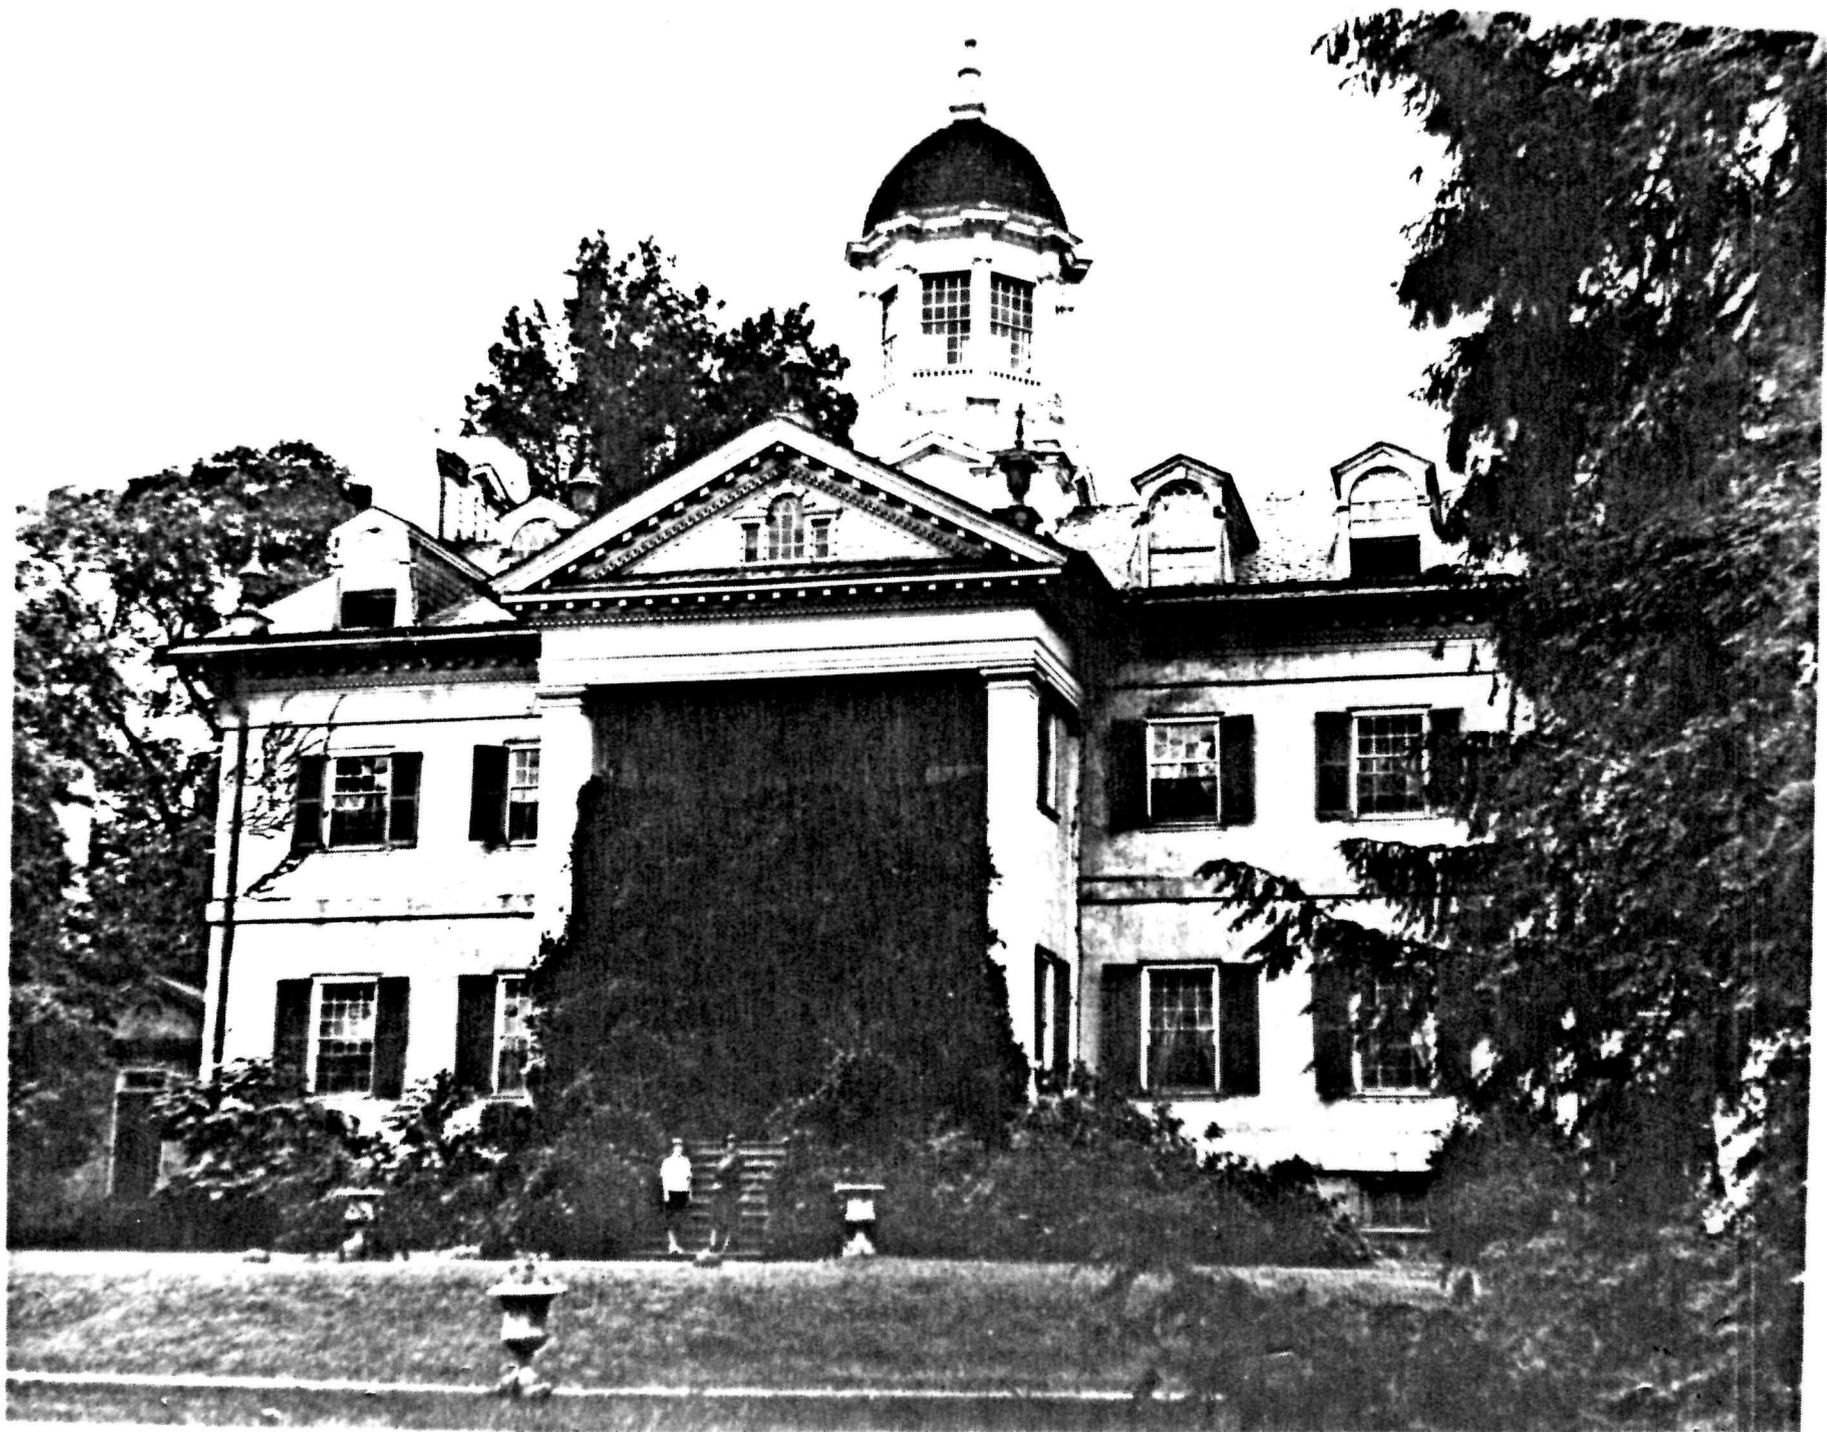
ILLUSTRATION 26: South Facade
1940s?

The Wisteria vine covering the south portico has in this view almost completely covered the first floor. Shutters are still in place on the west hyphen doors. No longer are potted trees to be found on the lawn, since the orangery burned in 1929. Jeanne Ridgely (on left) is shown with a friend on the portico steps.

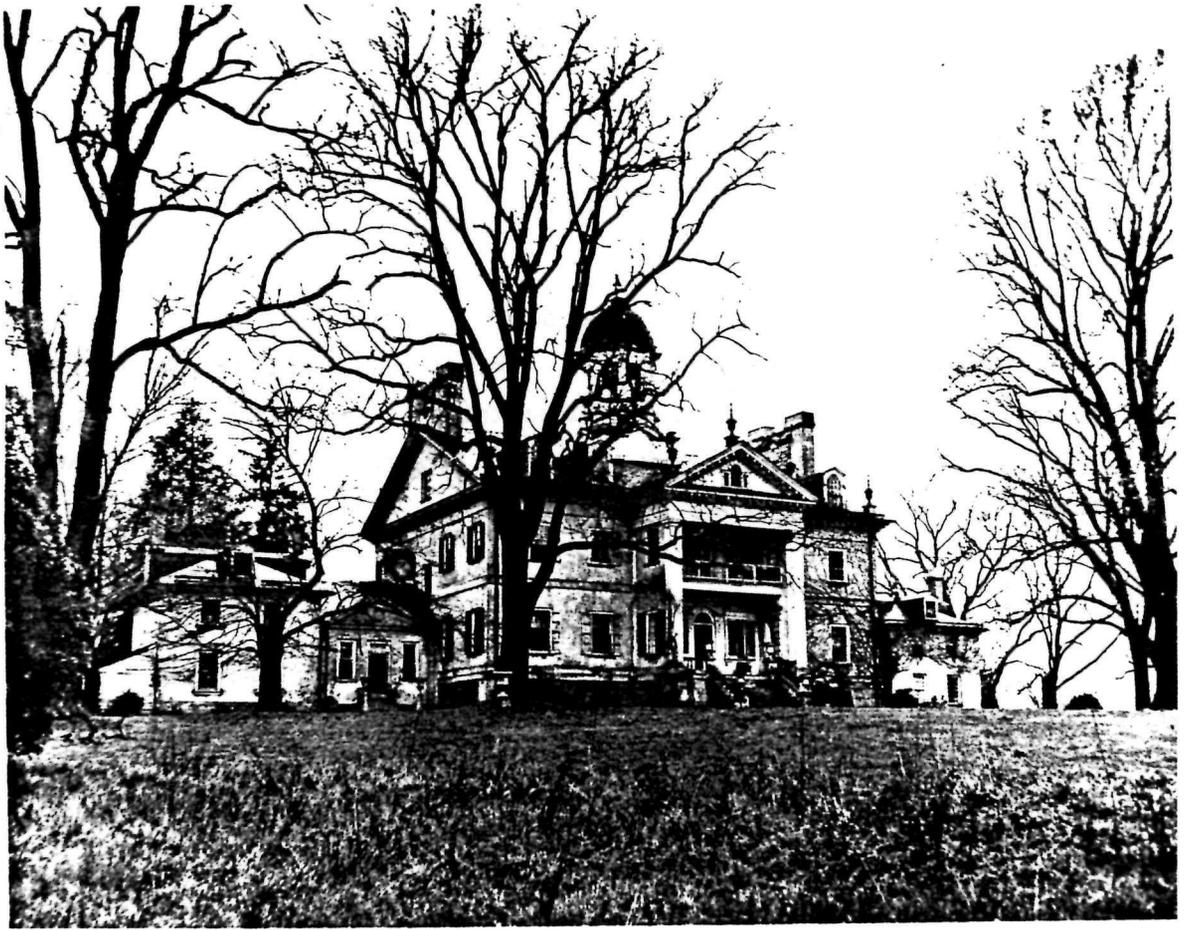
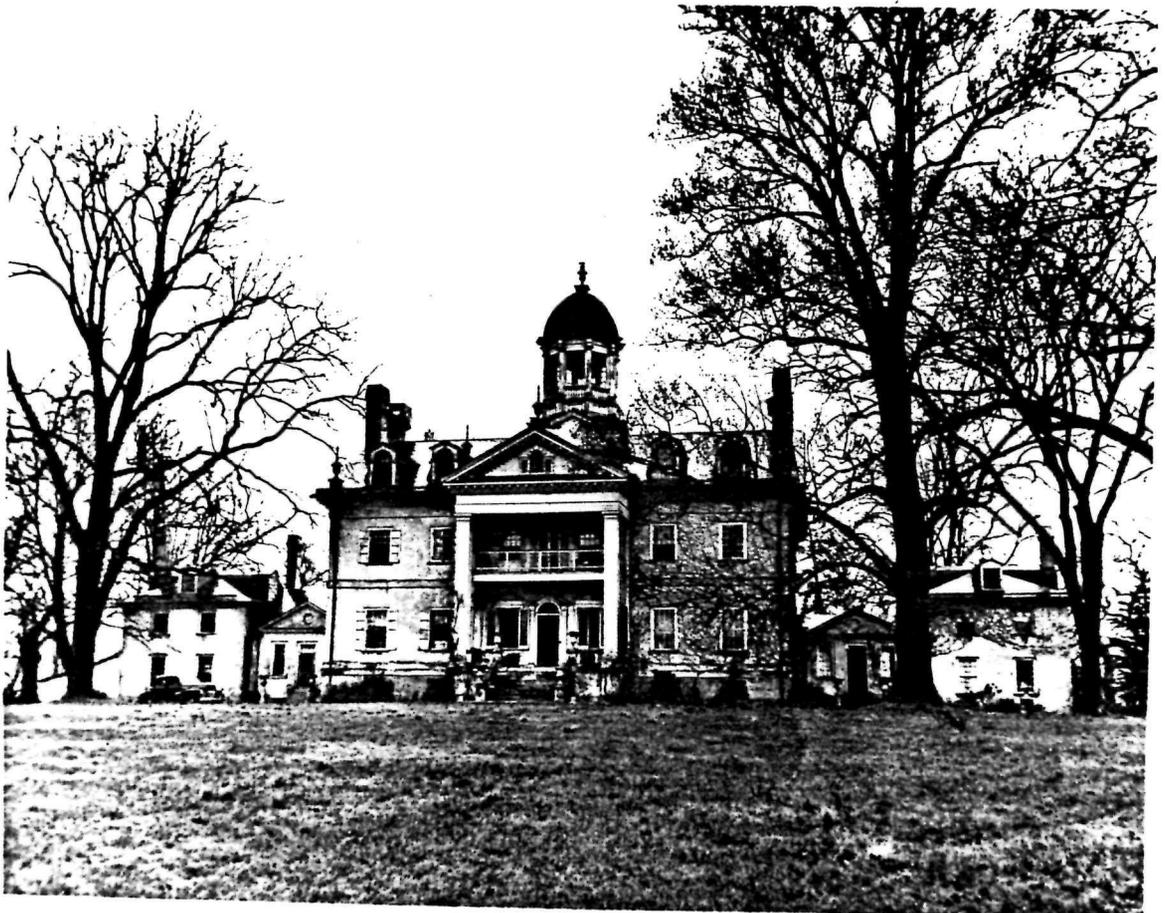
ILLUSTRATIONS 27, 28: North Facade
1940s

These two winter views of the north facade show Hampton in the last years before being taken over by the National Park Service. The shed on the east end of the east wing shows in both. Vines cover much of the west side of the house. The stucco is in bad condition and the woodwork needs painting. The glass shutters (storm windows) are still in place on the east side of the main block. The base of the house (below the water table) is still a dark color.

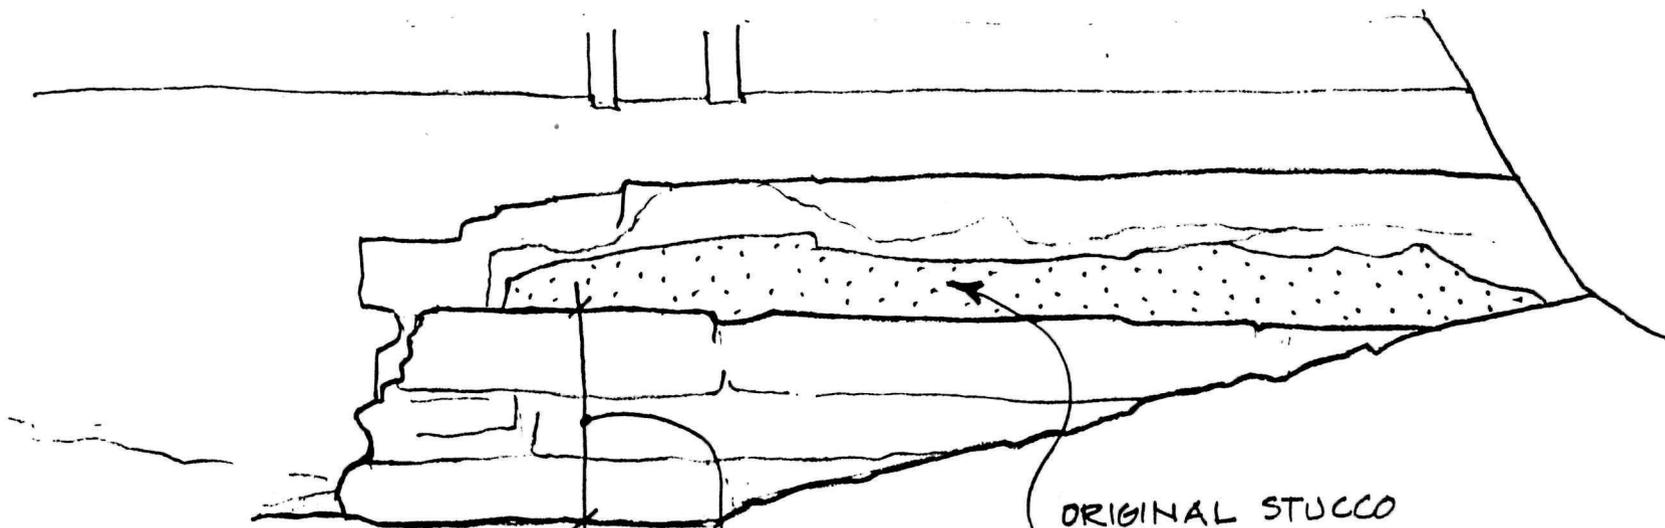
ORIGINAL STUCCO
REMAINS

EXPOSED STONE FOUNDATION, ORIGINAL
SOUTH WALL OF EAST HYPHEN
(VIEW TAKEN BENEATH FIRST FLOOR
OF EAST HYPHEN EXTENTION.)

When the east hyphen was extended about 10 feet to the south sometime in the early 19th century, a fair amount of the original stucco finish was covered over. Below the first floor level can be seen the stone shelf of the foundation where the stucco starts. At the first floor level the stucco was covered by plaster, much of which has now been chipped off to reveal the original stucco. At the attic level of the hyphen the top of one of the first floor windows of the main house is visible, showing the flat arch treatment.

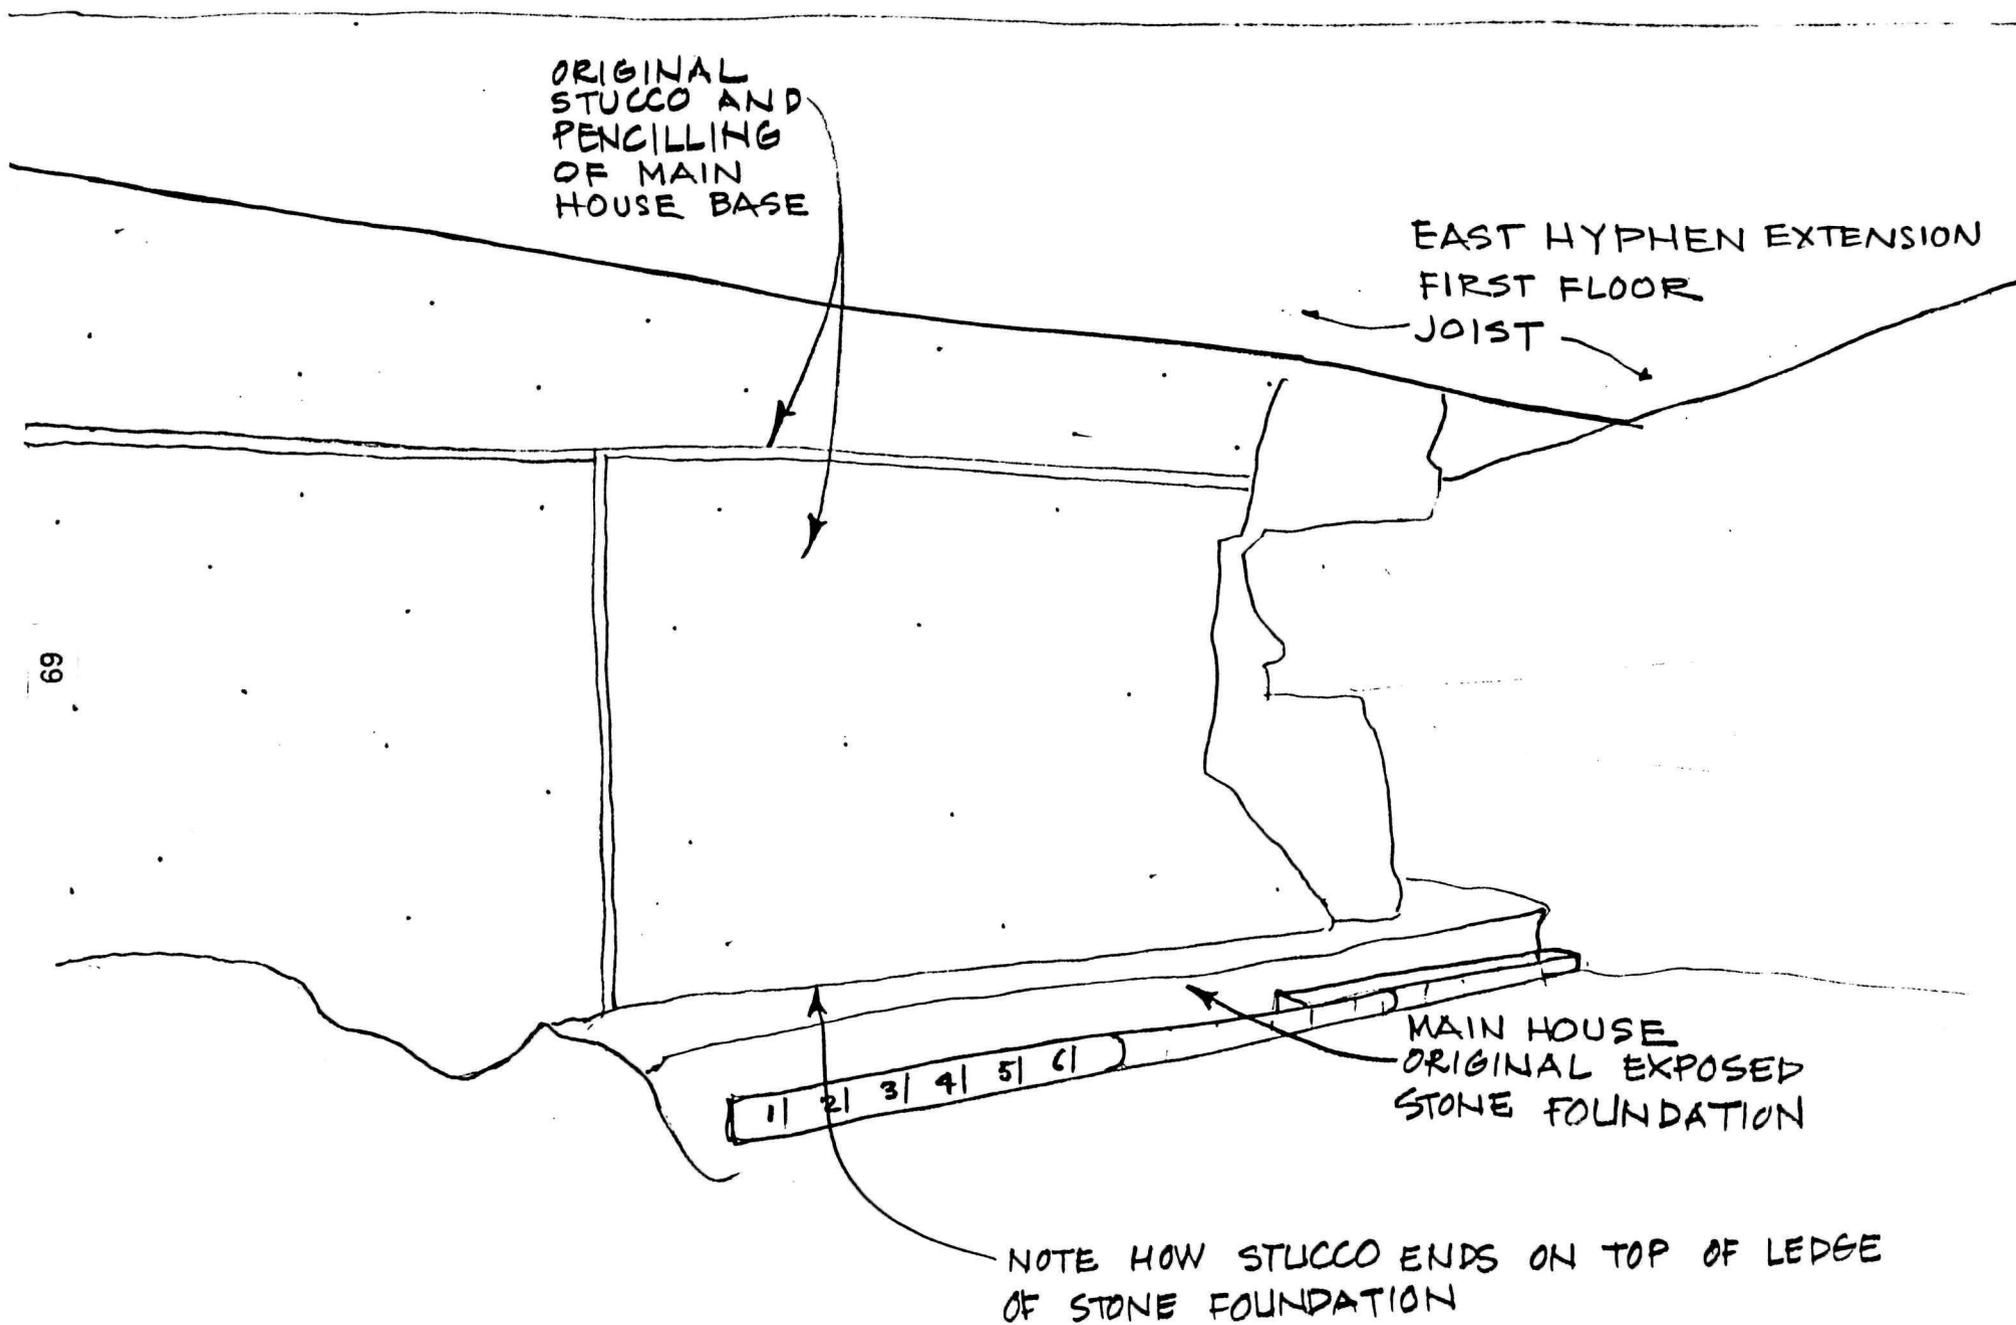
ORIGINAL
STUCCO AND
PENCILLING
OF MAIN
HOUSE BASE

EAST HYPHEN EXTENSION
FIRST FLOOR
JOIST

MAIN HOUSE
ORIGINAL EXPOSED
STONE FOUNDATION

NOTE HOW STUCCO ENDS ON TOP OF LEDGE
OF STONE FOUNDATION

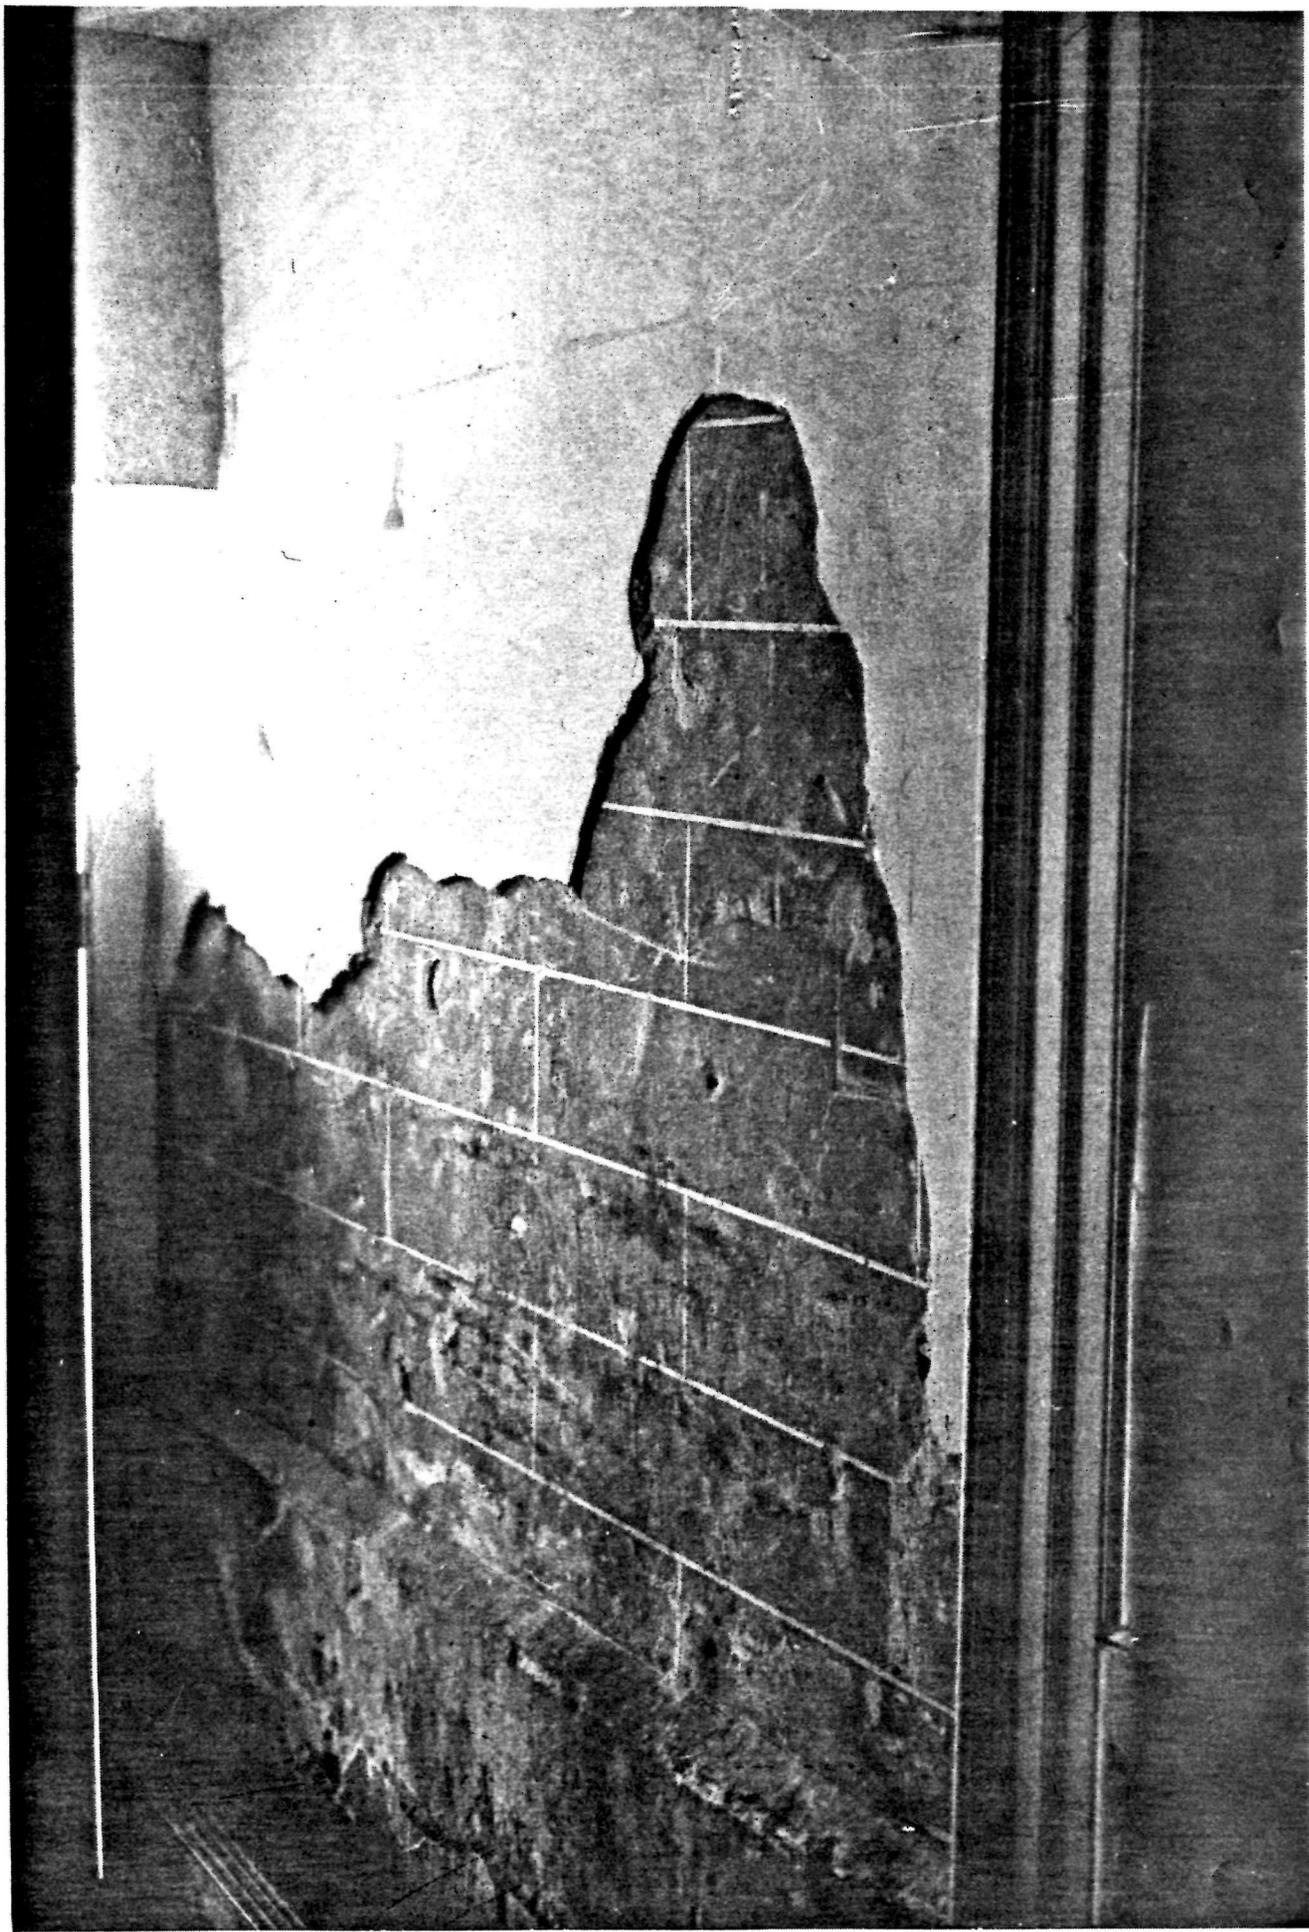
HAMPTON MANSION
ORIGINAL STUCCO EVIDENCE
MAIN HOUSE EAST WALL
COVERED BY
EAST HYPHEN
EXTENSION.

KNOCKED-OFF
PART OF
WATERTABLE

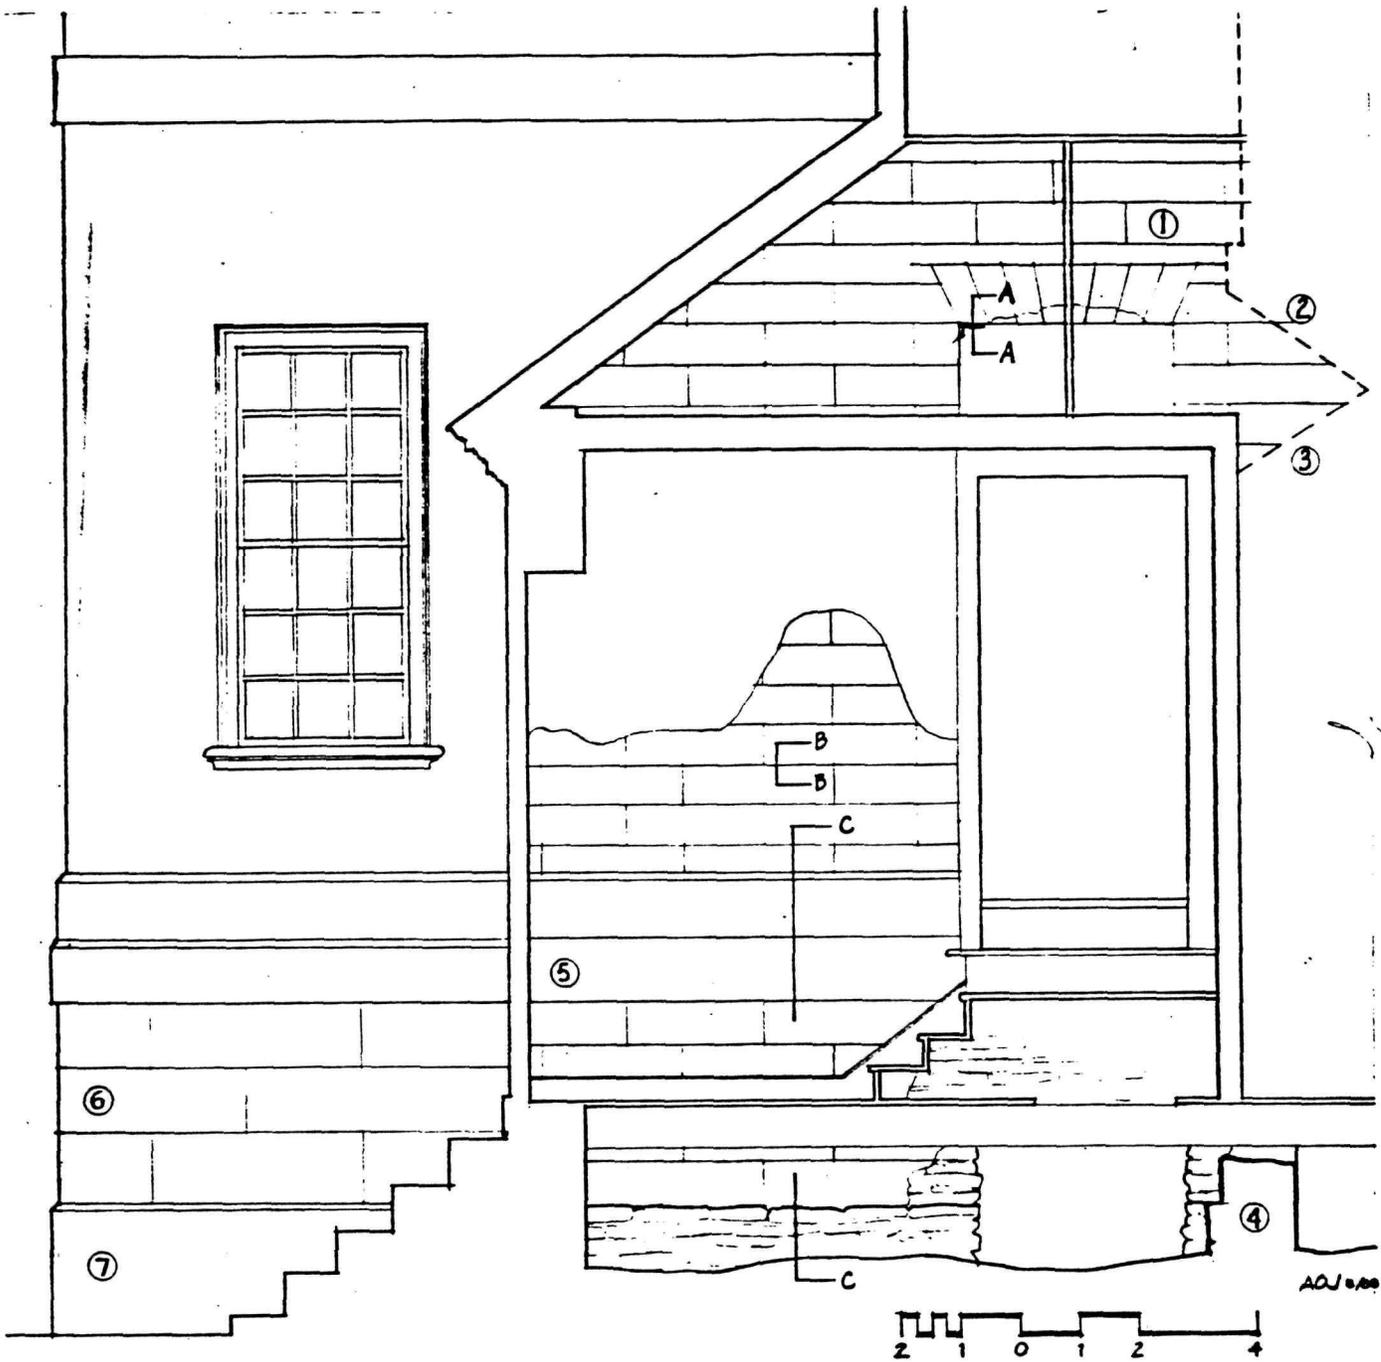
HAMPION MANSION ORIGINAL STUCCO EVIDENCE - EAST WALL OF MAIN BLOCK

- ① THIS SPACE USED AS A PIPE CHASE (ALL THE WAY TO BASEMENT); SOME MEASUREMENTS WERE THEREFORE DIFFICULT TO OBTAIN.
- ② STAIR STRINGER HERE.
- ③ ORIGINAL ROOF SLOPE OF EAST HYPHEN (IMPRESSION IN PLASTER).
- ④ ORIGINAL EXTERIOR WALL OF HYPHEN. SOME STUCCO REMAINS ABOVE STONE BASE.
- ⑤ THIS BAND OF WATERTABLE KNOCKED OFF WHEN WALL WAS PLASTERED.
- ⑥ THIS AREA PRESENTLY SCORED AS INDICATED; 1976 WORK BASED ON PREVIOUS BASE SCORING (3-COURSE PATTERN GOING BACK TO AT LEAST THE 1870'S).
- ⑦ THIS PART OF BASE (PRESENTLY STUCCOED) WAS ORIGINALLY EXPOSED STONE.

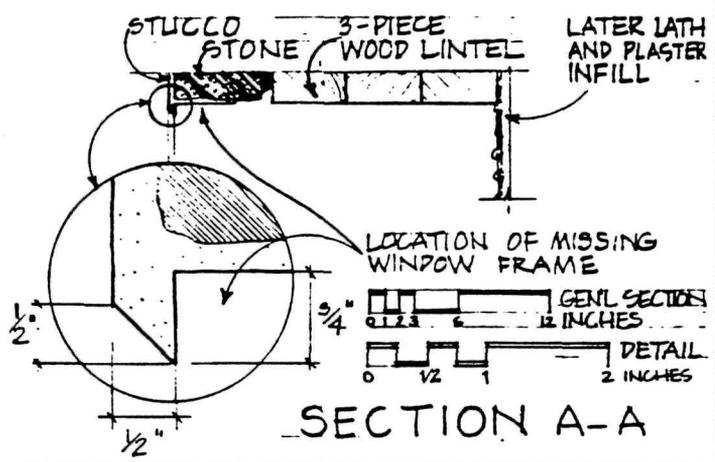
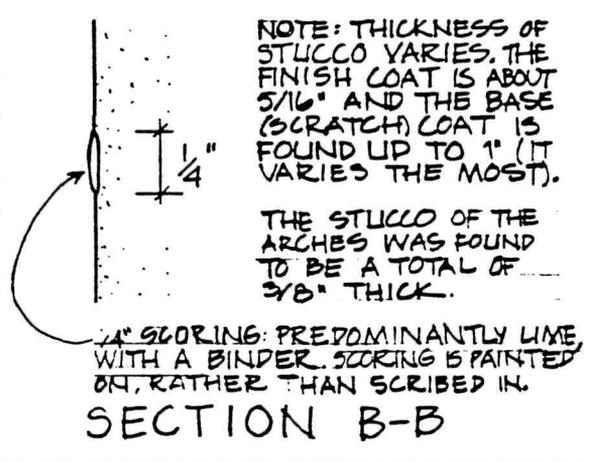
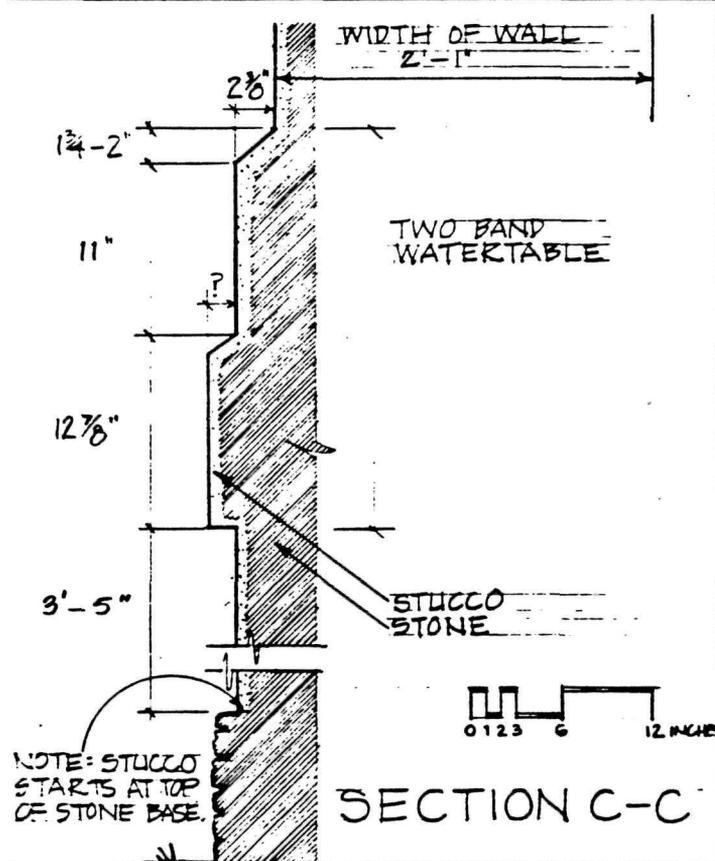
SECTION THROUGH WINDOW HEAD

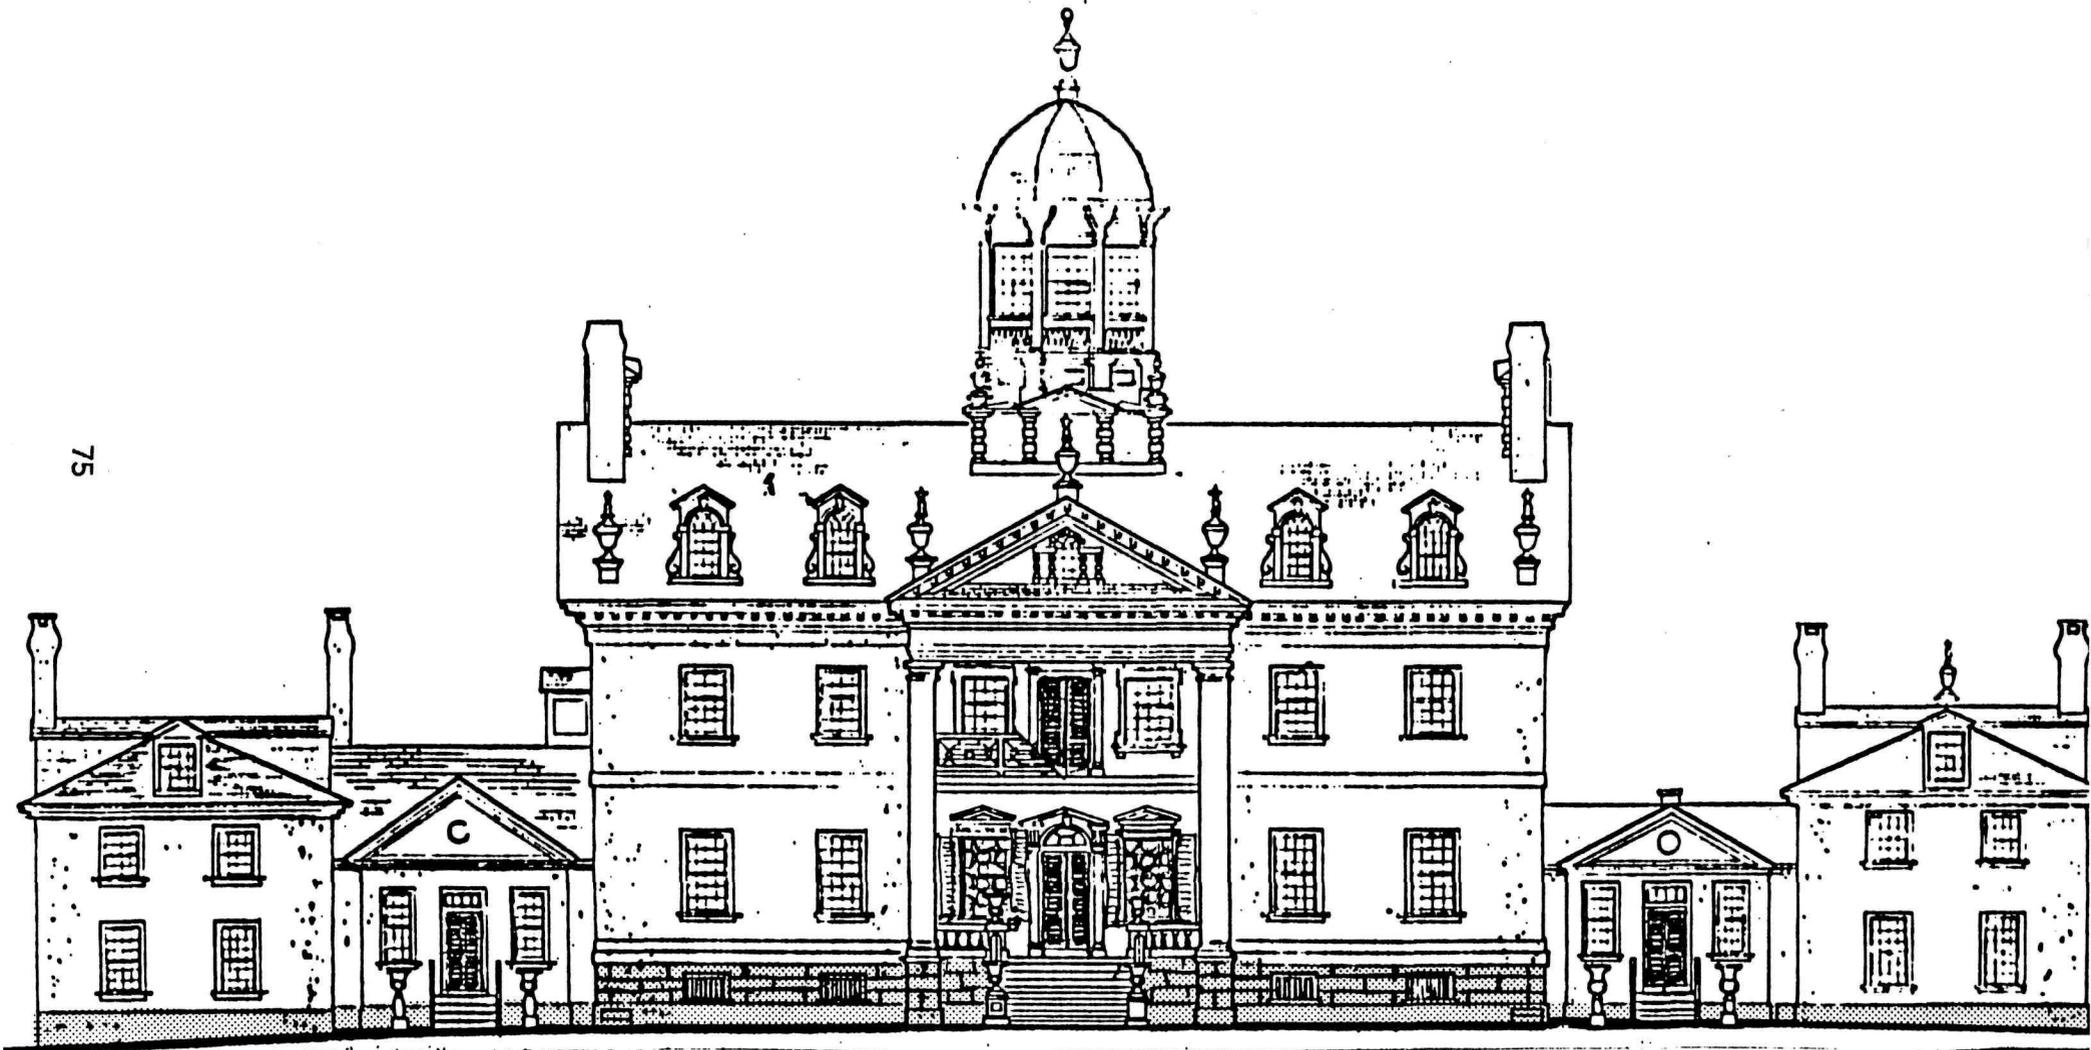
STUCCO
ALT. B

HAMPTON MANSION, NORTH FACADE
VICTORIAN, c.1867-1900
