HAMPTON MANSION

ADDENDUM
HISTORIC STRUCTURE REPORT
ARCHITECTURAL DATA SECTION
HAMPTON MANSION
HAMPTON NATIONAL HISTORIC SITE
TOWSON, MARYLAND

Prepared by
Anthony O. James
and
Penelope Hartshorne Batcheler

DENVER SERVICE CENTER
MID-ATLANTIC/NORTH ATLANTIC TEAM
BRANCH OF HISTORIC PRESERVATION
NATIONAL PARK SERVICE
UNITED STATES DEPARTMENT OF THE INTERIOR
DENVER, COLORADO

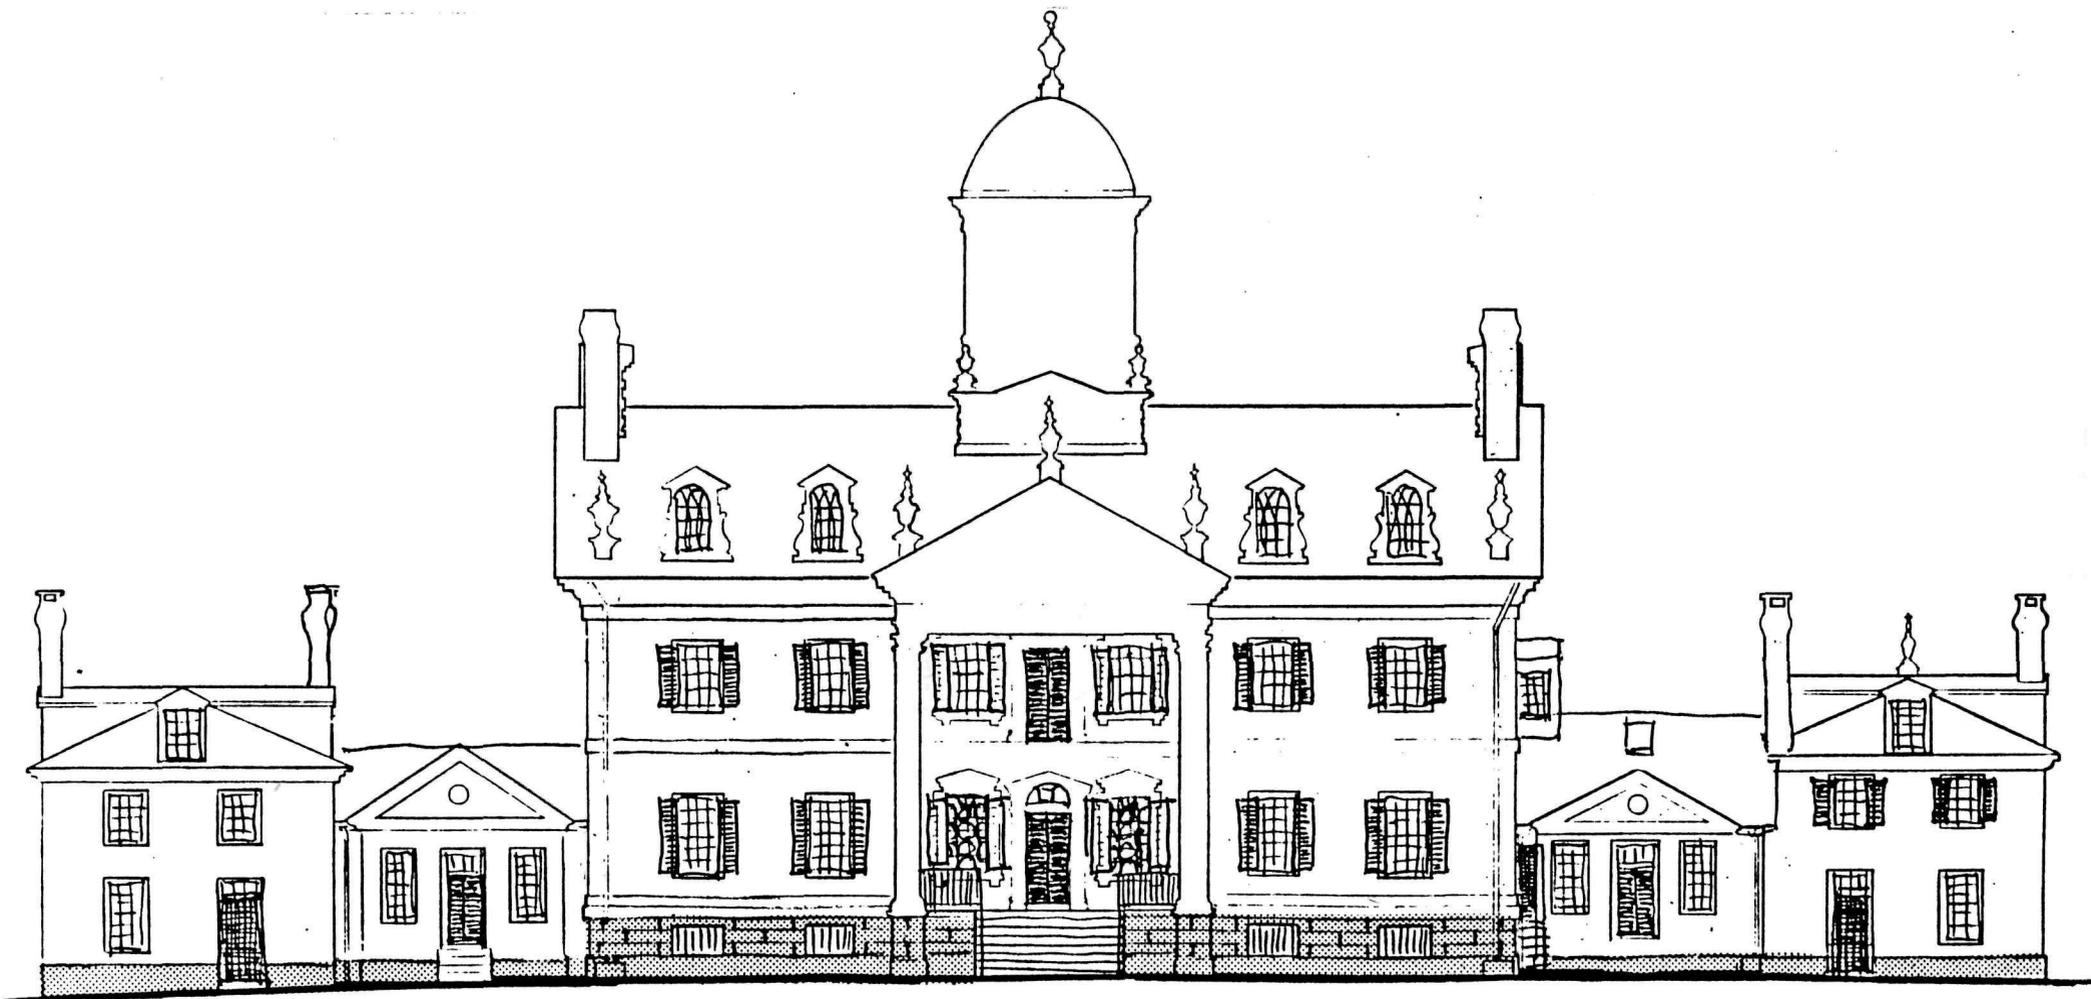
STUCCO

HAMPTON MANSION, SOUTH FACADE
VICTORIAN, c.1867 - 1900

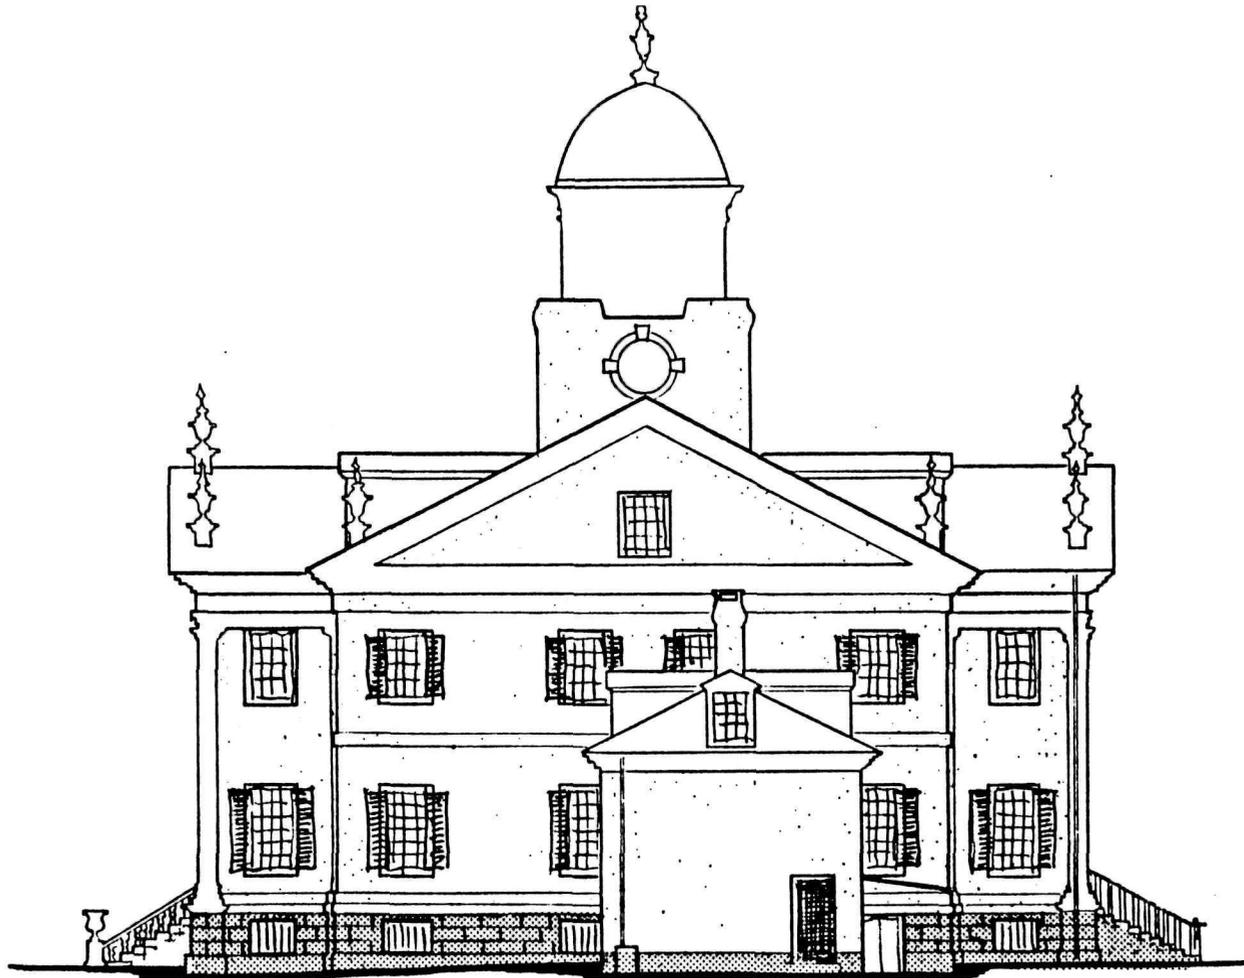
STUCCO ALT. B

HAMPTON MANSION WEST ELEVATION
VICTORIAN 1867 - 1900

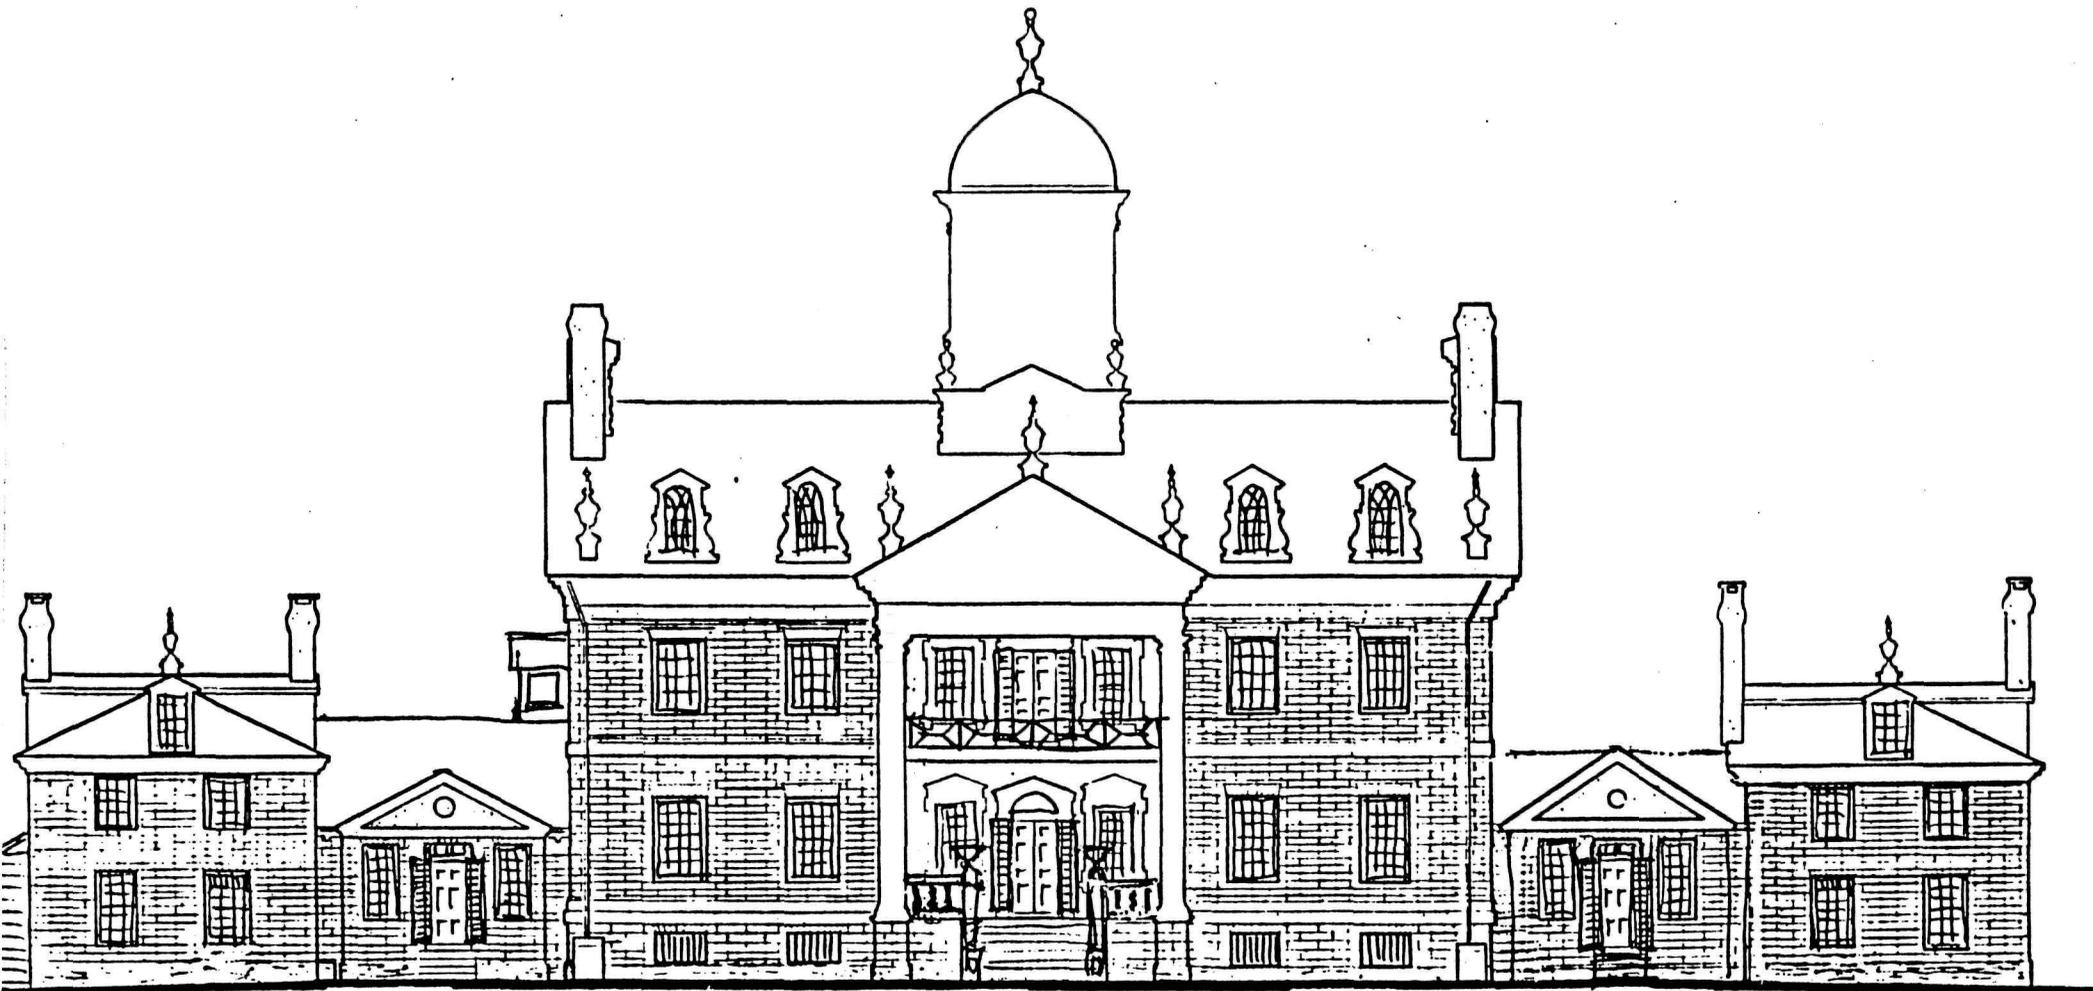
EXCEPTION, 1867 STAIR

STUCCO
ALT C.

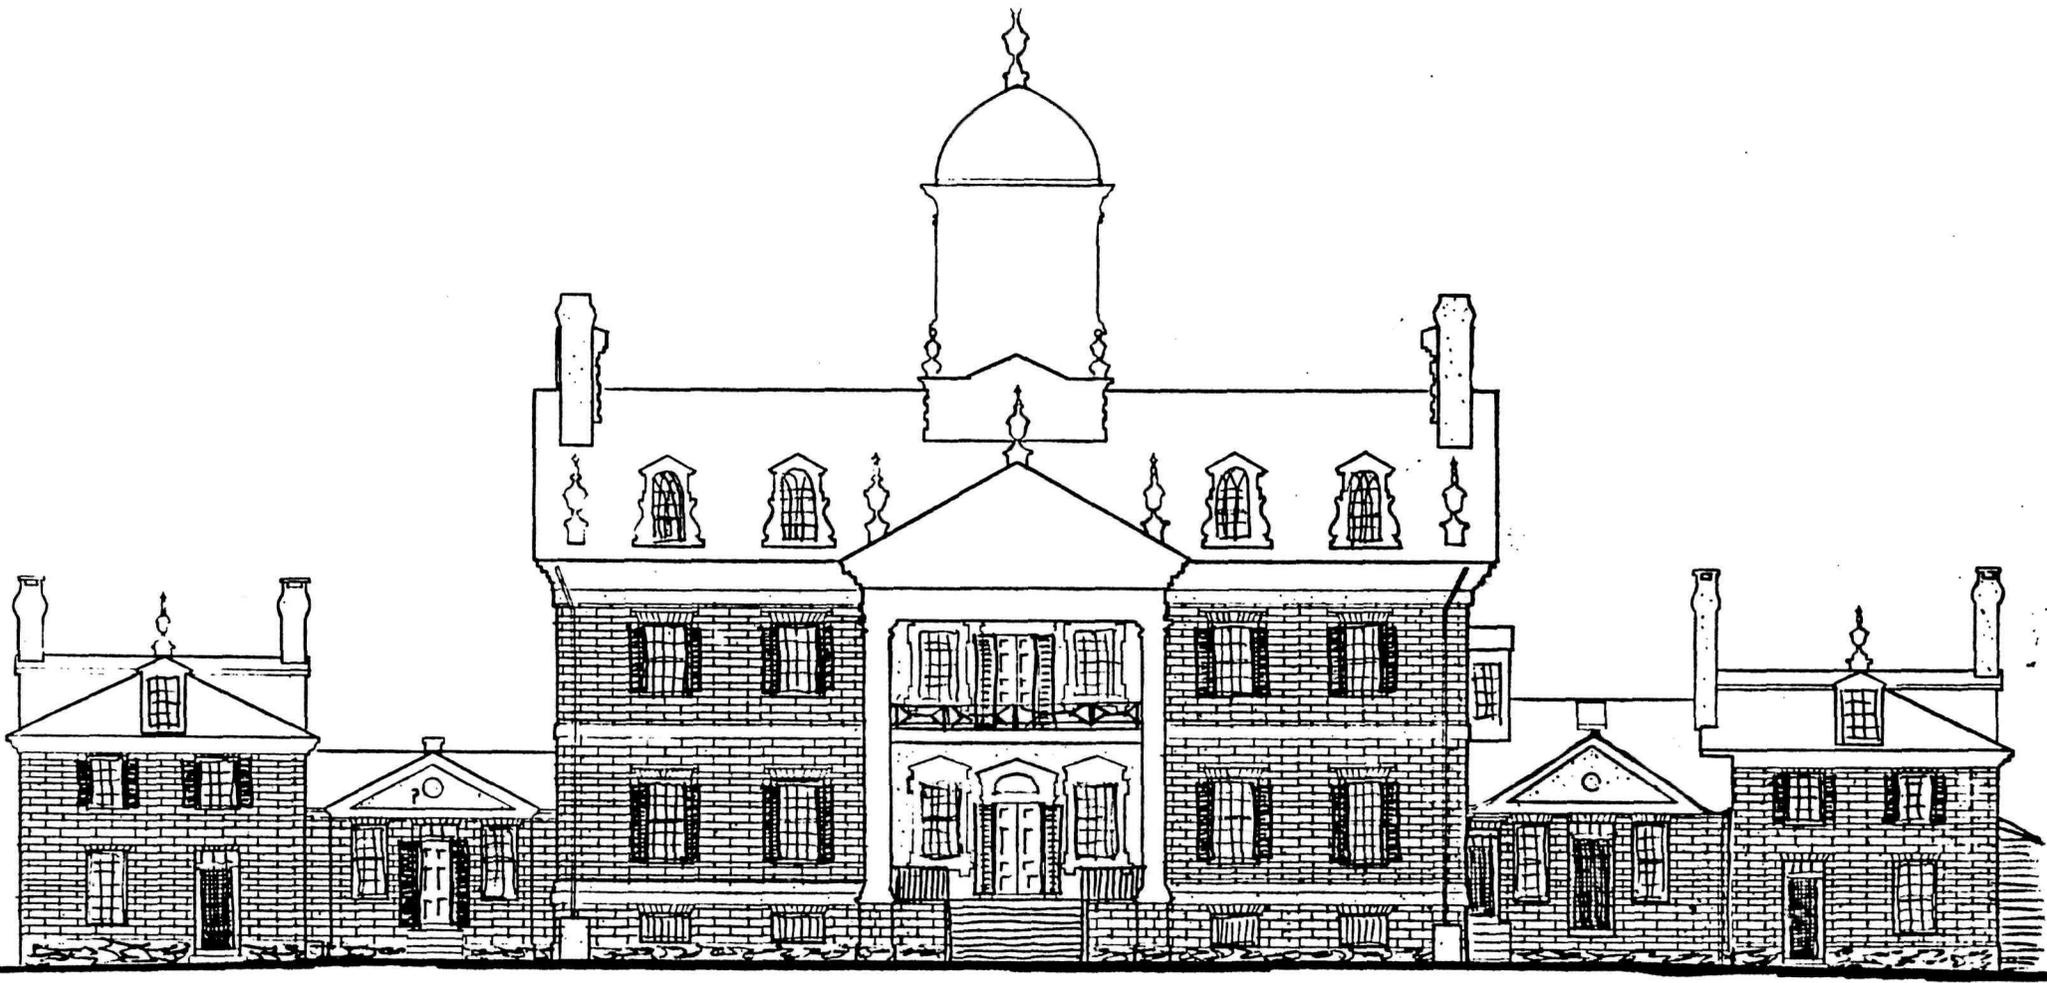
STUCCO
ALT. C

HAMPTON MANSION, SOUTH FACADE
c.1838

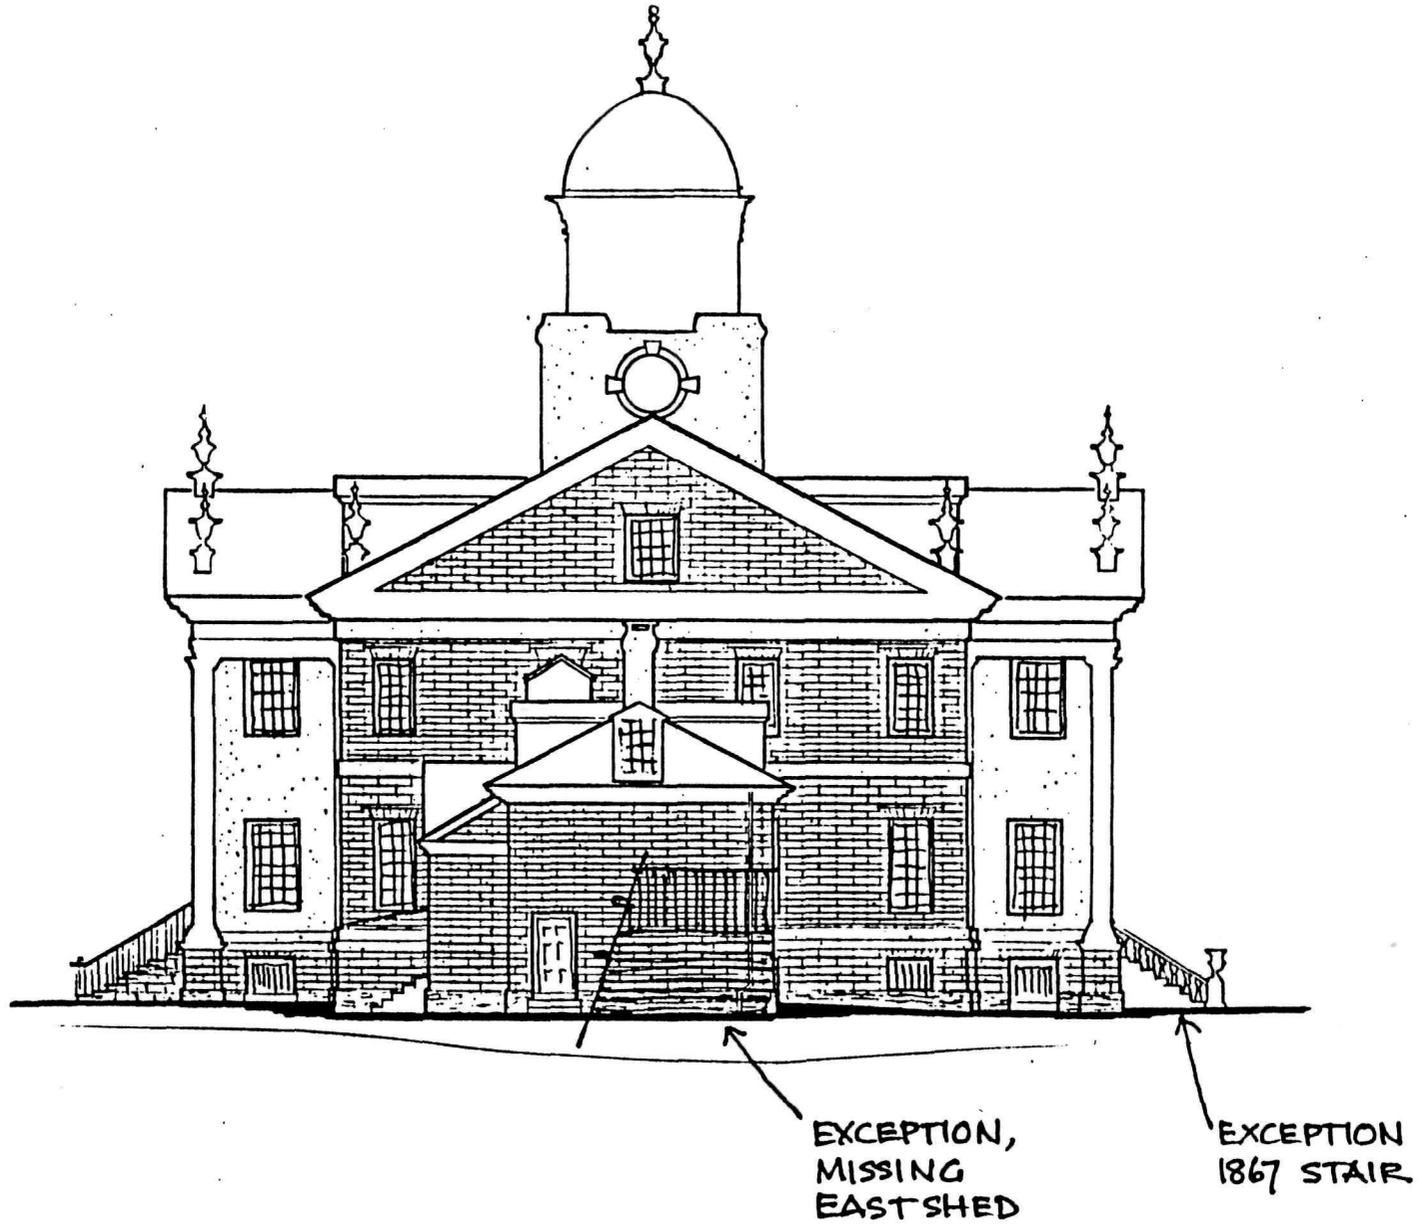
STUCCO ALT. C. HAMPTON MANSION EAST ELEVATION
c. 1838
