REFERENCE MARKER - PHOTOPOINT RESOURCES MANAGEMENT SYSTEM

RESEARCH/RESOURCES MANAGEMENT REPORT SER-62

Research/Resources Management Report SER-62

December, 1982

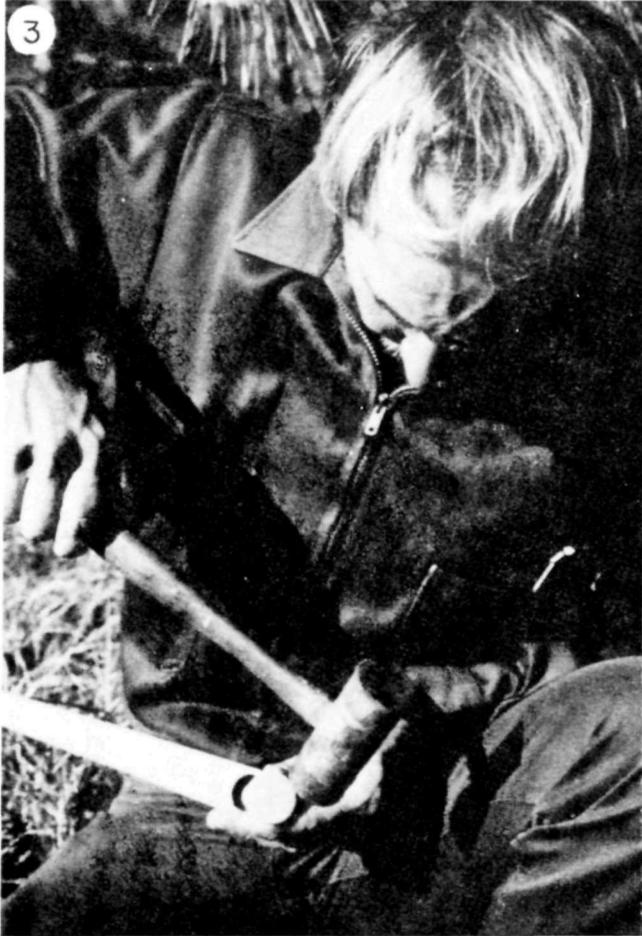
Fig. 3. Inserting survey plug.

After the location had been chosen, the reference marker was planted with the use of a posthole digger. The PVC pipe was then cut off approximately 6 inches (15 cm) above the ground. A prenumbered survey plug was placed into the opening

and secured with the hammer until flush against the pipe, taking care not to mar the numbers (Fig. 3).

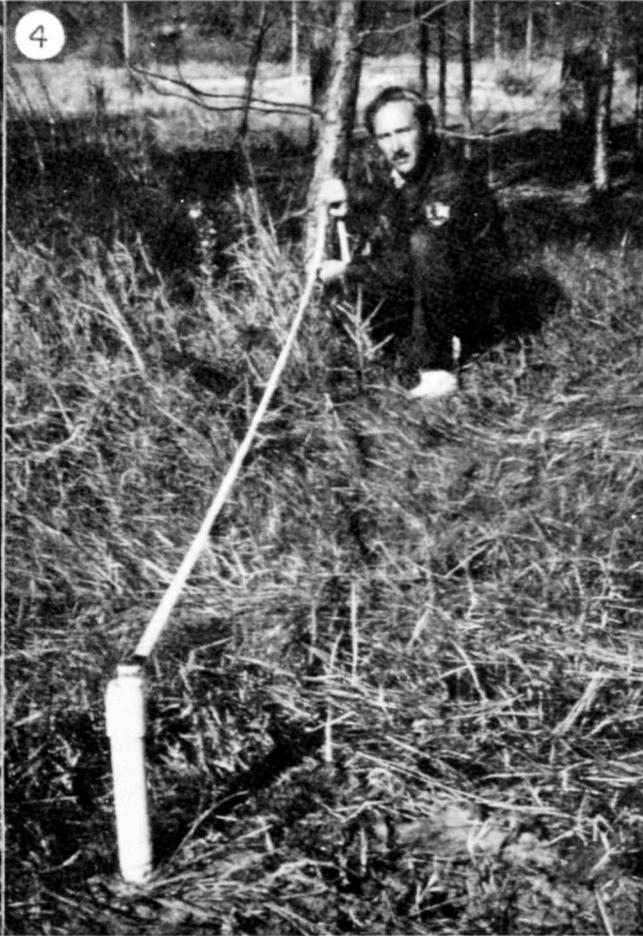
Fig. 4. Measurement.

From the reference marker, photopoints were established at set azimuths and distances (Figs. 4 and 5). The compass was placed on the top of the reference marker and the azimuths determined. To assist in taking measurements, a cap was constructed from the expanded portion of a 1 inch (2.5 cm) PVC pipe, 3 inches (7.5 cm) in length, to slip over the reference marker. A screw hook was placed in the side of the cap to hold the end of the 100-meter tape. Measurements are easier with two people; however, one person can do it with little trouble. From the photopoint a picture or pictures of the area(s) to be monitored was taken. The azimuth from the photopoint to the center of the photograph was recorded to assist in taking photo(s) of the same area(s) the next time photographs were taken (see Table 2 and Fig. 6).

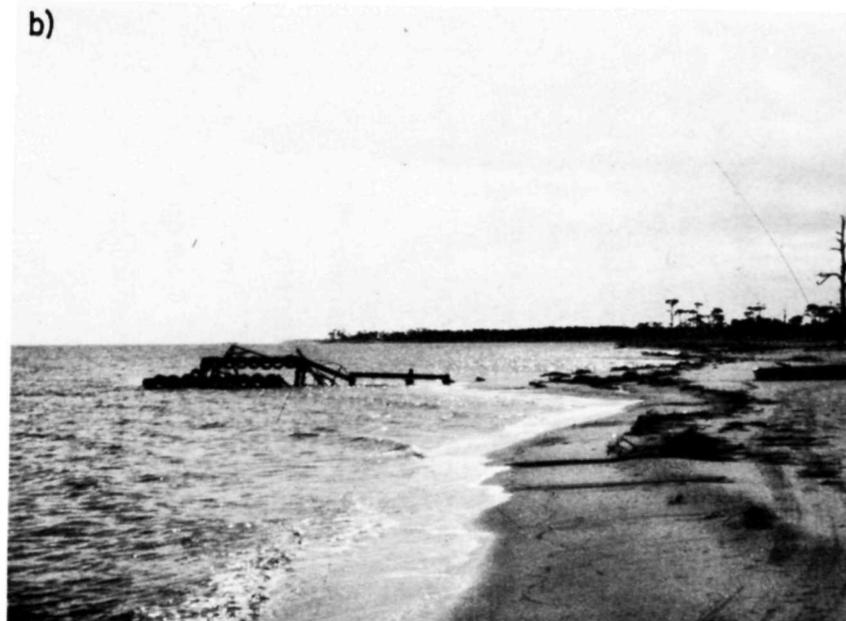
The series in Figure 8 demonstrates the tenuous nature of human occupation of barrier islands in storm hazard areas.

Fig. 8. Reference Marker #20, Photopoint #1, azimuth 105° , Horn Island, looking at boat hoist and diesel shed. a) In November 1978, b) In September 1979 following Hurricane Frederic, c) In November 1980, d) In February 1981.

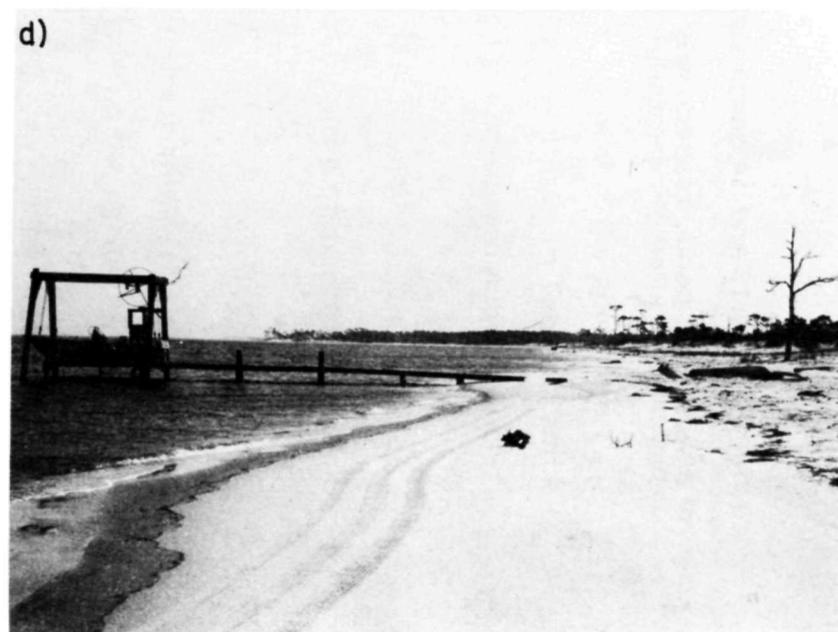
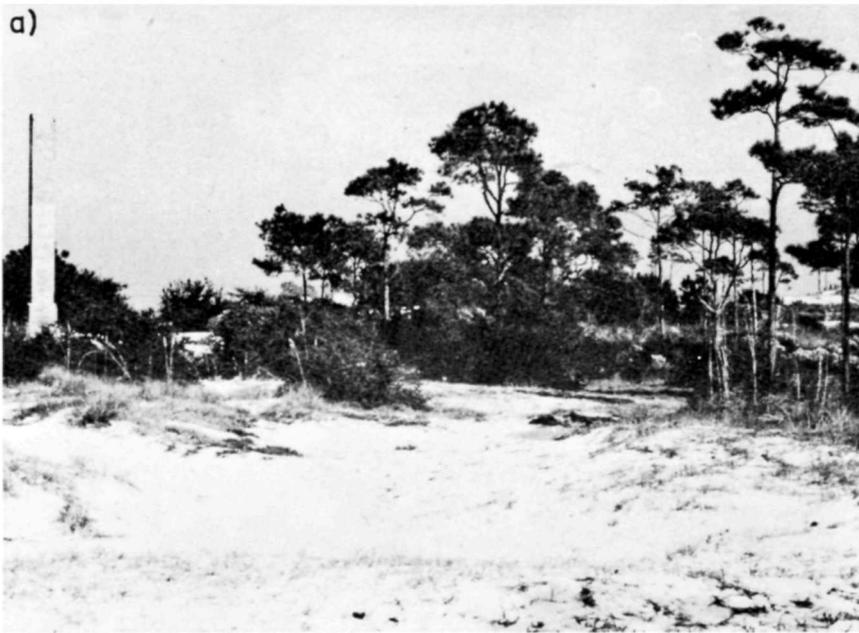
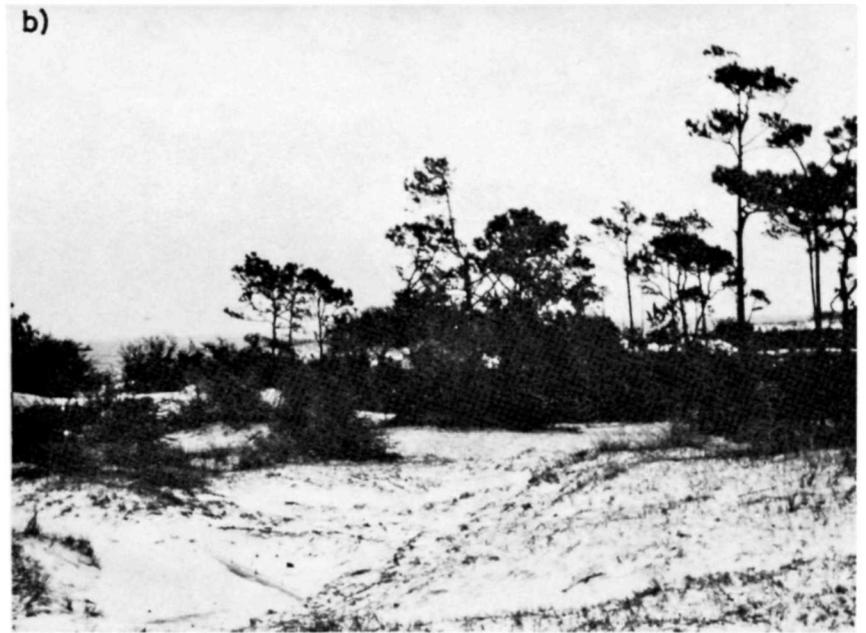
Figure 9 shows the loss of a World War II incinerator chimney from hurricane impact and demonstrates very little natural change during the period of record.

Fig. 9. Reference Marker #18, Photopoint #1, azimuth 70° , Horn Island, Chimney area.
a) In November 1978, b) In September 1979 following Hurricane Frederic. Note that destroyed chimney (see Figs. 9a and 9c) was cropped during reproduction of B&W from the color transparency, c) In April 1980, d) In February 1981. Note very little relative vegetational change is observed for the period of record.

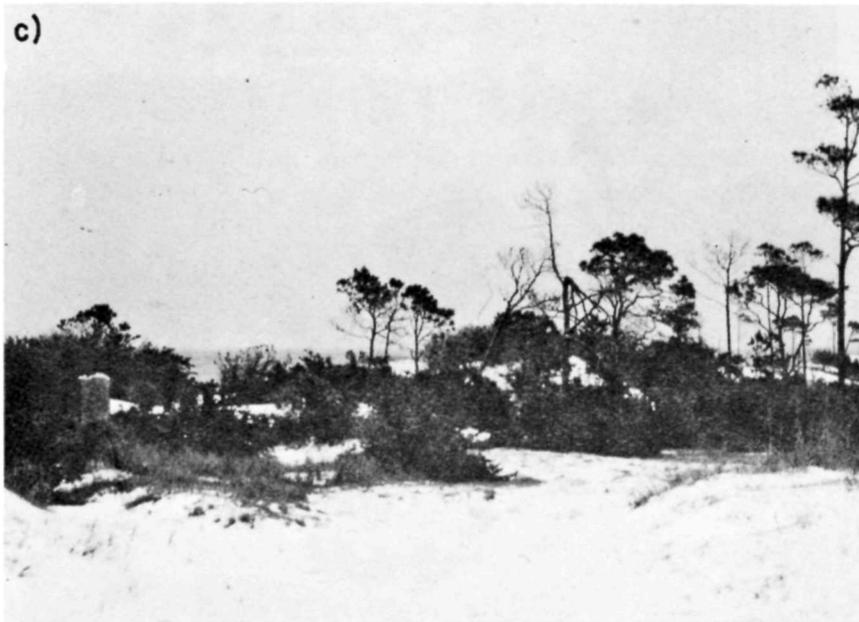
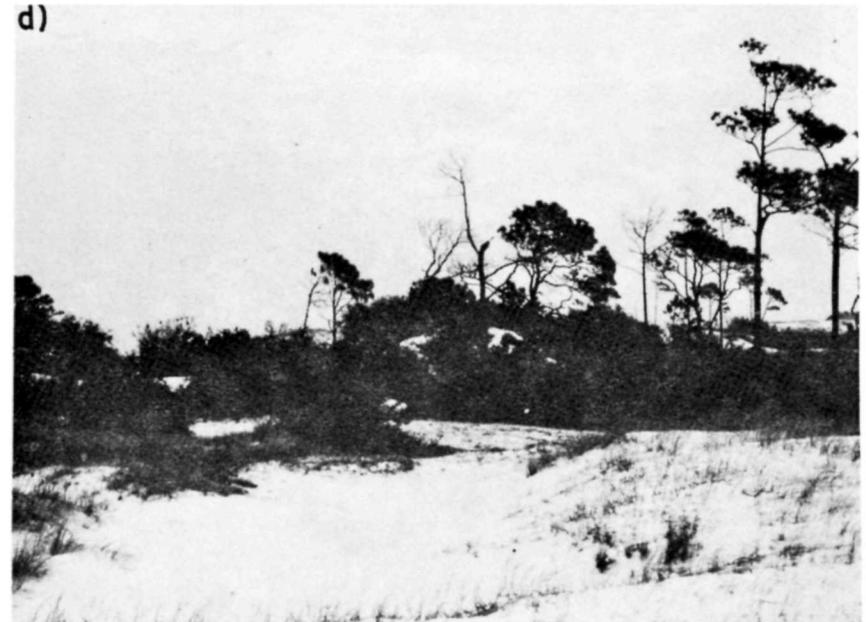
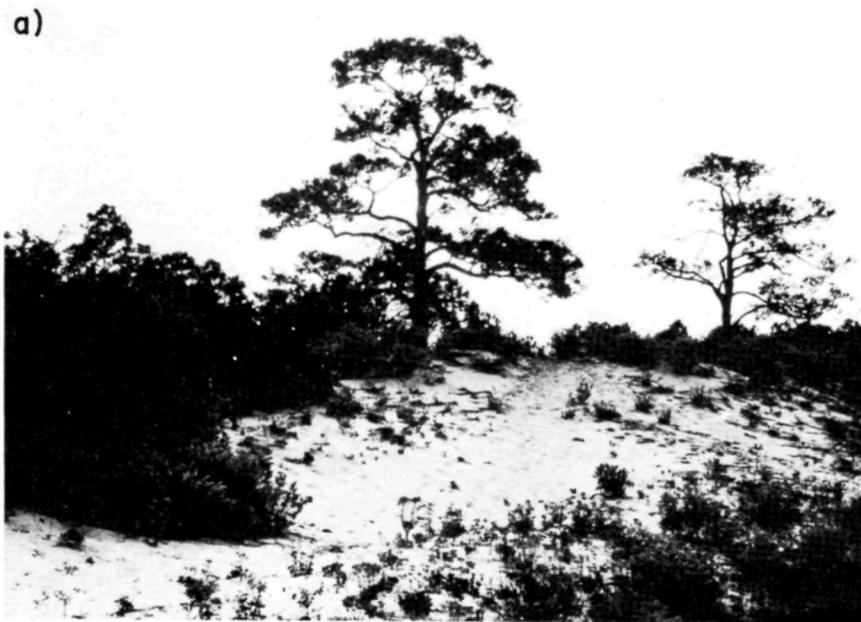
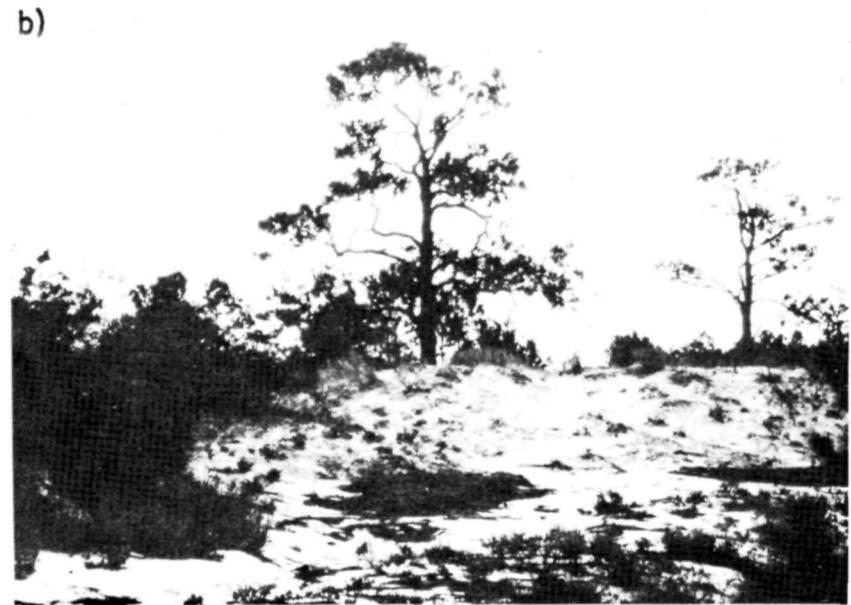
Figure 10, also in the incinerator chimney area, shows a major pedestrian trail in the area. Such a series would document, through time, human related changes along the trail. For example, losses of vegetation or trail erosion might suggest to management that the trail be closed until monitoring demonstrated its recovery.

Fig. 10. Reference Marker #17, Photopoint #1, azimuth 160° , Horn Island, Chimney area, looking along major pedestrian trail to Chimney. a) In November 1978, b) In September 1979 following Hurricane Frederic, c) In February 1980. Note cross-trail transect tape used for quantifying vegetation and ground profile, d) In April 1980. Note persistence of drift deposited during Hurricane Frederic and lack of observable change in vegetation and profile.

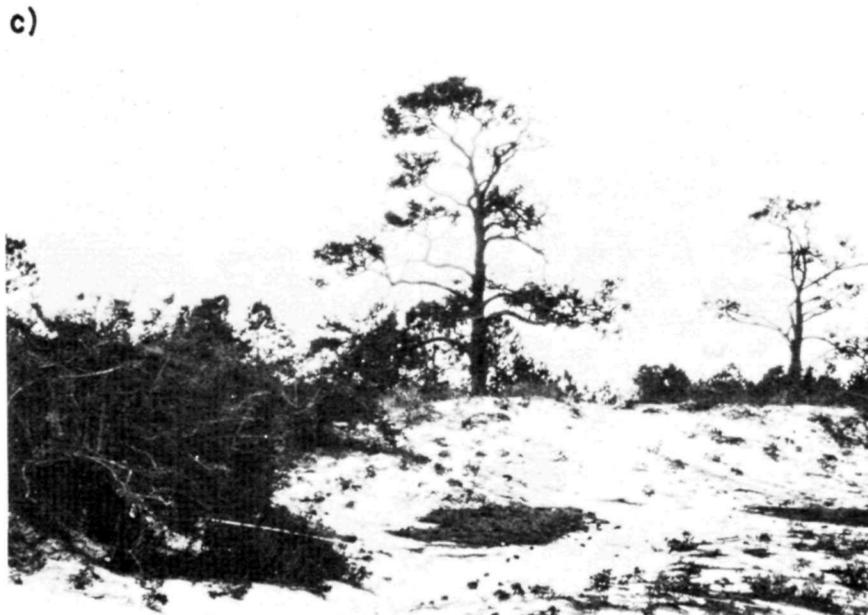
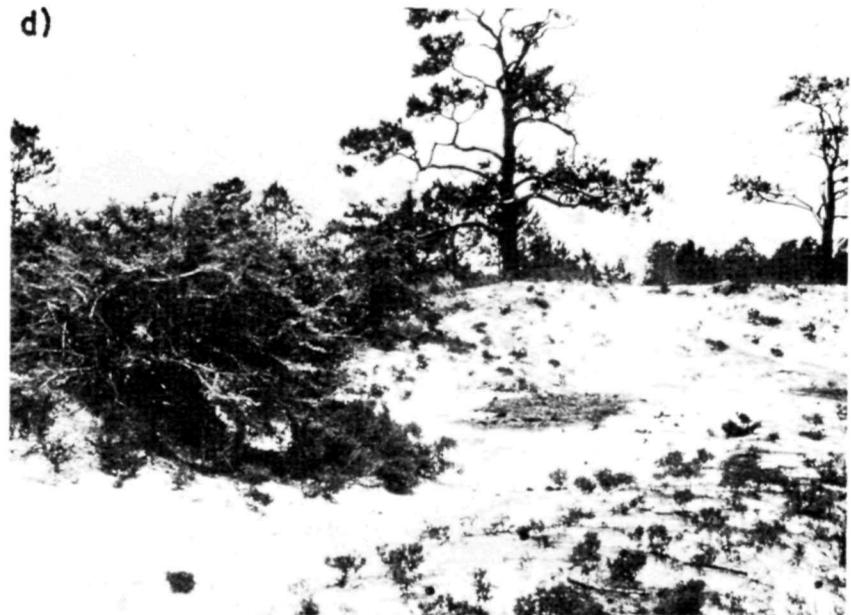
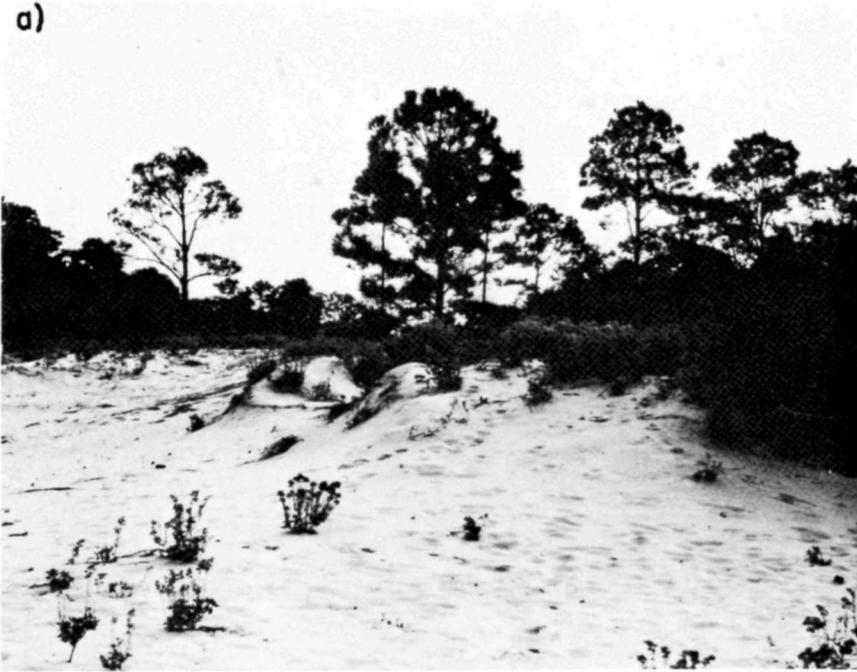
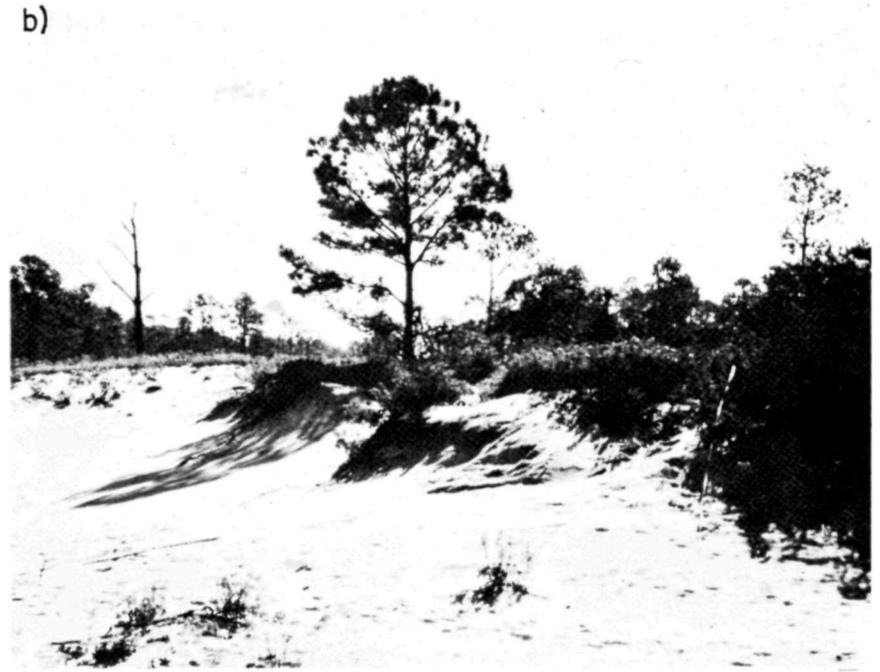
Figure 11, another pedestrian trail in the incinerator chimney area, shows the formation of a dune scarp. Whether this escarpment is human related or attributable to wind-water erosion is unknown. A series of photographs through time will allow resource managers to evaluate the status of the area.

Fig. 11. Reference Marker #17, Photopoint #1, azimuth 130° , Horn Island, Chimney area: pedestrian trail. a) In November 1978, b) In November 1980. Note escarpment near path. Cause and effect?

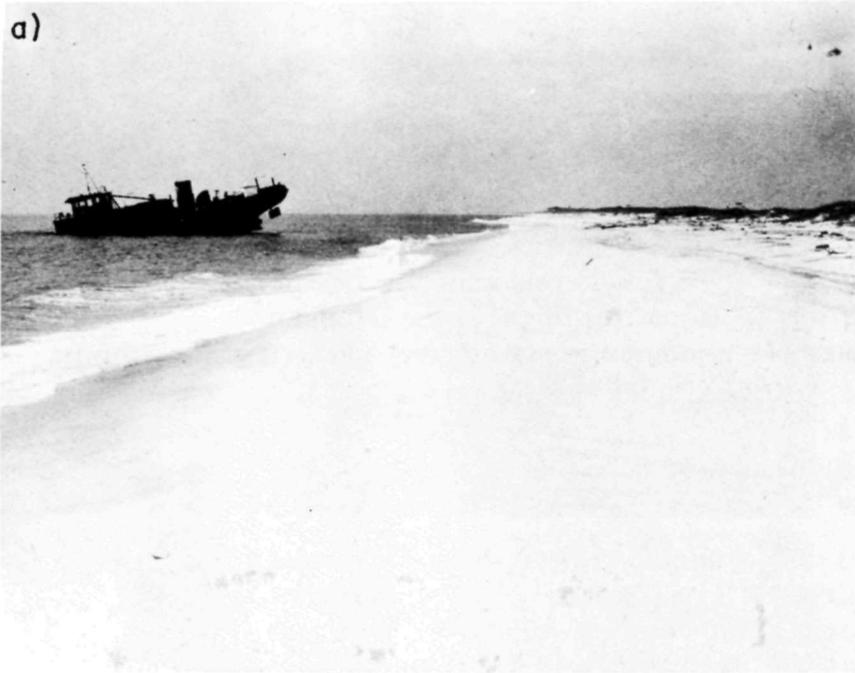
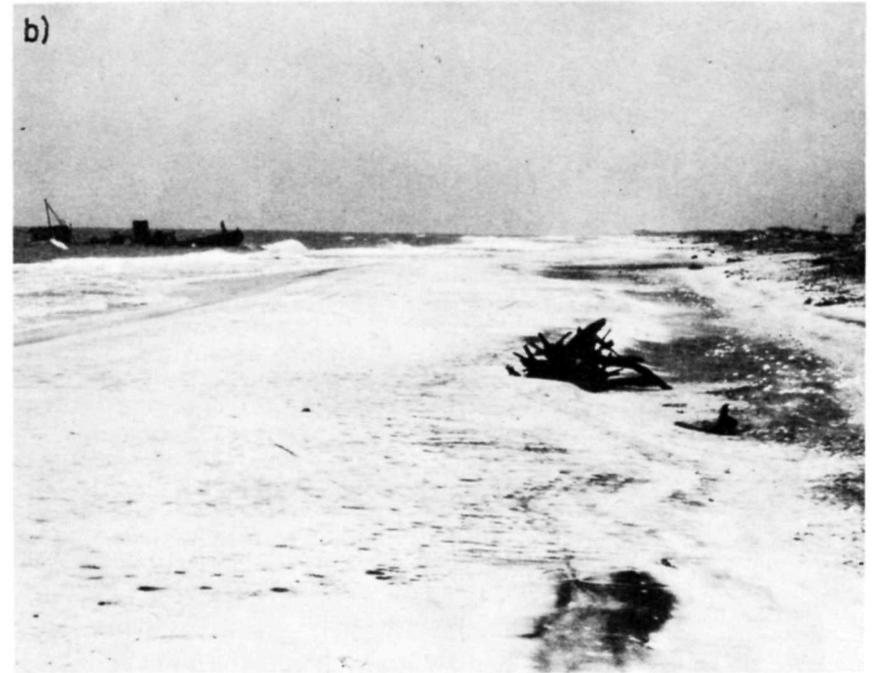
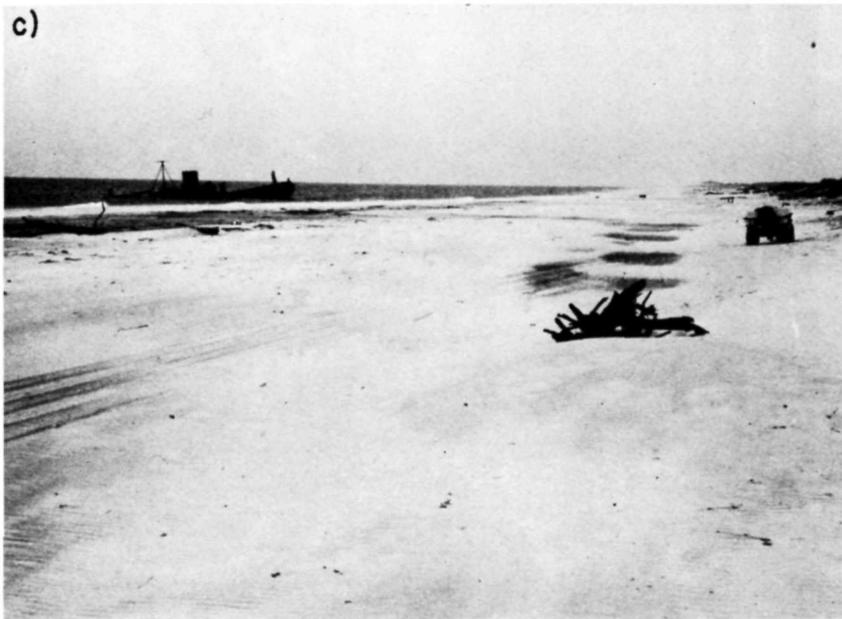
Human-related shoreline changes are demonstrated in Figure 12. The shrimp boat wreck acted as an offshore breakwater (Fig. 12a) and ultimately a groin after the wreck became attached to the shore (Fig. 12c). While detached from the shore, the wreck formed a wave-current shadow between it and the shore. Consequently, waves and currents passing through the shadow deposited sediments as their transport capacity was reduced by a reduction in their sediment carrying capacity.

Fig. 12. Reference Marker #9, Photopoint #1, azimuth 270° , Horn Island, looking west toward wreck of shrimp boat Arcturus. a) In November 1978, b) In September 1979 following Hurricane Frederic. Note expansion of beach and subsidence of wreck, c) In May 1980.

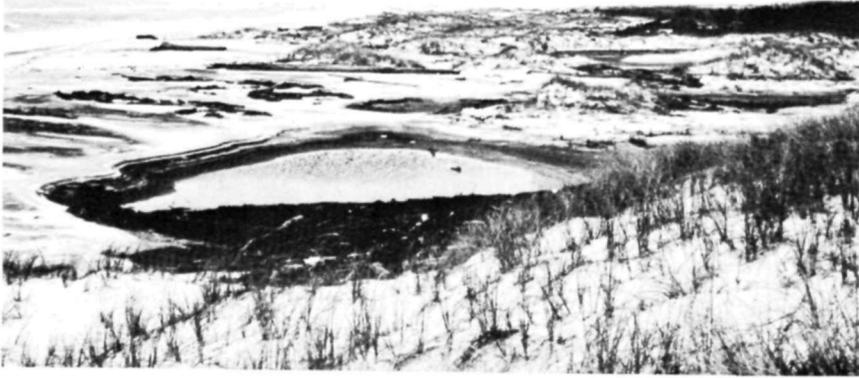
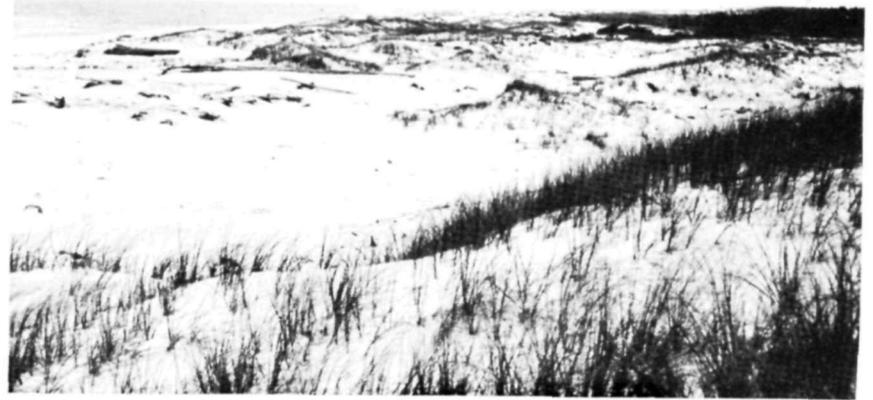
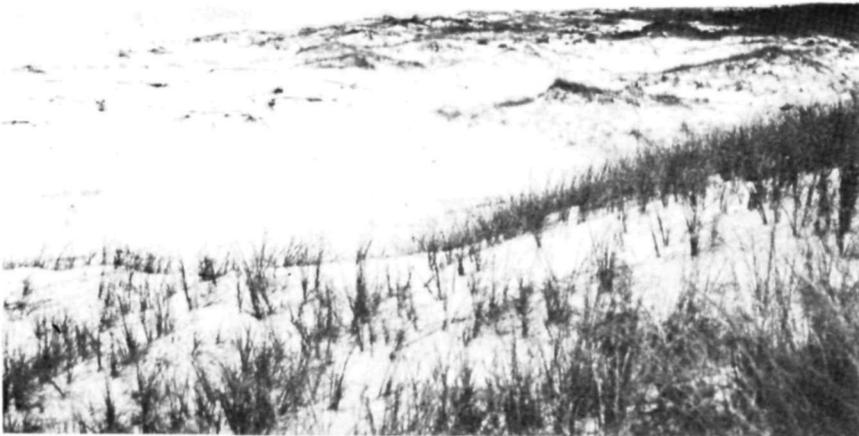
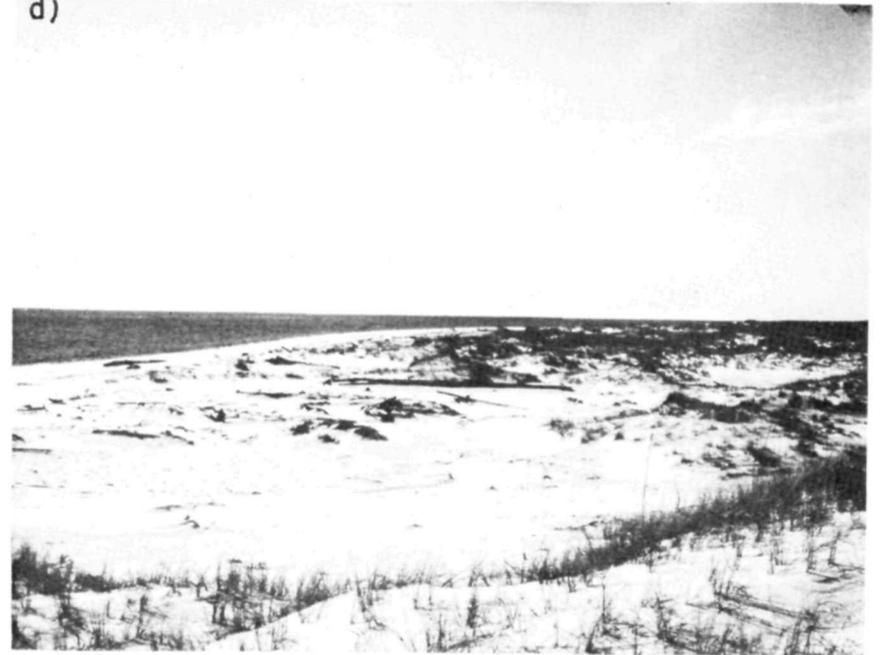
Fig. 14. Reference Marker #8, Photopoint #1, azimuth 265° , Horn Island, south shore, looking southwest. a) In September 1979. Note small overwash pond, b) In May 1980. Note absence of pond, c) In November 1980, d) In February 1981. Note continued absence of overwash pond.

Figures 13 and 14 demonstrate natural shoreline recession and the filling of a washover pond, respectively.
