Drakesbad Guest Ranch  
Lassen Volcanic National Park

# Cultural Landscape Report for Drakesbad Guest Ranch

# **CULTURAL LANDSCAPE REPORT FOR DRAKESBAD GUEST RANCH LASSEN VOLCANIC NATIONAL PARK**

March 2005

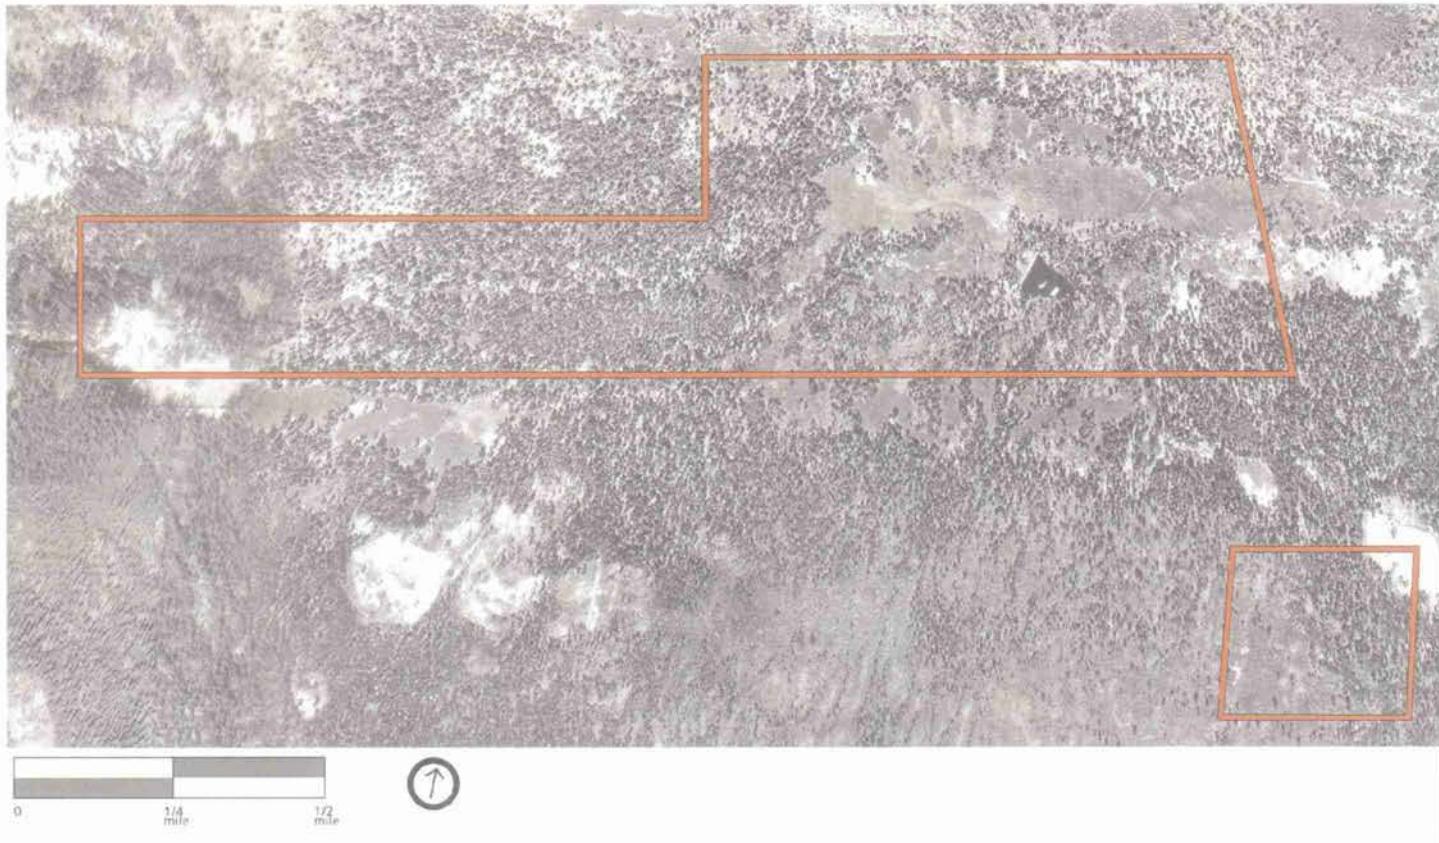
The project boundary, as defined by the National Register Nomination, reveals two discontiguous parcels which make up Drake's original claim and Sifford's later purchase.

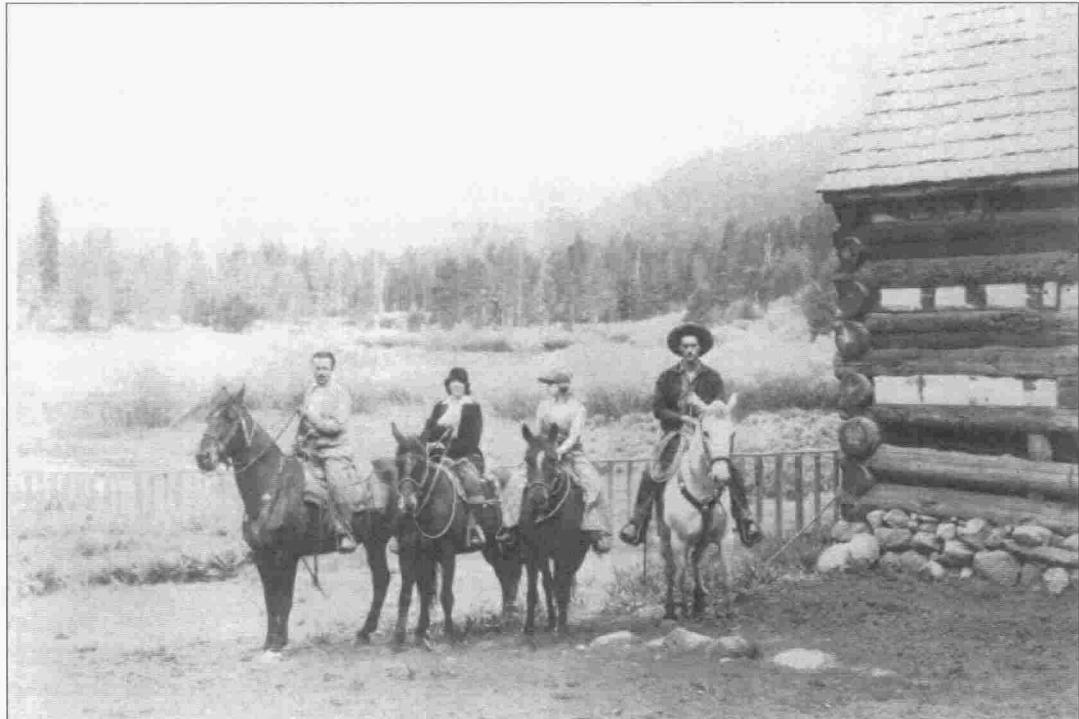
The picket fence (visible behind the riders) designed by the Siffords extended from the barn, on the right, south across the meadow to Hot Springs Creek. Roy Sifford is the rider on the left. Photo, circa 1928. (LAVO Collection, DB136)

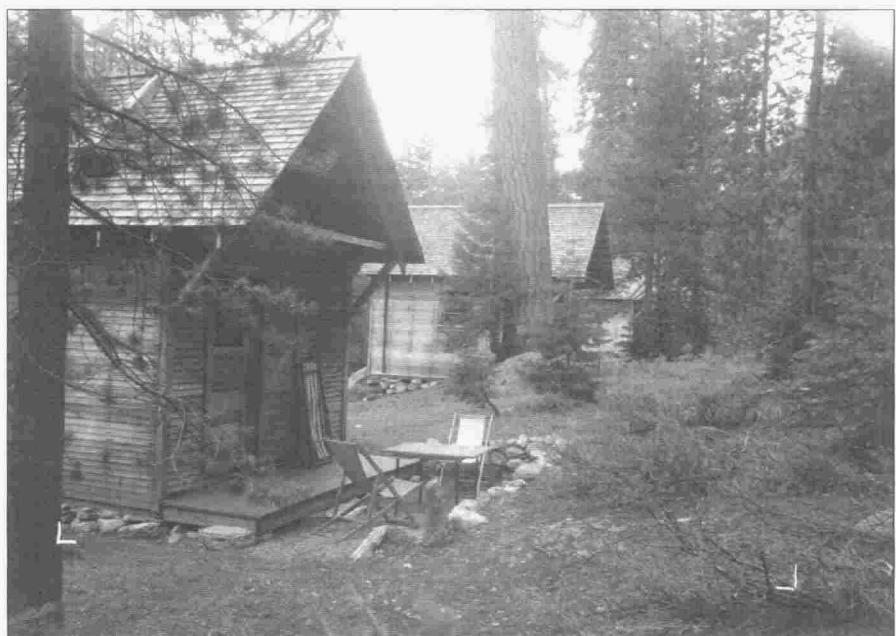
Typical entry with private patio on the north side of the single room cabins. Photo, 1936. (LAVO Collection, B-182-1-1936.)

Sometime around 1936, Sifford added four cabins to the property. These cabins, nearly identical in design, were sited in a linear fashion, spaced on average 30' apart, west of the lodge and near the foot of the slope of Flatiron Ridge. The cabins featured steep gable roofs, sheathed in sawn cedar shingles, and of wood frame construction on concrete foundations. Exterior walls were sided with clapboards. The cabins faced the hill and had dry laid rock retaining walls which created small private patios at the entrances. Access and parking for these cabins was along a spur of the existing road that provided access to the tents south of the dining room.<sup>54</sup> The cabins offered more private and substantial accommodations than the tent campsites, of which there were approximately 20 at this time, all located south of the main lodge, in the meadow, and on either side of the trail to the pool.

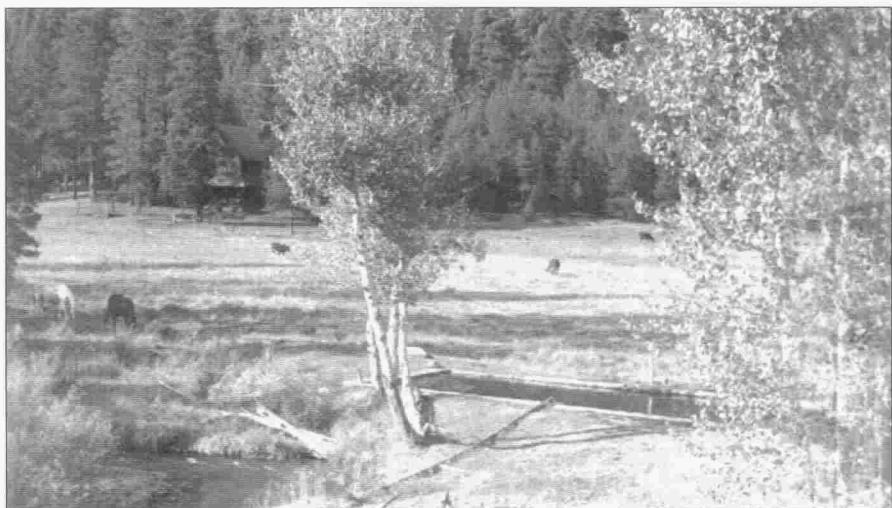
**View north from Hot Springs Creek shows cattle and horses grazing in the meadow; the pool is in the foreground and the lodge is just visible in the tree line on the left of the photograph. Photo, circa 1952.**  
(LAVO, Collection, Neg 135)

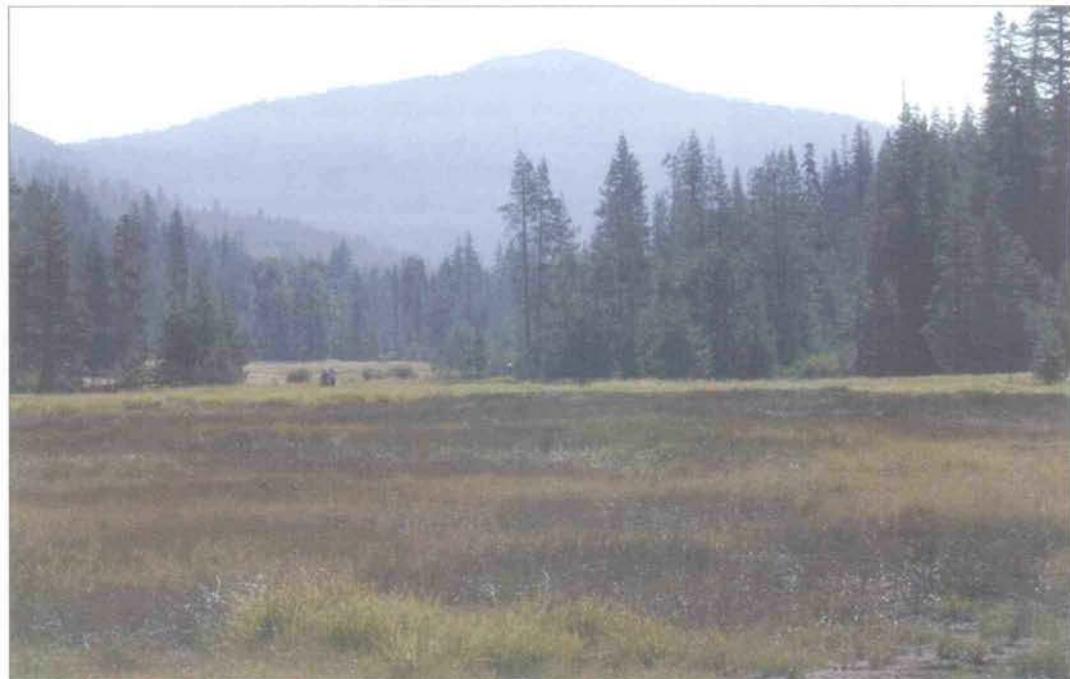
Drakesbad Meadow, looking east toward Mount Harkness. The valley runs east-west and is open and level in contrast to the surrounding forested slopes. Photo, 2004. (National Park Service)

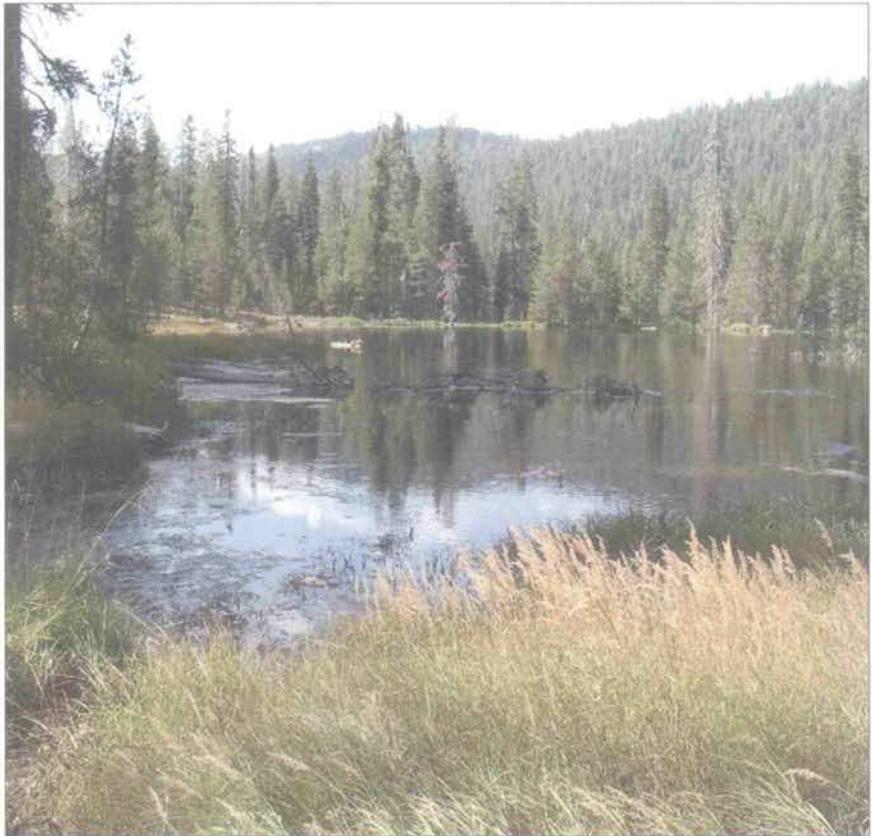
Right: Looking east across Dream Lake. The earthen dam, with conifer trees growing along the top edge, is visible on the far side of the water.

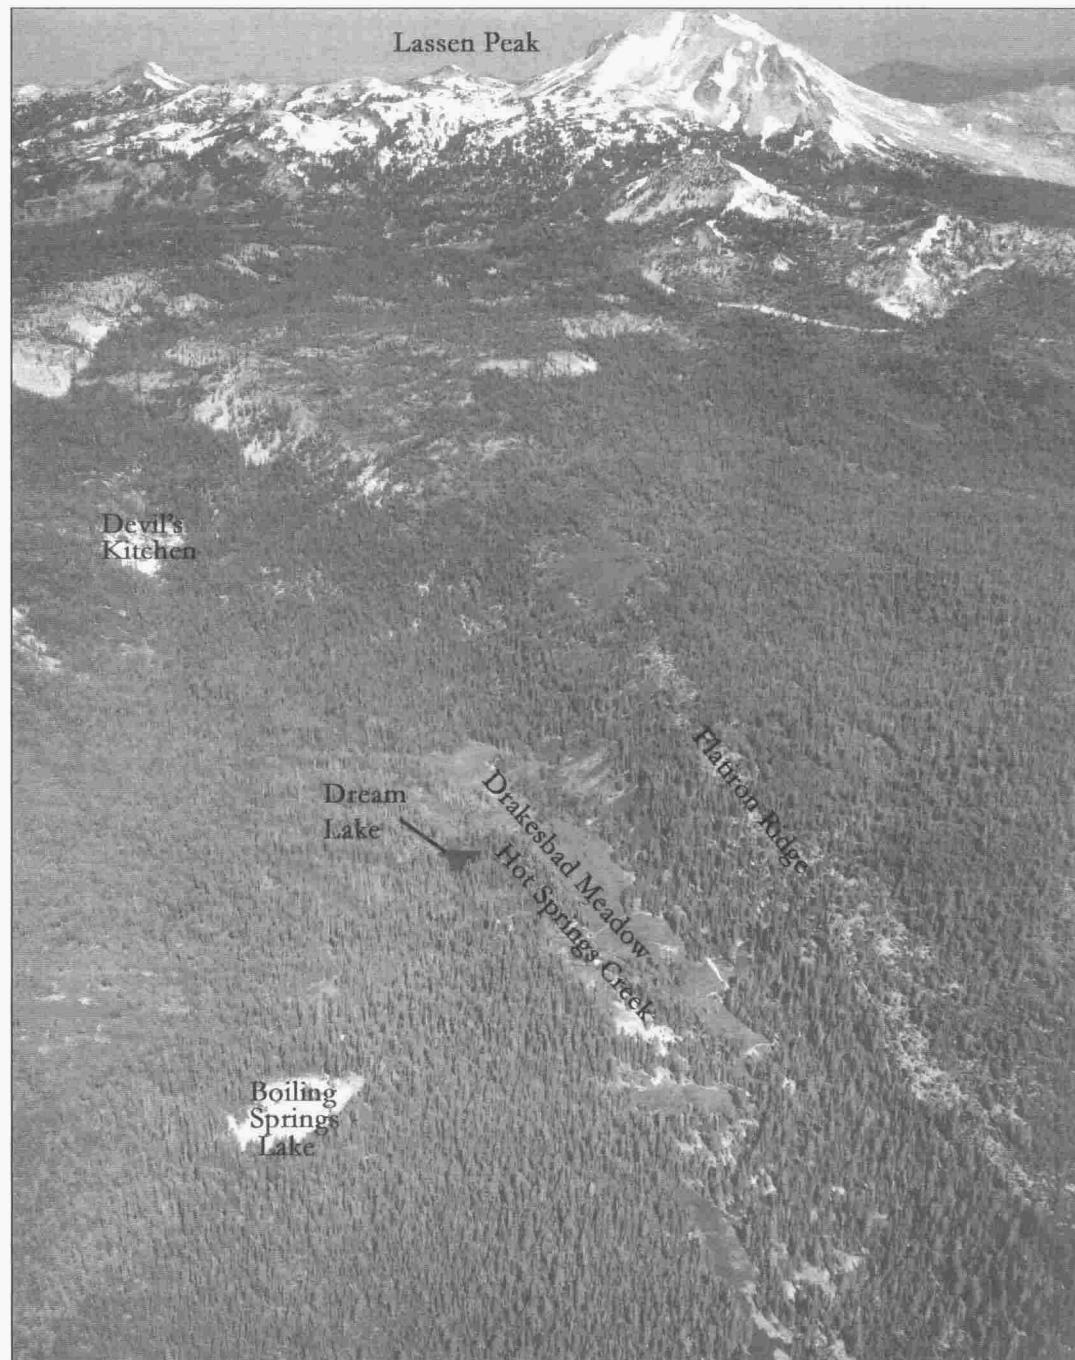
1967 aerial photograph showing key natural systems associated with the historic district including the relatively level, open area of Drakesbad Meadow, surrounding forests, Boiling Springs Lake and Devil's Kitchen . Photo July, 1967 by Clay E. Peters. (LAVO Collection)

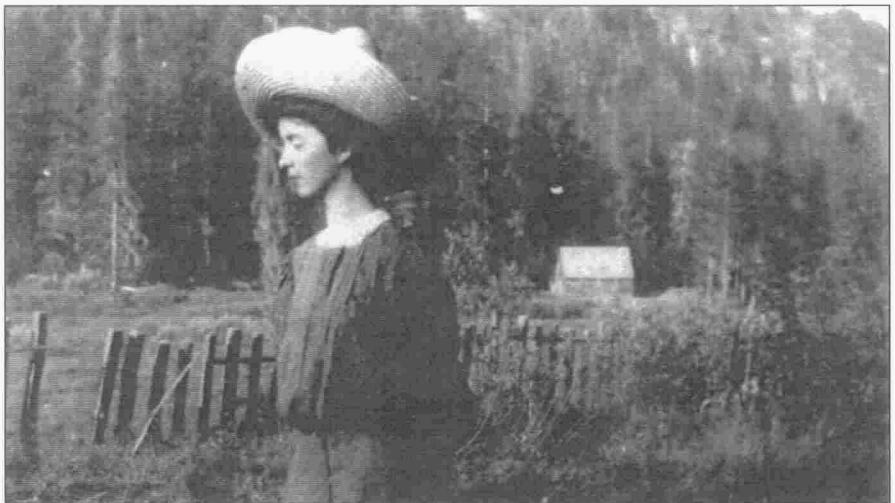
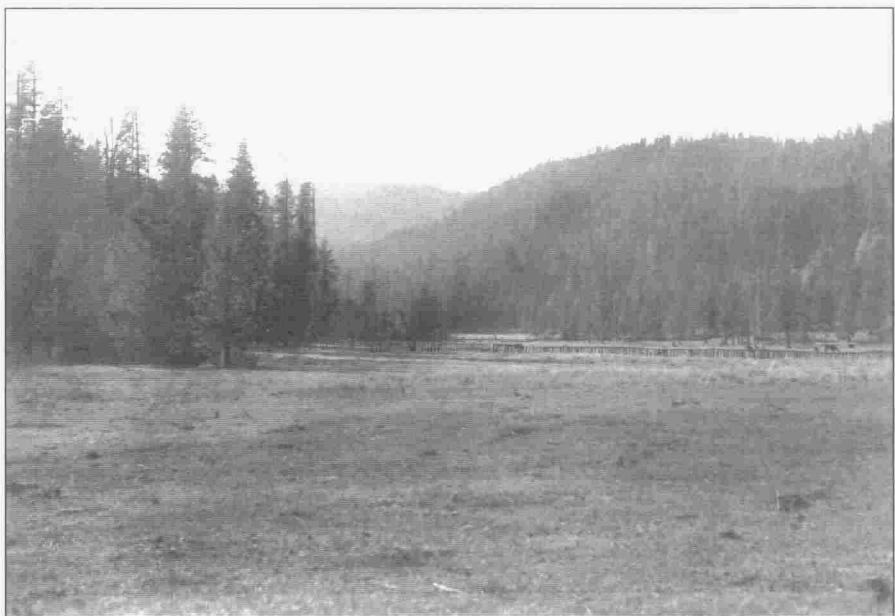
**Upper:** A distinct line of evergreen trees border the area of the meadow, which in 1905, was defined by an open character filled with shrubby willows and alders. Photo, circa 1905. (LAVO Collection, Image 44-1905)

**Middle** The swampy, shrubby area was transformed into a grassy pasture due to continuous hard work by the Siffords and their decision to graze both horses and cows throughout the meadow. Photo, 1952. (LAVO Collection, Neg253)

Seasonal fluctuations in hydrology as well as minor variations in the topography of the meadow caused Drake and the Siffords to constantly monitor water flows and regulate water levels. Digging a series of ditches and channels functioned to drain low-lying sections, and irrigate areas of higher, dryer ground. Where the water flowed and pooled, alder and willow

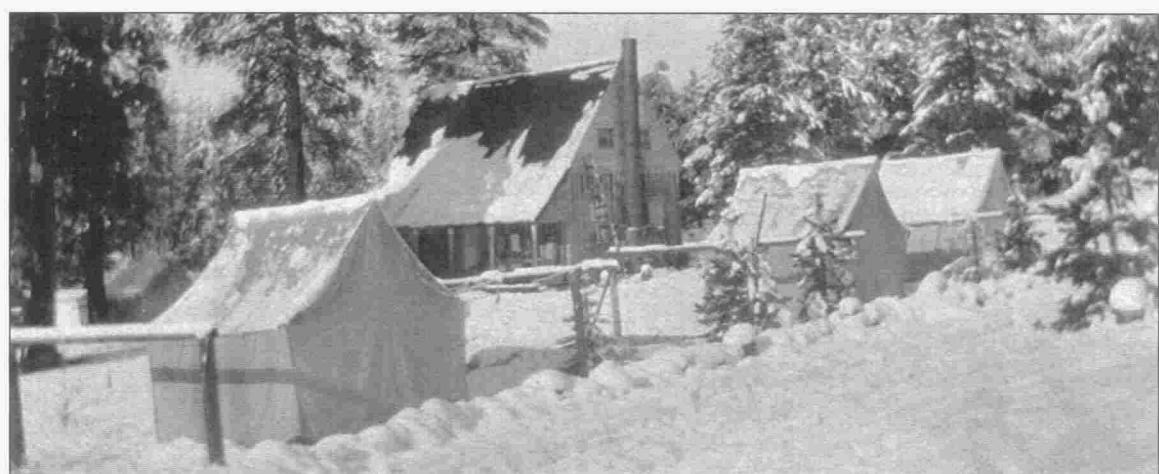
**Annual winter snowfall blankets Warner Valley, which limits the season of operation to the summer months. Depth of snow often dictates opening day. Photo, circa 1922. (LAVO Collection, Dscf0430-1922)**

In addition, because of these extremes of weather, structures at the site have been constructed to accommodate heavy loads. Winter storms of 1937-38 caused severe damage to the lodge as well as to four cabins and a storehouse, and in 1951-52 the dining hall was destroyed.<sup>6</sup> Today, permanent buildings have steep-pitched metal roofs designed to withstand the heavy snowfall.

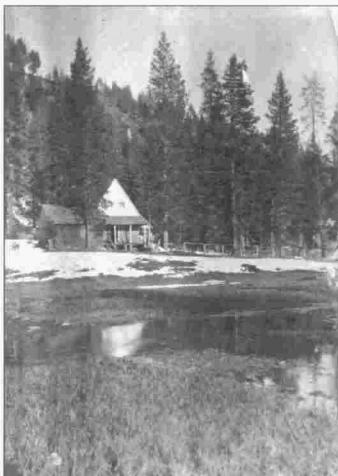
**View from the south to the "big house" constructed by Edward Drake across standing water in the meadow. The natural topographic bench provided a dry building site. Fences are visible on the right hand side (east) of the house and Flatiron Ridge is in the background. Photo, circa 1902. (LAVO Collection, 1902cabin)**

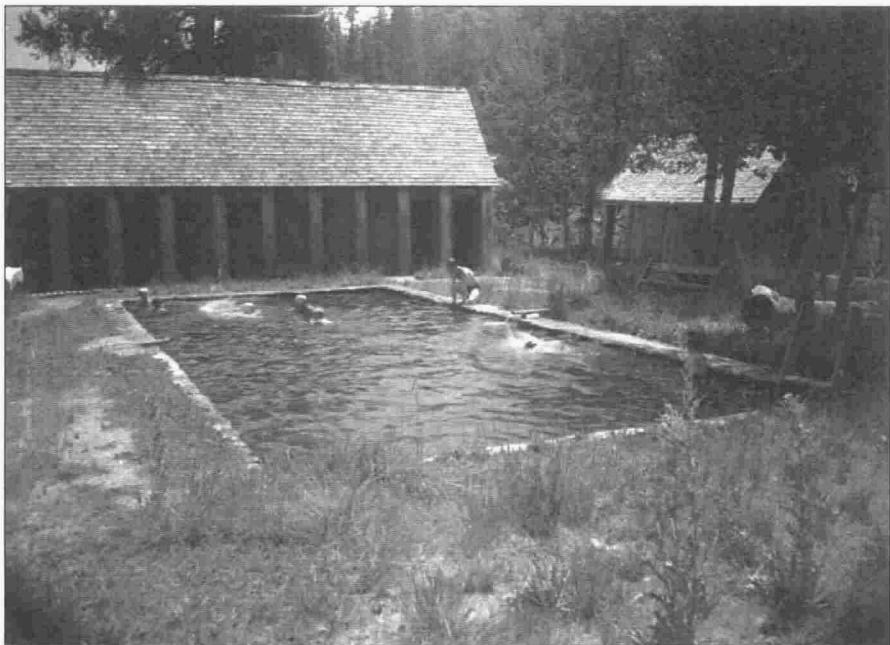
**Upper:** The swimming pool and dressing rooms were located south of the meadow, along the bank of Hot Springs Creek. These facilities were located east of the original plunge constructed by Drake. Photo, circa 1942. (LAVO Collection, P-0417-1942)

Early recreational facilities established by Drake were also expanded by the Siffords, largely within the vicinity of the original developments. Sifford replaced the original hot bath or plunge pool first with an earthen pool, and then with a stone and concrete pool sited east of the original plunge.<sup>6</sup> The enhancements to the bathing facilities by the Siffords also included a new bath house constructed south of the pool. The new bath house soon proved to be inadequate and the Siffords again expanded with an even larger structure located at the east end of the pool.

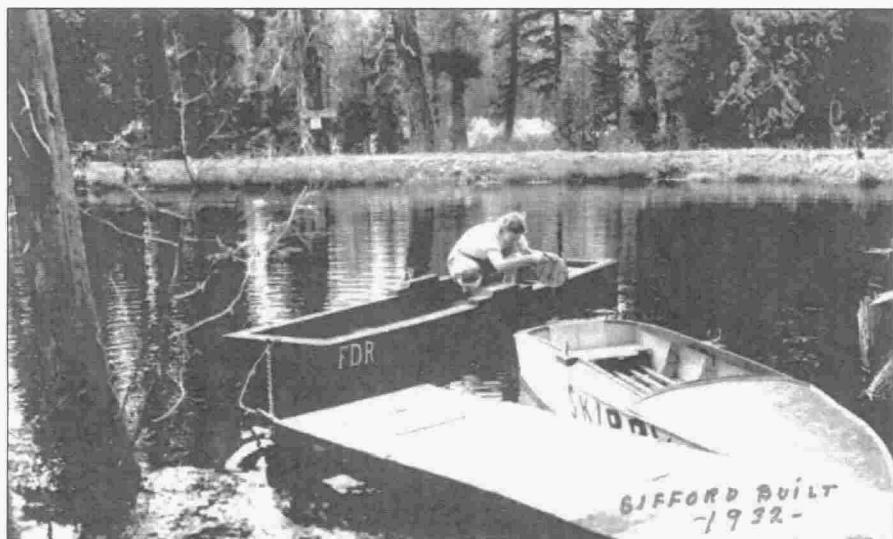
**Lower:** The construction of Dream Lake, approximately one half mile southwest of the core building area, expanded the recreational features at Drakesbad. The reservoir was formed by the earthen dam, which is visible in the background. Photo, circa 1932. (LAVO Collection, Image 6-1-1932)

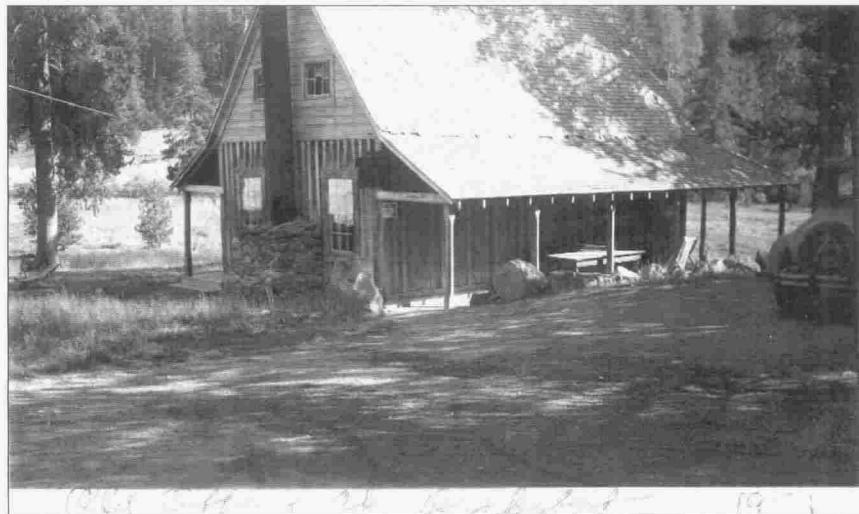
The parking area west of the lodge was cleared, graded, and lined with large stones. Photo, 1931. (LAVO Collection, Susan Watson photos Tandy History.042)

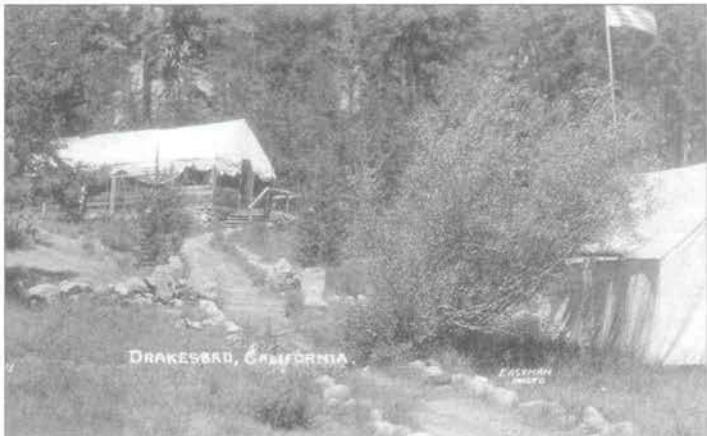
The trail between the lodge and the dining hall was lined with large stones and surfaced with dirt. Photo, circa 1924. (LAVO Collection, DB60.)

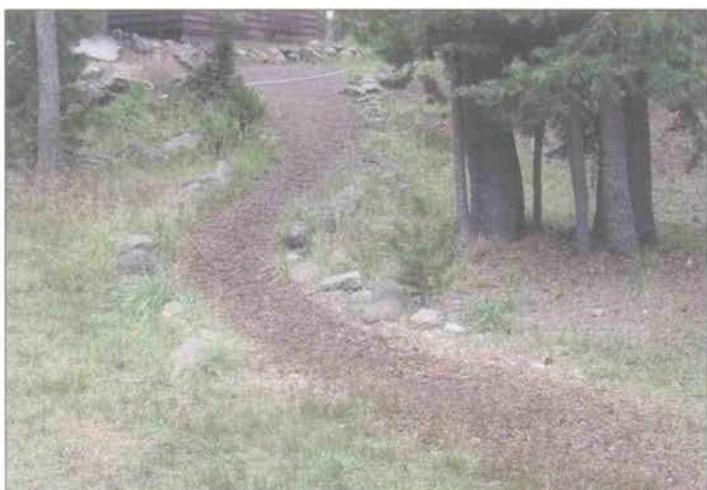
Contemporary conditions of the trail between the lodge and the dining hall include shredded bark on the tread and a reduction in quantity and size of stones that line the path. The trail alignment has been modified. Photo, 2003. (National Park Service) 2003

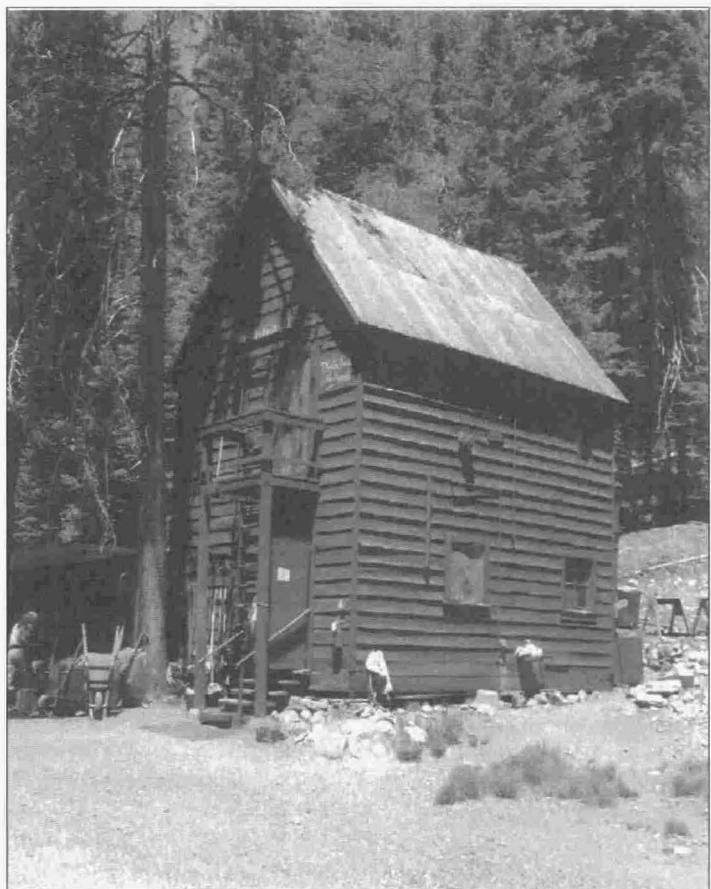
**Contemporary view looking northwest at the storage building, more commonly known as the Hilton. The upstairs is used as housing for concession staff, and the main floor is used as a laundry room and storage area. Photo, 2003.**  
(National Park Service)

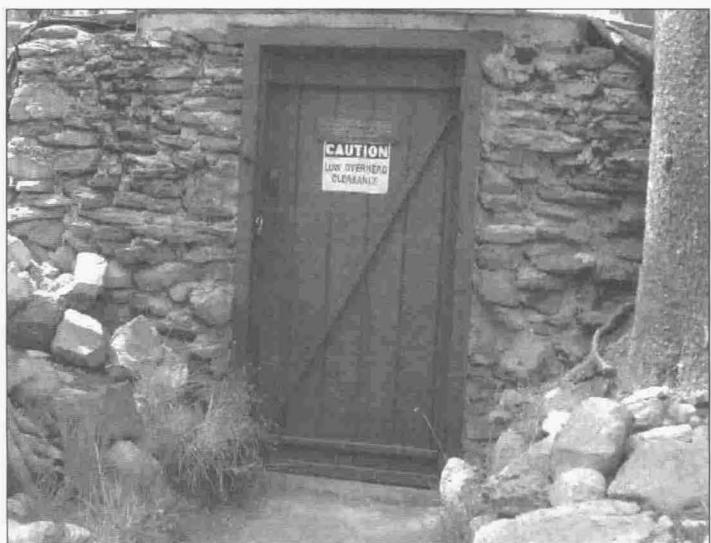
**Contemporary view of the food locker (HS-3). Built into the slope, this structure is believed to have been constructed in 1900 as a cold food storage facility. View looking southwest.**  
Photo, 2003.  
(National Park Service)

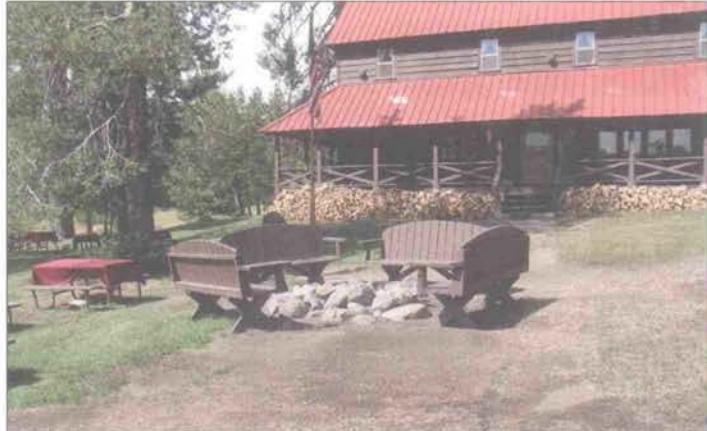
View looking west toward the campfire ring surrounded by benches, which are contemporary additions. Photo, 2003. (National Park Service)

The stone campfire ring that exists today is approximately six feet in diameter and is comprised of boulder size rocks laid in a single course. It is located on the east side of the lodge and is similar in appearance and contributes to the character of the historic district.

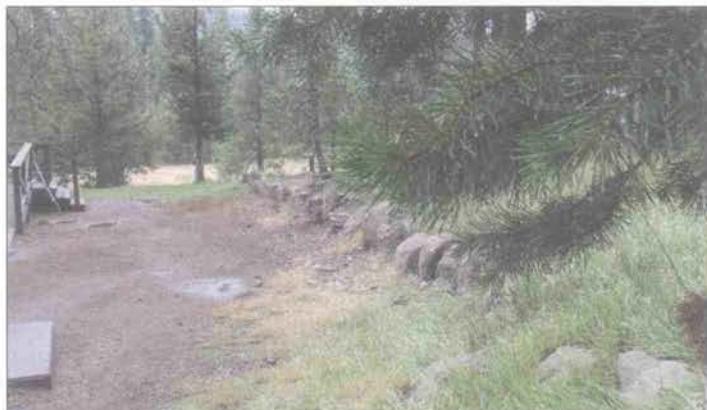
West of the lodge a single-course, dry-laid retaining wall separates the parking lot from the lawn area. Photo, 2003. (National Park Service)

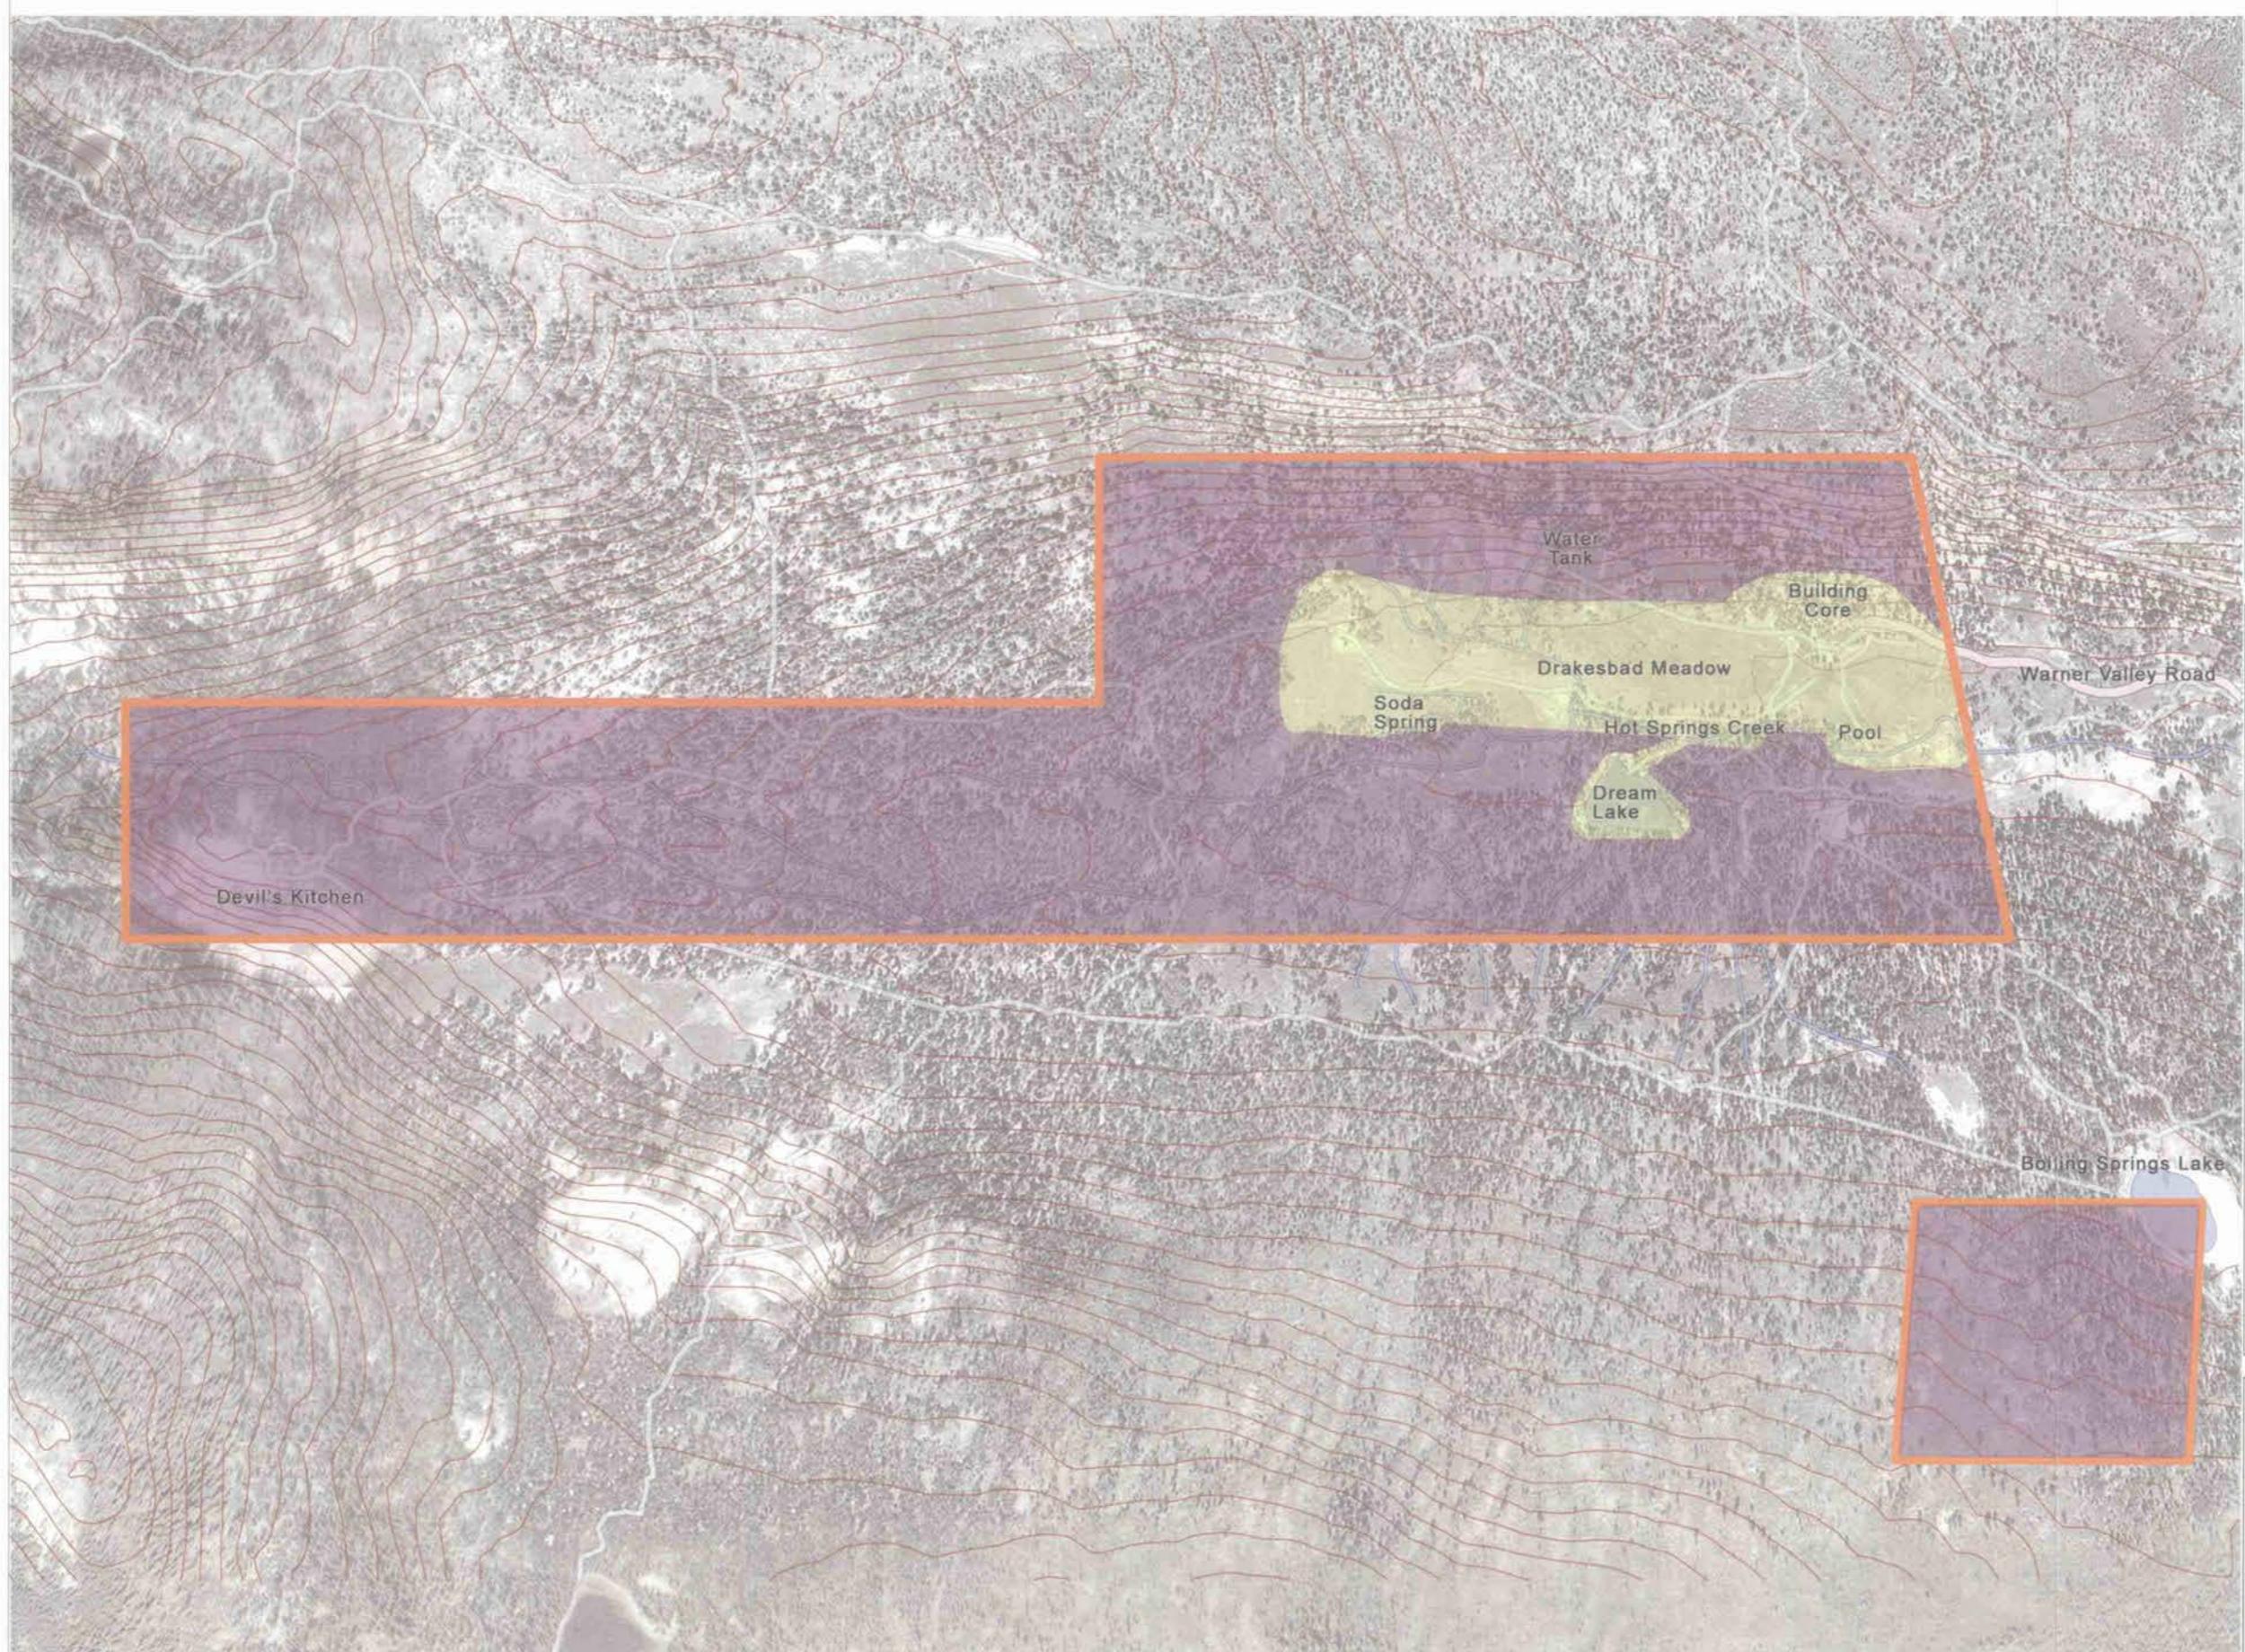
- Zone A (approx 70 acres)
- Zone B (approx 370 acres)
- National Register Boundary
- 20 Foot Topographic  
Contours

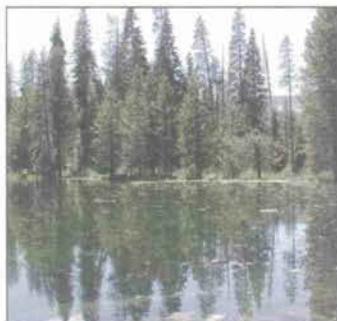
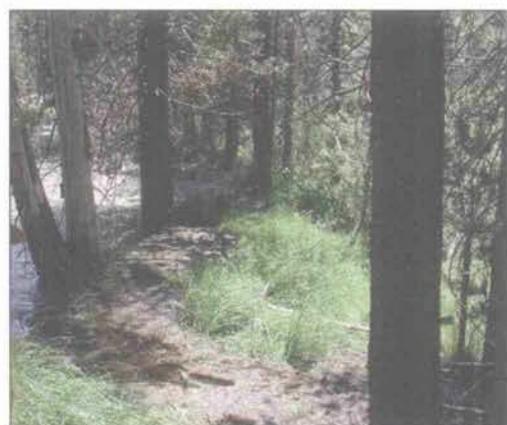
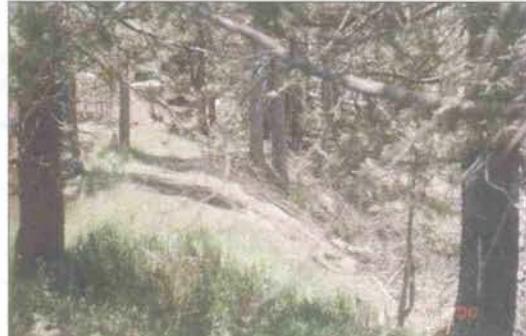
**Left to right:** Mature trees along the top of Dream Lake Dam, silt and water breaching the dam, woody vegetation growing on the top and downslope of the dam. Photos, 2003. (National Park Service)

Dream Lake, including the earthen dam is listed in the National Register as a contributing resource of the historic district. The dam is individually listed in the LCS. It has not been maintained in many years and is in poor condition (LCS, 2003). The dam has failed twice, both times due to record snowfall and heavy rains, resulting in rapid snow melt that exceeded the structural capacity of the dam. There are several natural resource issues and concerns affecting current management of the resource. A range of treatment alternatives for the management of Dream Lake and the earthen dam will be addressed in the CSP, factoring in all resource values. Recommendations in this report address baseline stabilization of the structure until long-term treatments are determined through the planning process.

1. Consideration should be given to retaining Dream Lake as a contributing resource to the historic district.
2. Work with natural resources staff and structural experts to remove any trees and woody vegetation from the dam in a manner that does not damage the integrity of the structure. Integrate ongoing vegetation maintenance into a cyclic maintenance preservation plan for the historic structure.
3. Develop a range of alternatives for management of Dream Lake in consultation with technical experts from multiple disciplines (such as a structural engineer, historical architect, historical landscape architect and natural resource staff) to assure all safety and structural issues are balanced with critical resource issues.

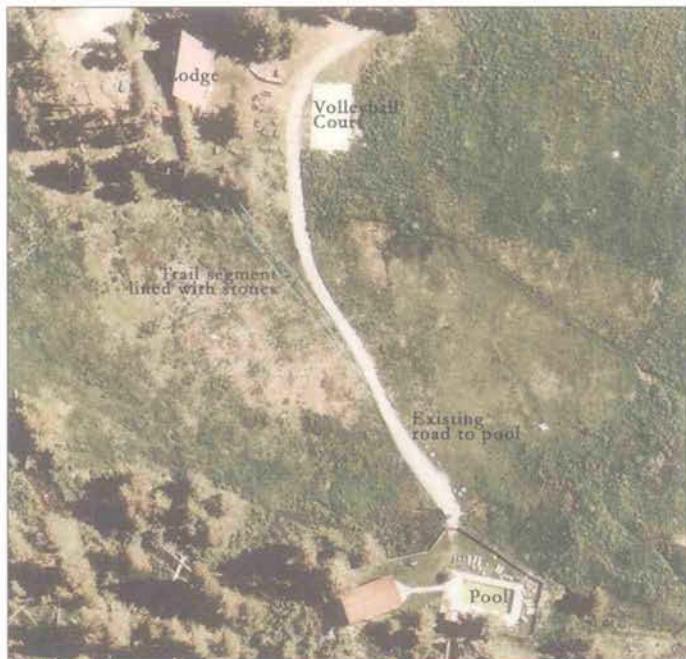
**Historic trail segment located between the southeast lawn of the Lodge and the existing road to the pool.**

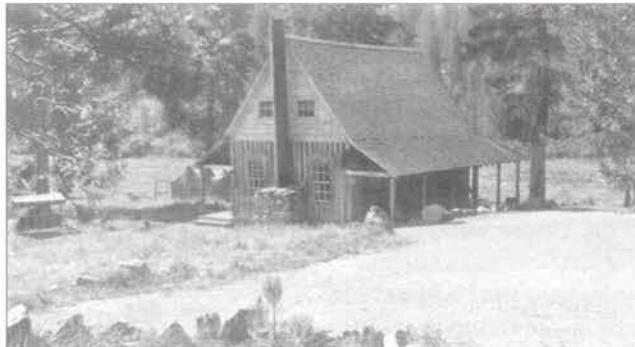
Large rocks, seen on either side of the road, were historically used to define the edges of the roadbed. This is a compatible treatment to prevent resource impacts created by vehicles parking on road shoulders. Photo, 1931. (LAVO Collection, 1931lodge1)

- lift station when this structure is relocated. If water tank is relocated, consideration should also be given to removal of the access road to correct drainage problems as appropriate and revegetate disturbed areas in consultation with natural resource staff.
3. Consideration should be given to the use of large stones or partially buried boulders to define the edge of service roads and prevent vehicles from parking on the shoulders creating resource impacts.
  4. The addition of new service roads within the historic district is strongly discouraged.

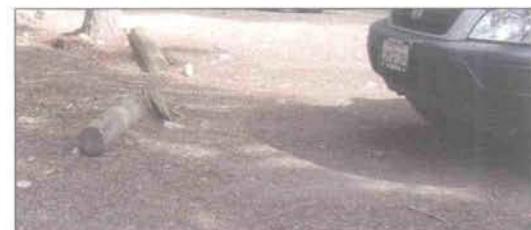
**Existing stone bumper stops set on grade are potentially unsafe.**

2. Replace existing log bumper stops which are undersized and lack proper set or grounding. Large stones or logs, set into the grade, may be used as bumper stops and to define the perimeter of parking areas, parking spaces associated with cabins, and any new parking areas.

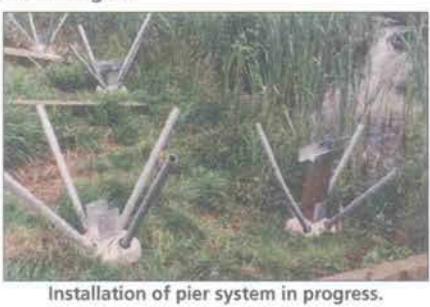
Installation of pier system in progress.

As a second option, a low-profile boardwalk is an acceptable for replacement of portions of the trail tread. A soil survey is required to establish suitable hardware to support the structures. (One product option is the Pin Foundation Diamond Pier™; other structures suitable for saturated soils are available.) Trail treads should be located to provide minimal clearance for water flow. Decking should be constructed from rough-hewn timbers and laid side by side. Decking should be constructed from rough-hewn timbers and laid side by side. Walkways may have wooden curbs (bull rails) of peeled logs no more than twelve inches in diameter. Boardwalks should be constructed to mimic the alignment of the original trail whenever possible and to follow a curvilinear route, avoiding rectilinear angles.

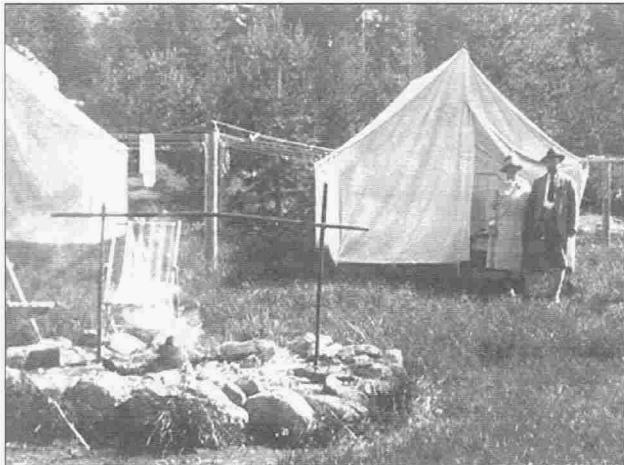
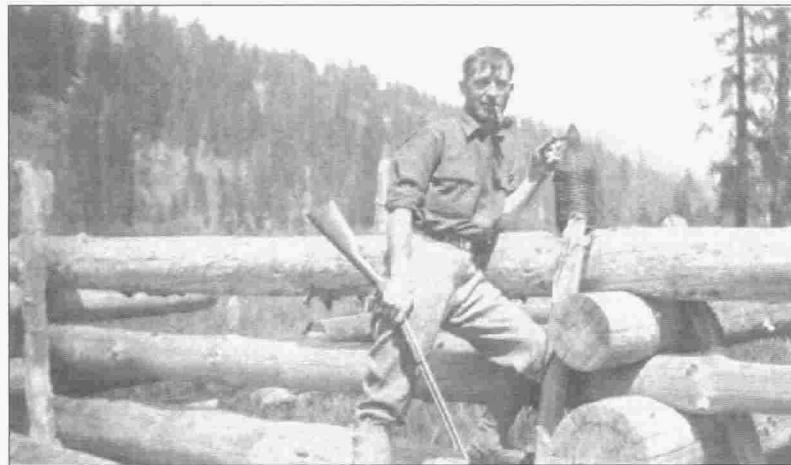
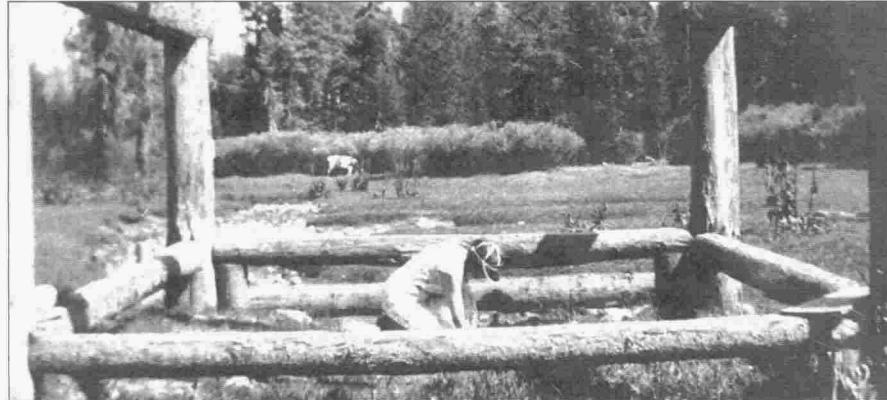
**Small scale features including fences made from logs and the stone fire ring demonstrate the historic use of natural, local materials for construction of site features.**  
Photos, circa 1880-1900. (LAVO Collection, upper left: DB-2; upper right: DB304; lower right: DB1719)

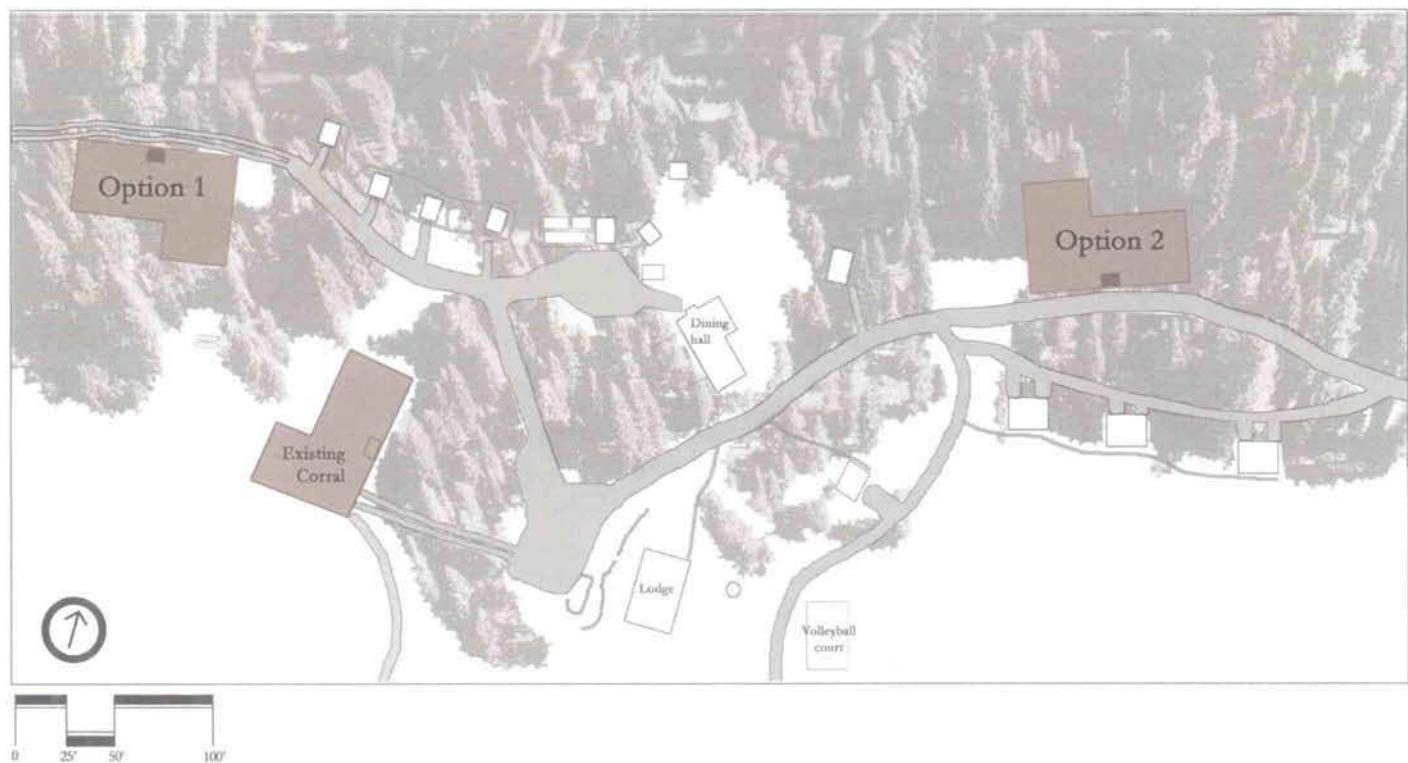
### Compatible Locations for the Horse Corral within the Building Core

Both diagramed locations met the following criteria\*:

- Compatible with the historic land use practice of locating the corral within the building core
- Easily accessed by existing roads
- Remote from the meadow
