TASSI RANCH, TASSI SPRINGS
Grand Canyon-Parashant National Monument
Littlefield vicinity
Mohave County
Arizona

HISTORIC AMERICAN LANDSCAPE SURVEY

TASSI RANCH AND SPRINGS

HALS No. AZ-2

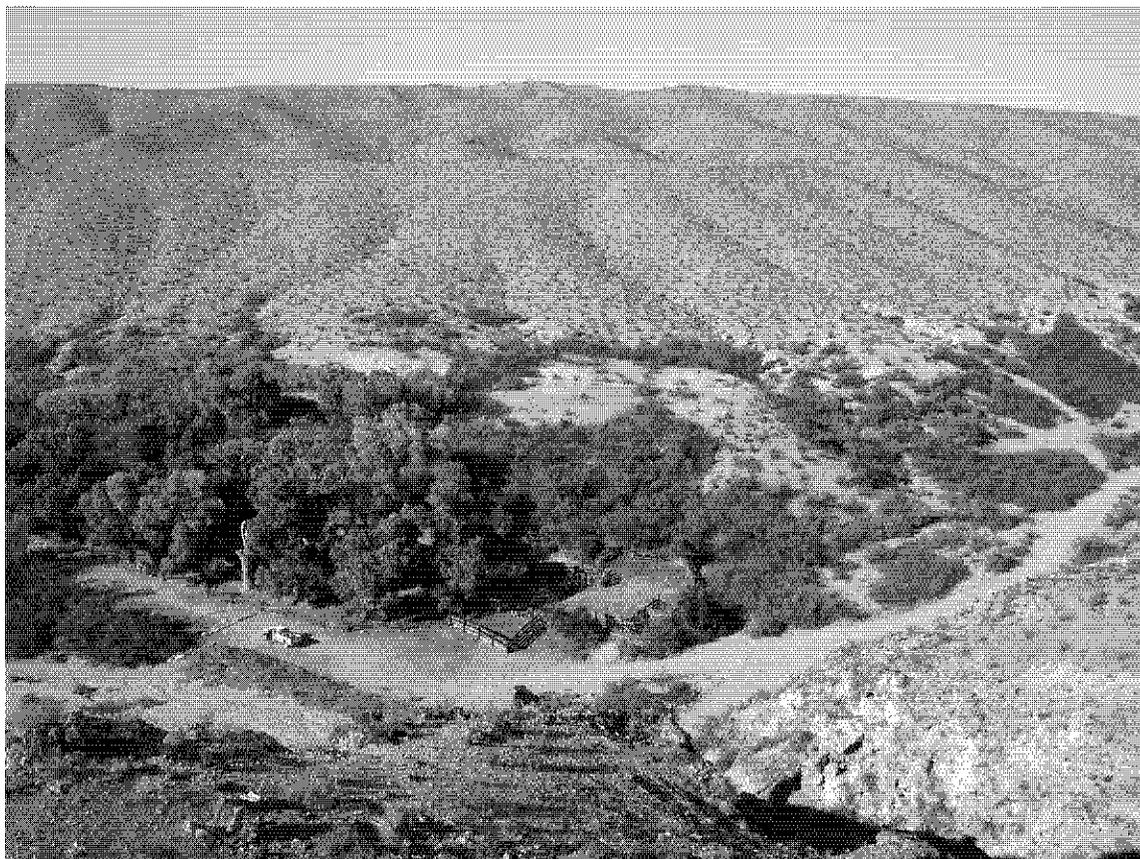
Fig. 1. The core area of Tassi Ranch, looking northwest from the top of the adjoining range. Lake Mead National Recreation Area Approved Road 152A enters from the right and passes the corrals near the lower middle of the photograph. The ranch house and barn are hidden amid the cottonwood trees to the left of the corrals. The largely barren, non-irrigated pasture above the ranch house and its enclosing fence are visible in the center of the image. Photograph by Alexander Matsov, November 2009.

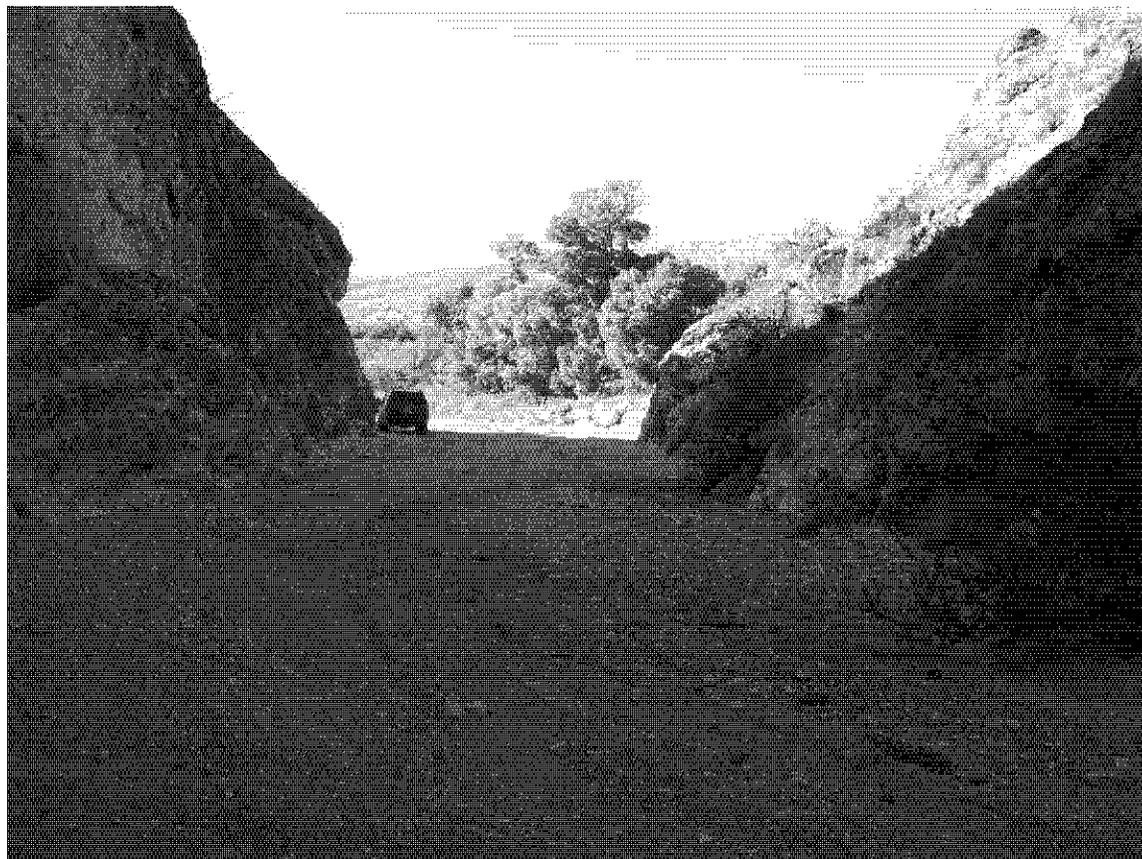
Fig. 2. The narrow walls of this pass, called the Box, tend to channel seasonal flood waters toward the ranch core. Flood damage in 2000 led the National Park Service to install the boulders visible on the far edge of Pigeon Wash as an erosion deterrent. Photograph by Christopher Stevens, November 2009.

Over time, NPS crews made extensive repairs to the ranch house, stabilized the stone boxes, removed brush, and installed a French drain to channel water away from the buildings into Pigeon Wash. To repair damage to the area immediately south of the ranch house caused by a flash flood in 2000, crews “re-channeled the wash and placed large boulders along the bank just upstream from the ranch to help dissipate the water’s energy and reduce erosion.” They also rebuilt the slope between the boulders and the ranch core that the flooding had washed away.⁴² Brush clearing and basic maintenance continue on a limited basis at the site today.

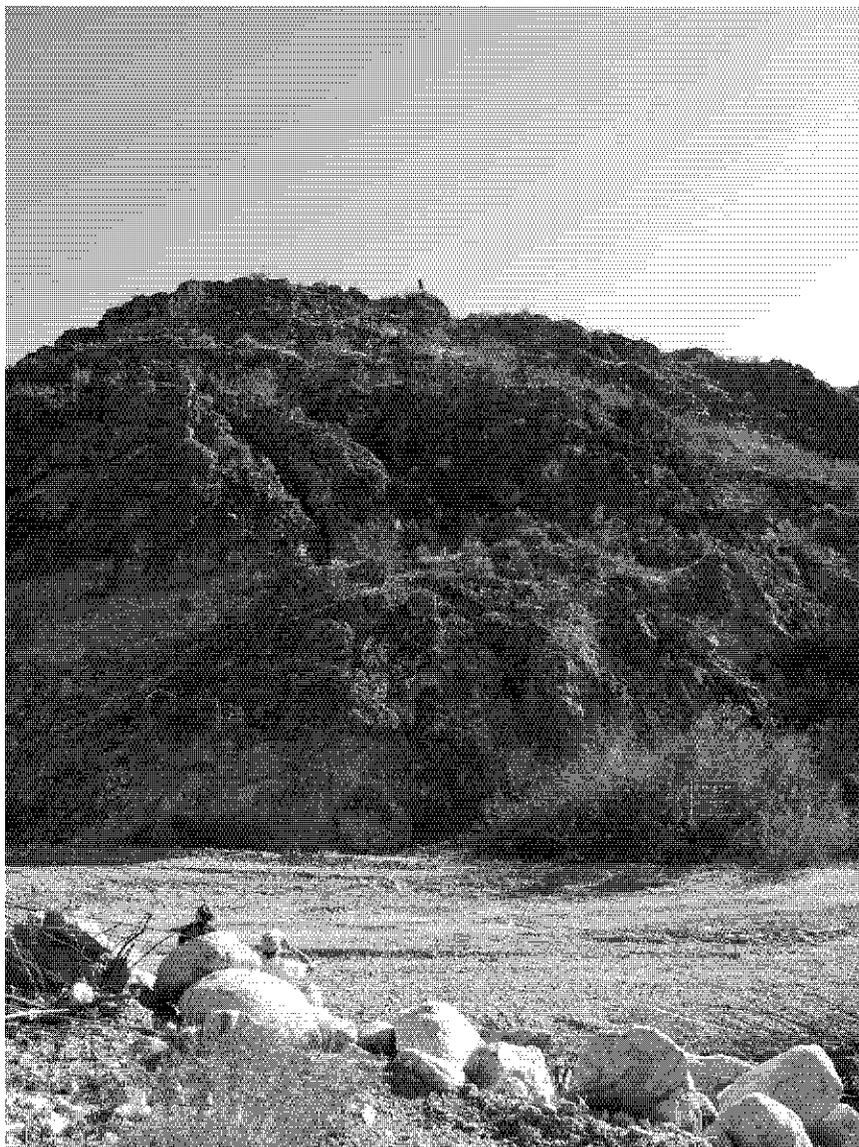
Fig. 3. Erosion-preventing boulders, the bed of Pigeon Wash, and the rock formation opposite the ranch core. Photograph by Christopher Stevens, November 2009.

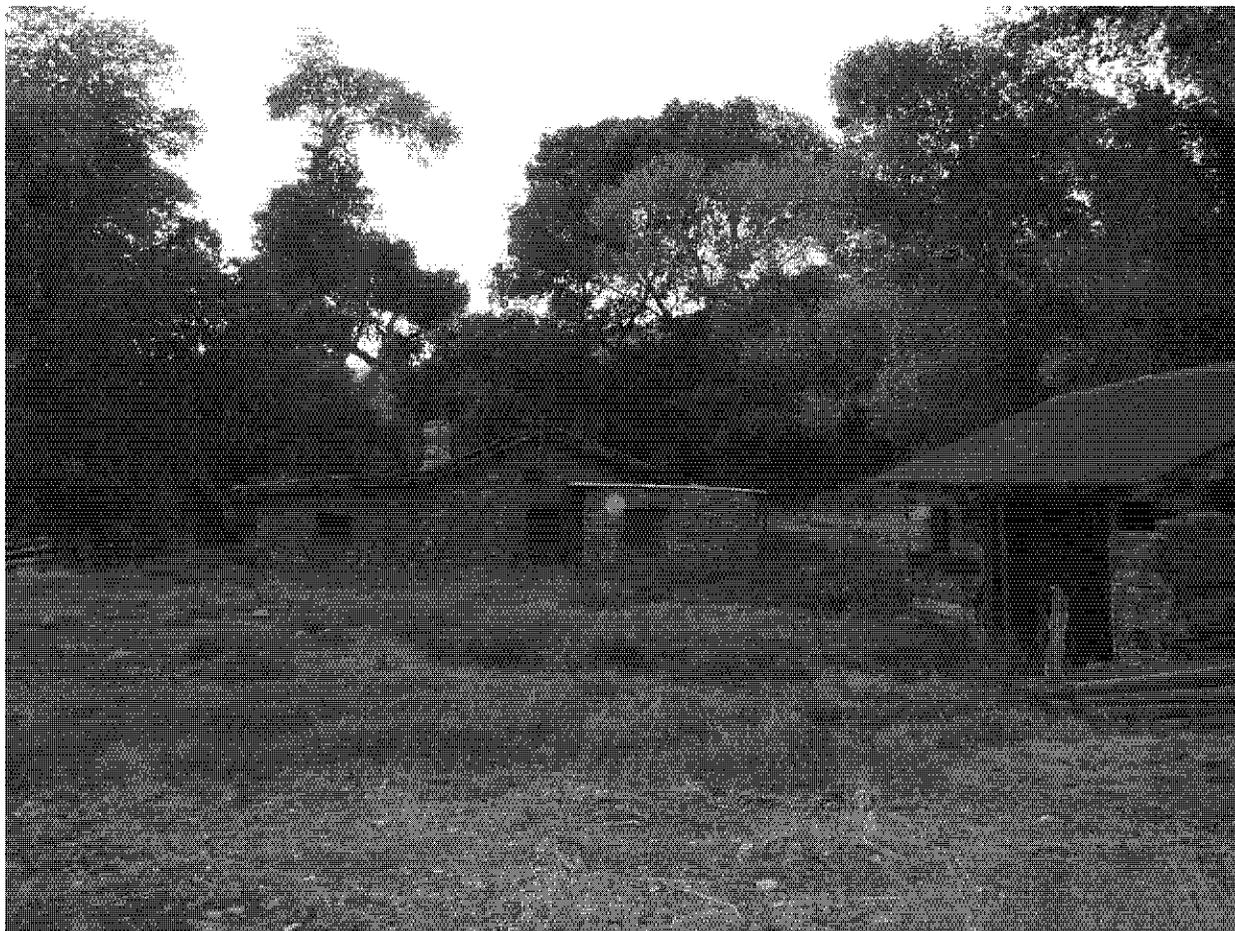
Fig. 4. The ranch house and barn. Photograph by Christopher Stevens, November 2009.

Barn. A small barn about 24' x 17' stands 31' east of the ranch house adjacent to the northwest corner of the corrals. It is built of salvaged railroad ties, stacked with notched and lapped ends in the manner of a log cabin. It rests on a dry fieldstone foundation and has a pitched wood frame roof covered by corrugated sheet-iron panels. The building contains two spaces, a large outer room (about 14' x 15') open to the yard along its south wall with a window facing east, and a small inner room (about 8' x 15') with south- and west-facing windows that opens off the outer room. The barn has dirt floors. A wood and wire coop, now in ruins, is attached to the barn's northeast corner. Photographic evidence reveals the barn was built before 1947.

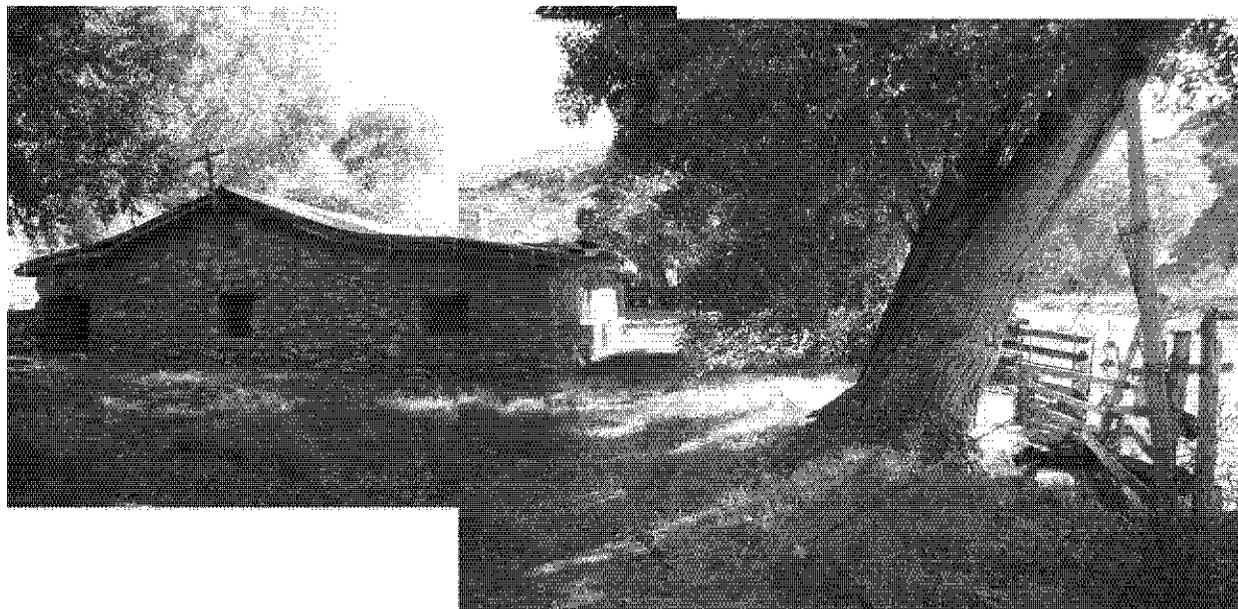
Fig. 5. Composite view of the ranch house, the row of cottonwood trees, and the worm fence installed by the National Park Service in 1994. The metal stock tank sits on the ground under the fence at right. Photographs by Alexander Matsov, November, 2009.

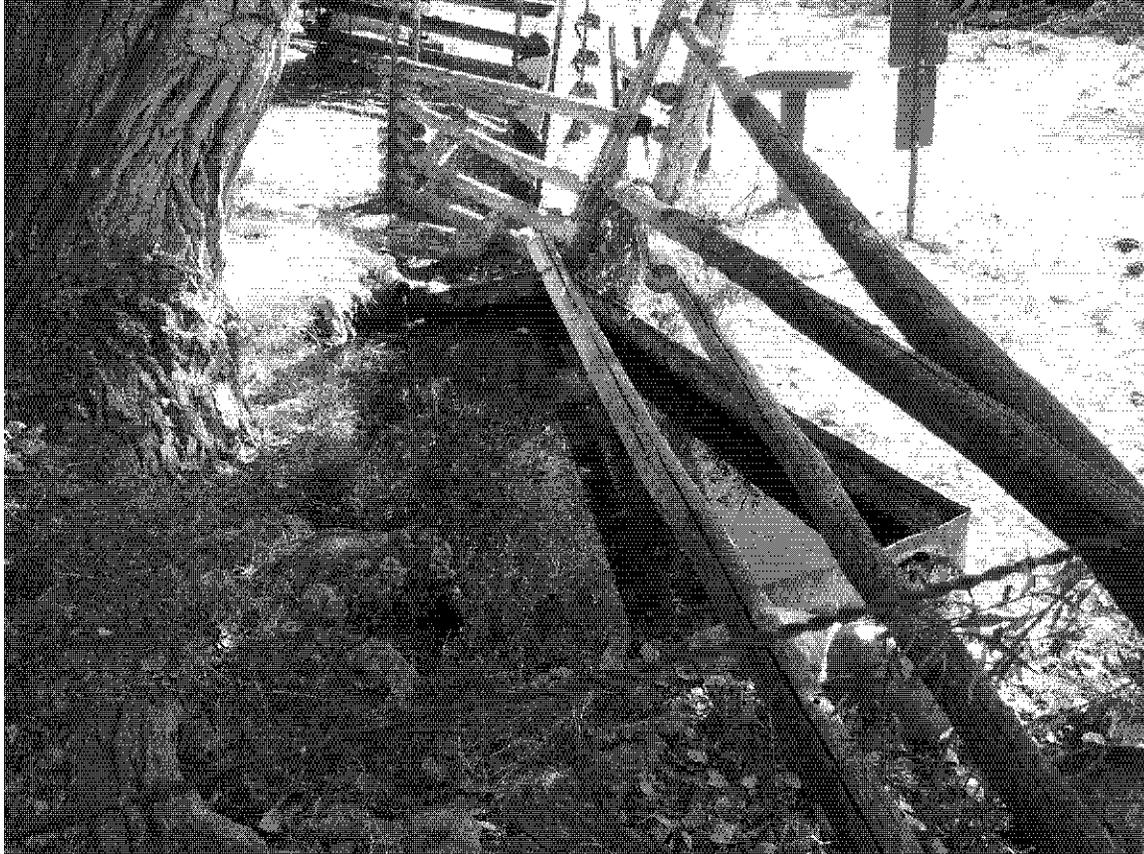
Fig. 6. The metal stock tank. Water from spring heads above the ranch house is brought to the tank by a partially buried hose. This hose was once longer and was used to fill a tanker truck used by the Whitmores to haul water to stock-watering tanks located throughout their grazing allotments. Formerly, the overflow from this tank flowed downhill along Pigeon Wash; now, a hole in the tank allows the water to seep directly into the surrounding ground, and the area has become a habitat for relict leopard frogs. Photograph by Christopher Stevens, November 2009.

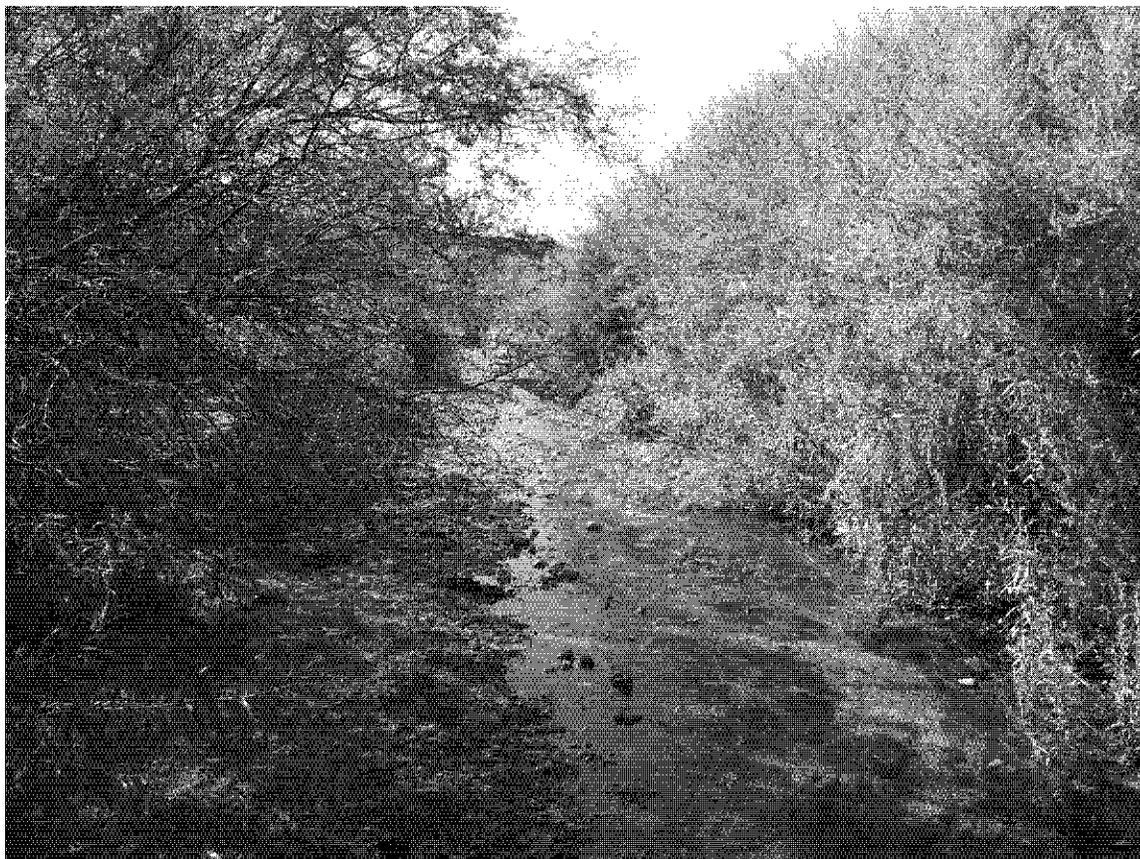
Fig. 7. Spring water flowing southwest from the ranch core along part of the bed of Pigeon Wash. This view demonstrates the extent to which the presence of water encourages dense plant growth around Tassi Springs. Photograph by Christopher Stevens, November, 2009.

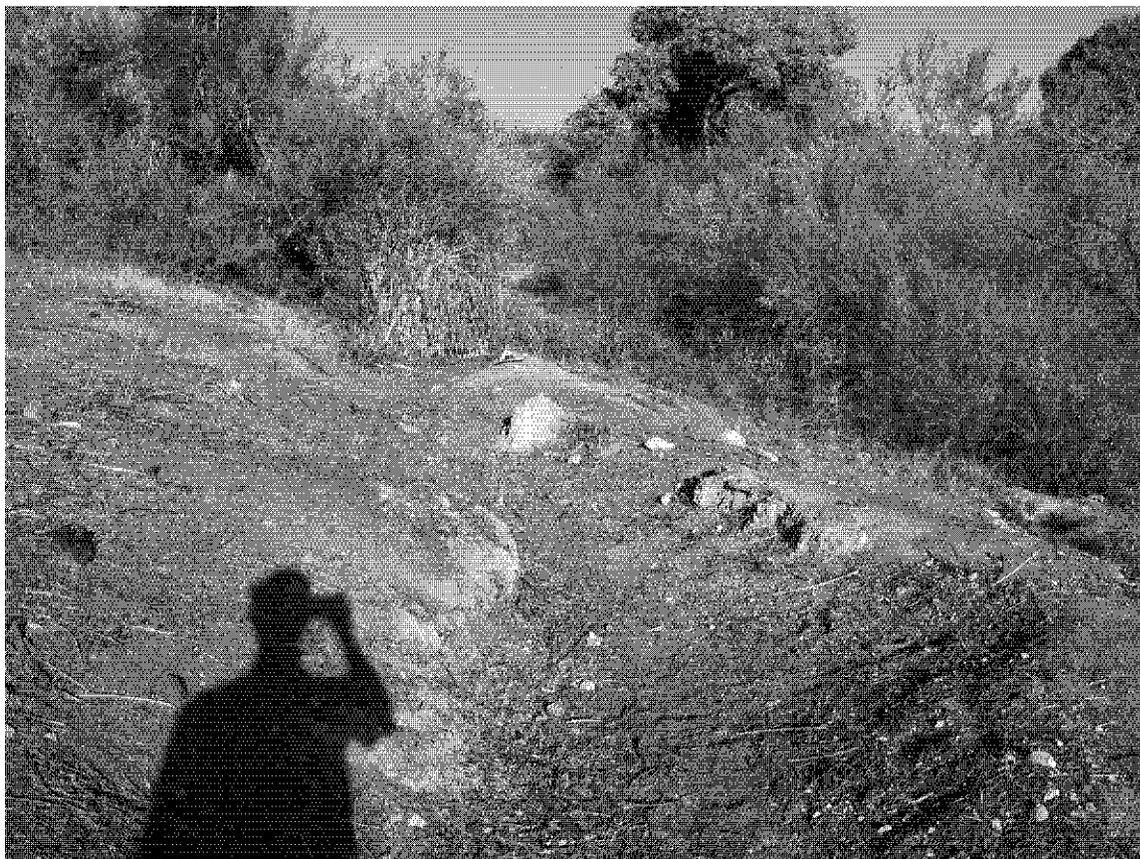
Fig. 8. The main irrigation ditch, looking east toward the ranch core. The clear demarcation between plant growth and desert shows the effects of a breach in the ditch. Photograph by Christopher Stevens, November 2009.

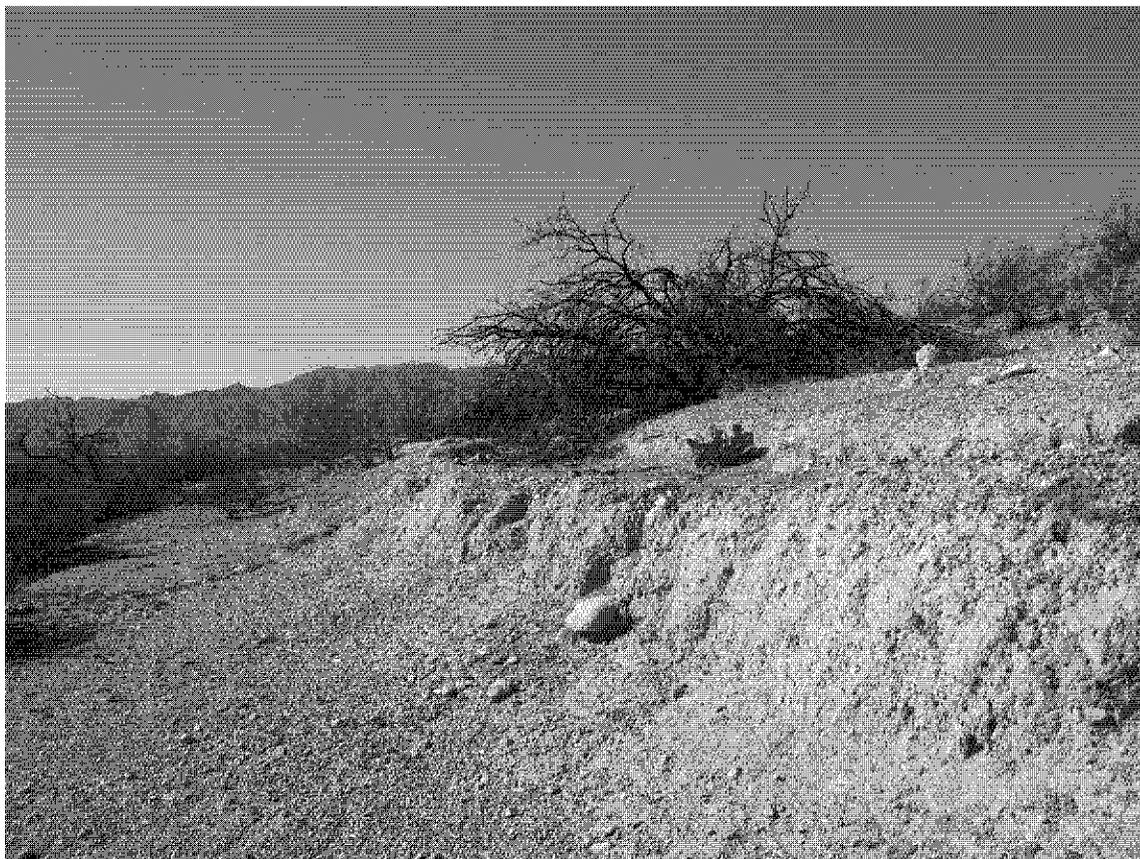
Fig. 9. The access road from Pigeon Wash to the west holding pond. The main irrigation ditch runs along the top of the rise above the road, where the prickly pear cactus is seen growing. Photograph by Christopher Stevens, November 2009.

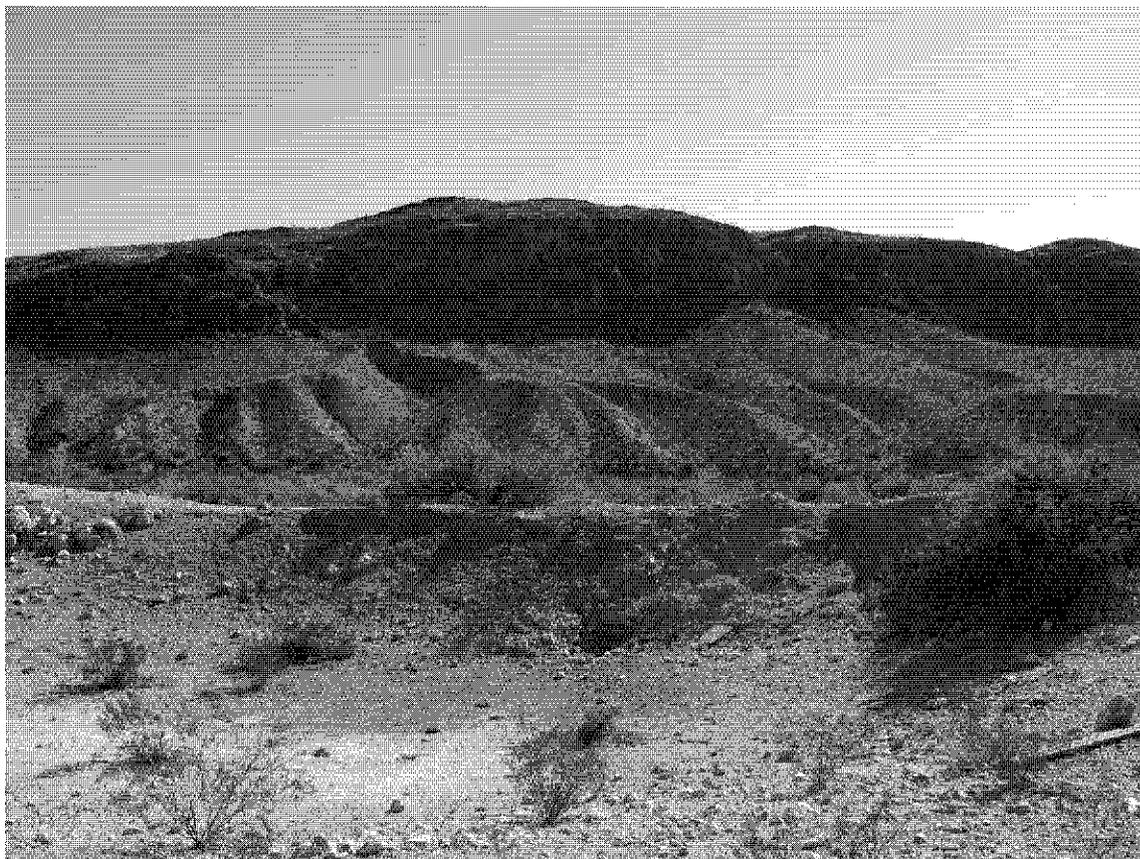
Fig. 10. The basin of the west holding pond, looking toward the mountains south of the ranch. The indentation along the lower edge of the berm in the center of the photo is one of the pond's two drains. Photograph by Christopher Stevens, November 2009.

²¹ Field measurements made by the HAER team in 2009 indicate the west holding pond has a capacity of about one acre-foot, which is twice the size authorized by Yates’s water certificate. Is it unknown if Yates

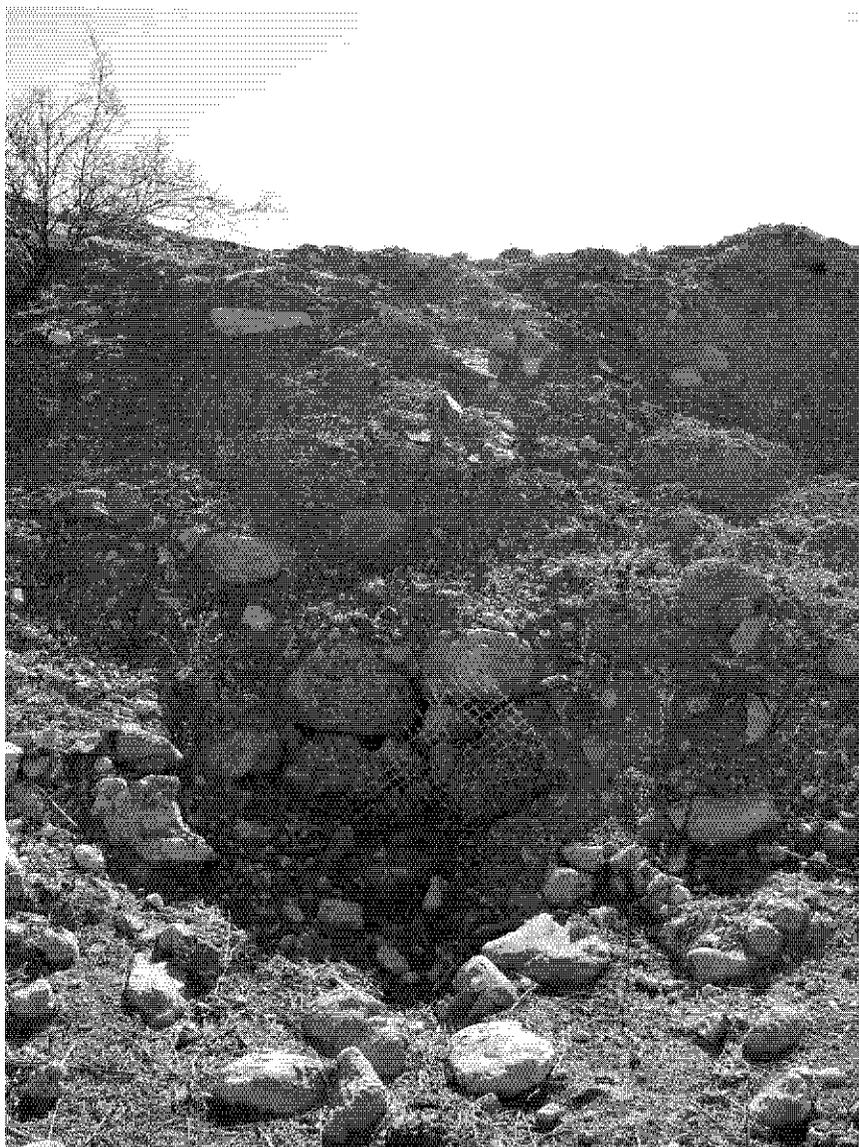
Fig. 11. The south drain in the west holding pond. Photograph by Christopher Stevens, November 2009.

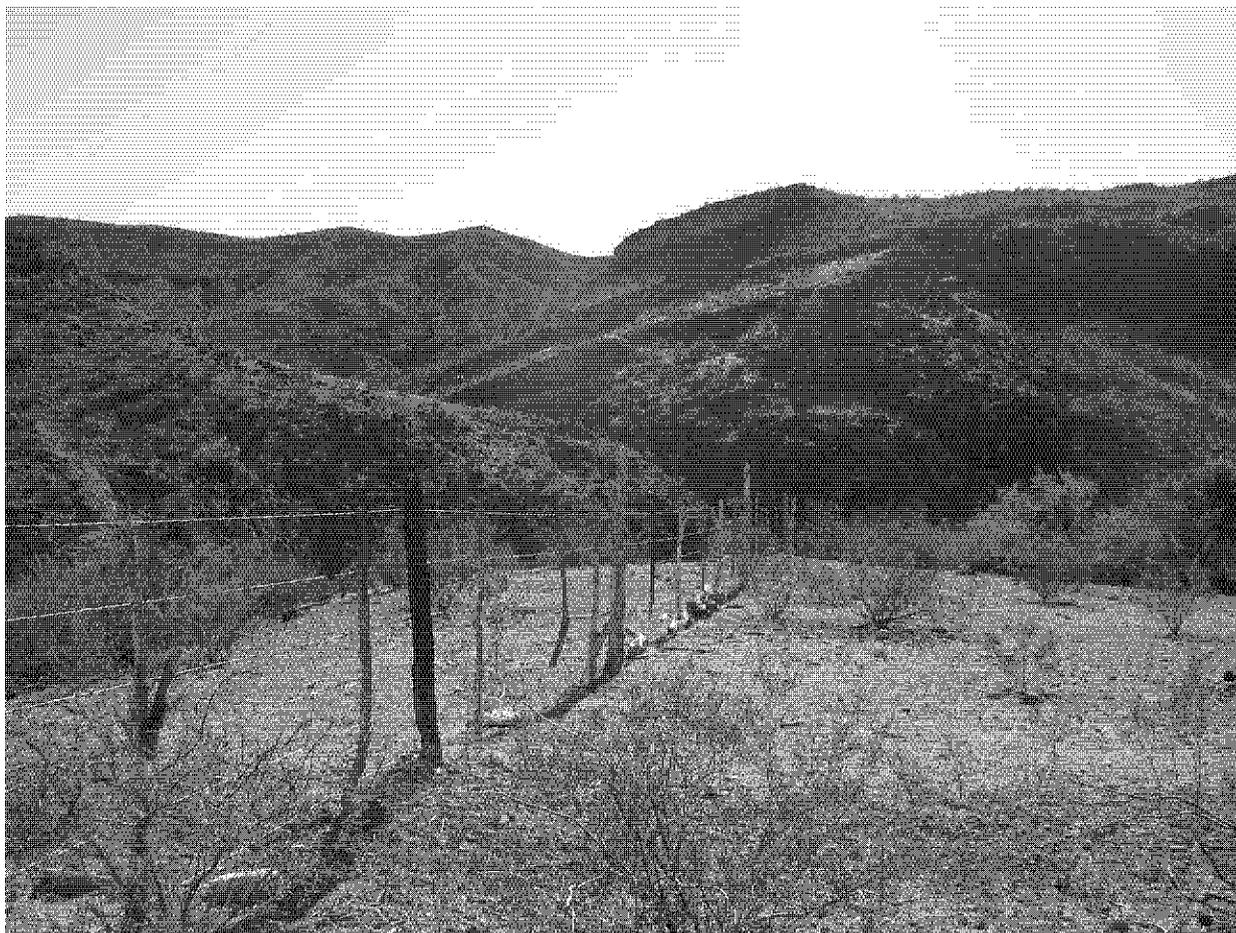
Fig. 12. The restored fence enclosing the pasture above the ranch core, showing the rough wood posts fashioned from native tree trunks and limbs that historically supported most of the barbed-wire fencing at the ranch. Photograph by Alexander Matsov, November 2009.

the ranch into eastern and western zones. The northern fence line runs for about 2,240' along the northern edge of the upslope pastures. The western fence line runs approximately 340', although a section 92' in length is missing. The southern fence line follows the north side of Pigeon Wash, a run of about 2,500'. Part of this line is obscured by dense vegetation, however, while large sections comprising about 770' are collapsed or missing, many from erosion into the wash. A section of wood worm fence installed by the NPS immediately south of the ranch house and barn in 1994 replaces a lost run of post-and-rail fence that once formed part of this fence line. The corrals form the southeastern corner of the ranch's fence system, connecting the southern line to the eastern line, which proceeds uphill for about 270' to the northeast corner of the ranch. The middle fence runs north to south about 220' and separates about 5 acres containing the ranch core from the about 21 acres of fields and pastures to the west.⁵⁹

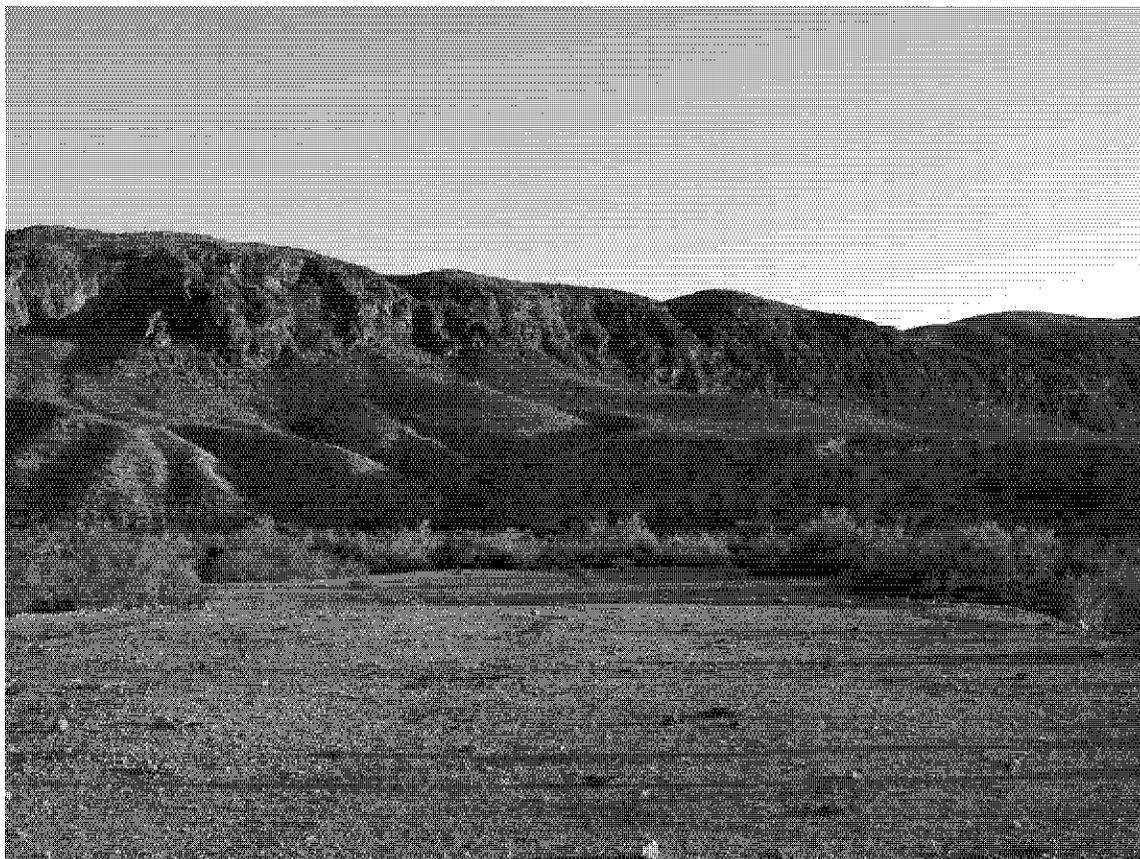
Fig. 13. The low table land at the western end of the ranch that was formerly irrigated for use as pasture. Lake Mead National Recreation Area Approved Road 148 rises out of Pigeon Wash on the far side of the valley, leading past the Whitmores' landing strip to Lake Mead, about three miles to the southwest. Photograph by Christopher Stevens, November 2009.
