CLASSIFIED STRUCTURE FIELD INVENTORY REPORT
(Attach 4" x 5" Black and White Photograph)

REGION RMR PARK/AREA NAME ROMO PARK NUMBER 1520
STRUCTURE NAME Fern Lake Patrol Cabin STRUCTURE NUMBER HS 14
LOCATION OF STRUCTURE Fern Lake PARK LOCATION CODE PG
NATIONAL REGISTER 0 DATE: / / MANAGEMENT CATEGORY: (A) (B) (C) (X) (D)
NPS LEGAL INTEREST Fee MANAGEMENT AGREEMENT: No

CONTINUATION FROM FRONT SHEET - STRUCTURE NAME 14 Fern Lake Patrol Cabin

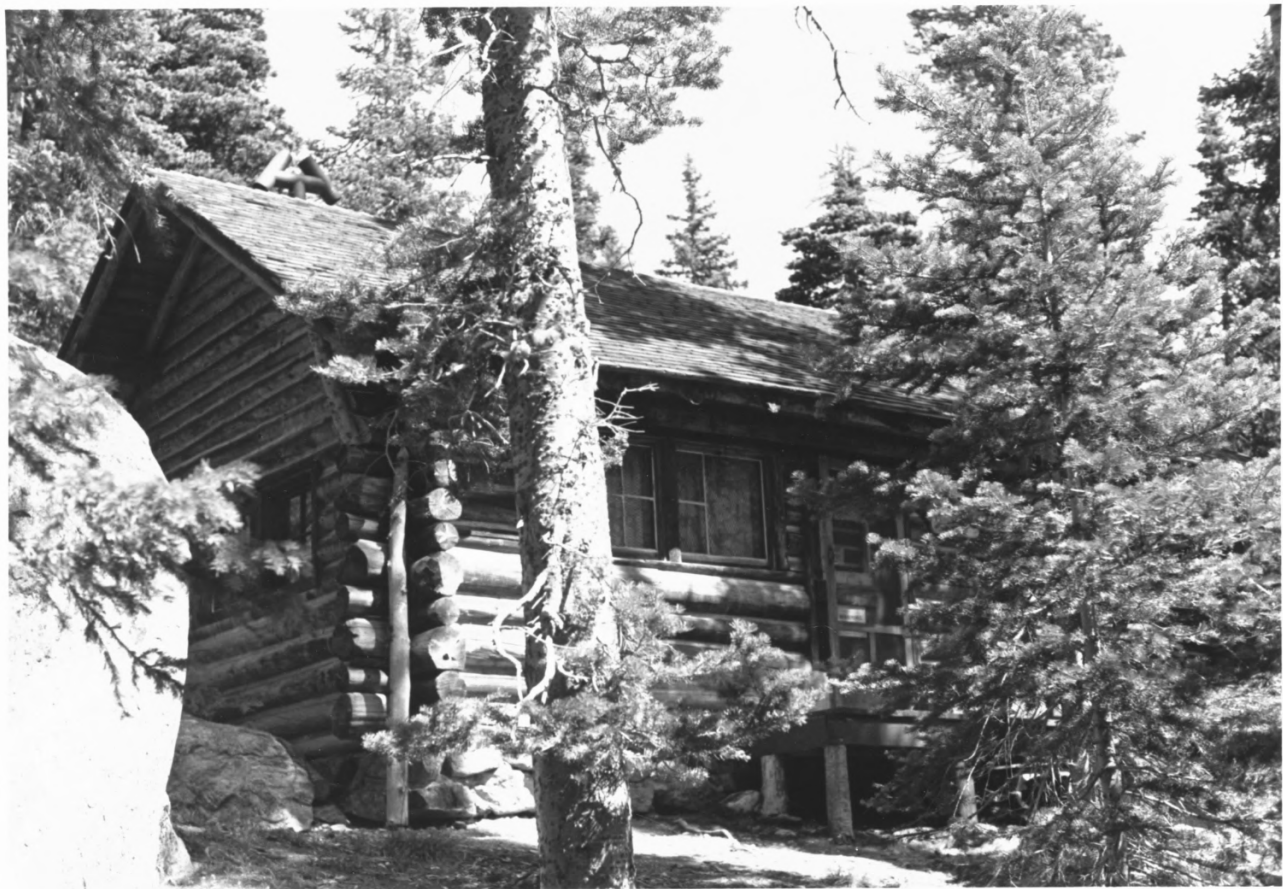
NAME: Fern Lake Patrol Cabin (HS-14)
LOCATION: Rocky Mountain National Park, Colorado
VIEW: South
LOCATION OF NEGATIVE: National Park Service,
Rocky Mountain Regional Office, Denver, CO
DATE: Summer 1985
PHOTOGRAPHER: McWilliams
