CLASSIFIED STRUCTURE FIELD INVENTORY REPORT
(Attach 4" x 5" Black and White Photograph)

REGION RMR PARK/AREA NAME ROMO PARK NUMBER 1520
STRUCTURE NAME Mess Hall and Residence STRUCTURE NUMBER HS-220
LOCATION OF STRUCTURE Milner Pass Road Camp PARK LOCATION CODE PG
NATIONAL REGISTER 0 DATE: / / MANAGEMENT CATEGORY: (A) (B) (C) (D)
NPS LEGAL INTEREST Fee MANAGEMENT AGREEMENT: NO

Report prepared by: Carl and Karen McWilliams Date: 8 /20 /1985

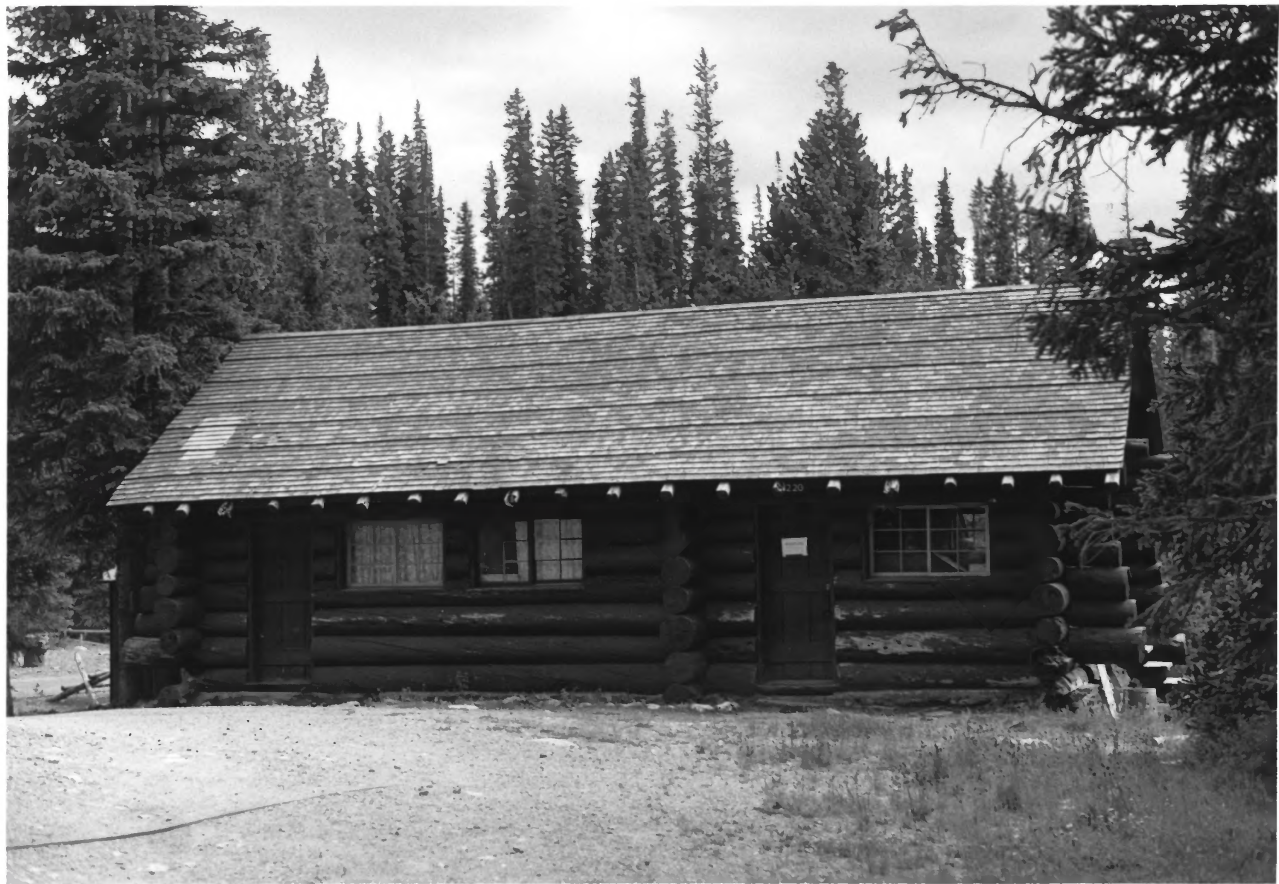
NAME: Mess Hall and Residence (HS-220)
LOCATION: Rocky Mountain National Park, Colorado
VIEW: Northeast
LOCATION OF NEGATIVE: National Park Service,
Rocky Mountain Regional Office, Denver, CO
DATE: Summer 1985
PHOTOGRAPHER: McWilliams

FOUNDATION: Low to medium, 0'0" to 3'4", of uncoursed fieldstone.

WALLS: Brown. Logs, with saddle notching at corners.

ROOF: Gable. Green wood shingles doubled every fifth course, with exposed log rafter ends. Roof is badly deteriorated. Structure still retains historic character.

CHIMNEYS: One - of red brick, on the interior of the SW ele Brick is crumbling. Two - Metal vent pipes.
