CLASSIFIED STRUCTURE FIELD INVENTORY REPORT
(Attach 4" x 5" Black and White Photograph)

REGION RMR PARK/AREA NAME ROMO PARK NUMBER 1520
STRUCTURE NAME Residence STRUCTURE NUMBER HS32
LOCATION OF STRUCTURE Wild Basin PARK LOCATION CODE WB
NATIONAL REGISTER 0 DATE: / / MANAGEMENT CATEGORY: (A) (B) (C) (D)
NPS LEGAL INTEREST Fee MANAGEMENT AGREEMENT: No

CONTINUATION FROM FRONT SHEET - STRUCTURE NAME 32 Residence

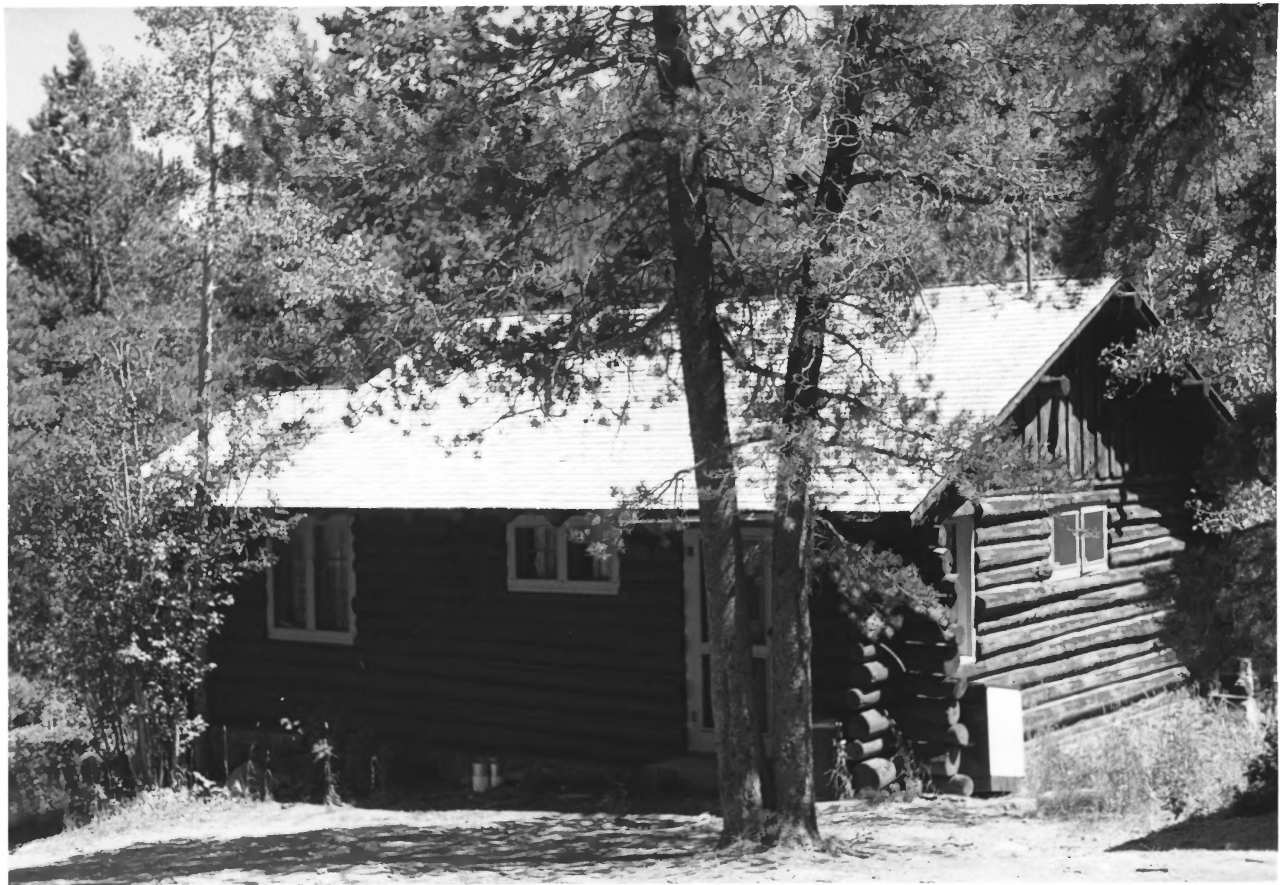
NAME: Wild Basin Residence (HS-32)
LOCATION: Rocky Mountain National Park, Colorado
VIEW: West
LOCATION OF NEGATIVE: National Park Service,
Rocky Mountain Regional Office, Denver, CO
DATE: Summer 1985
PHOTOGRAPHER: McWilliams

STORIES: one
FOUNDATION: low, 0'0" to 3'4". of uncoursed fieldstone,
buttressed at corners

WALLS: Brown logs, with saddle notching at corners

ROOF: Gable. Brown wood shingles with exposed log rafter
ends, purlins, ridgepole and plate logs
