Timber Creek Bunkhouse and Mess Hall  
Trail Ridge Road  
Rocky Mountain National Park  
Grand Lake Vicinity  
Grand County  
Colorado

HABS No. CO-86

WRITTEN HISTORICAL AND DESCRIPTIVE DATA

HISTORIC AMERICAN BUILDING SURVEY  
TIMBER CREEK BUNKHOUSE AND MESS HALL

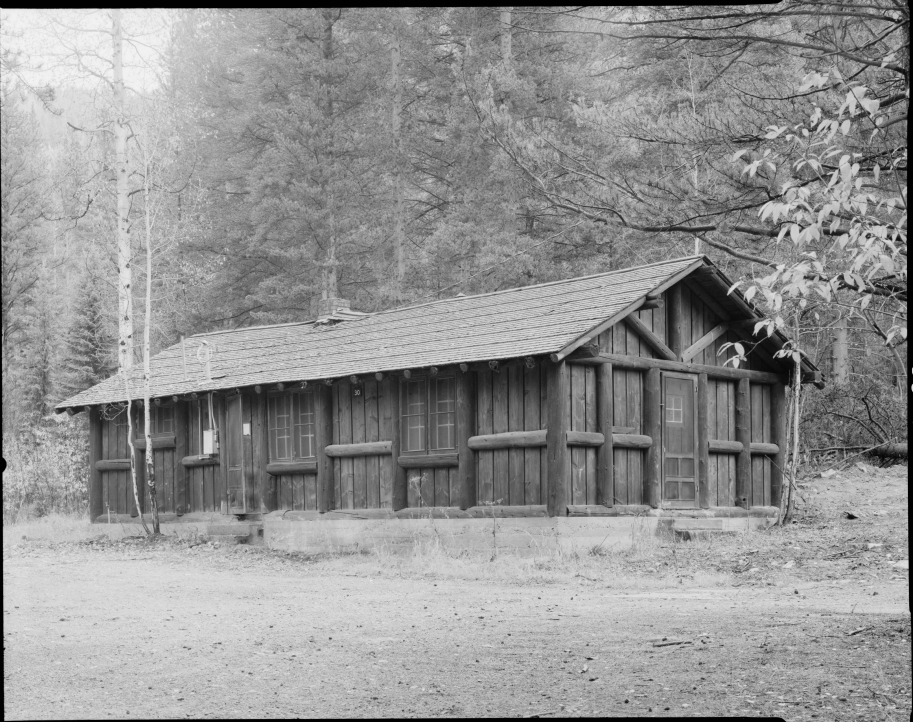
HAAS No. C-86-1

- CO-86-1       TIMBER CREEK BUNKHOUSE AND MESS HALL, ROCKY MOUNTAIN NATIONAL PARK. VIEWING EAST.
- CO-86-2       TIMBER CREEK BUNKHOUSE AND MESS HALL, ROCKY MOUNTAIN NATIONAL PARK. VIEWING NORTH.
- CO-86-3       TIMBER CREEK BUNKHOUSE AND MESS HALL, ROCKY MOUNTAIN NATIONAL PARK. VIEWING WEST.
- CO-86-4       TIMBER CREEK BUNKHOUSE AND MESS HALL, ROCKY MOUNTAIN NATIONAL PARK. VIEWING SOUTH.
- CO-86-5       TIMBER CREEK BUNKHOUSE AND MESS HALL, ROCKY MOUNTAIN NATIONAL PARK. VIEWING SOUTHEAST.
- CO-86-6       TIMBER CREEK BUNKHOUSE AND MESS HALL, ROCKY MOUNTAIN NATIONAL PARK. INTERIOR, BUNK AREA, VIEWING SOUTHWEST.
- CO-86-7       TIMBER CREEK BUNKHOUSE AND MESS HALL, ROCKY MOUNTAIN NATIONAL PARK. INTERIOR, KITCHEN AND DINING AREA, VIEWING NORTH.
