**Timucuan Ecological and Historic Preserve
Kingsley Plantation**

KITCHEN HOUSE

**HISTORIC STRUCTURE
REPORT**

January 31, 2005

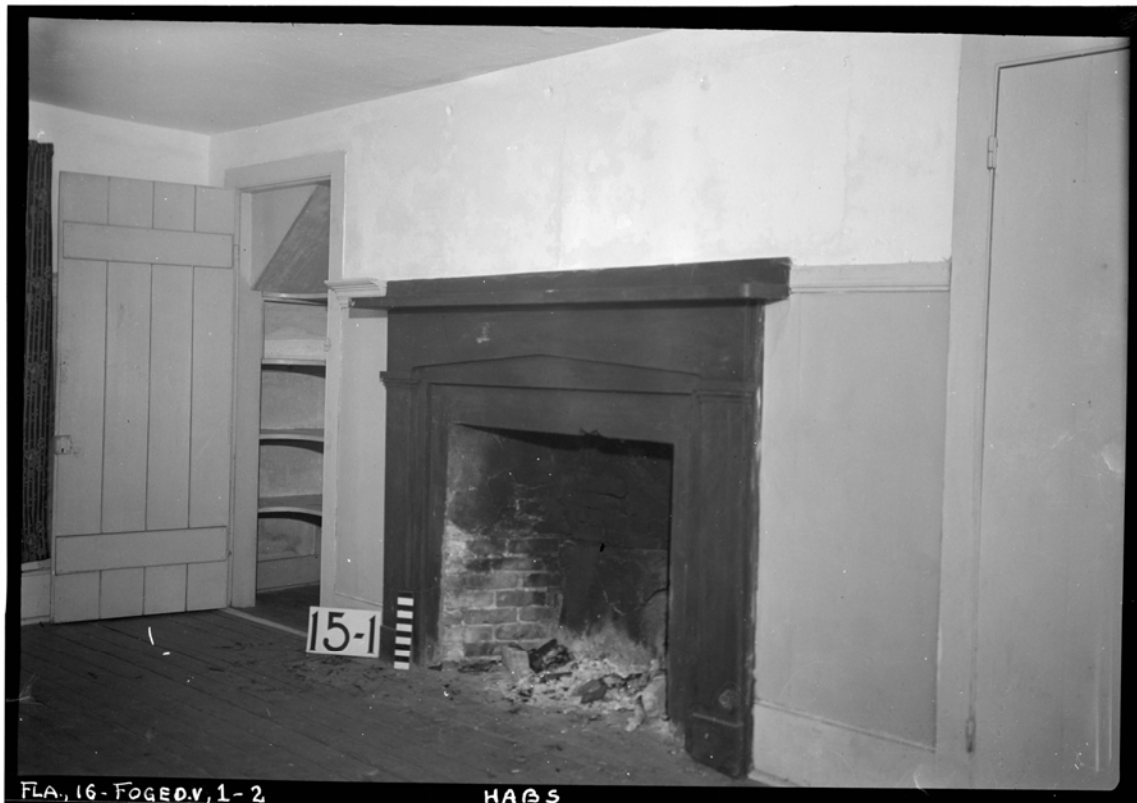
Figure 2: 1934 HABS photograph of Room 101. Note the closets, finished ceiling and molding on either side of fireplace. (Library of Congress.)

A corner cupboard was installed in the southwest corner of the expanded north room on the first floor (Room 101). This may have been used as a china closet. A 1934 HABS photograph of the east end

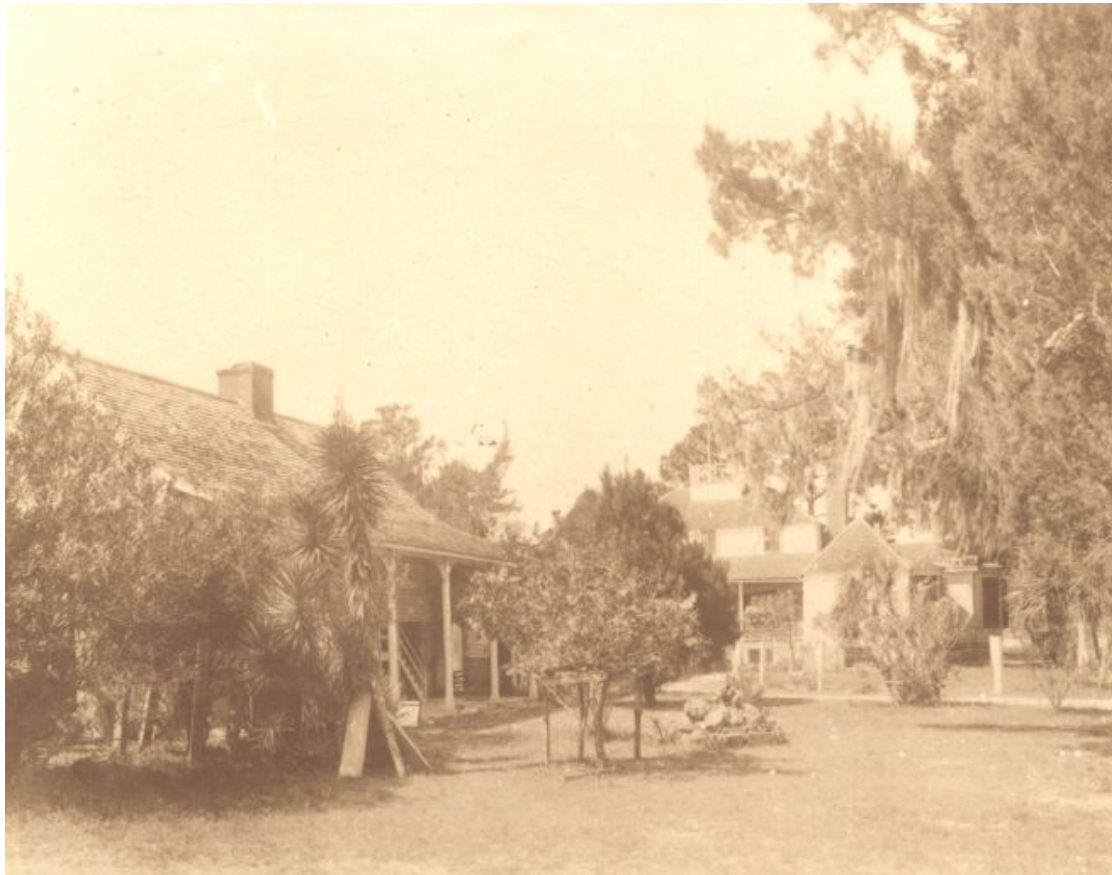
Figure 3: Kitchen House and Main House, looking north, dated circa 1920 by the State of Florida. Note the two-story front porch on the Kitchen House. (Timucuan Ecological and Historic Preserve.)

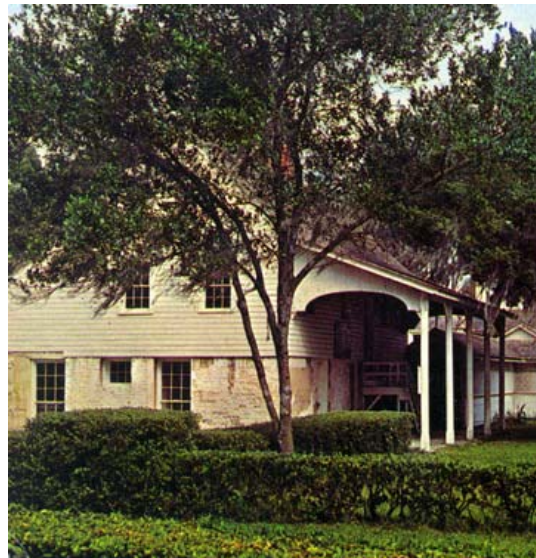
Figure 5: Kitchen House, looking north, undated, but possibly early 1950s. Note the small window on the south elevation that once let light into the Stores. (State Library and Archives of Florida.)

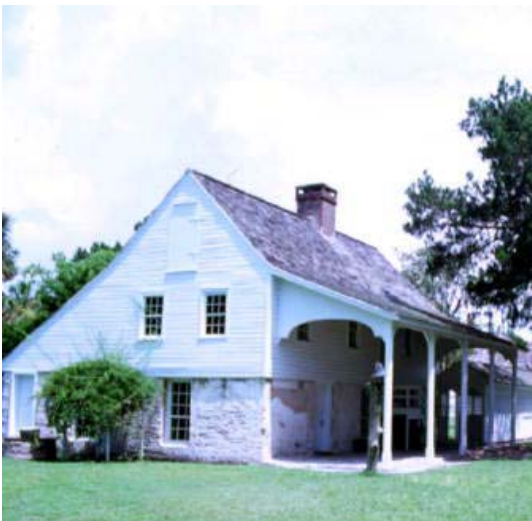
Figure 6: Kitchen House, looking north, 1982. Note the single door to the attic. (State Library and Archives of Florida.)

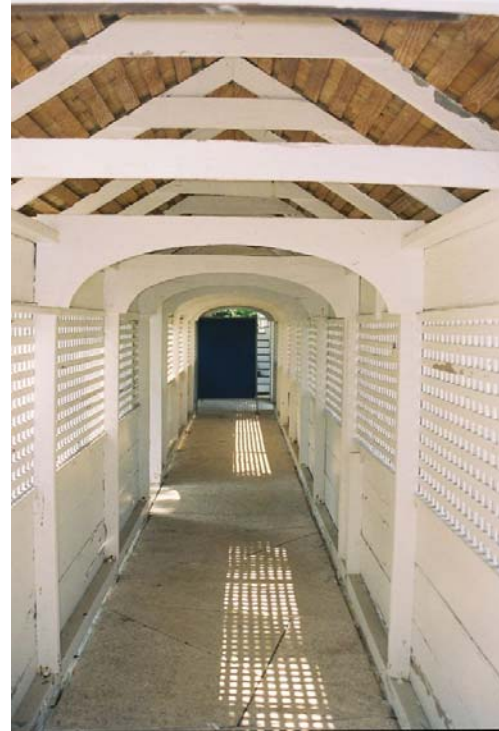
The ceiling of the Breezeway is the exposed roof framing and shingle roofing. The framing consists of rafters, collar ties, and arched tie beams. The rafters are nailed together at the ridge without a ridge board. The tie beams are notched into the top plates of the walls

Figure 11: Interior of Breezeway, looking south. (Photo by author.)

and connect to the exposed wall studs. The flooring of the Breezeway is poured tabby scored to resemble randomly sized triangular slabs laid together to form a straight pathway. The floor is 5'-4" wide.

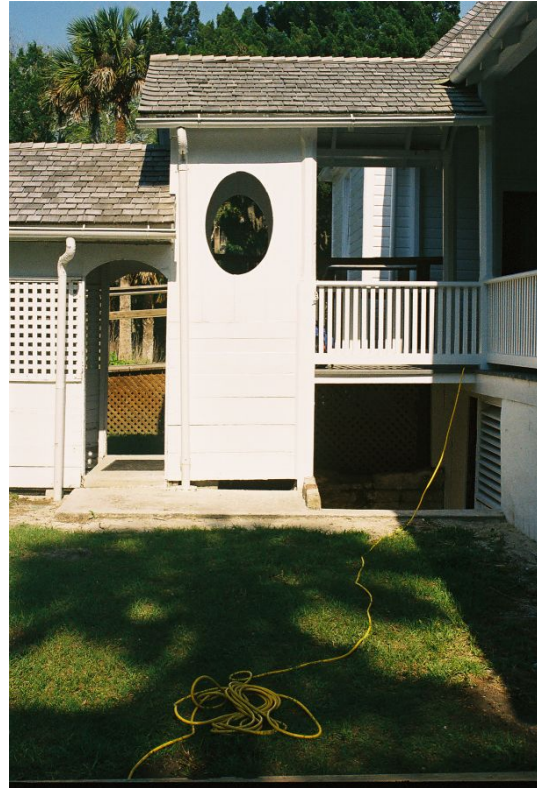
Figure 14: Northeast entrance to Breezeway, at rear of Main House. (Photo by author.)

The southernmost entrance on the east elevation of the Breezeway is through a small, gabled projection. The walls of this projection are the same as those of the main section. A small, wooden bench is mounted to each of the interior walls in the projection. West of the benches is an arched opening leading to the main section of the Breezeway. This opening measures 3'-11" by 7'-5" high to the base of the arch.

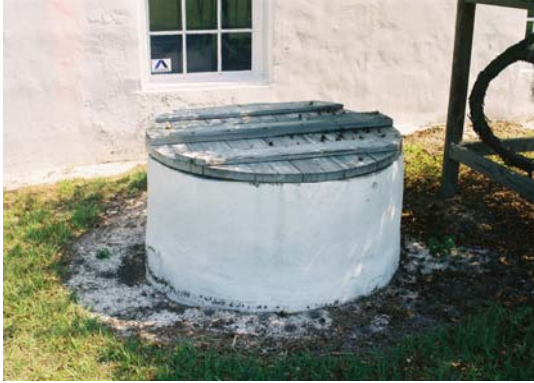
Located to the south of the Kitchen is a round, masonry well. The well is constructed of clay brick and finished with stucco and white paint. A wood cap is installed over the well for protective purposes.

Figure 15: Well located on the south side of the Kitchen House. (Photo by author.)

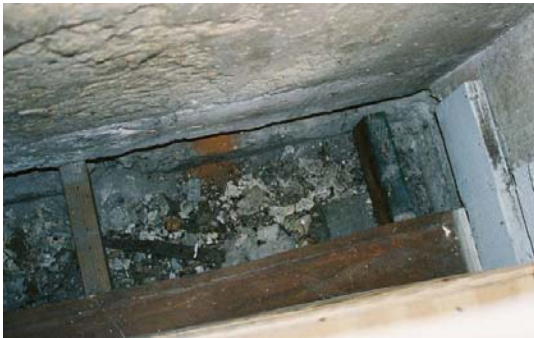
Figure 16: Exposed floor joists above sand/shell grade in Room 104. (Photo by author.)

The formed tabby and tabby-brick walls of the first floor were constructed on a poured tabby slab foundation. This foundation was poured at grade, probably in a slight depression excavated for that purpose, with no subsurface basement. The front porch

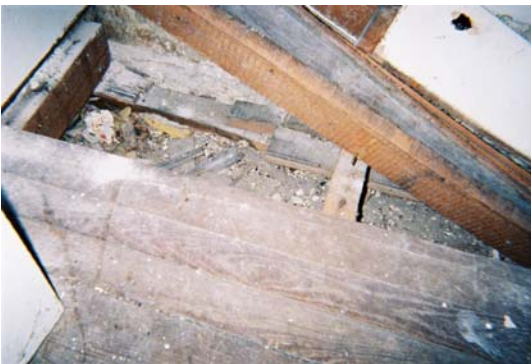
Figure 17: Floorboards and exposed joists over sand/shell grade in Room 103. (Photo by author.)

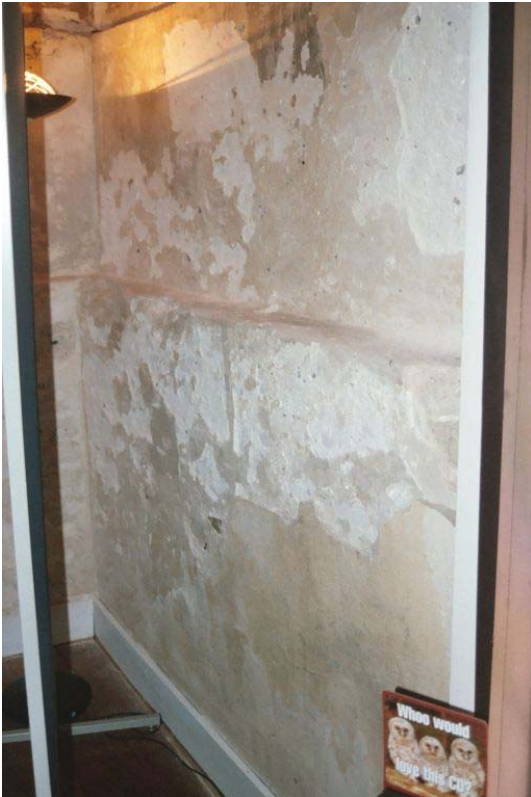
Figure 18: Detail of tabby wall of Room 104, looking southeast. Note the ledge formed by the earlier tabby brick portion of the wall. (Photo by author.)

The west half of the house was originally constructed of 14" thick formed tabby walls circa 1814-1820s. This includes the north-south wall between the two southern, ground floor rooms, likely constructed when Kingsley repaired or enlarged the building.

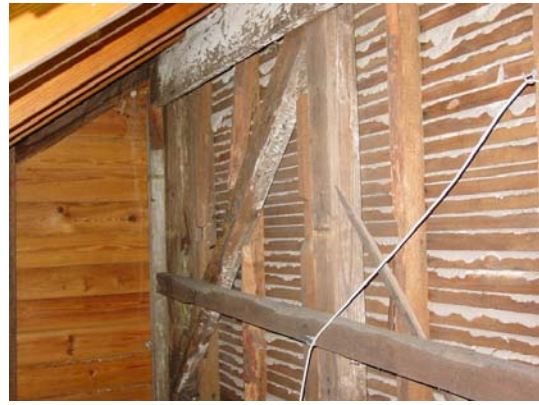
Figure 19: View of attic wall, west of Room 201. Note early siding board at top of photograph penetrated by circa 1880s rafters. (Photo by author.)

At the top of this wall, the rafters penetrate wide, painted boards. These boards appear to be the remains of an earlier, exterior, lap siding. Below these boards, two 2" by 4" sash-sawn boards are nailed to the wall at approximately 5'-0" above the floor joists, butted end to end, though the board are not perfectly aligned. Notches are spaced approximately 24" on center along the boards.

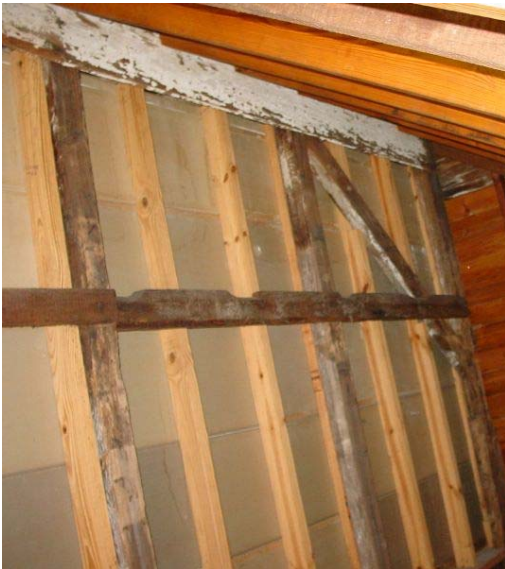
Figure 20: View of attic wall, west of Room 203. Note early siding board at top of photograph penetrated by circa 1880s rafters and notched beam below, possibly an earlier ridge beam. (Photo by author.)

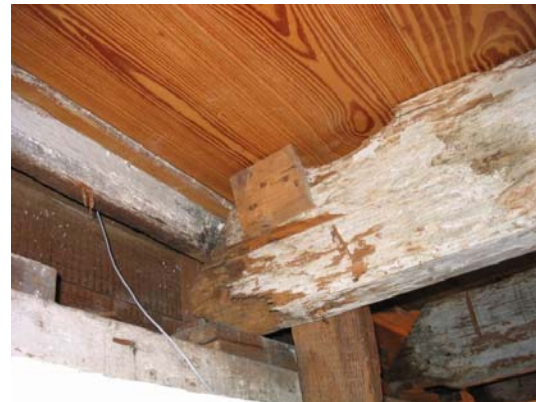
Figure 22: Hewn joist bearing on supplemental sash sawn beam and masonry wall. (Photo by author.)

The hewn floor framing of the second floor is exposed to the east half of Room 101 and Room 104. The joists in the east end of Room 101 measure 3¼" by 8½" and are spaced at 20½" to 34" apart. The historic connections are somewhat concealed by trim work. However, it appears that the joists are bearing on the masonry wall at the east end and on the hewn girder at the west end. The girder is set into joist pockets in the north and south masonry walls.

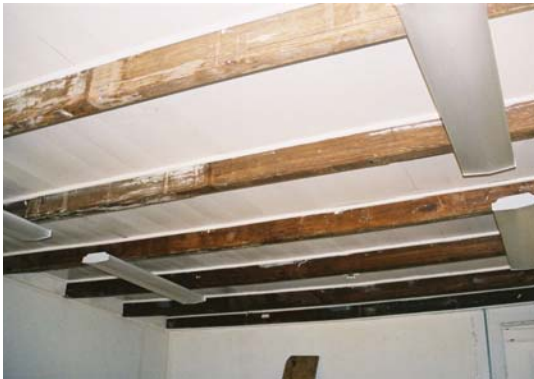
Figure 23: Floor joists of attic space above Room 203. (Photo by author.)

The ceiling framing of Rooms 105, 106, 107 and the western end of Room 101 is exposed in the west end of the attic. The joists measure 2" by 5" and are spaced at 2" to 19" on center. The smaller spacing is indicative of the installation of modern, supplemental joists. The joists are nailed to the sill plate. The earliest of this framing appears to date to the circa 1878-1886 remodeling of the house.

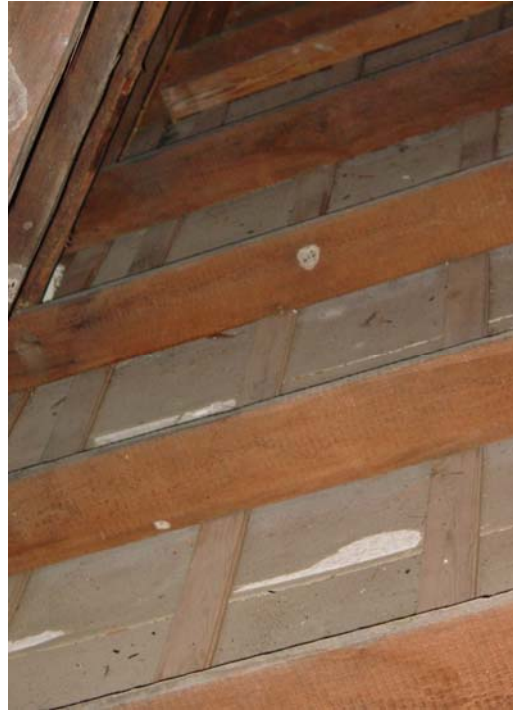
Figure 24: Ceiling joist of Room 201 exposed to east attic space. (Photo by author.)

and attic flooring. The ceiling joists for Room 201 are sash sawn and measure 1¼" by 7", spaced 33" on center. These joists are exposed to the attic and concealed in Room 201 by a gypsum board ceiling.

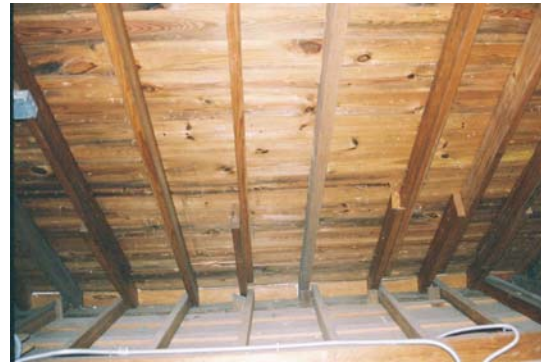
Figure 25: Attic space west of Room 201. Note the ceiling joists of the west end of Room 101. (Photo by author.)

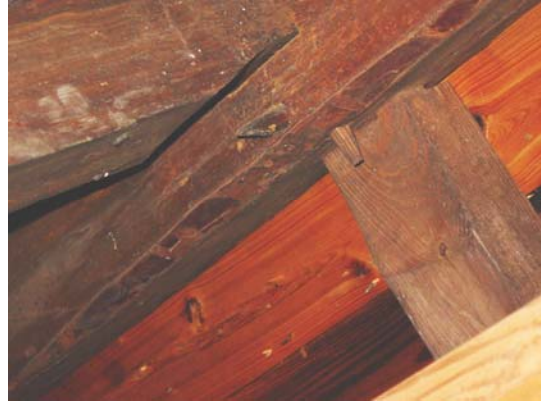
Figure 26: Hewn ridge beam in eastern attic. Note pegged connections. (Photo by author.)

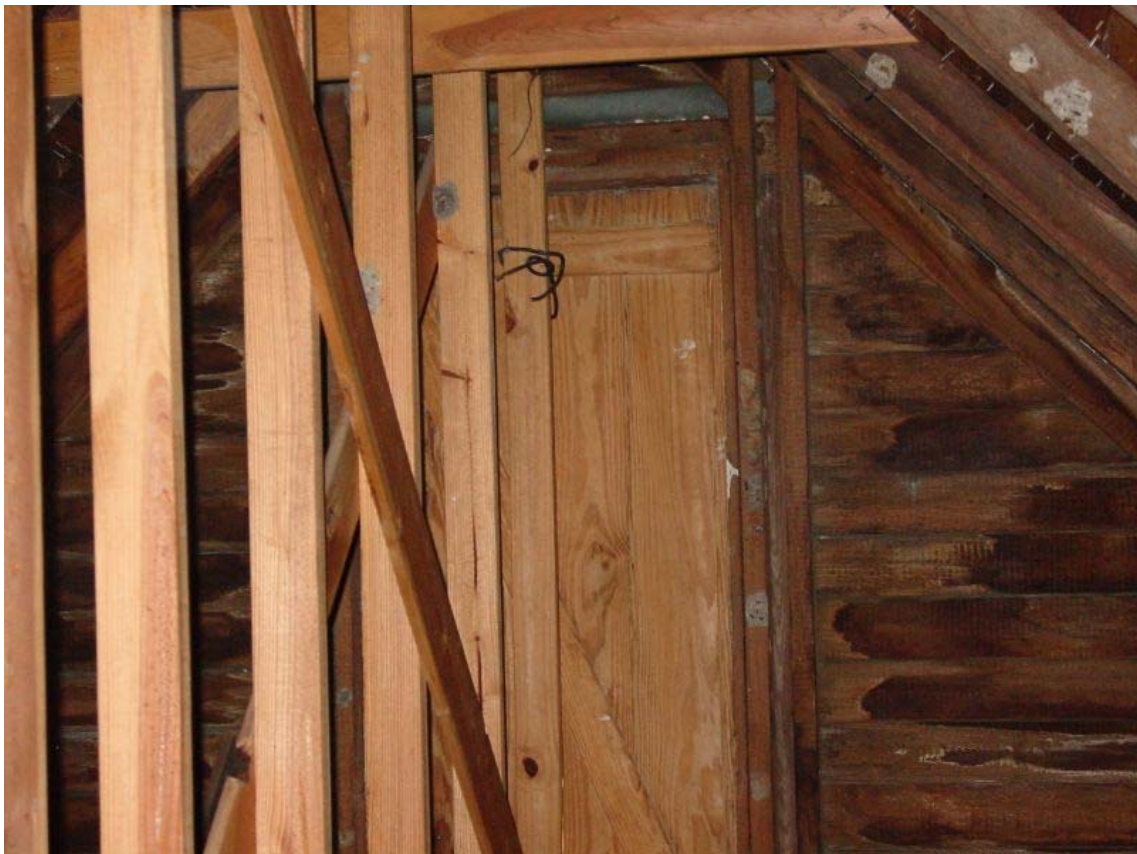
Figure 27: Load-bearing wall and roof framing at southern end of attic, above Room 203. Note Door 16 centered on wall. (Photo by author.)

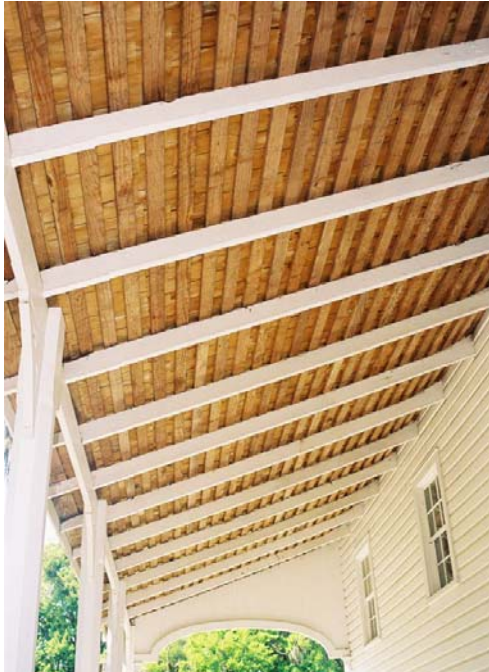
Figure 28: Porch rafters. Note that the shingle lath and shingles have been replaced. (Photo by author.)

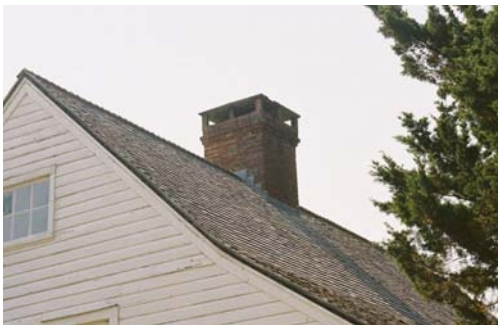
Figure 29: View of shingle roof, drop siding and chimney. (Photo by author.)

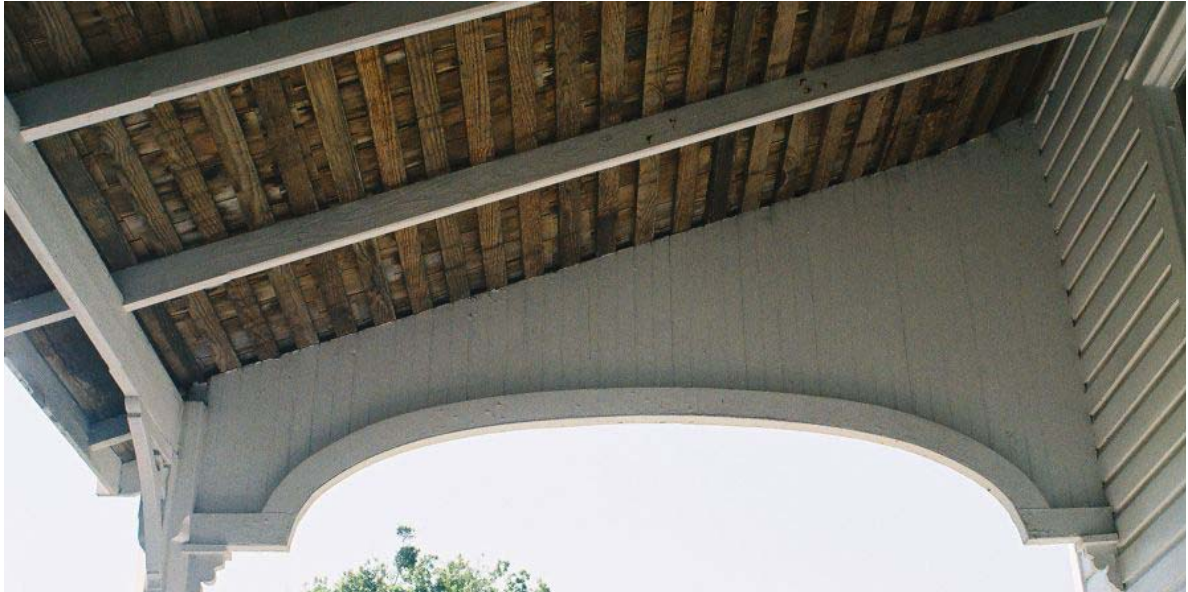
Figure 30: Detail of vertical siding on end of porch roof and drop siding on exterior walls. (Photo by author.)

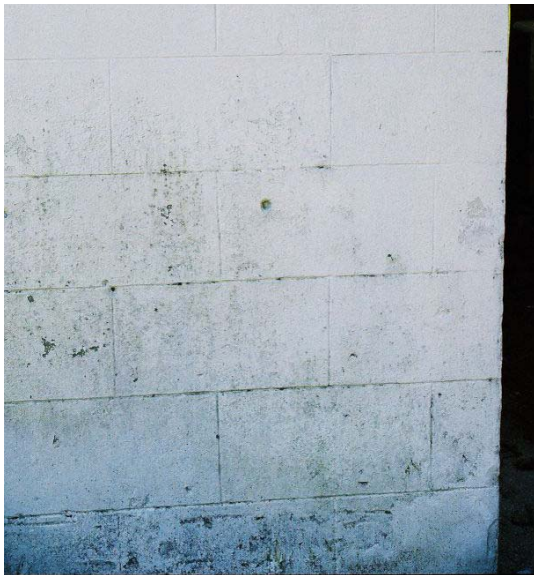
Figure 31: Detail of stucco wall, scored to resemble ashlar masonry joints. (Photo by author.)

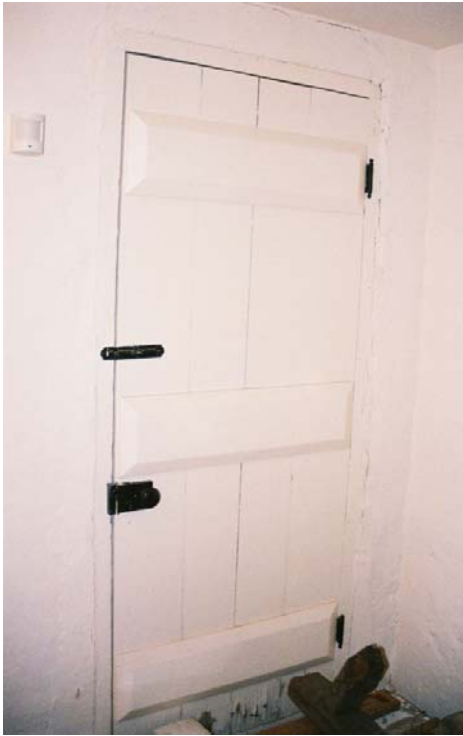
Figure 34: Door 7, a typical board-and-batten door. (Photo by author.)

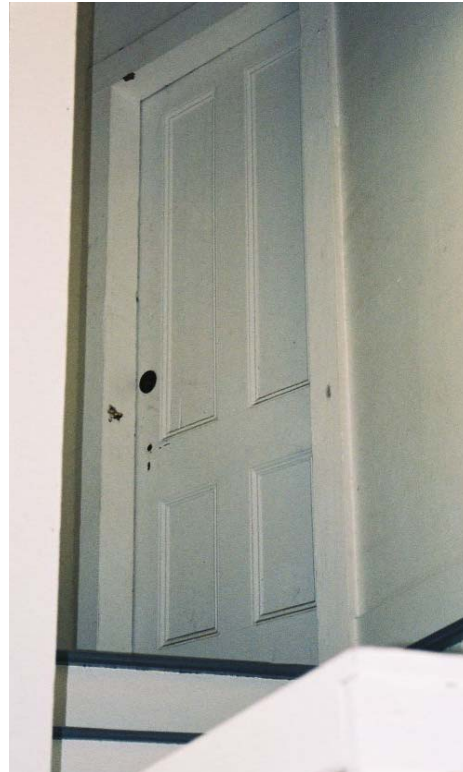
Figure 35: Door 11, a four-panel door. (Photo by author.)

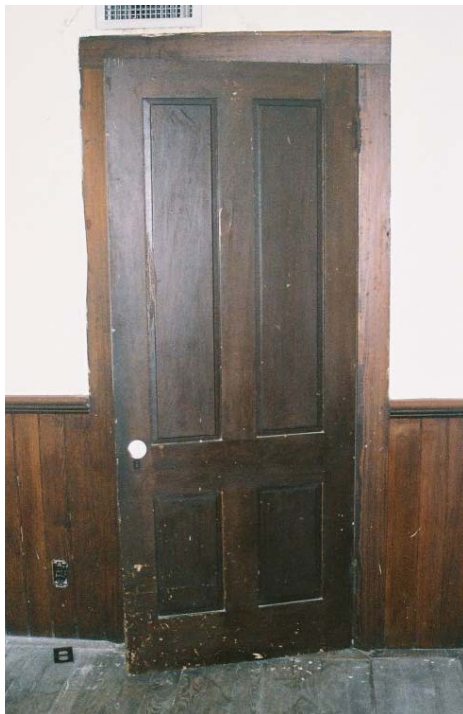
Figure 36: Door 12, a four-panel door. Note the raised panels. (Photo by author.)

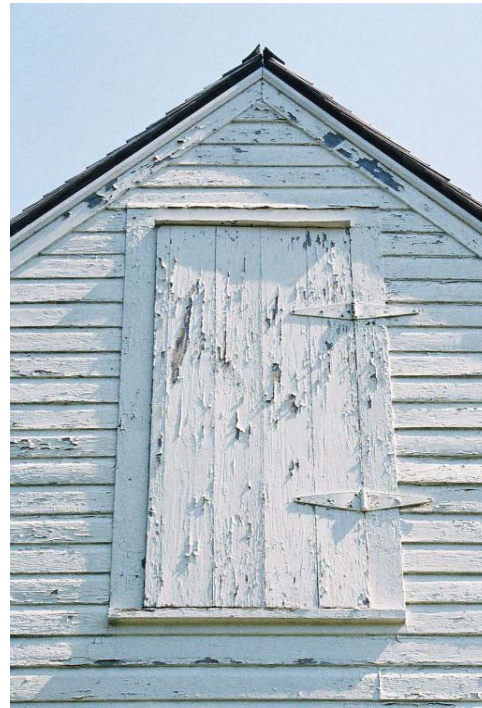
Figure 37: Door 16, a modern board-and-batten door. (Photo by author.)

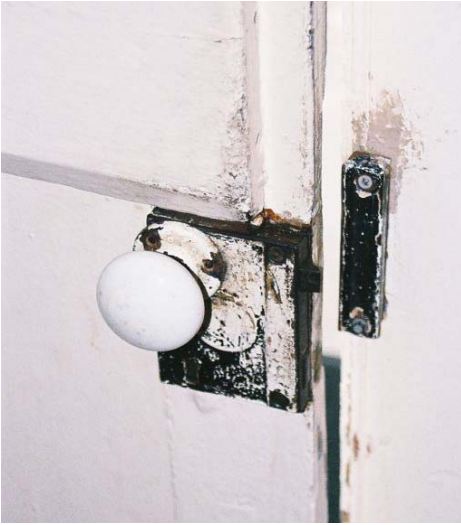
Figure 38: Door 1, white porcelain knob and iron rim lock. Note that the lock is stamped "A&D Manufacturing, Co. May 29, 1866." (Photo by author.)

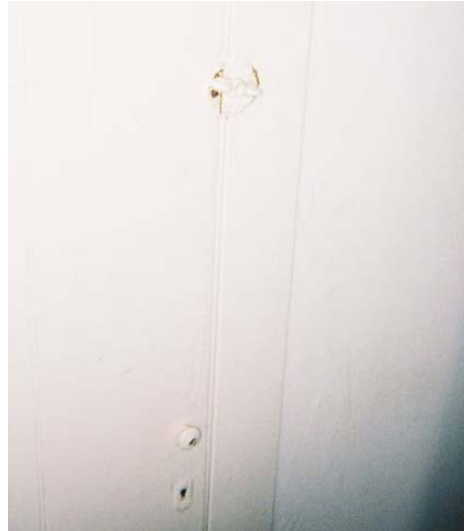
Figure 39: Door 3, wood door knob and metal turn latch. (Photo by author.)

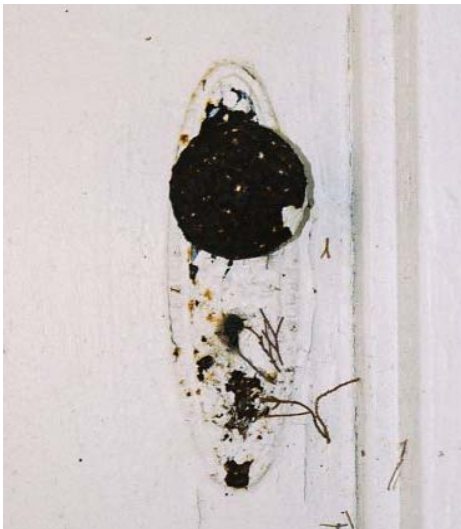
Figure 40: Door 8, exterior metal knob and plate. (Photo by author.)

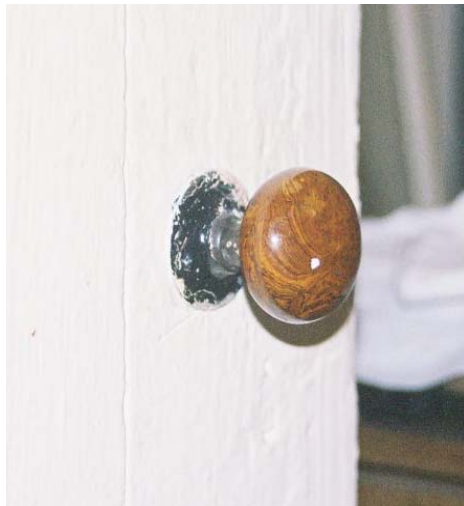
Figure 41: Door 9, tiger-eye porcelain knob. (Photo by author.)

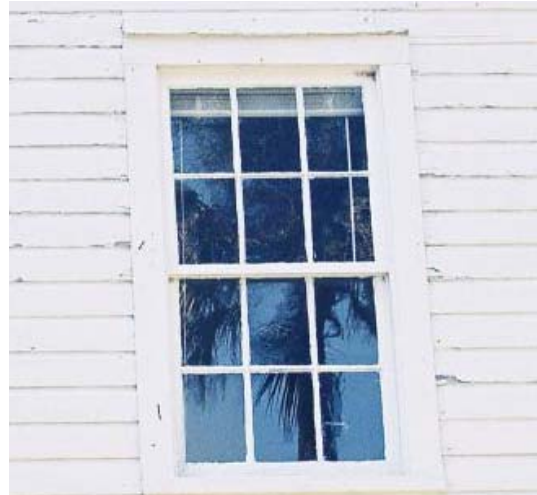
Figure 54: Window 14, example of 6/6 window, typical to the second floor. (Photo by author.)

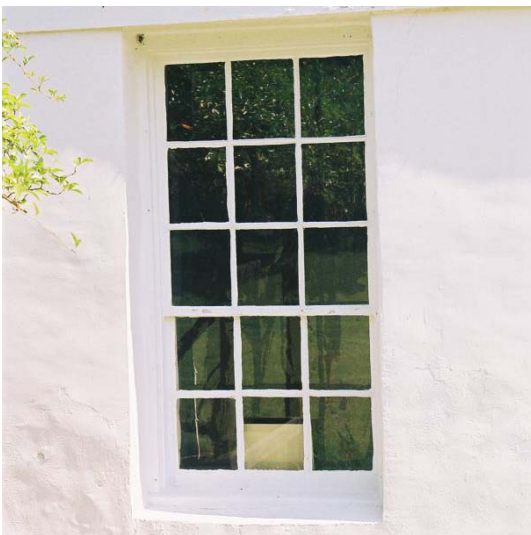
Figure 53: Window 7, example of 9/6 window, typical to first floor. (Photo by author.)

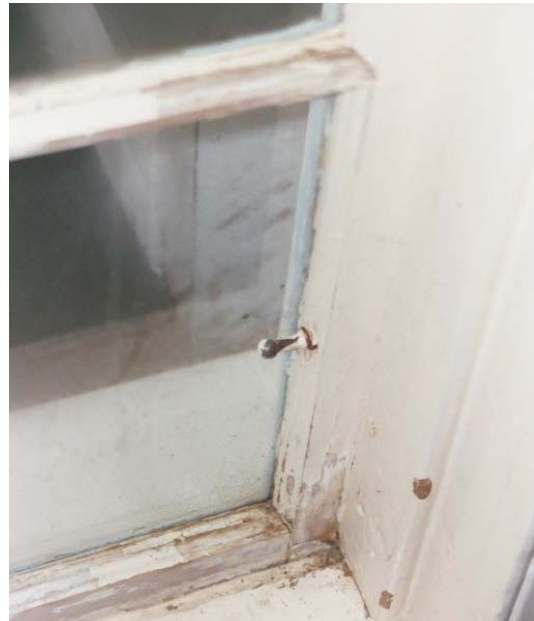
Figure 55: Typical window muntin. Note 20th century sash lift. (Photo by author.)

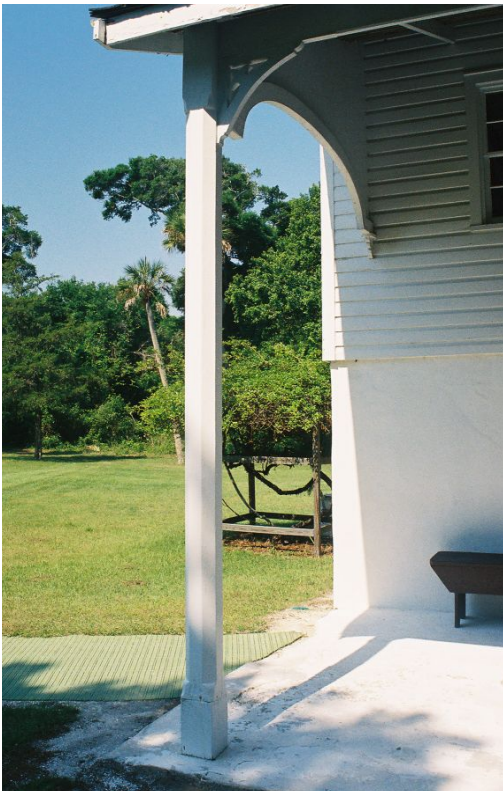
Figure 58: Chamfered porch post. (Photo by author.)

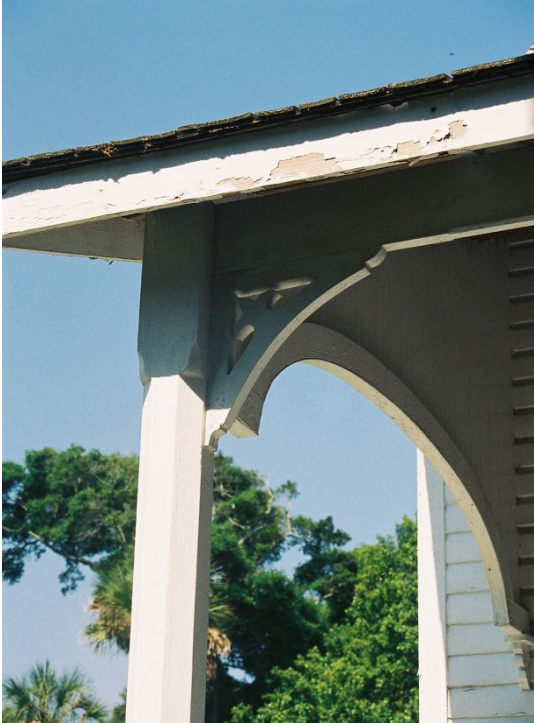
Figure 60: Detail of porch roof bracket. (Photo by author.)

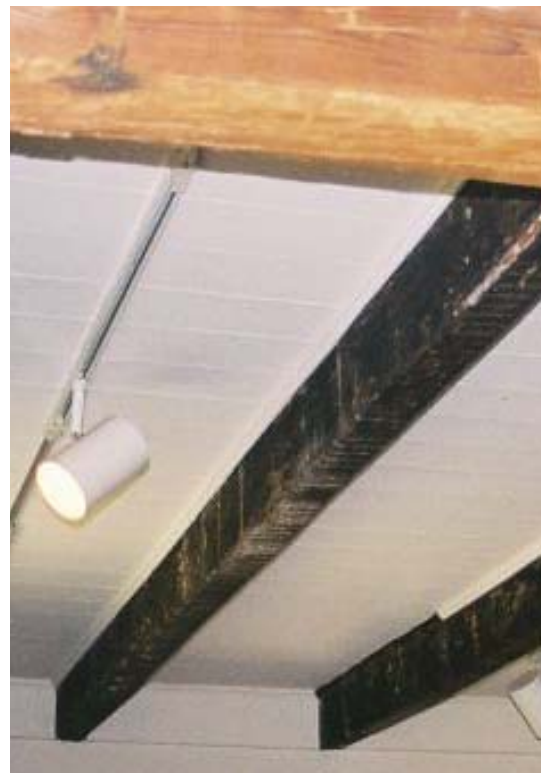
Figure 61: Exposed joists and beams at east end of Room 101. Note the ogee molding along the top. (Photo by author.)

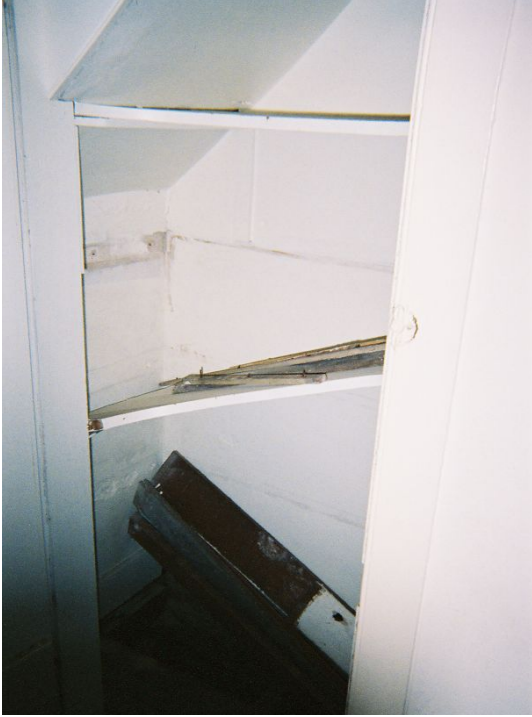
Figure 64: Room 103. Note slant in ceiling where exterior stairs penetrate the building. (Photo by author.)

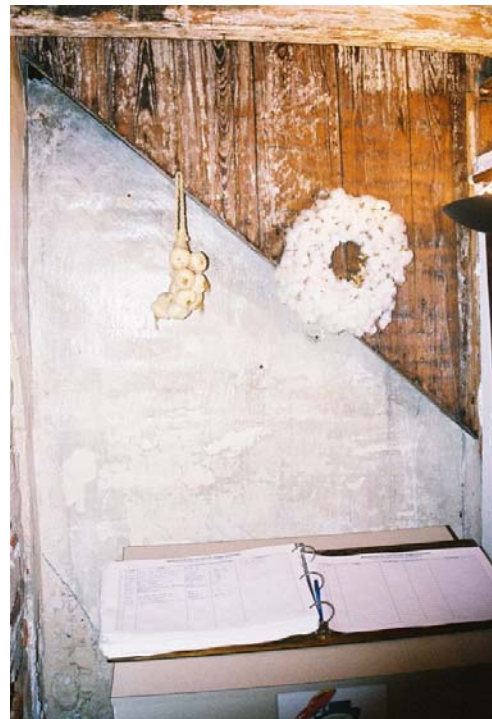
Figure 65: North wall of Room 104, east of fireplace. Note where exterior staircase penetrates the building. (Photo by author.)

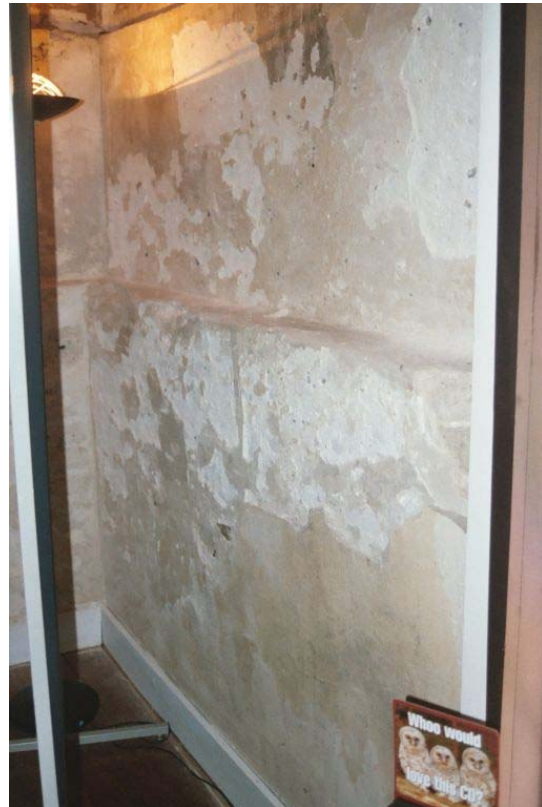
Figure 67: South wall of Room 104. Note ledge which wraps around to east wall. (Photo by author.)

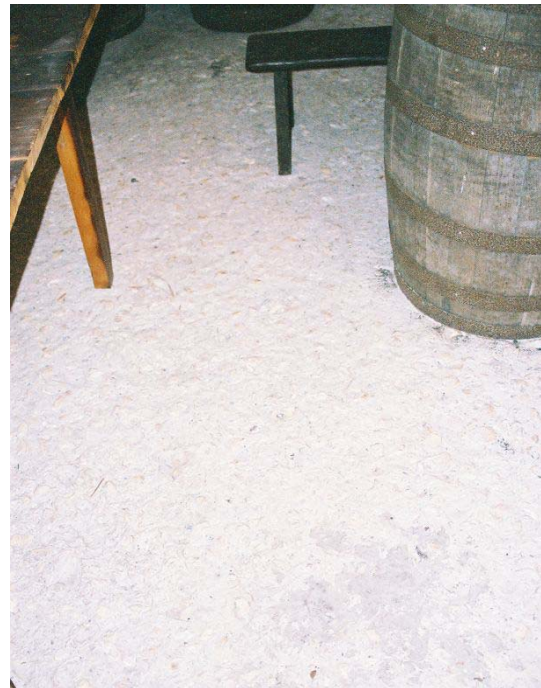
Figure 68: Poured tabby floor in Room 105. (Photo by author.)

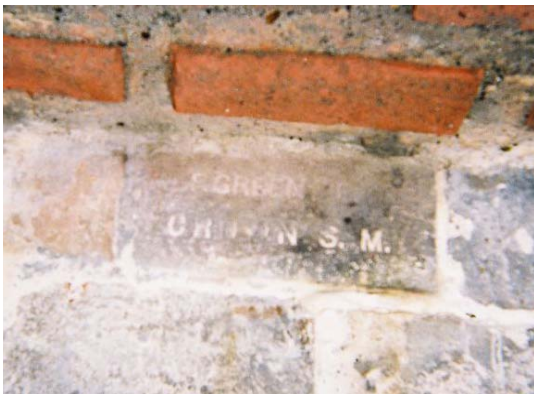
Figure 78: Brick in back of firebox in Room 203. (Photo by author.)

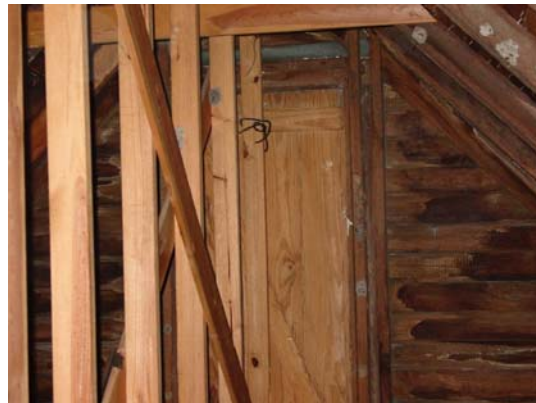
Figure 80: Southern view of attic space above Rooms 201, 202 and 203. Note the board and batten door in the center of the gable. (Photo by author.)
