Vanishing Treasures

Vanishing Treasures Program

A CLIMATE OF CHANGE Climate Change Issue

**Fiscal Year 2010 Year-End Report
and
Funded Projects for 2011**

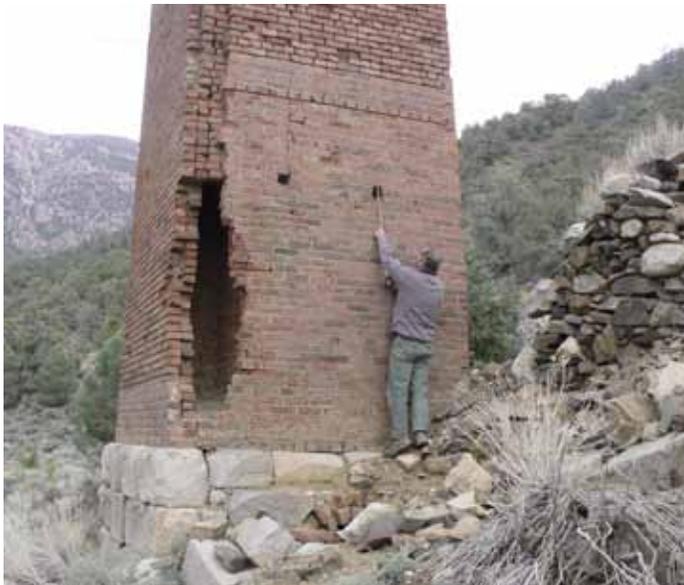
Randy measuring the stack at Panamint City, Death Valley National Park.

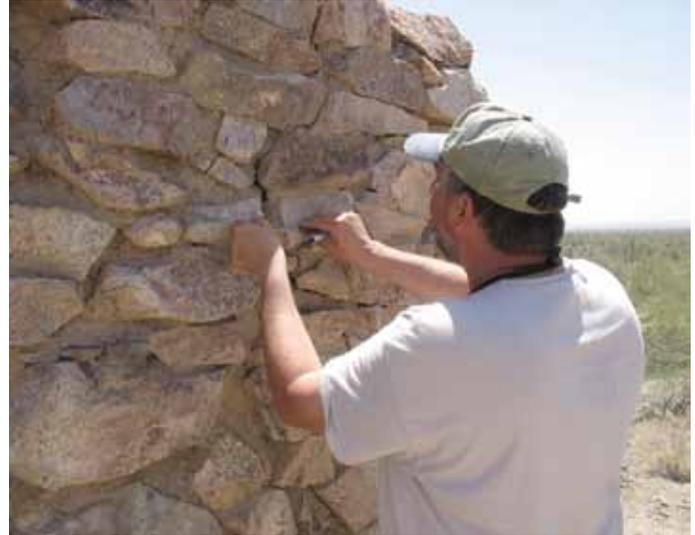
Preston investigating a wall crack at Victoria Mine, Organ Pipe Cactus National Monument.

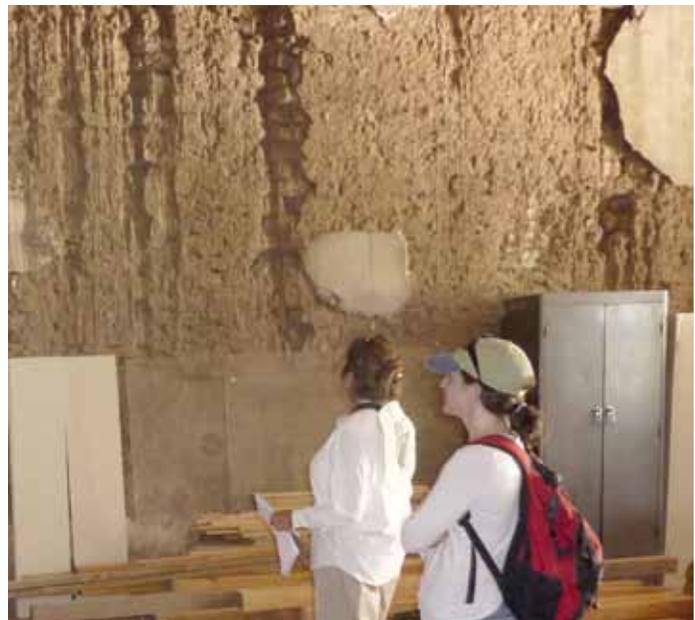
Lauren, along with Virginia Salazar-Halfmoon, assessing adobe damage at the Quartermaster Depot, Yuma National Heritage Area.

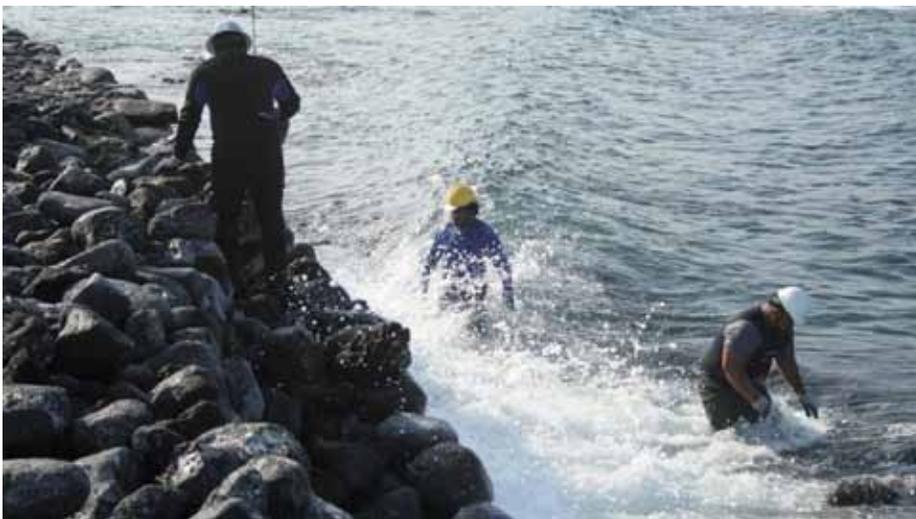
Hawaiians have traditionally understood their embeddedness in an impermanent landscape that arose from fire but will eventually erode back into the sea. Here, Masons at Kaloko-Honokohau NHP work to prevent the Kaloko Fishpond wall from washing back into the sea.

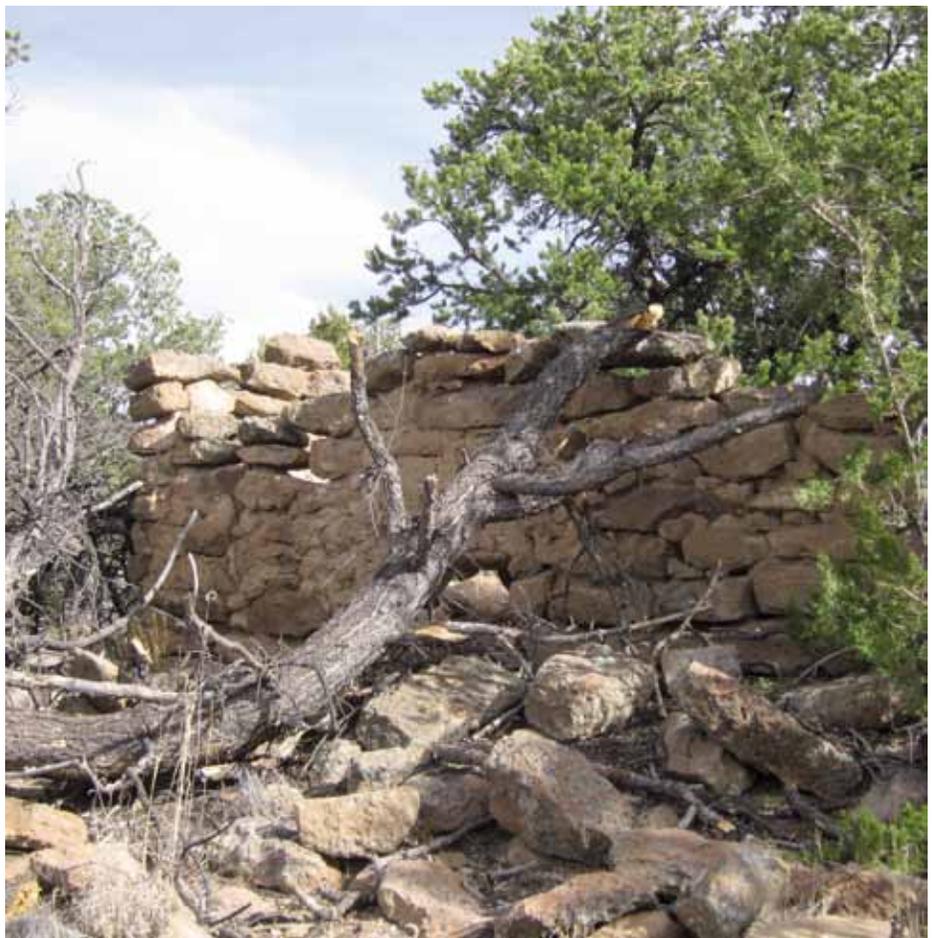
Drought-killed Piñon impacting archeological site in the Bandelier region. Fallen trees not only damage fabric but add to hazard fuel loading on the site. Photo: Courtesy Bandelier National Monument

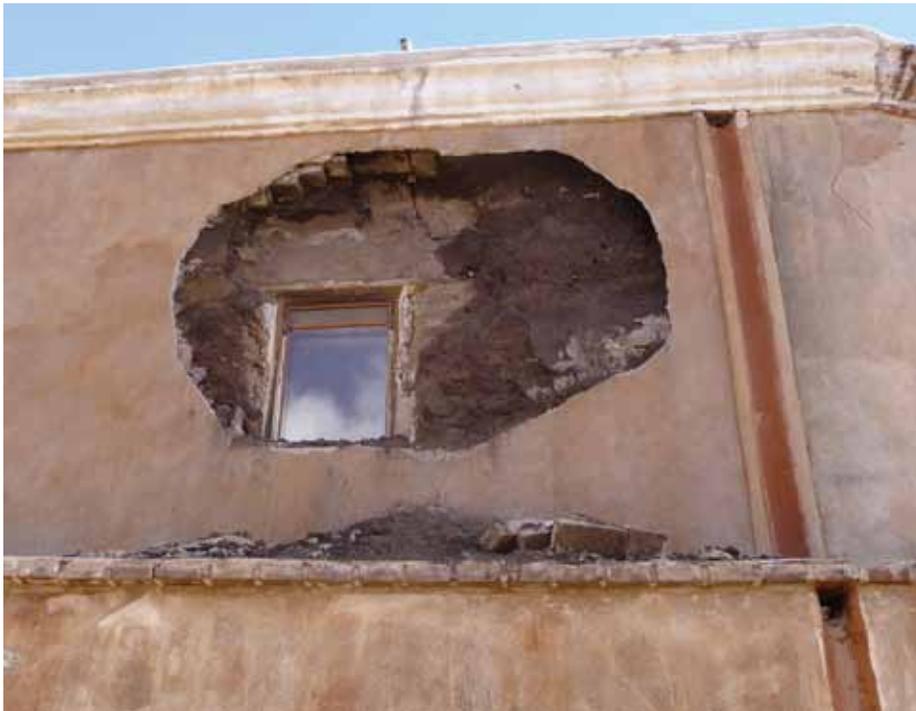
Figure 1: West sanctuary window, exterior 2010.
Photo: Courtesy Tumacácori National Historical Park

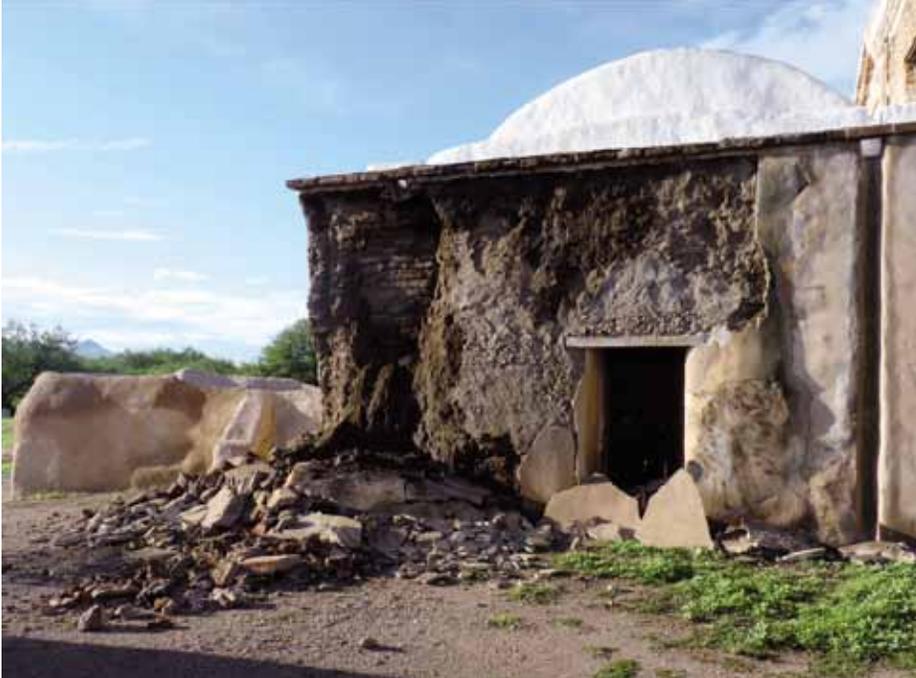
Figure 2: Sacristy, north wall exterior collapse, 2010.

The past year has been an interesting time at Tumacácori National Historical Park (NHP). Two major rainfall events within one year resulted in damage to our primary resource, the Franciscan church of San Jose de Tumacácori. This 200-year old adobe church is the primary resource for which Tumacácori NM was established in 1908. In the early winter of 2010, Tumacácori received almost 4 inches of rainfall over four days. On January 22, a hole formed around the west window exterior of the sanctuary. Over a ton of adobes and two window lintels were lost (Figure 1). Following monsoon season in 2010, a large portion of the north wall of the sacristy collapsed and is presently in repair (Figure 2). The two repairs required the replacement of over 500 hundred adobes, a third of which were historic fabric.

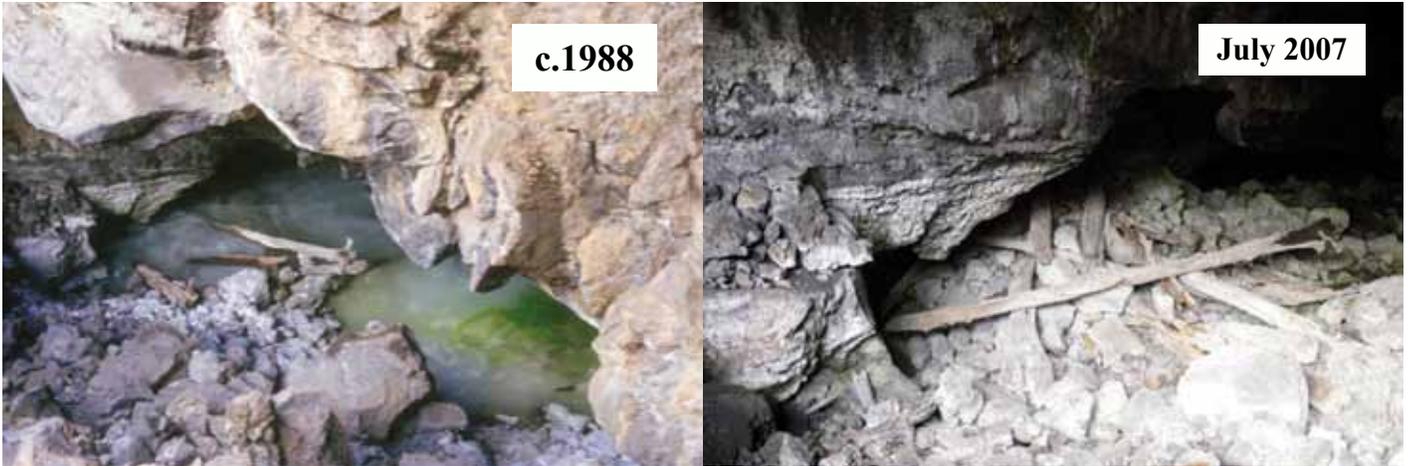
Figure 1a: View into Rusty Barrel Cave in the 1980s (left) showing the year-round ice. The same area seen in 2007 (right) shows that the ice is completely gone.

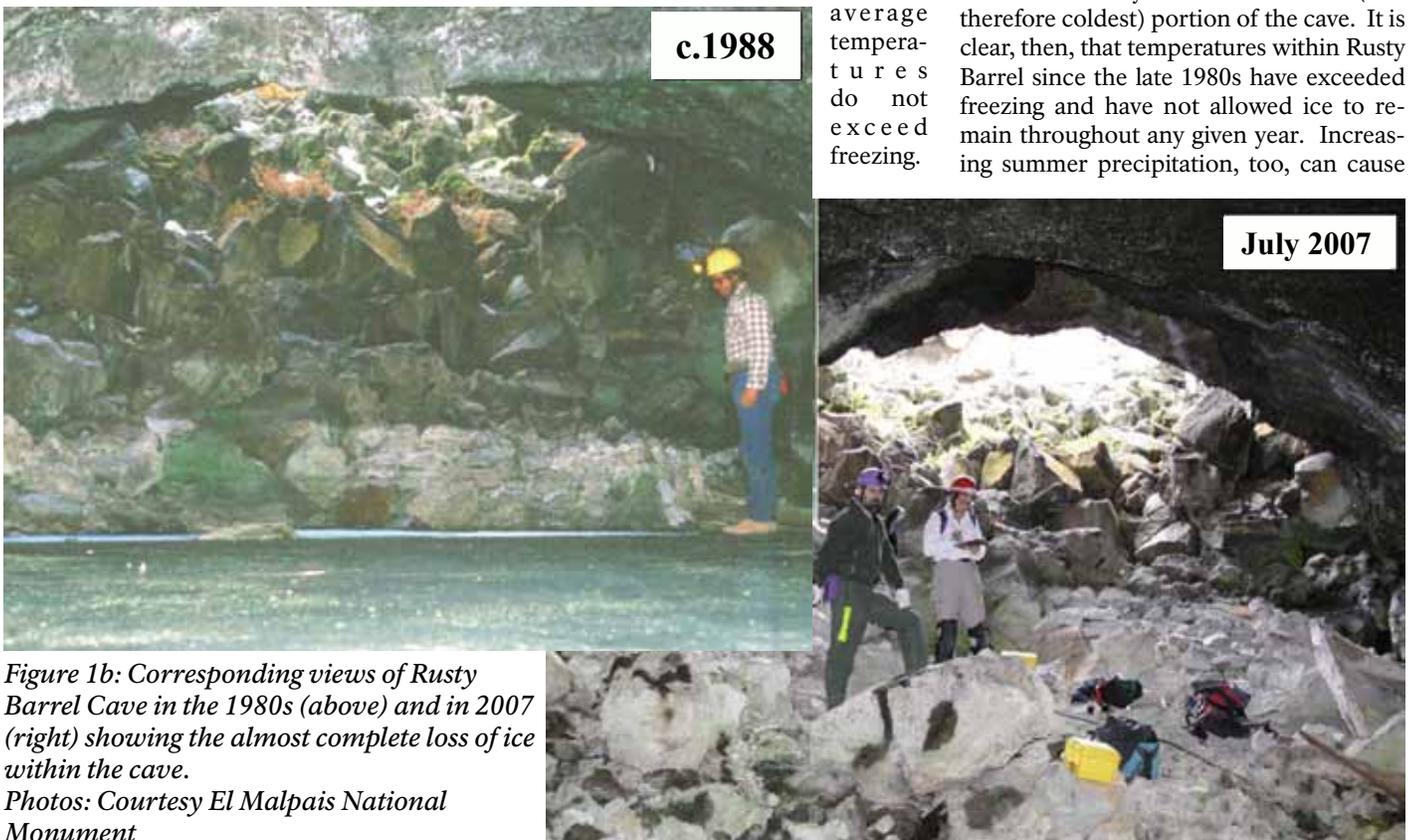
Figure 1b: Corresponding views of Rusty Barrel Cave in the 1980s (above) and in 2007 (right) showing the almost complete loss of ice within the cave.

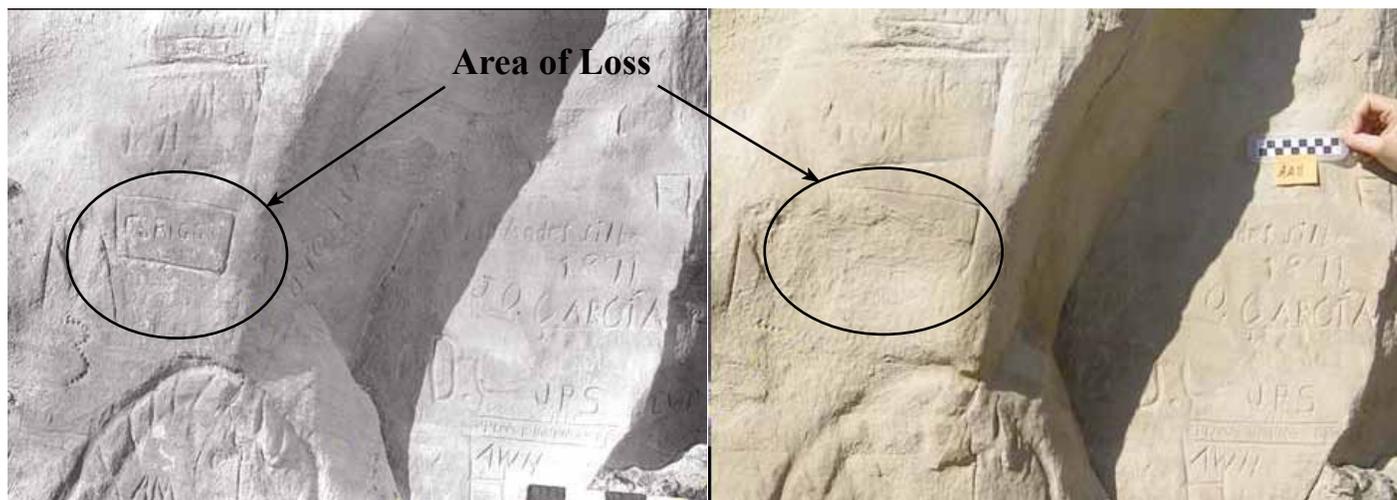
Figure 2: As part of the Inscription Preservation Project at El Morro, historic and contemporary photographs are compared to identify areas where inscriptions are being lost. Here a photo from 2006 (right) clearly shows deterioration on the face of the sandstone bluff when compared to a photo from 1994 (left).

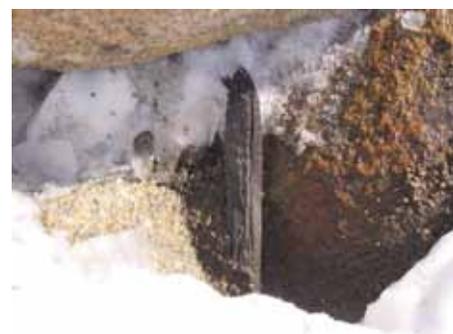
A wooden artifact that has been embedded and preserved in ice for centuries slowly emerges from the ice as regional temperatures rise.

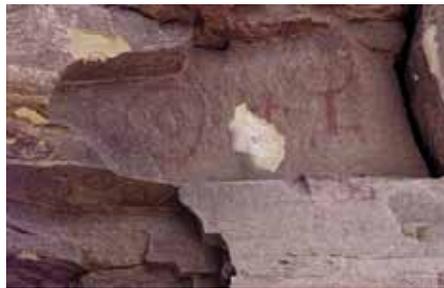
This rock face, containing pictographs, has spalled as a result of the heat from a wildfire.

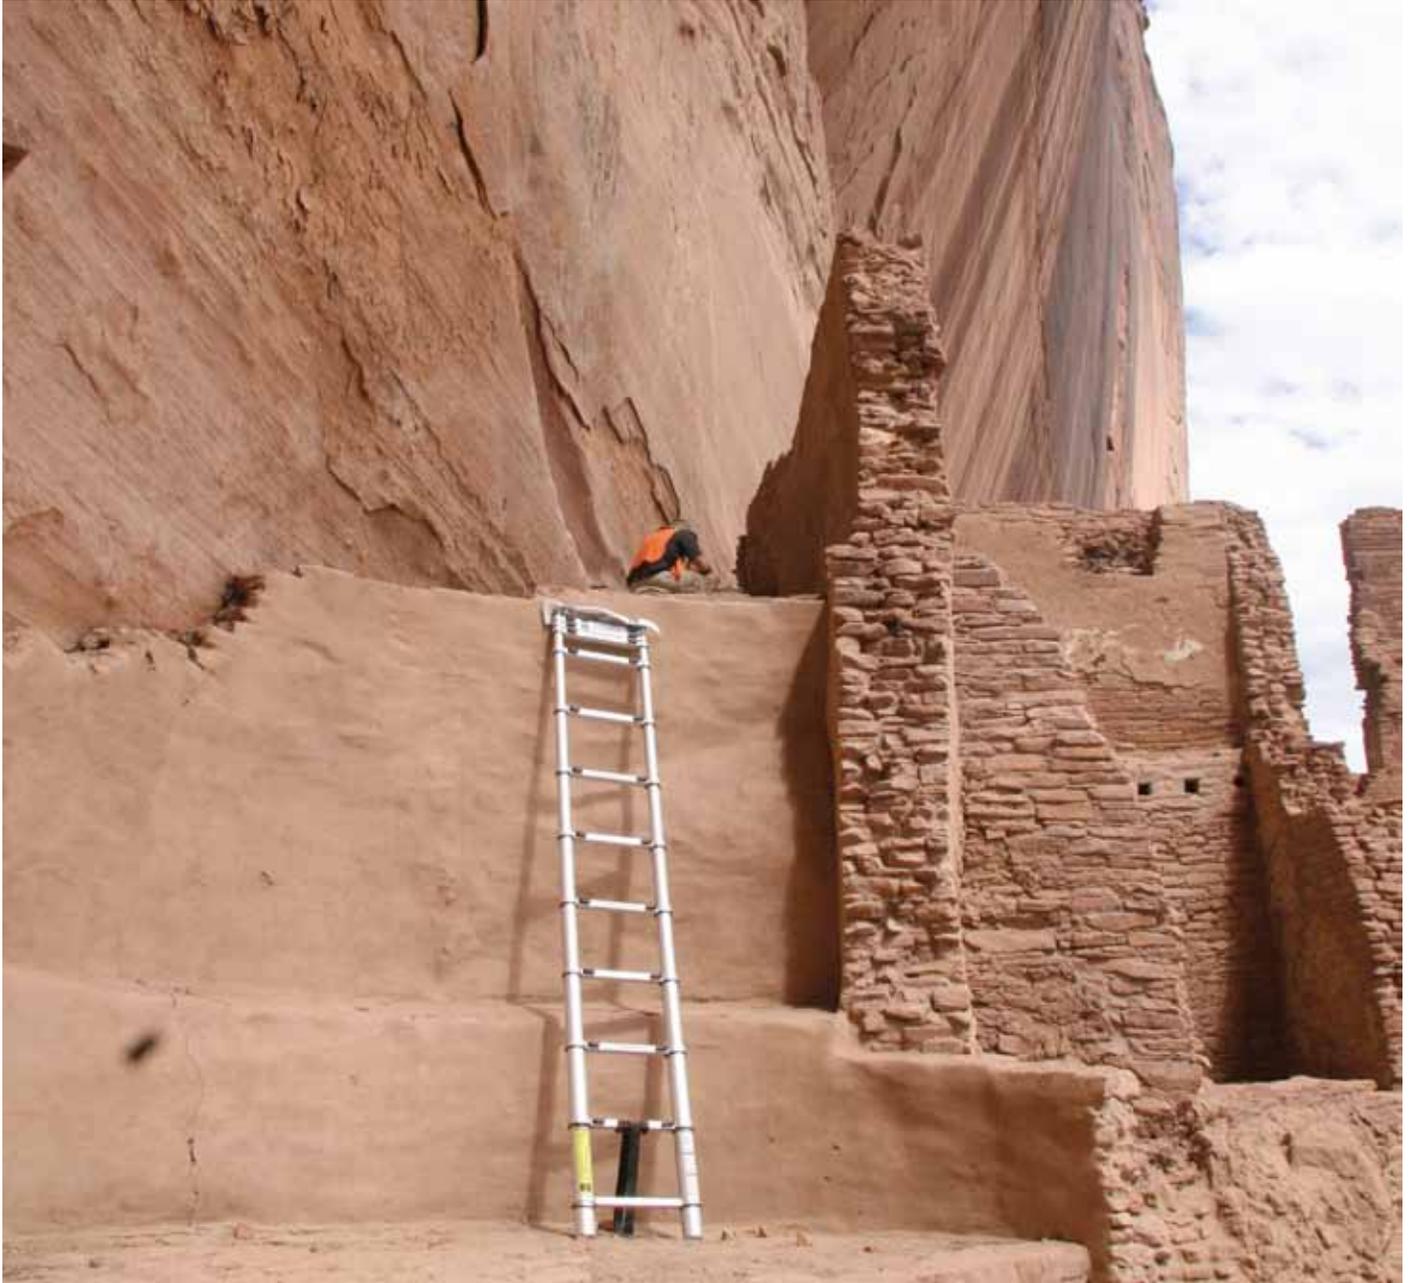
Recording wall data at White House Ruin, Canyon de Chelly National Monument

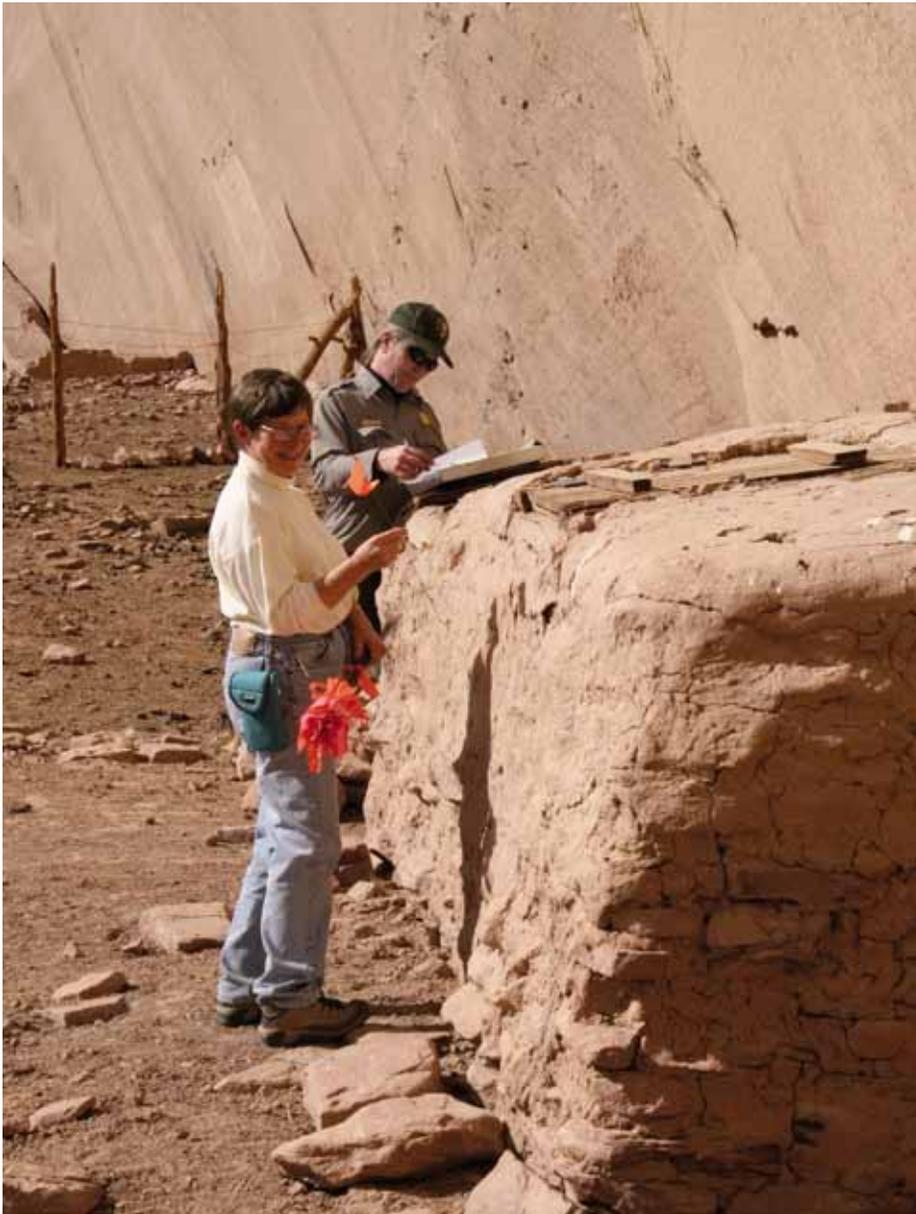
Keith Lyons, and Martha Pennington, record historic Navajo storage structures at Standing Cow Ruin, Canyon de Chelly National Monument.

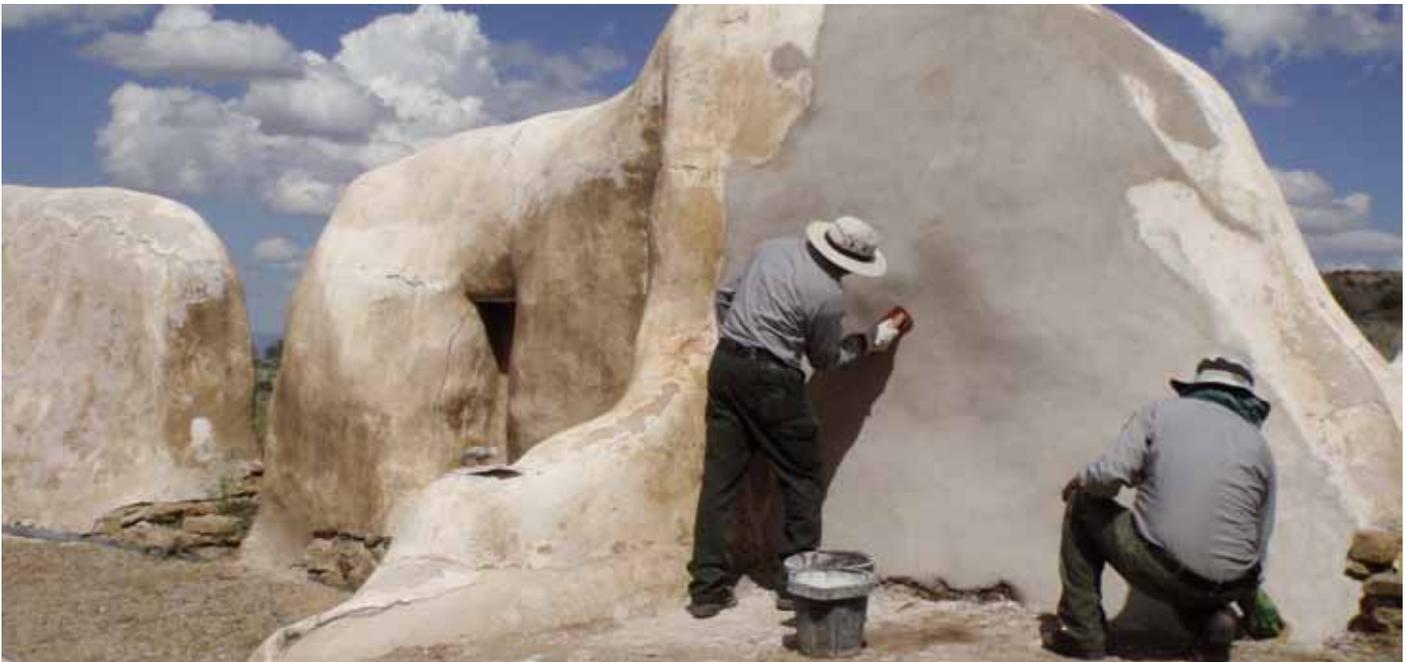
*Phil Tapia Jr. and Fernie Nunez repair the post trader's store, Fort Bowie National Historic Site.
Photo: Karen Weston Gonzales*

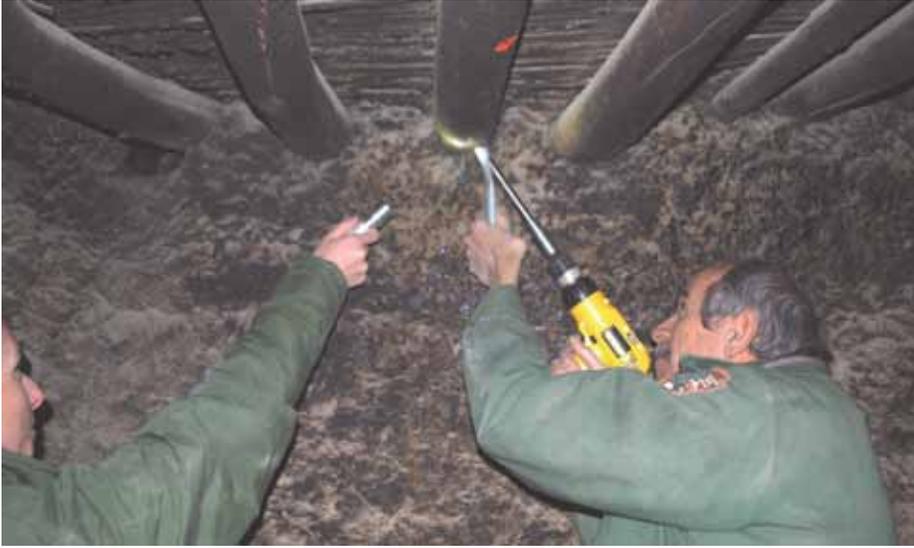
*Melissa Philibeck and researcher Thomas Windes extract a tree-ring core in room 3-4 of Montezuma Castle, Montezuma Castle National Monument.
Photo: Courtesy Montezuma Castle National Monument*

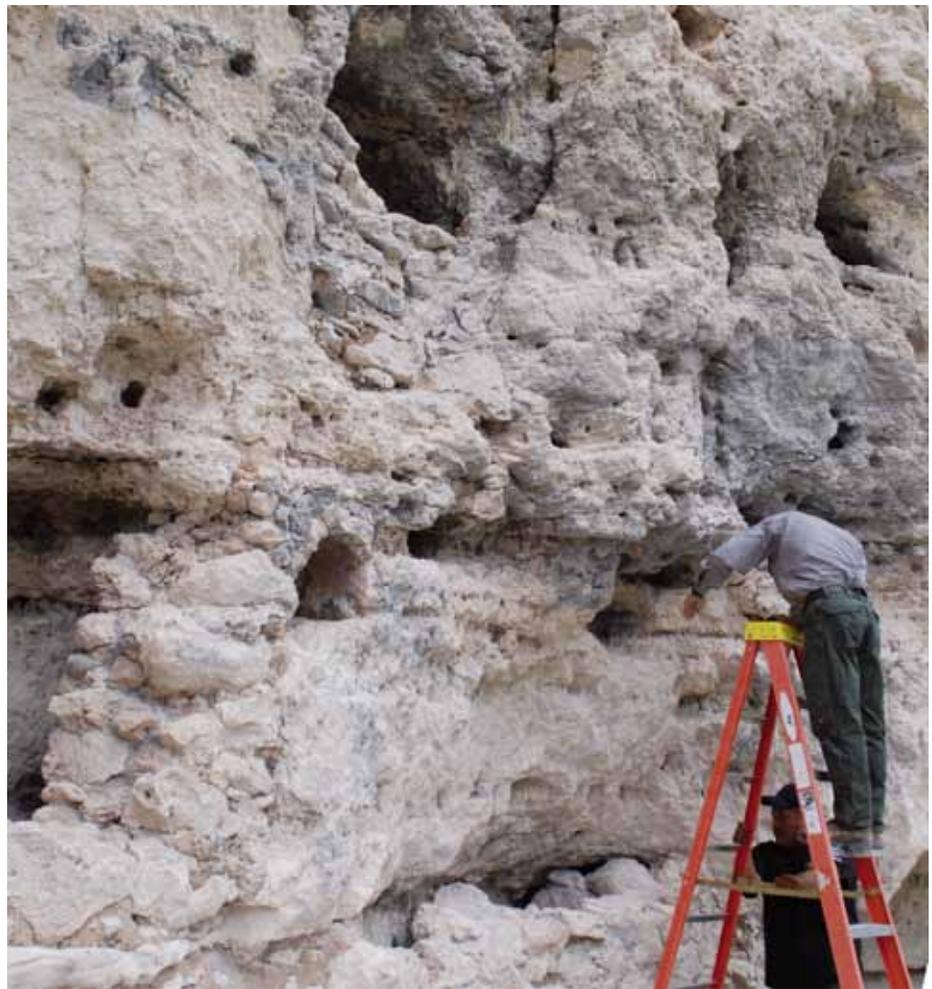
*Matt Guebard and Jeremy Navenma inspect the Castle A ruins at Montezuma Castle, Montezuma Castle National Monument.
Photo: Courtesy Montezuma Castle National Monument*

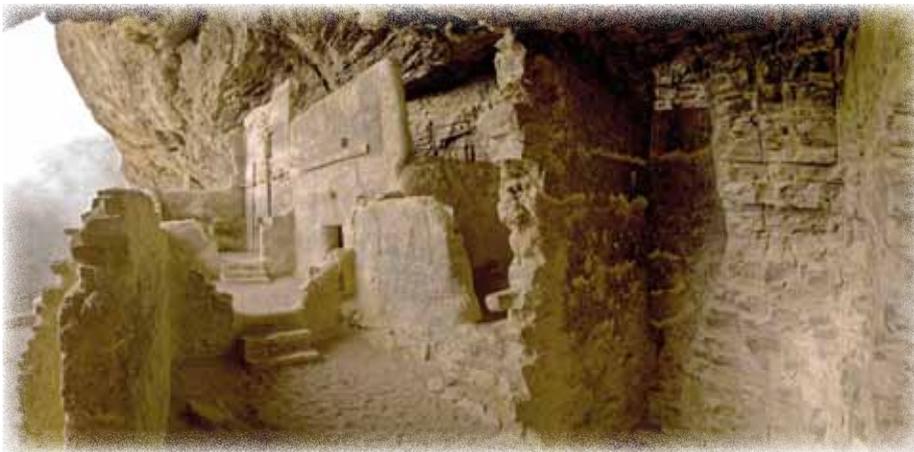
*Interior view of the Lower Cliff Dwelling, Tonto National Monument.
Photo: Courtesy Tonto National Monument*

In addition to the work on the retaining walls, preservation crews completed projects at the Upper, Lower, and North Annex Cliff Dwellings, including preserving prehistoric walls by injecting unamended mortar into areas of insect/animal damage and visitor disturbance, and preserving NPS constructed features (stairs, benches, and doorways) within the dwellings using stucco and stucco/soil mixtures.

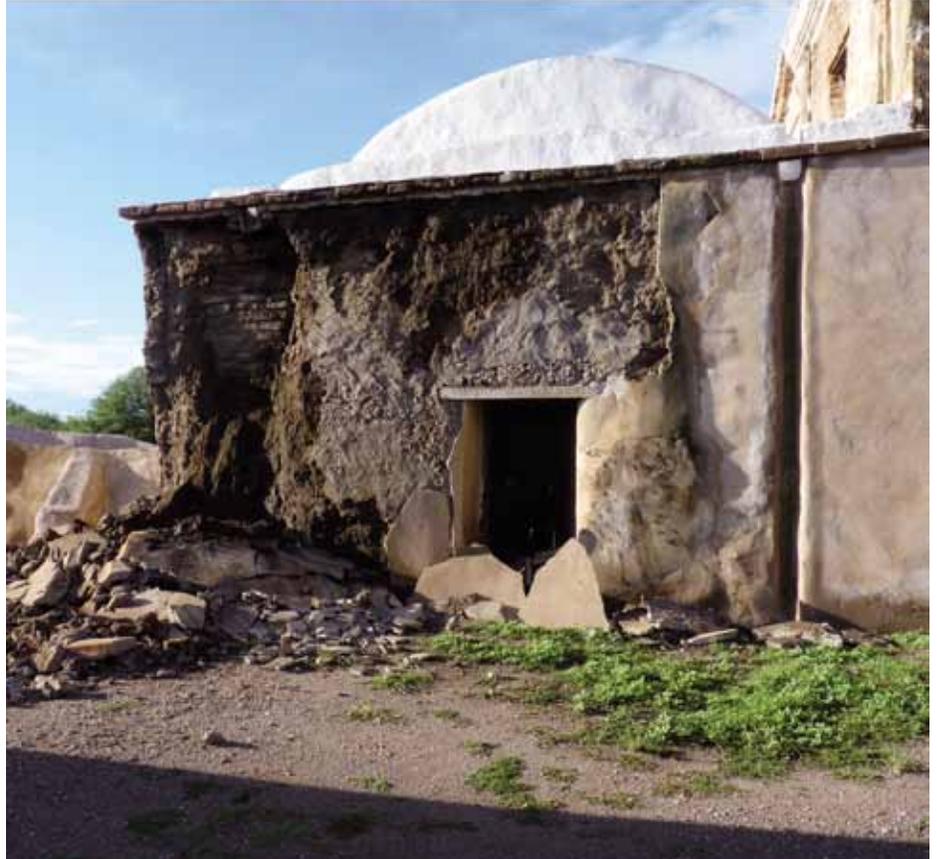
*Failure of the north wall of the sacristy, Tumacácori National Historical Site.
Photo: Courtesy Tumacácori National Historical Site*

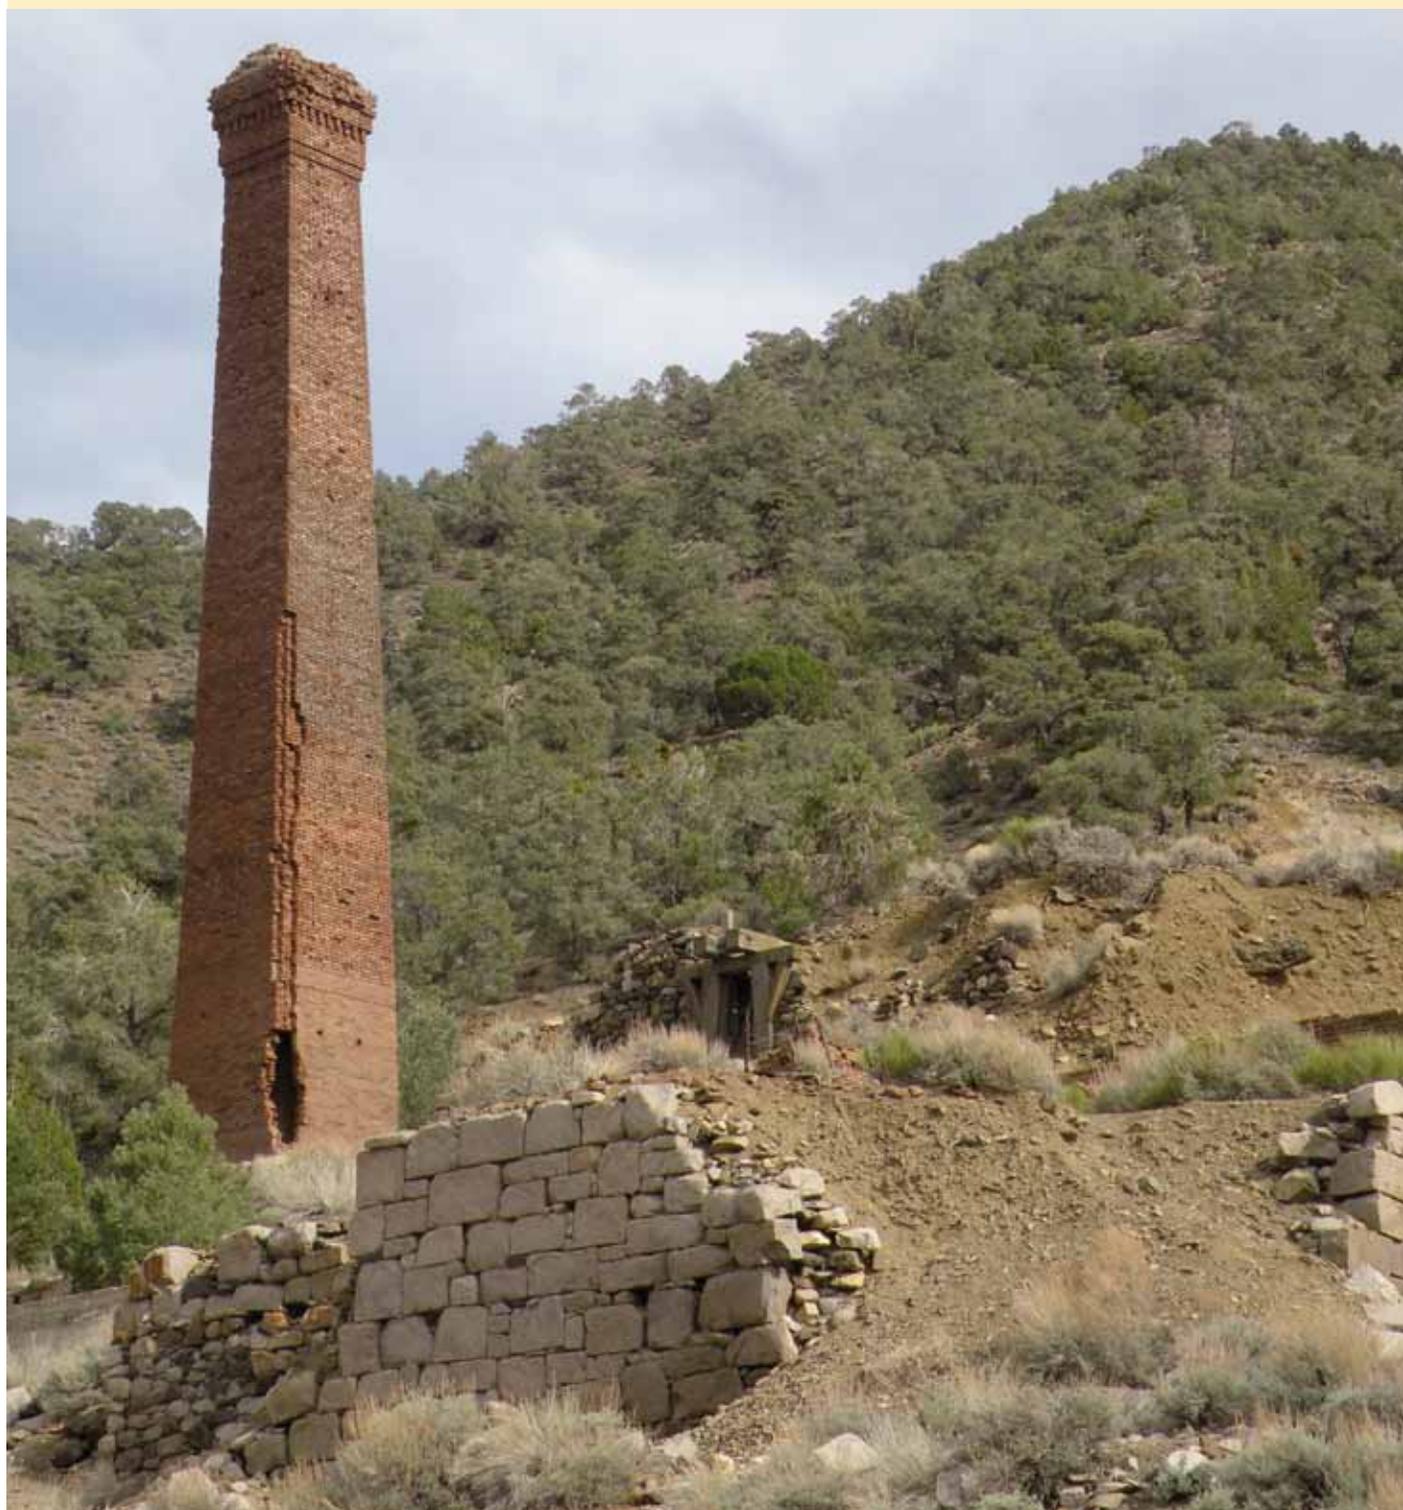
Retaining walls and a 70-foot brick stack are all that remain of the Panamint City smelter, Death Valley National Park

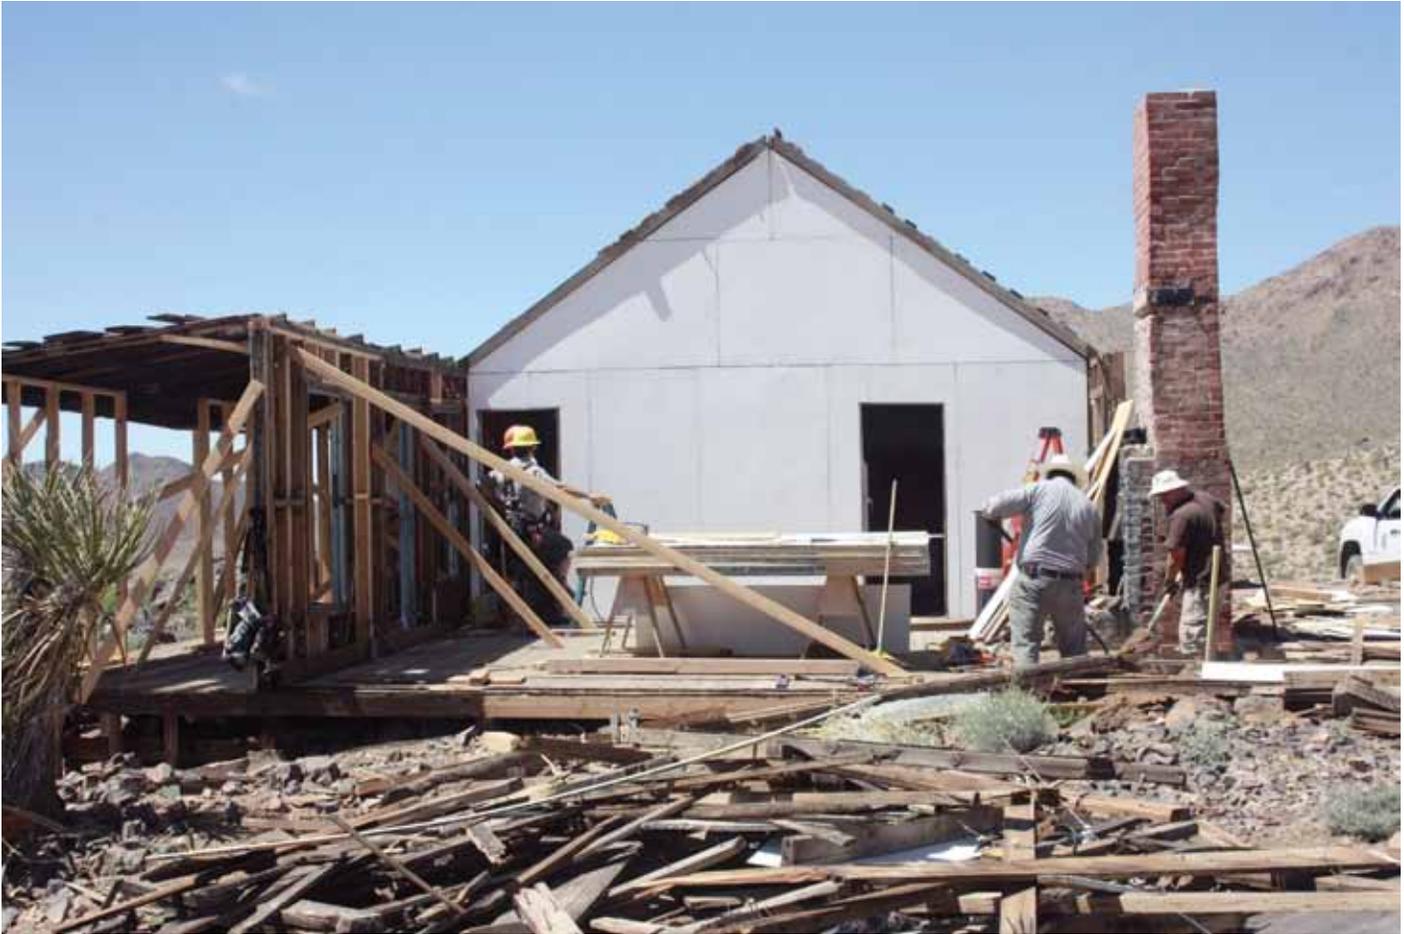
*The Mojave Historic Structures Maintenance Crew works on Hilltop House, Mojave National Preserve.
Photo: Jennifer Morrell*

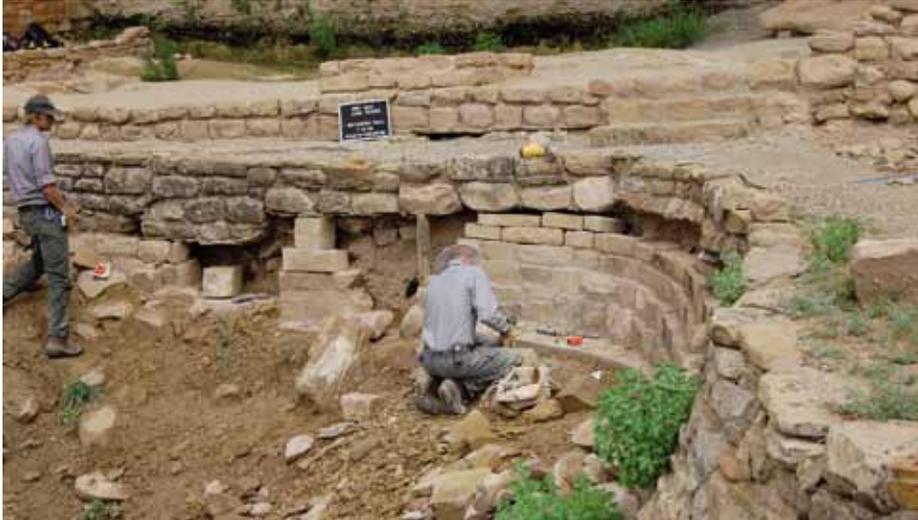
STEP employee Stephen Matt and Masonry Worker Neill Smith work on the retaining wall at Long House, Mesa Verde National Park.

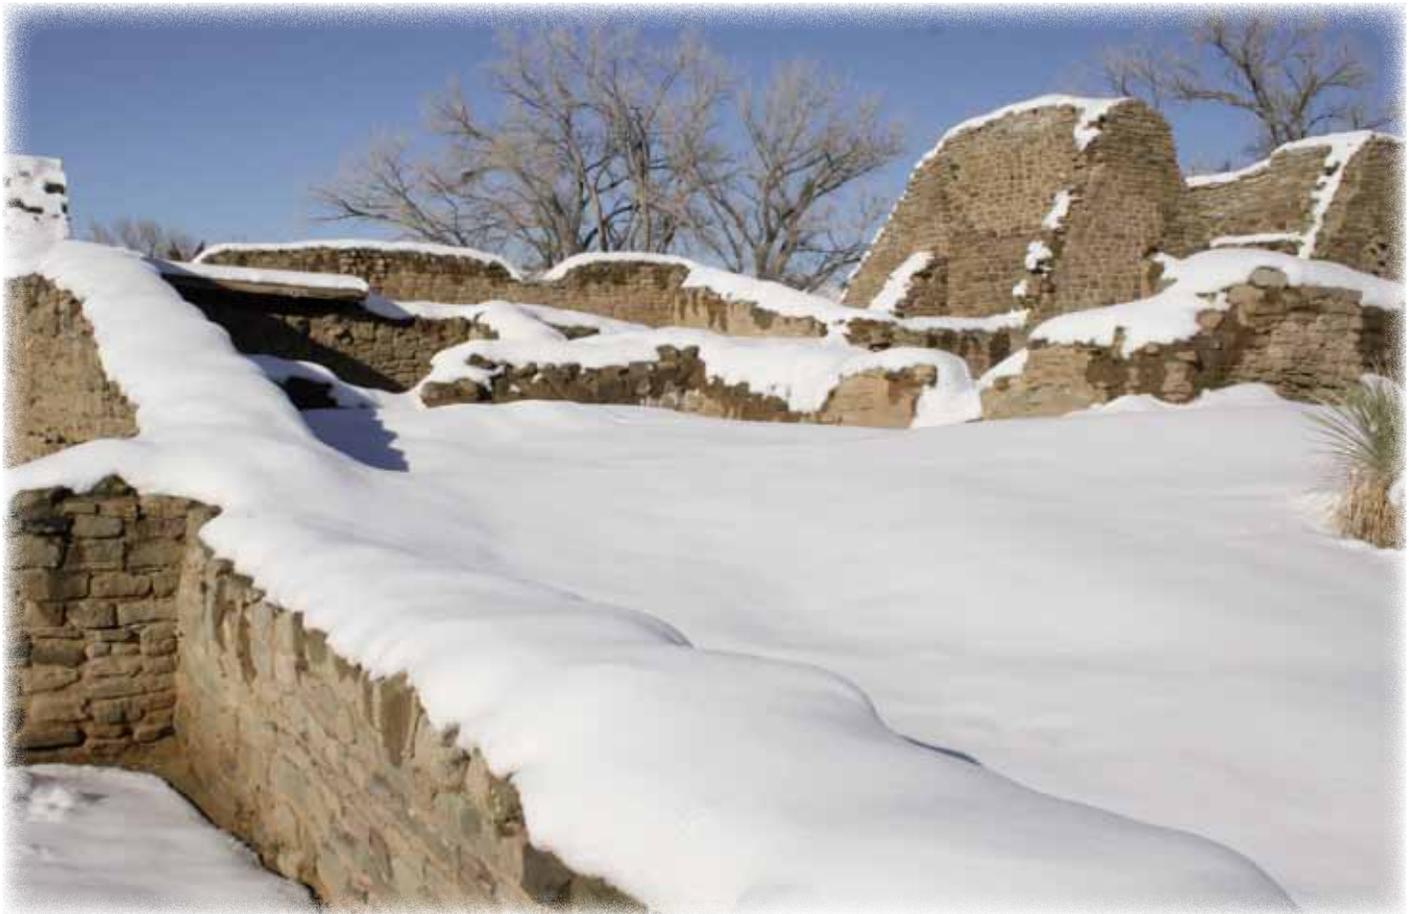
Although beautiful, the winter snow contributes to deterioration of the ancient architecture at Aztec West Ruin, Aztec Ruins National Monument.

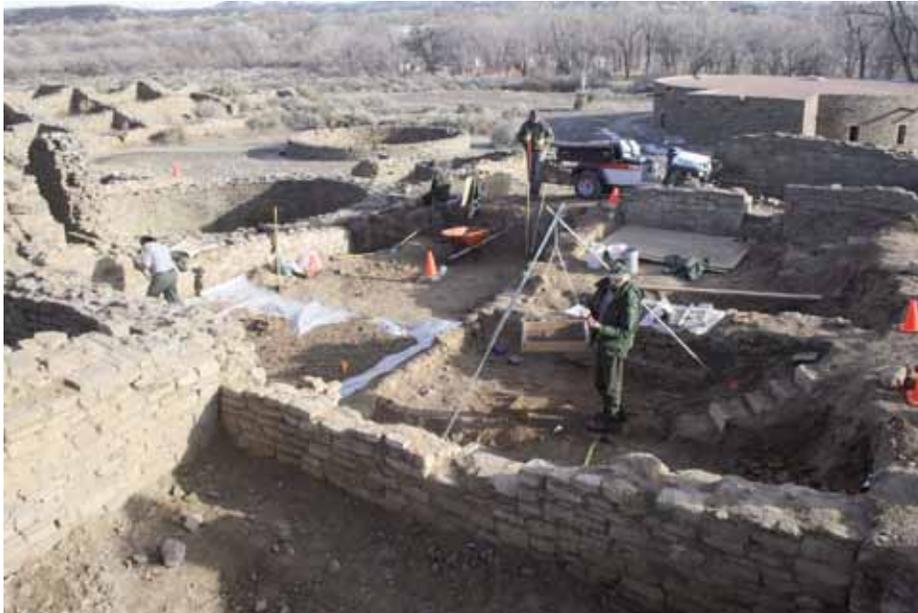
Archeological test excavations and backfilling in the Fill Levels Adjustment project area at Aztec West Ruin, Aztec Ruins National Monument.

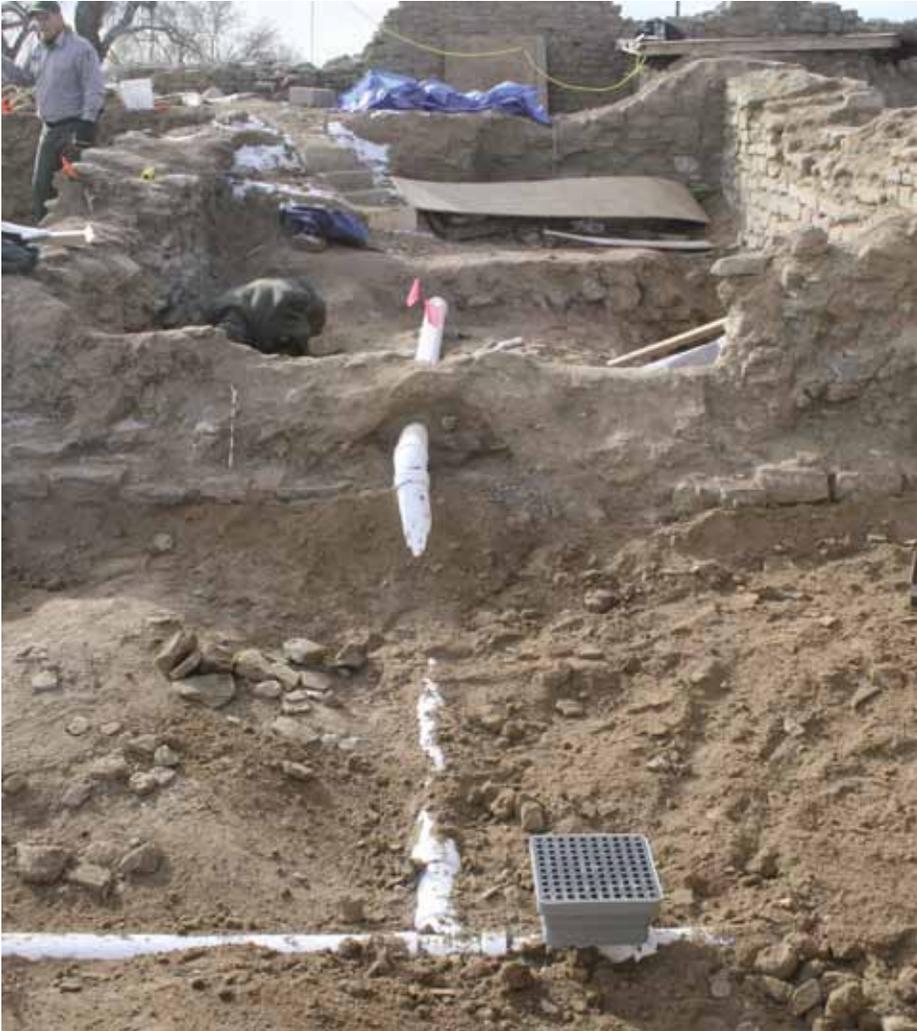
Installation of PVC drainage system during backfilling in Fill Levels Adjustment project area at Aztec West Ruin, Aztec Ruins National Monument.

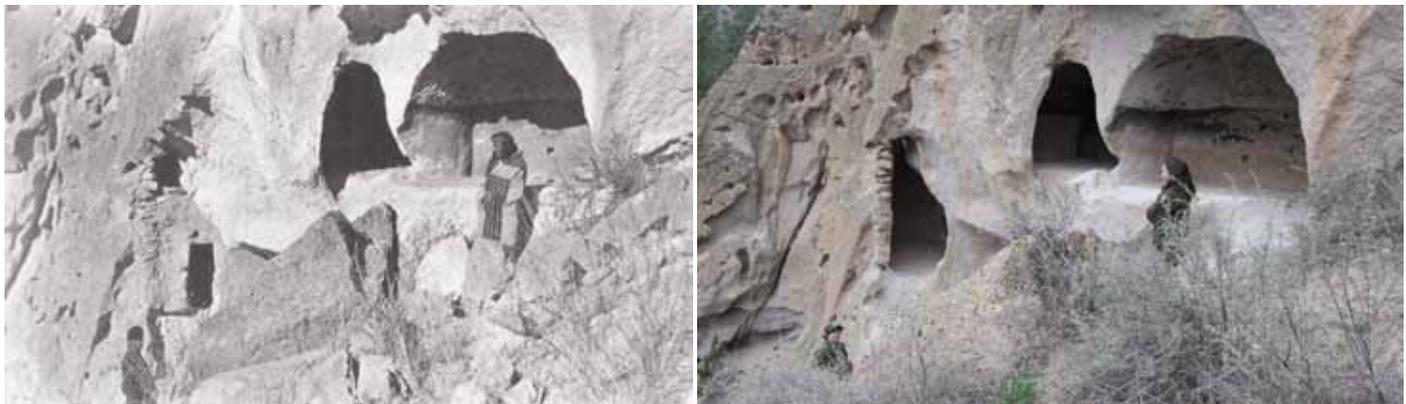
Bandelier monitors and documents incremental and catastrophic loss by recreating photo points from historic images. In this scene, Stephen Merkel and Lauren Meyer (right) stand in front of cavate B002, illustrating the loss of an intact masonry doorway that is visible in a late 19th century photograph (left), Bandelier National Monument. Photos: Courtesy Bandelier National Monument

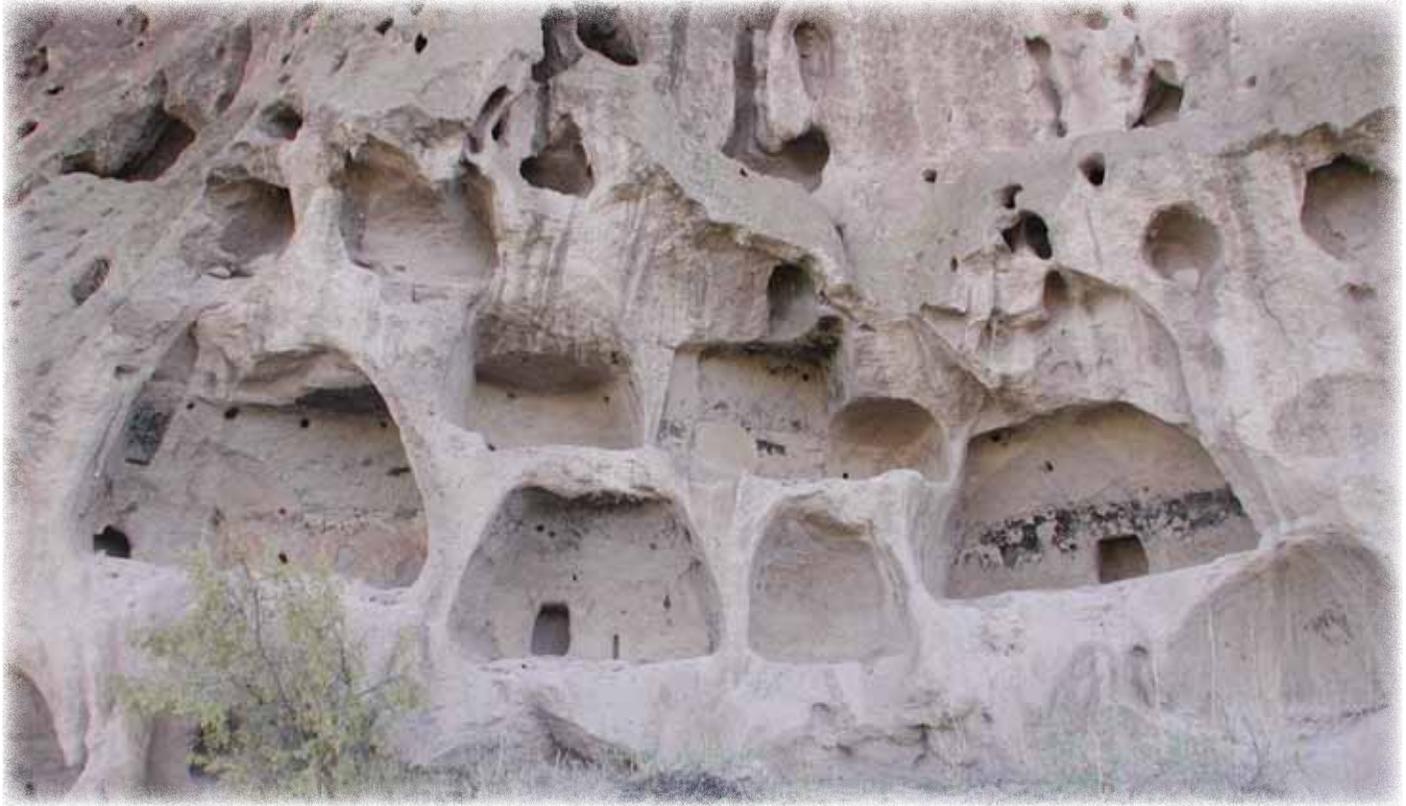
Group M in Frijoles Canyon, a three-story cavate pueblo comprised of earthen plastered interconnected cavates, architectural features such as smoke holes and viga sockets on the cliff face, standing masonry walls at the cliff base and, shallow depressions that remain as the rear walls of once constructed rooms, Bandelier National Monument.
