Vanishing Treasures

Vanishing Treasures Program

A CLIMATE OF CHANGE Climate Change Issue

**Fiscal Year 2010 Year-End Report
and
Funded Projects for 2011**

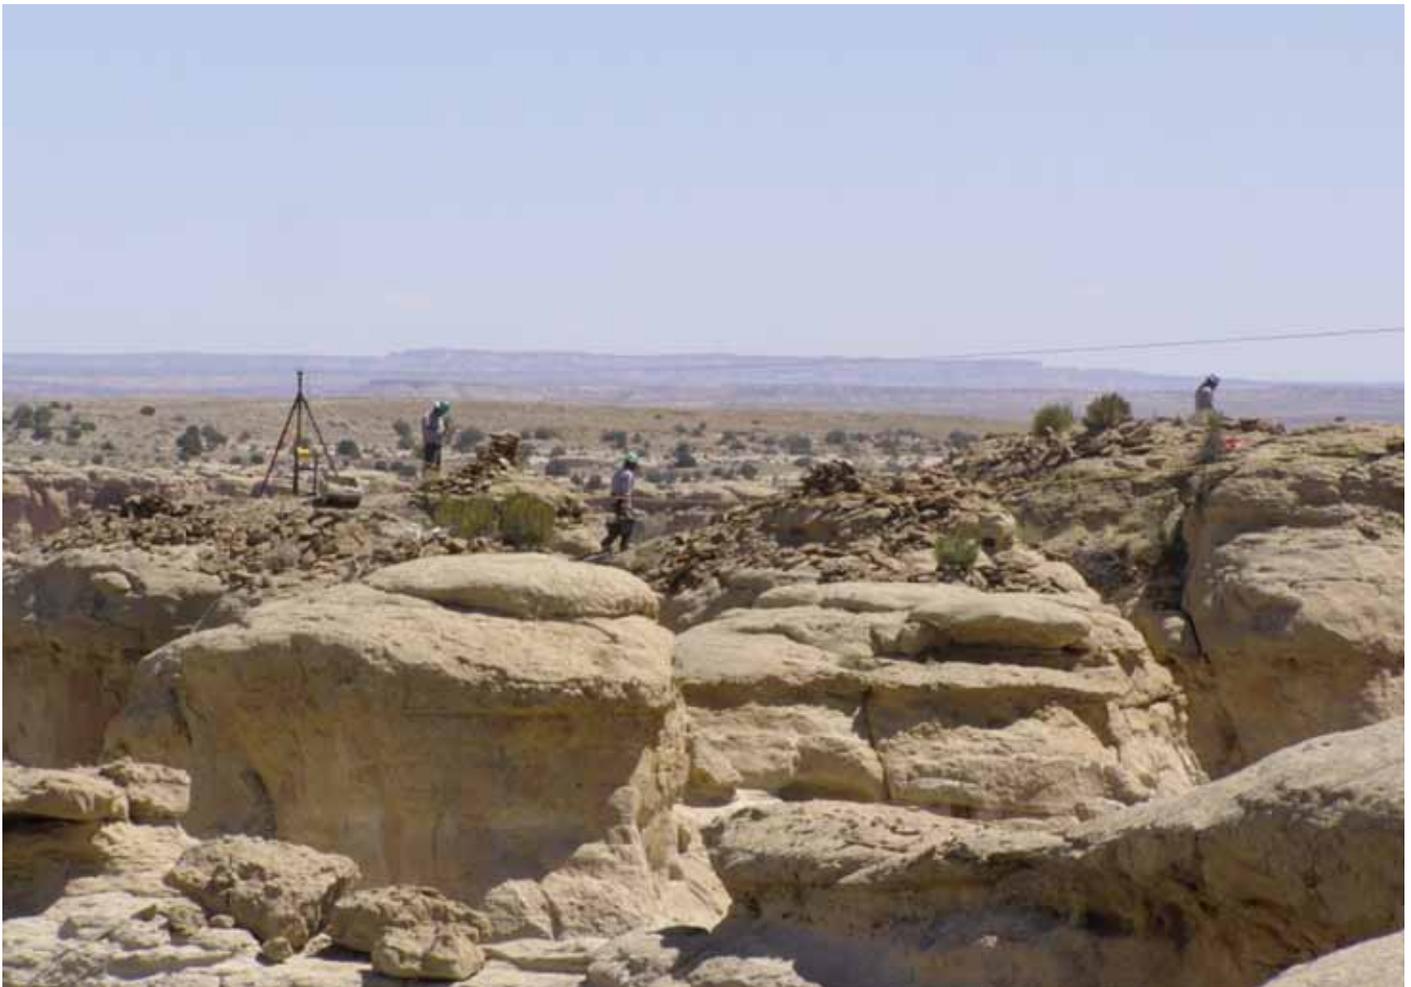
To work on the Chacra Fortress Site the preservation crew had to design and build a conveyor system to get mud and equipment to this difficult-to-access site which is located on several adjoining 20-foot tall sandstone pinnacles on a narrow mesa finger, Chaco Culture National Historical Park.

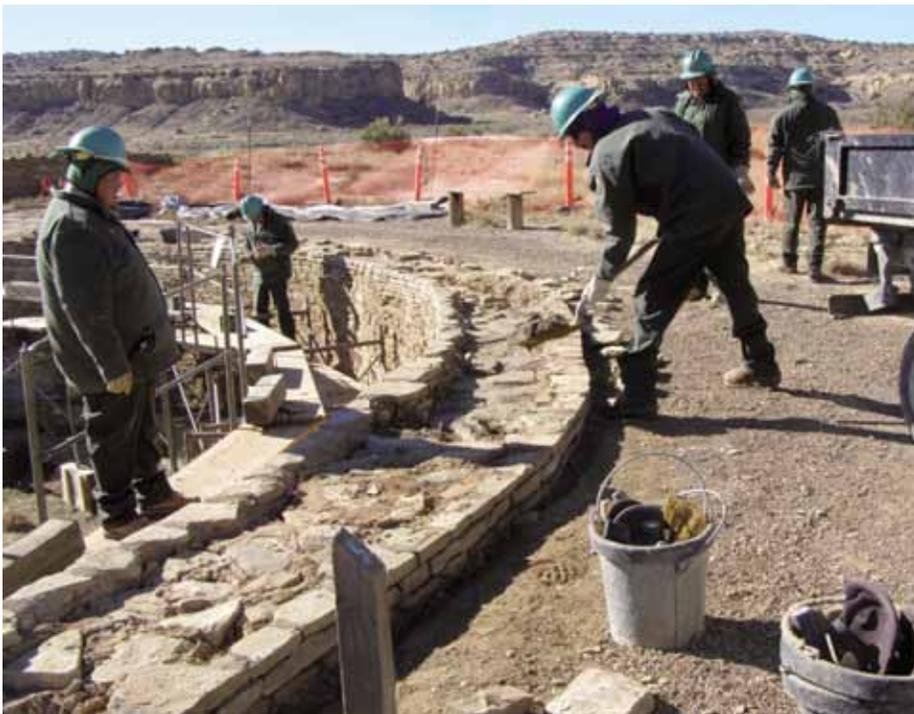
Adding additional capping to the great kiva at Chetro Ketl will allow the grade to be raised around the kiva's perimeter so moisture will flow away from the kiva walls, Chaco Culture National Historical Park.

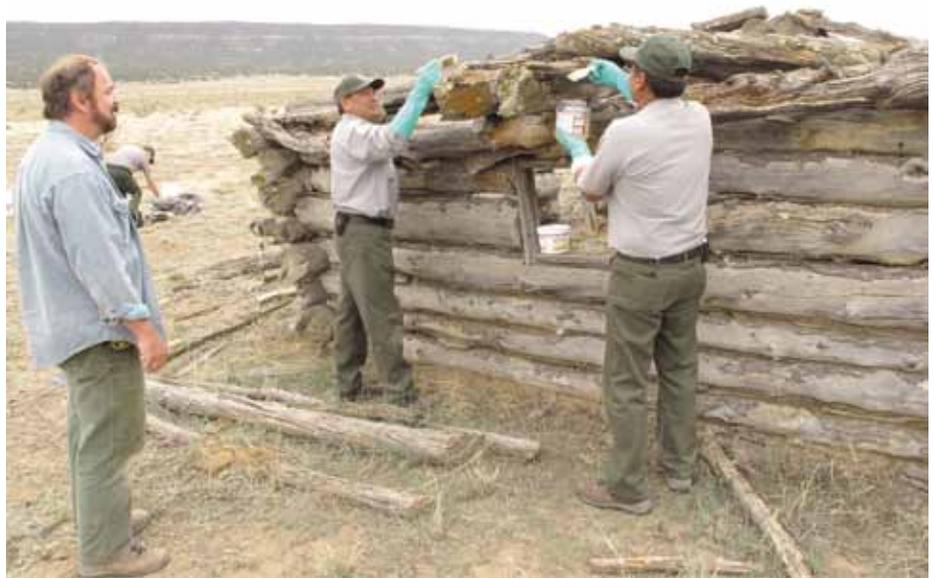
Calvert Ondelacy and Edwin Seowtewa apply borate solution to the Head Homestead during a one-day field school under the direction of VT Historical Architect Randy Skeirik, El Malpais National Monument.

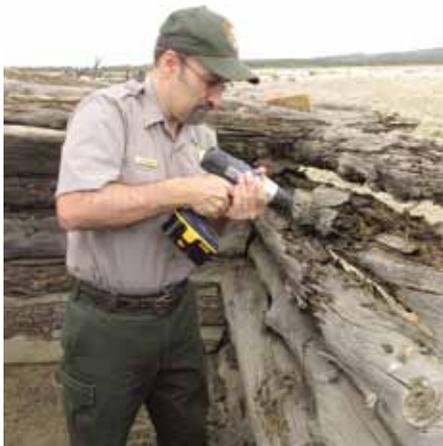
Using a drill and a long, narrow bit, Jim Kendrick looks for deterioration in a wall timber at the Head Homestead during a one-day field school conducted by VT Historical Architect Randy Skeirik, El Malpais National Monument.

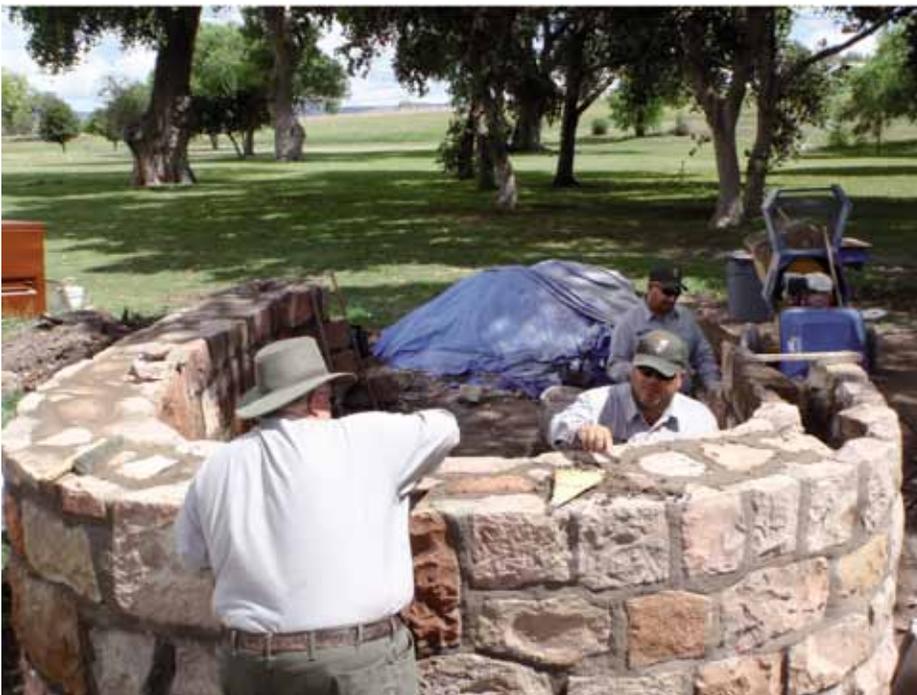
Fort Davis preservation staff work on the spring enclosure, Fort Davis National Historic Site.

VT Challenges and Successes: Our greatest challenge for FY 2010 was the stabilization effort on the historic Spring Enclosure, a project that was funded with regular cyclic funds. The original scope of the project called for repointing of existing stonework. However, when we removed support bands placed during a previous stabilization effort, the enclosure fell apart. It was subsequently discovered that the enclosure sat on an unstable surface. After the collapse, a contracted archeologist was brought in to conduct investigative excavations, which revealed an earlier dry-laid enclosure below the surface. This earlier structure was documented and encapsulated by recompacting the soil around it, installing a time medallion, covering it with filter fabric, and pouring a subsurface concrete pad over it, on which the reconstructed spring house now sits. When the partially collapsed enclosure was deconstructed, the stones were numbered, mapped, and photo-documented. The section that was still standing in 1916 photos was then

reconstructed to match. The additional stones were cleaned, reused, and relaid in a matching pattern. Mortar analysis was performed on the historic mortar and it was found to have used natural cement as a binder.

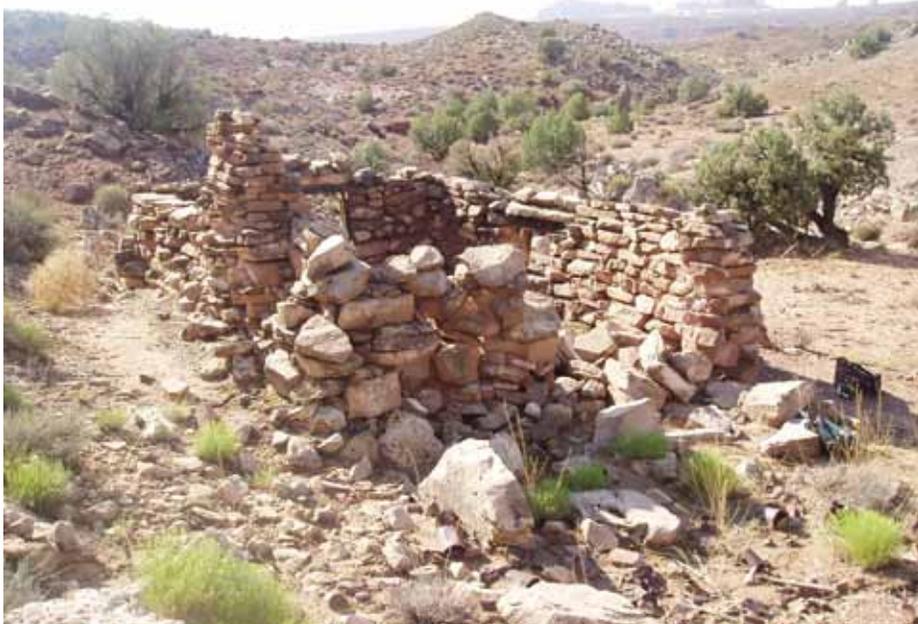
The remains of the Stone Cabin, Arches National Park. Photo: Randall Skeirik

Condition assessments were performed in 2006 and again in 2009, and the park was provided with a Treatment Recommendation Report for the structure (Skeirik, 2009). The most immediate concern is the stabilization of the south wall, where a poor foundation and a failed wood window frame have caused the wall to lean precariously outward. In the short-term it is essential that this wall be braced to prevent its collapse. Once stabilized with temporary bracing, the deteriorated members of the window frame will be replaced and the wall slowly jacked back to a vertical position. Similar, though less drastic, repairs will be made to the wood window

frame on the east wall. Deteriorated mortar will be removed from all remaining masonry and the walls, fireplace, and chimney repointed with new mortar formulated to match the original in composition and appearance. Particular care will be taken to appropriately cap the walls to minimize the entry of moisture into the restored walls. Before work can be conducted on the fireplace, chimney, and north wall, the flue and firebox must be cleared of packrat nest material. This work will require Tyvek suits and respirators in order to protect against infection with Hantavirus. Other challenges in executing this project stem from its relatively remote location, the lack of a nearby water source, and its location in an area rich in cryptobiotic soils.

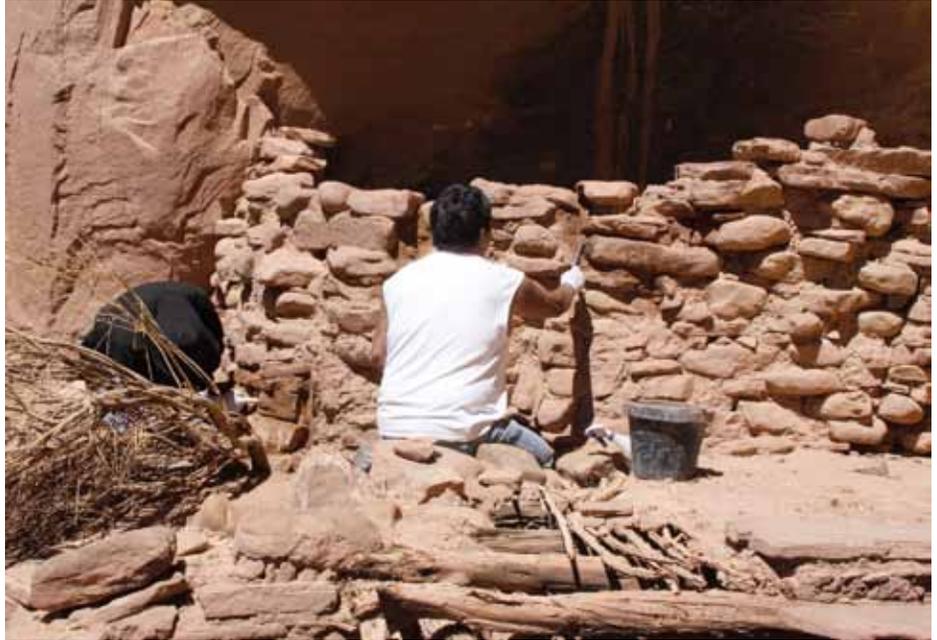
Herschel Talashoma repointing the exterior of a kiva wall, Natural Bridges National Monument.

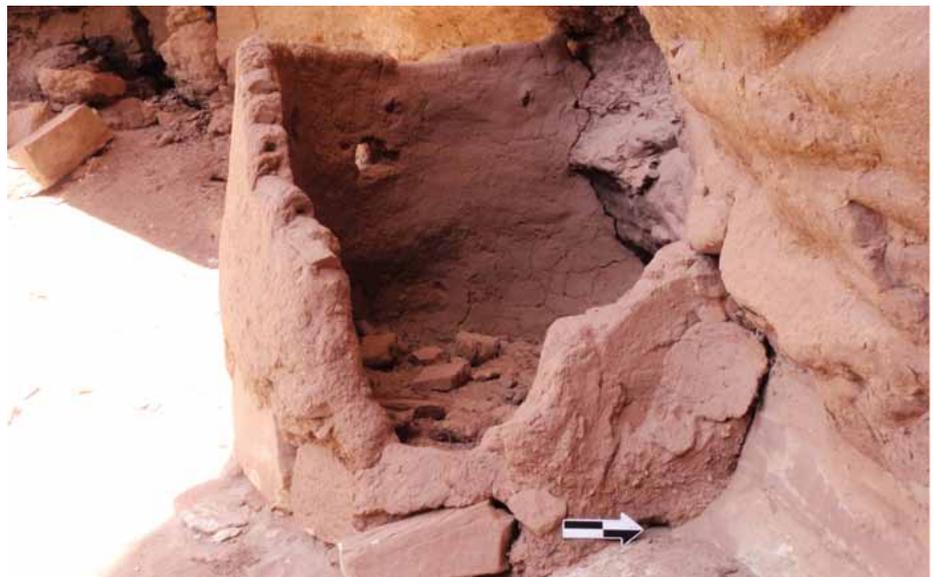
"Turtle-Back" style adobe construction at 42SA6815, Natural Bridges National Monument.

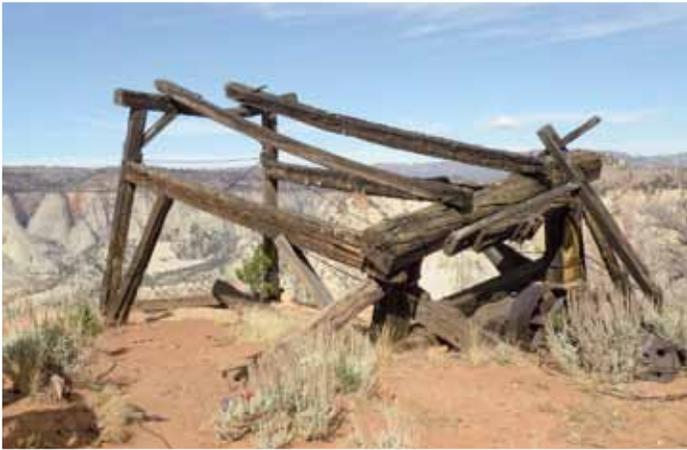
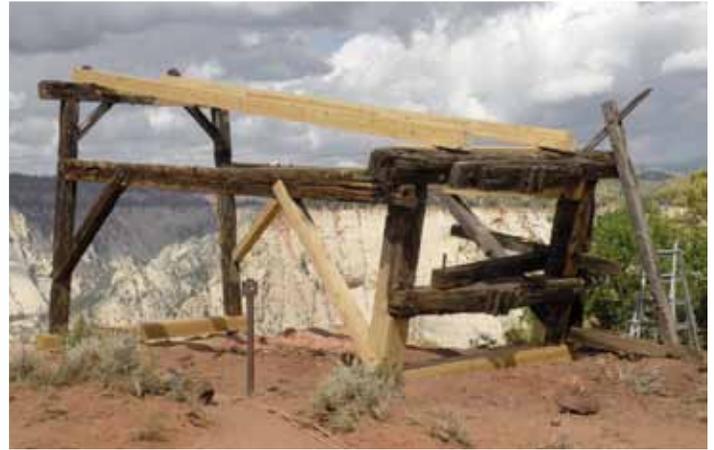
The Cable Draw Works before and after rehabilitation.
Photos: Randall Skeirik

Project Accomplishments: The Cable Mountain Draw Works is an aerial cableway that was historically used to move harvested timber and sawn lumber from East Mesa, down 2,000 feet to the Zion Canyon floor below. Established in 1901, the Draw Works was used to move hundreds of thousands of board feet of lumber before its closure in 1926. Prior to construction of the Draw Works, movement of timber from the mountains and mesas to settlements on the canyon floor typically took several days of arduous travel.

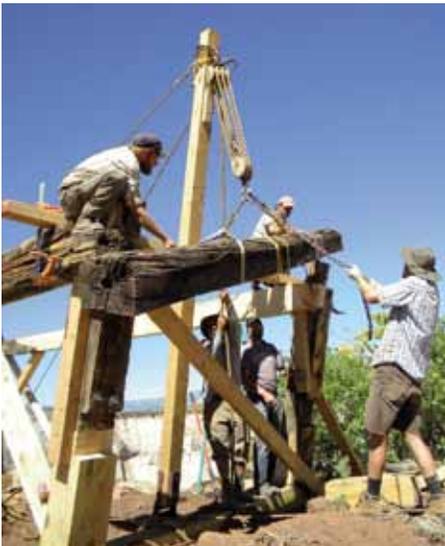
Doug Porter, Mike Cotroneo, Paul Ide, Jason Norris, and Chris Patton reconstruct the Draw Works, lifting the top brace of the east bent using a gin pole and block and tackle, Zion National Park.

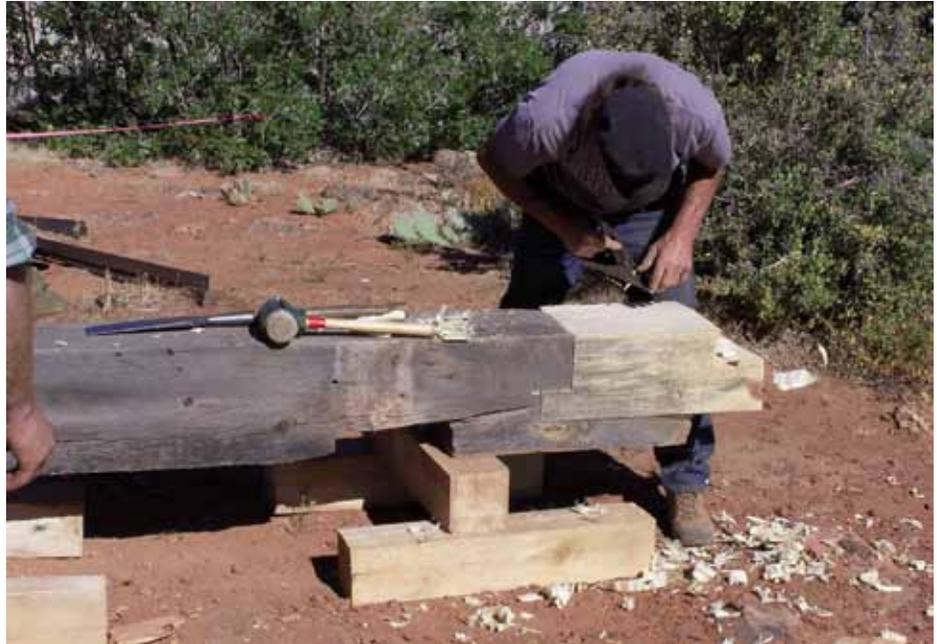
Paul Ide splicing a new end on one post of the Cable Draw Works, Zion National Park.

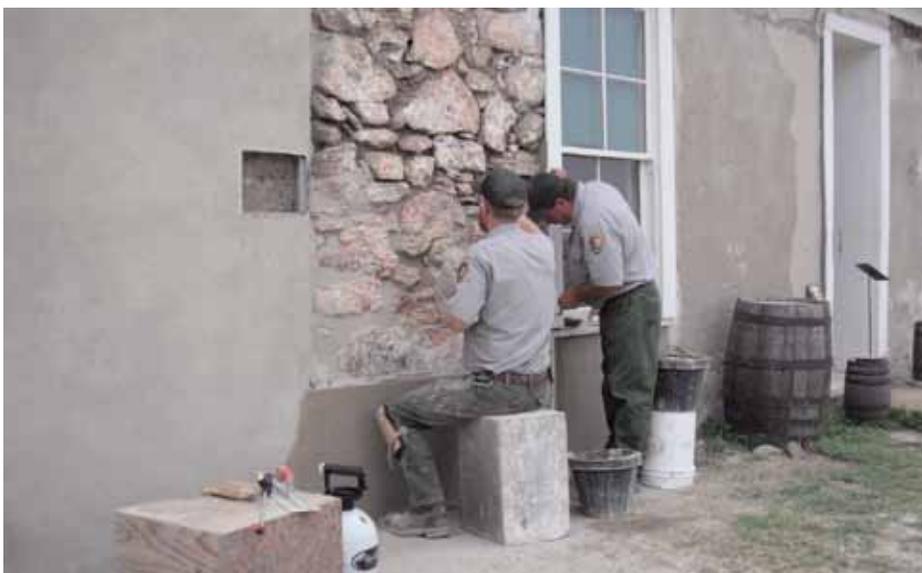
Masons repointing stonework on the Sutler's Store, Fort Laramie National Historic Site.
