**The Archeological Investigation of
Four Lighthouse Complexes at the Western End of Lake Superior:
The 1988 Testing Program Within Apostle Islands National Lakeshore**

Vergil E. Noble

Midwest Archeological Center
Technical Report No. 8

1993

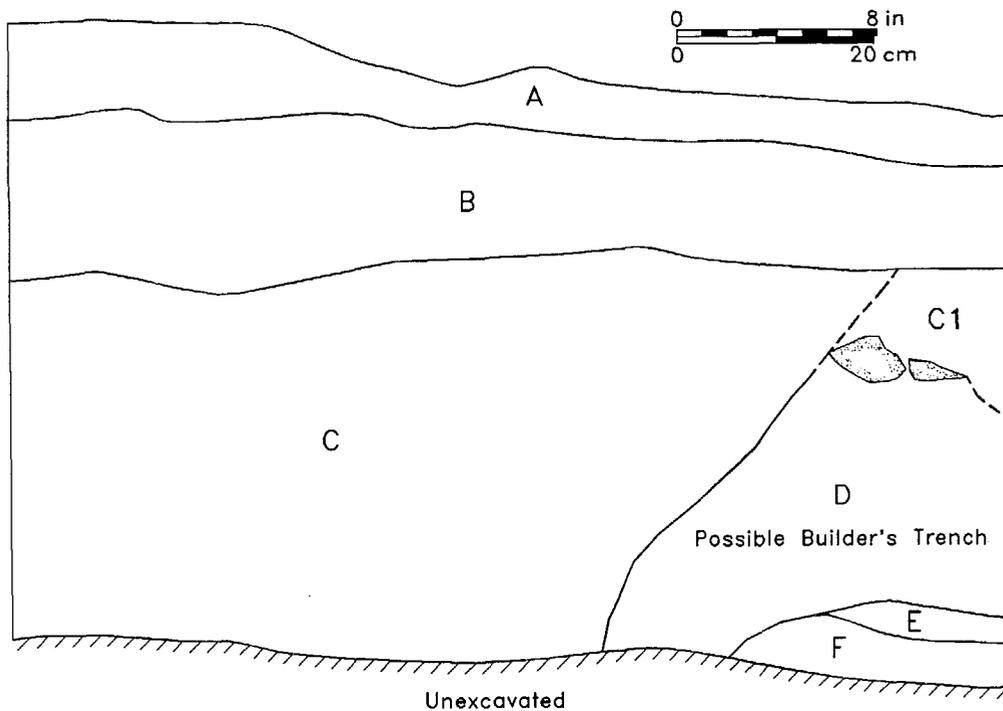
Figure 19. Michigan Island, Test Unit 1, south profile.

Sandstone Cobble

Zone A—Sod Layer, Brown Silty Loam

Zone F—Light Brown Silt

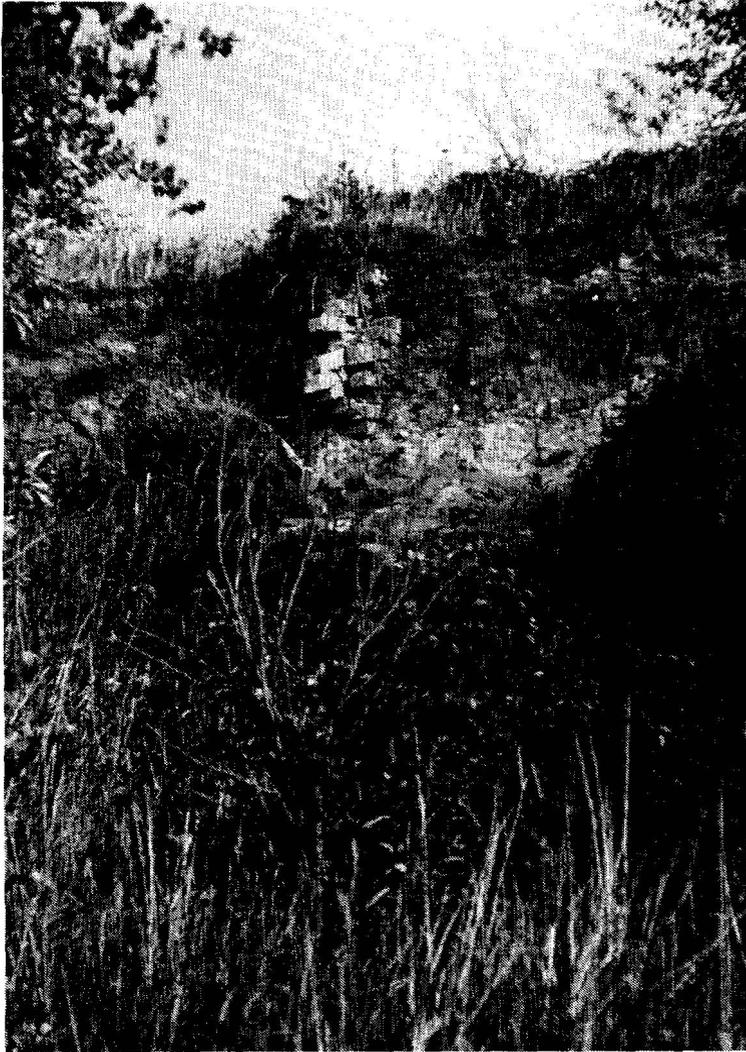
Figure 26. Fog signal foundation remnant, Outer Island.

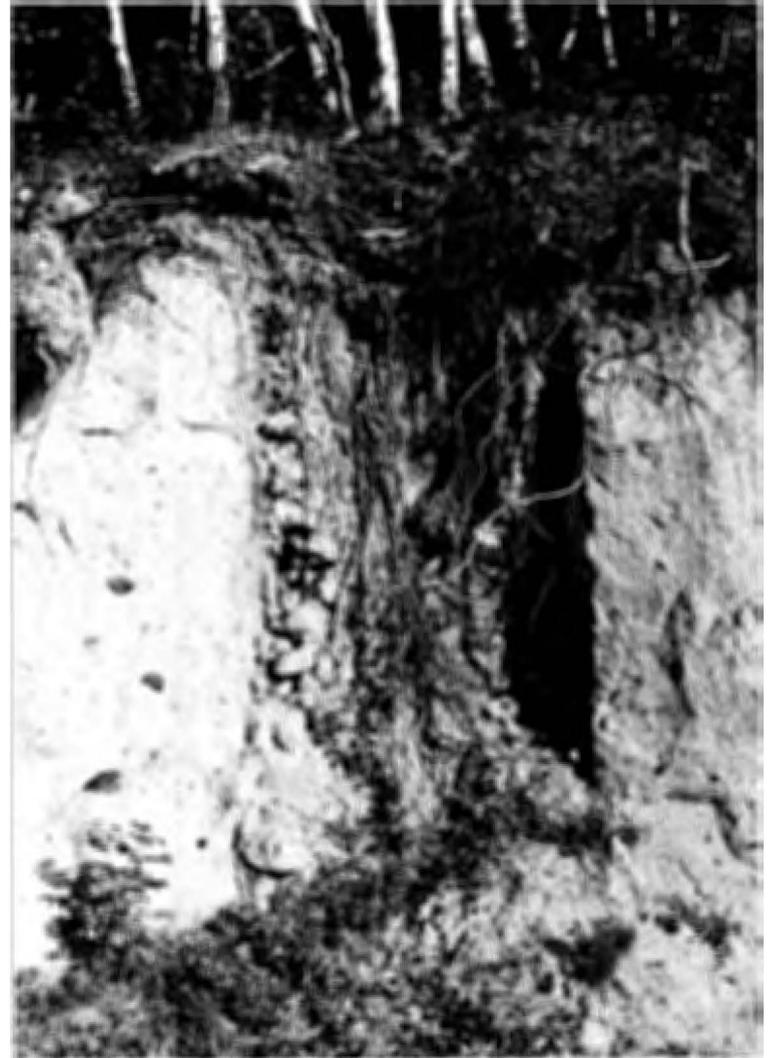
Figure 27. Well ruin in eroding bluff face, Outer Island.
