# Kaloko-Honokōhau National Historical Park

## *'AI'ŌPIO FISHTRAP DOCUMENTATION*

**'Ai'ōpio Fishtrap Documentation  
Kaloko-Honokōhau National Historical Park  
SRC Technical Report Number 24  
PMIS #98241**

Technical Report  
Number 24

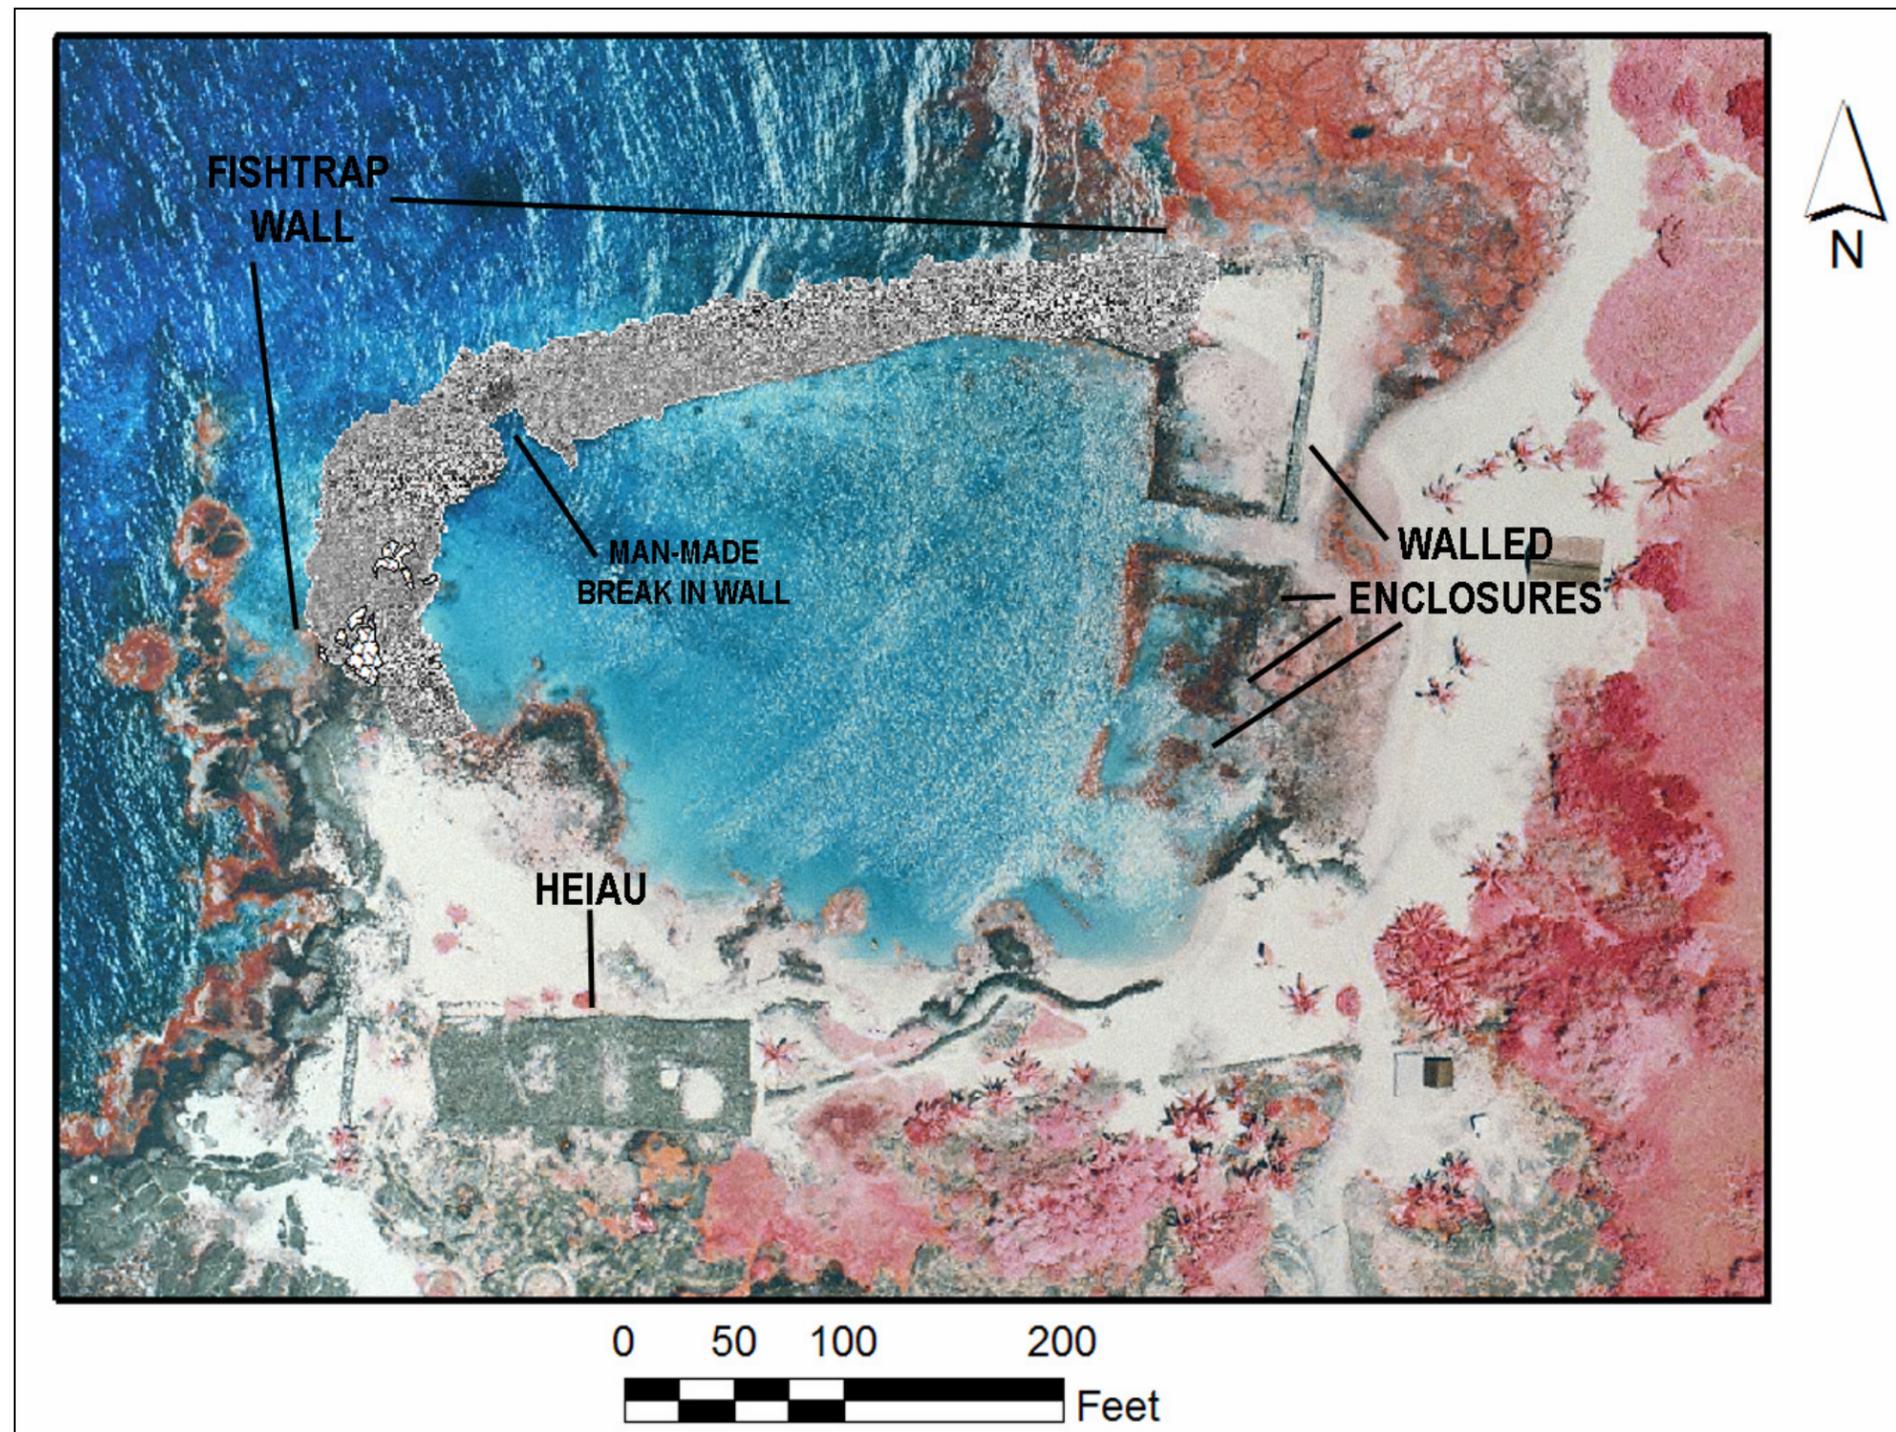
Figure 2. Aerial view of the 'Ai'opio Fishtrap including the walled enclosures and the associated *heiau* south of the fishtrap, with the site map of the outer fishtrap wall overlaid on the aerial image. Note the noticeable break through the center of the fishtrap wall.

used as holding pens for netted fish (Figure 2; see also Kikuchi and Belshe 1971: B9). 'Ai'ōpio is a *loko kuapa*-type fishtrap, meaning the builders created a wall as an artificial means for trapping fish as opposed to using natural shoreline features or an inland pond (Apple and Kikuchi 1975:8).

The current condition of the 'Ai'ōpio Fishtrap is the product of both natural and human site-formation processes. Wave action and seasonal weather have damaged sections of the wall over time, while in the second half of the twentieth

century, occupants of the Honokōhau Bay shoreline dismantled a section of the outer seawall to create a break allowing canoe access to the ocean from the beach (personal communication, park staff).

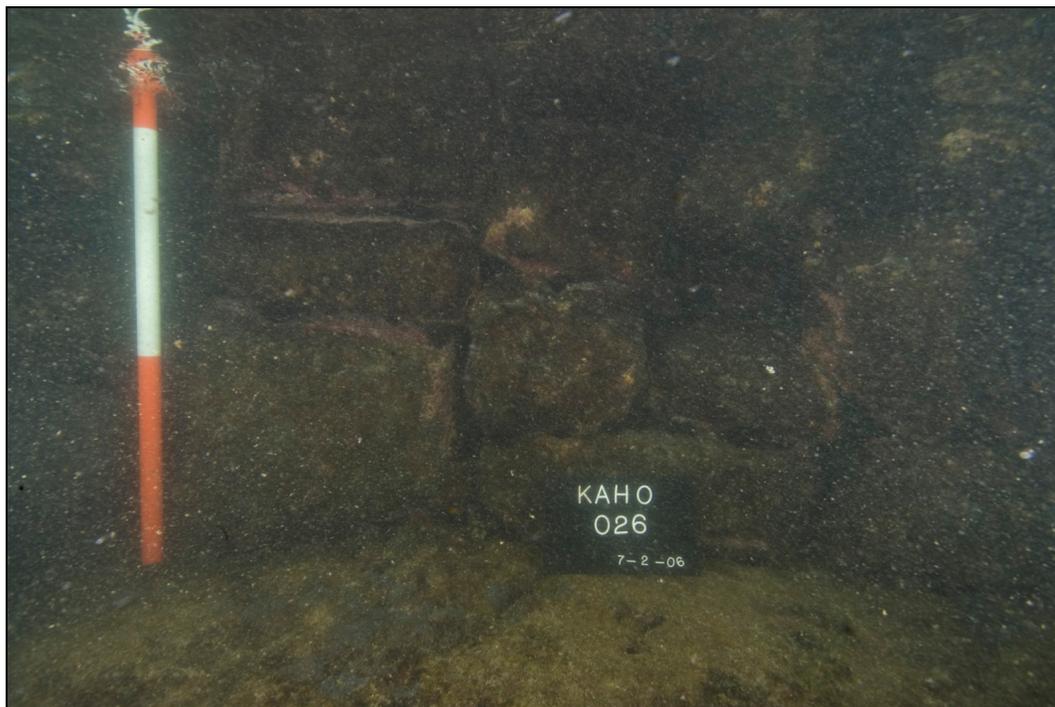
Figure 4. Capturing GPS Point 026 on the ocean-side of the fishtrap seawall. NPS Photo by Brett Seymour.

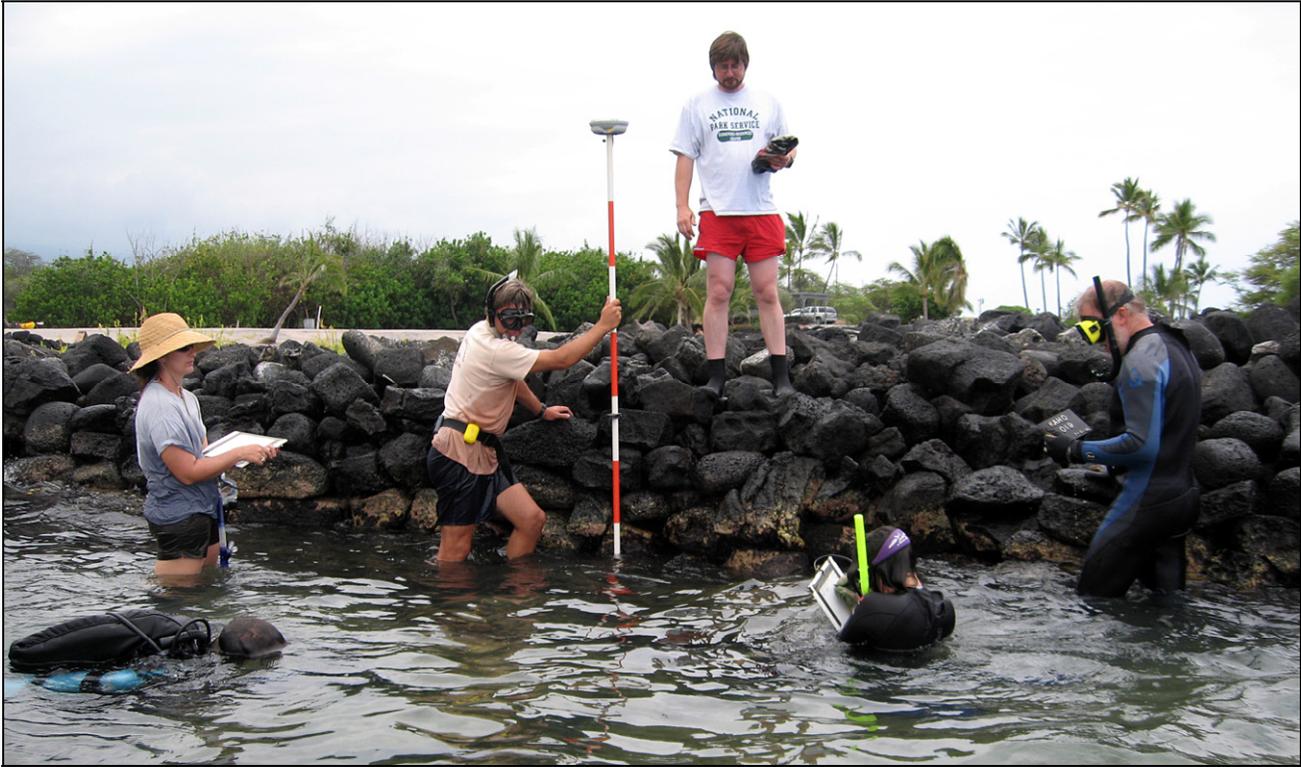
Figure 5. GPS documentation of intact sections of the ocean-side fishtrap seawall. NPS Photo by Matt Russell.

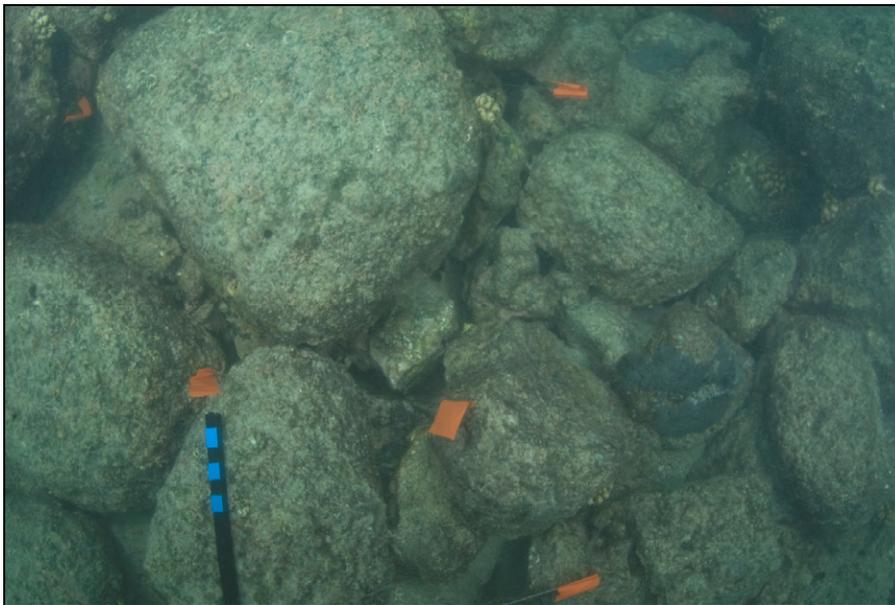
Figure 6. Pinflagged seawall foundation stones in the wall break during documentation. (1-foot Photographic scale) NPS Photo by Brett Seymour.

photographs to aid in reconstructing the base stone layout on a map (Figure 6). Direct measurement with photographic documentation also included two profiles of intact, ocean-side wall. These profiles were mapped by setting a level baseline along the length of each section and taking vertical measurements off the baseline to each rock making-up that section of wall (Figure 7). Finally, the team collected data for a plan view of a large marking stone near the eastern wall terminus.

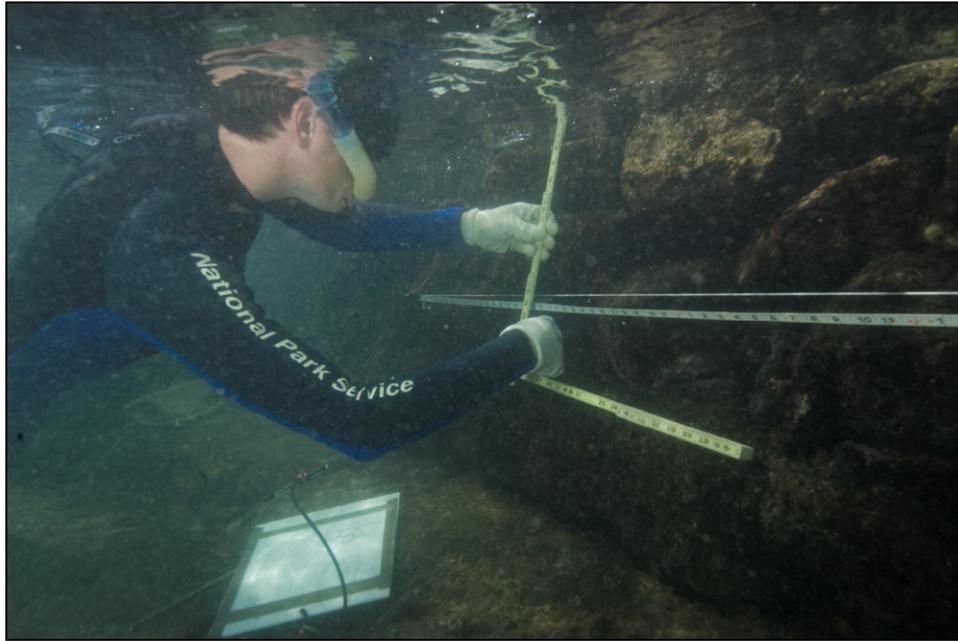
Figure 7. Hand-mapping an intact wall section on the ocean-side of the outer fishtrap seawall to create a profile drawing. NPS Photo by Brett Seymour.

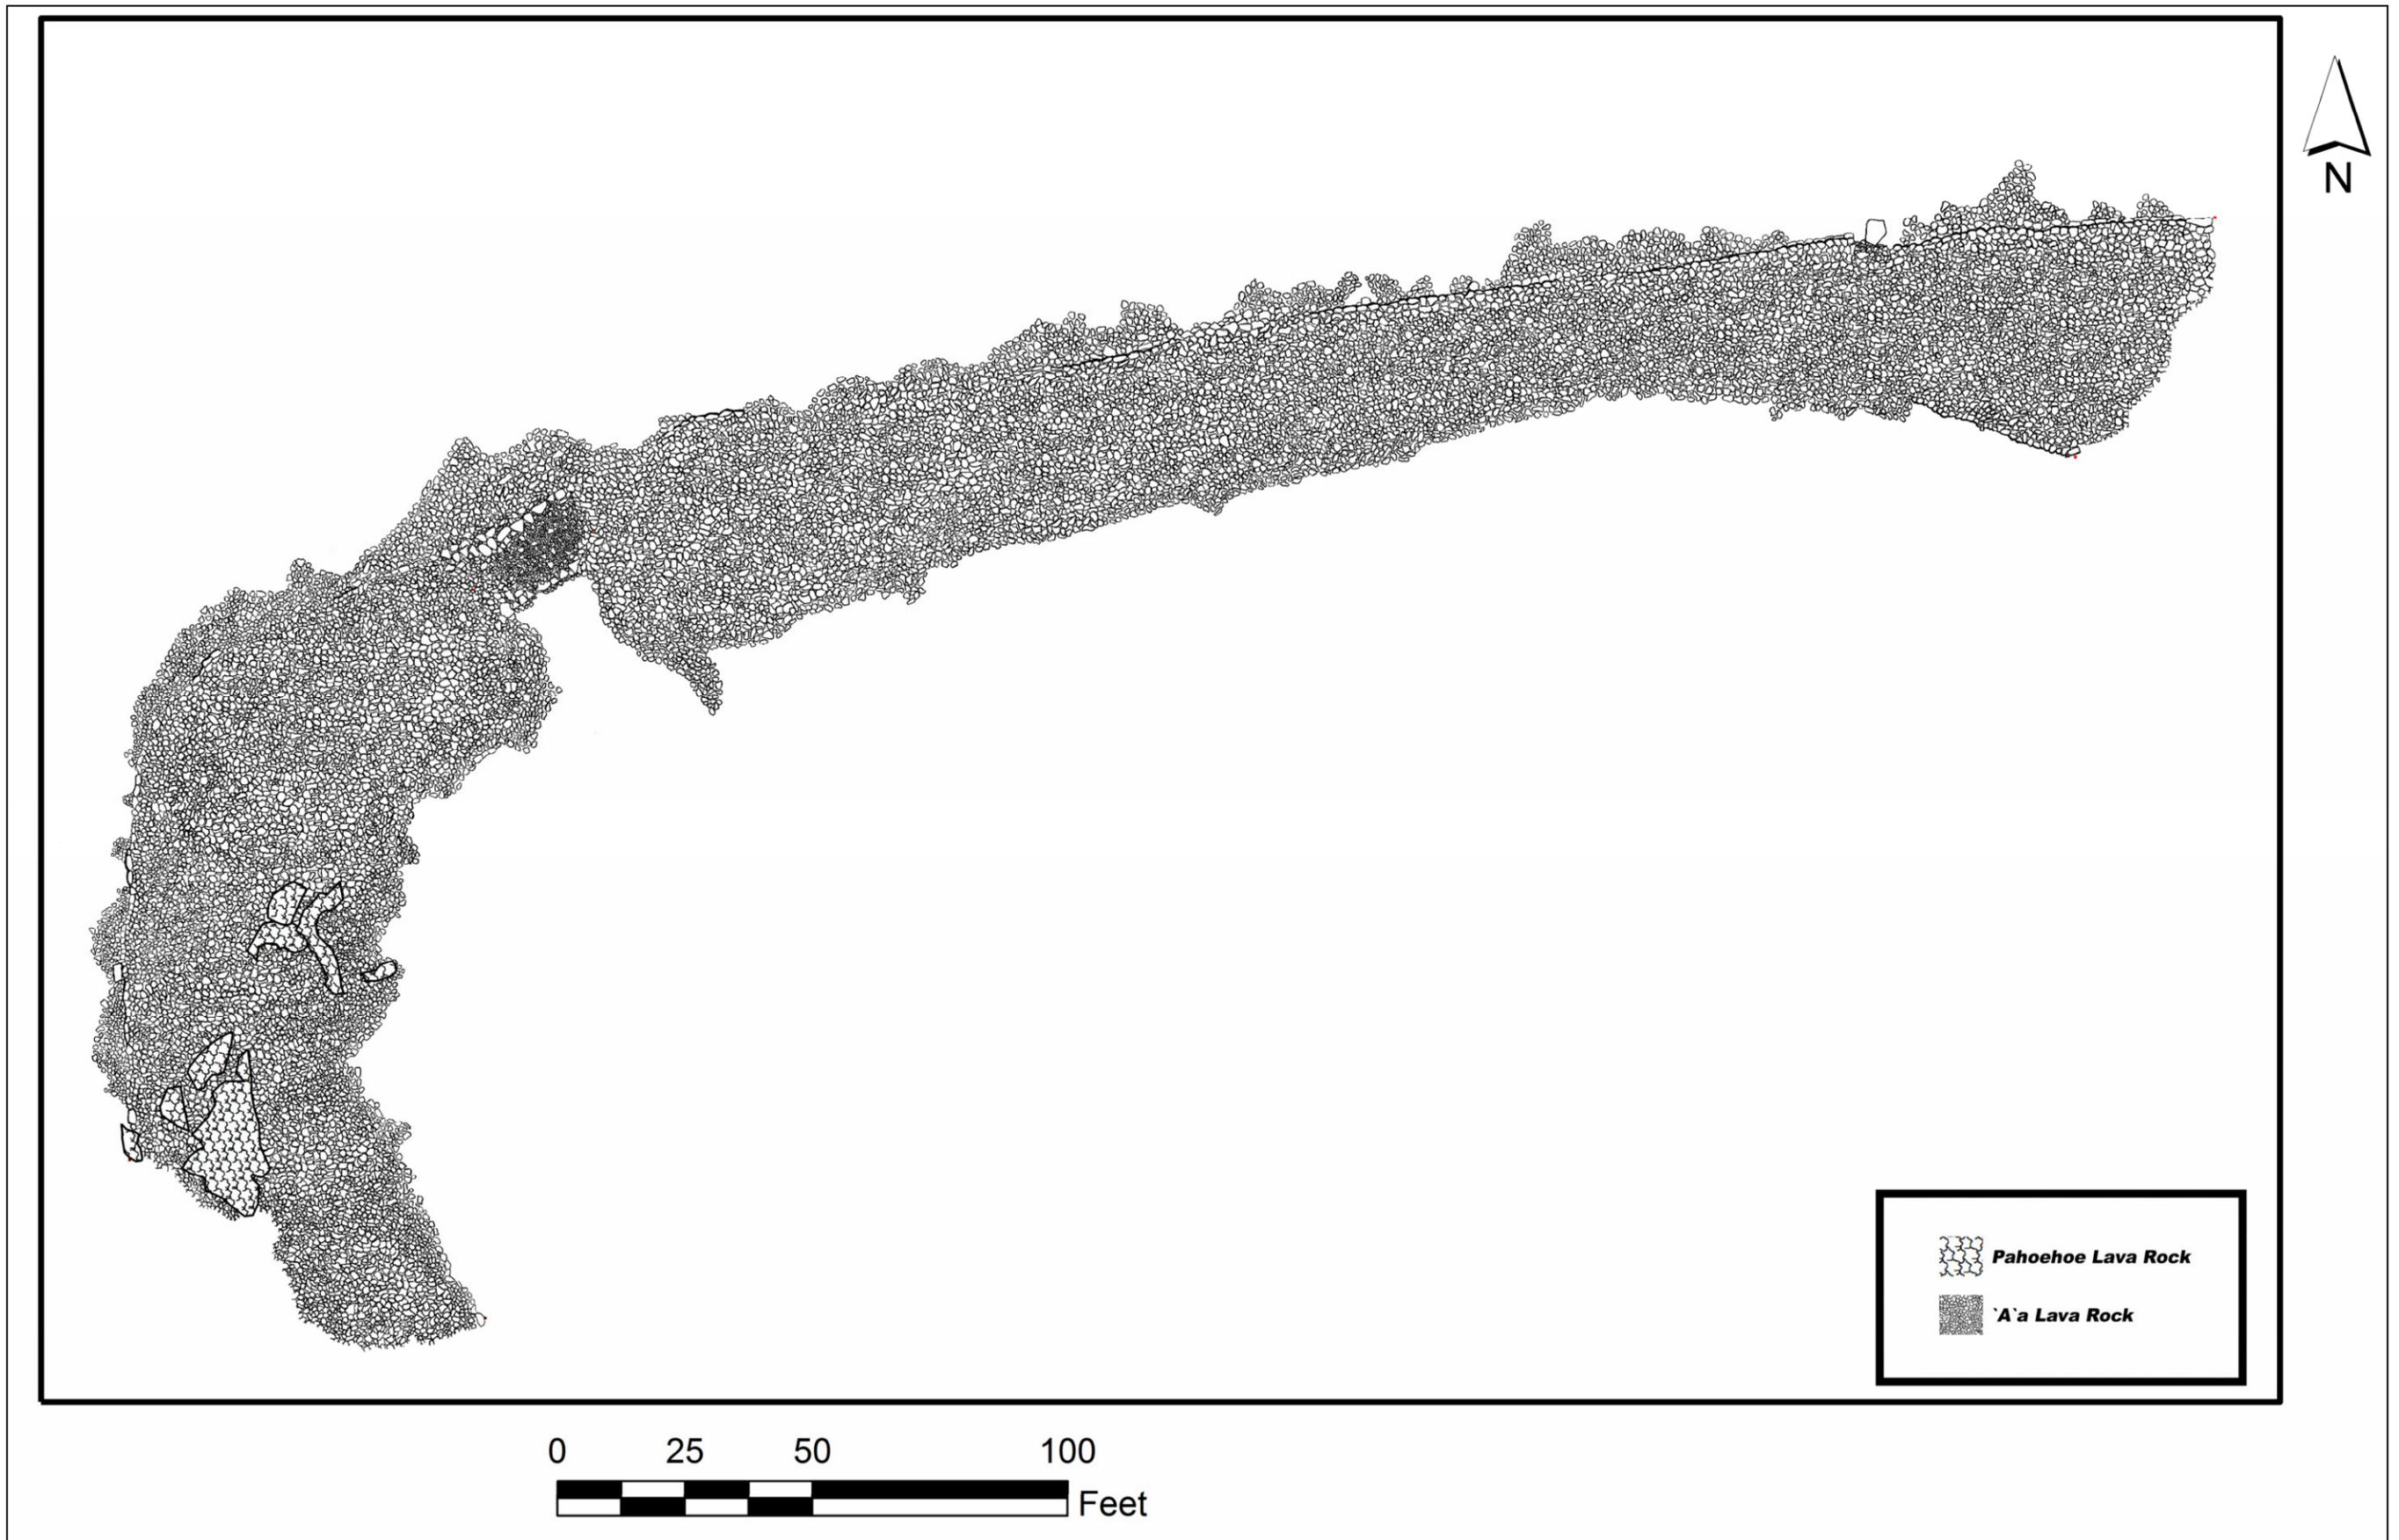
Figure 8. Planimetric map of the 'Ai'ōpio Fishtrap outer seawall. Drawing by Sami Seeb.

Fieldwork by the SRC/KAHO team resulted in a comprehensive documentation of the 'Ai'ōpio Fishtrap outer seawall, including a detailed, plan-view site map (Figure 8). Using the high-resolution GPS points as a skeleton, photographs and written descriptions provided the information necessary to complete the plan view outline of the wall. Once completed, the wall outline was scanned and filled with stones using Adobe Photoshop software.

Individual stones incorporated within the wall were not documented on site; their locations have been estimated based on observations and photographs.

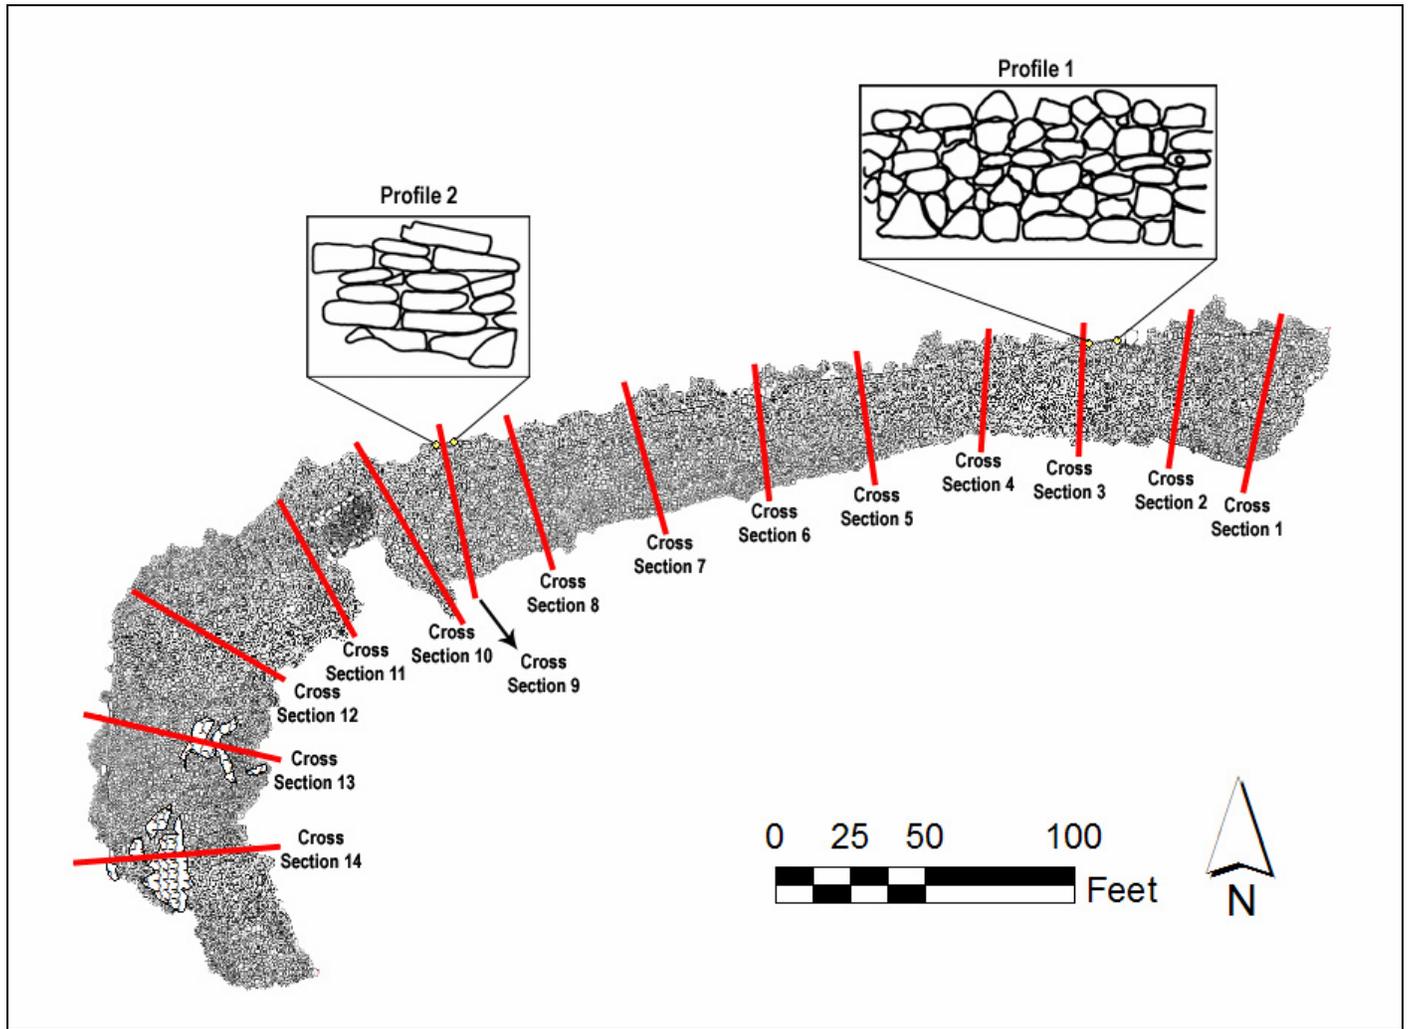
Figure 9. 'Ai'ōpio Fishtrap site map indicating locations of hand-mapped, intact wall profiles and GPS cross section positions. Map drawn by Sami Seeb.

GPS cross sections and direct-measured, hand-drawn profiles are georectified to allow them to be overlaid on the site map in ArcGIS for additional analysis (Figure 9).

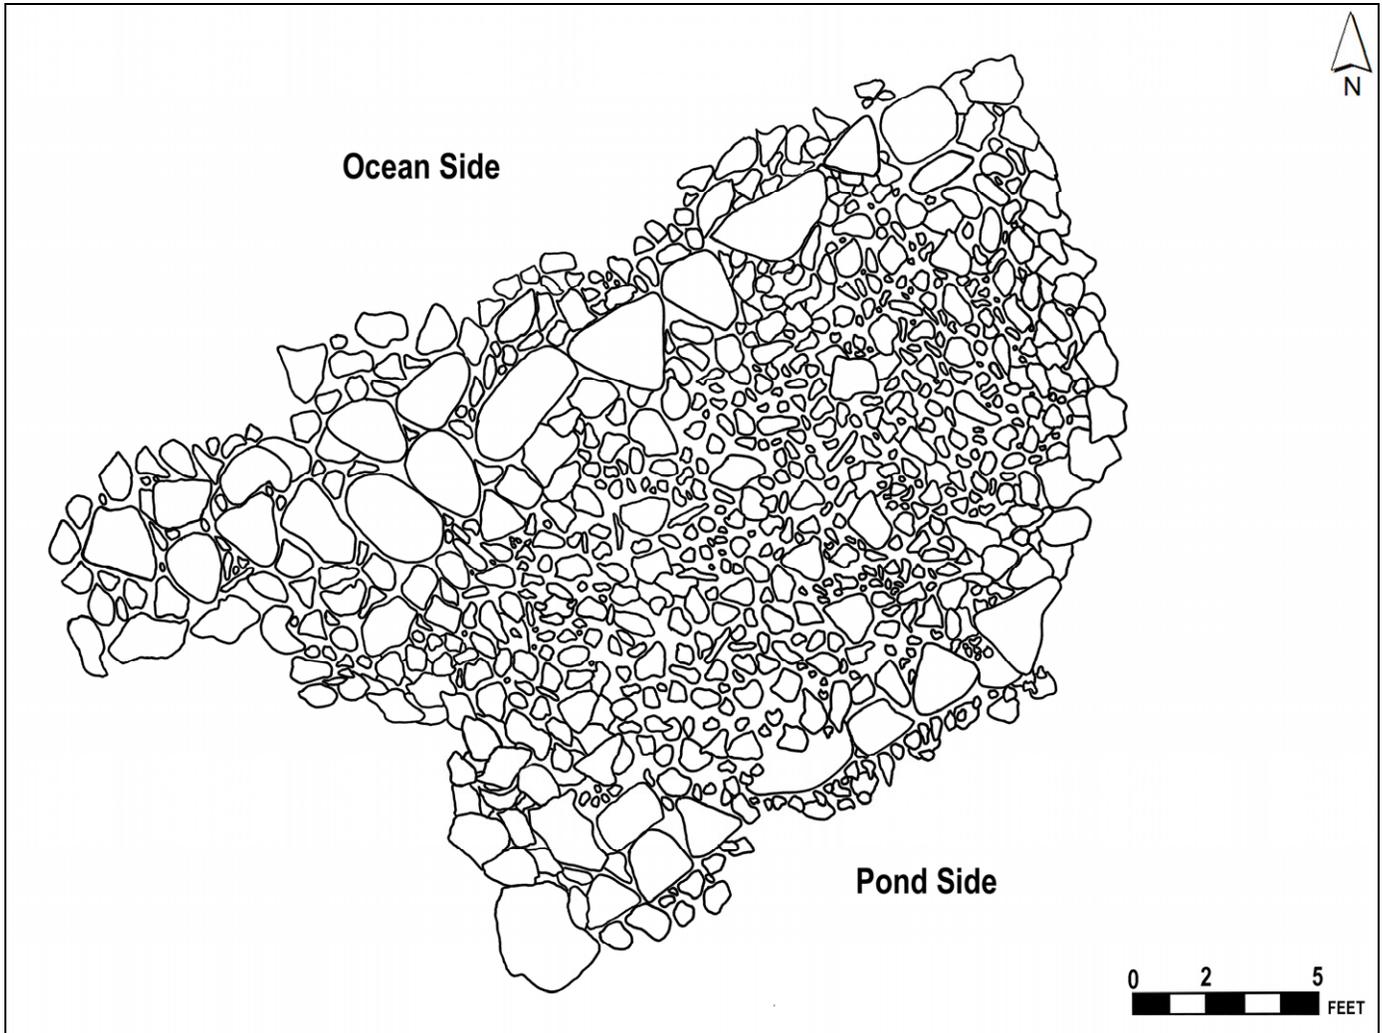
Figure 10. Detail of the outer fishtrap seawall break showing the large foundation stones that form the original interior and exterior wall faces. Drawing by Sami Seeb.

Scale drawings of fishtrap wall sections provide construction details and offer insight into the progression of the wall construction through various construction episodes. The fishtrap wall break reveals large base stones that may have been the original wall foundation and that may indicate

the original wall dimensions. Smaller stones are fill between the base stones. The SRC/KAHO team used data acquired from baseline trilateration combined with photographic documentation to draw a detailed scaled drawing of the base stones and fill (Figure 10).

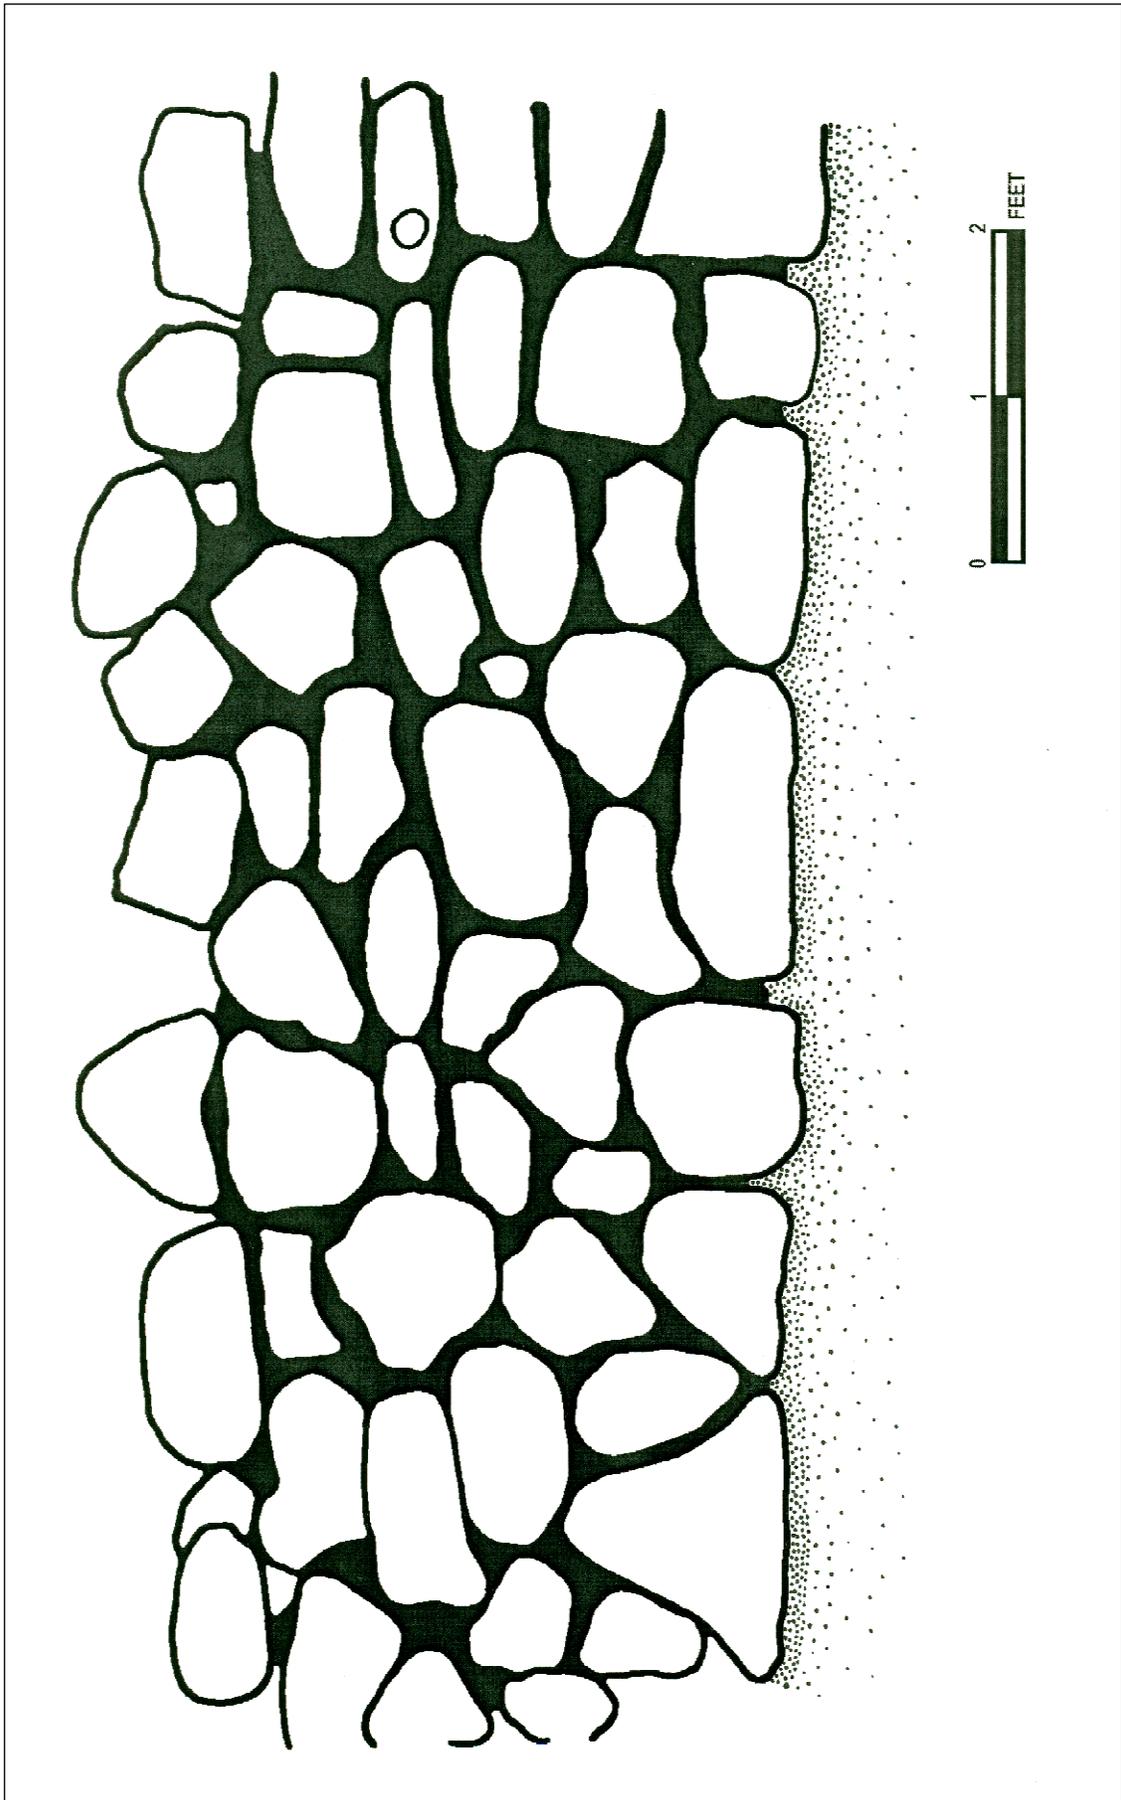
Figure 11. Profile 1, showing an intact section on the ocean-side of the fishtrap wall. Drawing by Matt Russell and Sami Seeb.

Two scaled profiles of intact sections of the ocean-side fishtrap wall demonstrate construction features of the original wall (Figures 11 and 12). These profiles provide representative examples for

the rehabilitation project to indicate the current conditions of intact wall sections. Also, the profiles will serve as guides for future reconstruction of displaced wall sections.

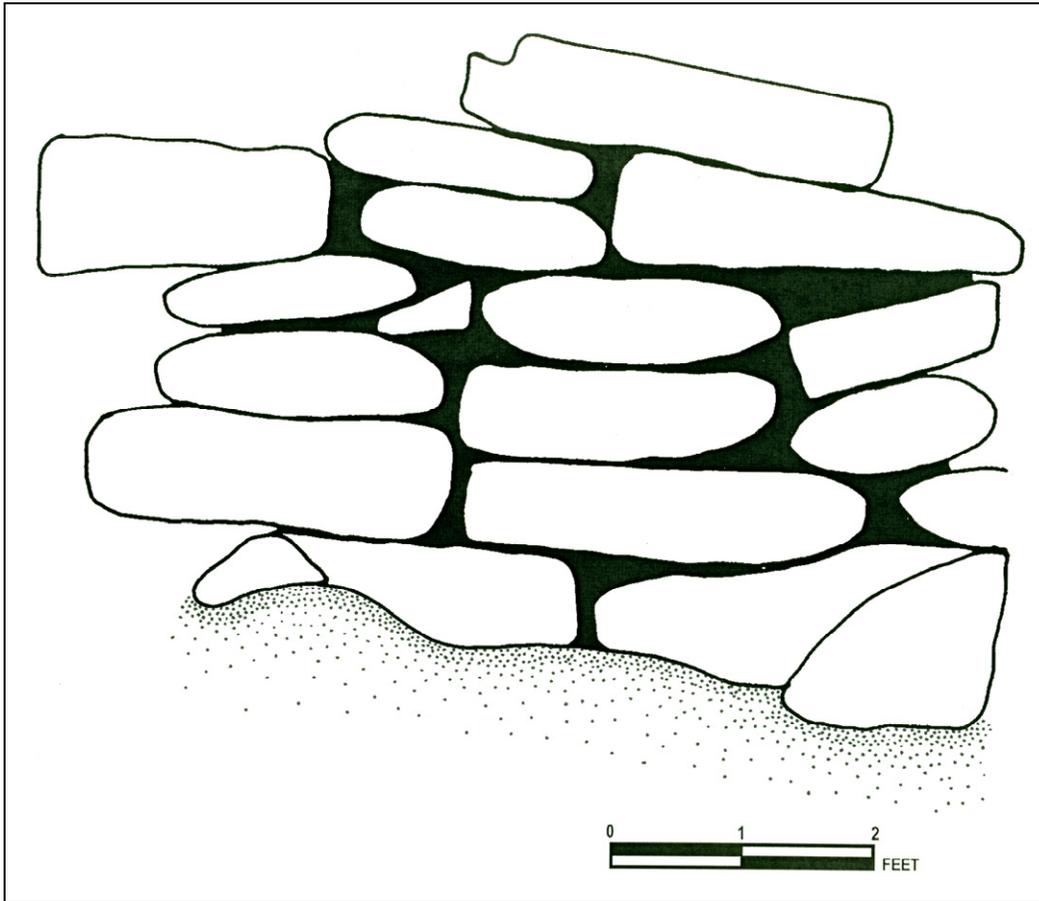
Figure 12. Profile 2, showing an intact section on the ocean-side of the fishtrap wall. Drawing by Matt Russell and Sami Seeb.
