# Kaloko-Honokōhau National Historical Park

## *'AI'ŌPIO FISHTRAP DOCUMENTATION*

**'Ai'ōpio Fishtrap Documentation  
Kaloko-Honokōhau National Historical Park  
SRC Technical Report Number 24  
PMIS #98241**

Technical Report  
Number 24

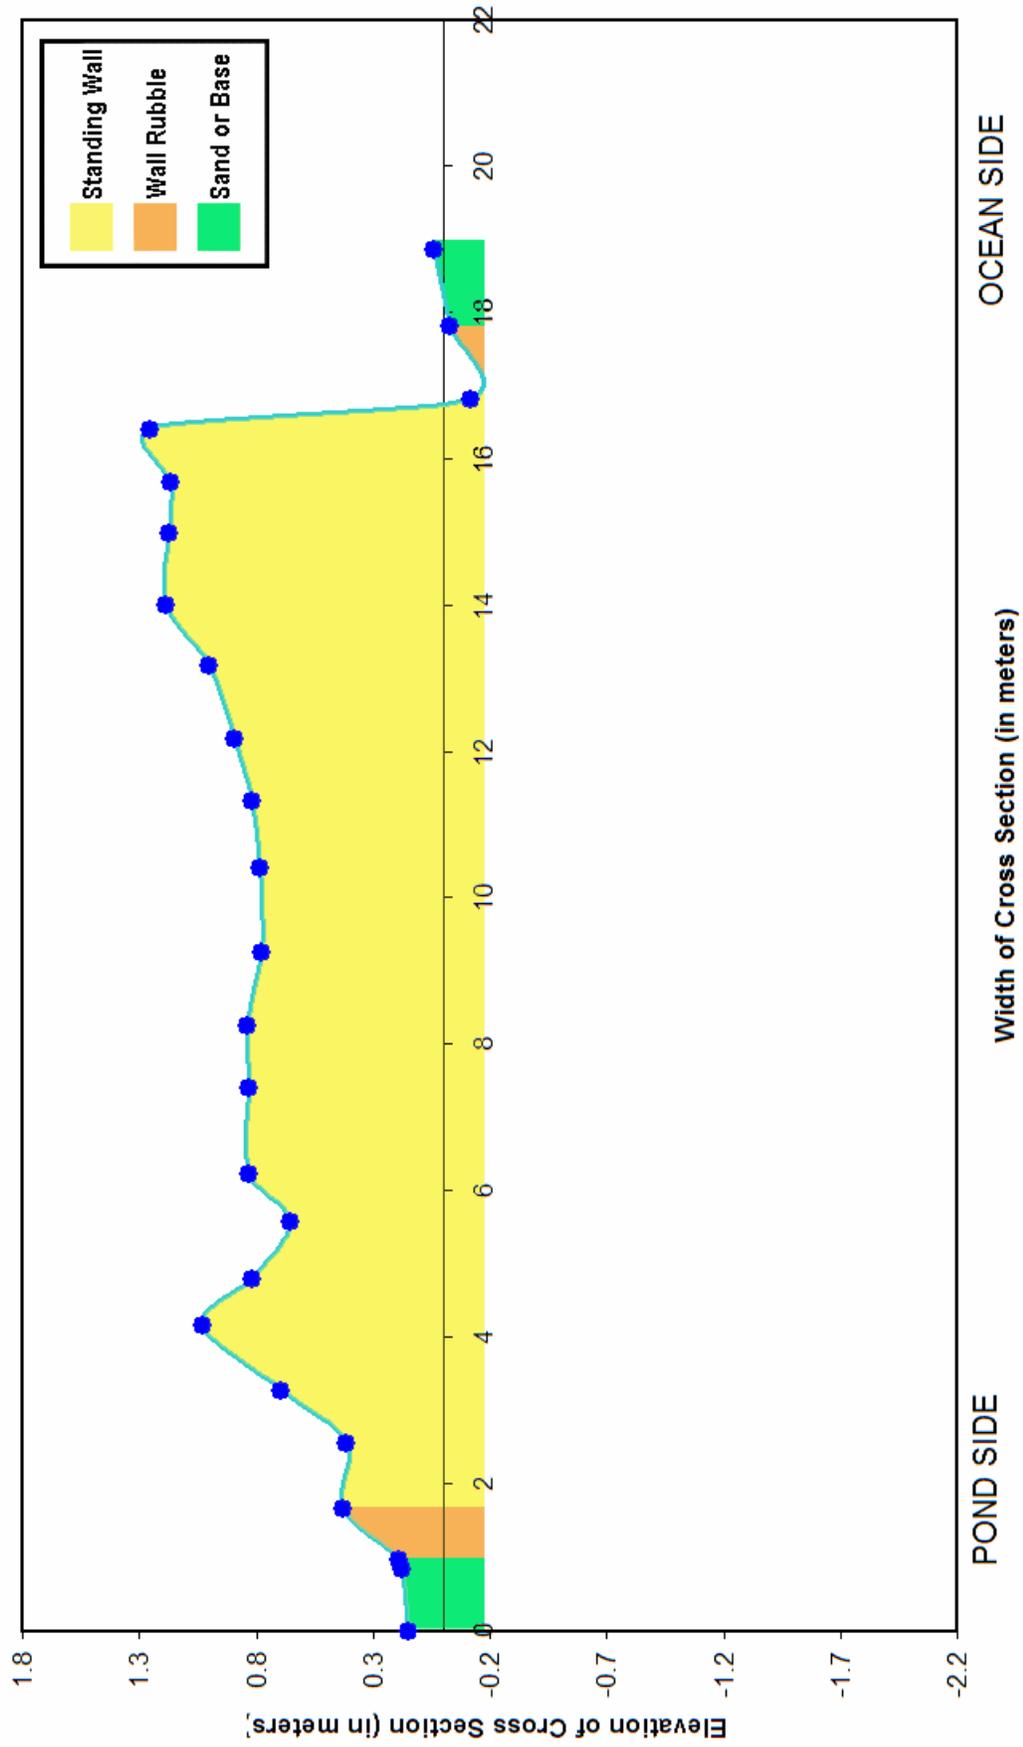
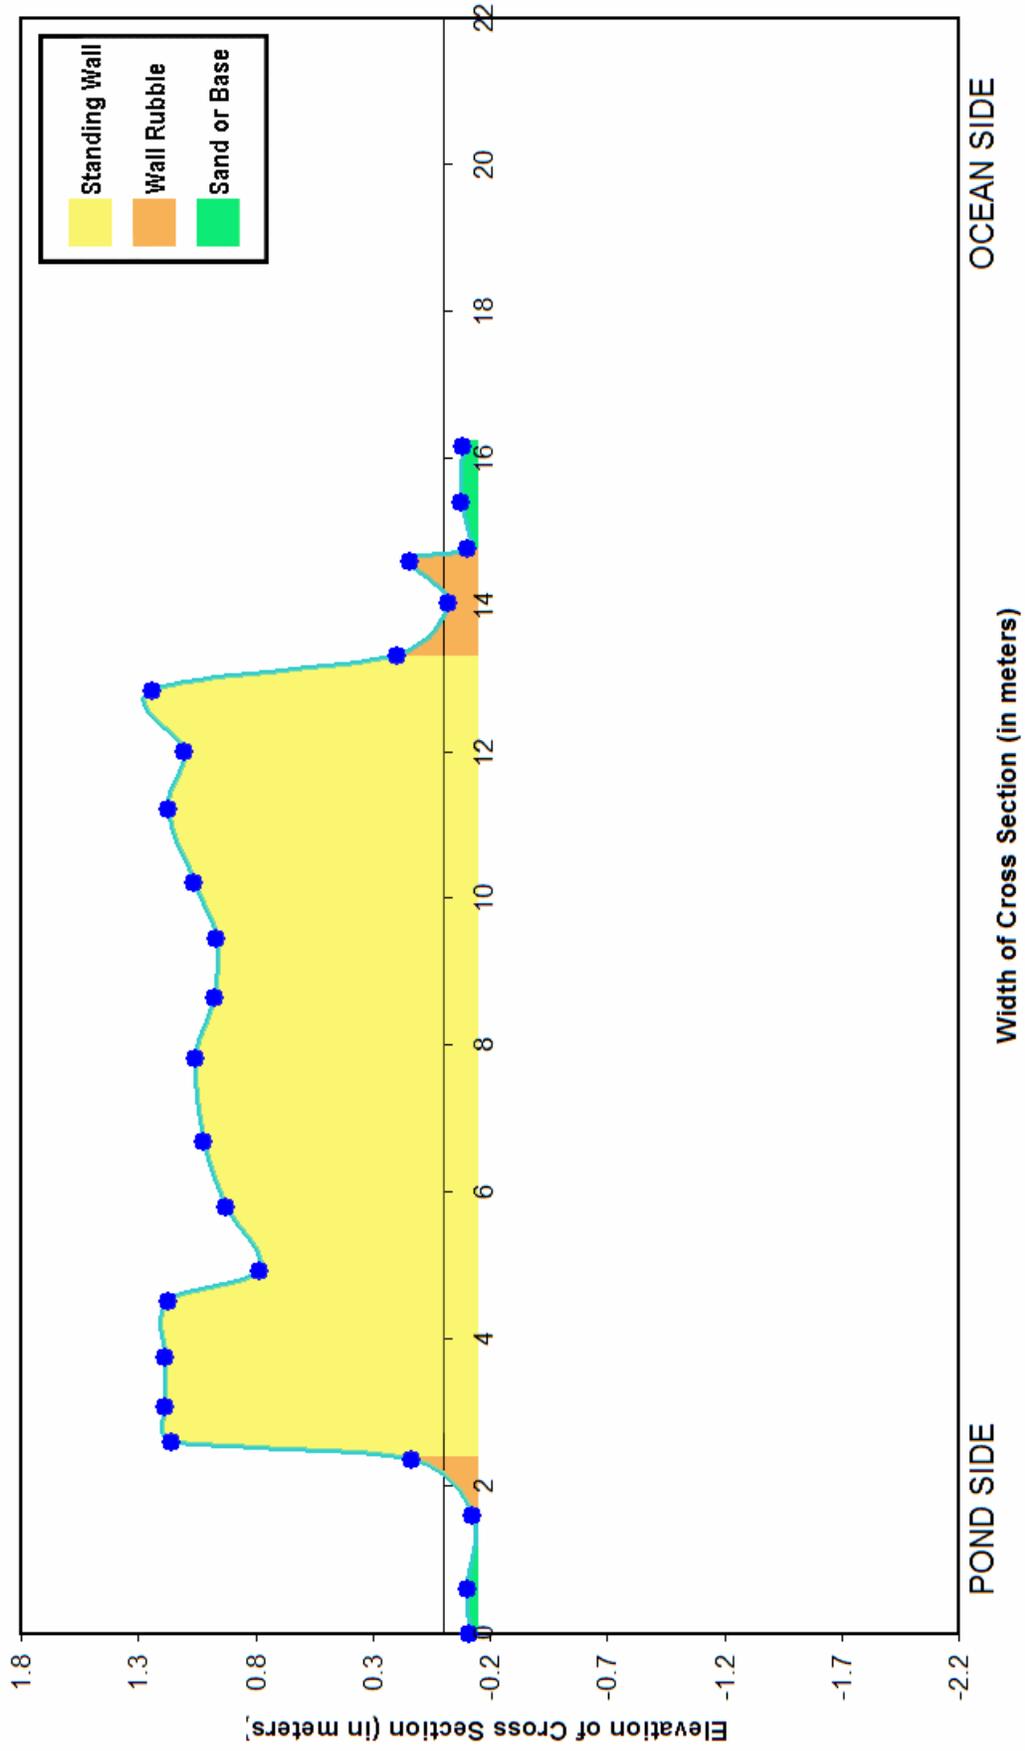
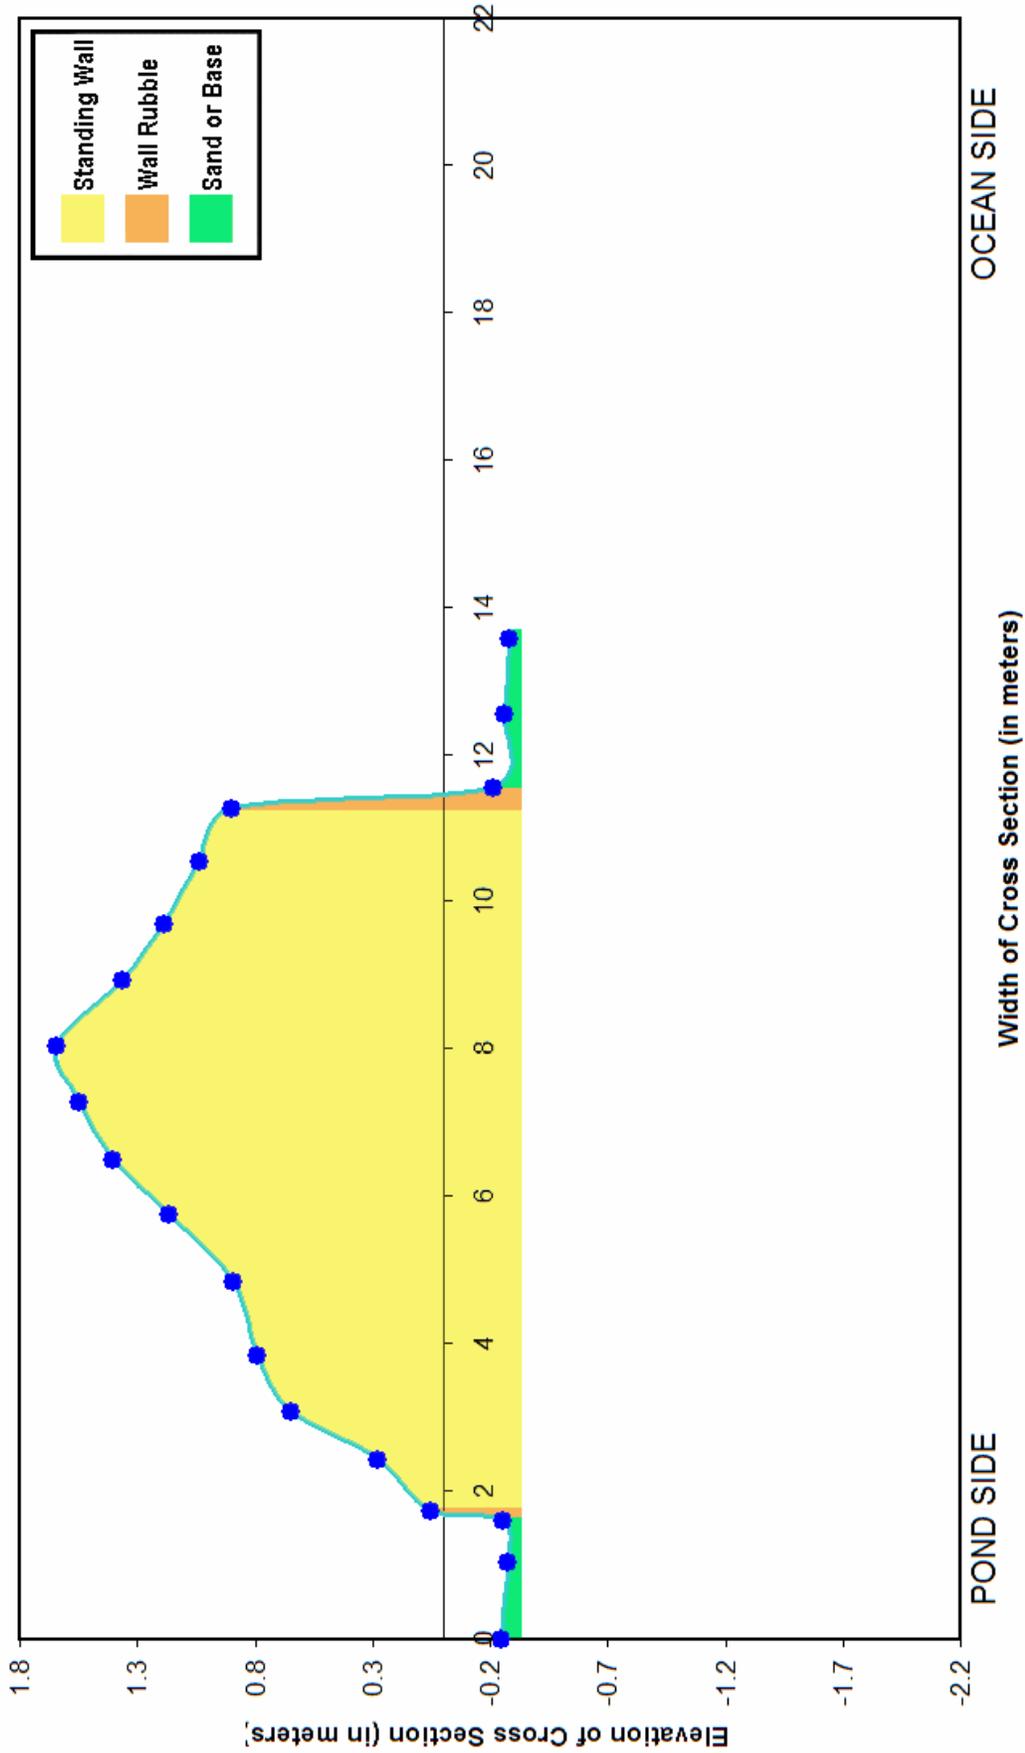
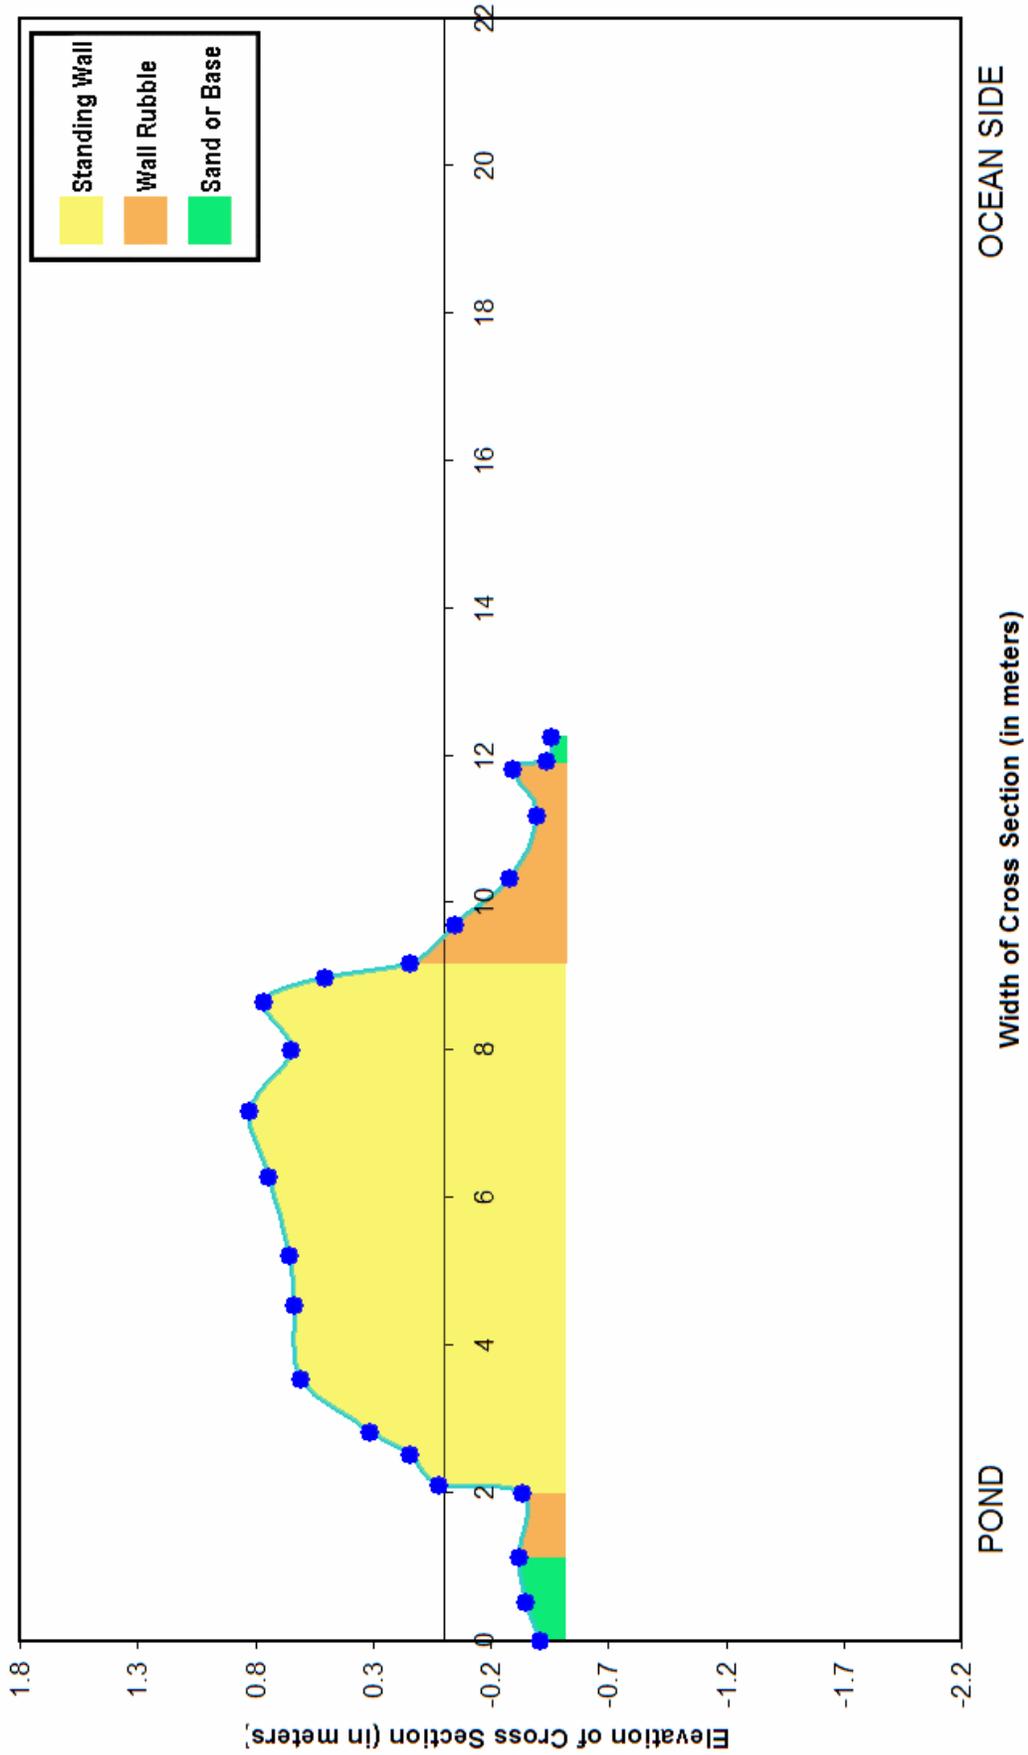
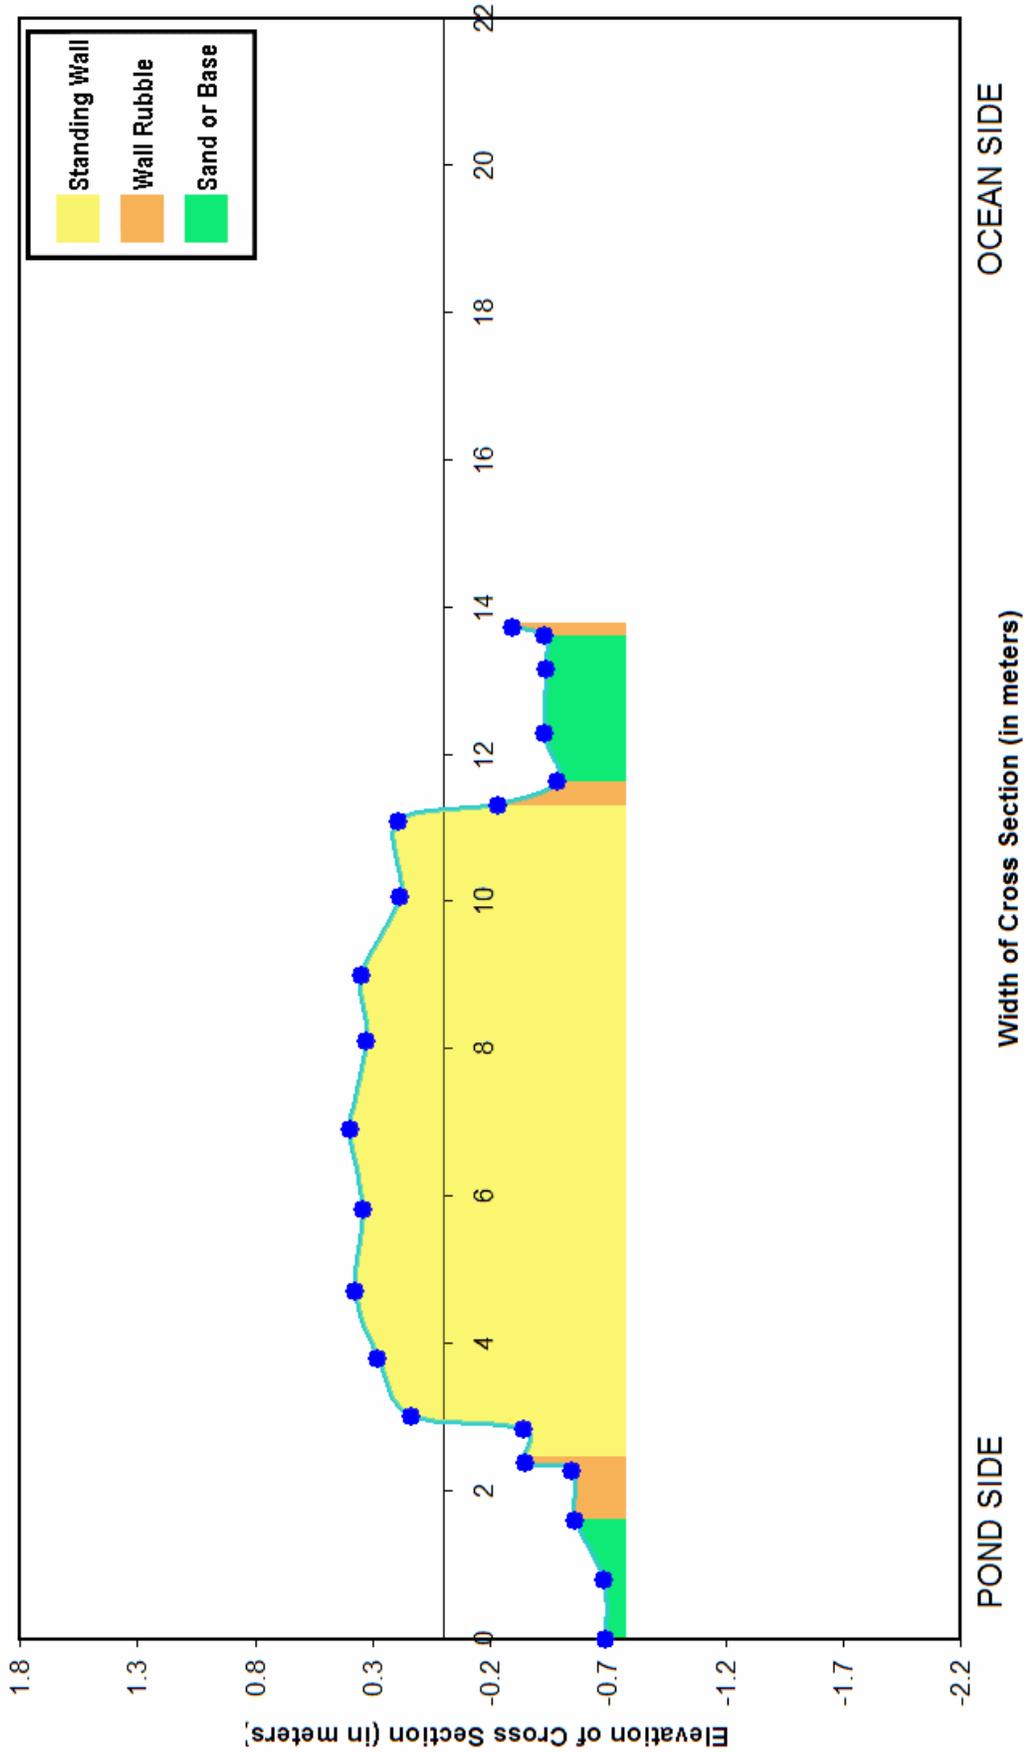
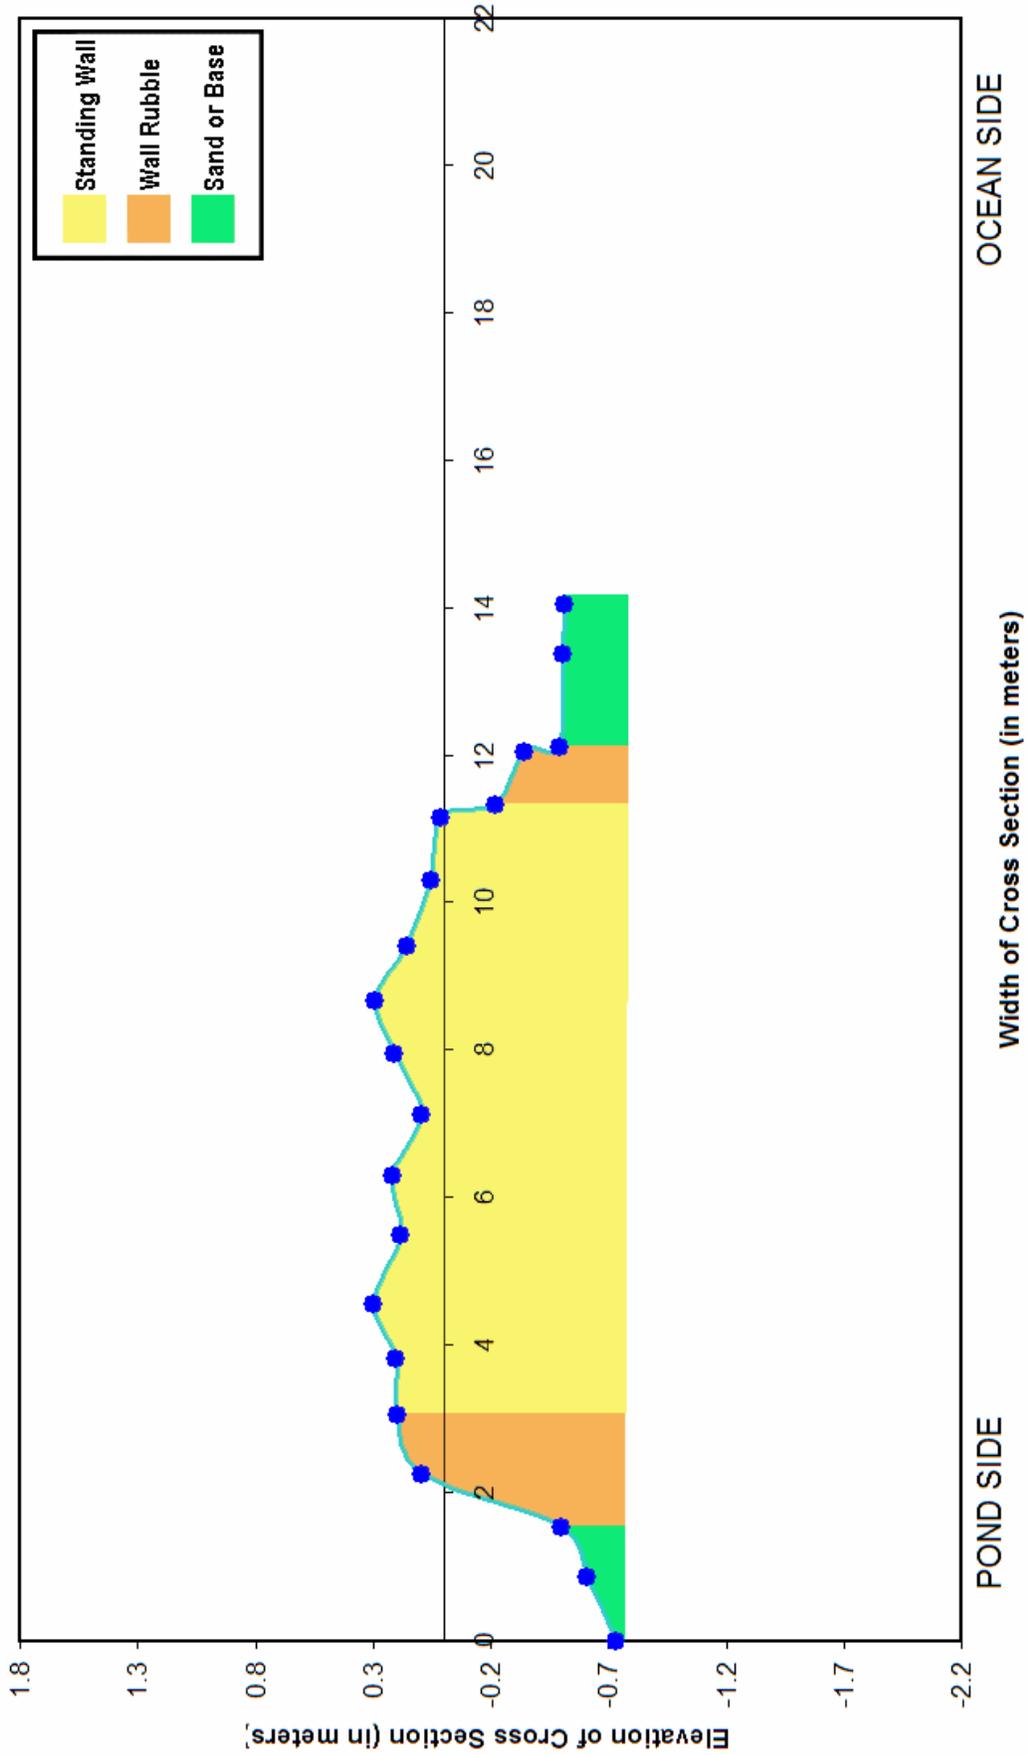
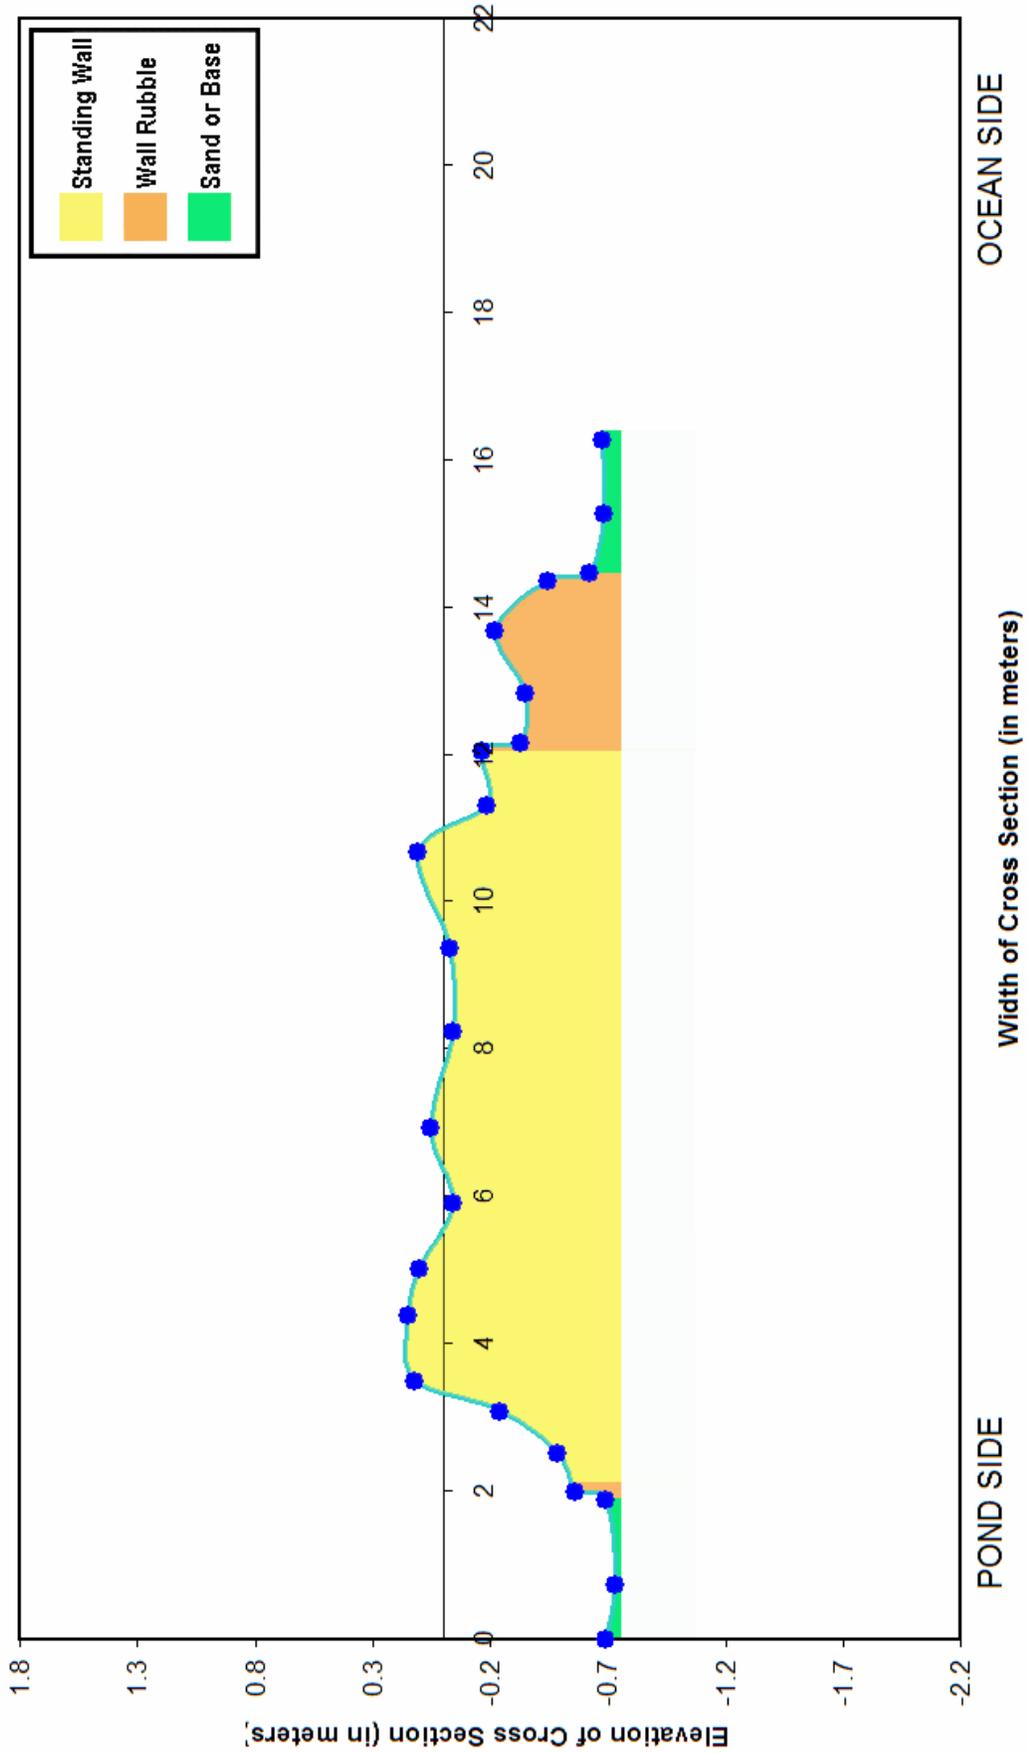
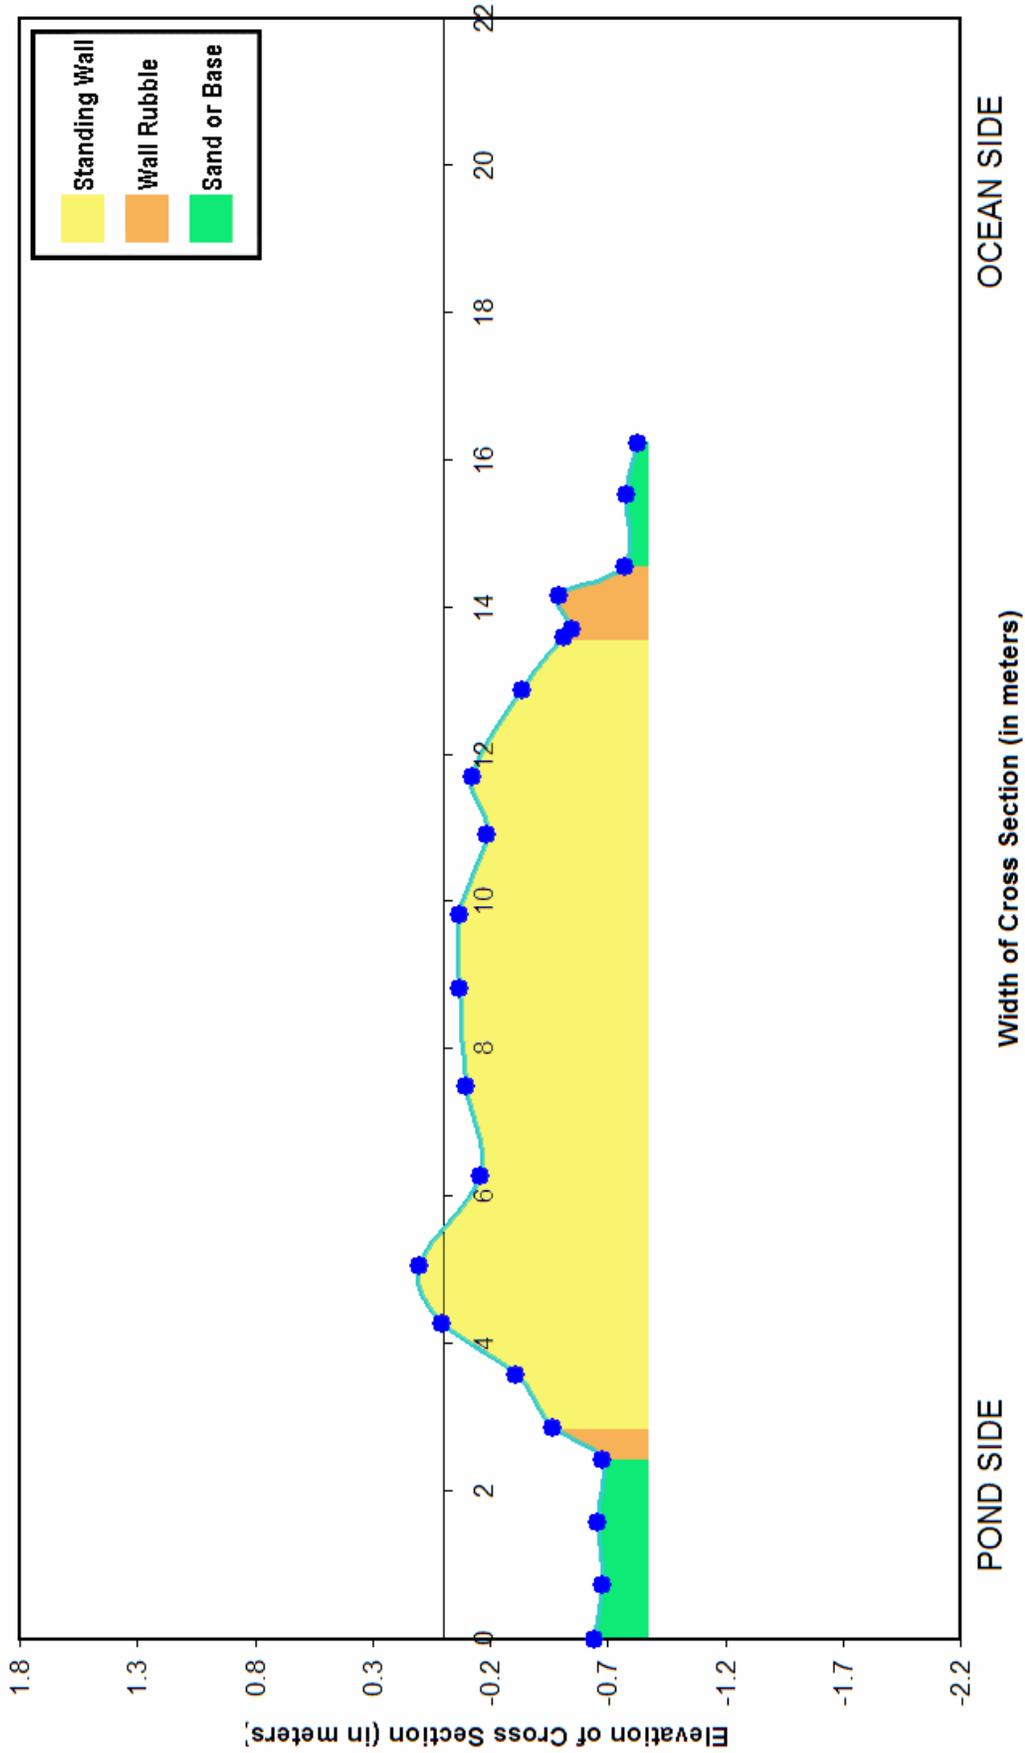
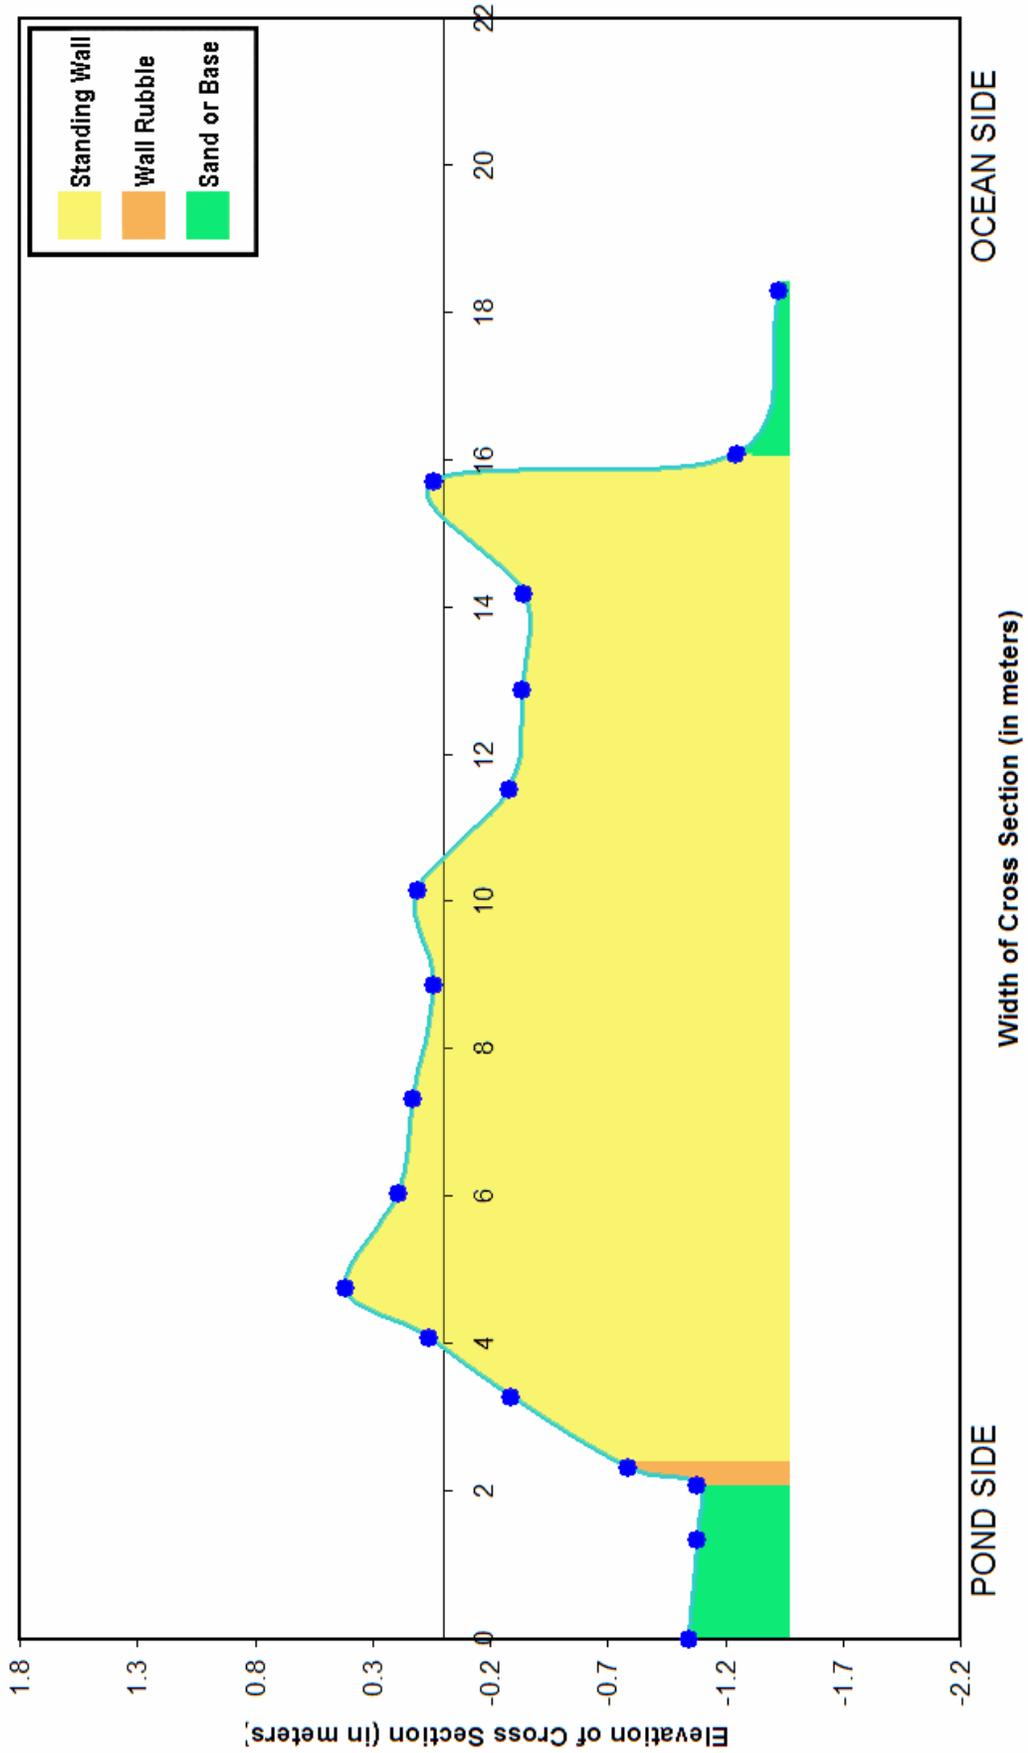
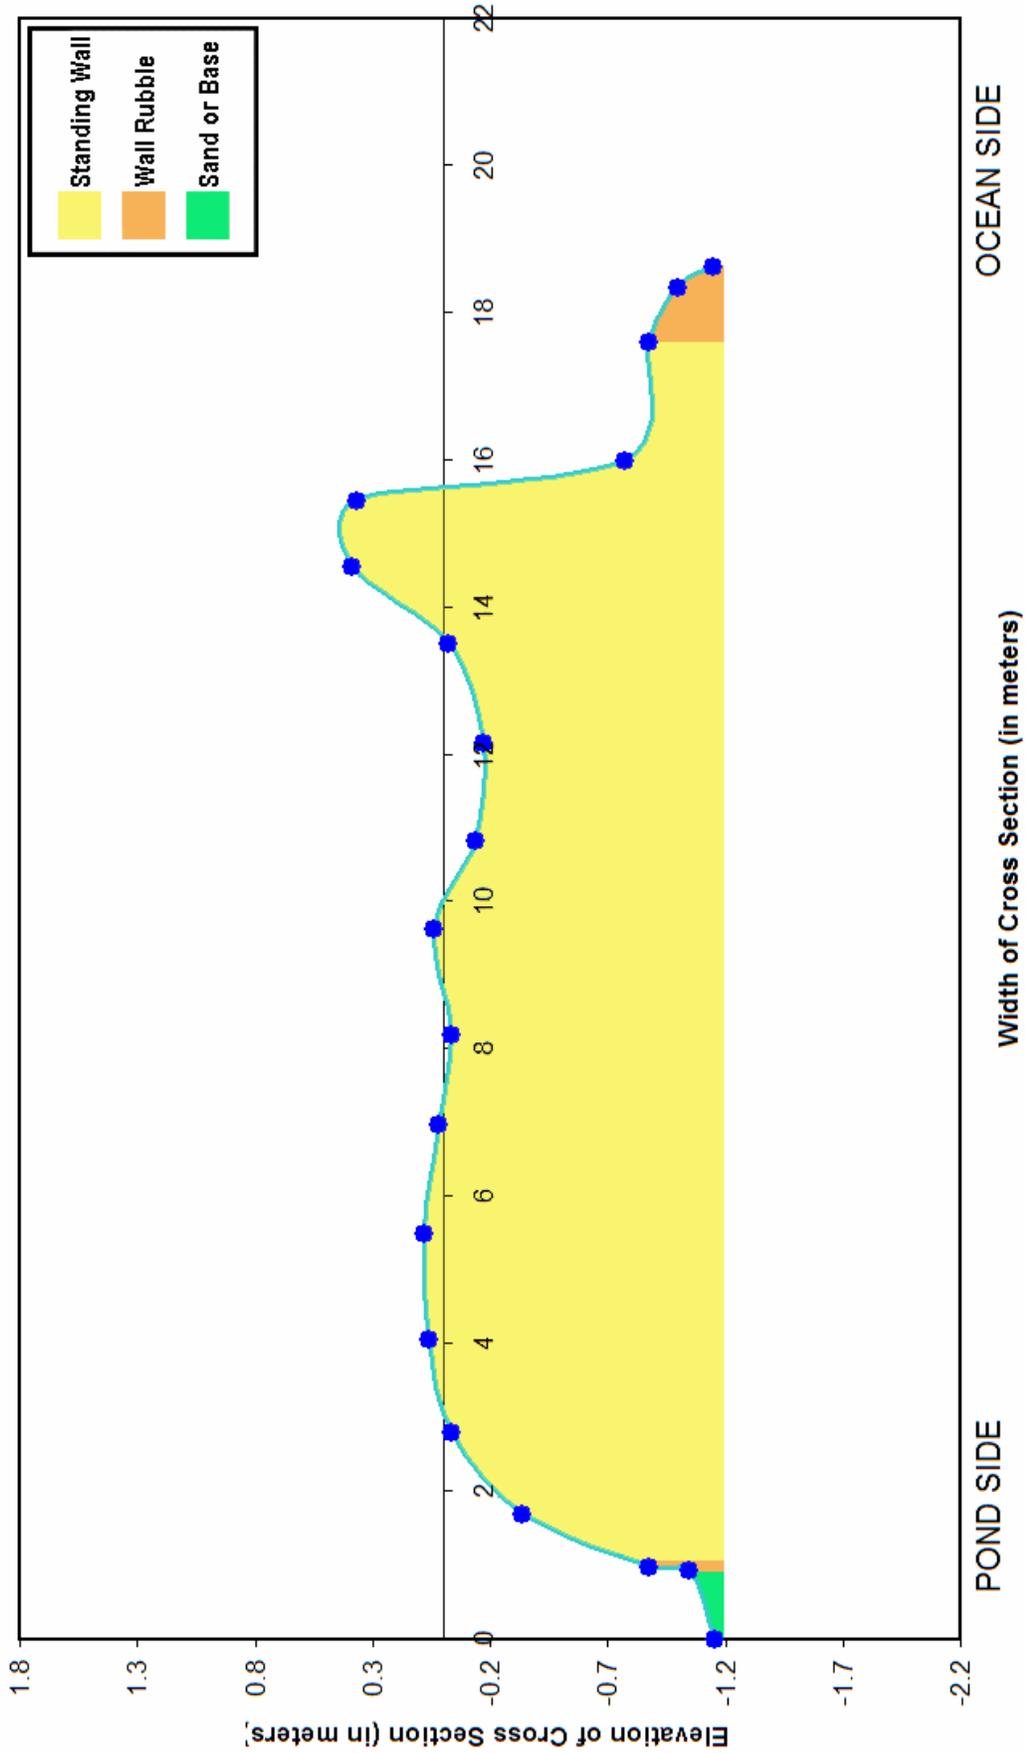
The SRC/KAHO team used the Trimble GPS unit to collect elevation points along 14 transects across the wall to create a series of wall cross sections (Figures 13-26). Examining cross sections individually shows the variation in wall height (relative to sea level datum) as well as the distance that fallen rubble extends beyond the original wall boundary. Looking at the cross sections together provides a relative indication of the varying state of integrity along the wall's length.

While the cross sections themselves are accurately calculated and depicted in Figures 13-26 from the project GIS using high resolution GPS data, the designations within the cross sections are based on assumptions made while taking GPS points in the field. Without prior knowledge of the exact width of the original wall, it was difficult to say with certainty in some sections what remained of the standing wall and what was wall fall or rubble—Figures 13-26 show classifications of

standing wall, wall rubble, and sand or base within each cross section based on direct field observations. The zero value on the y-axis represents sea level at that location based on the 1988 North American Vertical Datum. The yellow sections in each figure indicate standing wall, the orange areas denote wall rubble, and the green sections represent the sand or base. The blue dots represent individual GPS points taken across the wall.

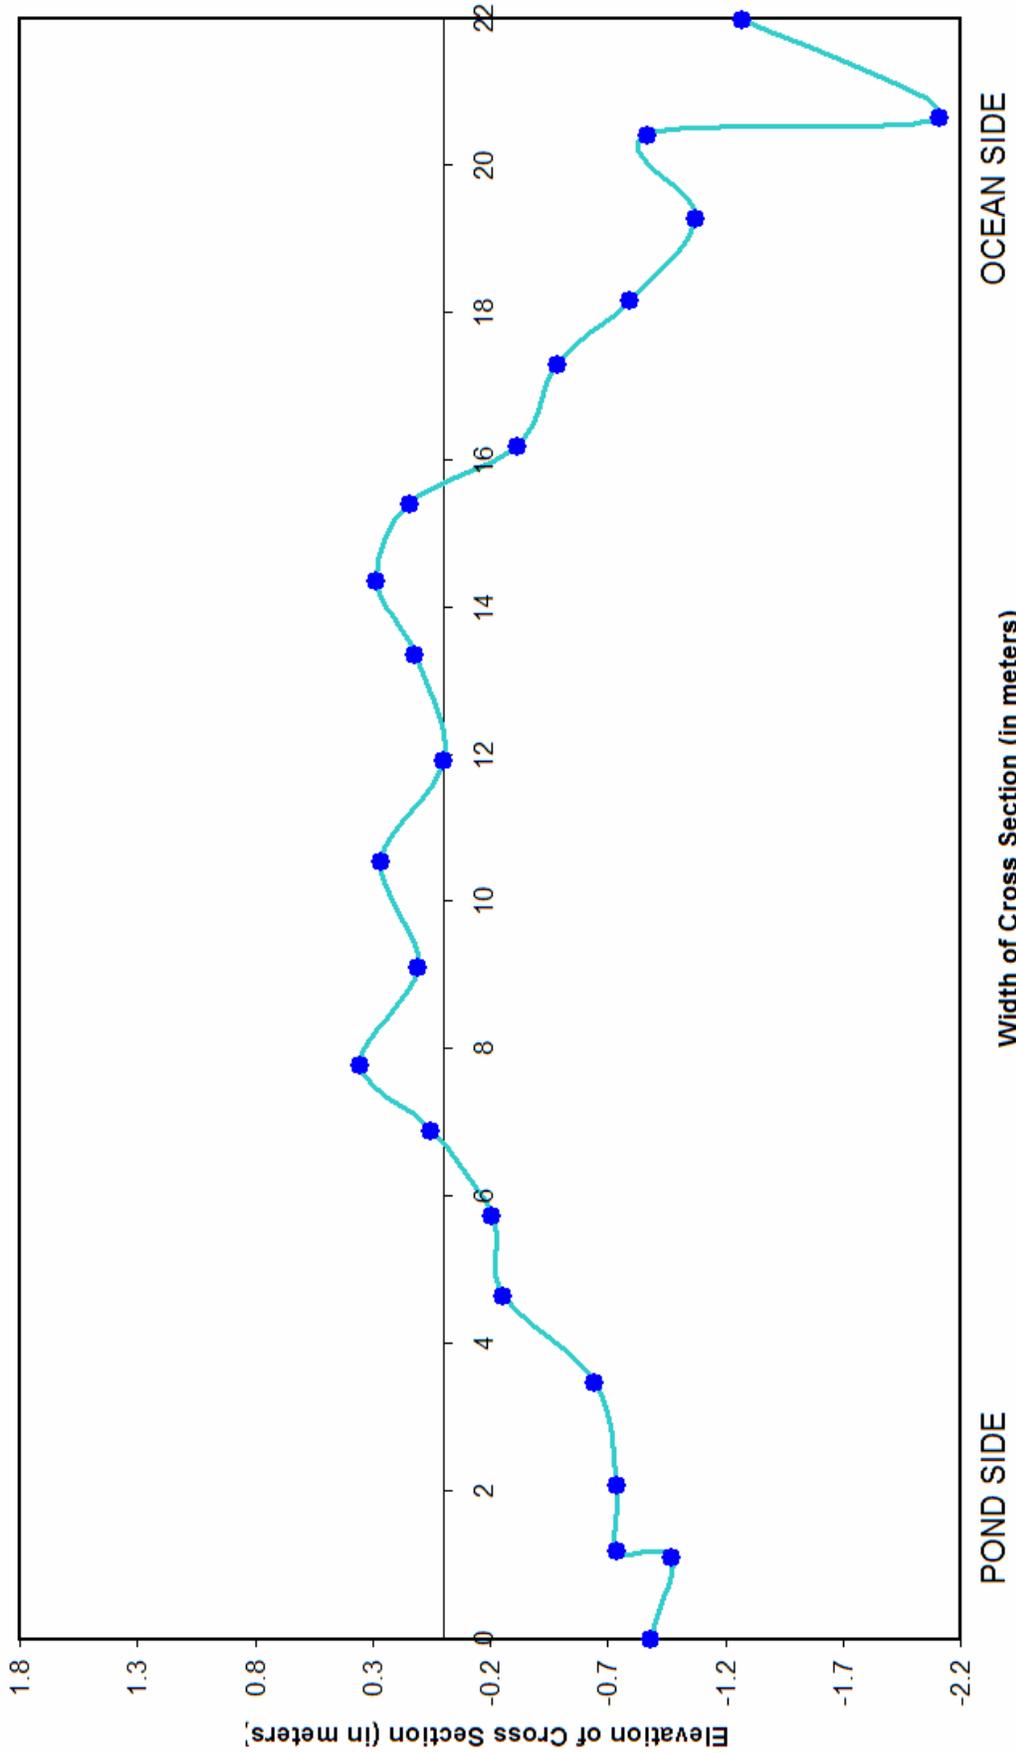
Figure 22. Cross section 10.

The two cross sections containing no color fill (Cross Sections 10 and 11, Figures 22 and 23) border the break in the wall on either side—because it is likely that those who made the break removed the rocks from the wall and relocated them adjacent to the break on both sides and to the north, resulting in a large amount of displaced rock adjacent to these two cross sections, it was impossible to discriminate between standing wall and scattered rubble.

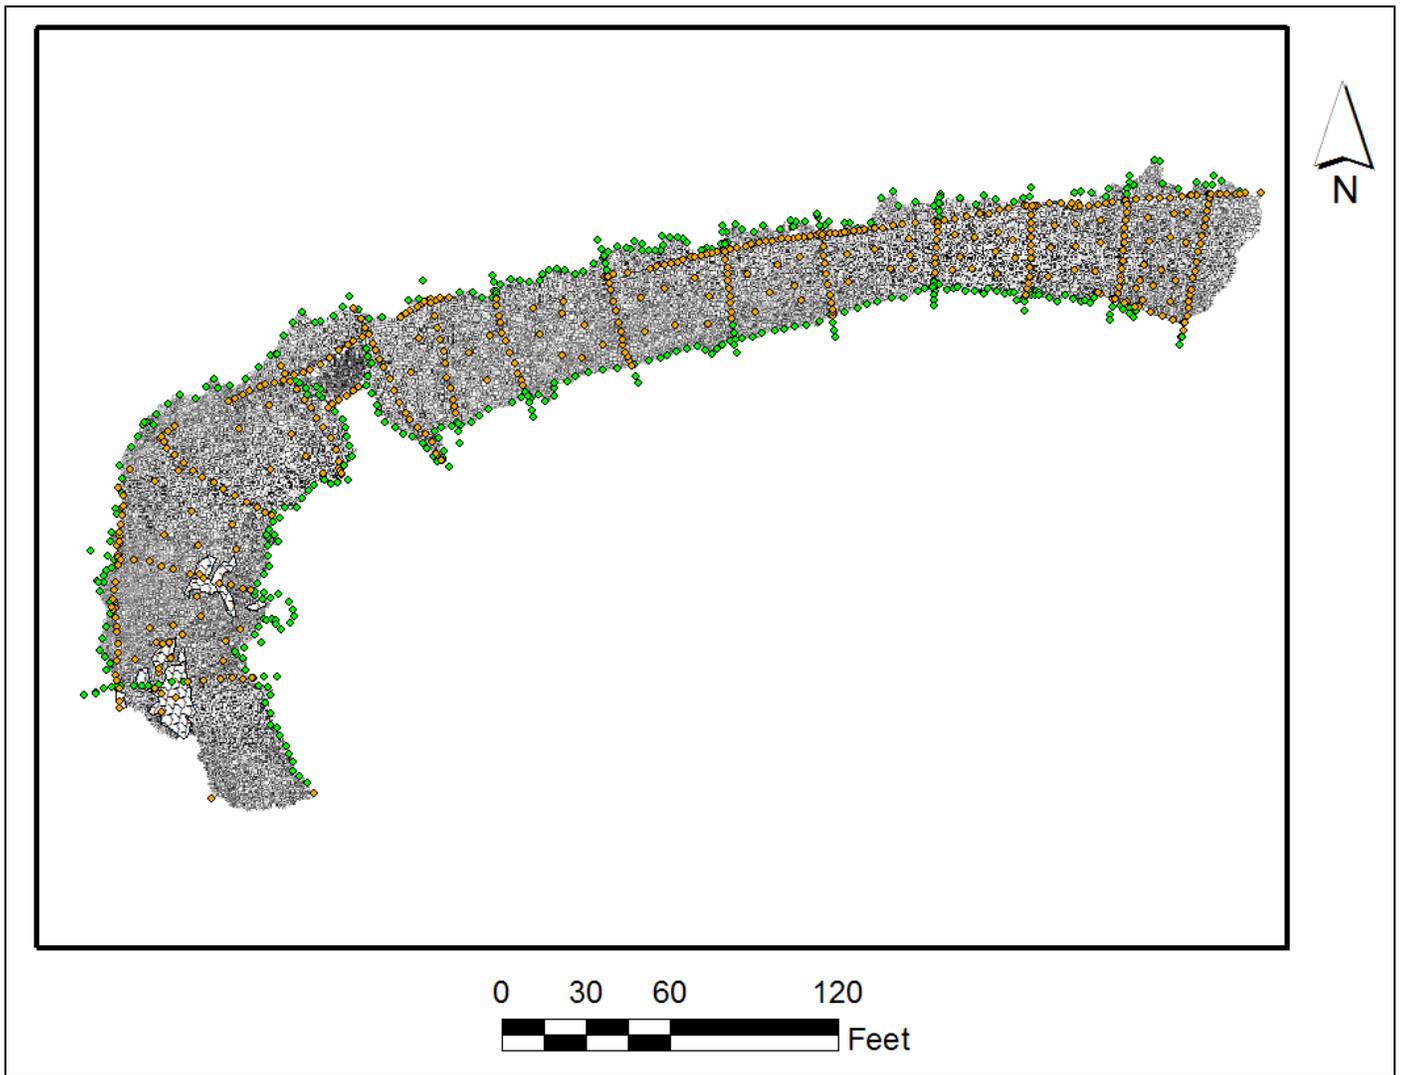
Figure 27. Isolated points used to calculate the more conservative volume. The orange symbols show points located on standing or intact wall sections. The green symbols show other points delineating the entire wall.

To calculate the volume of displaced material, we isolated the material in the standing wall from the total material recorded, which included the scattered rubble on both the wall's exterior and interior. The total wall points collected included all standing wall points and associated wall rubble. Point descriptions were used to isolate the points within the standing wall for the conservative estimate (Figure 27).
