# Kaloko-Honokōhau National Historical Park

## *'AI'ŌPIO FISHTRAP DOCUMENTATION*

**'Ai'ōpio Fishtrap Documentation  
Kaloko-Honokōhau National Historical Park  
SRC Technical Report Number 24  
PMIS #98241**

Technical Report  
Number 24

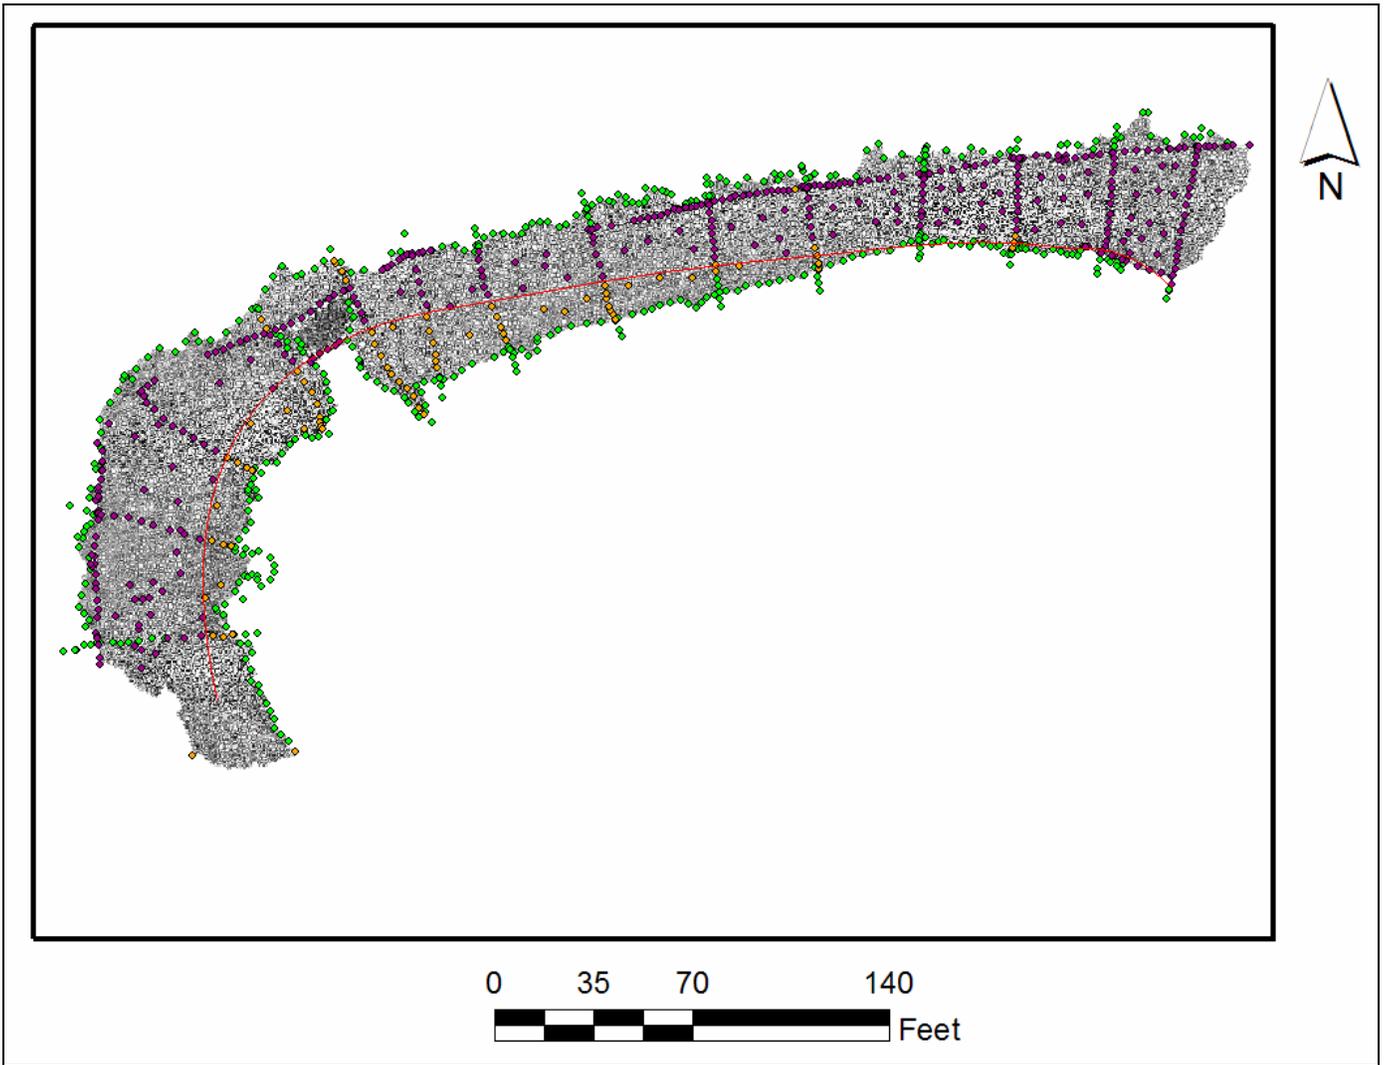
Figure 28. Line and points used to calculate the less conservative volume of wall fall. The red line represents the extrapolated pond-side wall face. The purple symbols represent the standing wall points based on the extrapolated wall face. The orange symbols are points that were considered standing in the conservative calculation, but are considered rubble in the less conservative calculation. The green symbols, again, show other points delineating the entire wall including rubble.

For the less conservative estimate, archaeologists extrapolated the pond side face of the wall based on a number of indicators in the archaeological remains. First, the previously reconstructed portion of the eastern terminus was used to delineate the standing wall at that location. Next, the base stones in the cut section provided sufficient evidence to suggest the original width of

the wall at that location; a line was drawn from the intact section on the eastern terminus along the pond side base stones in the cut section. Finally, this extrapolated line connected on the western terminus based on a series of rock alignments that indicated the possible original wall face in that location (Figure 28).

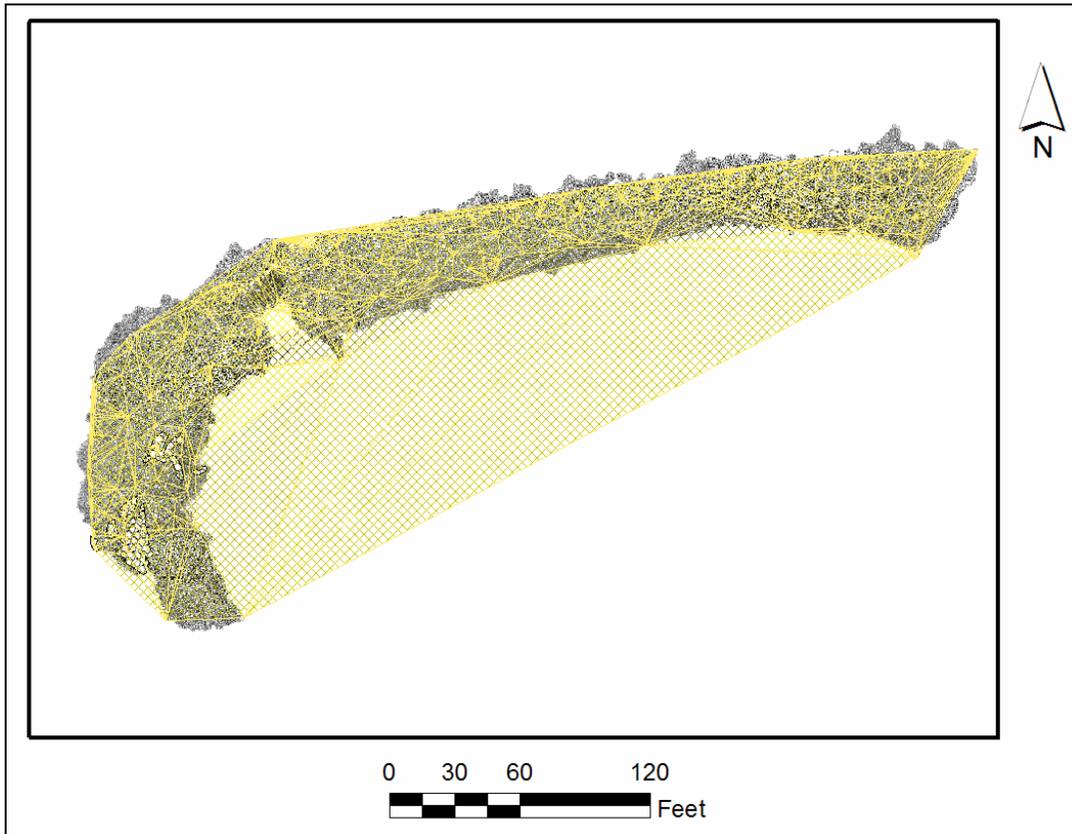
Figure 29. TIN model of the standing wall data (conservative) overlaid onto the planimetric site map.

structure of the input data. The 3D model depicted in Figure 29 represents the portions of the standing wall based on the conservative data, Figure 30 shows the TIN resolved from the non-conservative standing wall data, and Figure 31 shows the resolved TIN of the total wall including standing wall and associated rubble scatter.

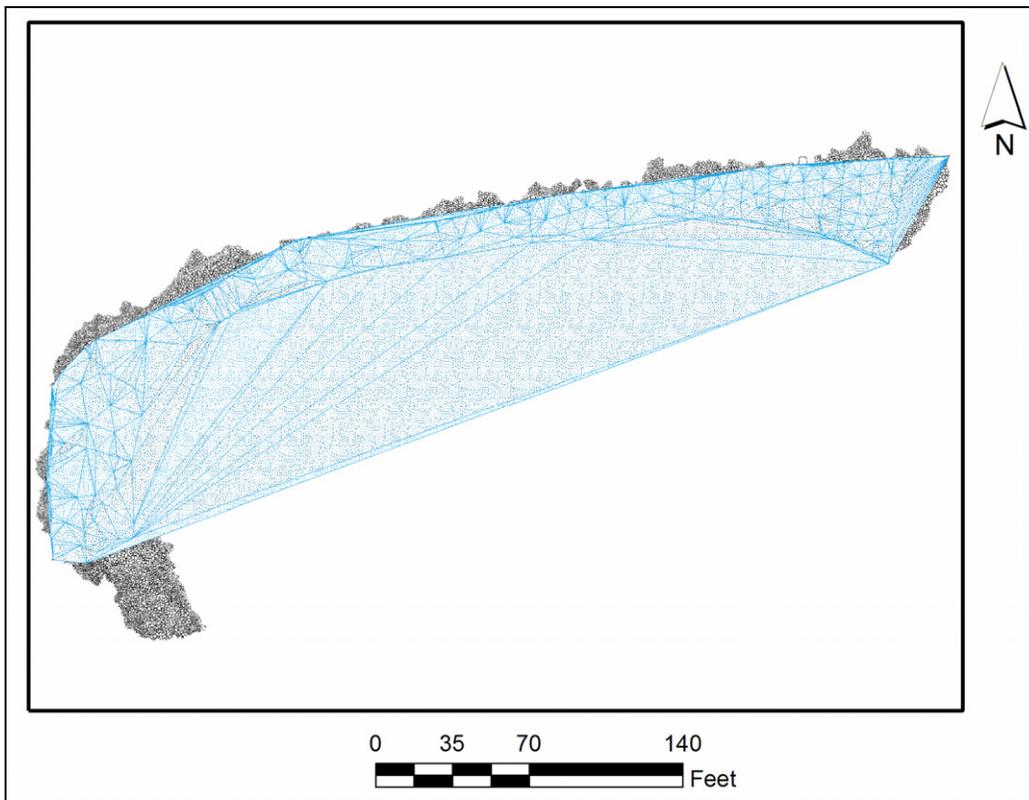
Figure 30. TIN model of the standing wall (non-conservative) overlaid onto the planimetric site map.

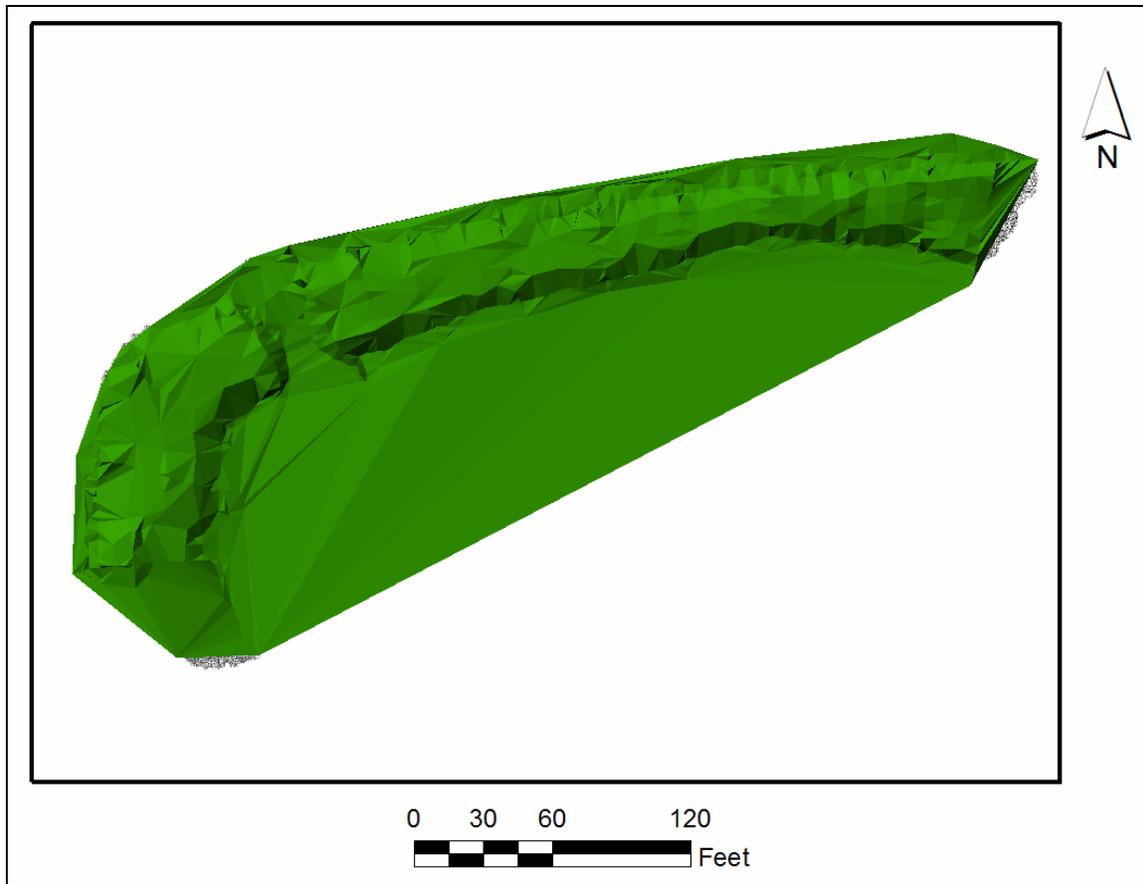
Figure 31. TIN model of the entire wall structure, including both the standing wall and associated rubble scatter.

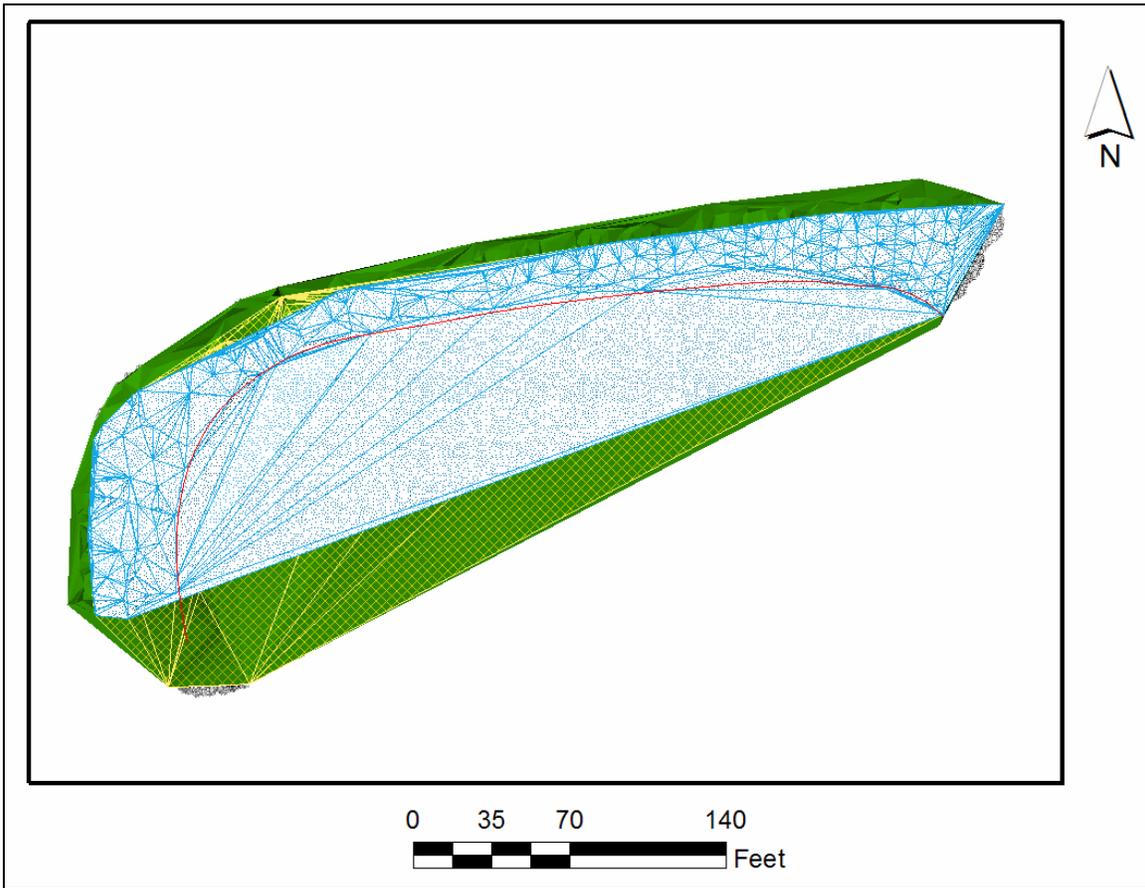
Figure 32. The standing wall TINs (yellow and blue) overlaid on the total wall TIN (green). The difference in volume represents the amount of displaced material.

After the 3D model creation, the surface volume of each TIN could be calculated in ArcGIS. The total volume of displaced material was calculated from overlaying the standing wall TINs on the total wall TIN, with error added to the difference (Figure 32 and Table 1).
