# **NATIONAL REGISTER OF HISTORIC PLACES DETERMINATION OF ELIGIBILITY FOR MISSION 66-ERA RESOURCES**

## **ABRAHAM LINCOLN BIRTHPLACE NATIONAL HISTORICAL PARK, LARUE COUNTY, KENTUCKY**

July 2023

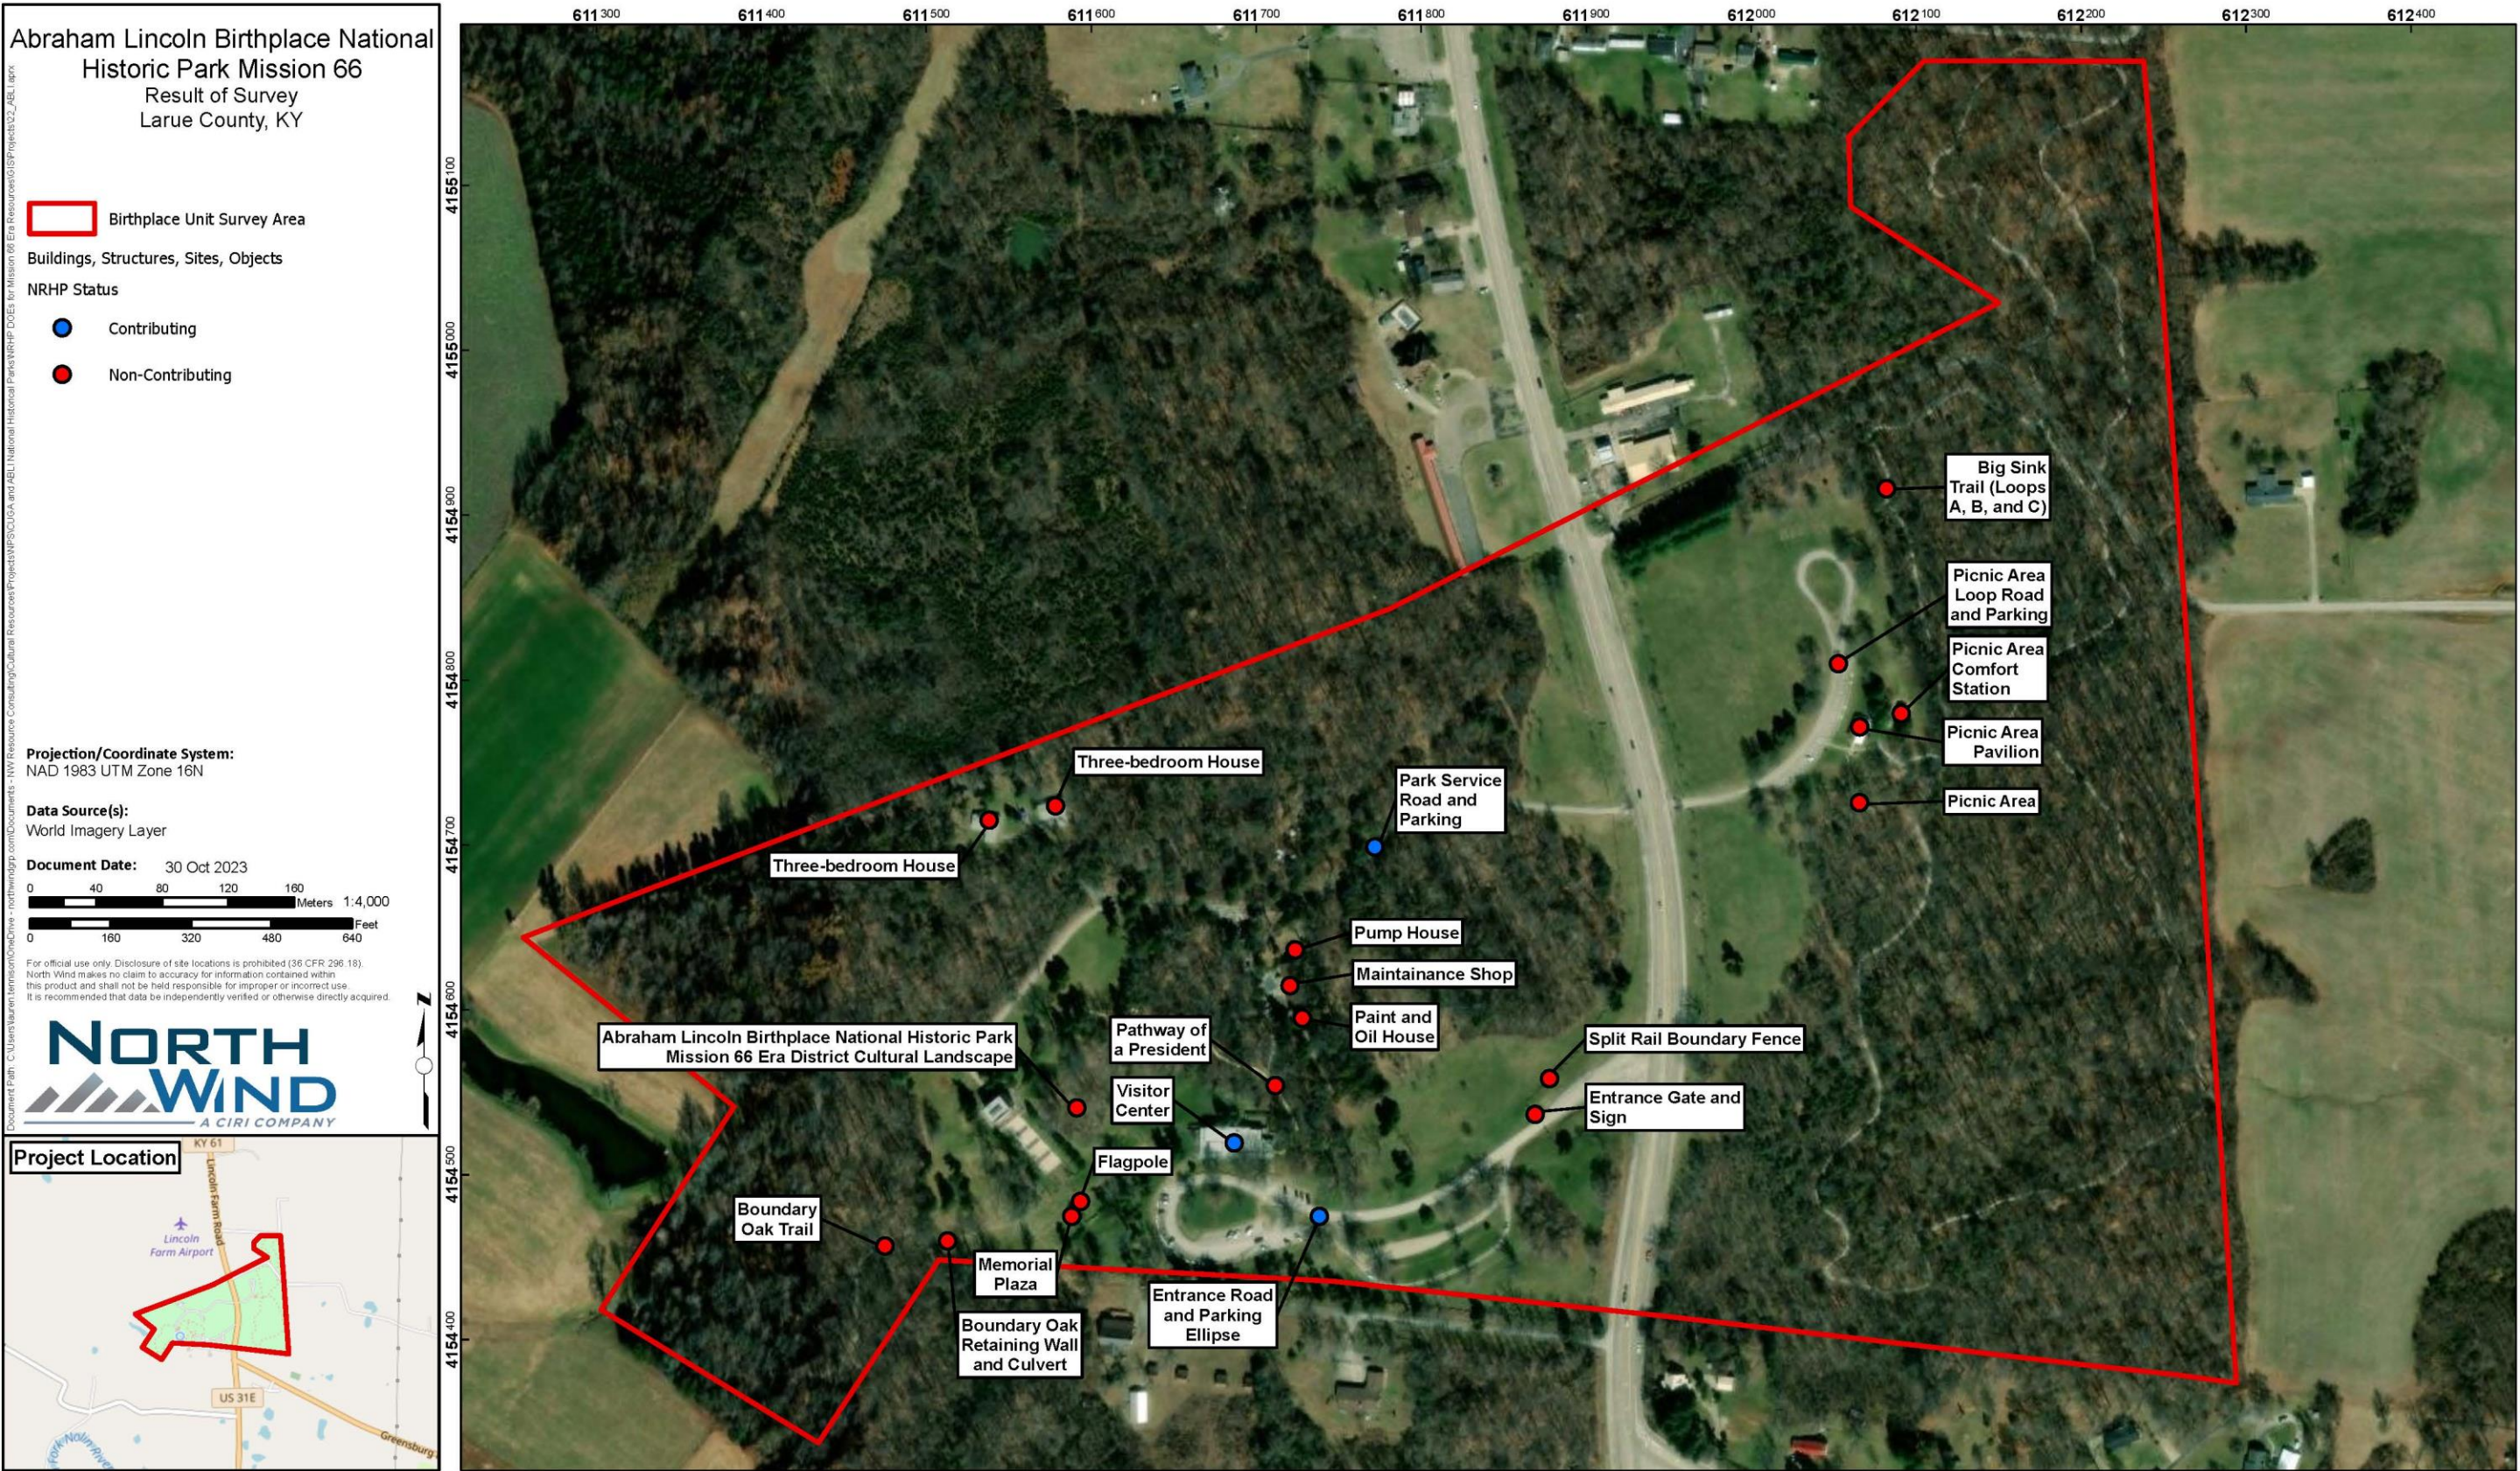
Figure 11. Documented resources within the Birthplace Unit of Abraham Lincoln Birthplace National Historical Park, Birthplace Unit.

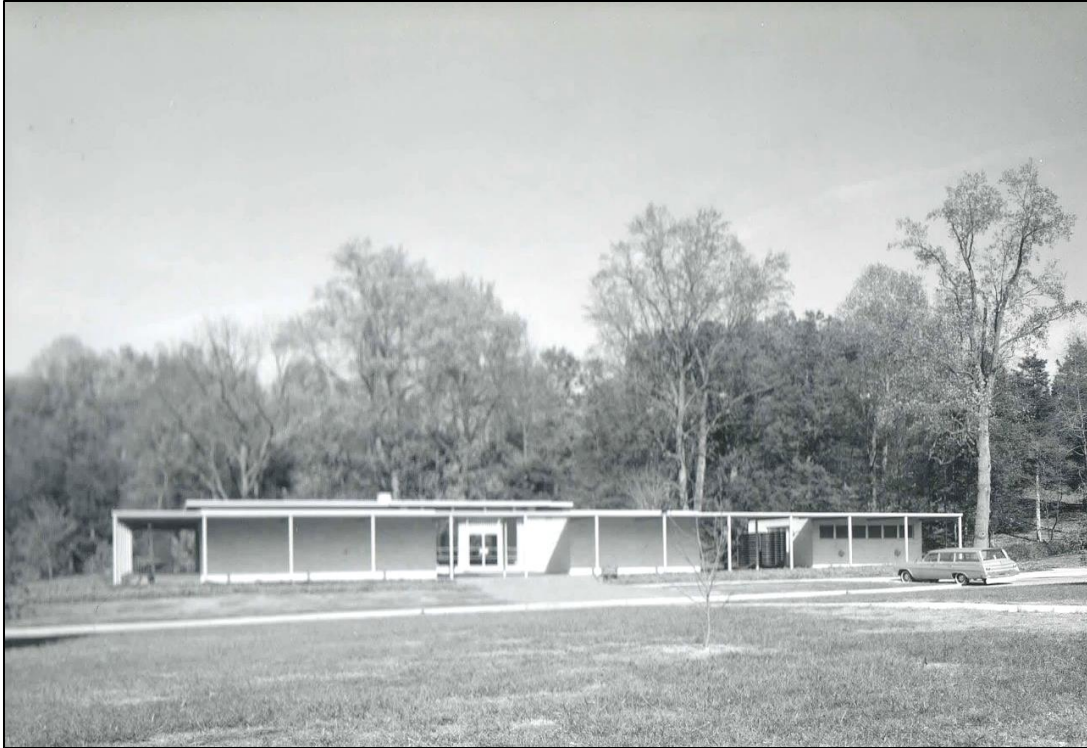
Figure 14. Primary (south) façade of the Visitor Center, ca. 1950s (Image courtesy of the NPS, Denver Service Center [ETIC no. 885373-ABLI\_338\_P19\_0001\_of\_0001]).

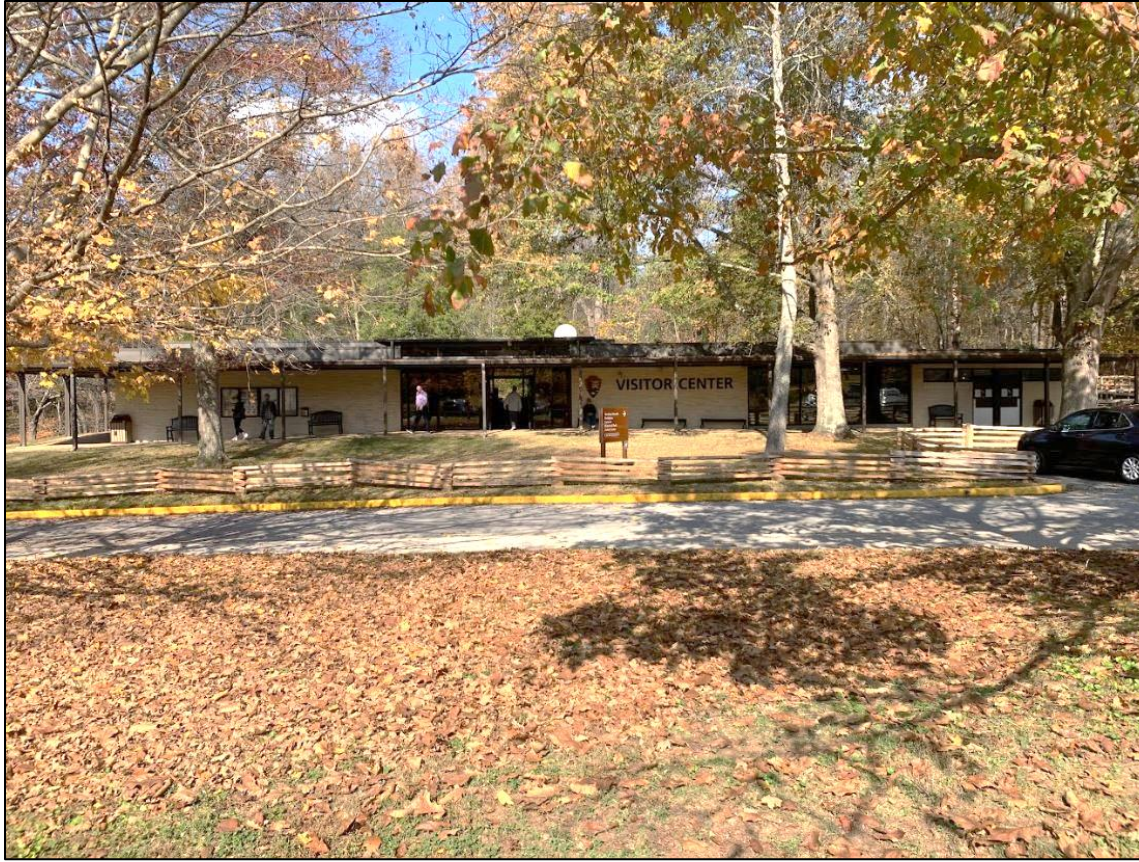
Photograph 1. Current photograph of the Visitor Center, showing sympathetic modern alterations, facing north.

In the 64 years since the Visitor Center was built there have been several interior renovations of the exhibits and administrative space, as well as upgrades to its essential systems (e.g., plumbing, electrical, and mechanical/heating, ventilating and air conditioning). There have also been three distinct expansion projects to create more functional space for NPS staff. The technical upgrades and renovations had no aesthetic effect upon the facility, and the expansions have, with one exception that was subsequently and successfully reversed, been sympathetic with the original design and in keeping with the *Secretary of the Interior’s Standards for the Treatment of Historic Properties (Treatment: Rehabilitation)* (Photograph 1). Table 2 provides a summary of the physical changes made to the Visitor Center through time.

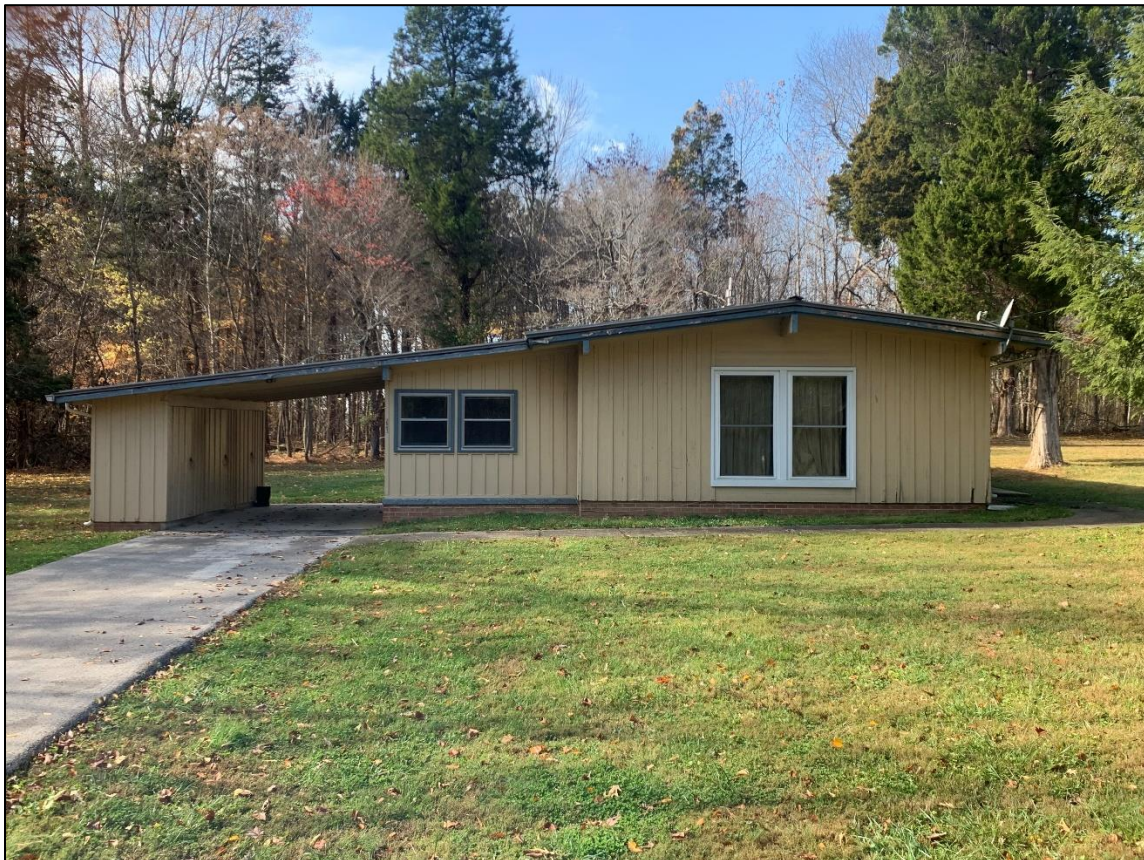
Photograph 2. Current photograph of the three-room residence, showing infilled screen porch and modern window replacements, facing west.

Due to the alterations made to House 250, including the infill of the original screen porch with board-and-batten siding and modern one-over-one sash windows; removal and replacement of all original windows, including two jalousie style windows on the east facade, with modern one-over-one sash windows; and removal of original built-up roofing with

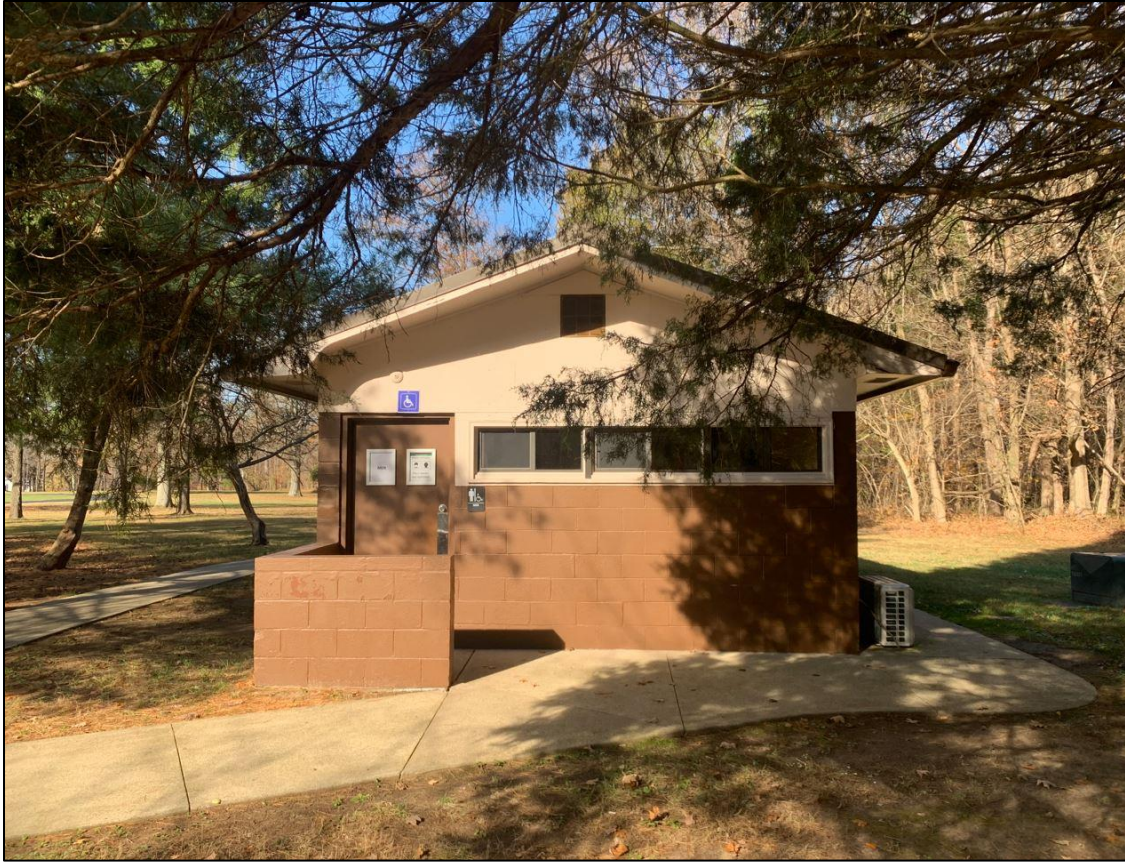
The structure now in place at the picnic area is a symmetrical, rectangular building built of 8-inch-thick concrete block, measuring 25 feet 4 inches in length, plus a similar 4-foot-deep entrance alcove at each end, and 16 feet in width, without a service corridor in between (Photograph 3). The concrete block walls are painted inside and out, and there is no brick veneer. As the comfort station was not constructed by the NPS and lacks a clear association with the park's Mission 66 program, it is a non-contributing resource.

Photograph 3. Current photograph of the picnic area comfort station, facing north.

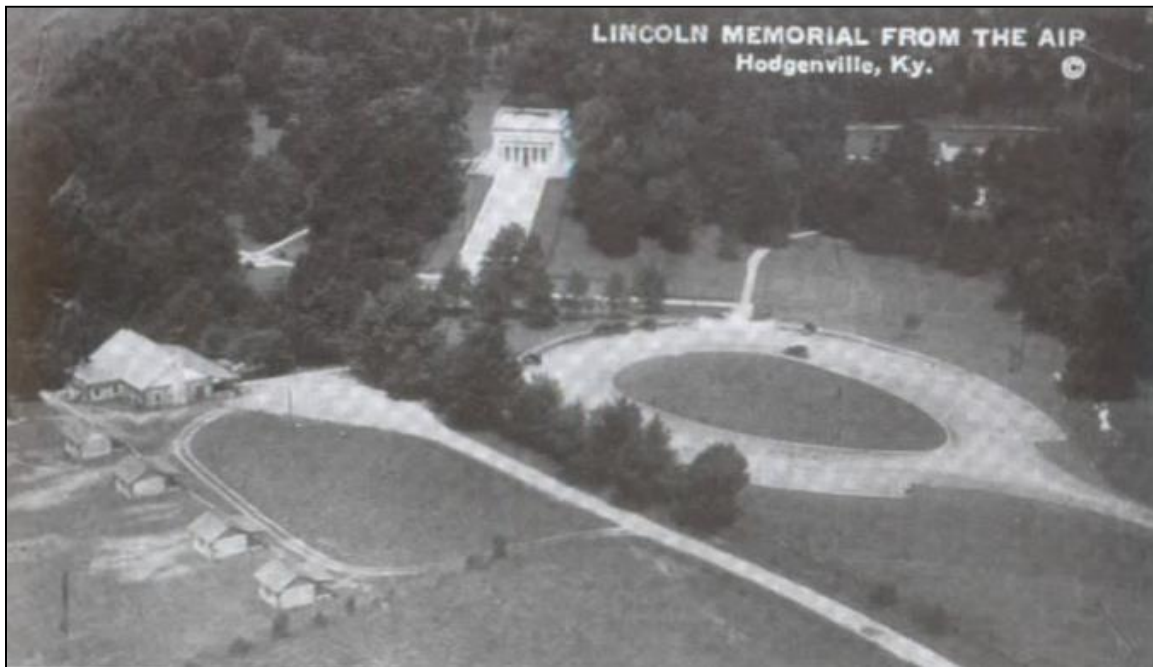
Figure 18. Aerial photograph showing the parking ellipse as designed and constructed by the War Department, 1938 (Image reprinted from Hotchkiss and Lawless 2004:27).

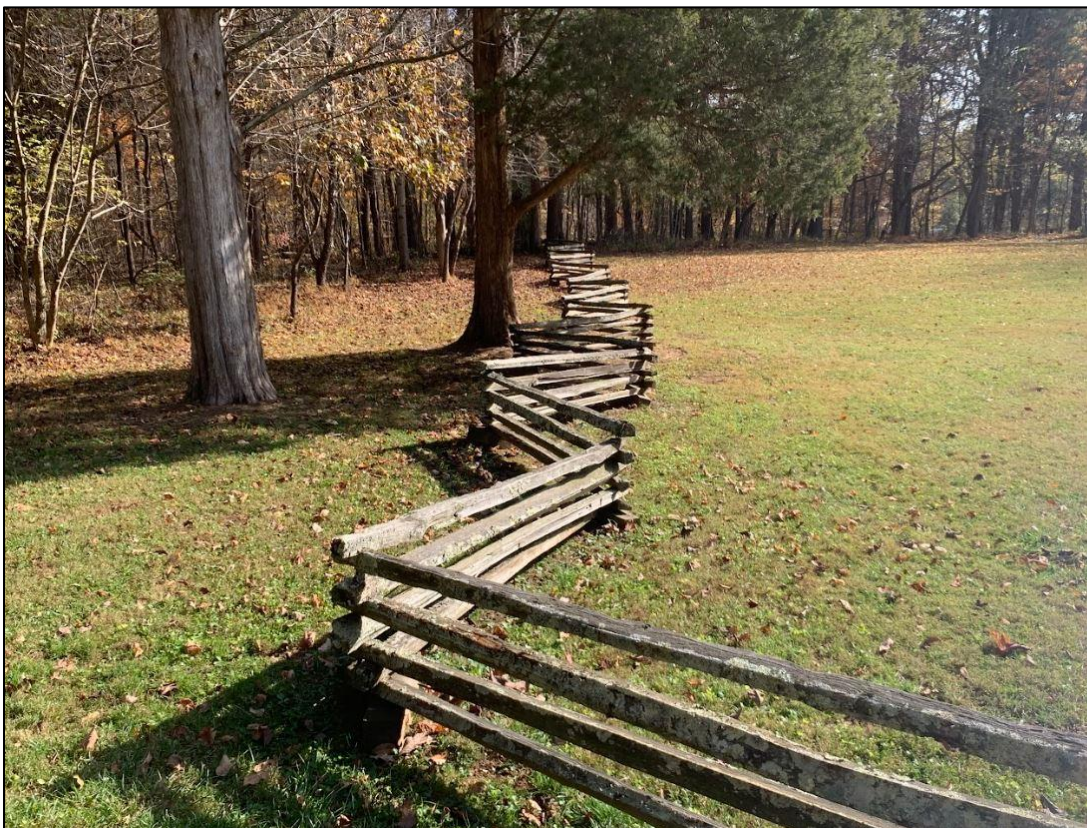
Photograph 4. Current photograph of the split-rail boundary fence, facing northeast.

The split rail boundary fence was originally constructed by the War Department in 1920s or 1930s using rails recovered from U.S. Army installation Fort Knox in Kentucky. As originally constructed, the fence was an eight-rail snake fence with a two-rail vertical cross support (Figure 20). The fence has been relocated by the NPS during the expansion of U.S. Highway 31E, and its wood rails were most recently replaced in 1991 (Photograph 4).

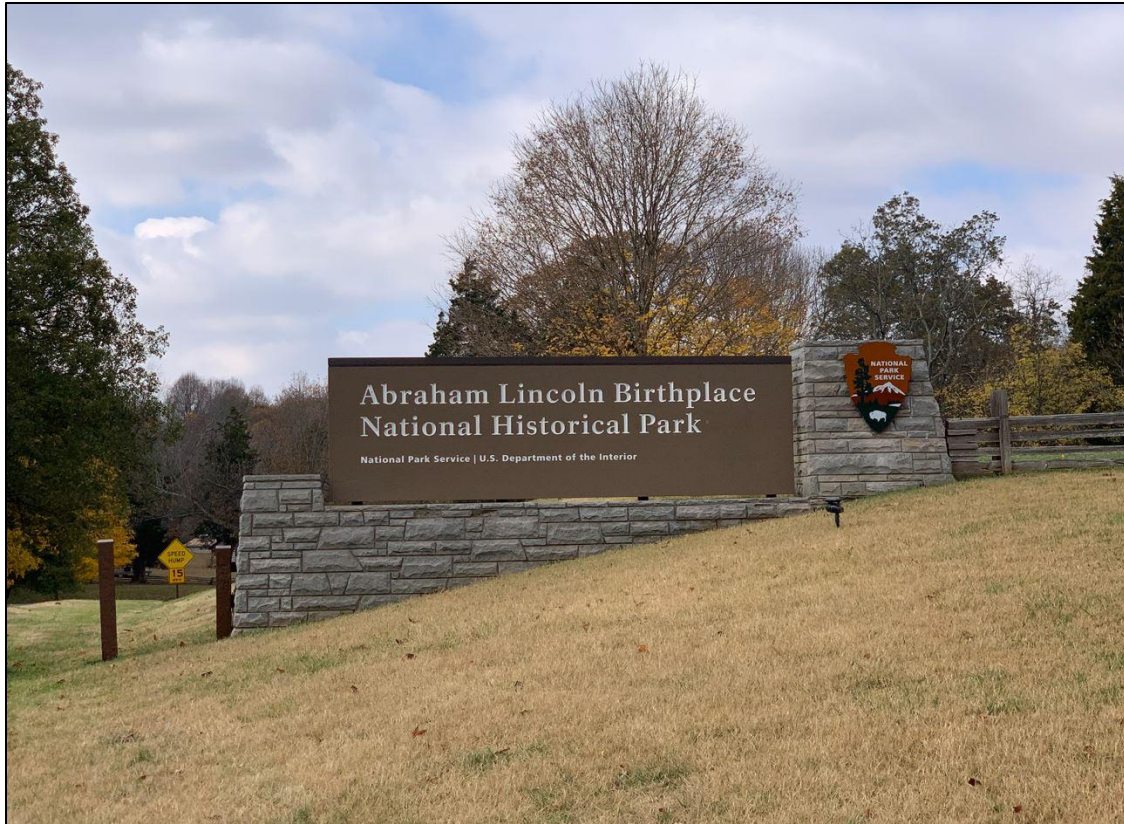
Photograph 5. Current photograph of the entrance gate and sign, facing southwest.

The entrance gate consists of three battered stone pillars with one on the north side of the entrance drive and two on the south side of the drive. All are set in a random ashlar pattern and have reinforced concrete foundations. The pillars flanking the road and swing gate are approximately 3 feet tall by 2 feet square at the base. The support posts for the metal swing gate are attached to the flanking pillars. The southernmost pillar is approximately 4 feet long by 2 feet wide by 3 feet high. This pillar and its neighbor to the north are connected via three 4-foot-long horizontal wood boards with ends set into the stone faces of the pillars. This configuration was originally mimicked on the north side of the road; however, all that remains are three support posts. The split rail boundary fence is connected to the south face of the southernmost pillar, and the northern face of the sign. A parking pullout is located to the east to allow visitors to pose for photographs with the sign.

The entrance gate and sign have been altered since originally constructed. The sign board itself has been replaced at least twice with the most recent having been installed after 2008. Additionally, the NPS logo was affixed to the east face of the sign, and the boards connecting the sign to the flanking pillars were removed. It is not known when these changes were made. The most significant change is the replacement of the original sign board which was much larger and wider than the current sign board, was constructed of wood with routed lettering and the NPS logo (Figure 21). Due to these alterations, the entrance gate and sign can no longer convey the principles of the Modern Movement, or “Park Service Modern” style, as defined in the *NPS Mission 66-Era Resources Multiple Property Documentation Form* and are therefore considered to be non-contributing.

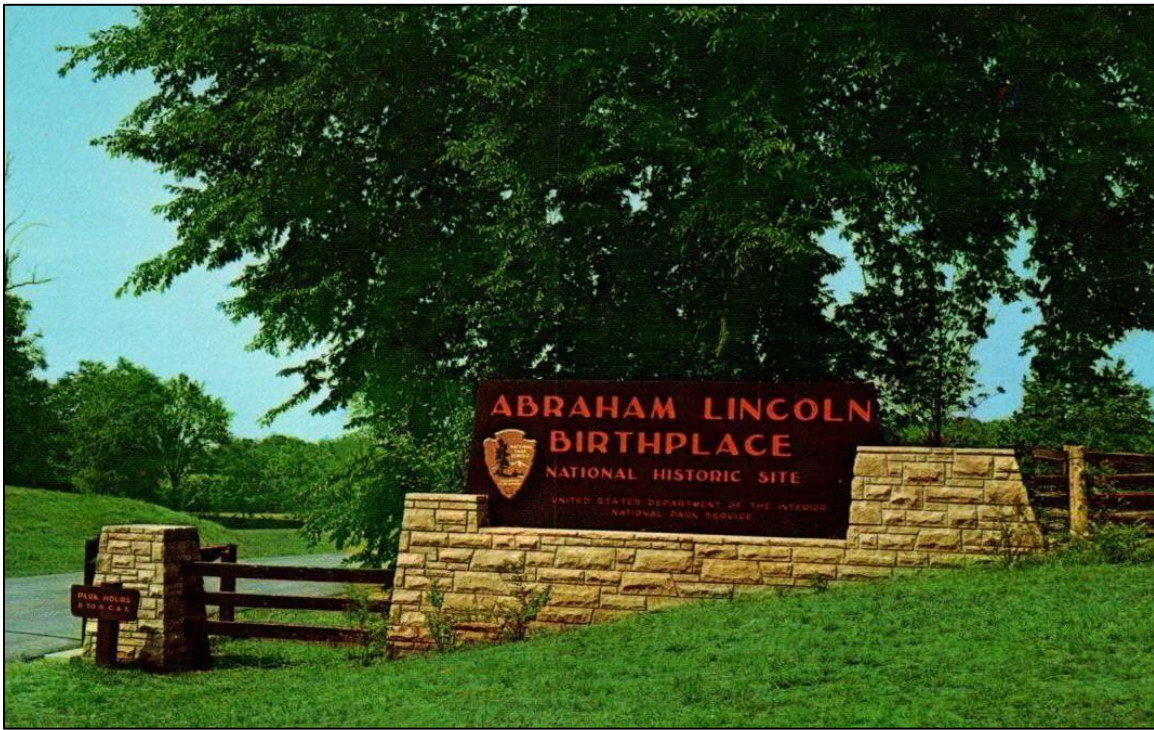
Figure 21. Postcard showing a detailed view of the Mission 66-era entrance gate and sign at Abraham Lincoln Birthplace National Historical Park, ca. 1961 (Image courtesy of Curt Teich Company, Chicago, Illinois).

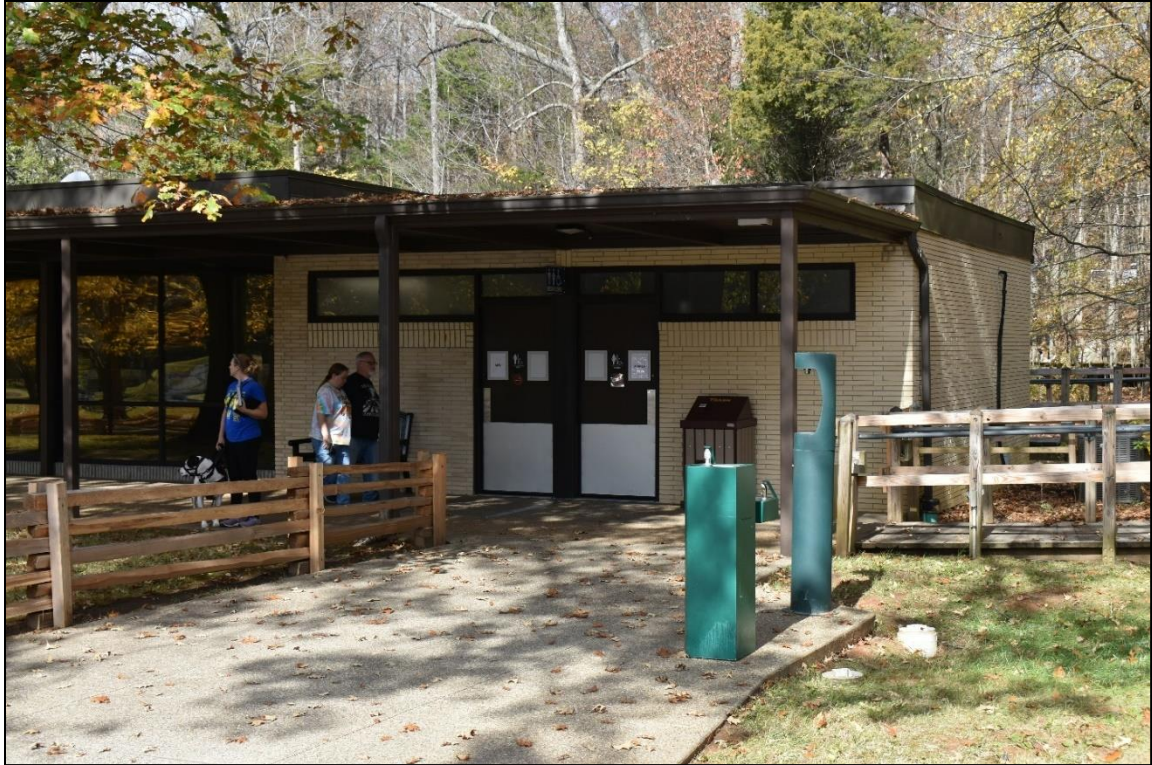
Photograph 3. Restroom at the east end of the Visitor Center, Abraham Lincoln Birthplace National Historical Park, facing northwest.

Photograph #3. Visitor Center at Abraham Lincoln Birthplace National Historical Park, showing bathroom addition at the east end of the building, facing northwest.

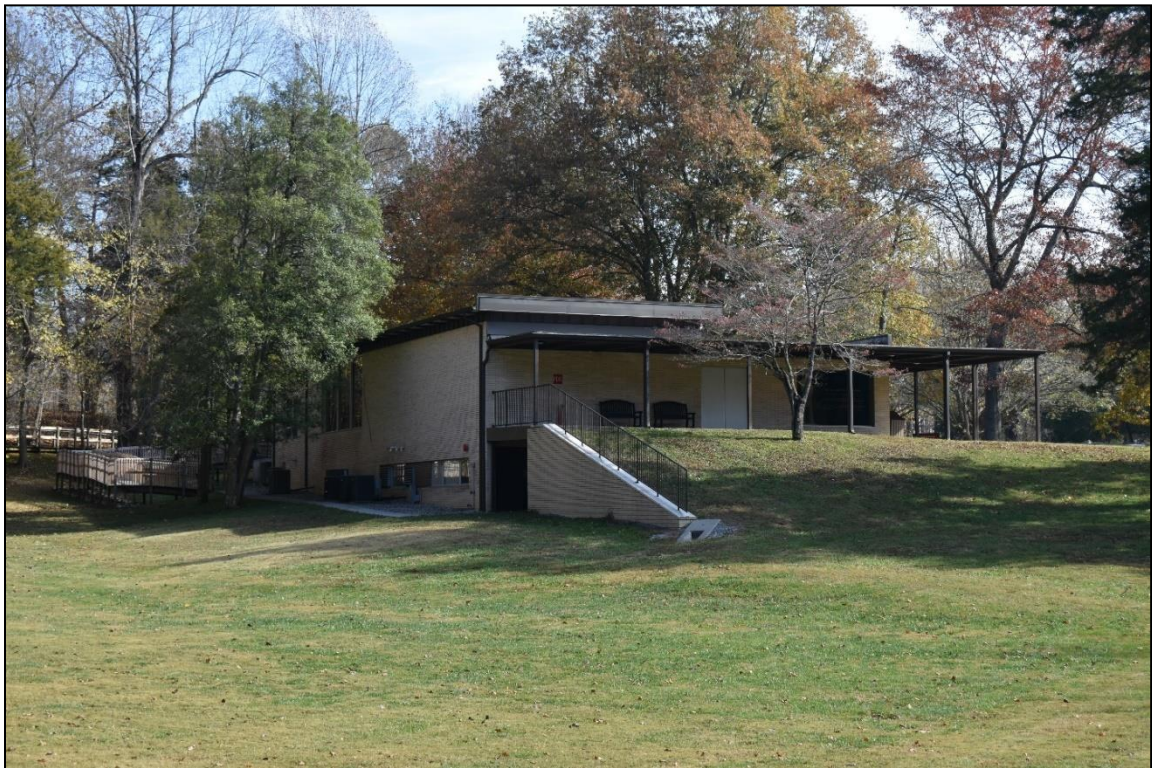
Photograph 4. North (rear) and west facades of the Visitor Center, facing east.

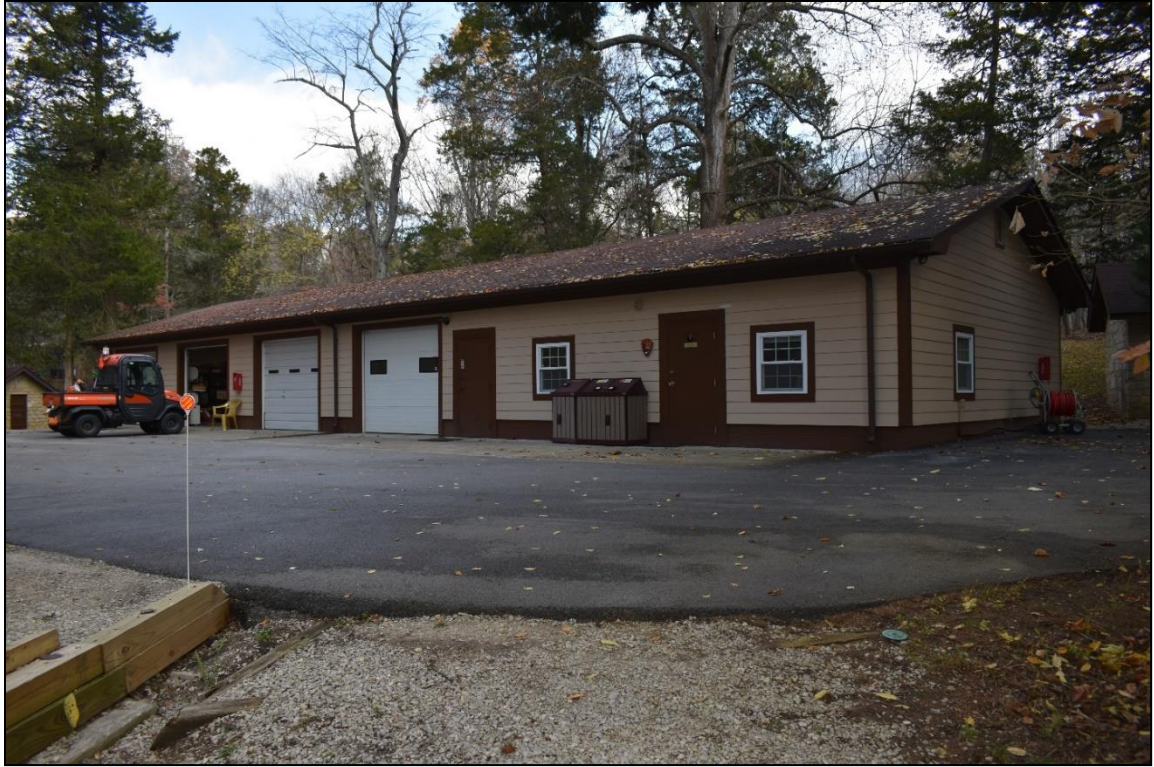
Photograph 5. Maintenance building in the service area to the north of the Visitor Center, facing northeast.

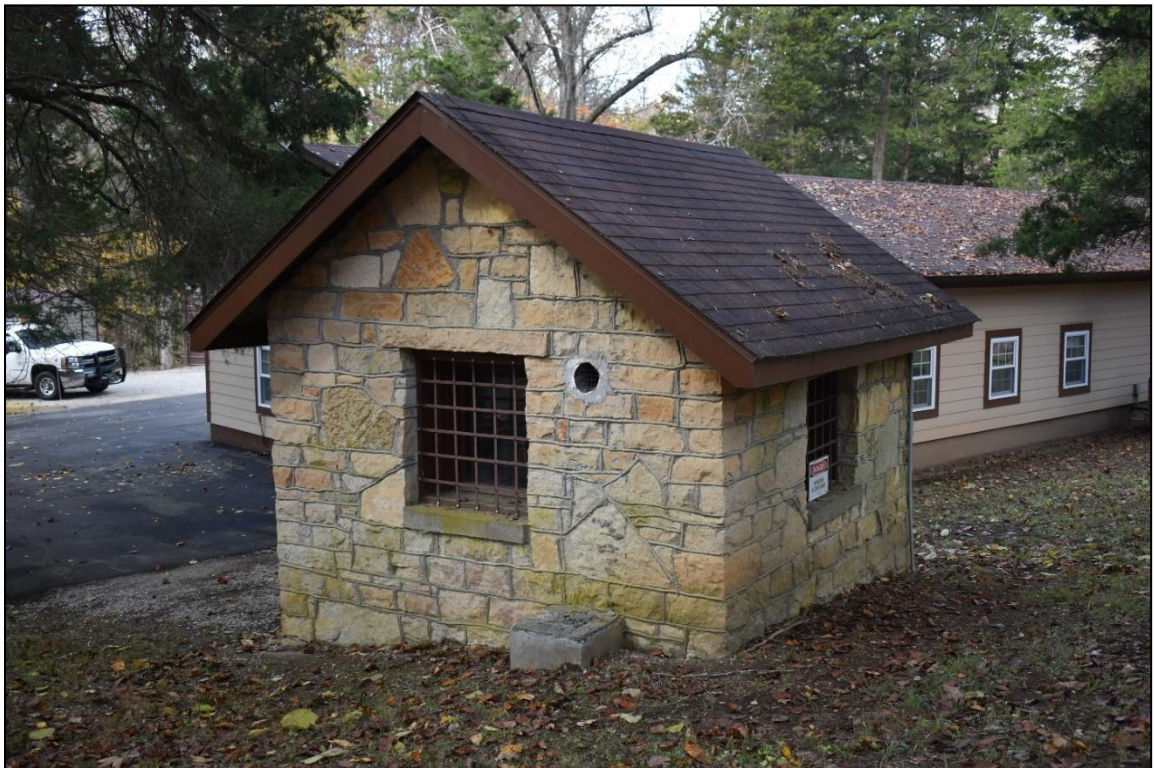
Photograph 6. Paint and oil house in the service area to the north of the Visitor Center, facing northwest.

Photograph #6. Paint and oil house in the service area to the north of the Visitor Center, facing northwest.

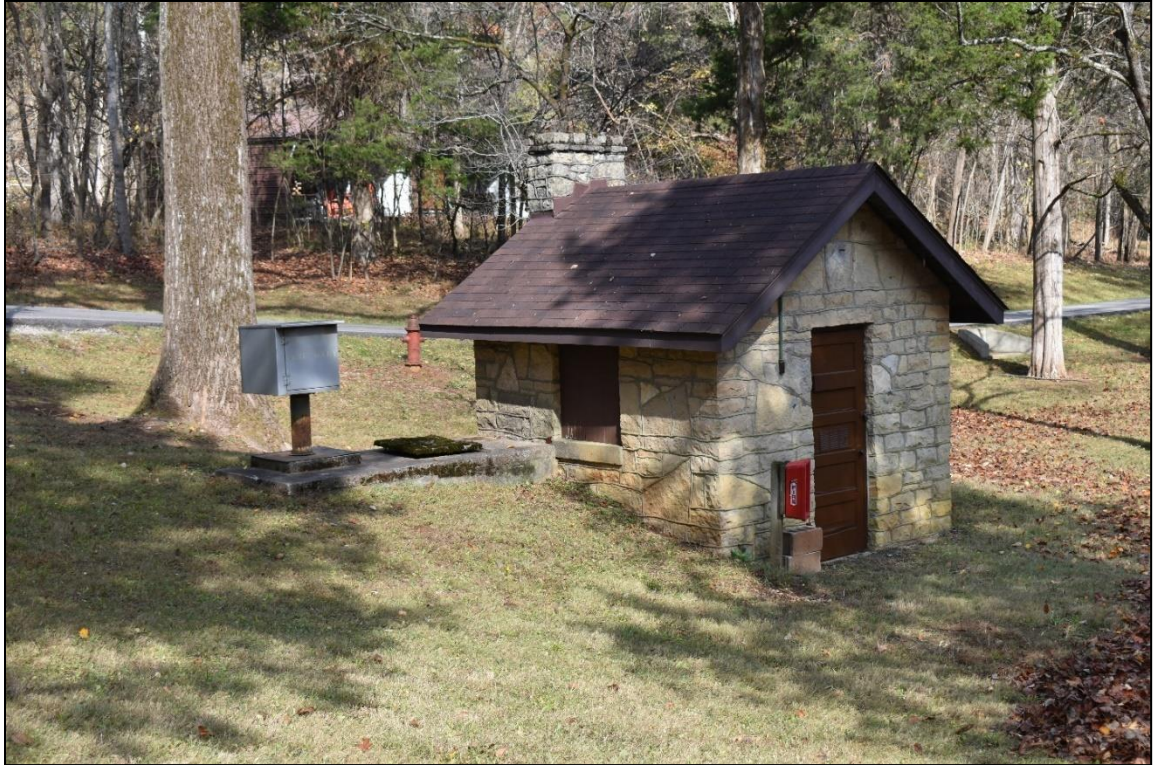
Photograph 7. Pump house located in the service area to the northwest of the Visitor Center, facing north.

Photograph #7. Pump house located in the service area to the northwest of the Visitor Center, facing north.

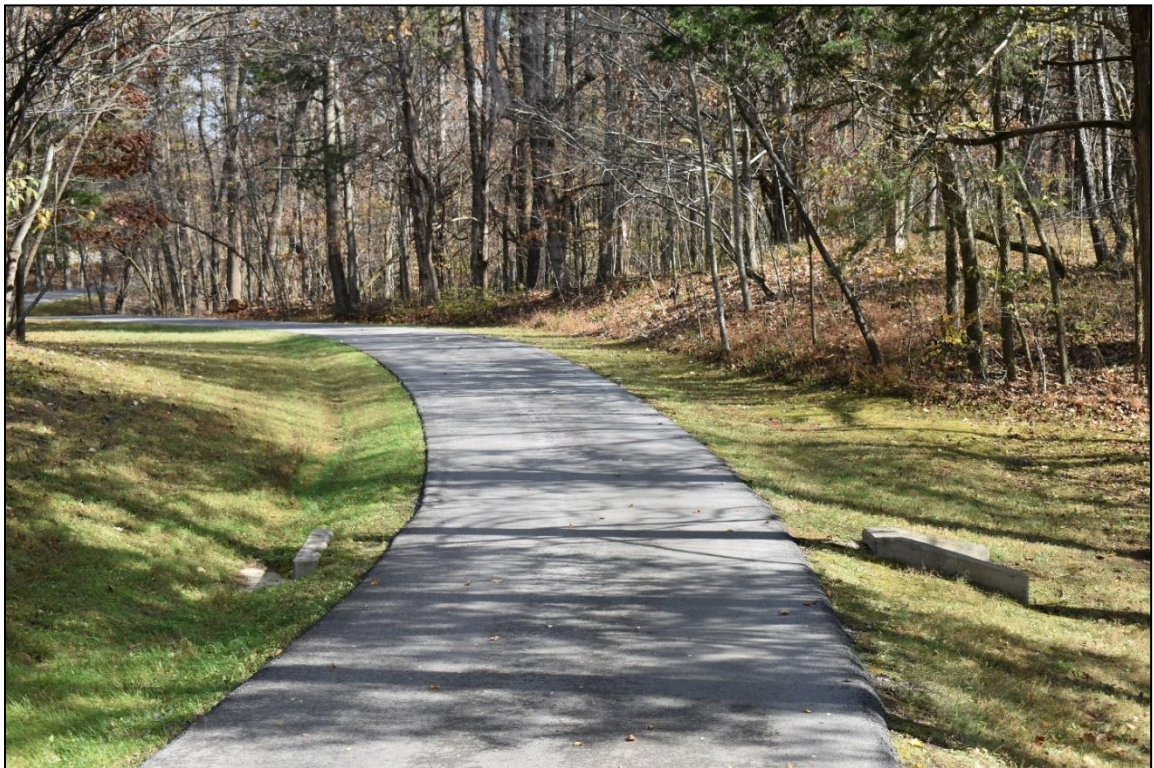
Photograph 8. Overview of the service road, showing concrete culverts along the north and south shoulders, facing east.

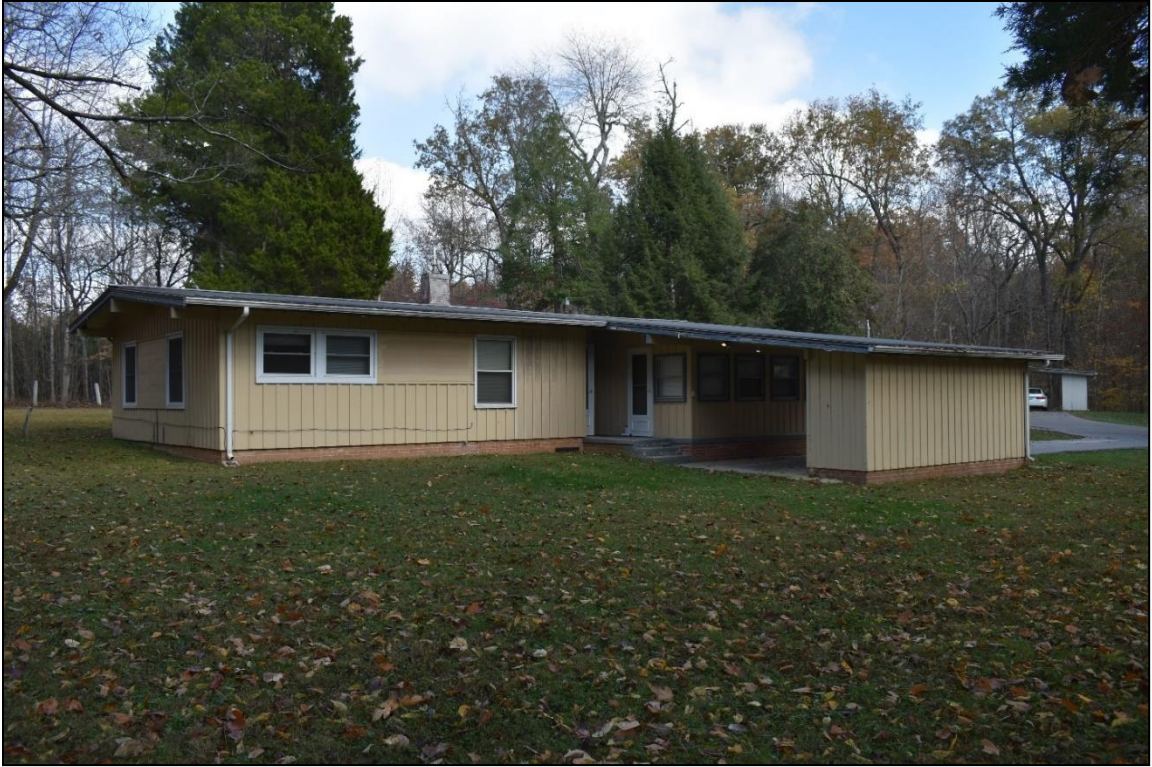
Photograph 9. South (main) and west facades of Three bed-room residence, facing northeast.

Photograph #9. South (main) and west facades of three-bedroom residence, facing northeast.

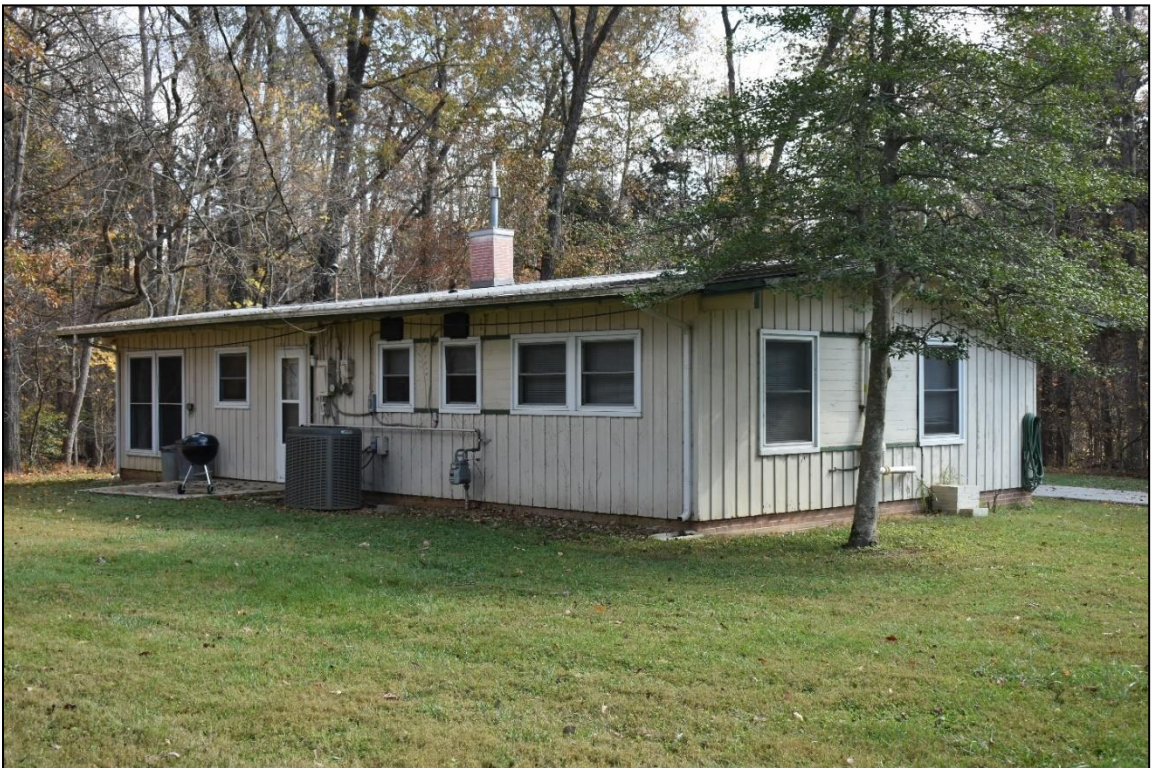
Photograph 10. North (rear) and east facades of Three-bedroom residence, facing southwest.

Photograph #10. North (rear) and east facades of three-bedroom residence, facing southwest.

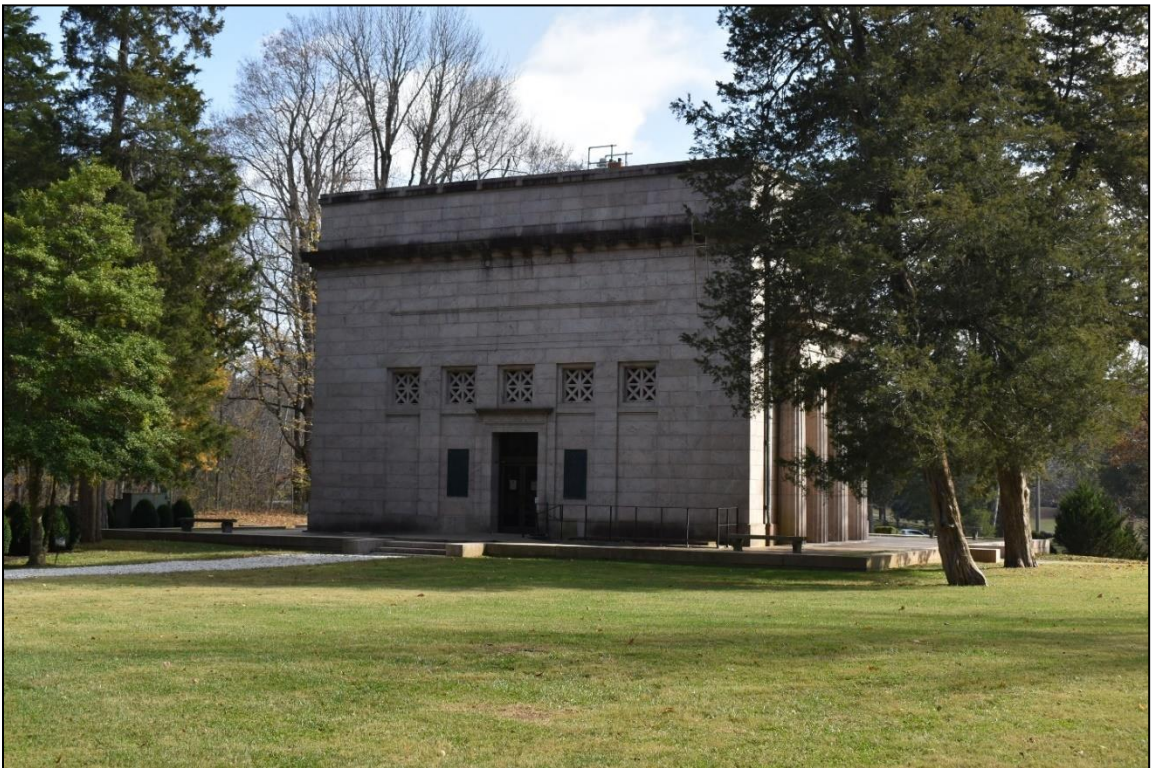
Photograph 14. Rear (northwest) façade of the Memorial Building, facing southeast.

Photograph #14. Rear (northwest) façade of the Memorial Building, facing southeast.

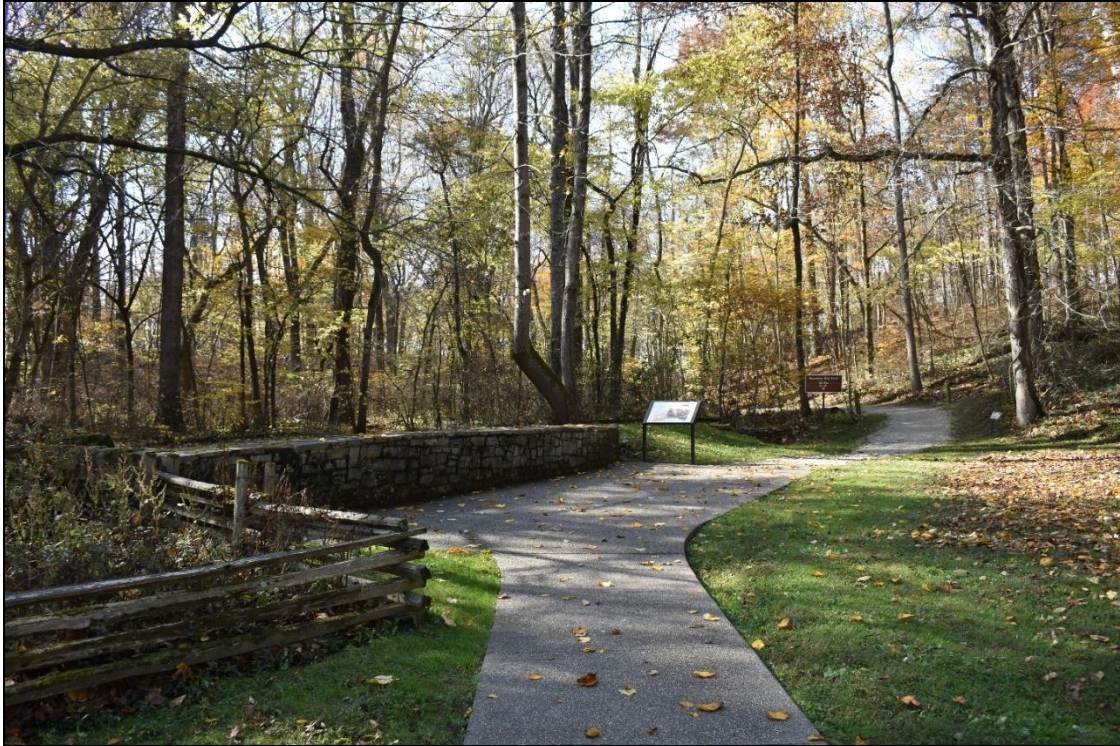
Photograph 17. Location of the Boundary Oak tree, showing paved path, split rail fence, drainage features, and interpretive sign, facing northwest. The Boundary Oak Trail begins just beyond the interpretive sign.

Photograph #17. Location of the Boundary Oak tree, showing paved path, split rail fence, drainage features, and interpretive sign, facing northwest. The Boundary Oak Trail begins just beyond the interpretive sign.

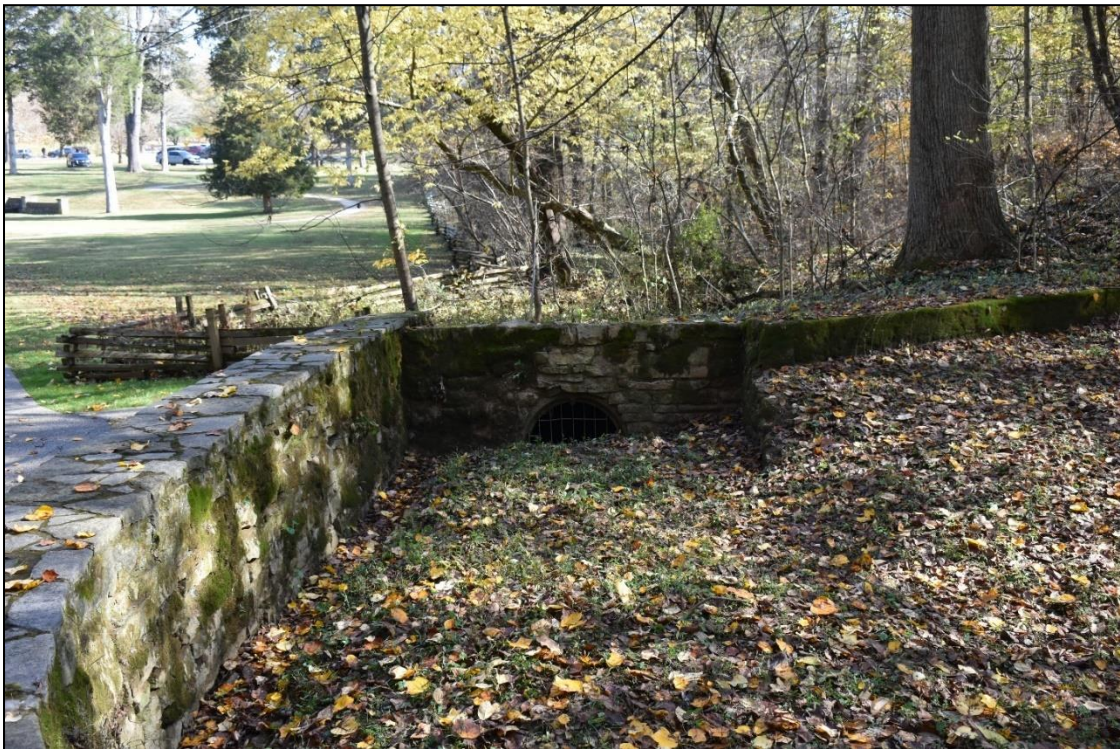
Photograph 18. Overview of the location of the Boundary Oak tree, showing stone retaining wall and culvert and earthen dam, facing west.
