# **NATIONAL REGISTER OF HISTORIC PLACES DETERMINATION OF ELIGIBILITY FOR MISSION 66-ERA RESOURCES**

## **ABRAHAM LINCOLN BIRTHPLACE NATIONAL HISTORICAL PARK, LARUE COUNTY, KENTUCKY**

July 2023

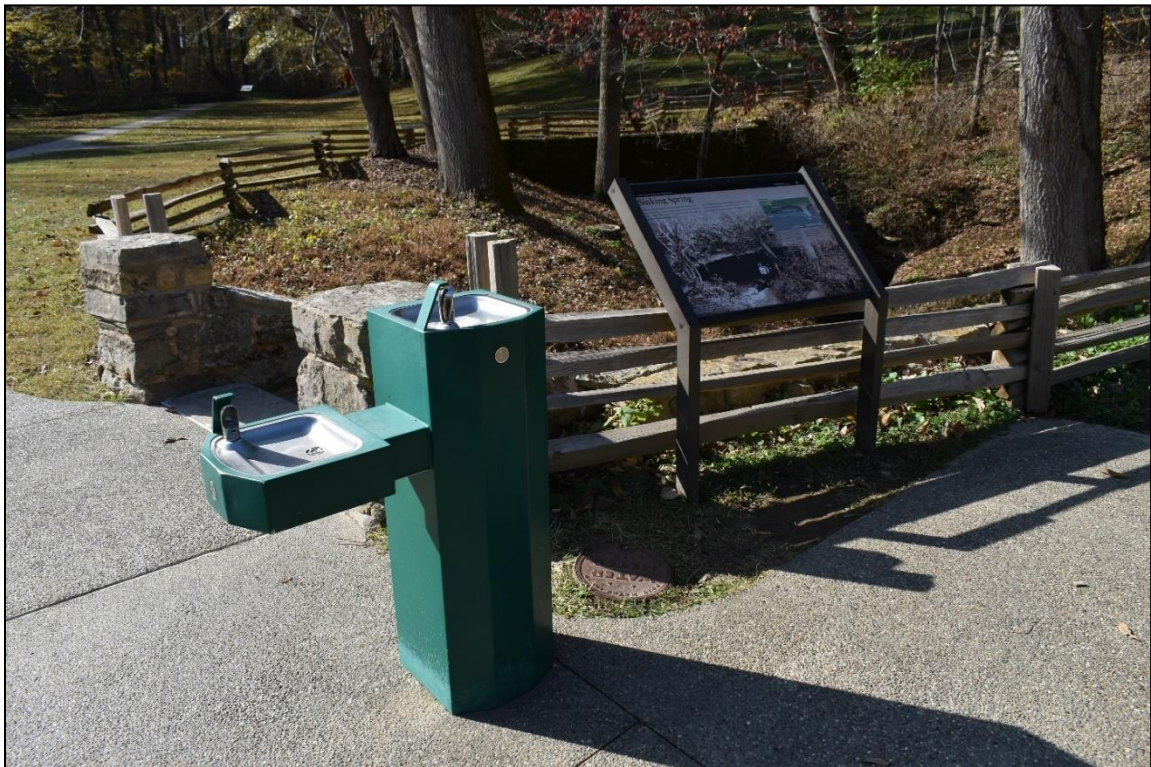
Photograph 20. Area immediately south of the stairway to Sinking Spring, showing water fountain, stone wall, split rail fence, and interpretive signage, facing west.

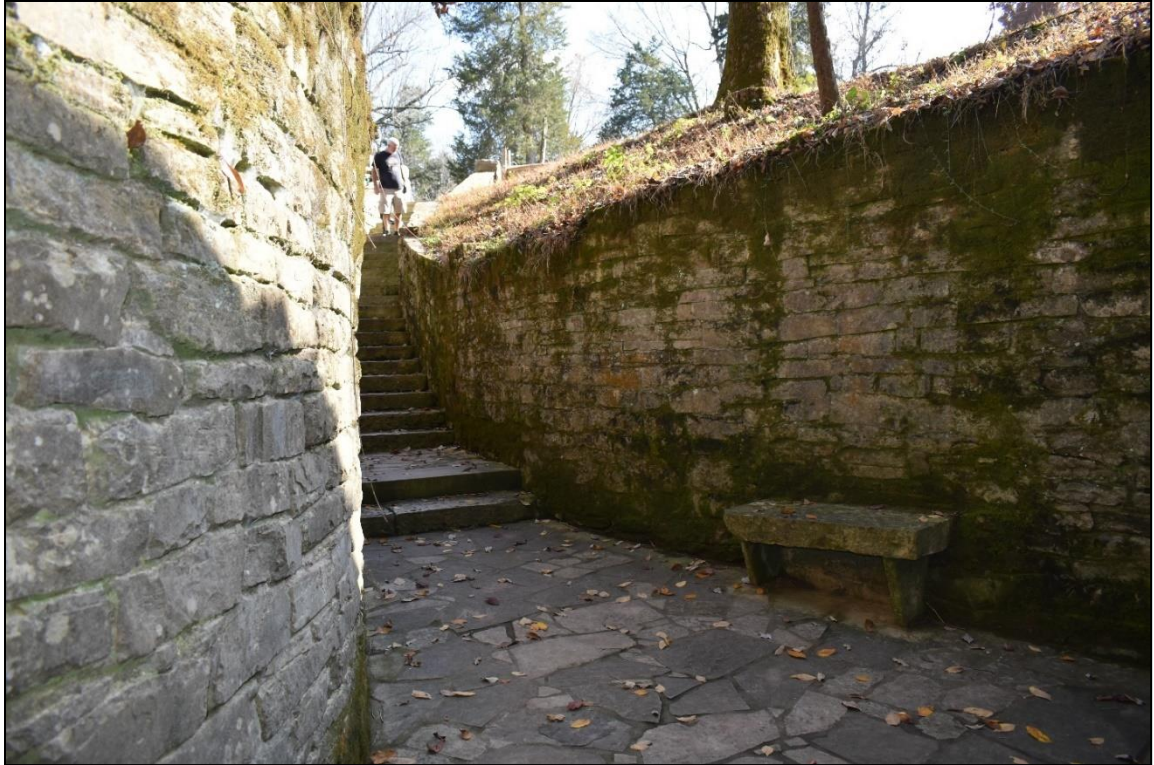
Photograph 21. Stone retaining walls, stairway, and bench at Sinking Spring, facing southeast.

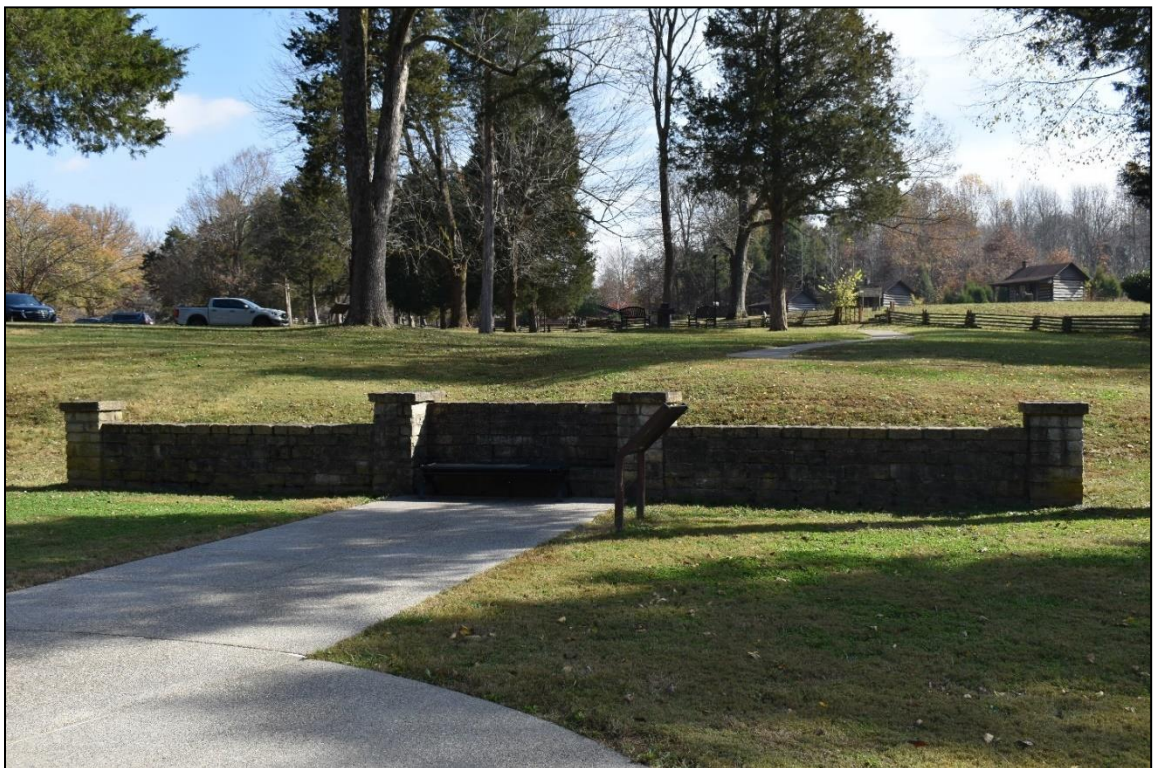
Photograph 22. Stone wall, bench, and interpretive sign at the south end of the plaza, facing southeast.

Photograph #22. Stone wall, bench, and interpretive sign at the south end of the plaza, facing southeast. The Visitor Center parking area is visible at the left edge of the photograph, and buildings associated with the former Nancy Lincoln Inn are visible at right.

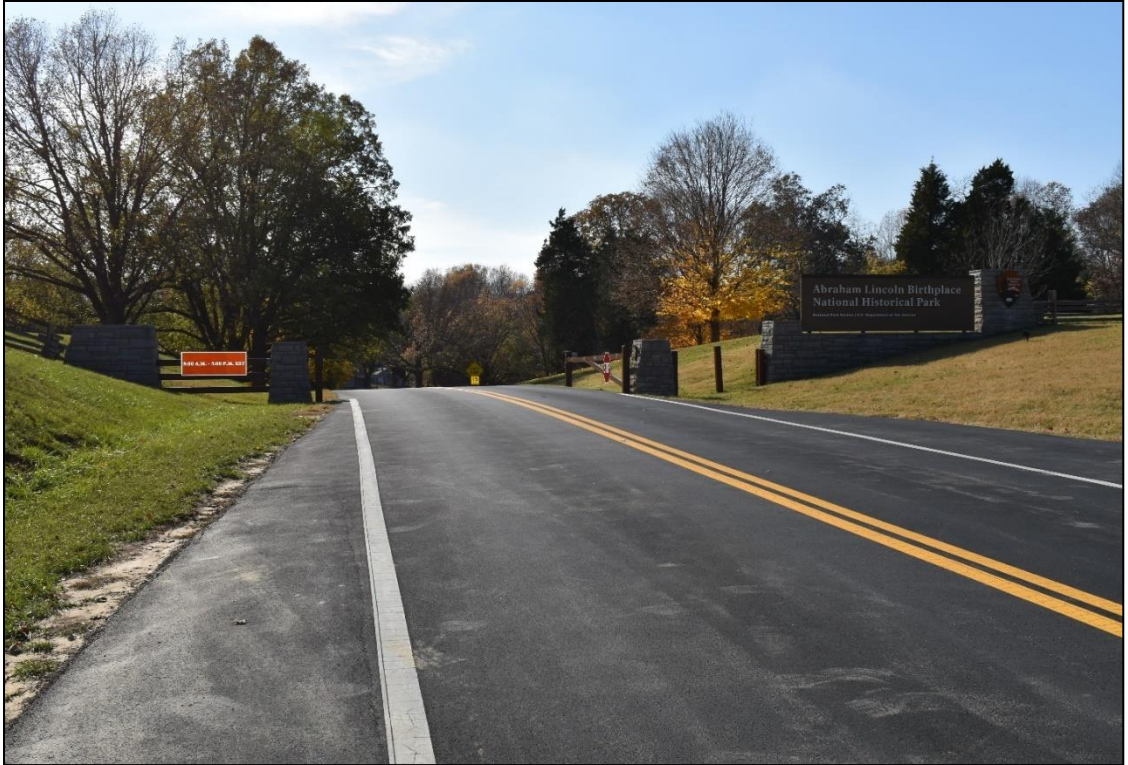
Photograph 30. Overview of the entrance road, gate, and sign, facing west.

Photograph #30. Overview of the entrance road, gate, and sign, facing west.

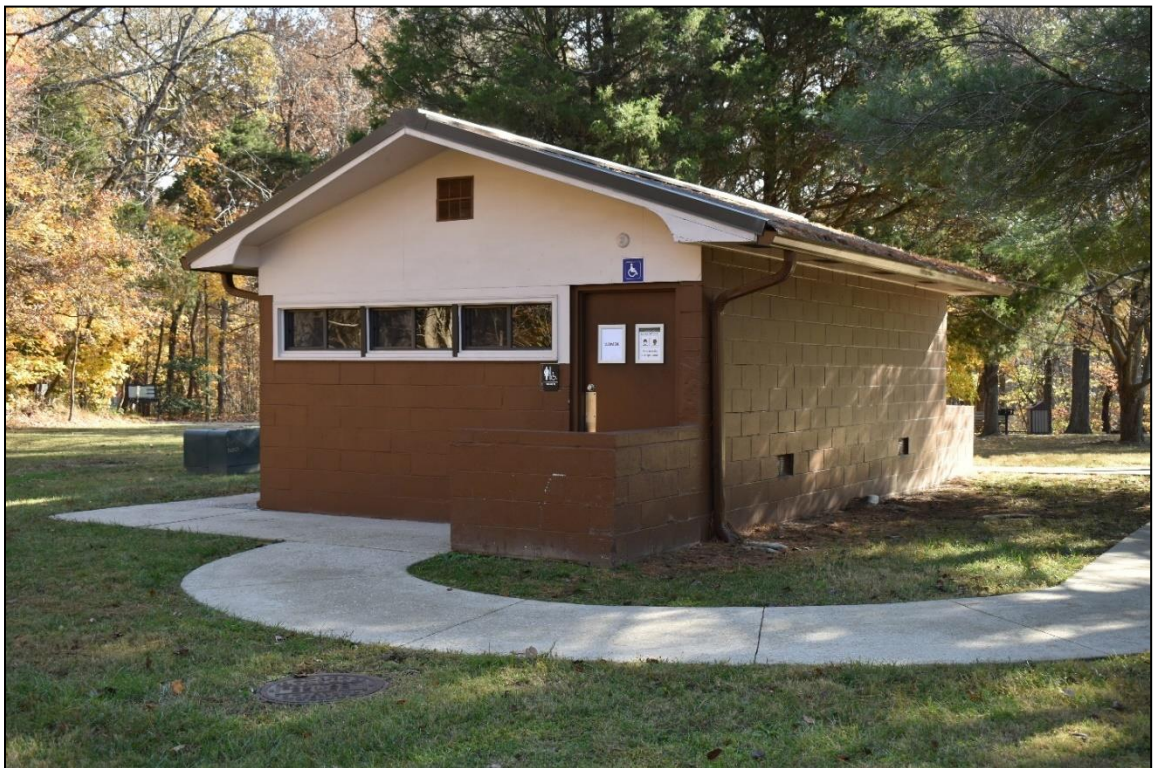
Photograph 31. North and west facades of the Picnic Area Comfort Station, facing southeast.

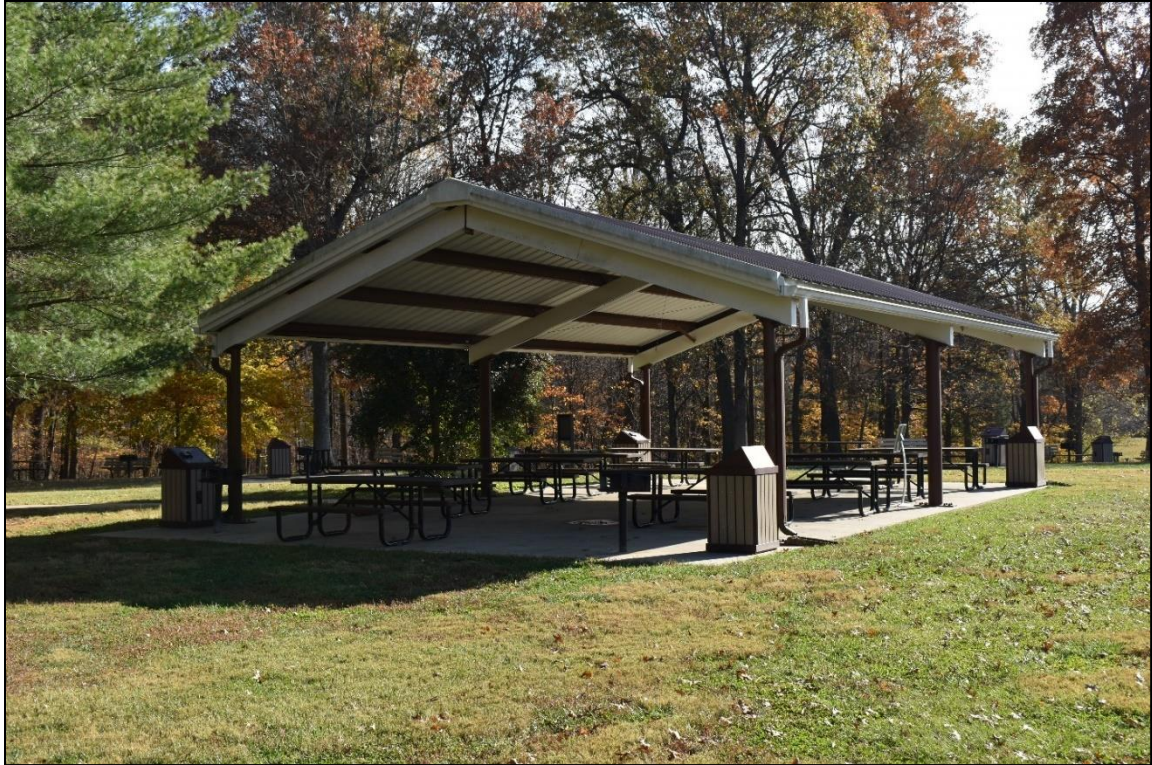
Photograph 32. Picnic area pavilion, facing south.

Photograph #32. Picnic area pavilion, facing south.

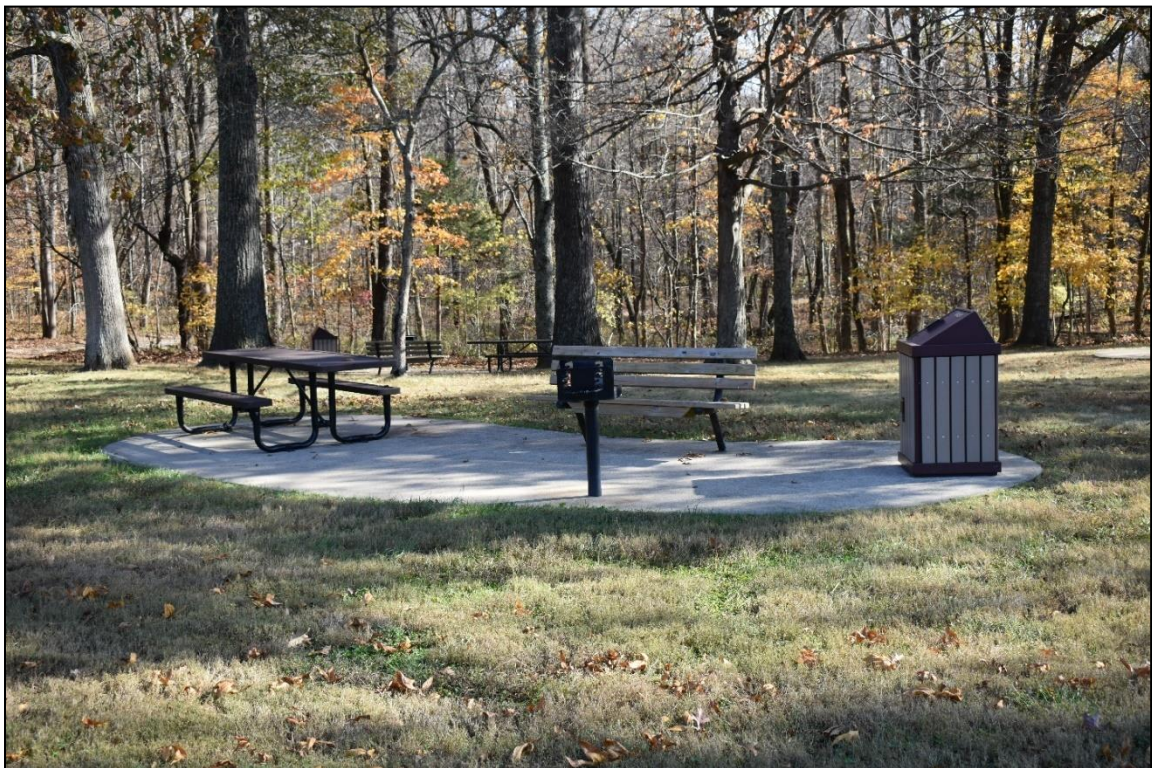
Photograph 33. Overview of picnic area, showing standard amenities (e.g., picnic table, grill, bench, and trash can), facing southeast.

Photograph #33. Overview of picnic area, showing standard amenities (e.g., picnic table, grill, bench, and trash can), facing southeast.
