National Park Service  
Cultural Landscapes Inventory

Revised: 7/2024

Parks Farmstead  
Antietam National Battlefield

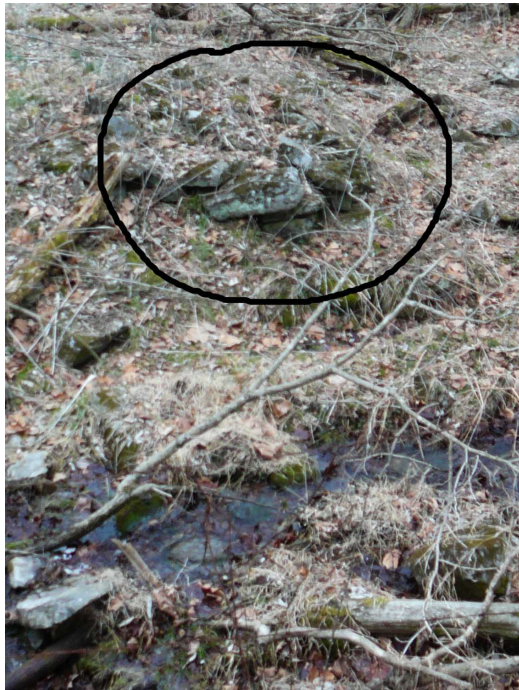
*Bridge pier ruin, located on the west side of the intermittent stream. (NCR-CLP 2011)*

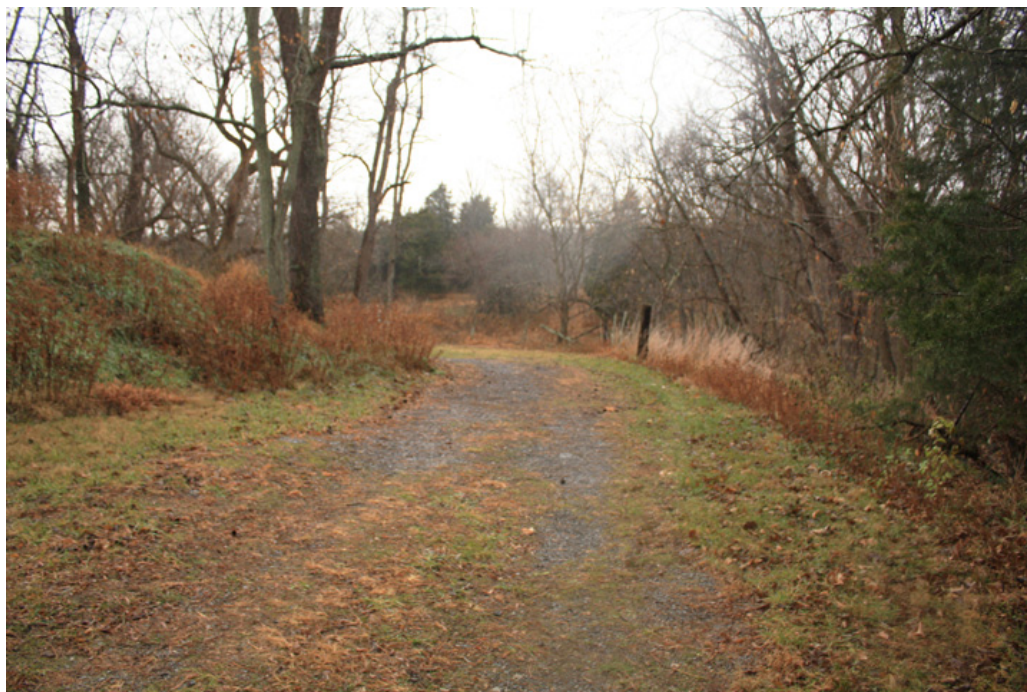
*Condition of the farm lane in 2016 (NCR CLP 2016)*

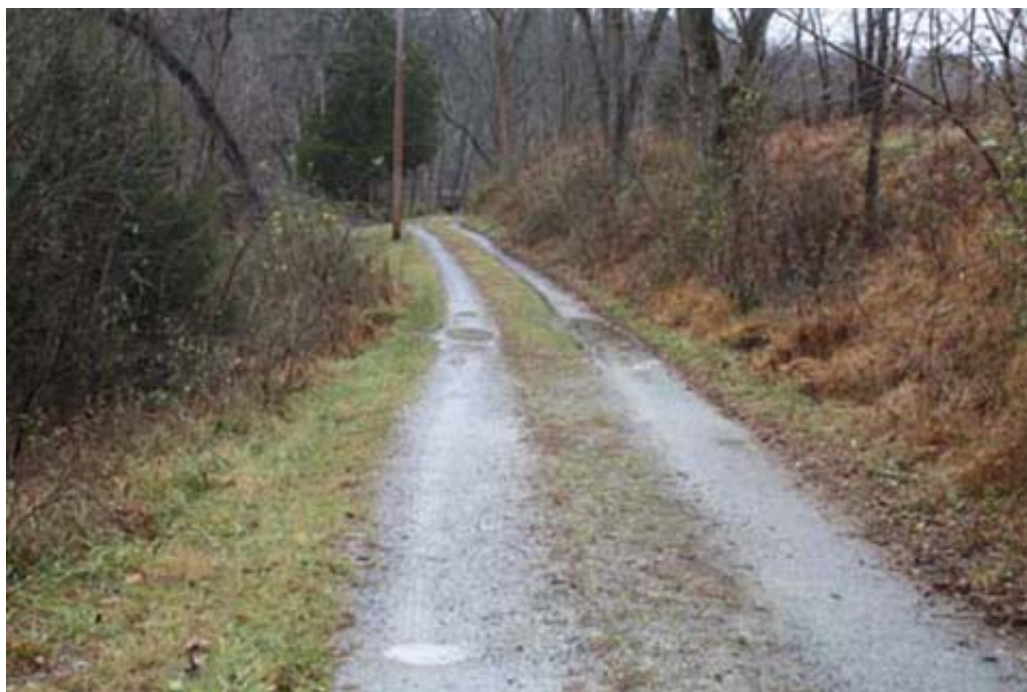
*Entrance road to the Parks Farm cluster facing south (NCR-CLP 2016).*

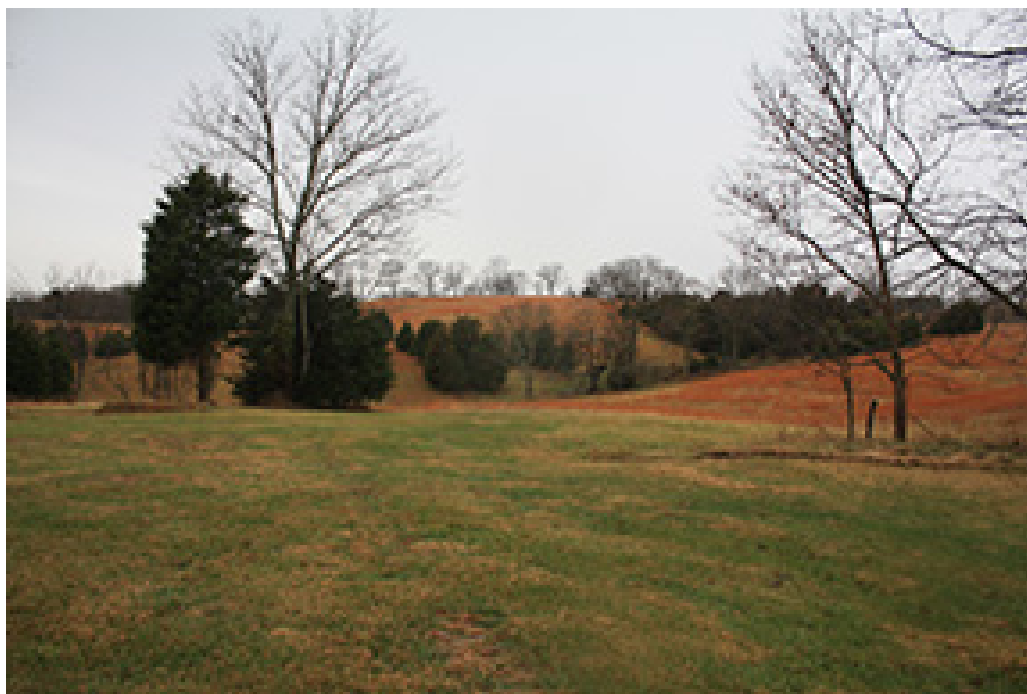
*View of the pasture space north of the Out Kitchen. Note the encroachment of eastern red cedars into the field space (NCR CLP 2016).*

Since 2017, the Parks Farmstead has undergone multiple preservation and rehabilitation activities. These activities include the reforestation of the riparian area of the property (CLI Feature ID 149759) and the initiation of a project to replace the wooden shake shingles of the barn with a standing seam metal roof (CLI Feature ID 149763). The following actions should be completed to improve the condition of the cultural landscape: 1) rehabilitate the Parks Farmhouse, 2) remove eastern redcedars (*Juniperus virginiana*) from the pastures, and 3) cover the well in a compatible manner.

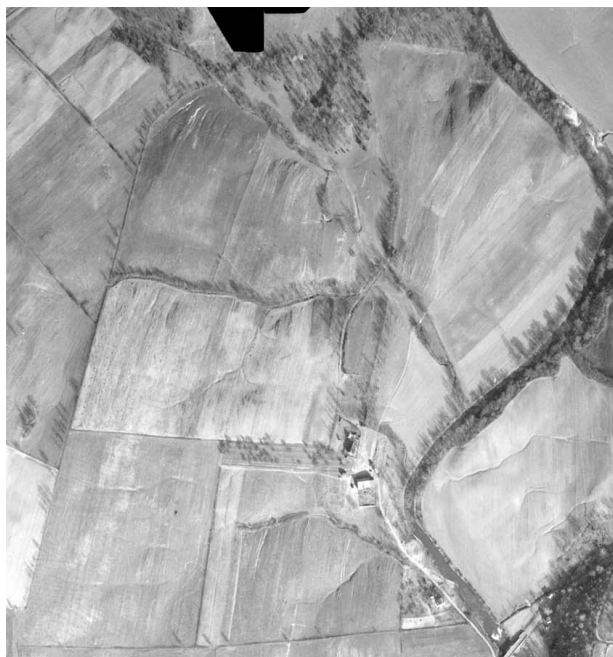
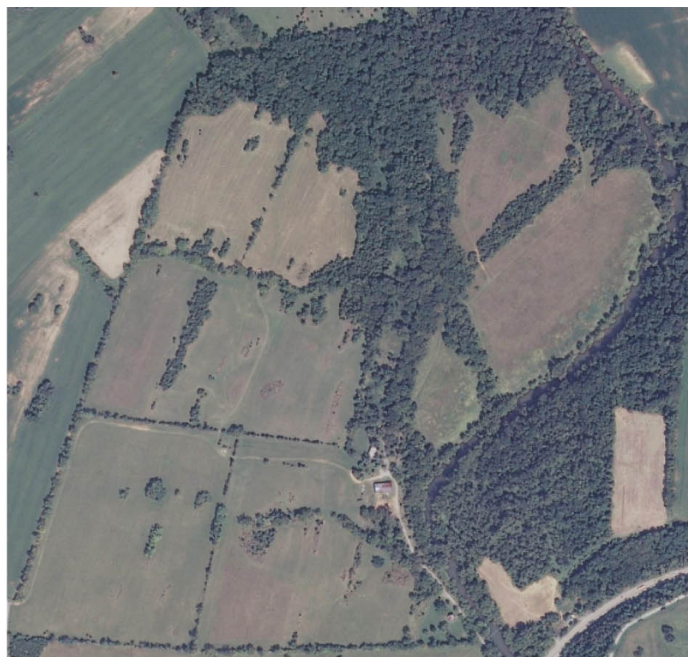
Comparison of aerial photos of the Parks Farm. On the left:1943: on the right 2010. Notice the increase in vegetation along the the creek, intermittant streams, and field and road edges.  
(USDA,SCS:1943, USGS:2010)

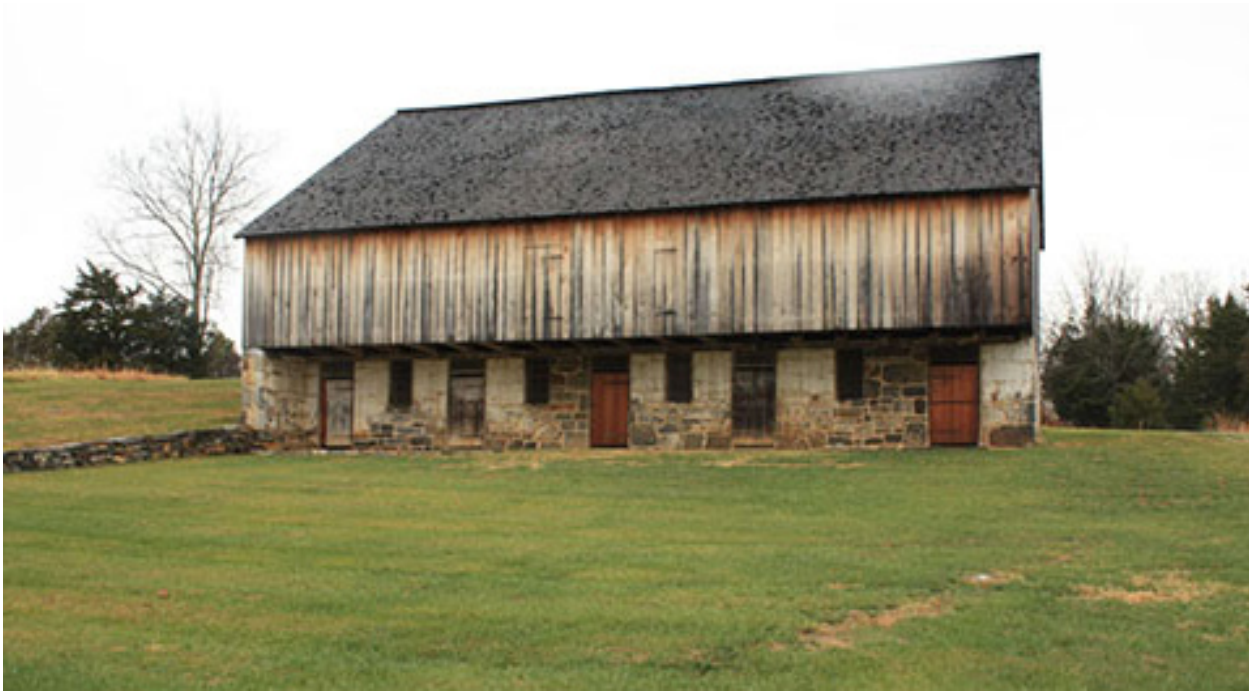
The barn recently completed a rehabilitation project to repair and replace failing features. The extant roof is V-crimp metal. Alterations have been made to the structure since the historic period. Circa 1870 a gabled dormer was add over the forebay on the south elevation. It was probably built to accommodate improved threshing machines (Parks Barn HSR 2008:1.2.7). This feature is still

*View of the south elevation of the Parks Barn after the rehabilitation (NCR CLP 2016).*

As a result of the completion of the Joseph Parks Barn HSR, the barn was rehabilitated in 2014. The rehabilitation included the repointing of the limestone foundations, and the reconstruction of portions of the interior and exterior walls. The hayloft and shed additions were removed. Structural members throughout the structure were stabilized. Deteriorated rafters and lathe were replaced in kind. Missing portions of the wall structural system were reconstructed. On the exterior, the poplar siding was reinstalled. The main barn door had missing hardware replicated and replaced. At the same time the barn was rehabilitated, the stone wall south of the barn was rebuilt (PEPC 45472). As of FY2024, the park is completing a reforestation project at the Parks Farmstead that will increase the woody riparian vegetation on 19 acres and is also planning to replace the wooden shake shingle roof of the Parks Barn with a standing seam metal one (PEPC 119060, PEPC 120704).

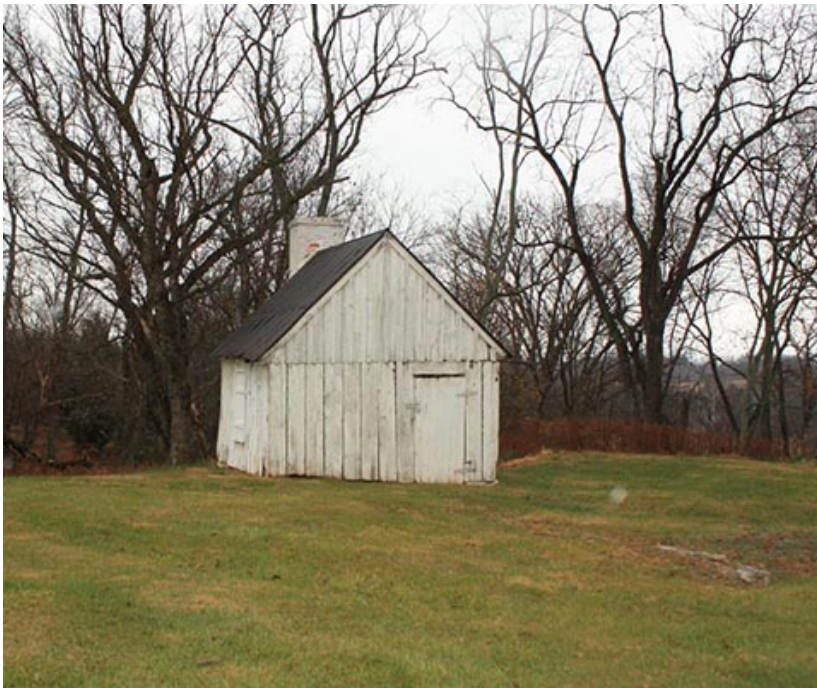
Located just northeast of the main house, the lack of windows and its location suggest this building functioned as a kitchen or summer kitchen. It is about 16 by 16 feet and constructed of single-pen logs. A large brick and stone chimney is located on the north gable end and the roof is of terne metal. It has stone foundation two doors, one on the south gable end and one on the east elevation. A large brick and stone hearth with a metal crane is located inside the building, which has a dirt floor. This crane should be preserved because although it has not been precisely date, parts are clearly hand forged. In 2007, the NPS stabilized the kitchen. Vegetation was removed, the foundation was repaired and the chimney was rebuilt and repaired. The structure was whitewashed and a non-historic addition was removed (LCS 2010).

*The detached kitchen located north of the main house (NCR CLP 2016)*

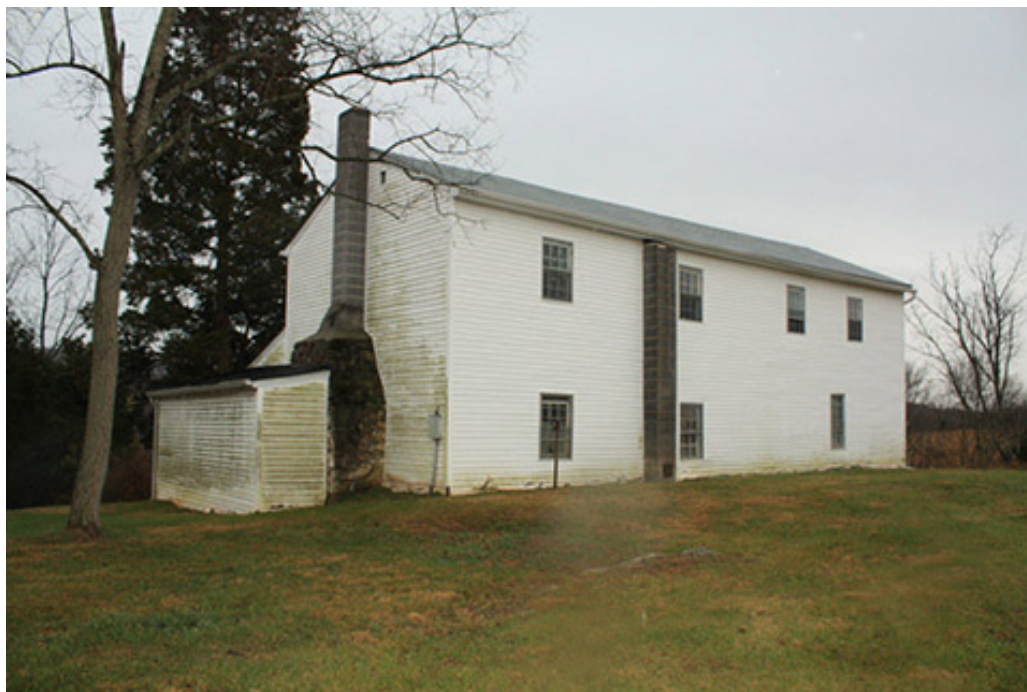
*The Parks Farm main house from the rear elevation facing southeast (NCR CLP 2016).*

| Year | Event | Major Event Narrative |
|---|---|---|
| CE 2013 - 2014 | Rehabilitated | The roof of the main house was damaged during Hurricane Sandy. The asphalt shingles were replaced in kind. Downspouts were placed along the edge of the roof of the house as well. It was noted at the time of this project that the porch was experiencing decay and rotting due to moisture damage. However, funds were not available for this portion of the project (PEPC 48431). |

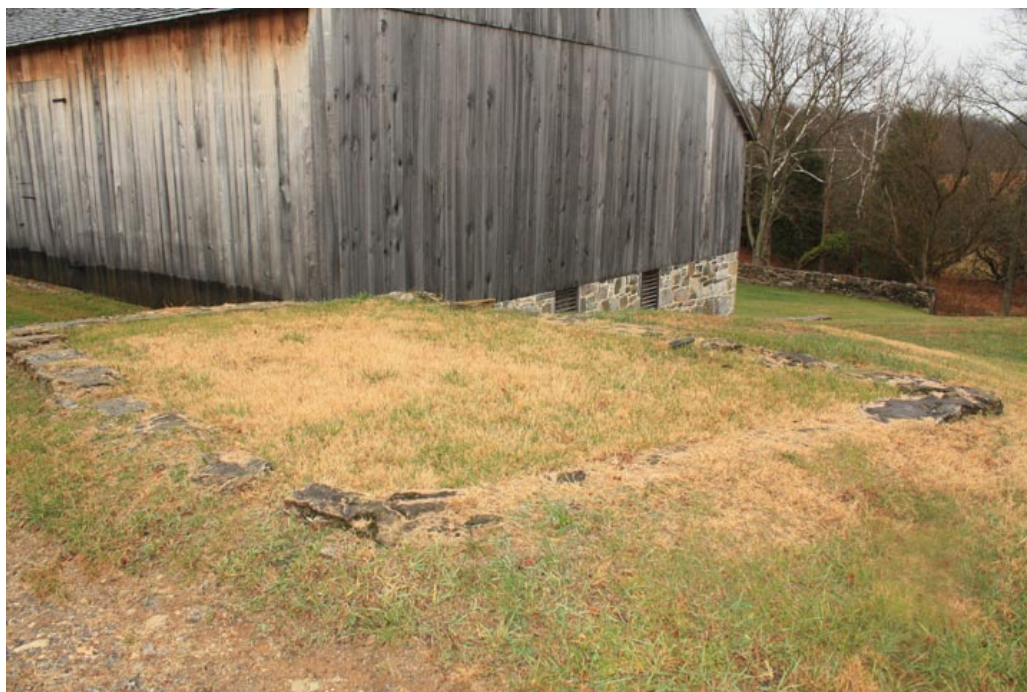
Trapezoidal Foundation [at northwest corner of the barn]  
Little is known about this foundation ruin, but its proximity to the barn suggests it was an integral component to the farming practices of the building. Further research is needed to date this ruin.

*Trapezoid foundation north of the barn (NCR -CLP 2016).*

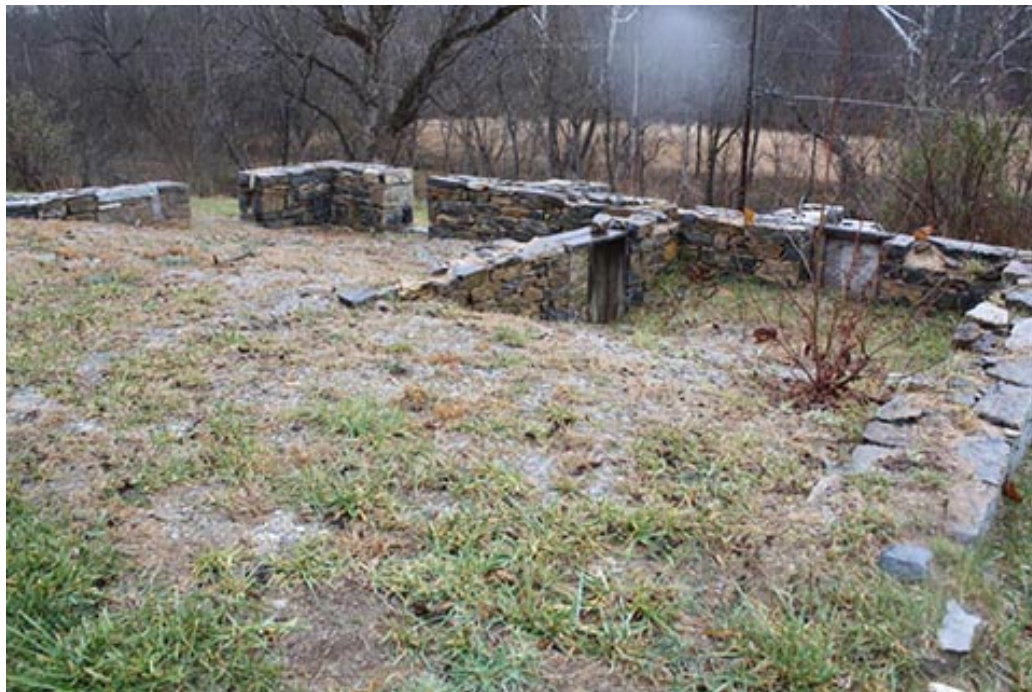
*Tenant House foundations*

The tenant house was located about 1/8 of a mile south of the barn, on the west side of the entry road. Built circa 1905, it was a two-story, three-bay, double-pile frame structure. The front elevation faced the road (east) and the house was built into a slight hill leaving about 4 feet of the foundation exposed to the east and none exposed on the west elevation. It had a gable roof of standing seam metal with two brick chimneys at each gable end. The windows varied and included two-over-two, four light (both wooden), as well as vinyl windows. A shed roof addition porch was located on the west elevation and the original wood (German) siding was covered in with modern vinyl siding.

This building does not appear on any of the battle maps and cannot be seen in the 1862 Gardner/Gibson photo. The architectural details of the building suggest an early 20th century date of construction. However, the stonework of the foundation points to early 19th century construction. It is possible that a pre-Civil War house stood on this foundation, but by 1862, it was gone. The foundation may have then been reused later in the farm's history.

| Year | Event | Major Event Narrative |
|---|---|---|
| CE 2011 | Demolished | The tenant house was demolished in July, 2011. The foundation were filled with gravel in order to maintain its structure (PEPC 28428). |

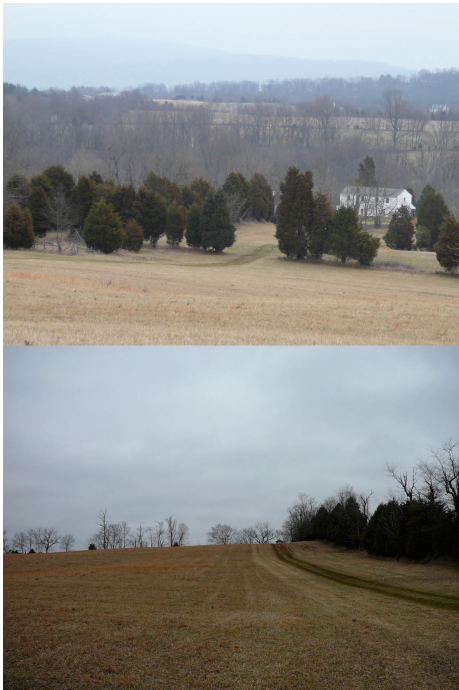
*Top: Looking towards Antietam Creek from an upper field. The main house can be seen on the right.  
Bottom: Looking towards Bloody Lane from the same upper field. Note the Observation Tower roof where the farm lane ends.  
(NCR-CLP 2011)*

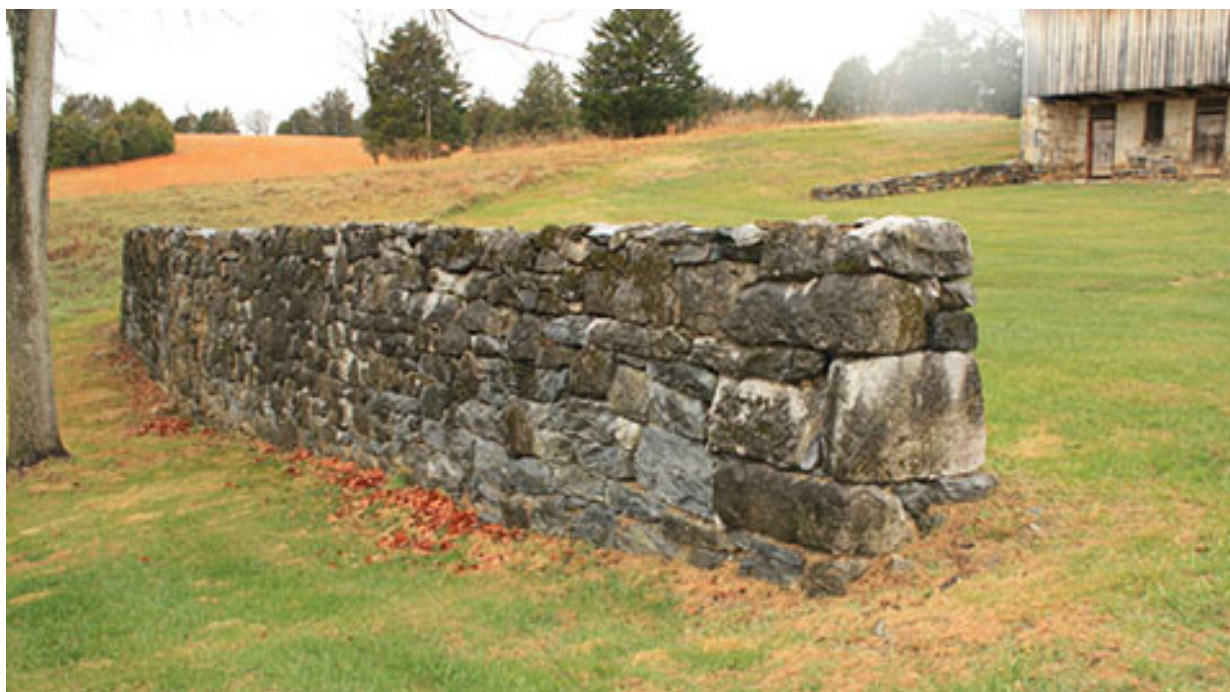
The only extant small scale features on the Parks Farmstead are the retaining walls along the entry road and the barnyard wall. However, since the location and type of fences found on the property during the period of significance is well documented, especially in Cope-Carmen maps, replica fences could be installed. These would then be non-contributing, but compatible features. Therefore the integrity of this feature is intact to the period of significance.

*Barnyard Wall facing northwest (NCR CLP- 2016).*
