# Joseph Poffenberger Barn

## Historic Structure Report

Antietam National Battlefield  
Sharpsburg, Maryland

25 May 2011

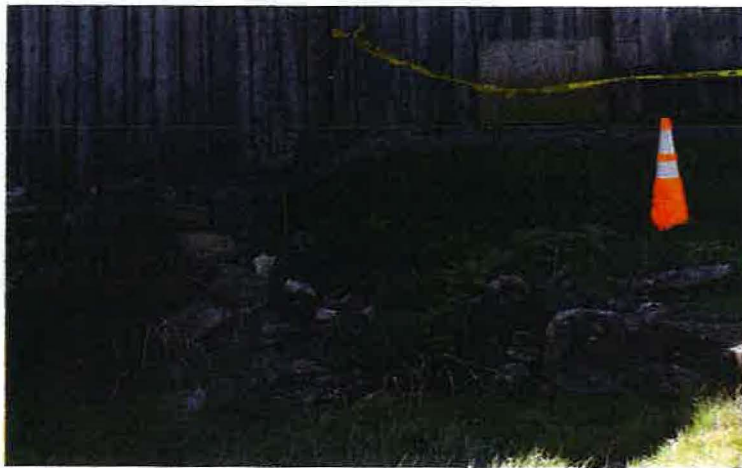
*Collapsed ramp wall.*

- B. The remains of the ramp’s supporting wing walls, constructed of local fieldstone, are visible on each side. These walls could easily be reconstructed, using the remaining fieldstone

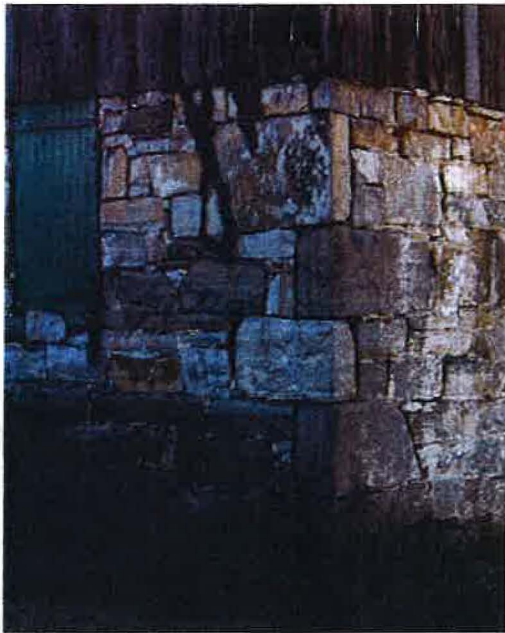
*Northeastern corner of foundation.*

the quoins, while still rusticated, are alternated with a narrow stone stacked over a much wider stone. Another decorative touch can be found in the diamond shaped stone, similar to a larger one on the western elevation of the structure.

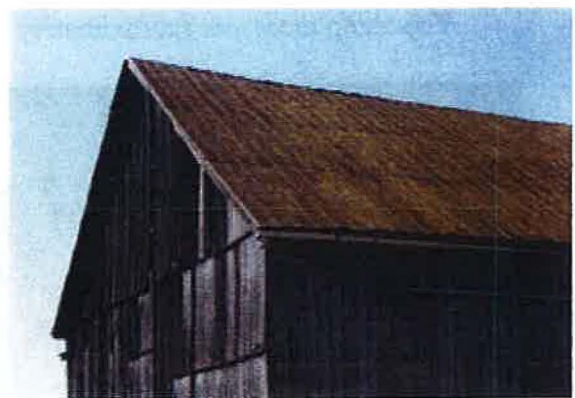
*Standing seam roof.*

**H.** The roof peak of the barn stands at 35'-3 1/2". The barn has standing seam metal roofing measuring 15'-4 5/8" in length. The eastern half of the roof appears to be deteriorating more rapidly than the western section. Metal roofs were used as early as 1880.

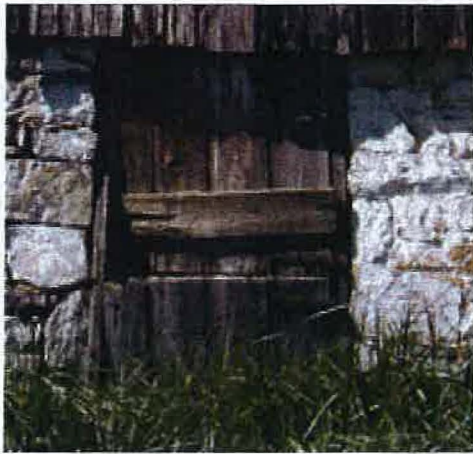
*Dutch door.*

**B.** A wooden door is located approximately 4 feet from the northern corner of the eastern elevation. The door is a Dutch door. The top of the door opens independently in order to provide light and ventilation to the animals housed in

the lower level of the barn, while restricting escape by the animals.

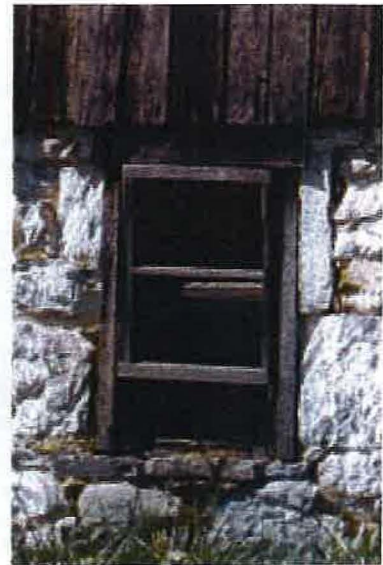
*East elevation window.*

- C.** 1"x 2" window is located 2 feet south of the door. The window still retains its timber frames.

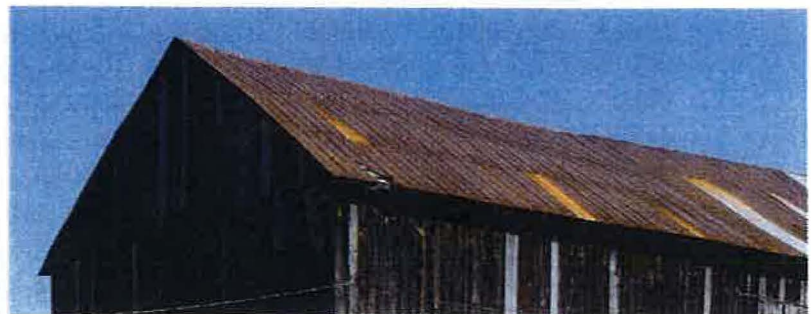
F. The roof peak of the barn stands at 43'-3 3/4". The barn has standing seam metal roofing measuring 15'-4 5/8" in length. There is evidence that several sections of the roof have been repaired and patched. While the metal roof could date as early as 1880, the barn would have originally been covered with a wood shingle roof.

*Metal seamed roof.*

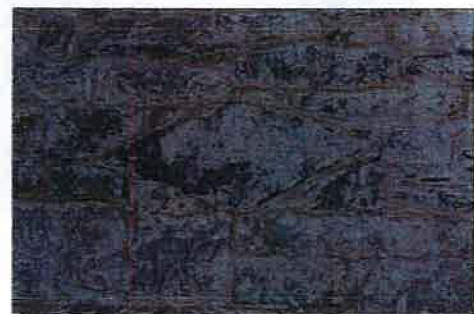
- A. The foundation on the west side of the barn is of similar style and construction to the other elevations. On this side, approximately thirteen courses of the limestone foundation are visible. The quoins follow a similar pattern of alternated vertical and horizontal rusticated limestone. The foundation wall is interrupted only by three vertical windows. The west elevation is distinguishable by a diamond shaped decorative stone located in the foundation (A1).

*Diamond shaped decorative stone.*

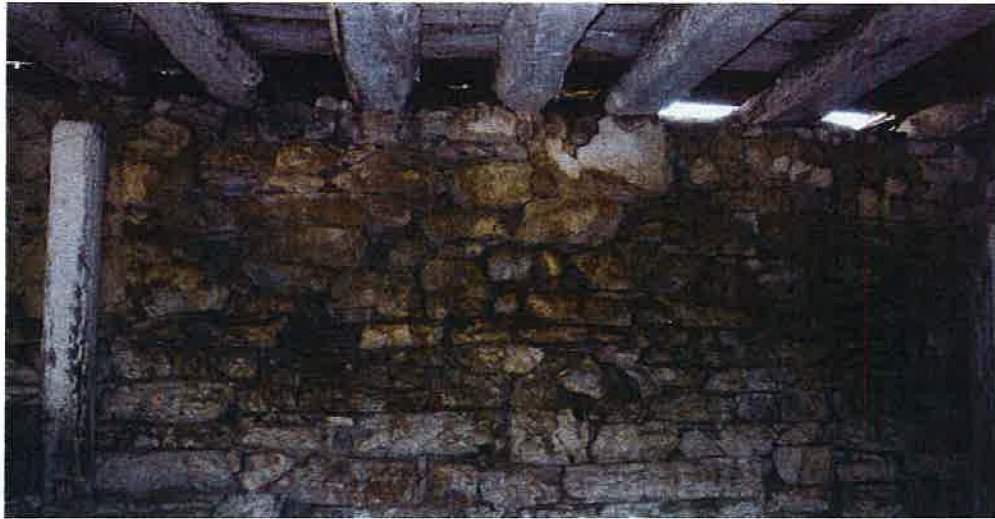
**BAY 3:**

- A. Post and beam construction
- B. Earthen Floor.
- C. Wooden hay rack.

- D. Hand hewn summer beam
- E. Hand hewn floor joists.
- F. Rear foundation wall. Note red discoloration.
- G. Newer, 20th century, hay rack.
- H. Slatted ventilation wall.
- I. Oak board and batten dutch door.
- J. Access door to bay 4.
- K. Dividing wall, wood plank siding.

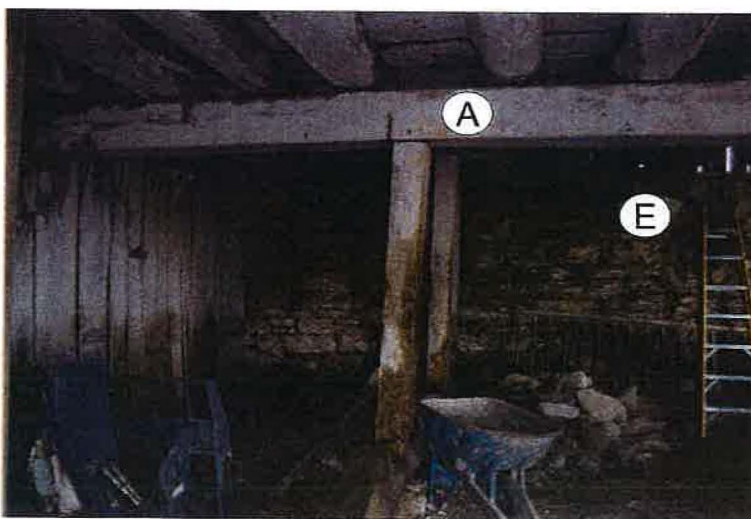
**BAY 4 and 5**

- A. Post and beam construction
- B. Earthen Floor. Image shows concrete, prior to removal.
- C. Wooden hay rack.
- D. Hand hewn floor joists.
- E. Rear foundation wall. Note red discoloration.
- F. Newer, 20th century, hay rack.
- G. Feeding troughs.
- H. Horizontal dividing wall, circular sawn, since removed.

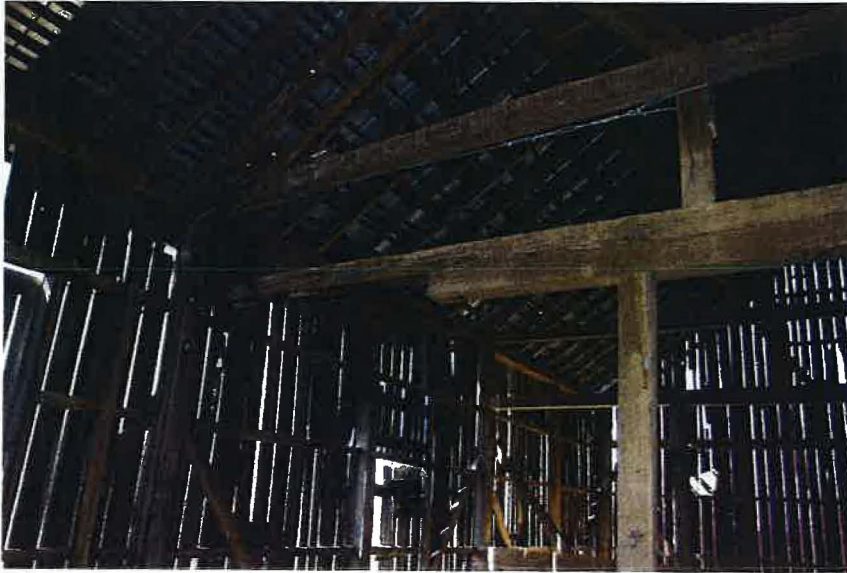
*Deteriorated top sill plate and members.*

- Replace damaged pine lathe.
- Remove the non-significant corrugated and seamed metal roof. The roof most likely dates to the 1890 construction of the upper level of the barn. The roof should be replaced the current metal roof with a similar seamed metal roof.

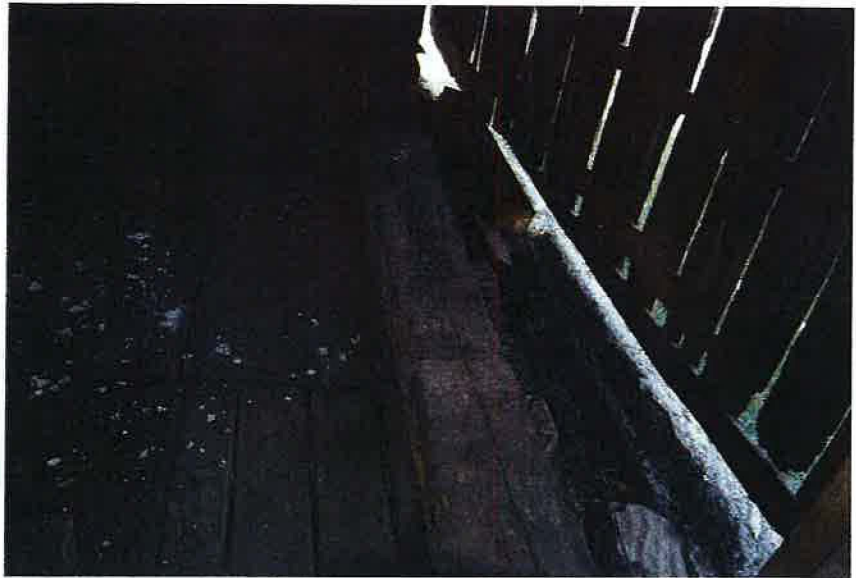
*Deteriorated bottom sill plate.*

- Confirm that structural framing can support a new roof and environmental loads.
- Top and bottom sill plates are severely rotted. They may need to be
