Apostle Islands National Lakeshore
Wisconsin

Hansen Fishery/Farm

Cultural Landscapes Inventory

July 2014

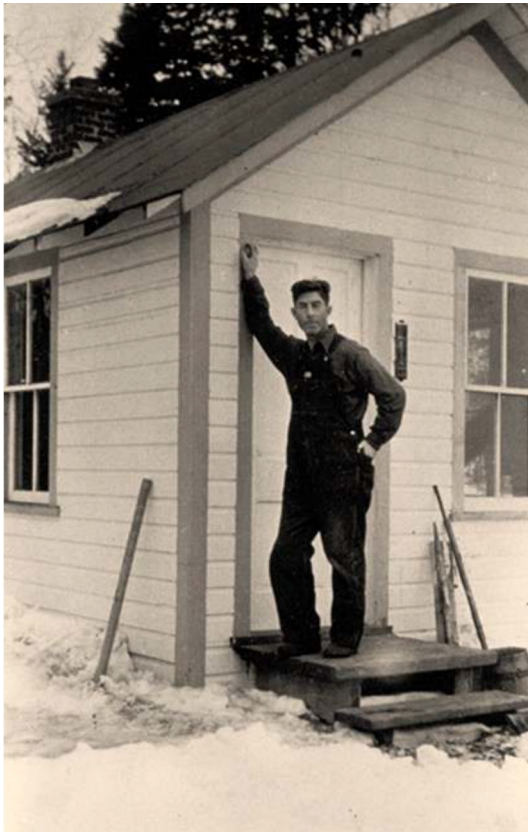
Fred Hansen in front of the Boar’s Nest, circa 1925.
(Apostle Islands National Lakeshore Archives)

The one story Boar’s Nest also has exposed rafter tails, 2/2 double hung windows, and panel doors. It is currently sited “cliffside,” with part of the building extending over the lake, and is supported by a concrete pier foundation. However, it should be noted this is not the original configuration, but the result of the lakeshore eroding beneath the building since the period of construction. The building was used by Fred and his son Jacob for mending and seaming fishing nets and as a gathering place for the men who would visit from nearby farms. After Jacob was married, he converted the building into a cottage.

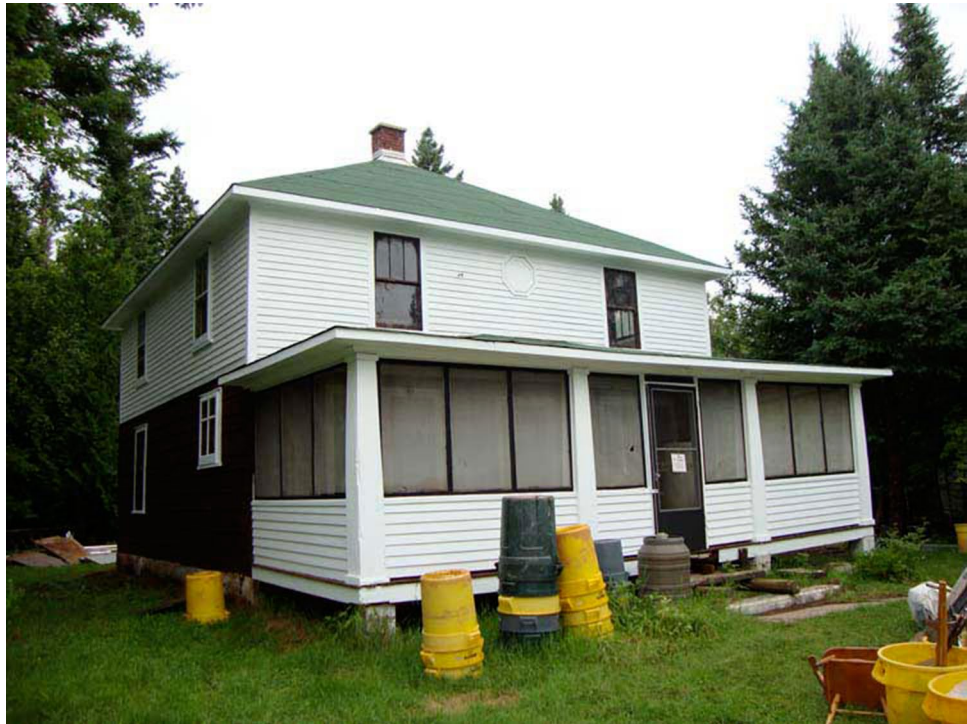
Hansen employed carpenters Clyde Nyland and Nels Anderson from the mainland to assist in building the main house. Although the house was not built using traditional Norwegian architecture, it was completely built by hand, including cutting and hewing the logs. Fred assisted in building much of his home: digging the foundation trenches, hewing logs, staining, and painting. Fred and his wife, Nettie, also gathered stones for the living room fireplace. The home was the third for the Hansen’s, much bigger and more comfortable than prior homes in their fishing camp.

Main House. (NPS 2010)

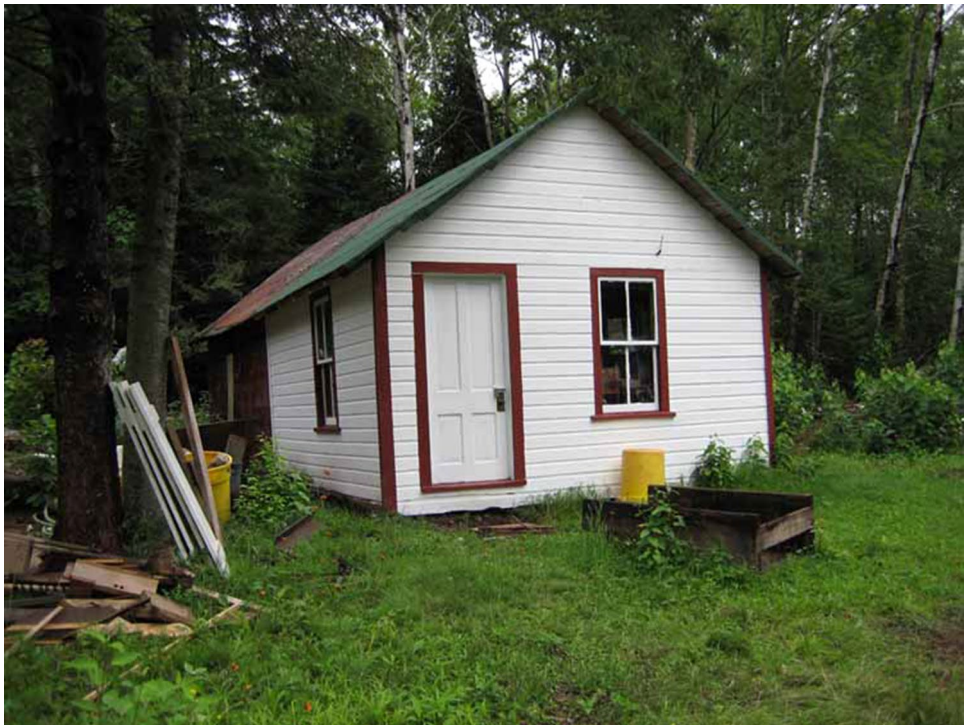
Guest House. (NPS 2010)

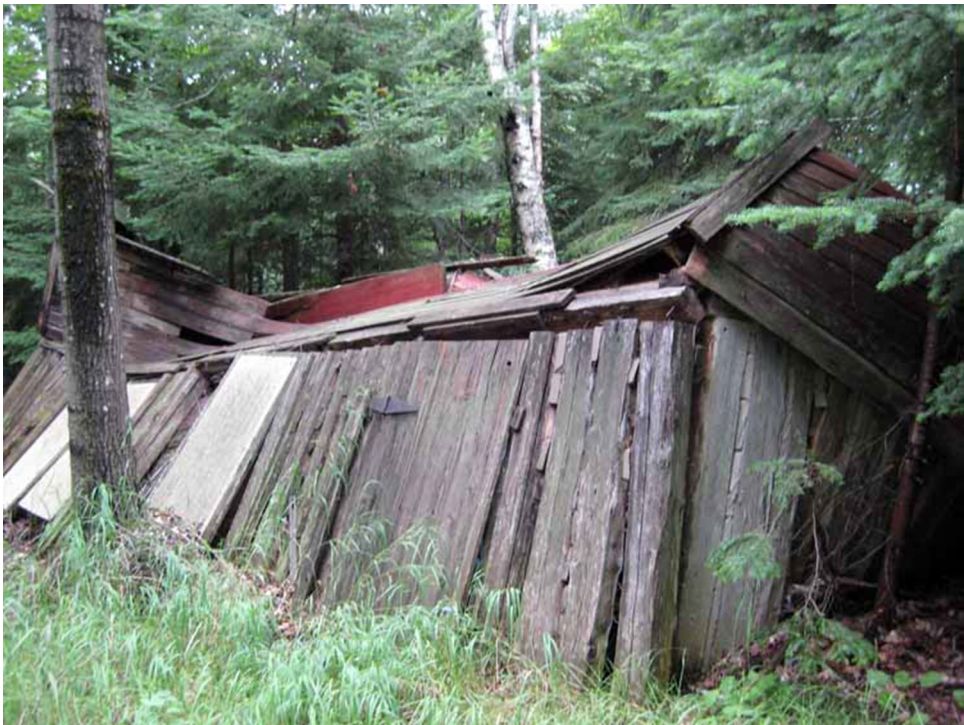
Machine Shed/Chicken Coop. (NPS 2010)

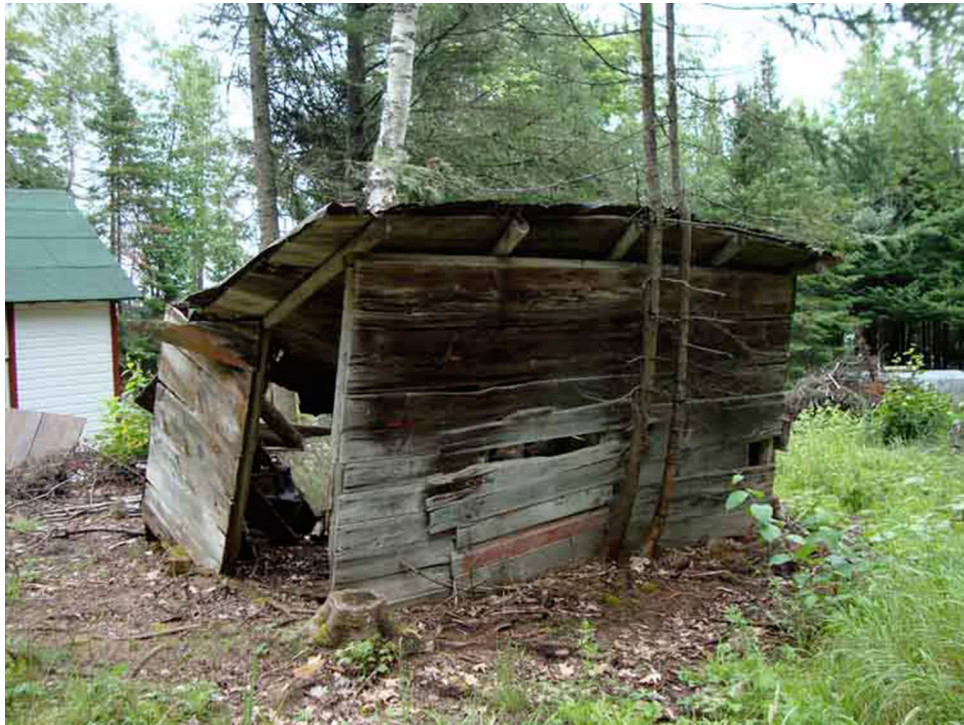
The wood shed is one story with an asphalt rolled shed roof and horizontal board siding. It has a dirt floor and no foundation, with vertical poles and log rafters.

Wood Shed. (NPS 2010)

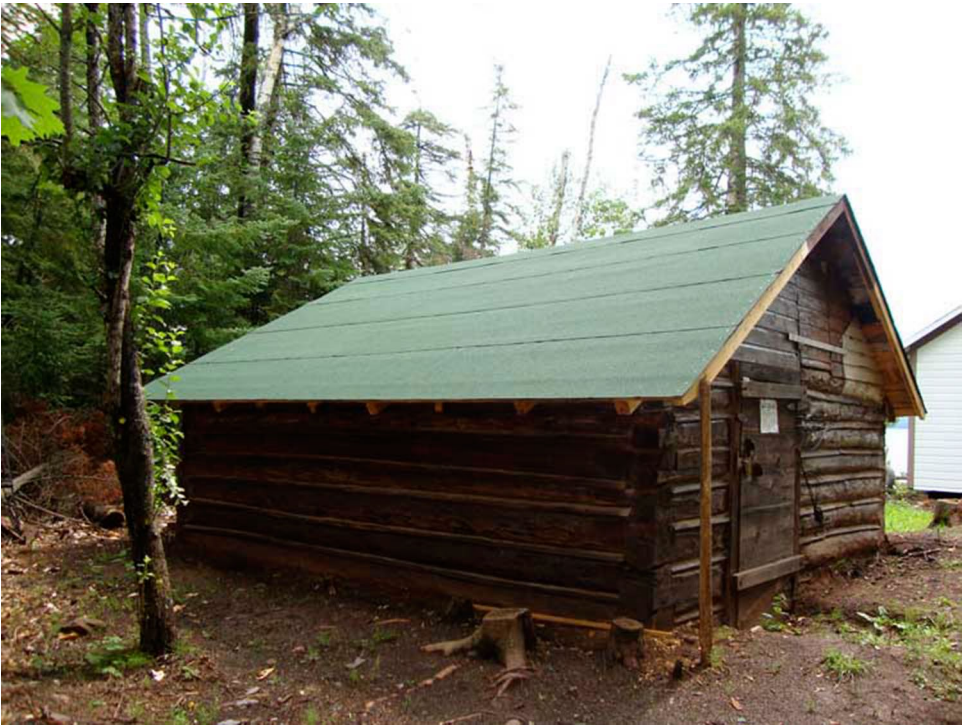
Ice House. (NPS 2010)

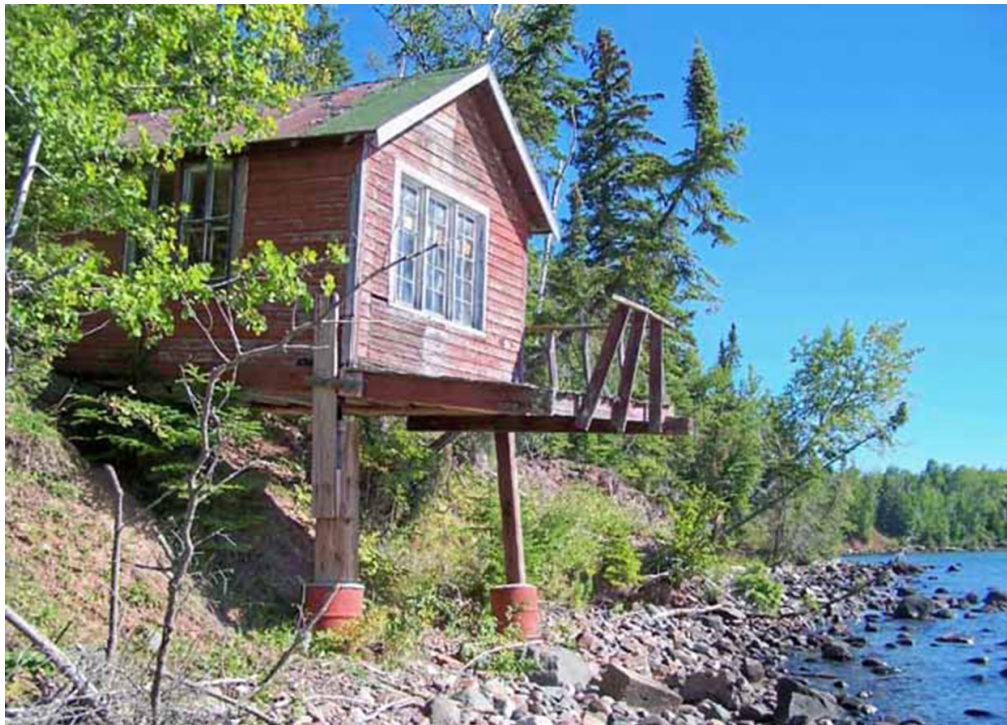
Boar’s Nest, facing northwest. (NPS 2008)

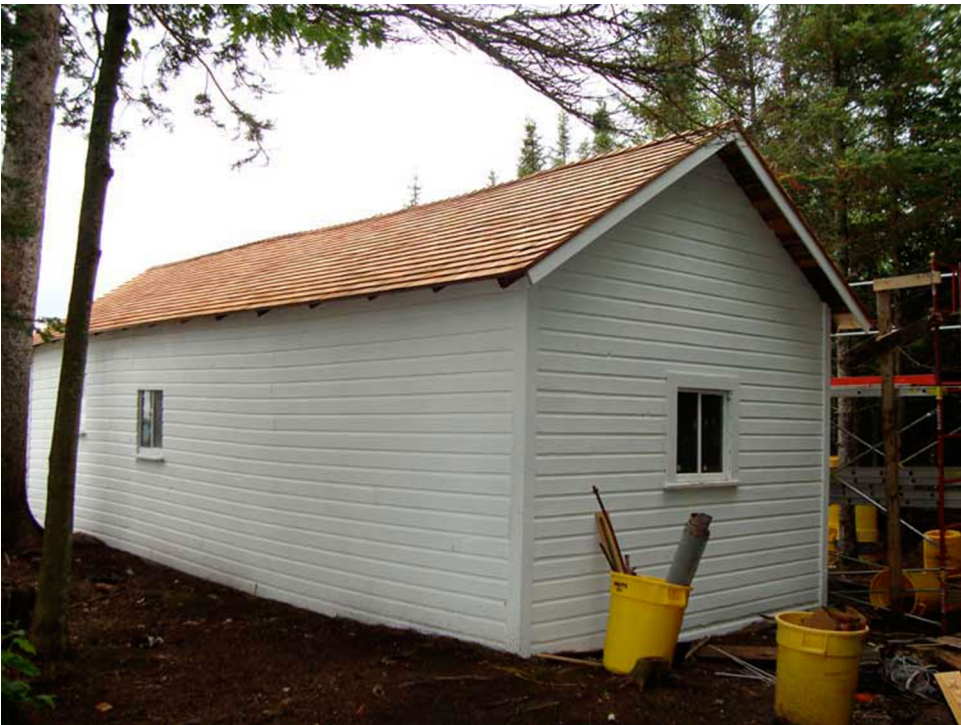
Twine SHed. (NPS 2010)

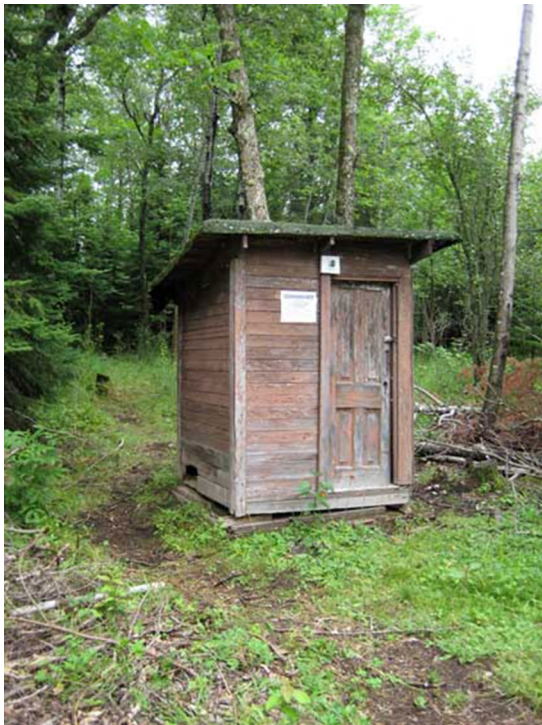
Hansen Privy. (2010)

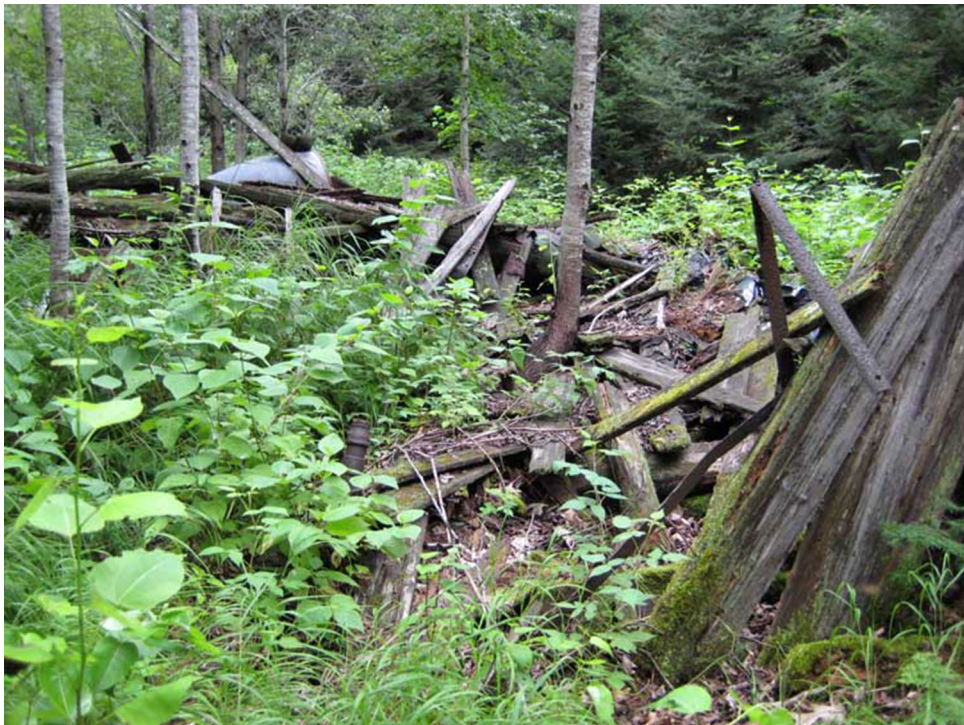
Year	Event	Annotation
CE 1944	Abandoned	By the fall, all families had moved off the island.
CE 1970	Established	Apostle Islands National Lakeshore established.
CE 1978-1983	Destroyed	Barn collapsed during this time due to heavy snowfall.

Barn Ruin. (NPS 2010)

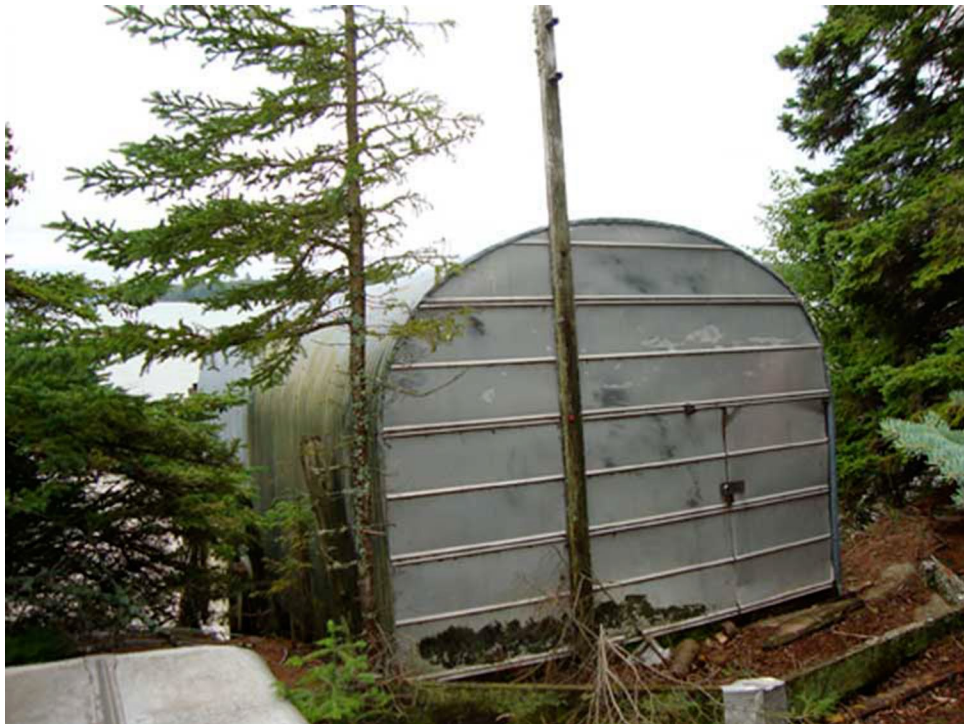
Boat House. (NPS 2010)

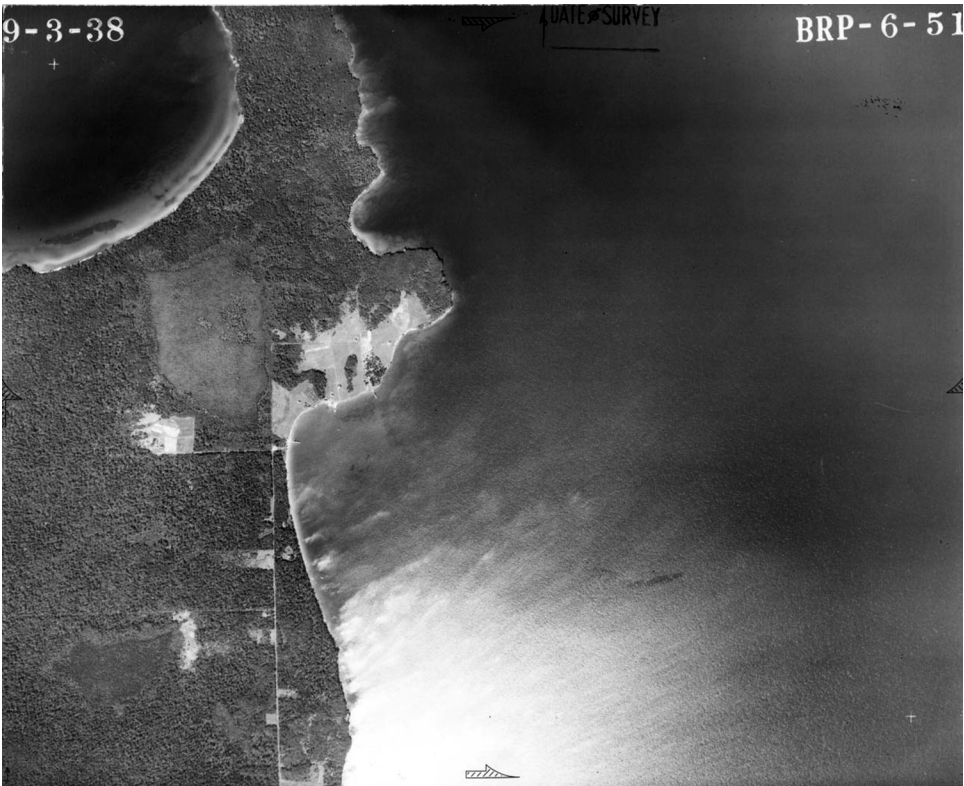
East Bay (Sand Island) aerial showing roadways and historic cleared agricultural areas (1938).

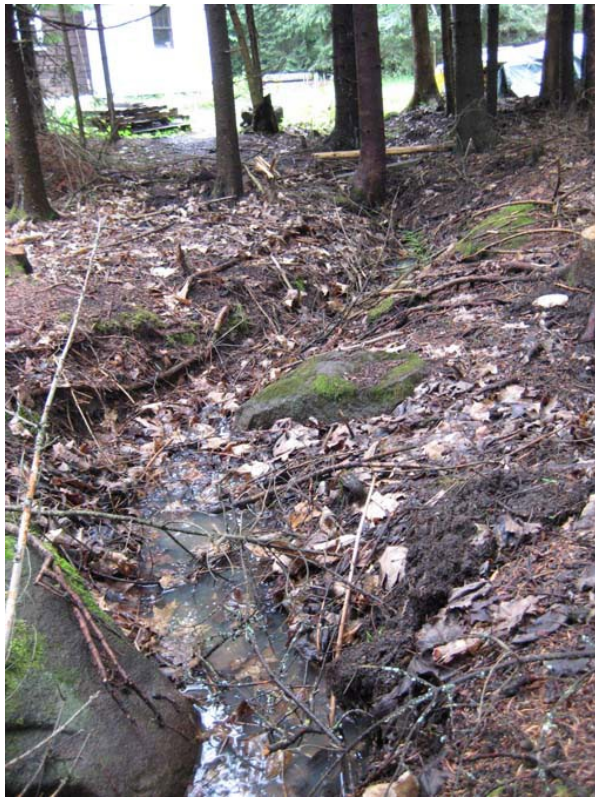
At right:
Meandering Drainage Ditch
(NPS 2010)

The topography of Sand Island is generally low and swampy with gently rolling, forested hills and steep rocky cliffs at the water's edge. The highest point of the island sits approximately 58ft above Lake Superior. Located between East Bay and Lighthouse Bay is the island's largest wetland. Originating near this wetland is the island's northernmost eastern stream. The grounds of the Hansen Fishery/Farm are mostly level. There is a small, meandering drainage ditch on the property.

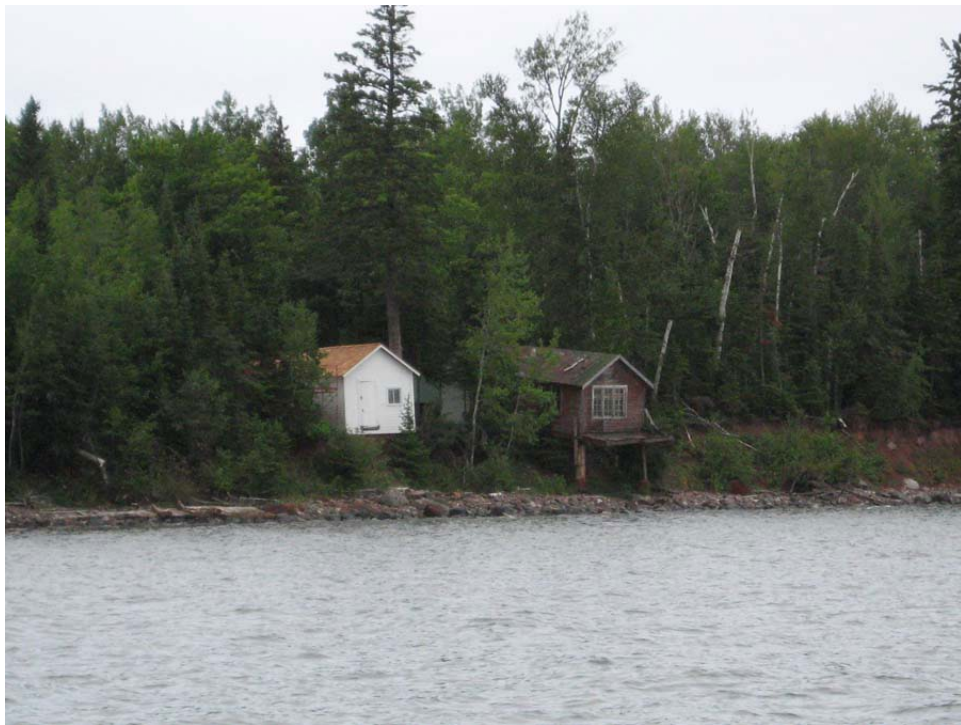
Below:
Shoreline erosion underneath the
Twine Shed and the Boar's Nest.
(NPS 2010)

The dynamic process of sand accumulation and erosion is quite evident throughout the lakeshore. The drift of littoral material, primarily sand, is east to west in the Sand Bay area. Some beaches continue to grow while others erode. Erosion is clearly noticeable at the Hansen Fishery/Farm. Historically, the Boar's Nest and Twine Shed were not located hanging off of a cliff or even cliffside. These buildings are currently at serious risk of falling into Lake Superior. There are plans are to move the buildings back and away from the shore, imitating their relationship to the lake before the shoreline eroded. This will change the spacing between buildings while saving historic fabric. Despite erosion, the topography of the site contributes to the cultural landscape.

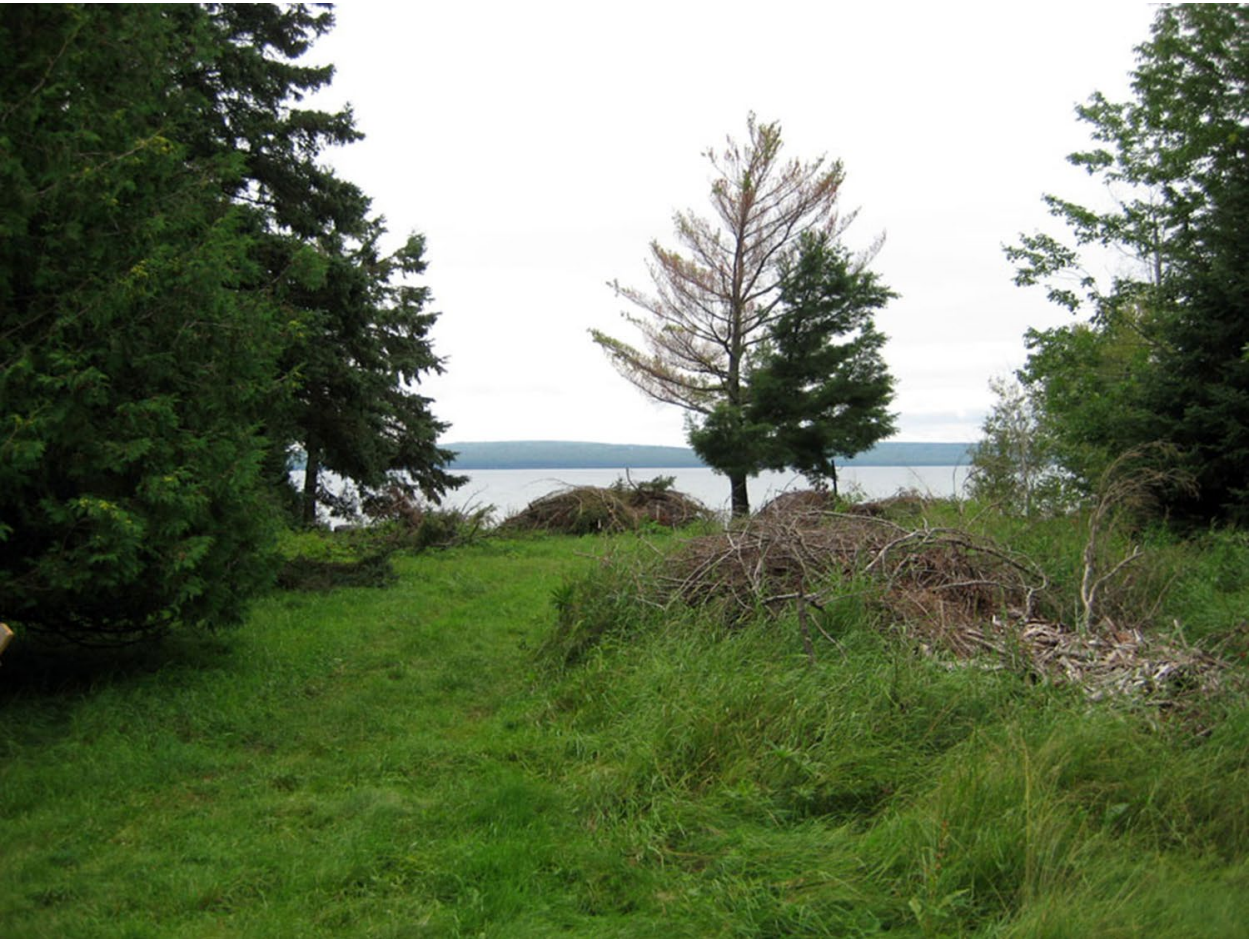
View from Hansen Site towards Lake Superior. (NPS 2010)

Notable views to the Hansen Farm/Fishery include those of the Boar’s Nest and Twine Shed from passing watercraft on Lake Superior as the buildings are almost hanging cliffside. The buildings were not originally sited this way, but erosion has led to this effect. Views from the property include those of Lake Superior as seen partially obscured by vegetation.

The extent of views and vistas to the site and away from the site has been reduced from the period of significance due to the encroachment of forest vegetation across East Bay. The agricultural clearings in this area are no longer maintained. Much clearing has recently been done on the Hansen site by the NPS. Although modified, the available views and vistas contribute to the landscape.

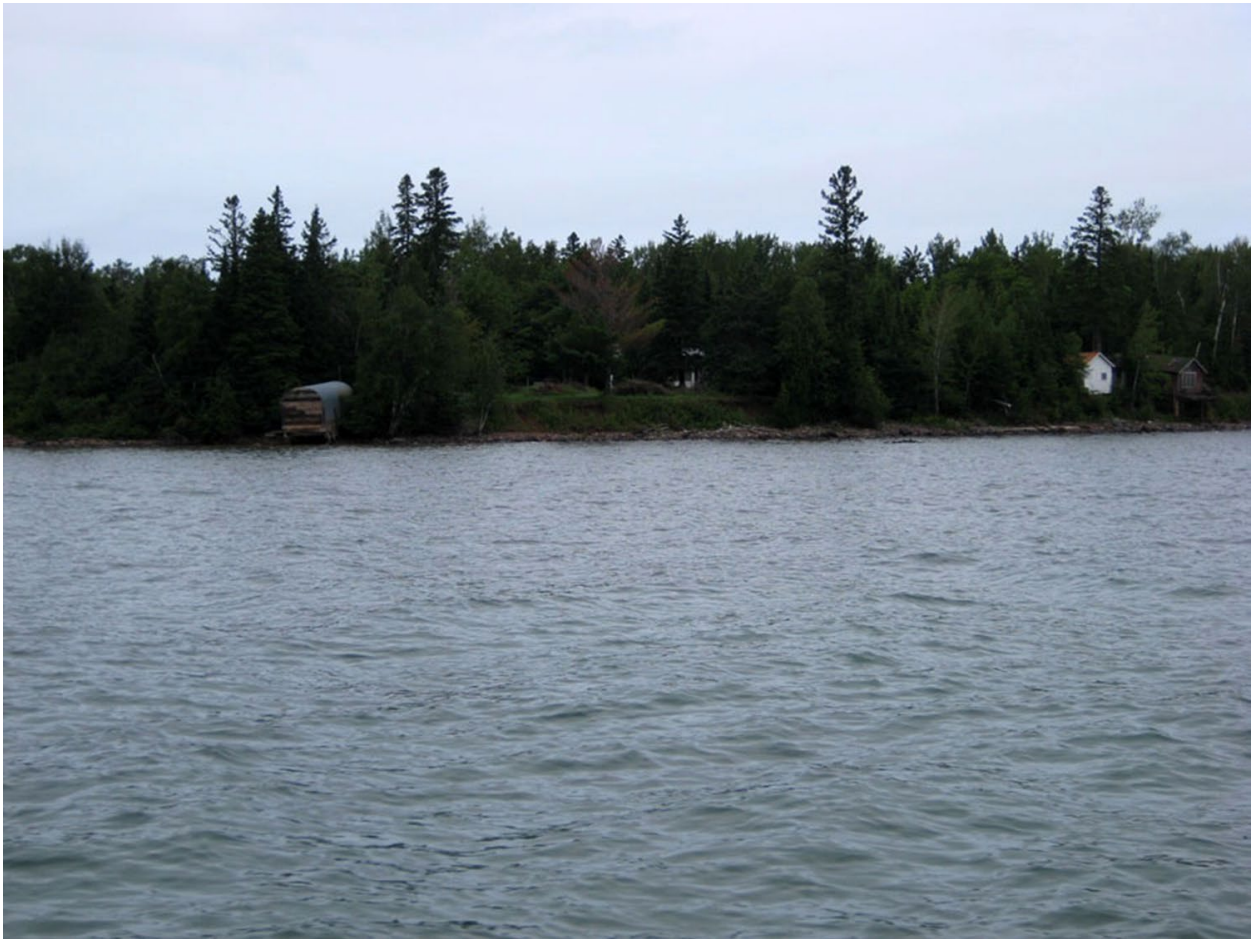
View from Lake Superior of the Boathouse (with rounded roof), the Main House (obscured), the Twine Shed (painted white), and the Boar's Nest (far right). (NPS 2010)
