Apostle Islands National Lakeshore
Wisconsin

Outer Island Light Station

Cultural Landscapes Inventory

July 2014

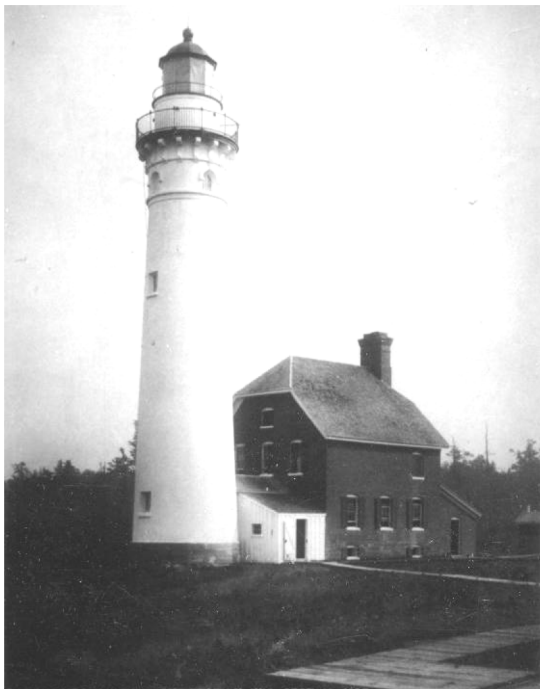
The brick Keepers Quarters (LCS ID 101140) was constructed on a locally quarried sandstone foundation. A one story passageway connected the house to the conical whitewashed brick tower (LCS ID 006376). The lighthouse was very similar to one under construction at Au Sable, which was also instigated while Major Poe was the District Engineer.

Outer Island Light Tower and Keepers Quarters, c. 1893 (NPS APIS Archives)

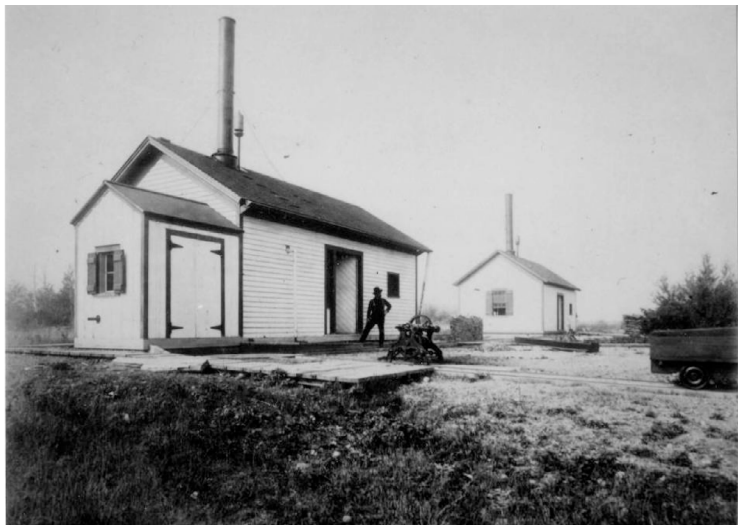
Outer Island Fog Signal Building 1 in the foreground with tram tracks inset on a wooden platform; Fog Signal Building 2 in the background, c. 1893 (NPS APIS Archives).

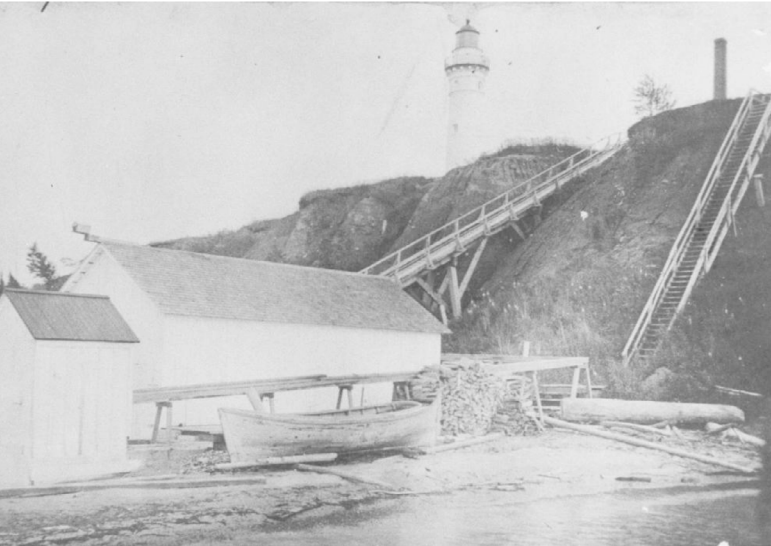
Outer Island Tramway, c. 1904 (NPS APIS Archives)

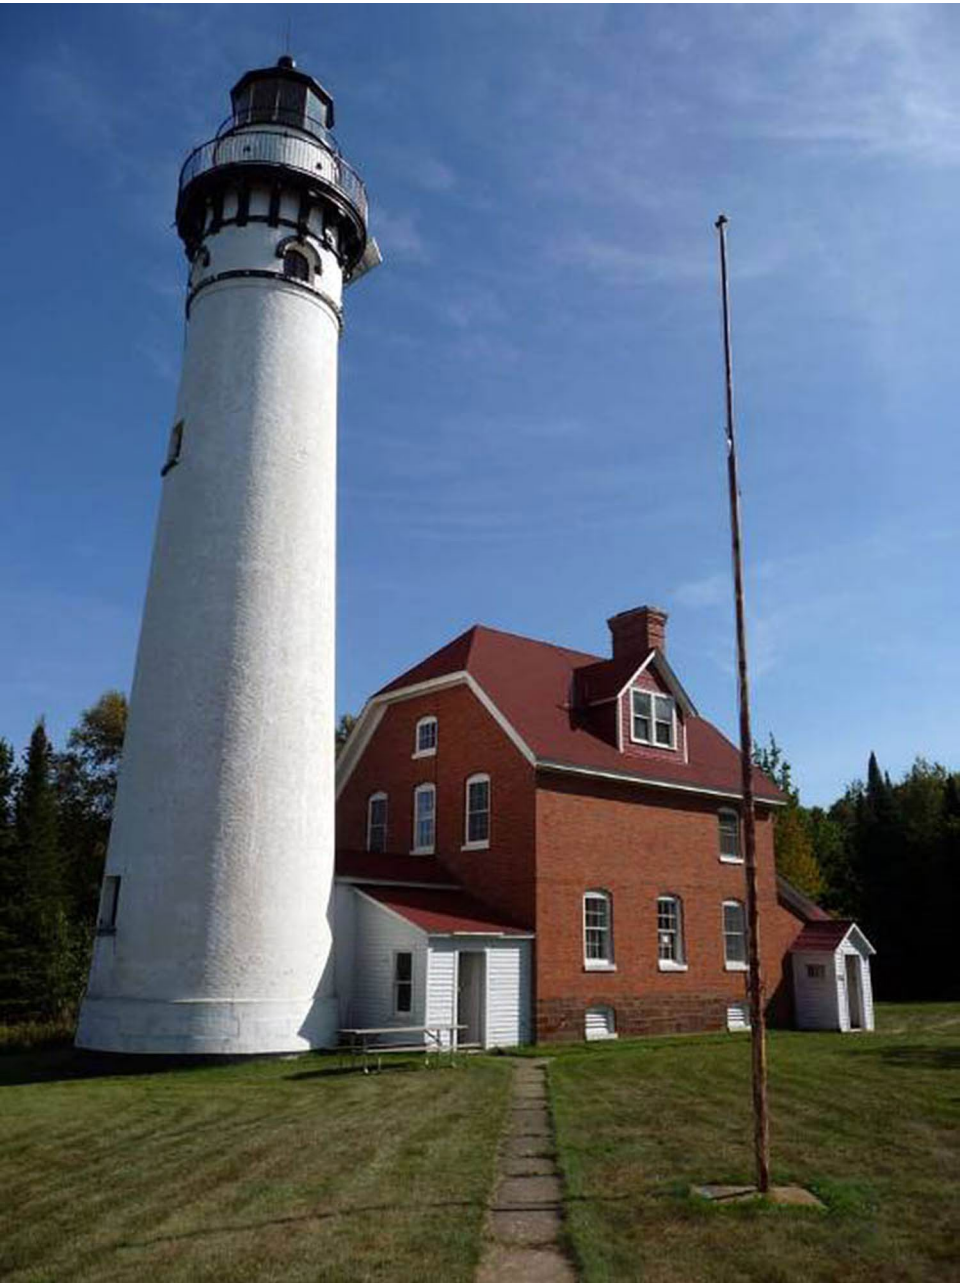
Outer Island Light Station, Tower and Keepers Quarters. (Anderson Hallas Architects PC/NPS 2010)

The extant historic period buildings and structures retain integrity of location, design, setting, workmanship, feeling and association. Outer Island Tower is in good condition with the exception of rust stains and peeling paint. The Keepers Quarters is also in good condition, but in fair condition on the interior. Most of the historic ceilings and floors are covered up or replaced. Despite minor losses, the buildings and structures at the station generally retain a high degree of integrity and are integral components of the cultural landscape (CLR 2010).

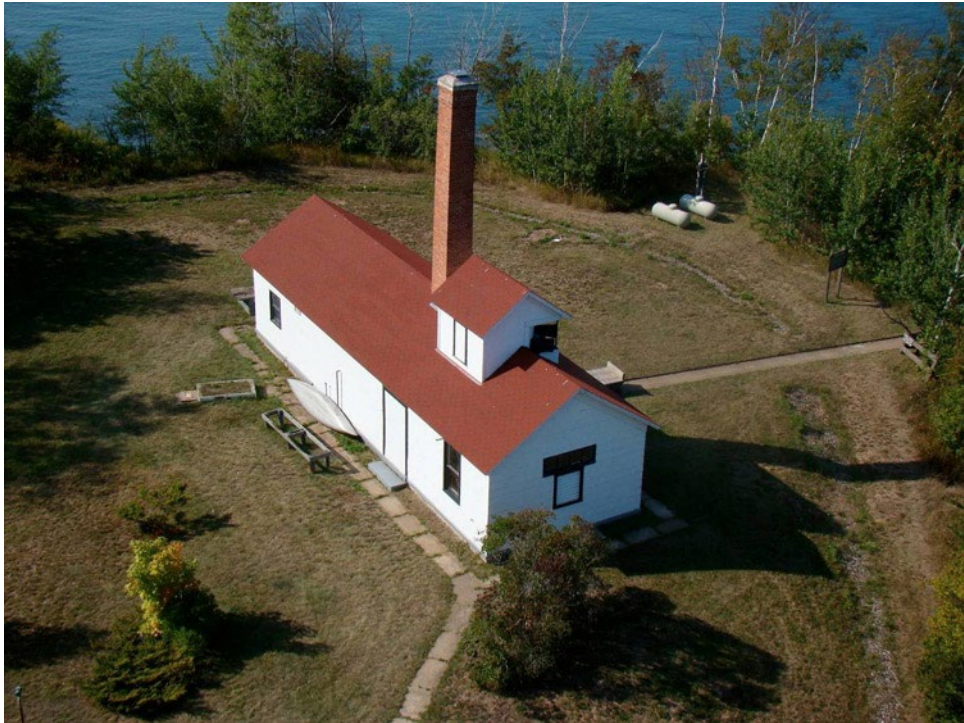
Fog Signal Building from the top of the Tower, facing west. (Anderson Hallas Architects, PC/NPS 2010)

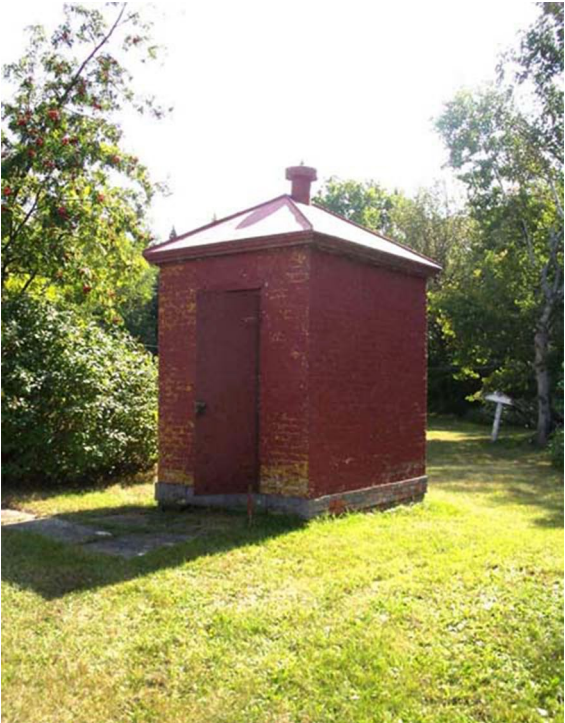
The Oil Storage (LCS 006379) was built in 1892 to provide a safe storage area for the kerosene needed to fuel the lamps. It has a sheet metal hip roof with a centered circular metal vent, brick foundation, brick water table, brick walls, metal door on north facade, stone lintel and threshold, and a concrete floor.

Oil Storage House, north and west elevations. (Anderson Hallas Architects, PC/NPS 2010)

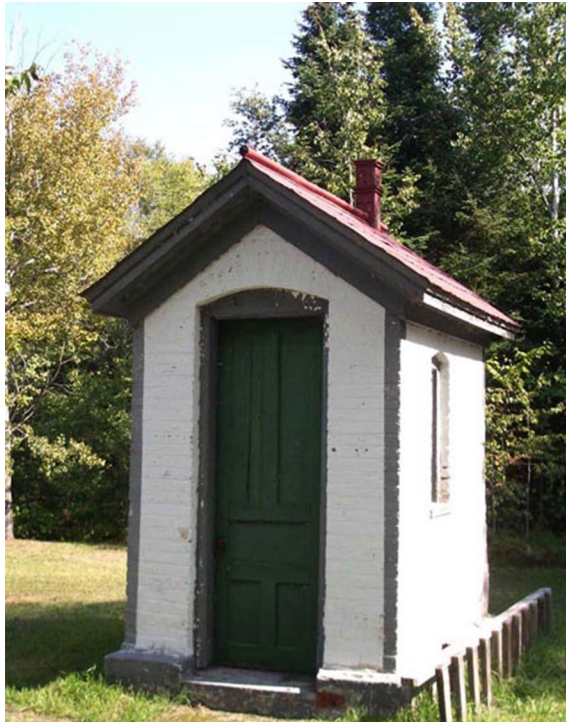
The Privy (LCS 006380) was built in 1874, but is presently inaccessible. It has a metal shingle gable roof with boxed rafter tails and a square wooden ridge vent, brick walls and foundation, a two pane casement window with arched opening, and a panel door with wood threshold in west gable end.

Brick Outhouse, west elevation. (Anderson Hallas Architects, PC/NPS 2010)

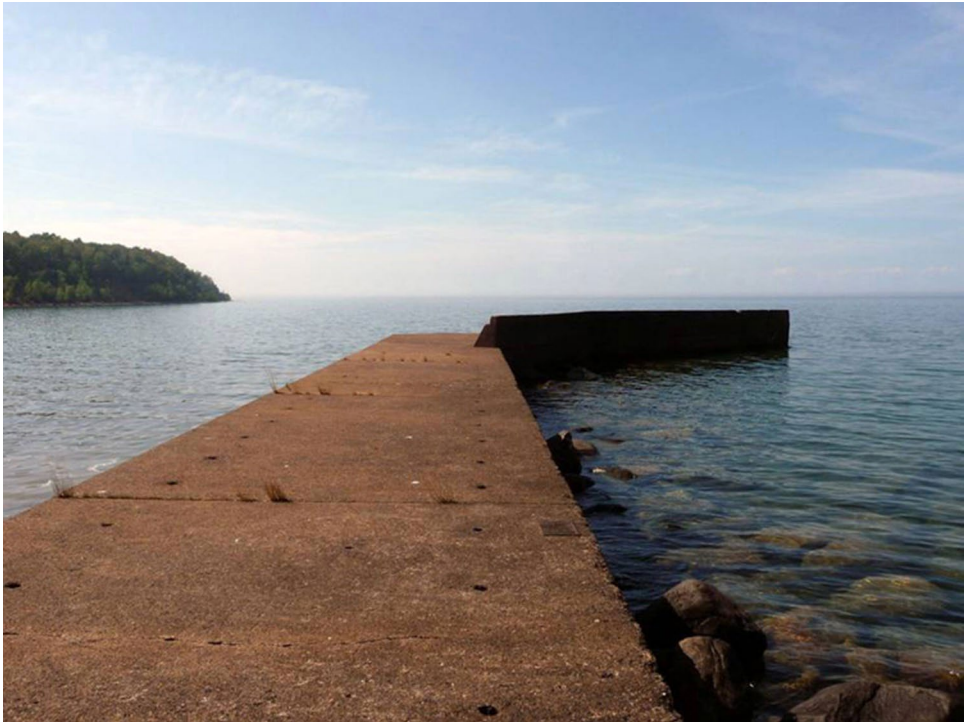
The concrete boat dock (LCS 006377) is 14 feet wide and extends north from the base of the banks 100 feet, then jogs west nearly 200 feet. The dock is bordered on the north by stone revetment. The existing “L” shape of the boat dock, to protect the harbor, reflects the original 1883 crib constructions. The dock has been modified and repaired multiple times since the initial implementation. Several Boathouses have existed at the dock, in varying orientations, but always within the protected area southwest of the dock. There is no extant boathouse remaining on the site.

Concrete Boat Dock, western portion, viewed from the east.. (Anderson Hallas Architects, PC/NPS 2010)

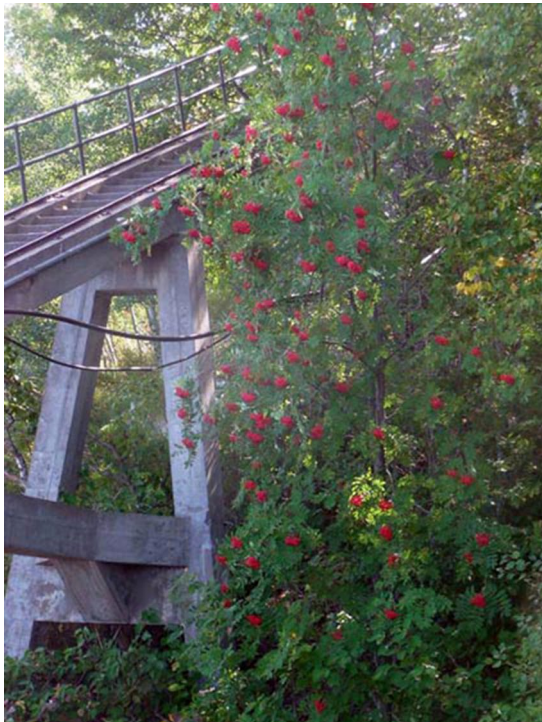
Tramway Concrete Footing. (Anderson Hallas Architects, PC/NPS 2010)

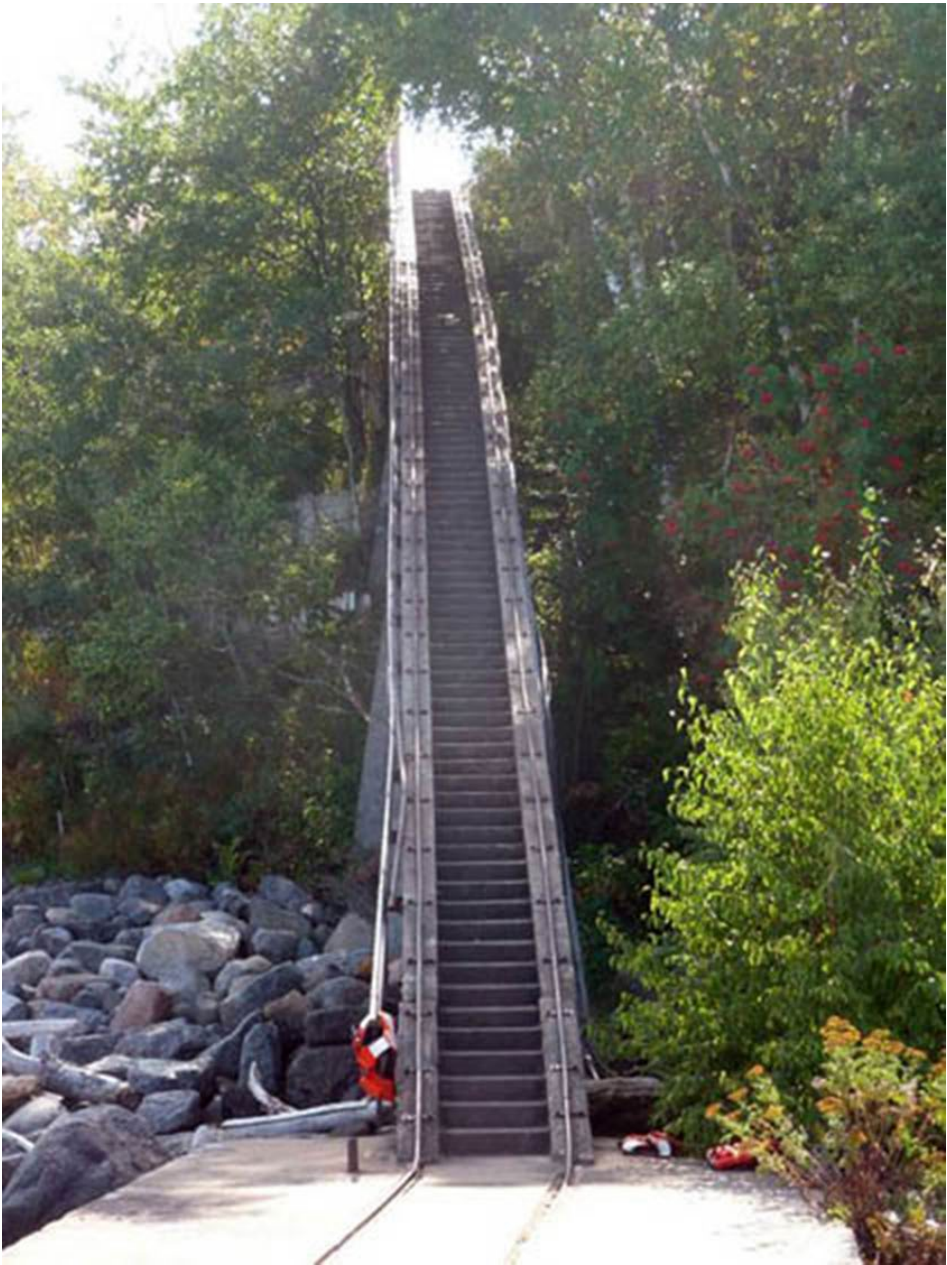
Tramway, viewed from the north. (Anderson Hallas Architects, PC/NPS 2010)

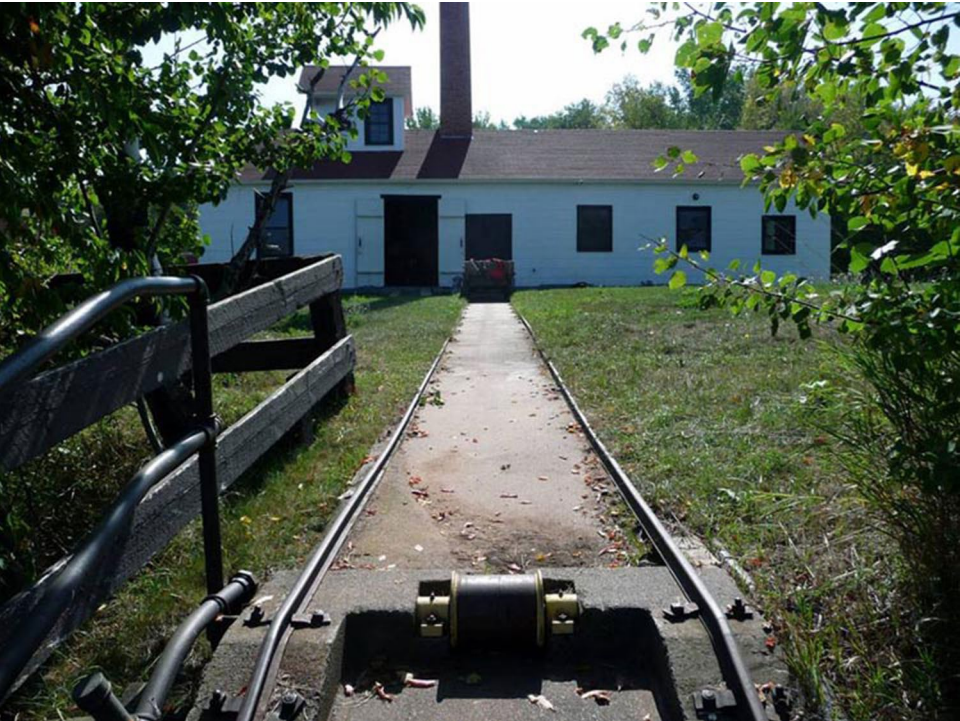
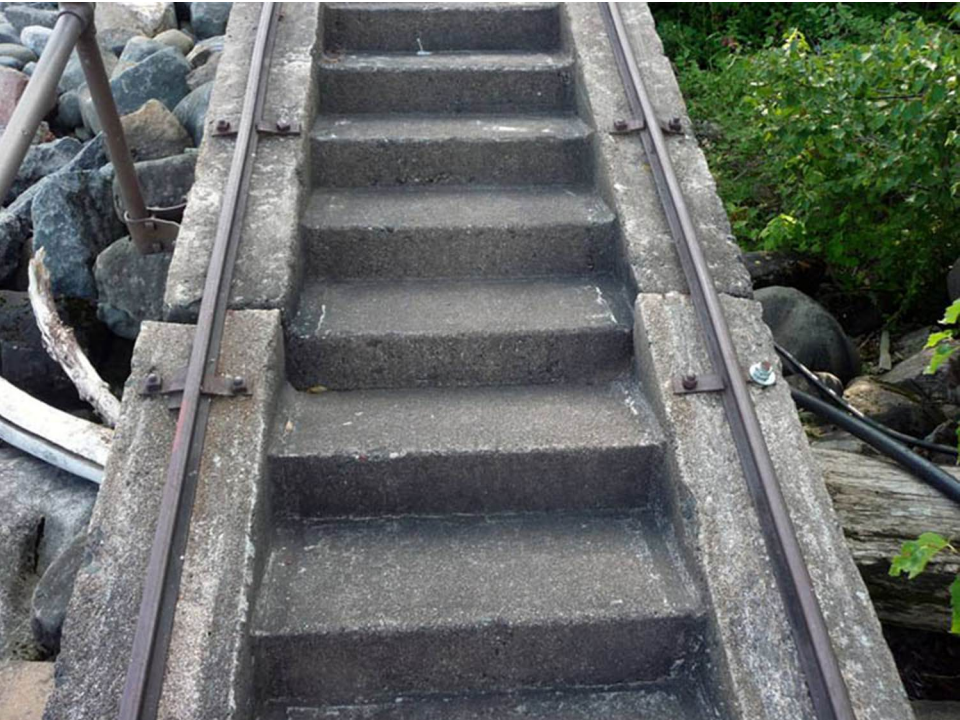
Above, tram tracks from the tramway to the Fog signal Building, viewed from the north.
Below, tramway steps and tram tracks.
(Anderson Hallas Architects, PC/NPS 2010)

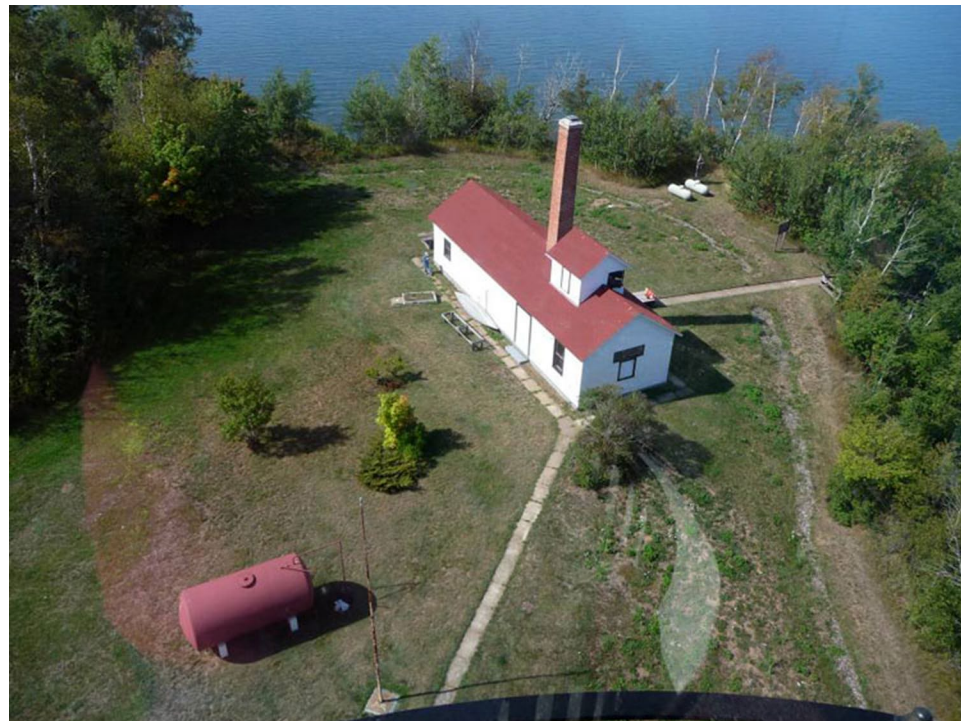
Light station grounds from the Light Tower towards the Fog Signal Building, looking west. Note the vegetation on the embankment. (Anderson Hallas Architects PC/NPS 2010)

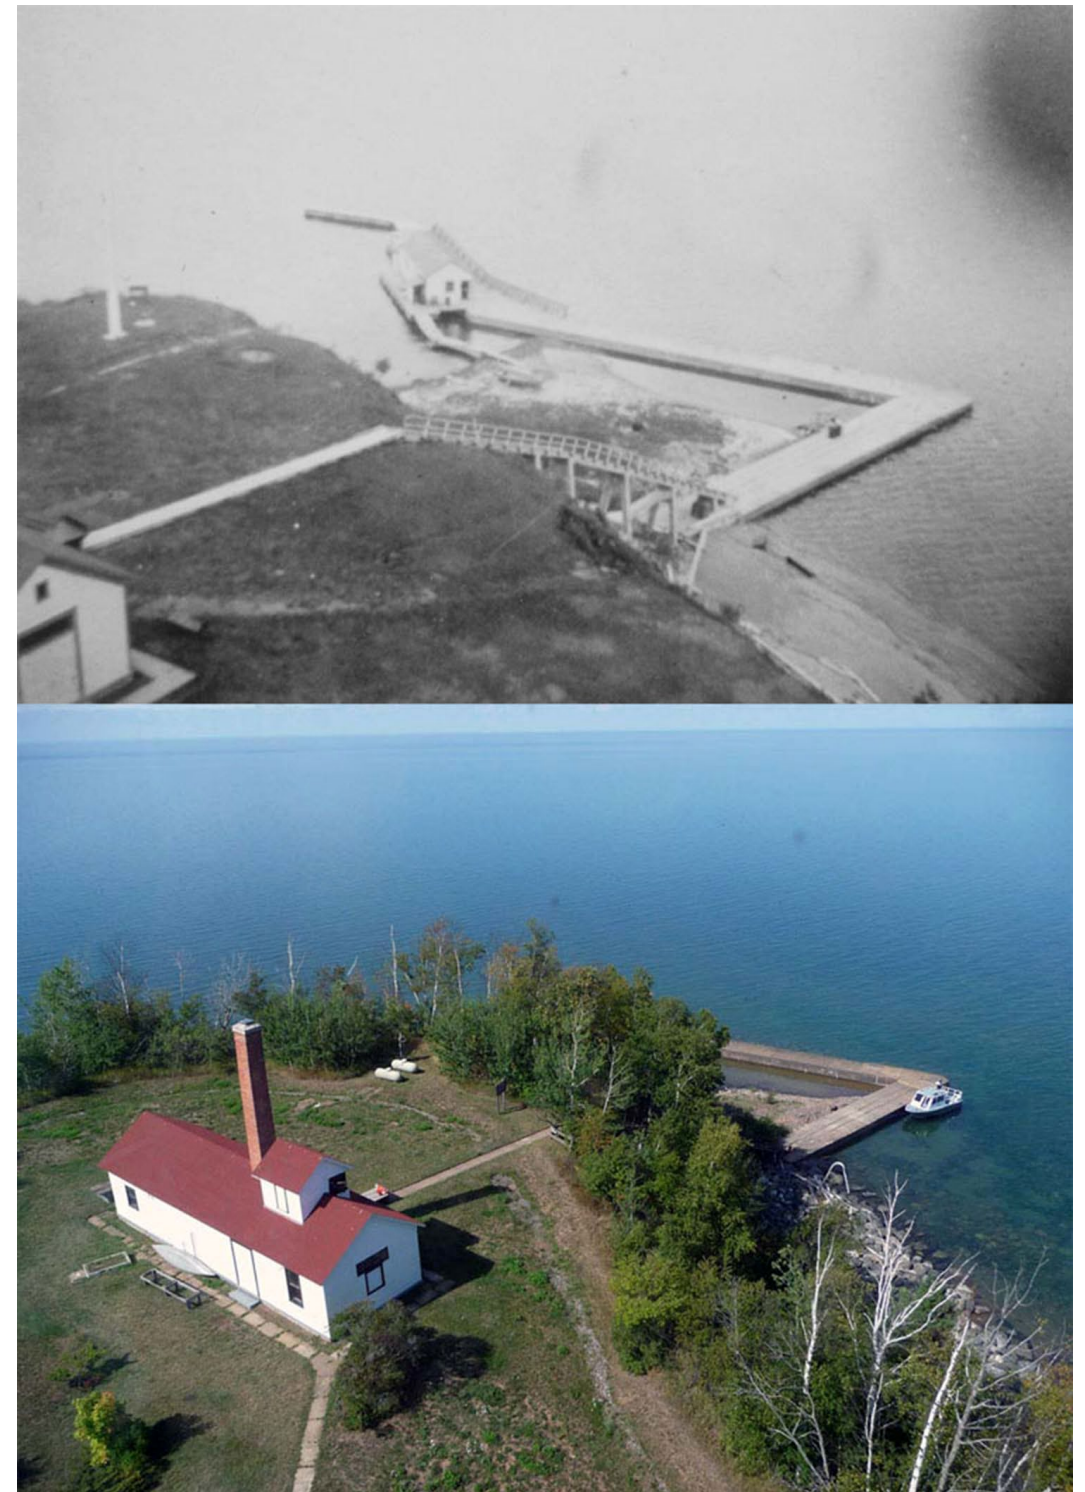
View west from the Tower with the (right to left) Boat Dock, Tram Tracks, and Concrete Walk from the Fog Signal to the Keepers Quarters. Note the encroaching vegetation on the embankment. above: after 1934 (NPS APIS Archives) below: 2010 (Anderson Hallas Architects PC/NPS)

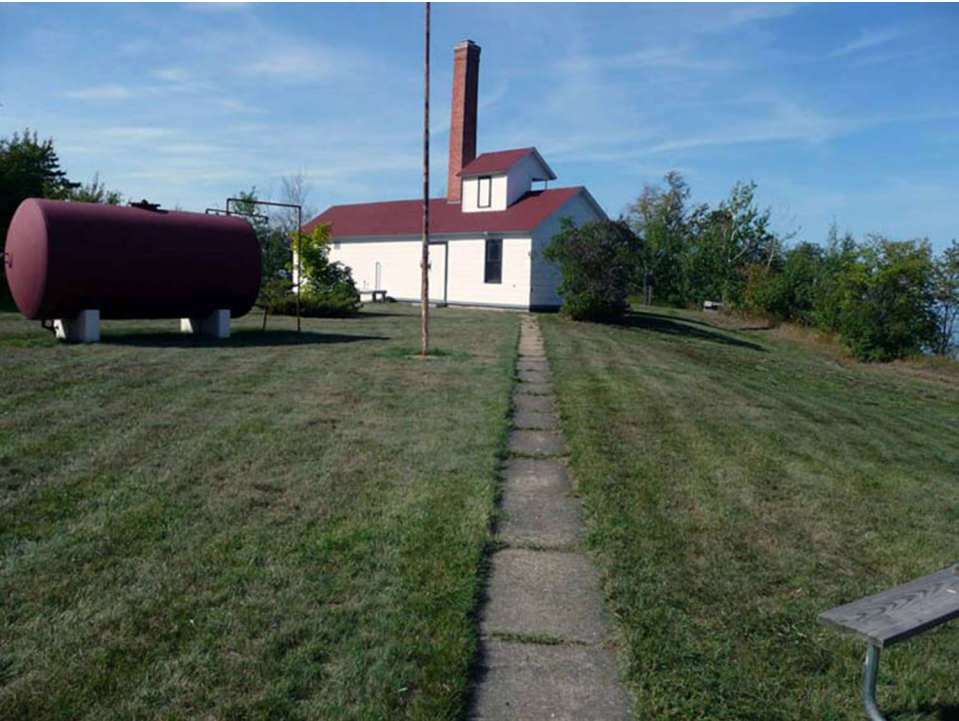
Concrete sidewalk, viewed from the west side of the Keepers Quarters, northwest to Fog Signal Building. Fuel tank and Flagpole visible at left and center. (Anderson Hallas Architects PC/NPS 2010)

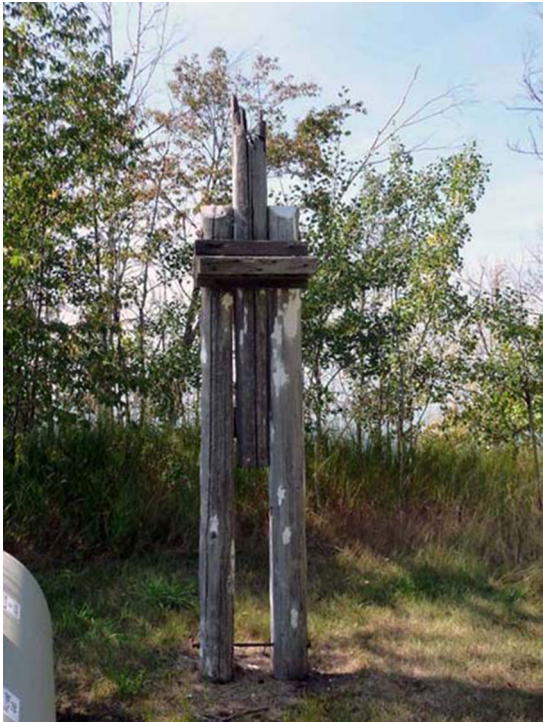
Remnant flagpole. (Anderson Hallas Architects PC/NPS 2010)

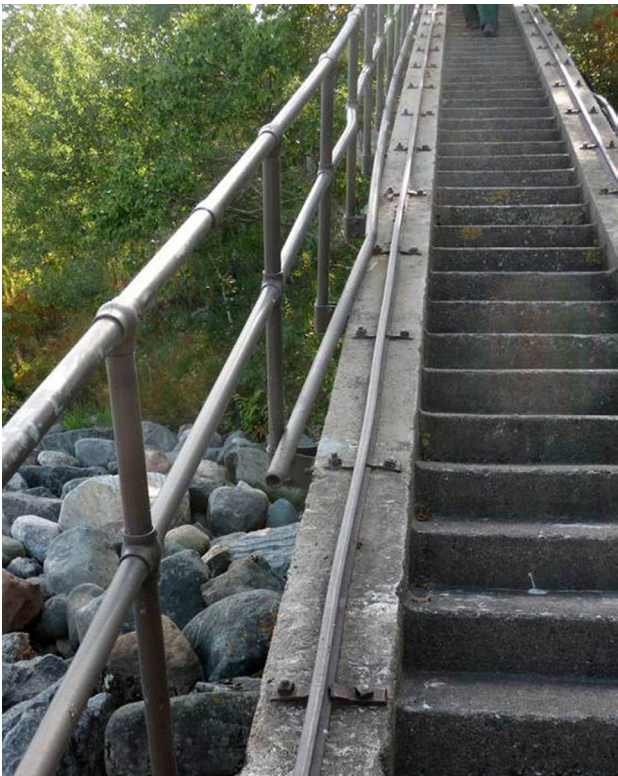
Concrete tramway pipe railing. (Anderson Hallas Architects PC/NPS 2010)

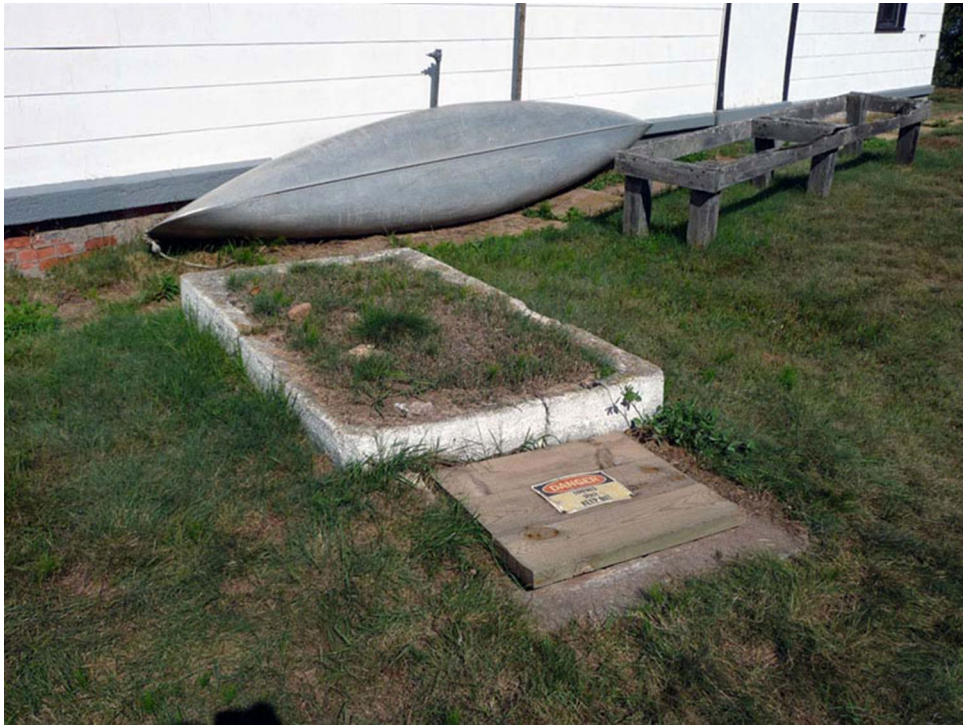
Well Foundation. (Anderson Hallas Architects PC/NPS 2010)

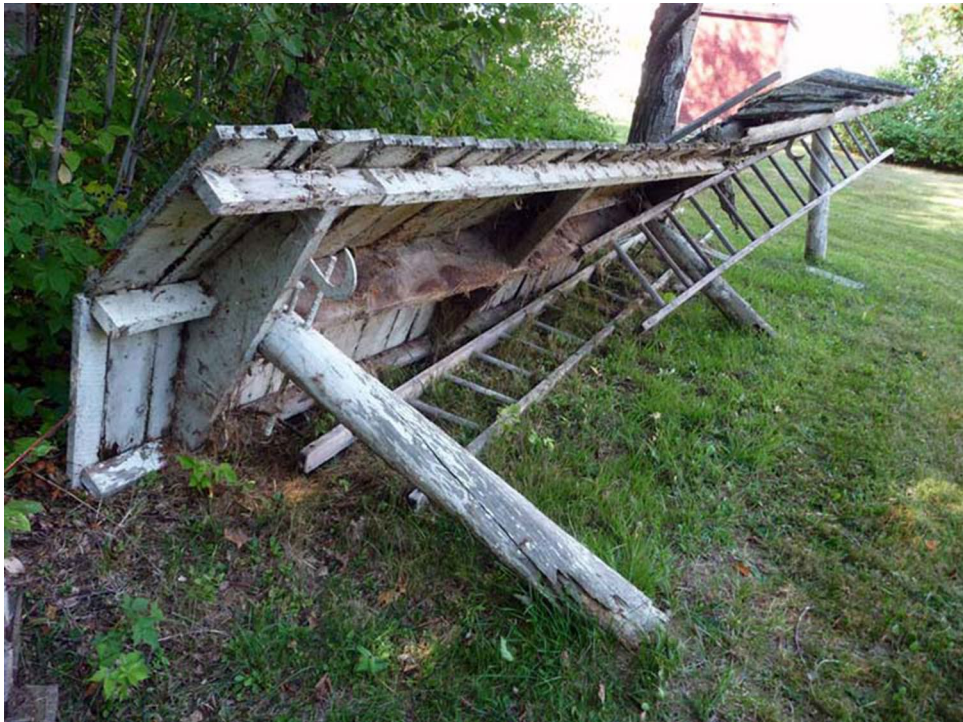
Collapsed ladder stand. (Anderson Hallas Architects PC/NPS 2010)

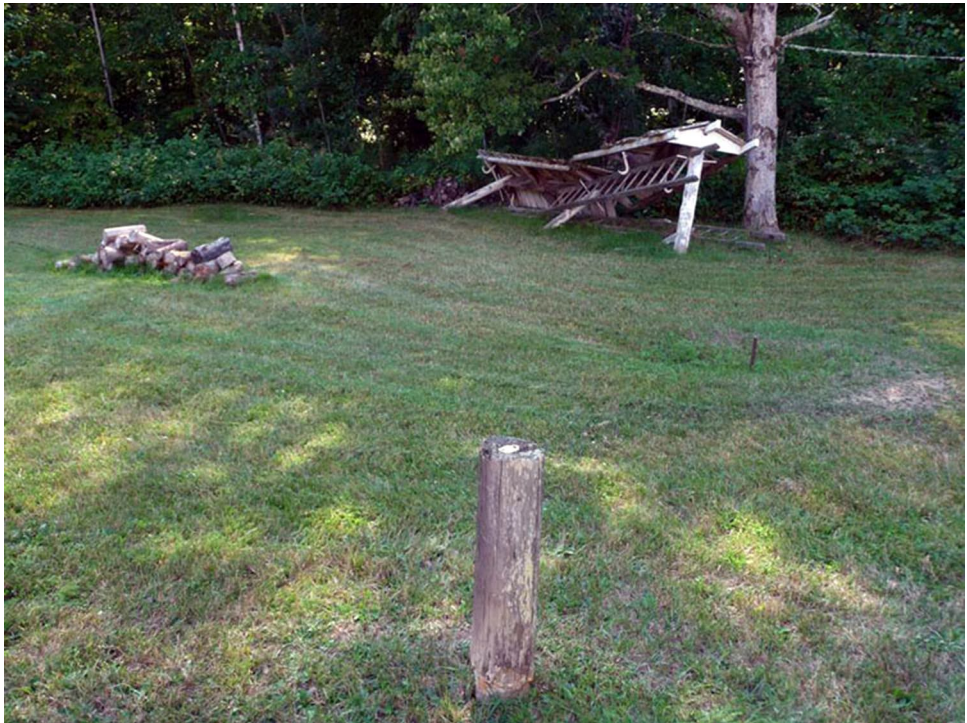
Remnant post in foreground. (Collapsed ladder stand in background). (Anderson Hallas Architects PC/NPS 2010)

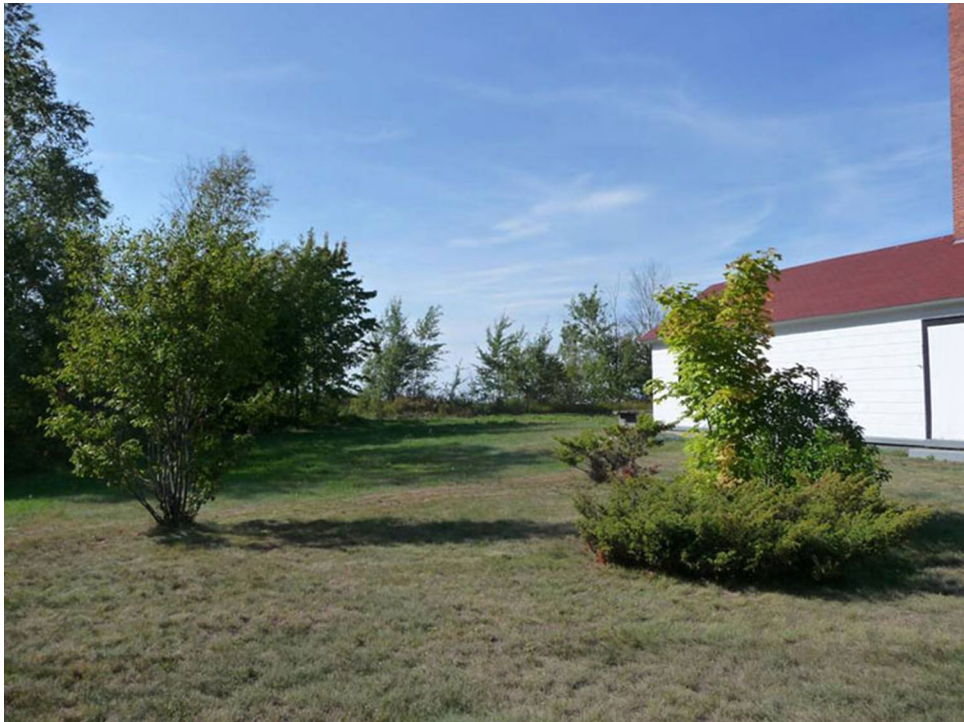
Serviceberry, Juniper, and Maple plantings near Fog Signal Building. (Anderson Hallas Architects PC/NPS 2010)

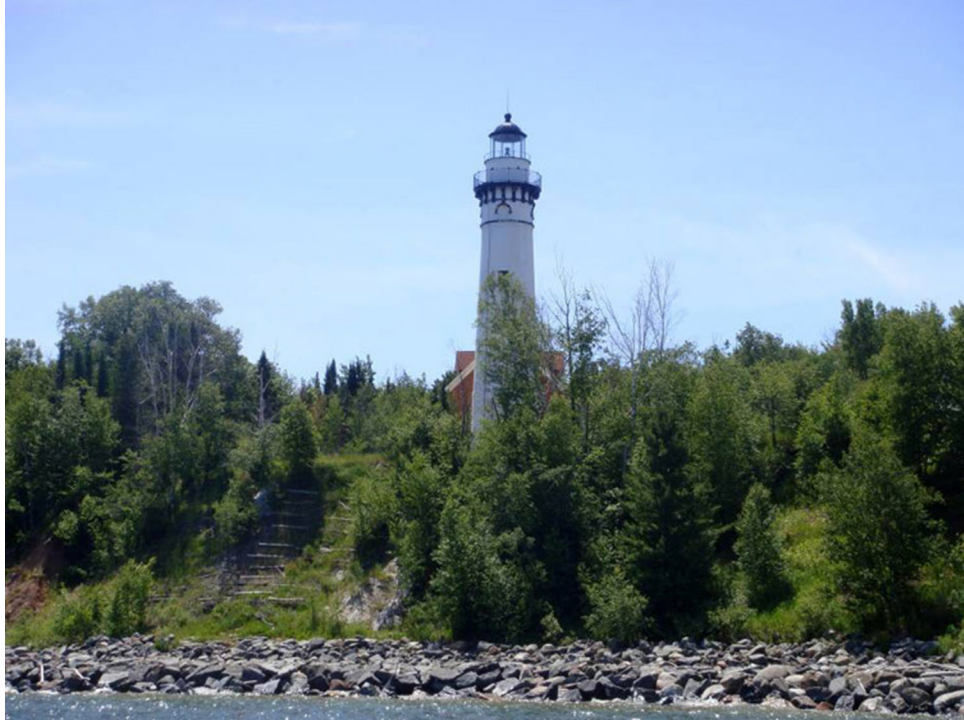
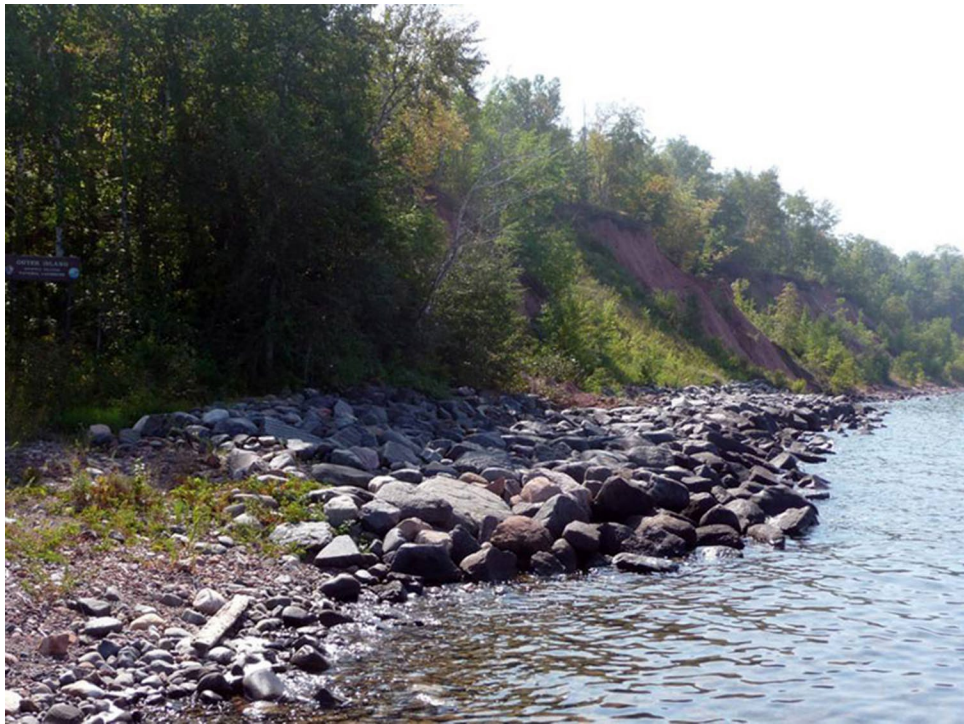
Banks and shoreline with erosion control and stone revetment.
Above, looking east from the dock. Below, looking west from the dock.
(Anderson Hallas Architects, PC/NPS 2010)

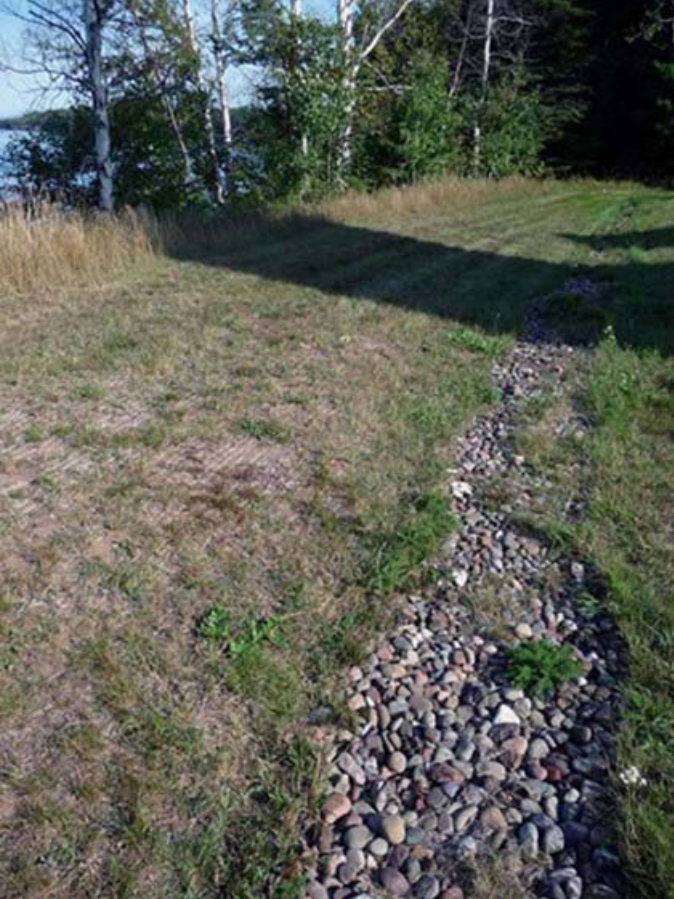
Drainage swale along the norther edge of the site, viewed east from the north of the Outer Island Tower. (Anderson Hallas Architects, PC/NPS 2010)
