Apostle Islands National Lakeshore
Wisconsin

Sand Island Light Station

Cultural Landscapes Inventory

July 2014

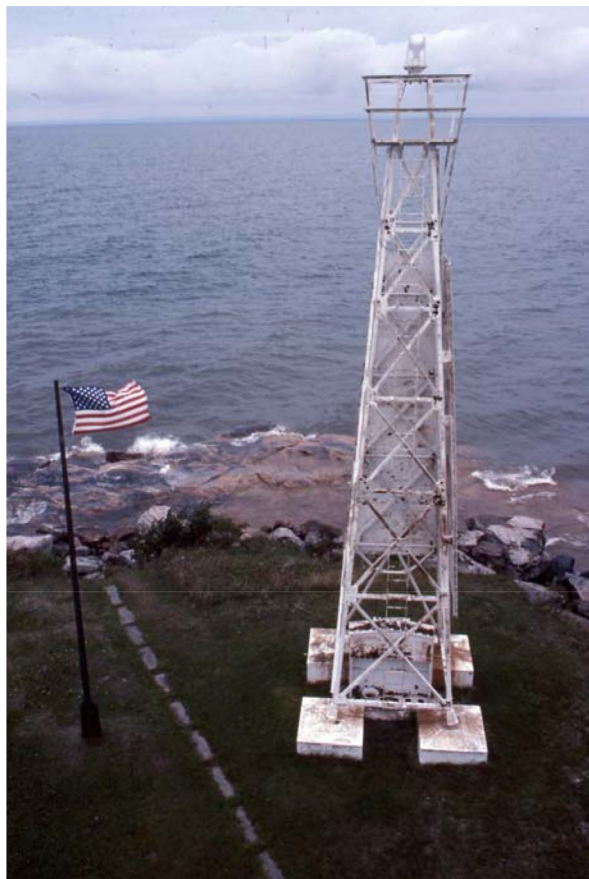
The 40-foot tall steel frame light tower, erected in 1933, seen here in 1984. It was removed in 1985. (NPS APIS Archive)

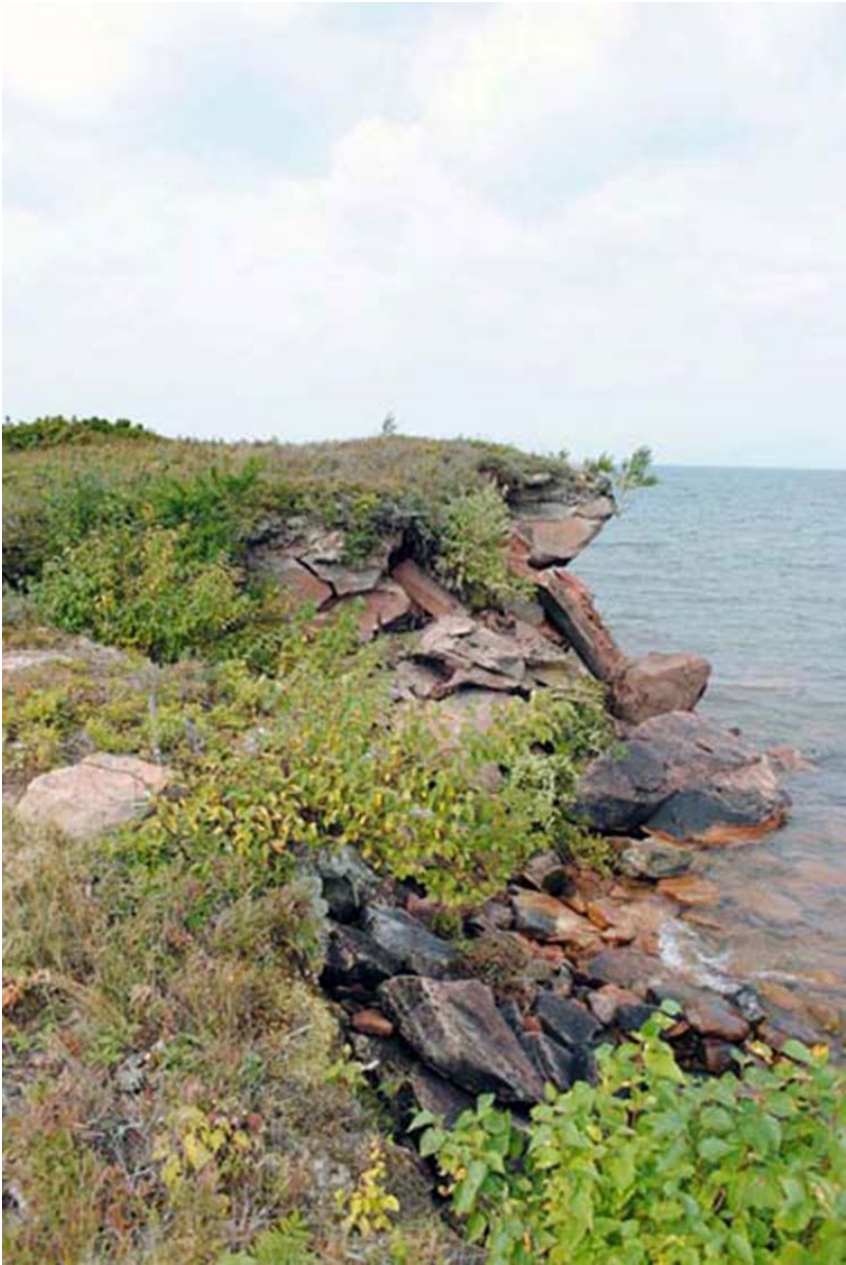
Rocky cliff to the east of the light station grounds (Anderson Hallas Architects, PC/NPS 2010).

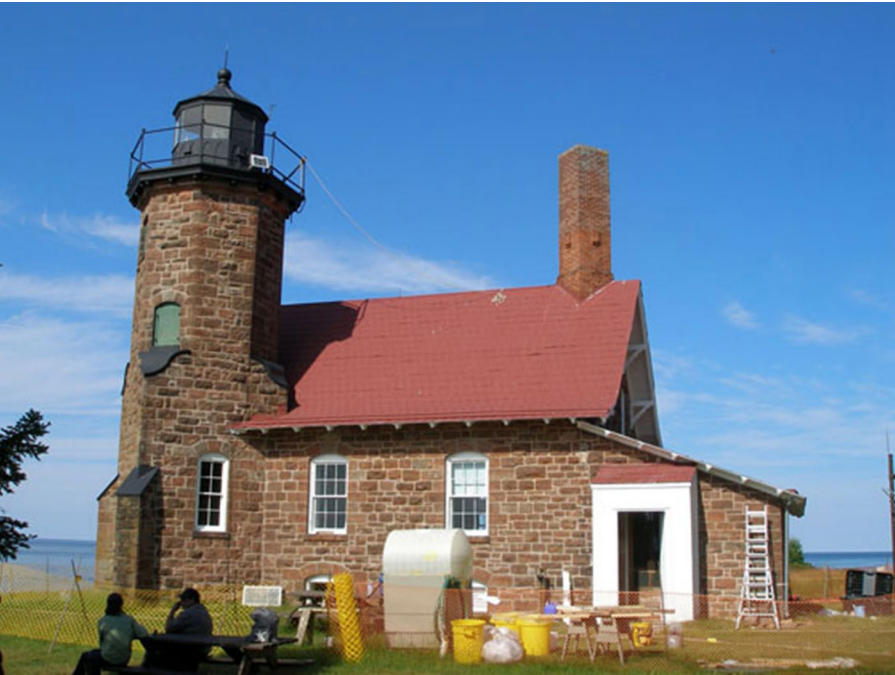
The octagonal light tower is attached to the northwest corner of the keeper’s dwelling at a 45 degree angle. It is square at the base with buttress like supports at the corners. At the second floor level, the tower makes a smooth transition to an octagon. The focal plane of the light was 52 feet above lake level (654 MSL). In 1921, an acetylene gas burner was installed, making Sand Island Light Station the first automated light in the Apostle Islands. In 1933 the light was moved from the lighthouse to a metal tower, where it remained for five decades. Following the creation of Apostle Islands National Lakeshore, the National Park Service persuaded the Coast Guard to return the optic to the lighthouse tower. The skeletal tower was removed in 1984. The current light is a 300mm plastic lens exhibiting a flashing white light.

Sand Island Lighthouse and Keeper’s Quarters (NPS 2008)

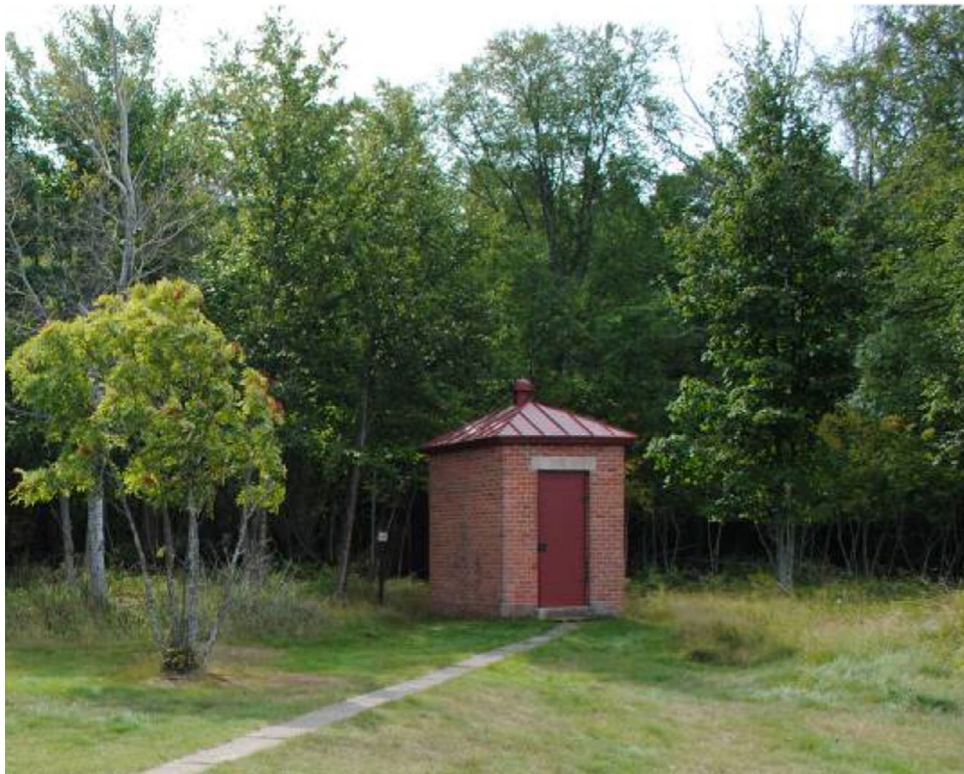
The oil house, built in 1901, is a typical small square magazine type utilitarian building made of brick on a concrete foundation. The standing seam metal hip roof has a circular metal vent at the center of the ridge, and the metal door located on the north side of the structure has a stone lintel and threshold.

Sand Island Light Station Oil House (Anderson Hallas Architects PC/NPS 2010)

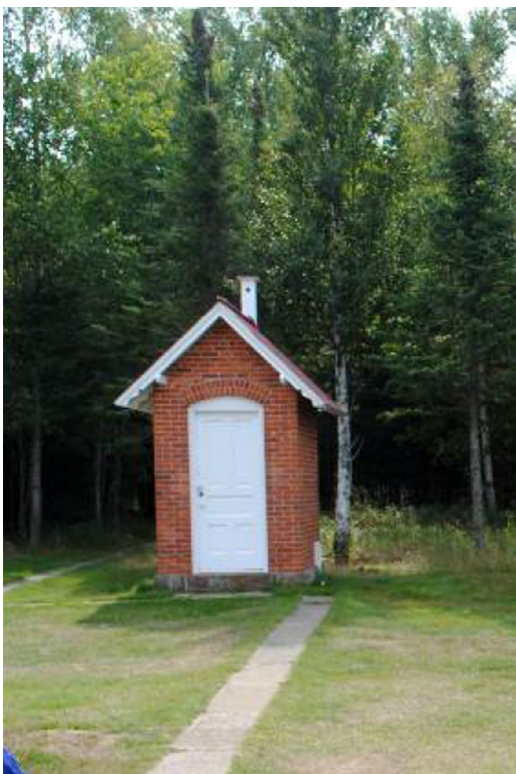
The brick privy, constructed in 1881, has three holes (two adult, one child) with a metal panel gable roof with carved brackets and rafter tails. The walls are brick, sitting on a brownstone foundation. There is a four pane casement window in an arched opening on the east side, while the wooden panel door is set in an arched opening in the north. There is a square wooden vent stack with ornamental cutouts at the south end of the roof ridge. The interior is finished with beaded board wainscoting and a wooden floor.

Sand Island Light Station Privy
(Anderson Hallas Architects PC/NPS 2010)

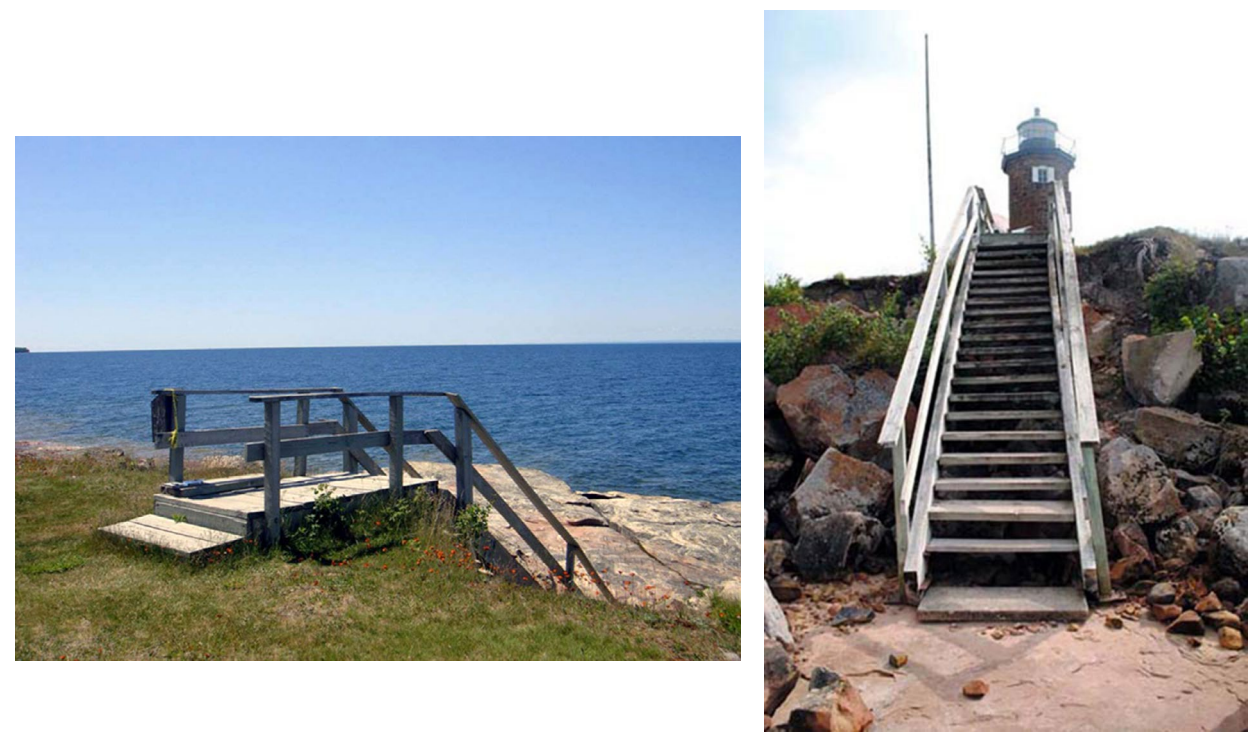
Stairway at the North Landing, see from on the bluff (left) and from the rock landing below (right). (Anderson Hallas Architects PC/NPS 2010)

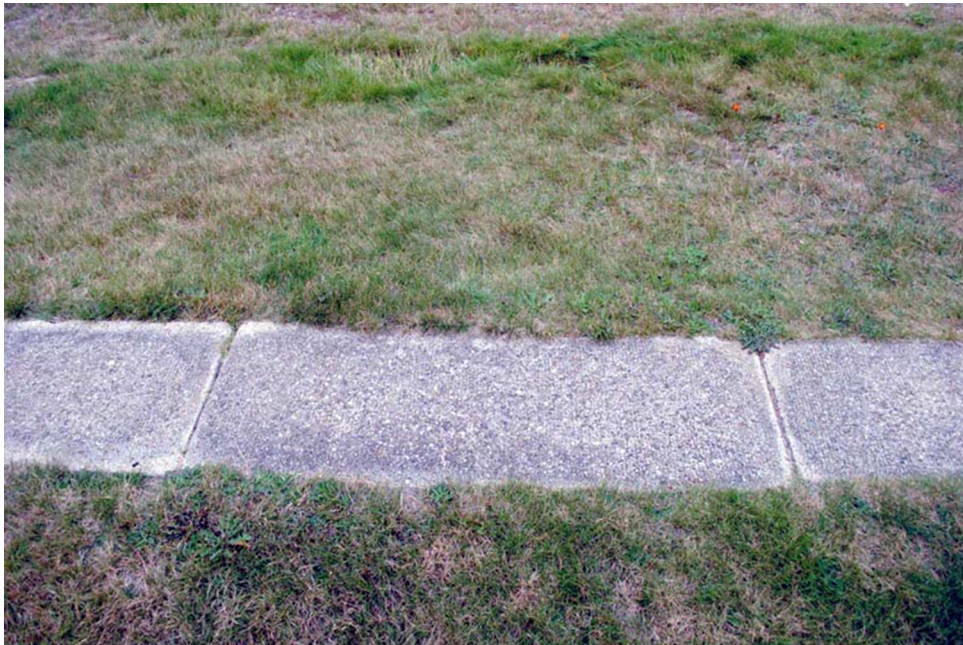
The small scale features at Sand Island Light Station include concrete walks, a flagpole, park signs, a fiber-glass battery storage unit, solar panel, foundations, dump sites and other site features. The walks are built of precast concrete slabs laid end to end, connecting buildings and structures in straight lines.

Historic photographs indicate that the concrete walks are precast concrete slabs placed directly on the ground. This method of construction was also found at Michigan, Outer, Devils, and Long Island Light Stations.

Typical concrete walk of precast slabs. (Anderson Hallas Architects PC/NPS 2010)

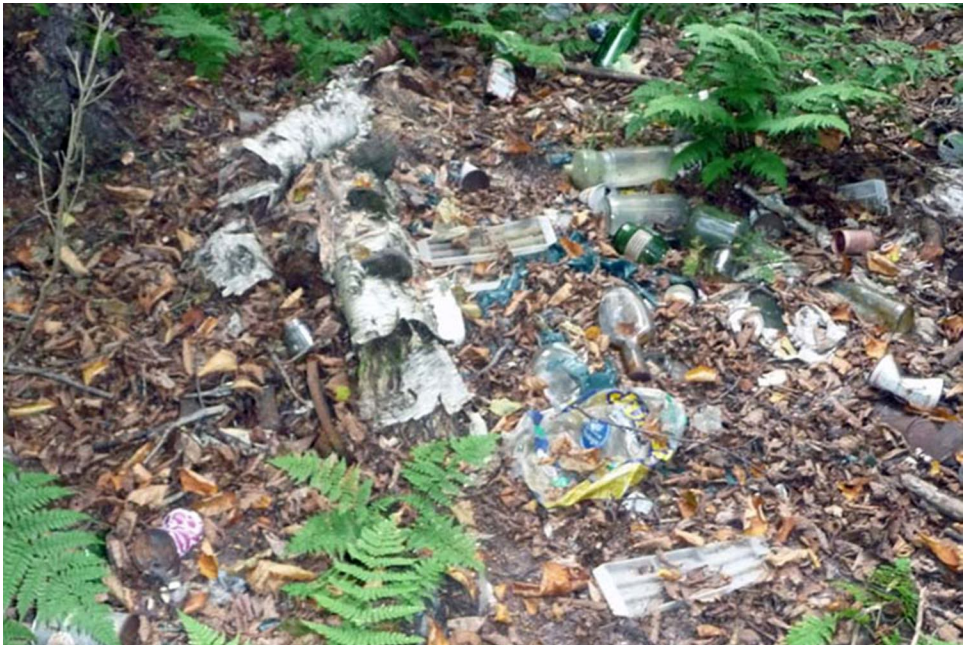
Dump Site No. 1. (Anderson Hallas Architects PC/NPS 2010)

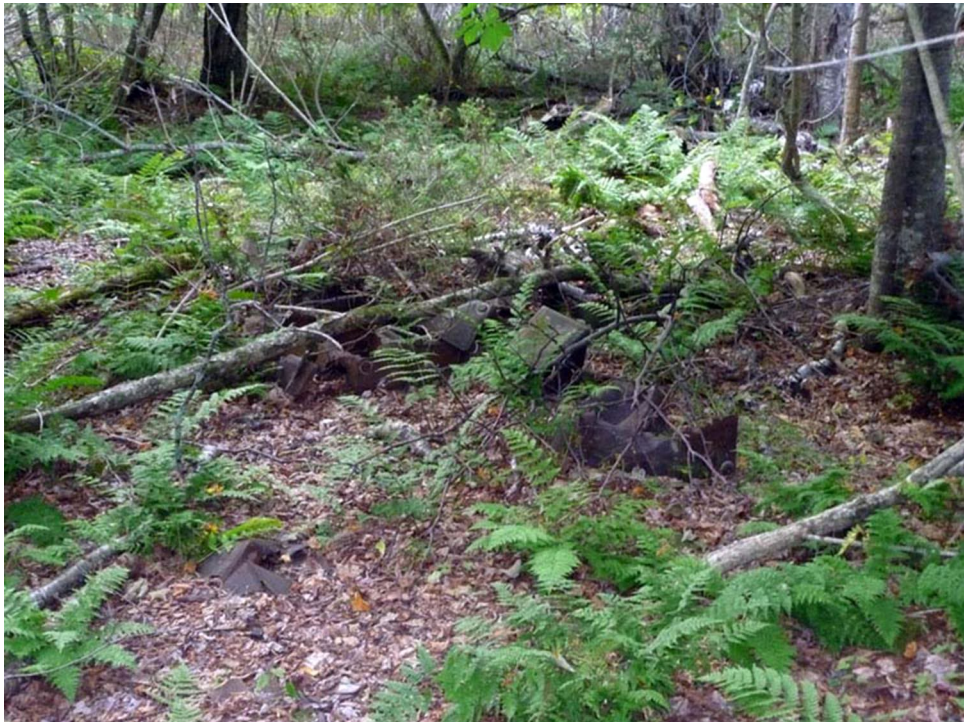
Feature:	Dump Site - 2		
Contributing?	Yes		
LCS Structure Name:	Not Currently Listed		
LCS ID Number			
LCS Historic Structure Number:			
Locational Data:			
Source:	GPS- Uncorrected		
Point Type:	Point		
Datum:	WSG84		
Zone: 15	Easting: 656775	Northing: 5207479	
Longitude: -90.937739	Latitude: 47.002266		
Associated Image Page Numbers in CLI: Page 42

Dump Site No. 2. (Anderson Hallas Architects PC/NPS 2010)

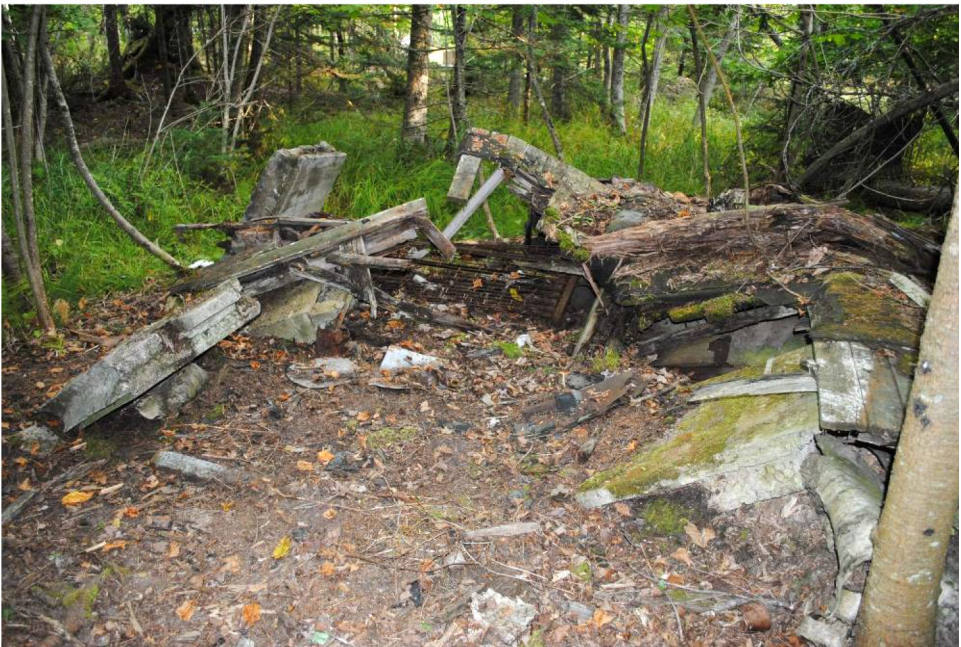
Feature:	Dump Site - 3		
Contributing?	Yes		
LCS Structure Name:	Not Currently Listed		
LCS ID Number			
LCS Historic Structure Number:			
Locational Data:			
Source:	GPS- Uncorrected		
Point Type:	Point		
Datum:	WSG84		
Zone: 15	Easting: 656836	Northing: 5207520	
Longitude: -90.936927	Latitude: 47.002619		
Associated Image Page Numbers in CLI: Page 42

Dump Site No. 3. (Anderson Hallas Architects PC/NPS 2010)

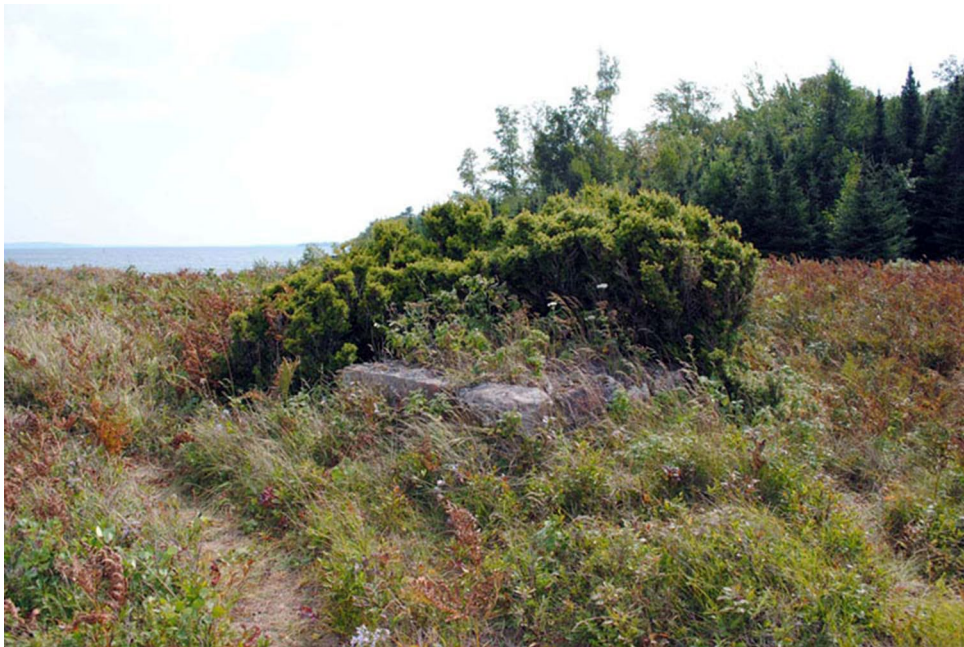
Stone Foundation east of Light Station Quarters. (Anderson Hallas Architects PC/NPS 2010)

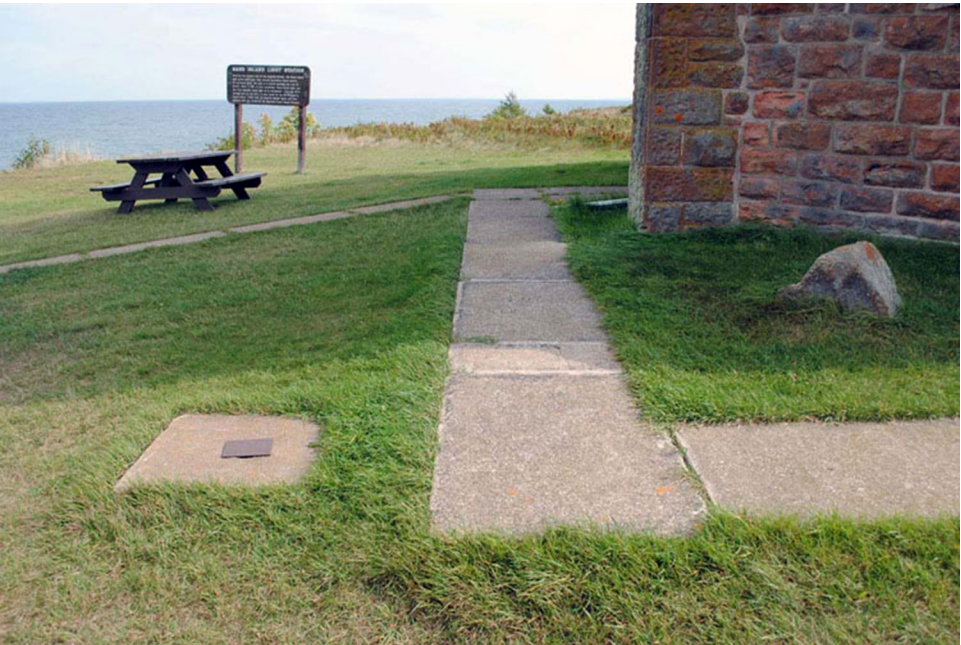
Concrete Pad with steel plate. (Anderson Hallas Architects PC/NPS 2010)

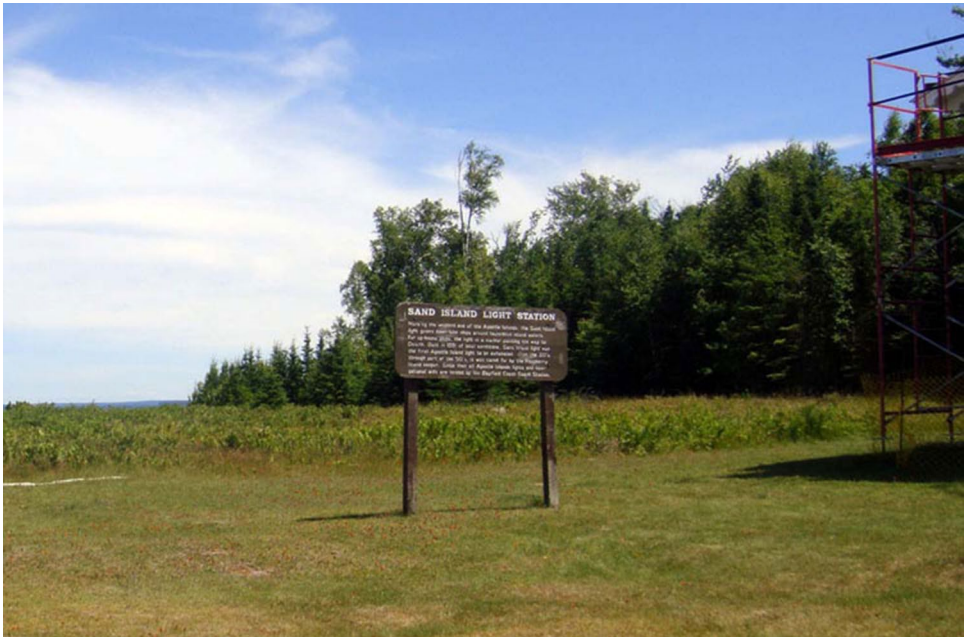
Feature:	Interpretive Sign		
Contributing?	No		
LCS Structure Name:			
LCS ID Number			
LCS Historic Structure Number:			
Locational Data:			
Source:	GPS- Uncorrected		
Point Type:	Point		
Datum:	WSG84		
Zone: 15	Easting: 656789	Northing: 5207581	
Longitude: -90.937517	Latitude: 47.003180		
Associated Image Page Numbers in CLI: Page 43

Park Interpretive Sign. (Anderson Hallas Architects PC/NPS 2010)

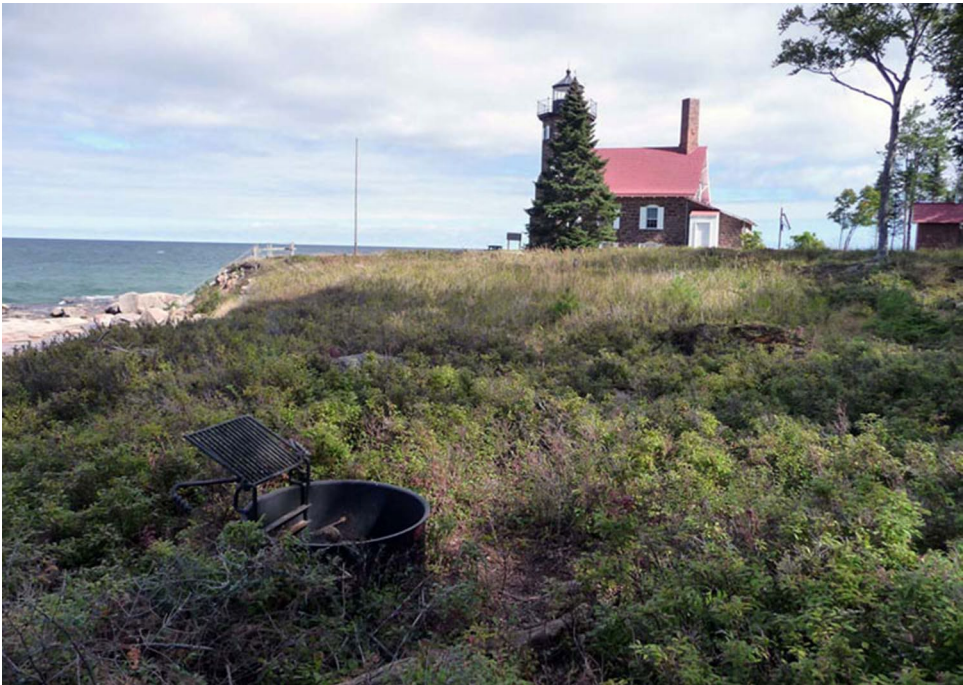
Feature:	Fire Pit		
Contributing?	No		
LCS Structure Name:			
LCS ID Number			
LCS Historic Structure Number:			
Locational Data:			
Source:	GPS- Uncorrected		
Point Type:	Point		
Datum:	WSG84		
Zone: 15	Easting: 656755	Northing: 5207550	
Longitude: -90.937975	Latitude: 47.002909		
Associated Image Page Numbers in CLI: Page 44

Fire Pit. (Anderson Hallas Architects PC/NPS 2010)

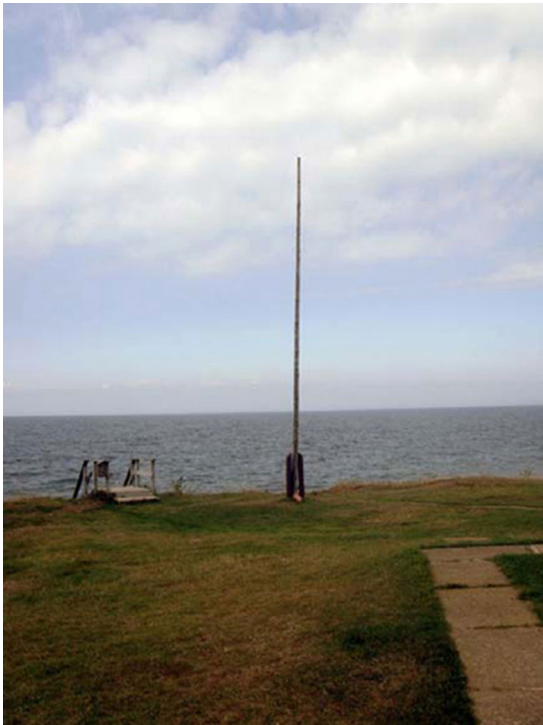
Flagpole. (Anderson Hallas Architects PC/NPS 2010)

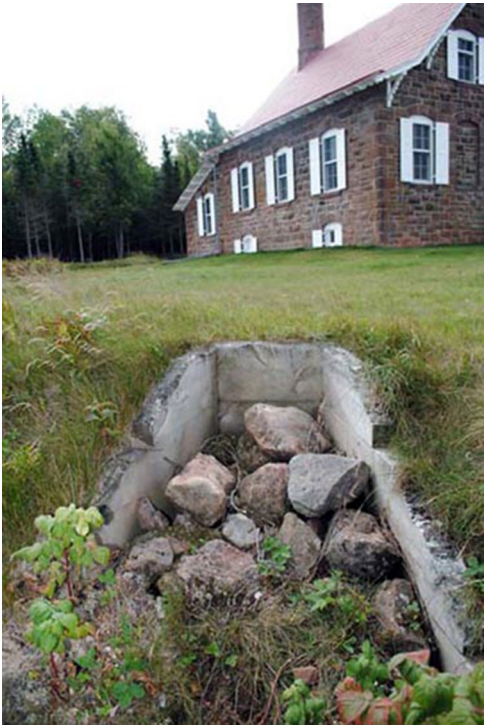
Wood headwall for drainage pip. (Anderson Hallas Architects PC/NPS 2010)

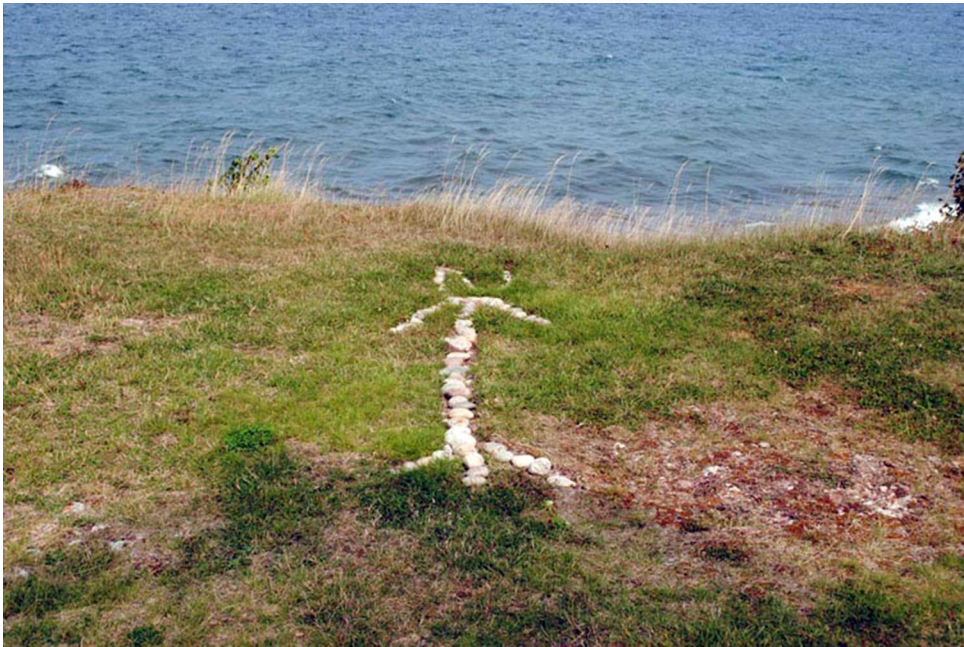
Feature:	Stone North Arrow		
Contributing?	No		
LCS Structure Name:			
LCS ID Number			
LCS Historic Structure Number:			
Locational Data:			
Source:	GPS- Uncorrected		
Point Type:	Point		
Datum:	WSG84		
Zone: 15	Easting: 656781	Northing: 5207590	
Longitude: -90.937624	Latitude: 47.003255		
Associated Image Page Numbers in CLI: Page 46

Stone north arrow located on the site of the non-extant steel tower. (Anderson Hallas Architects PC/NPS 2010)

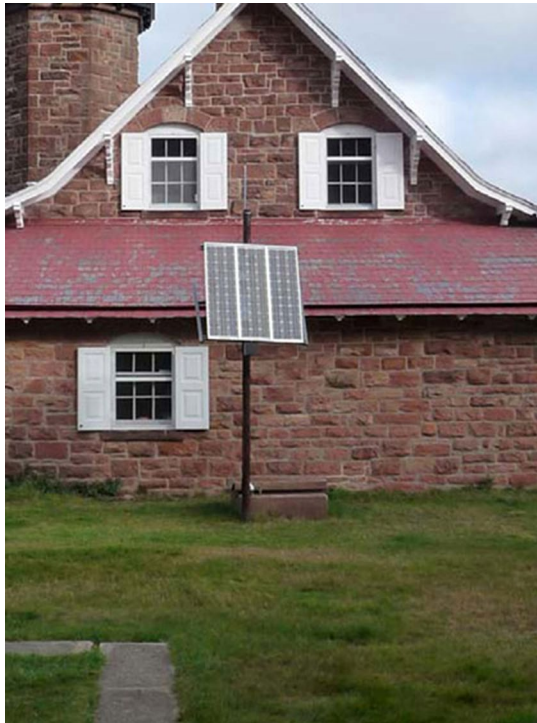
Solar Panel. (Anderson Hallas Architects PC/NPS 2010)

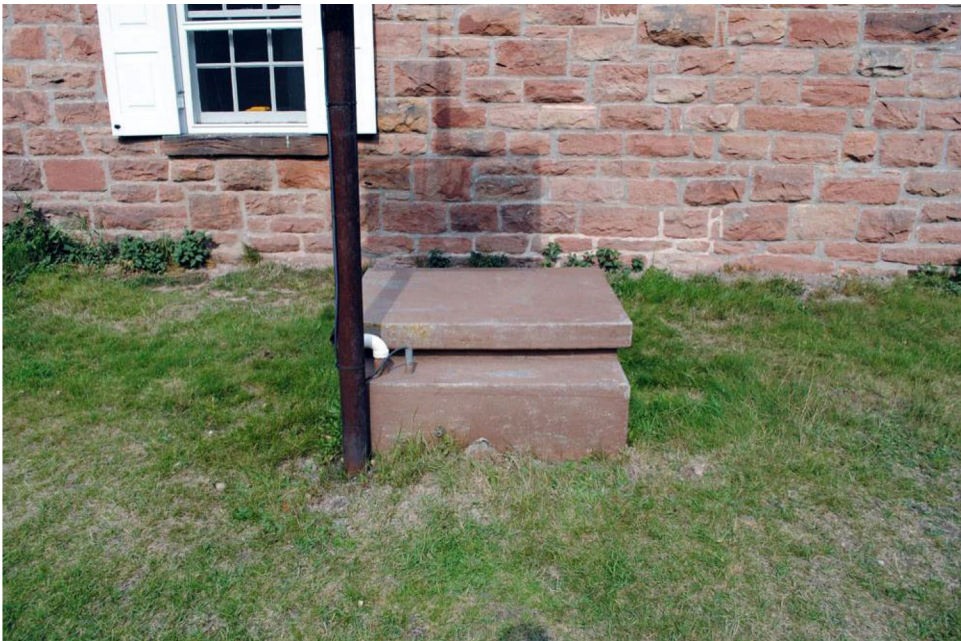
Fiberglass battery storage unit at rear of Light Station Quarters. (Anderson Hallas Architects PC/NPS 2010)

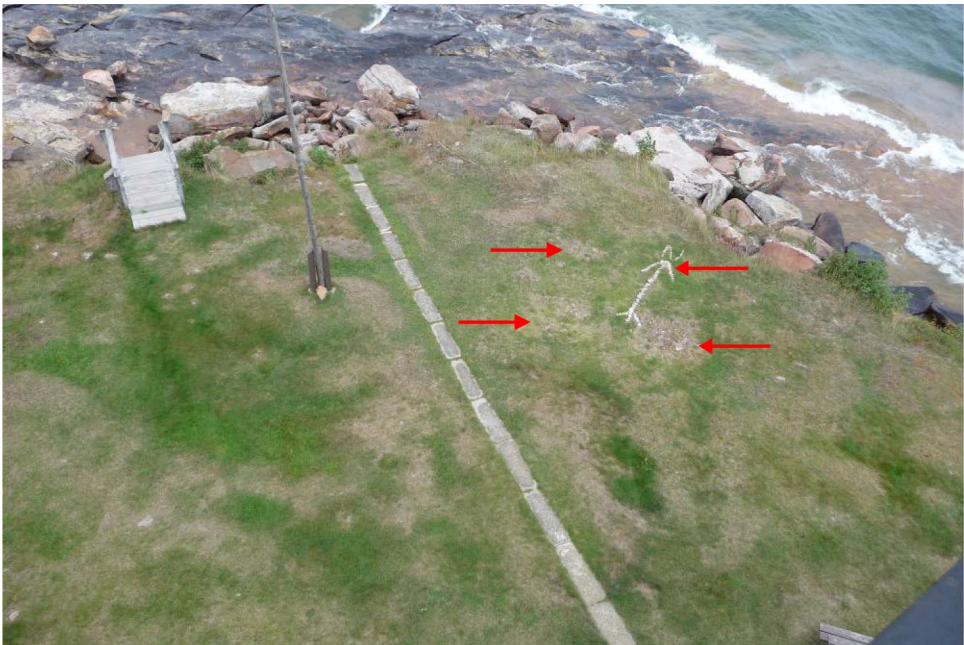
Footprint of the Steel Frame Tower Foundation, indicated by the arrows, around the stone north arrow.
(Anderson Hallas Architects PC/NPS 2010)

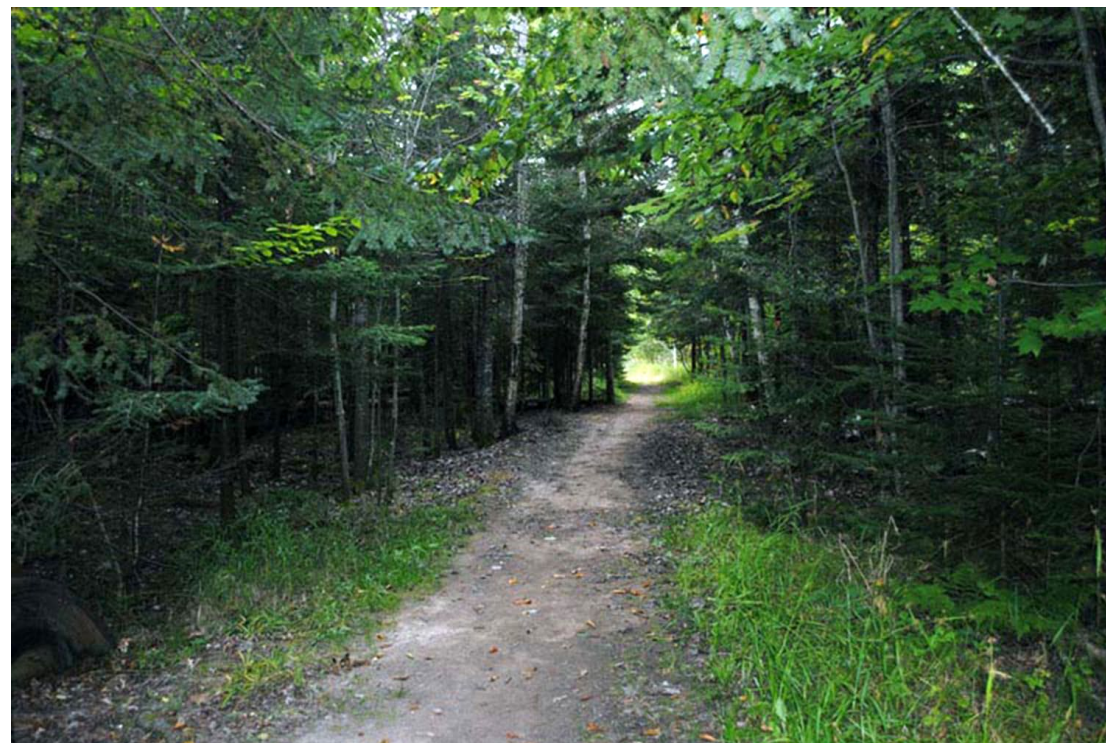
Trail corridor between the Light Station and the Boathouse, looking south toward the Boathouse site.
(Anderson Hallas Architects PC/NPS 2010)

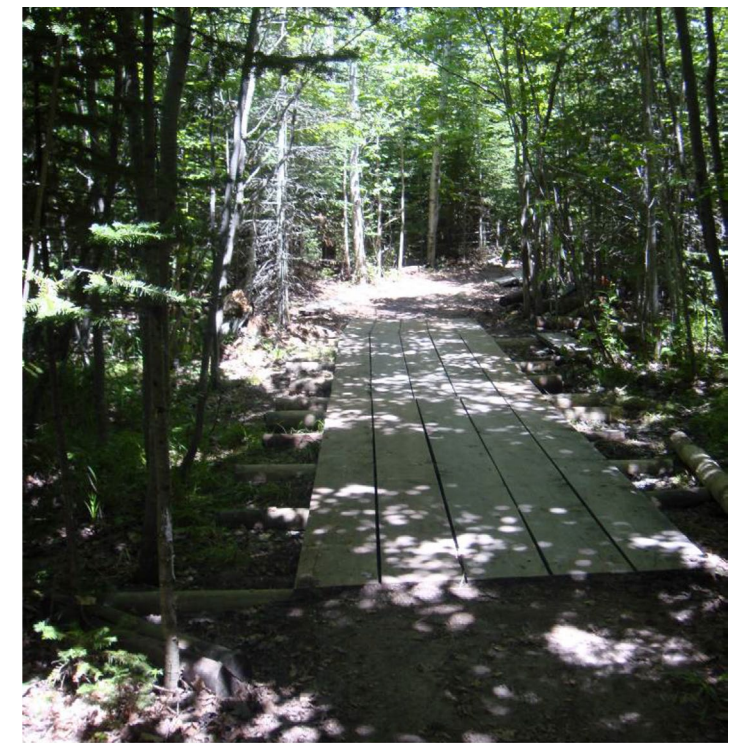
Boardwalk section of trail corridor between the Ligth Station and the East Bay Landing Dock.
(Anderson Hallas Architects PC/NPS 2010)

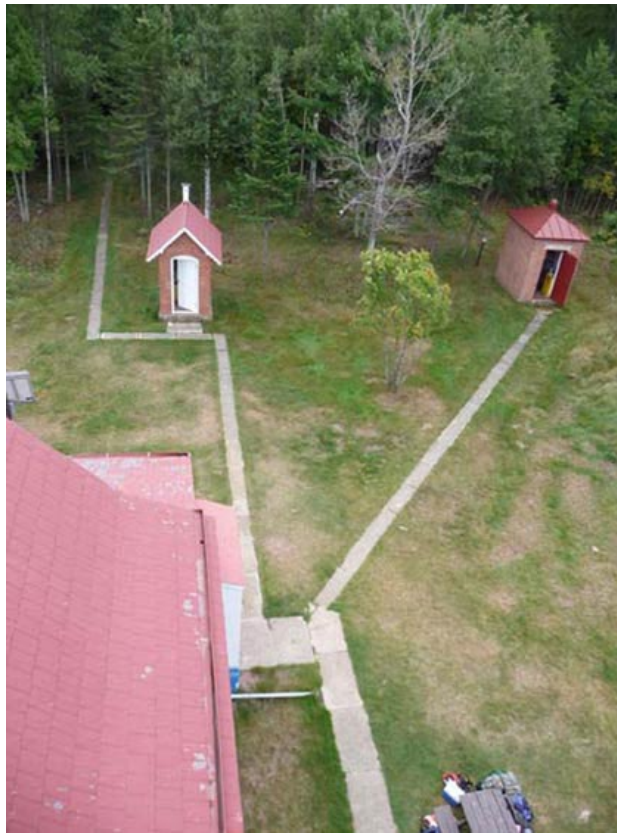
Arrangement of Privy (left) and Oil Building (right) to the south of the Light Station Quarters. The path to the left of the privy leads to the former garden area.
(Anderson Hallas Architects PC/NPS 2010)

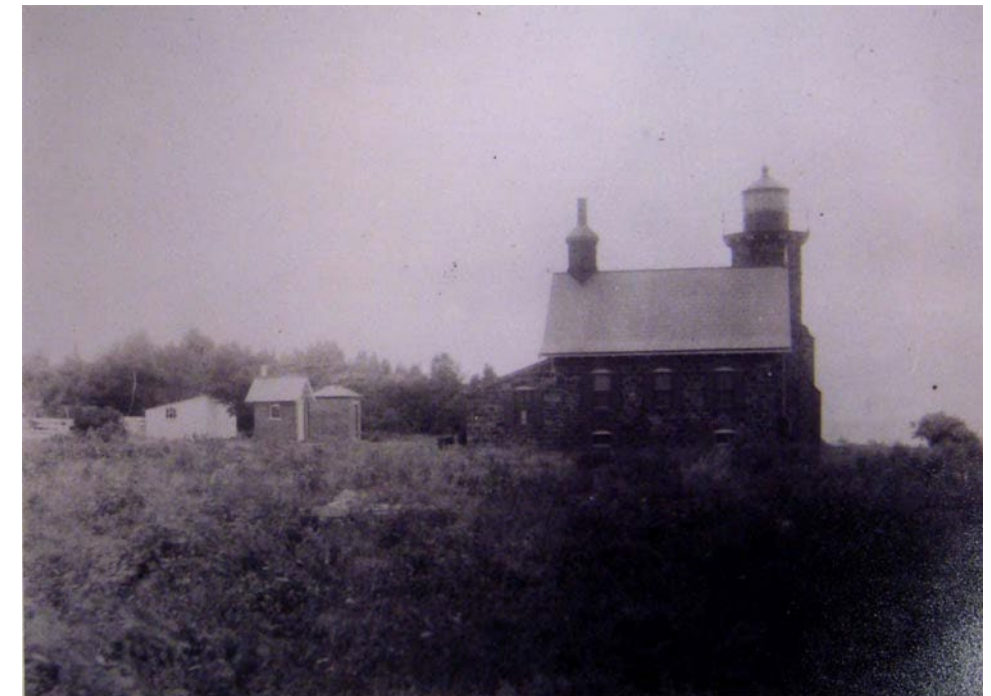
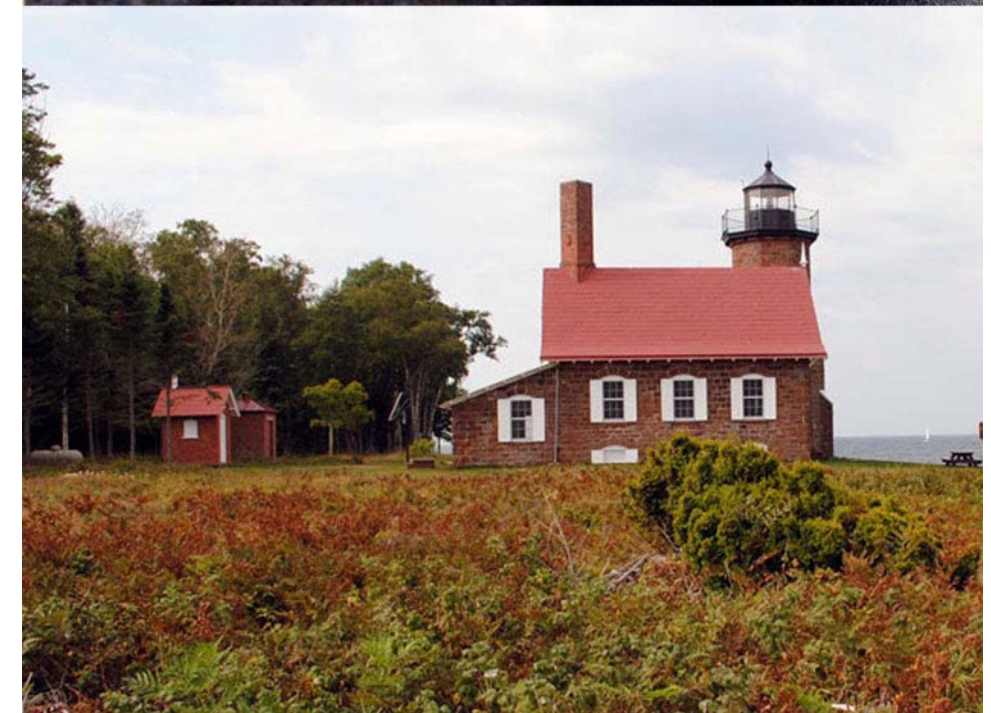
View of the Light station from the East -- note the reduction in the cleared area to the left and the height of the trees in the forest.
above: NPS APIS Archives, c. 1913. below: Anderson Hallas Architects PC/NPS 2010

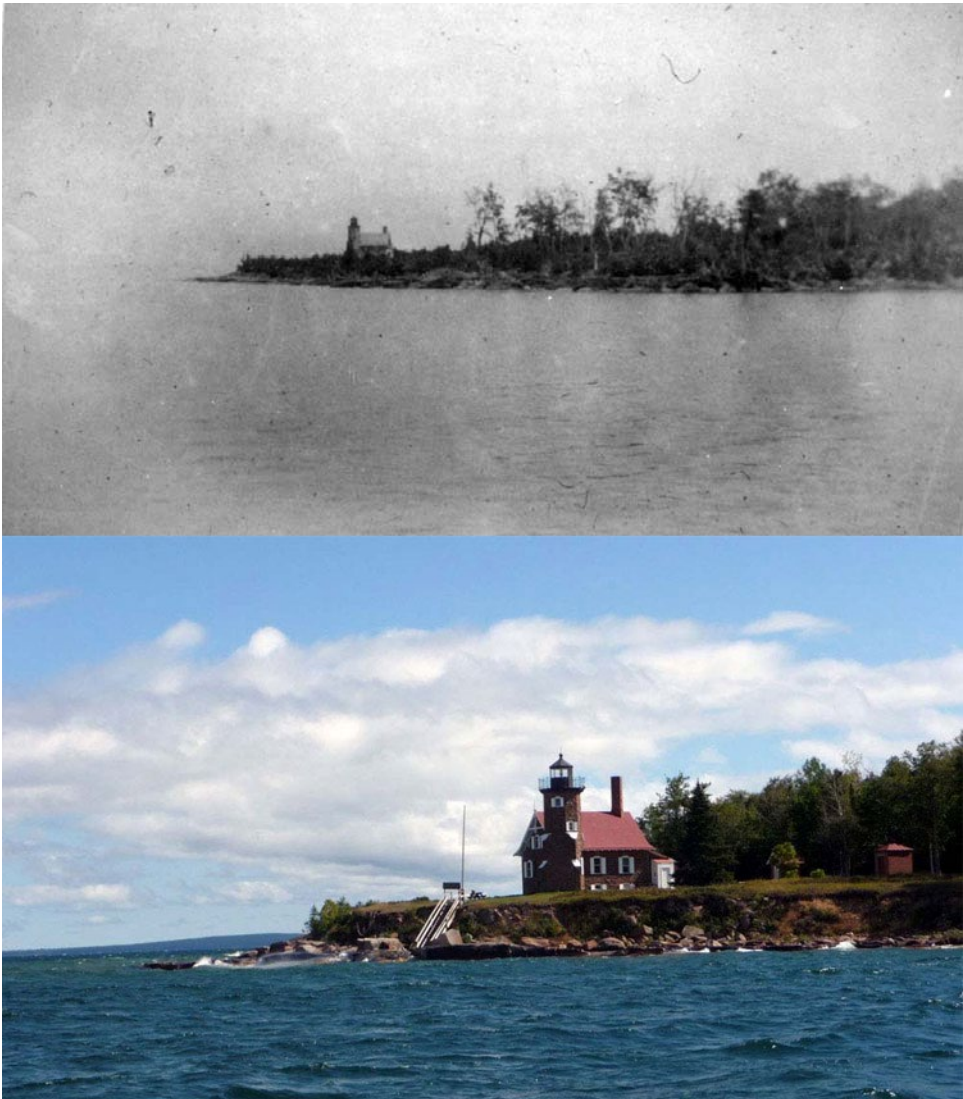
View of the Light Station Quarters from Lake Superior.
above: NPS APIS Archives, c. 1891. below: Anderson Hallas Architects PC/NPS 2010
