1186  
CLASSIFIED STRUCTURE FIELD INVENTORY REPORT  
(Attach 4" x 5" Black and White Photograph)

REGION RMRO PARK/AREA NAME Arches Natl. Park PARK NUMBER 1348

STRUCTURE NAME Rock House/Custodian's Residence STRUCTURE NUMBER ARCH - 31

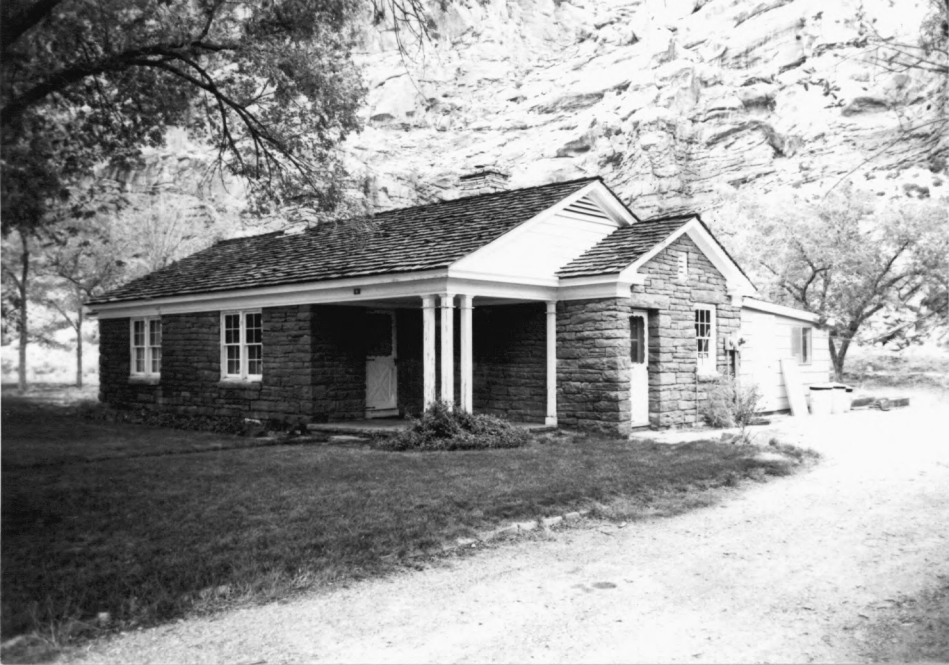
NS-ARCH 31

LOG No ARCH HS-31  
Photo No ~~19~~ 11, 19  
Subject Rock House  
Description of View REAR, w/side  
NE to SW  
Location of Subject ARCH  
Location of Negative RMRO  
By S. Mehls Date 9/86

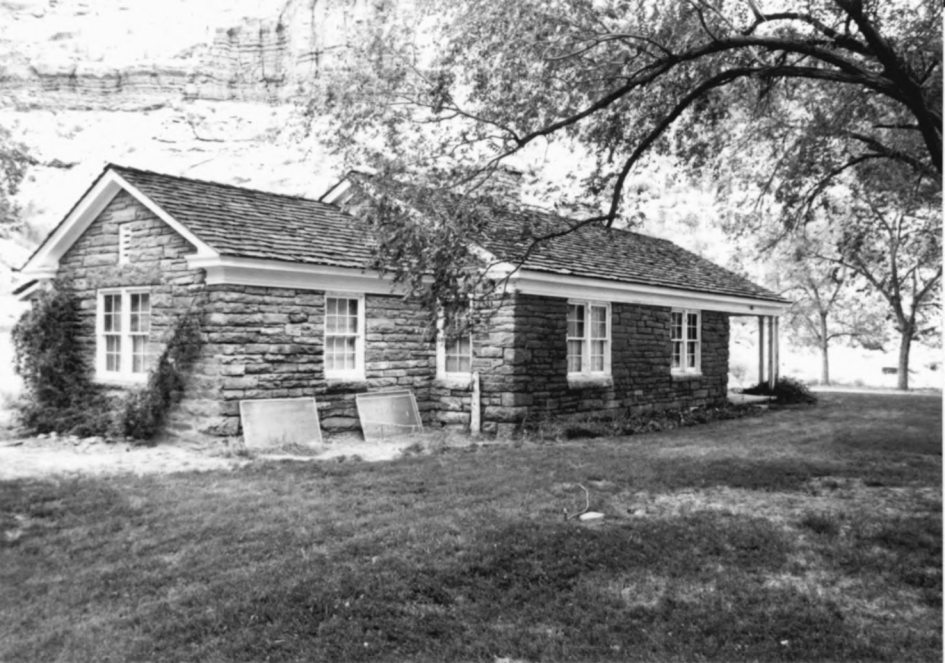
AK-ARCH31

LOG No ARCH NS-31  
Photo No 21  
Subject Rock House  
Description of View Front w/side  
NEW HOUSE  
Location of Subject ARCH  
Location of Negative RMKD  
By S. MEHLIS Date 9/86
