National Park Service  
Cultural Landscapes Inventory

2009

Arlington House, The Robert E. Lee Memorial  
Arlington House, The Robert E. Lee Memorial

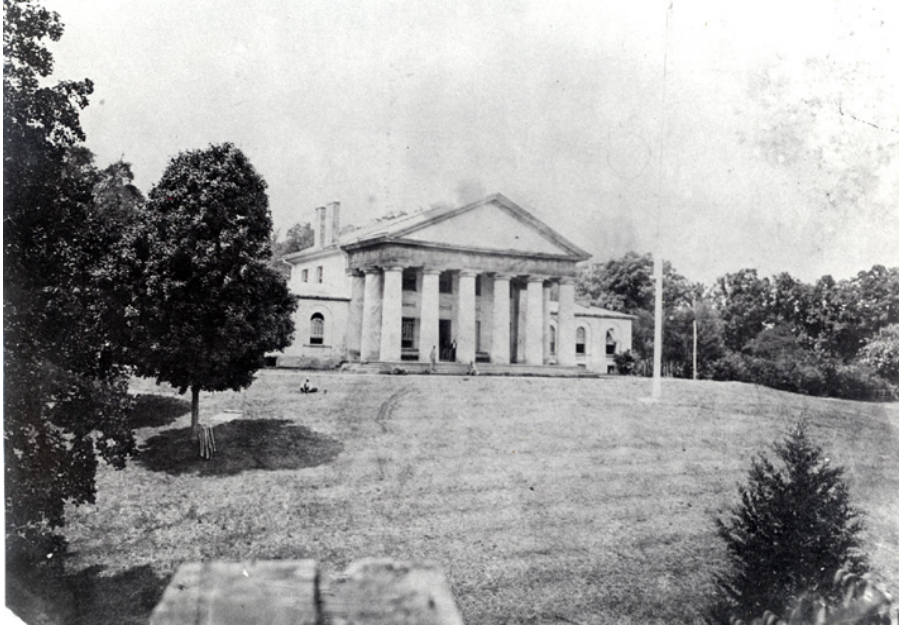
*Broad view of Arlington House from the "park" to its east c.1864 (ARHO, ARHO and grounds 1860\_1960 box 6 .tif II cat #237).*

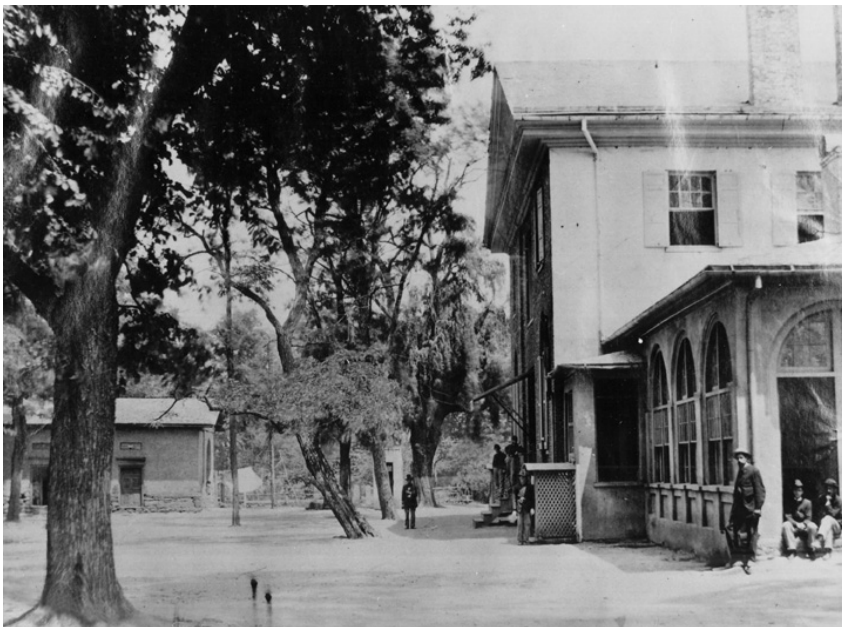
*Arlington House in June of 1864. From left to right, north slave quarters, kitchen garden fence, yard and house (ARHO restoration photos, box 8 photo by Andrew Russell).*

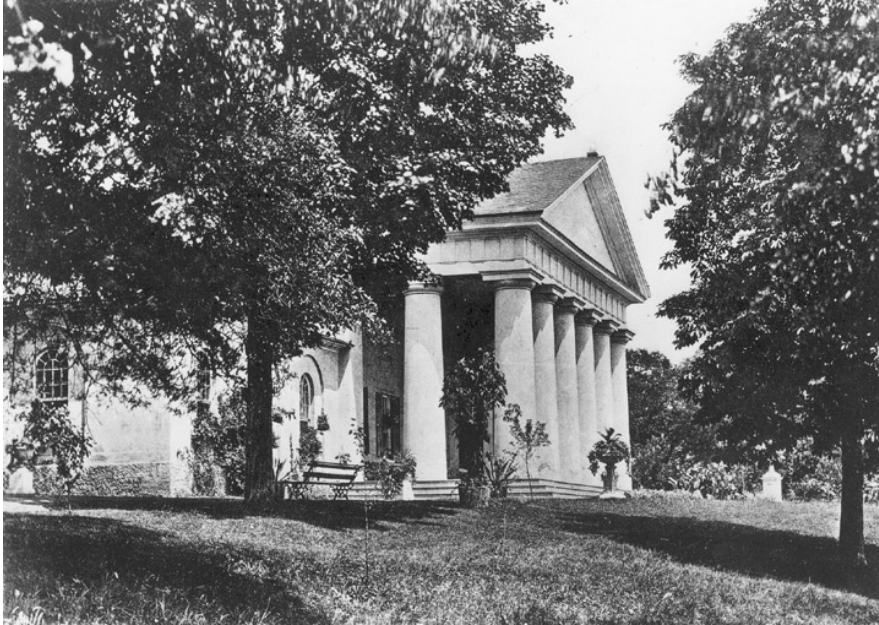
*Foundation plantings and urns are seen along the east side and portico of Arlington House c. 1895 (ARHO E.J., Lee, 438 1895 file ARHO photos of house 1).*

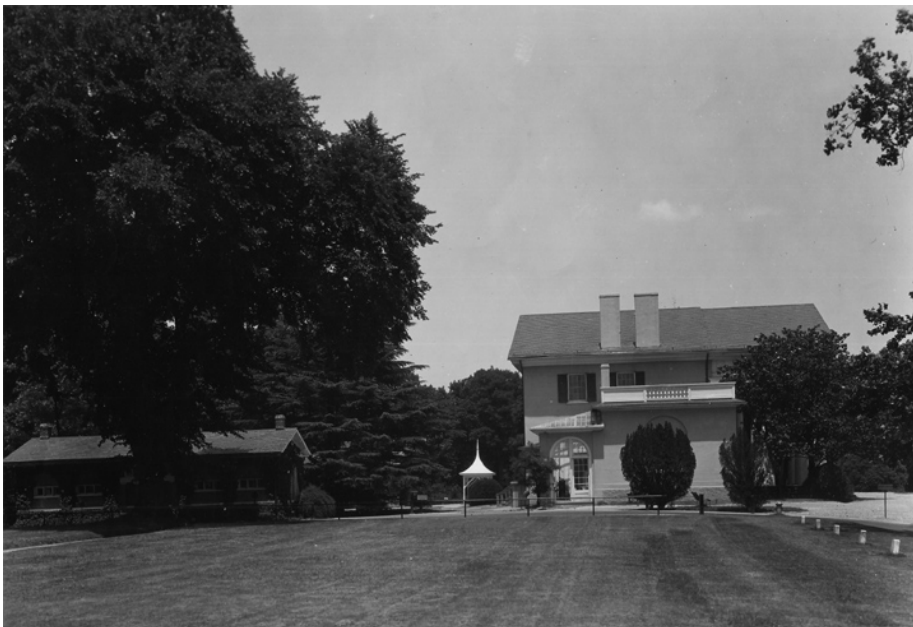
*Looking north towards Arlington House across the lawn planted after the flower garden was removed in the early 1930s (ARHO archives Signal Corps 95034-file slave quarters 1957-1959 box 1).*

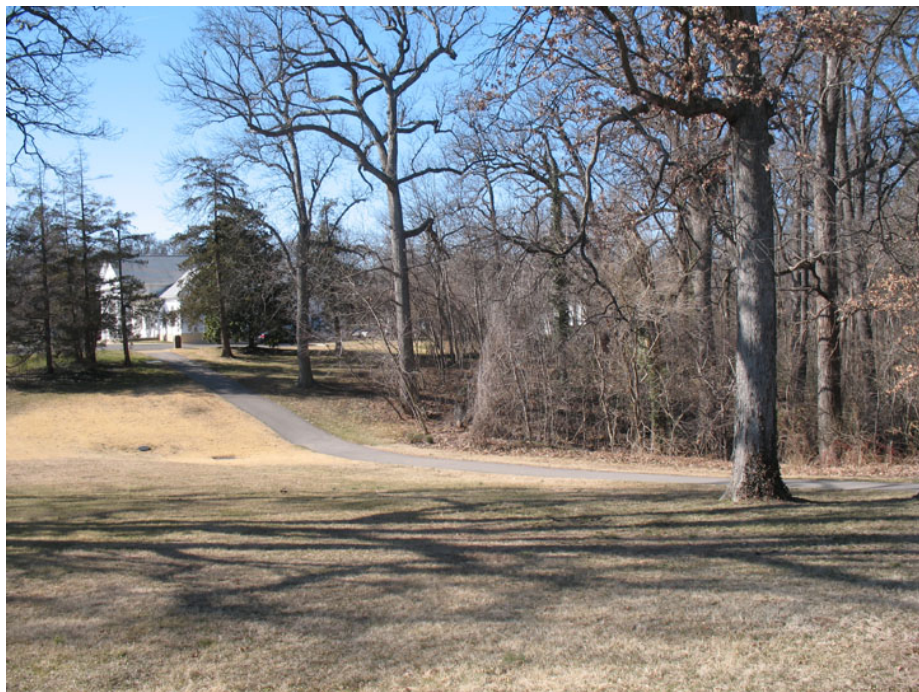
*An asphalt path through a ravine connects Arlington House and the Administration building. The most dense portion of Arlington Woods can be seen on the north side of the path and on the right-hand side of this image (NCR CLP 2009).*

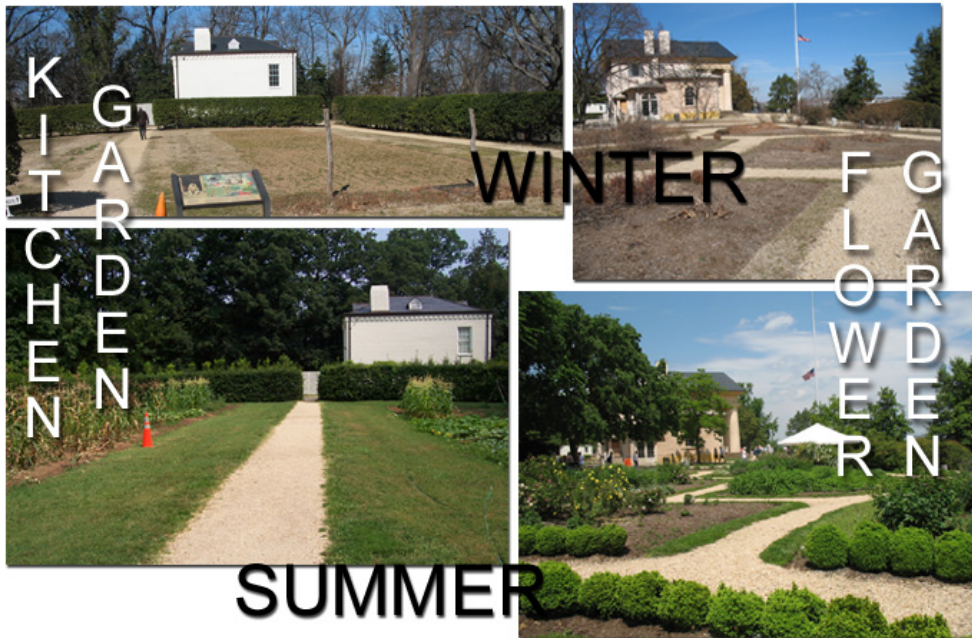
*The flower and kitchen gardens maintain much the same configuration as they did during the historic period. Edibles are still planted in the kitchen garden and the flower garden hosts plants from the historic period and the 20th century (NCR CLP 2009).*

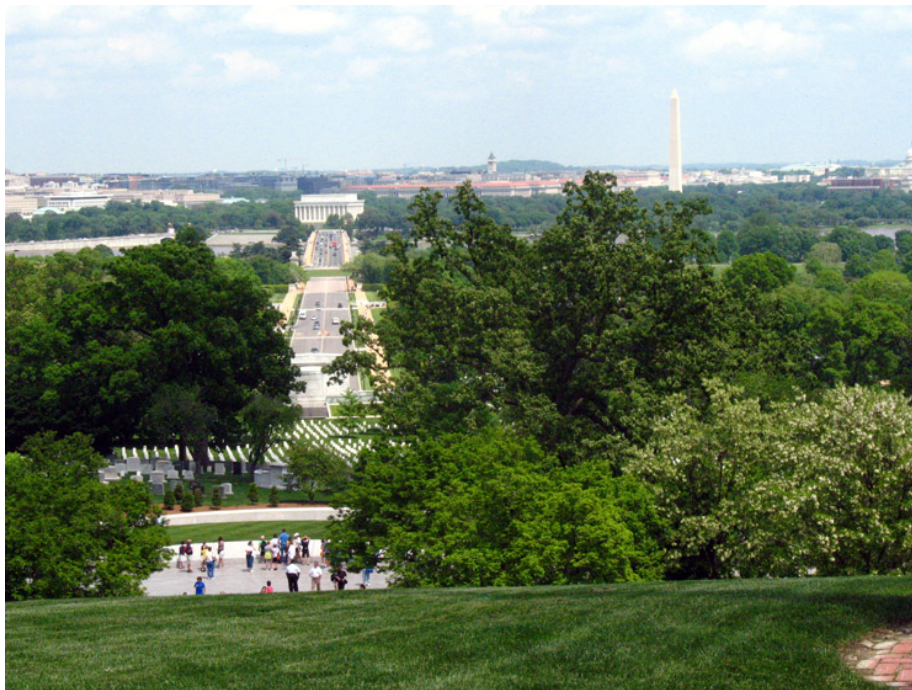
*A clear view of the gravesite of President John F. Kennedy, Memorial Bridge, the Lincoln Memorial, the Washington Monument, the U.S Capitol and much of Washington, D.C. is seen from the gravel plaza in front of the Arlington House portico. (NCR,CLP 2009)*

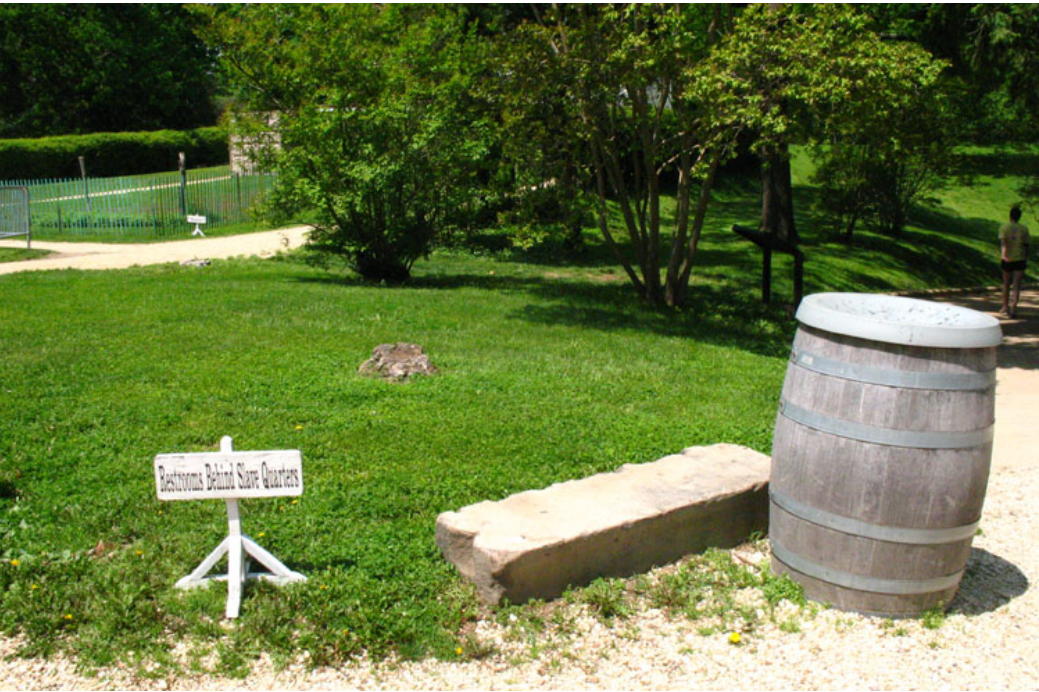
*This single feature, a cut rectangular stone thought to be used for sitting or mounting a horse, is the only small-scale feature on site dating back to the historic period. Signs and waste receptacles are non-contributing features.(NCR,CLP 2009)*

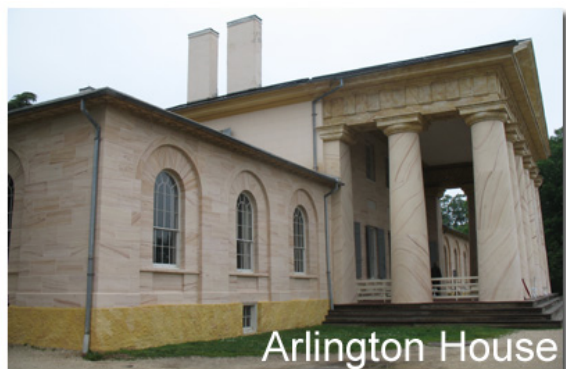
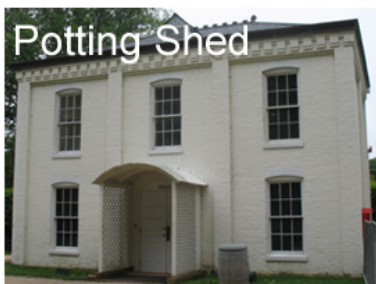
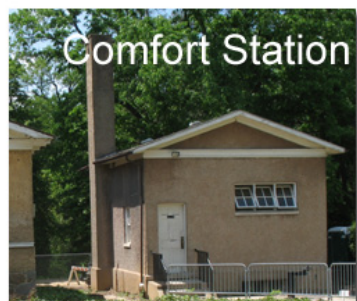
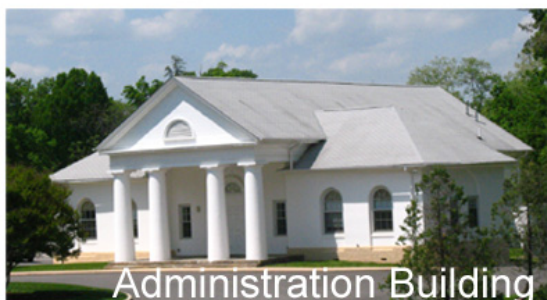
*Arlington House (built 1803-1818c) and the Potting Shed (1880) derive from the historic period. The comfort station (1925) and the administrative building (1907) came later (NCR CLP 2009).*

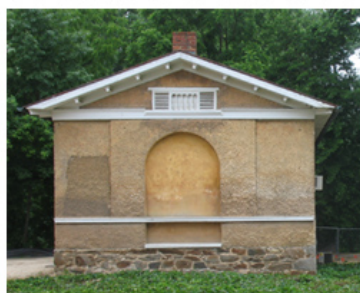
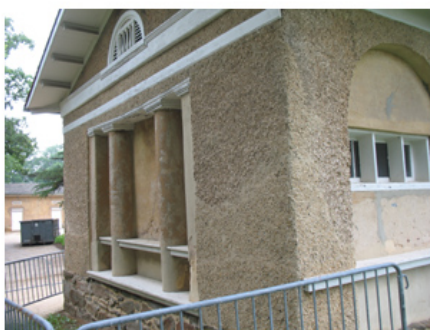
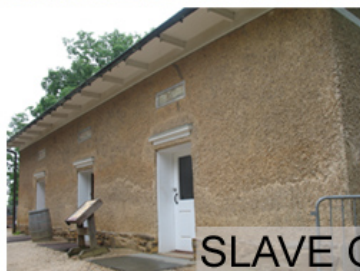
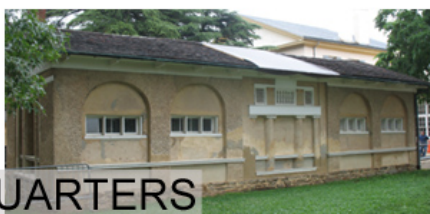
*The slave quarters were built during the same time as Arlington House (1803-1818c.). The less formal exteriors face the utilitarian yard area and house, and formal facades can be seen from the gardens and their west sides (NCR CLP 2009).*
