INVENTORY OF HISTORIC STRUCTURES

BIG BEND NATIONAL PARK

Regional Historian William E. Brown
in cooperation with
the Park Staff

Field examination and photographic
recording of inventoried structures
accomplished in October 1964 by
W.E. Brown, Douglas B. Evans, and
Arthur Allen.

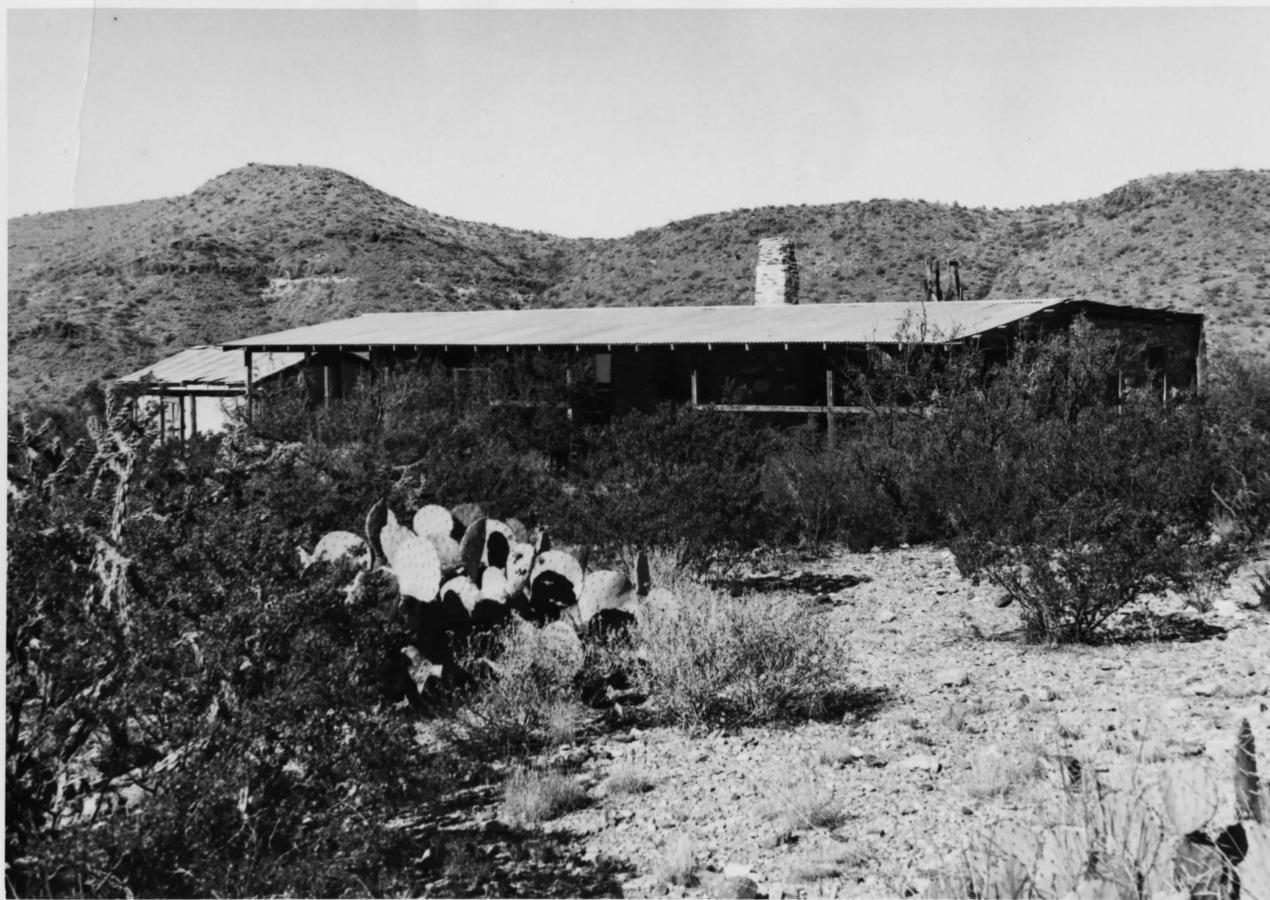
Wilson Ranch House (BH-16)

4. NOTABLE FEATURES, HISTORICAL SIGNIFICANCE AND DESCRIPTION		OPEN TO PUBLIC Yes	
<p>This house was built by pioneer rancher Homer Wilson. It served as headquarters for the southern section of the Wilson Ranch, one of the outstanding cattle, goat, and sheep ranches of the Chisos Mountains country. Beginning in the 1880's, Blue Creek Canyon, largest drainage out of the Chisos, was favored cattle country. General Gano's great G4 Ranch encompassed the area. In 1915 Francis Rooney bought Blue Creek Canyon, and Homer Wilson bought it from him ca. 1924. The present ranch complex dates from that time, but evidence presently available does not pinpoint exact years of construction. In addition to the ranch house, the complex includes an old-fashioned pole corral and snubbing post, a stock dipping chute, a stone cistern, and a small utility building.</p> <p>The Wilson Ranch is significant as the finest extant site for interpretation of the open range livestock industry within the confines of Big Bend National Park. Its strategic location with regard to Route 5 from Panther Junction to Castolon, and the integrity of the isolated environment and ranch structures, make the site ideal for this interpretive purpose.</p> <p><u>Description:</u> A one-story stone ranch house constructed of native stone walls, concrete floor, and log ceiling beams supporting a corrugated metal roof; interior walls plastered. Floor plan of ranch house consists of a large single room. Approximate dimensions 45' x 18', with screened porch running entire length of building for overall dimensions of 45' x 30'. Corral consists of vertical poles and is about 40' in diameter with a snubbing post in the center. Dipping chute is 20' long with cement apron. Utility building 15' x 18', concrete walls, cane ceiling on log joists with later tin roof added.</p>

5. PHYSICAL CONDITION OF STRUCTURE		Endangered	Yes
		Interior	Fair
		Exterior	Fair
See interim historical base map accompanying this report.			
6. LOCATION MAP (Plan Optional)		7. PHOTOGRAPH Attached

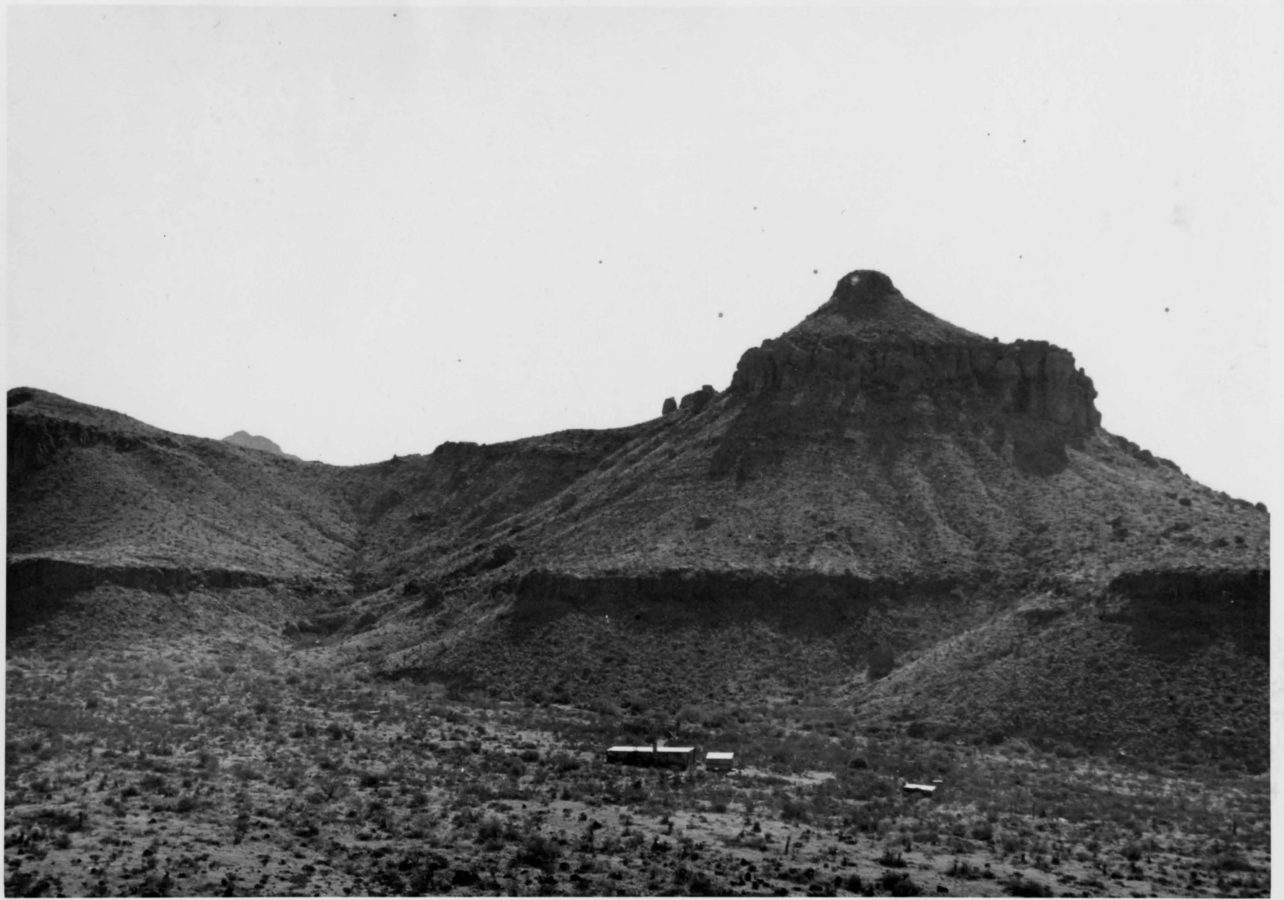
Wilson Ranch from new Park Route 5 overlook

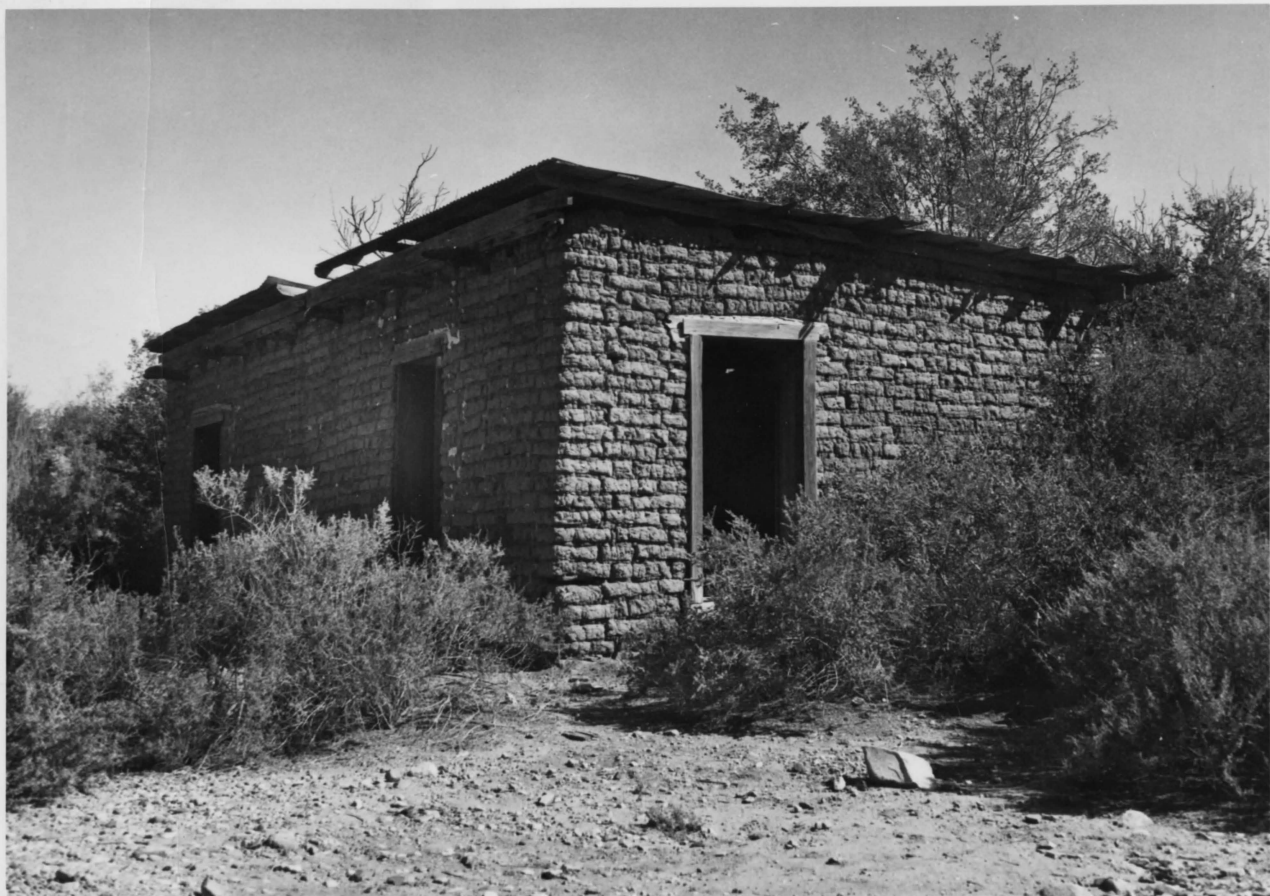
San Nail Ranch (BEH-17)

5. PHYSICAL CONDITION OF STRUCTURE Endangered Yes Interior Poor Exterior Poor			
See interim historical base map accompanying this report.			
6. LOCATION MAP (Plan Optional)		7. PHOTOGRAPH Attached

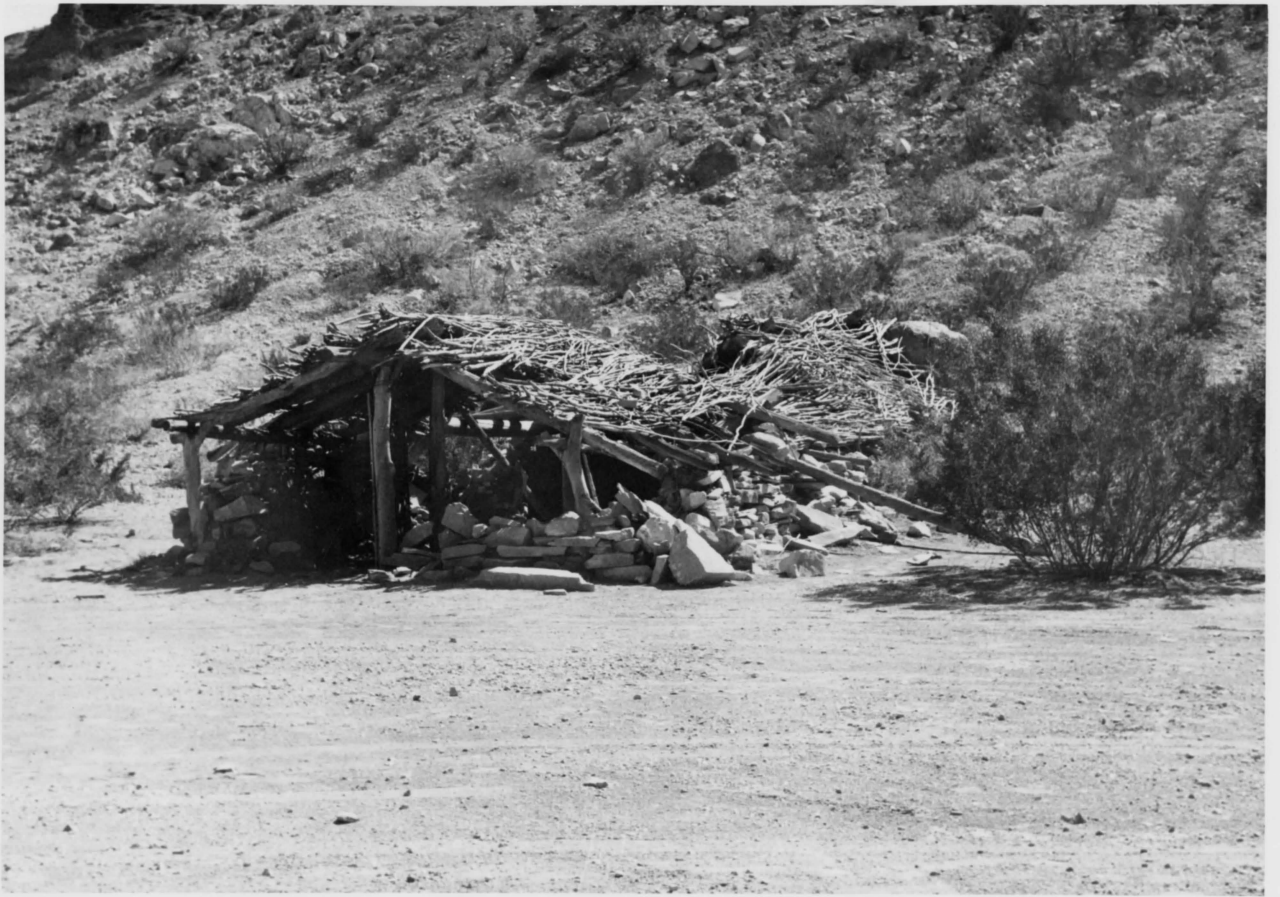
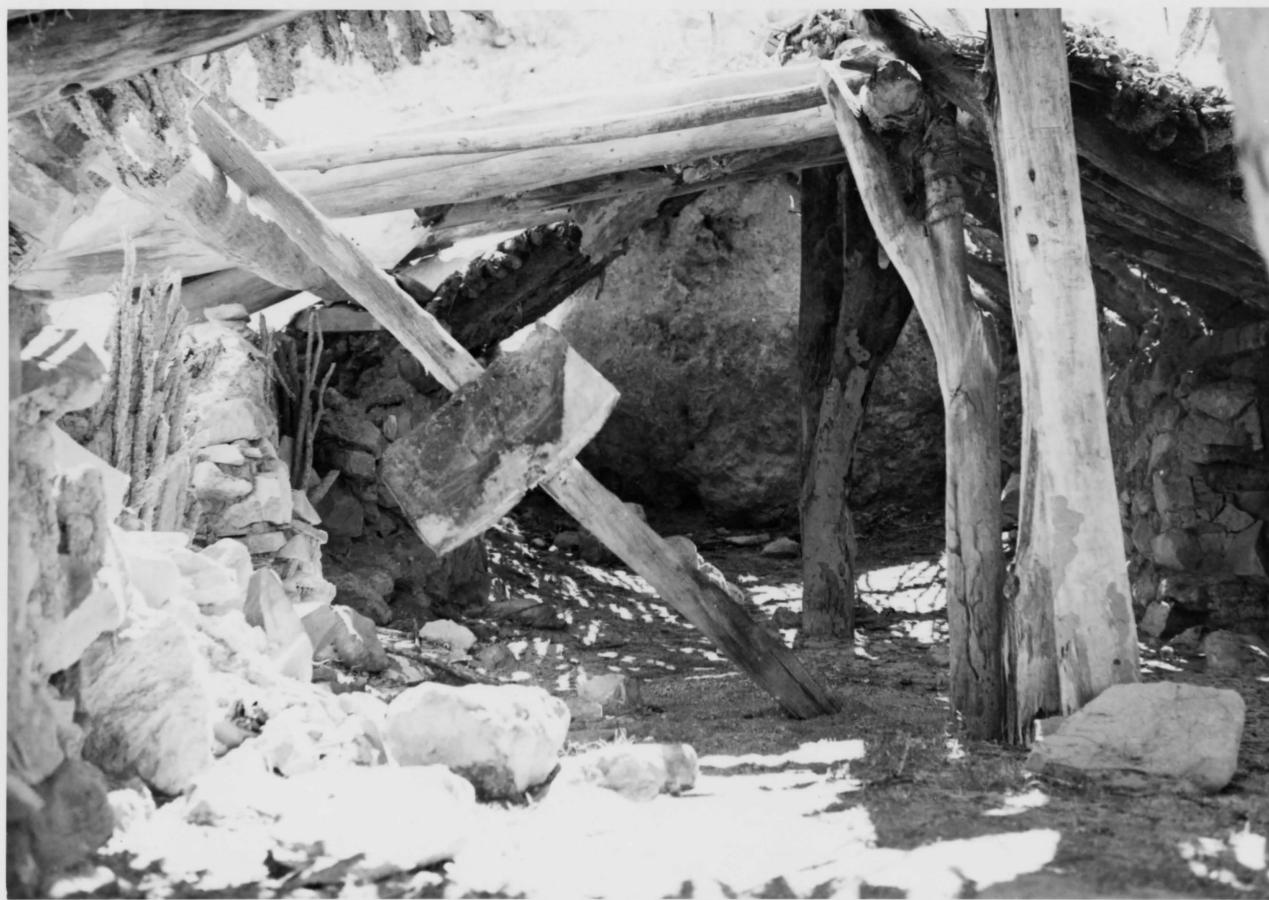
Luna Residence (BH-168)

<p>1. STATE Texas COUNTY Brewster (BIBE) TOWN VICINITY In the Alamo STREET NO. Wash section of the Park, south of Maverick Ranger Station. ORIGINAL OWNER Gilberto Luna ORIGINAL USE Farm House PRESENT OWNER NPS PRESENT USE Abandoned WALL CONSTRUCTION Stone and sod NO. OF STORIES one half</p>		<p>HISTORIC AMERICAN BUILDINGS SURVEY INVENTORY</p>	
<p>2. NAME Luna Residence (BBH-168) DATE OR PERIOD Late 19th century STYLE Mexican peon home ARCHITECT None BUILDER Gilberto Luna</p>		<p>3. FOR LIBRARY OF CONGRESS USE HSI Classification: CC</p>	
<p>4. NOTABLE FEATURES, HISTORICAL SIGNIFICANCE AND DESCRIPTION OPEN TO PUBLIC Yes</p> <p>Gilberto Luna was a pioneer Mexican farmer in the Big Bend country who settled in the Alamo Creek drainage, living there all his long life and raising a very large family. He died in 1947 at the age of 109. In the early years, Alamo Wash was on the Comanche War Trail through the Park, and Luna somehow established peaceful relations with these savage warriors and also with the Apaches resident in the vicinity. That he survived the incursions of these raiding Indians is a tribute to his diplomacy. That he succeeded for nearly a century in farming the dry Alamo Creek drainage using the technique of flood-plain farming is only slightly less amazing.</p> <p>The Luna Residence is significant as the prime example within the Park of the primitive Mexican house-shelter typical of earliest pioneer settlement.</p> <p><u>Description:</u> Rectangular in plan, the rear of the house utilizes a large flat boulder as one end of the structure. Walls of random limestone and sandstone blocks are laid up 3-4 feet high in mud mortar. They are 3' thick at the base and 2' thick at the top. Upright forked poles are set integral with the side-walls with longitudinal poles resting in the forks. Along the central long axis of the room are six similar but longer and heavier uprights supporting center ridge poles in relays. Primary beams extend on either side from center ridge pole to the side supports, flush with the masonry walls. Ocotillo branches, brush, earth, and stone for ballast form the roofing. Jacal curtain walls divided the interior, and the floor is earthen. A door was hung to one edge of the front upright.</p> <p>A popular stopping place for visitors, the Luna Residence should be stabilized and wood uprights and supports should be treated with preservatives.</p>

<p>5. PHYSICAL CONDITION OF STRUCTURE Endangered Yes Interior Ruins Exterior Ruins</p> <p>See interim historical base map accompanying this report.</p>			
<p>6. LOCATION MAP (Plan Optional)</p>		<p>7. PHOTOGRAPH Attached</p>	
<p>8. PUBLISHED SOURCES (Author, Title, Pages) INTERVIEWS, RECORDS, PHOTOS, ETC. Richert, "Stabilization Requirements, Big Bend National Park," 1962. Local interviews.</p>		<p>9. NAME, ADDRESS AND TITLE OF RECORDER William E. Brown Regional Historian Southwest Regional Office DATE OF RECORD October 1964</p>

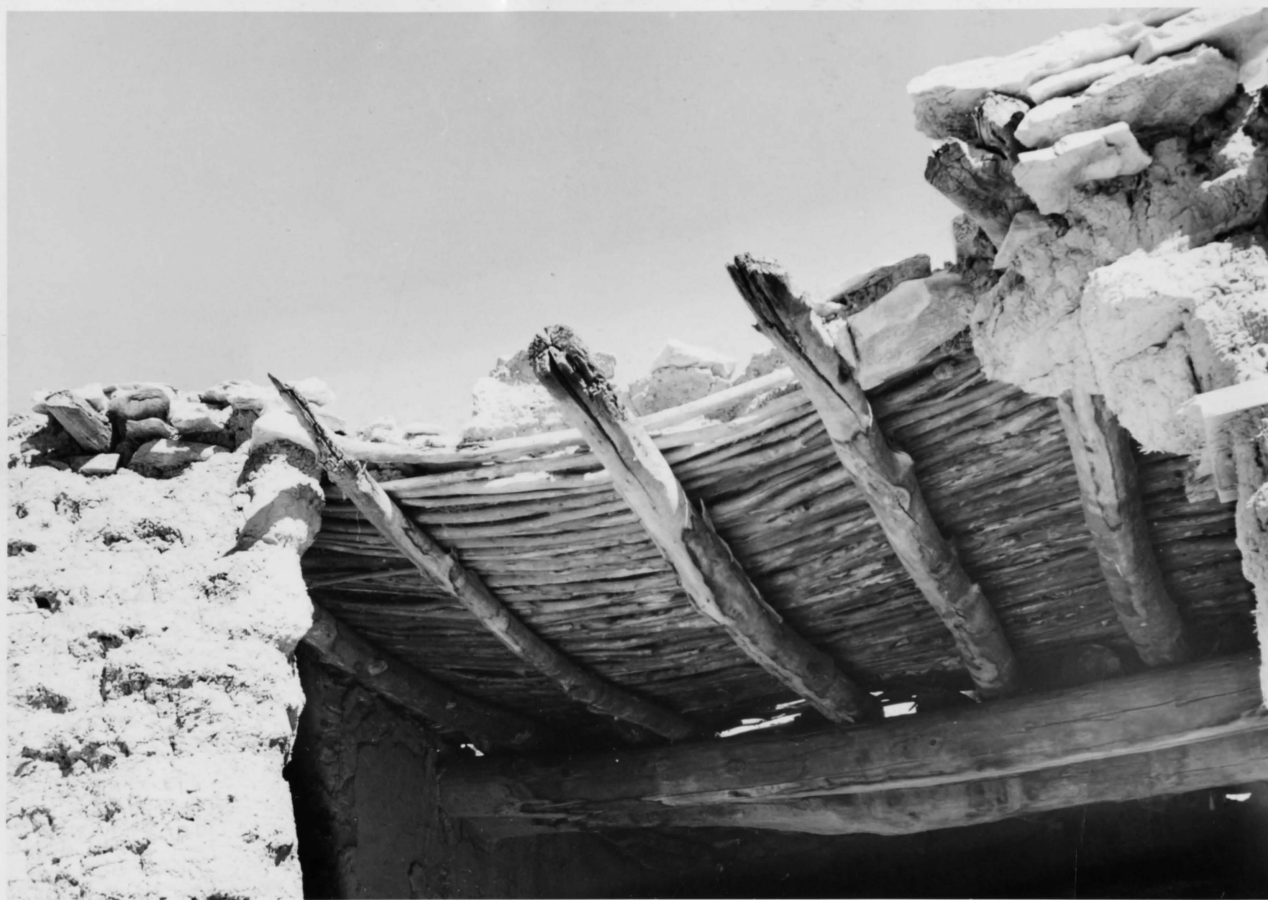
Sublett Farm Hand's Casita, showing
cane-and-viga ceiling

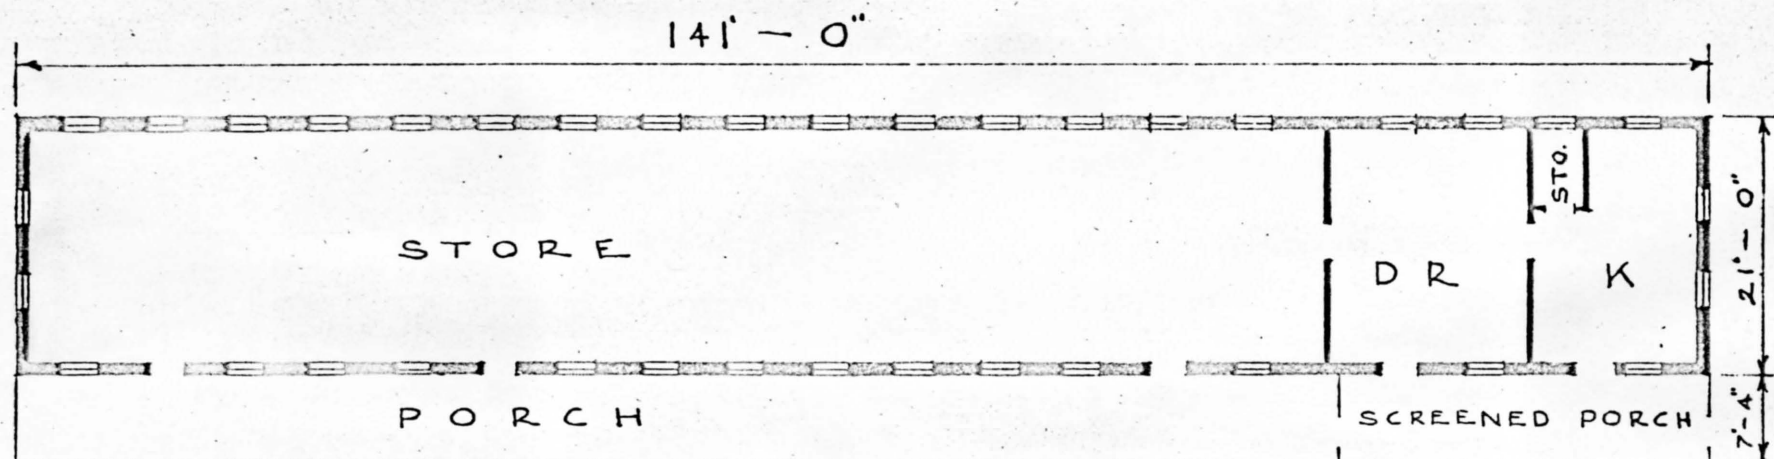
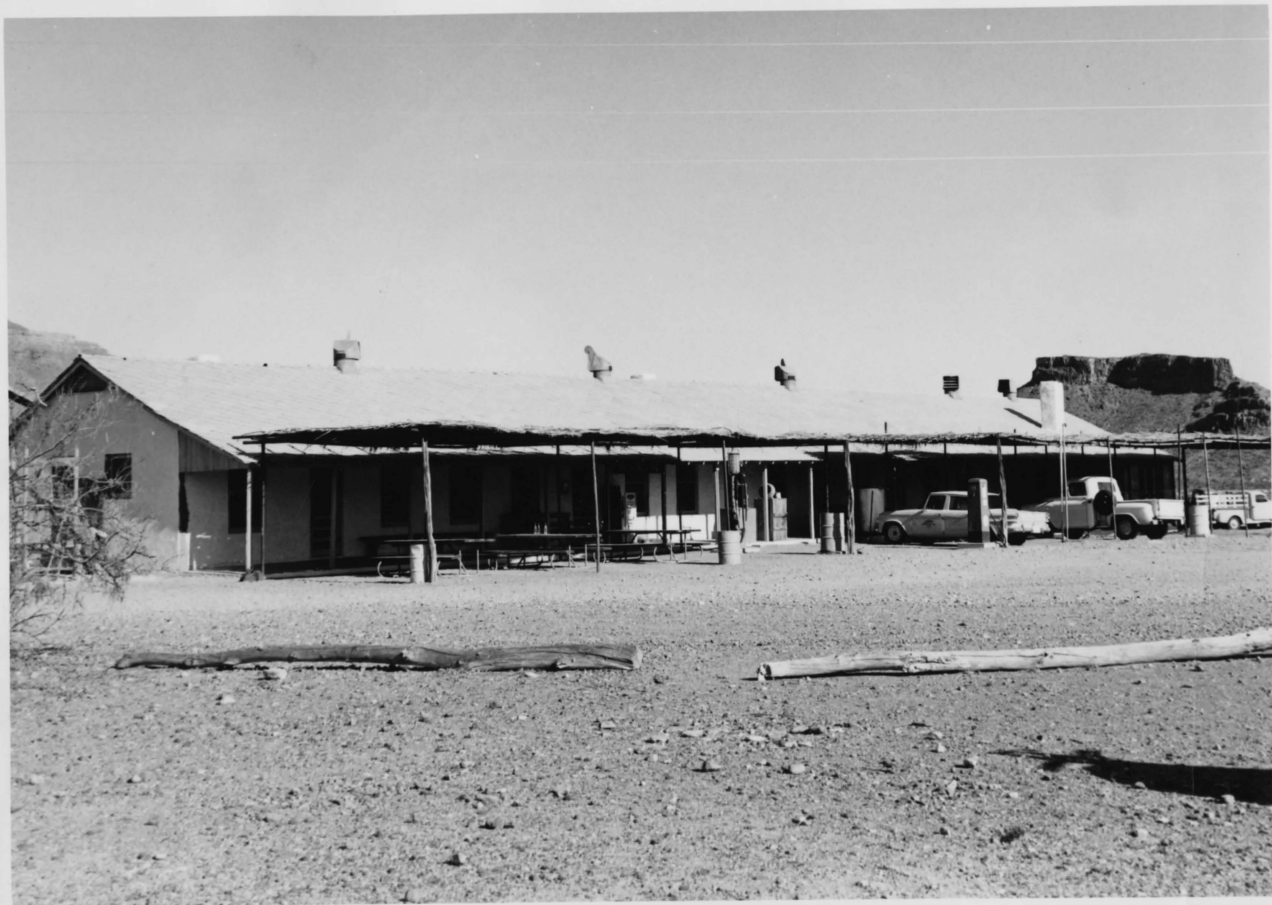
Castolon Historic Compound:
Castolon Store (BBH-600)

Description: A three-room adobe-wall structure with concrete foundation and floor and pitched asbestos-shingle roof. A covered porch runs the full length of the front (south) side of the building.

This building is in fair condition and will continue in use as a general store. The east end will be converted to a small exhibit room summarizing Castolon and Big Bend history.

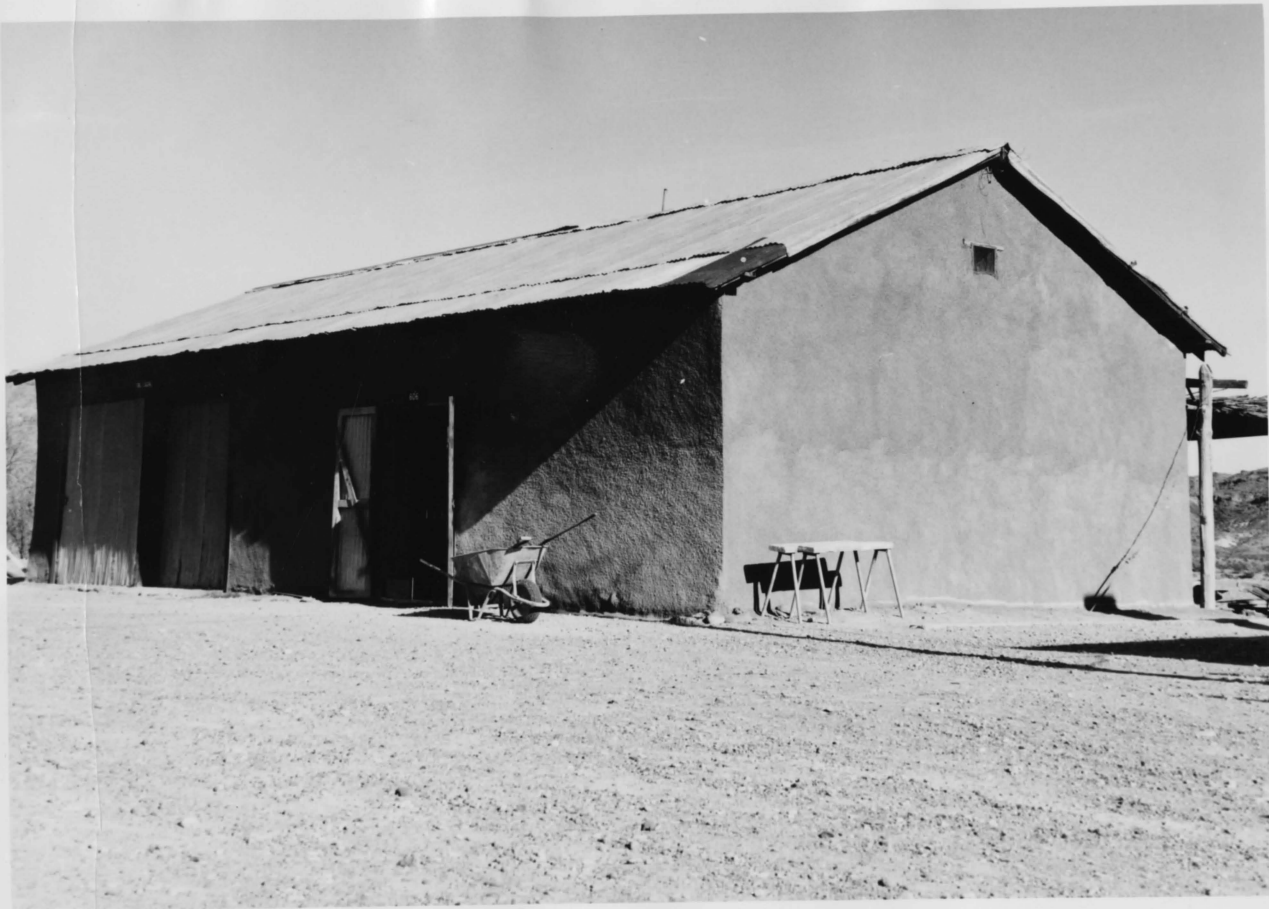
Castolon Historic Compound:
Army Utility Building (BBH-601)

Description: One story, two rooms, adobe block construction, earth floor, corrugated metal roof. Foundations concrete in part. Adobe is plastered inside and out. The building has been stabilized with steel cables to prevent bowing out of end walls. Outside dimensions are about 23' x 50', not including ramada and utility shed.

Adobe block walls - mud plastered
Corrugated metal roof

Routine maintenance and continued functional use is proposed.

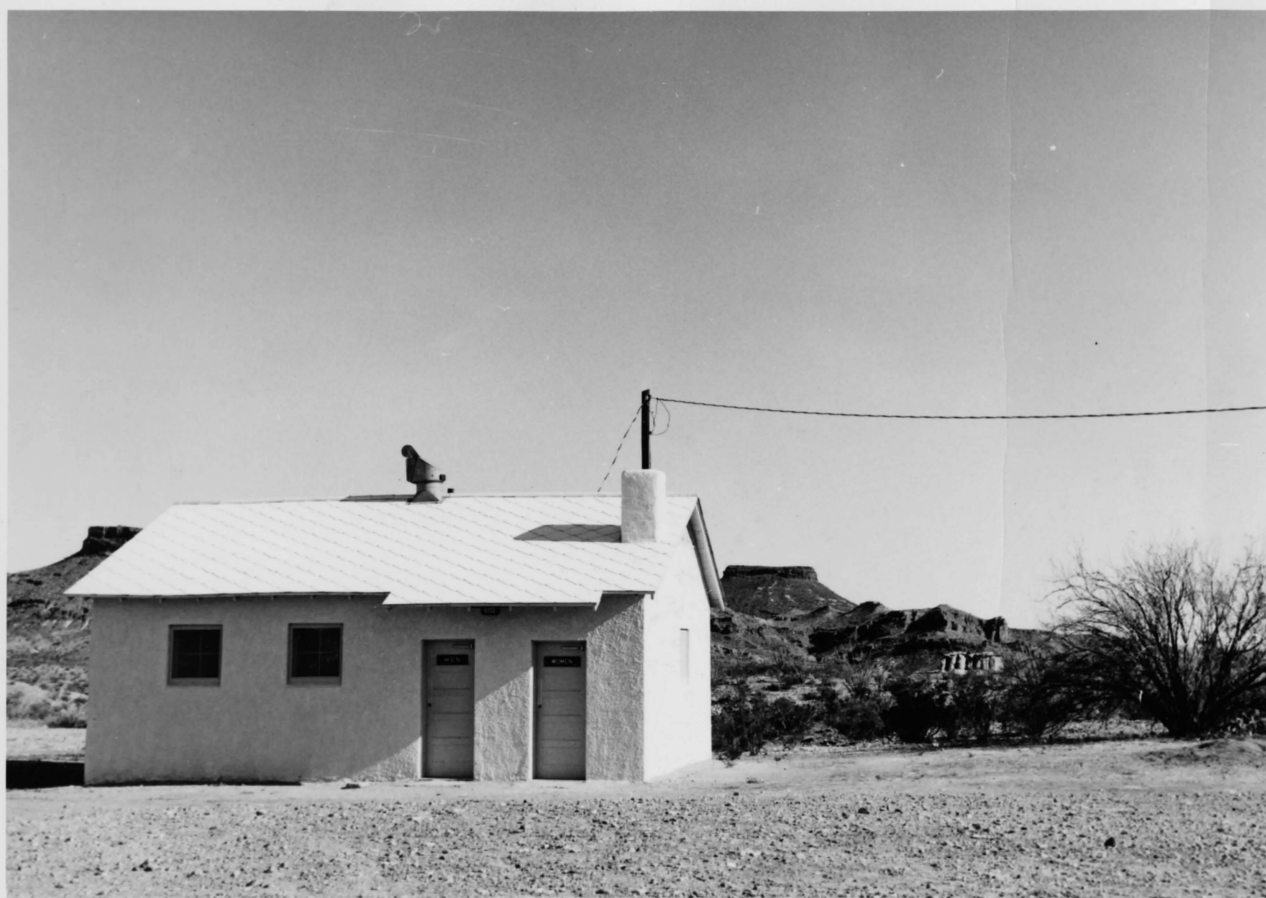
Castolon Historic Compound:
Army Latrine (HH-602)

Description: Adobe block walls with concrete foundations and floor and asbestos-shingle roof. Floor plan as shown on attached sheet has been altered to provide two rest rooms.

Building is in excellent condition and will continue in functional use.

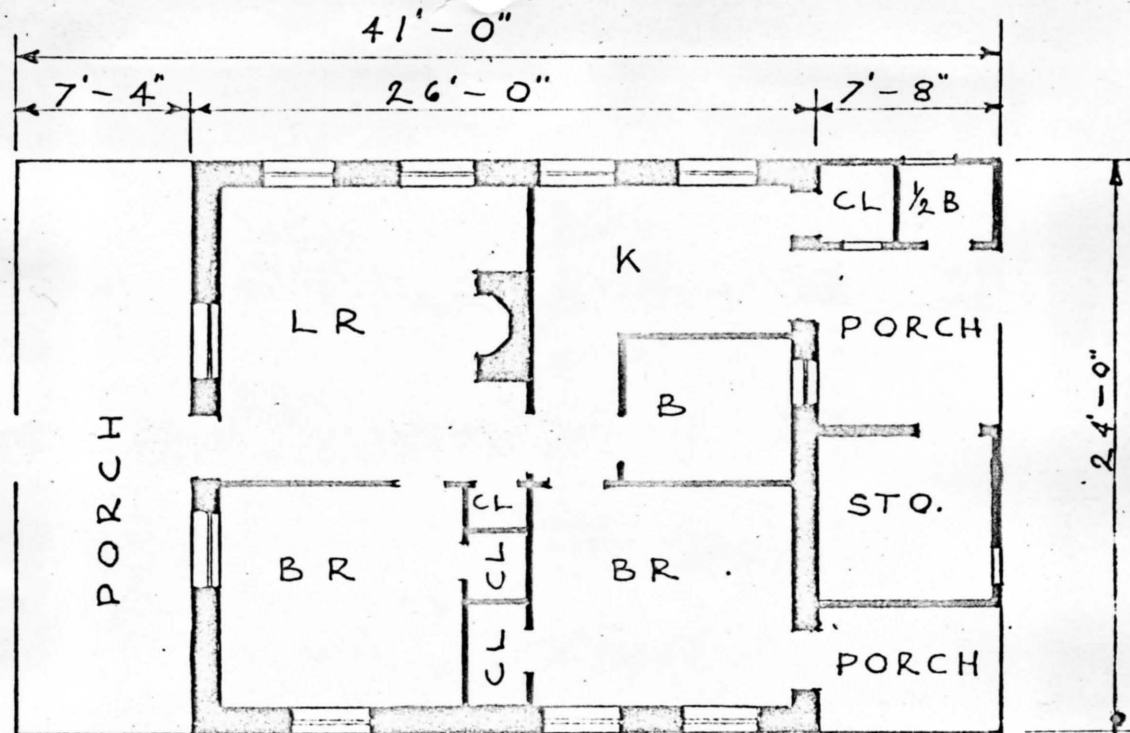
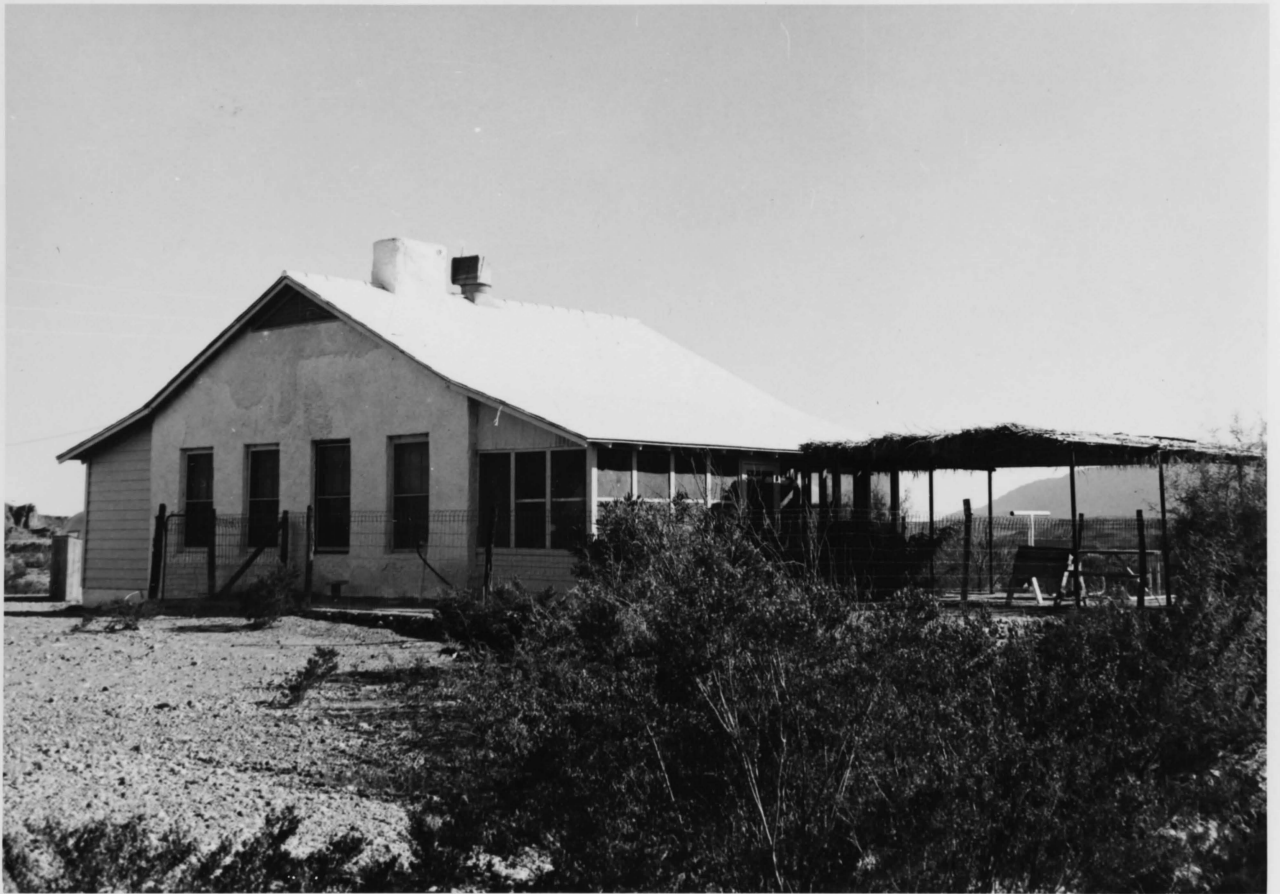
Castolon Historic Compound:
Officer's Quarters (HH-603)

Description: BBH-603: Adobe block construction with concrete foundation and floor and asbestos shingle roof. Five rooms and covered porch. Walls plastered in and out. BBH-604: Same except for being a smaller, four-room structure.

Routine maintenance and continued functional use is proposed.

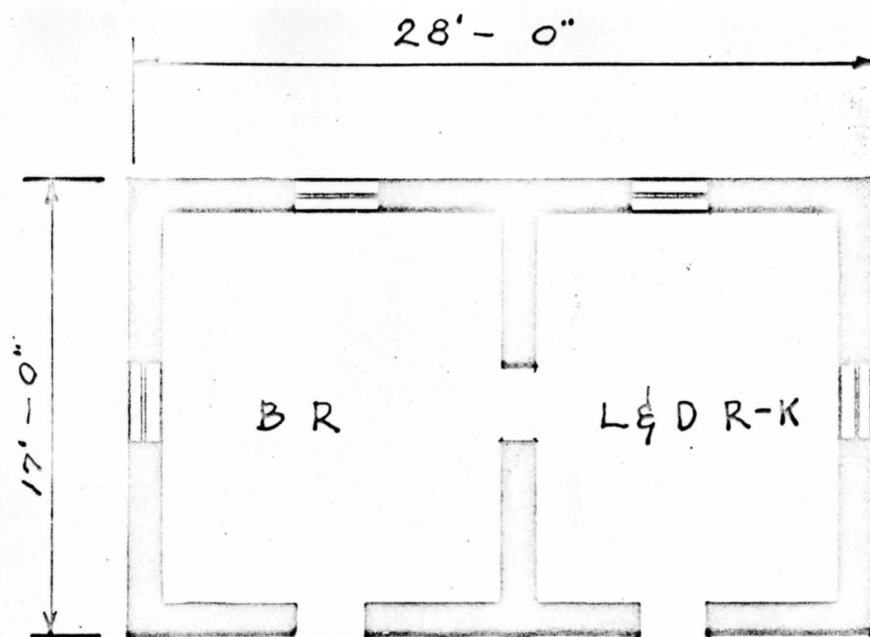
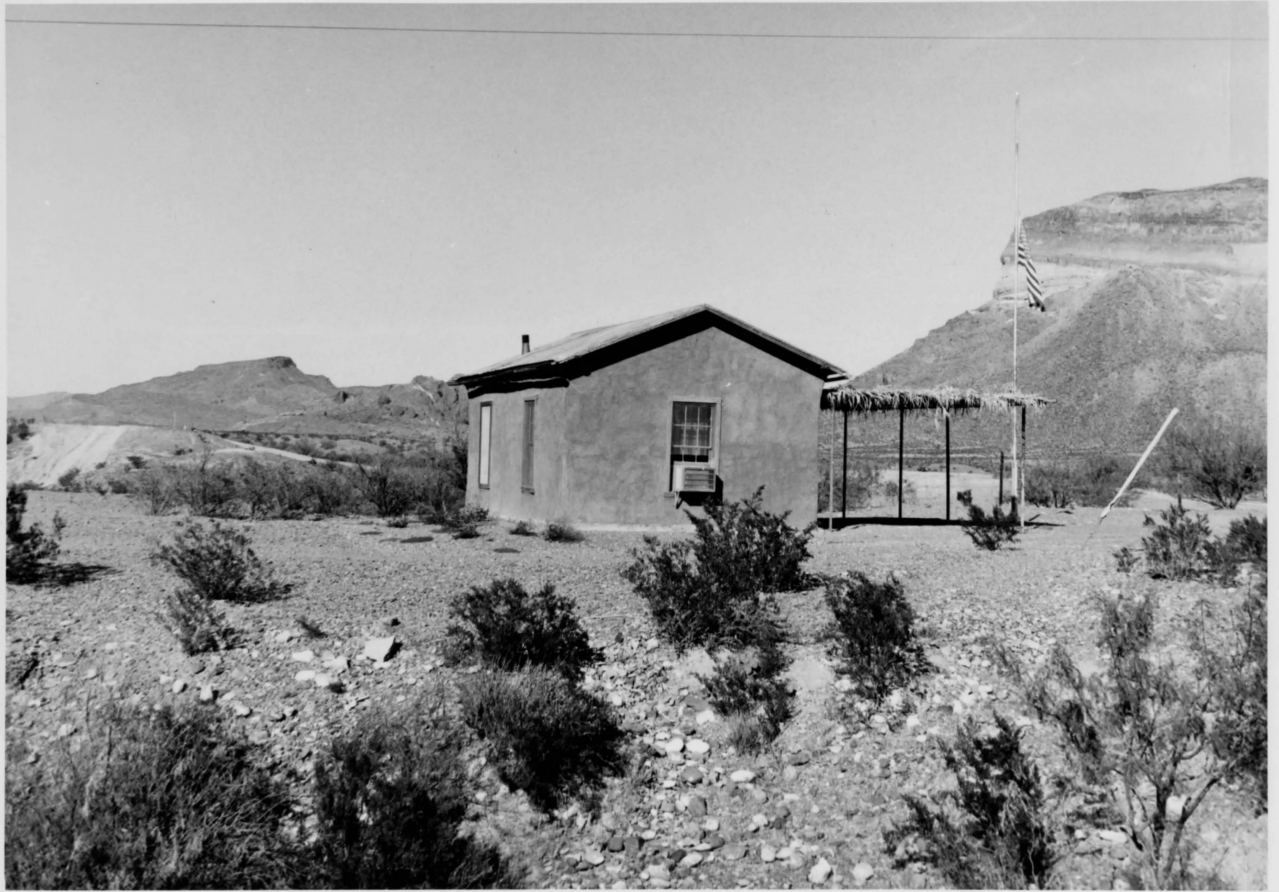
Castolon Historic Compound:
Magdalena House (BBH-605)

Description: One story, two-room adobe structure with pitched metal roof. Concrete foundation and wood floor. Building was stabilized and repaired in 1963 by Ruins Stabilization Unit and is now in excellent condition.

Routine maintenance and continued functional use is planned.

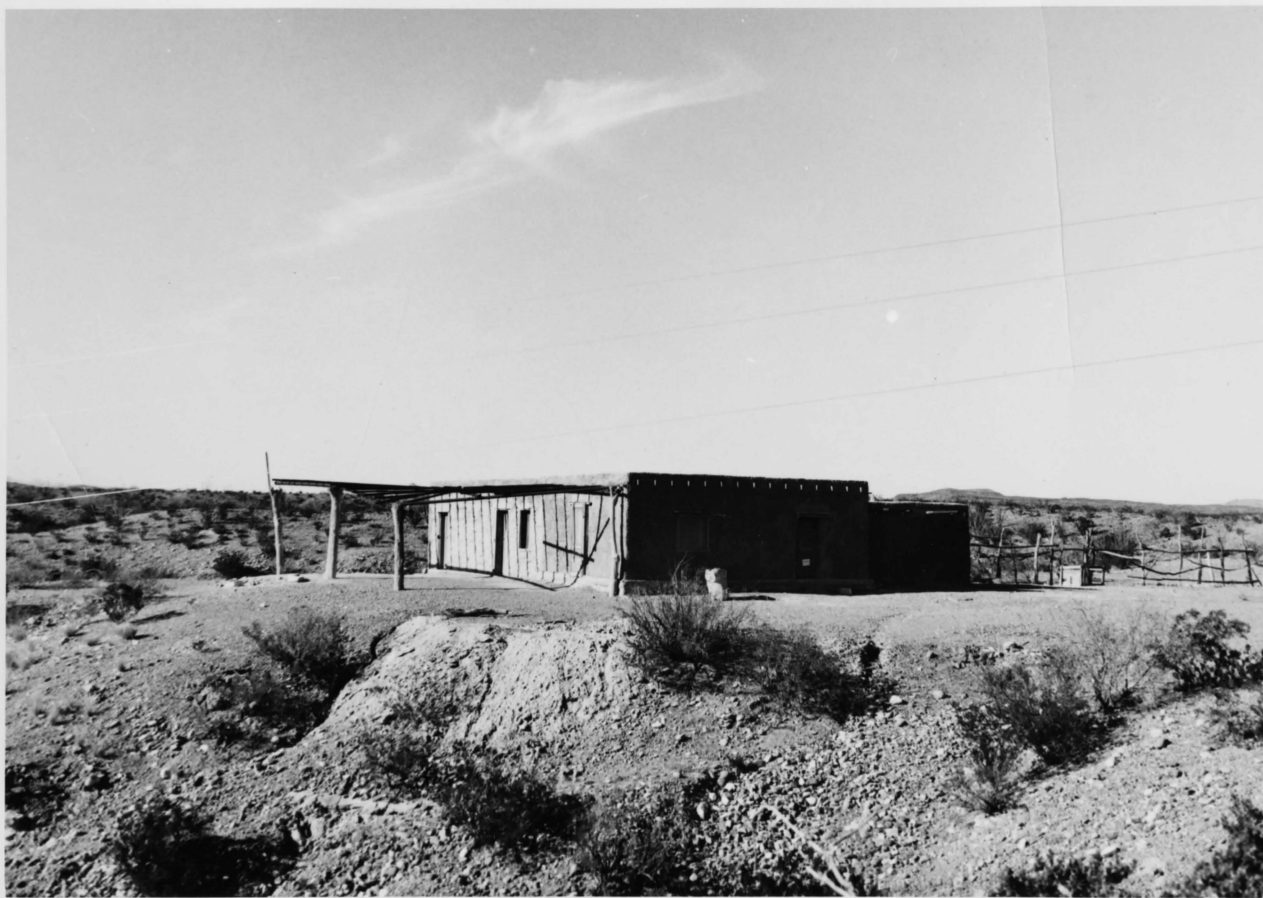
Castolon Historic Compound:
Garlic House (BBH-606)

Description: One-story, four-room adobe structure with adobe roof and shade ramada, concrete and sod floor. Split-log ceiling is an interesting architectural feature. Building was stabilized and repaired by the Ruins Stabilization Unit in 1963, and is now in excellent condition. The original adobe roof was replaced by a much lighter concrete material to reduce strain on supporting members.

The building is open to the public as a historic house exhibit.

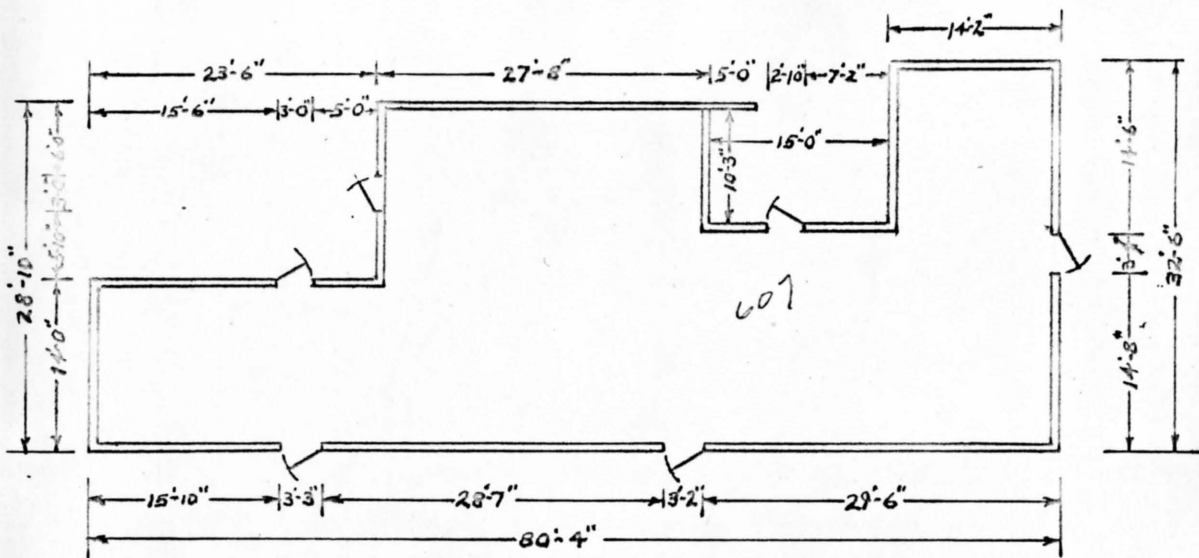
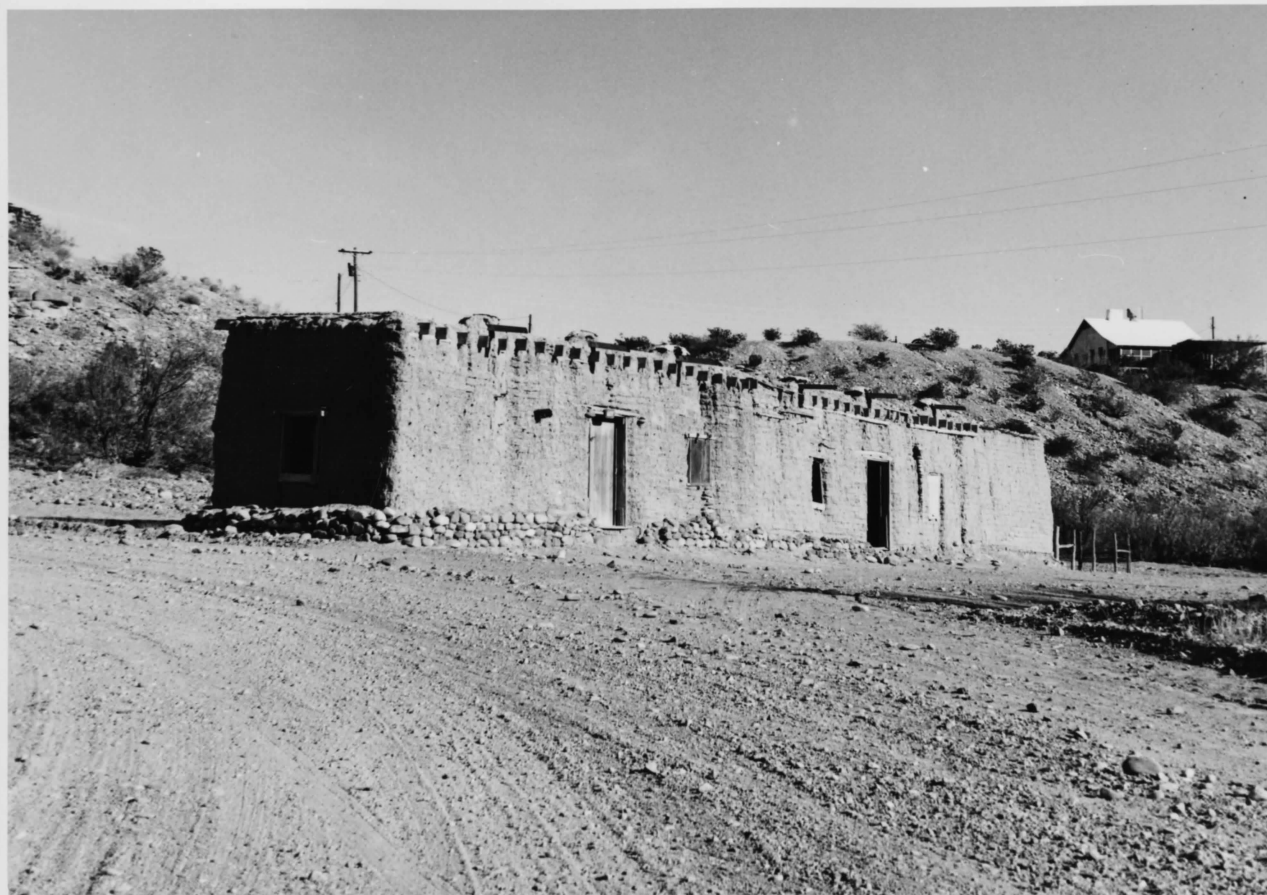
Castolon Historic Compound:
Alvino Residence (BHI-607)

Description: A one-story adobe residence with sod roof, concrete and sod floor, and stone foundations typical of Southwest primitive architecture. Comprising five rooms, the structure was built and added to in many stages which are easily traced by differing architectural details--another interesting aspect of the building's history. The construction holding up the sod roof is of 2 x 8 joists in some portions, and log vigas and cane sheathing in other areas. The building is in partial ruins.

Adobe block walls
 Adobe roof
 Concrete floor

Plans call for stabilization and limited rehabilitation of this structure as a historic house exhibit.

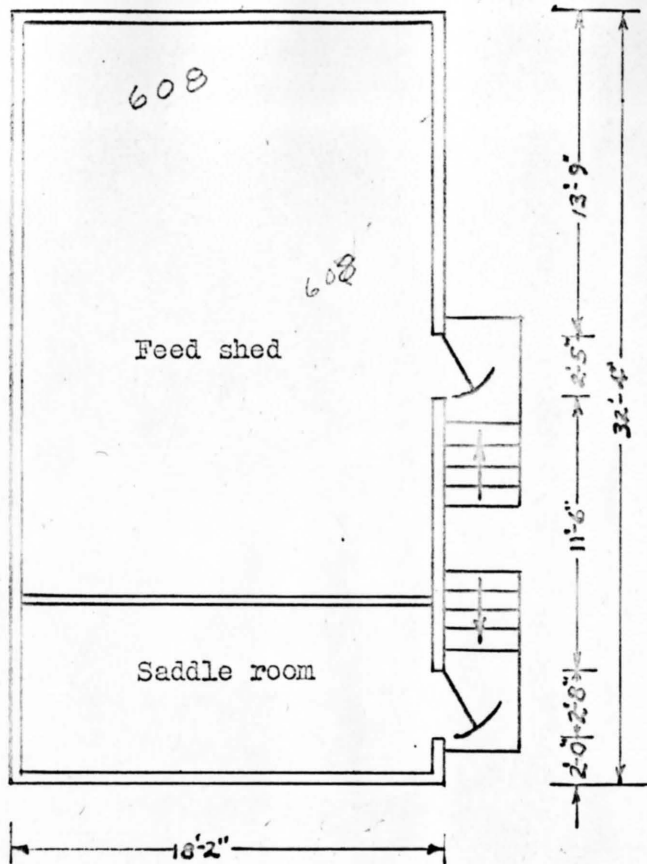
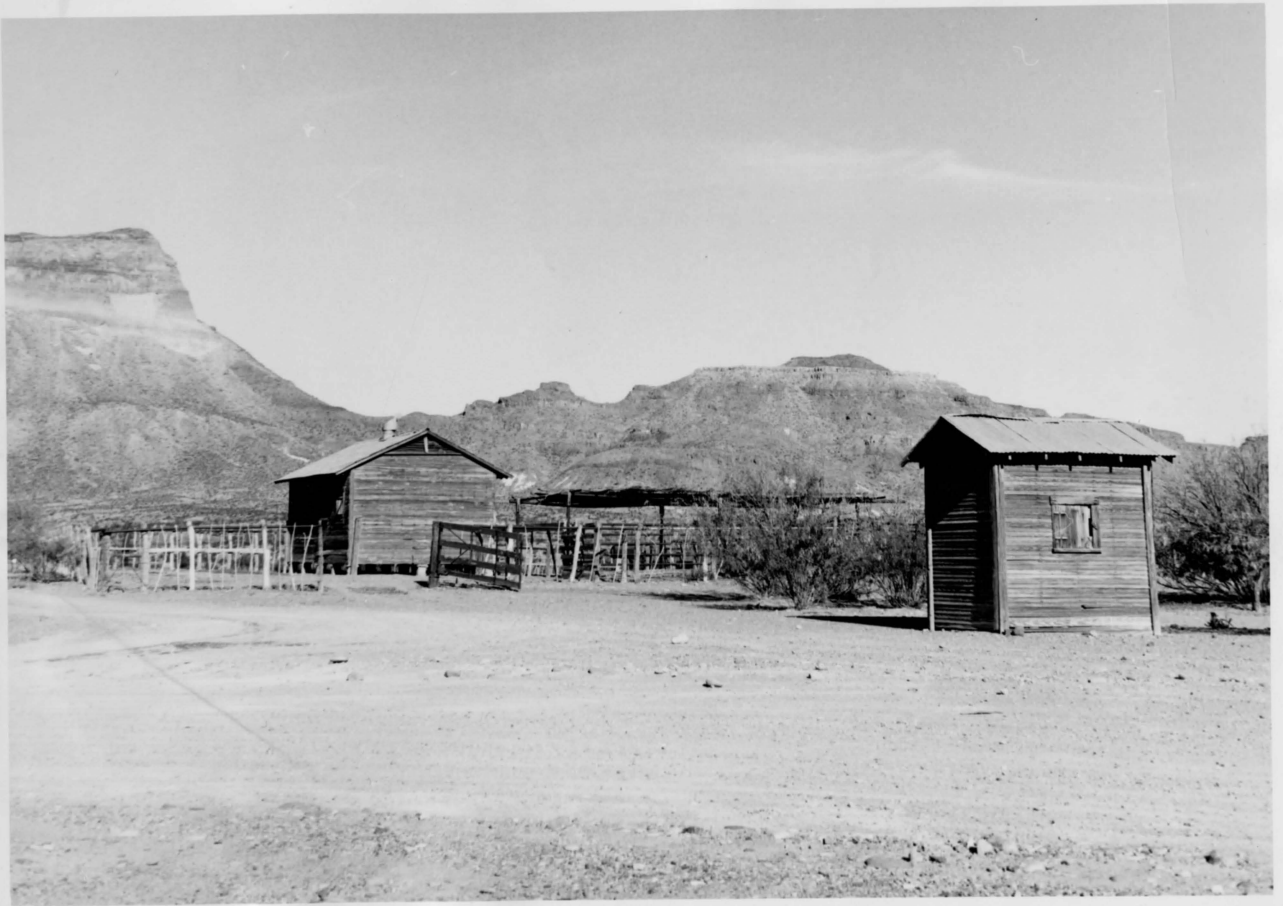
Castolon Historic Compound:
Granary and Tack Room (HES-608)

Granary and Tack Room (BBH-608): These small frame structures and their associated corral were built by the Army ca. 1919. When the Army horses were not out on patrol they were kept in this corral. The building inside the corral was used by the Army as a feed storage room. One part of the building was the tack room where the cavalrymen repaired their saddles, bridles, and other gear. Even now smuggling activities and drifting stock make patrols along the border necessary. The corral is still used for horses by the patrolling officers, including National Park Rangers.

Description: Frame structures in fair condition. Routine maintenance for preservation will be required.
