INVENTORY OF HISTORIC STRUCTURES

BIG BEND NATIONAL PARK

Regional Historian William E. Brown
in cooperation with
the Park Staff

Field examination and photographic
recording of inventoried structures
accomplished in October 1964 by
W.E. Brown, Douglas B. Evans, and
Arthur Allen.

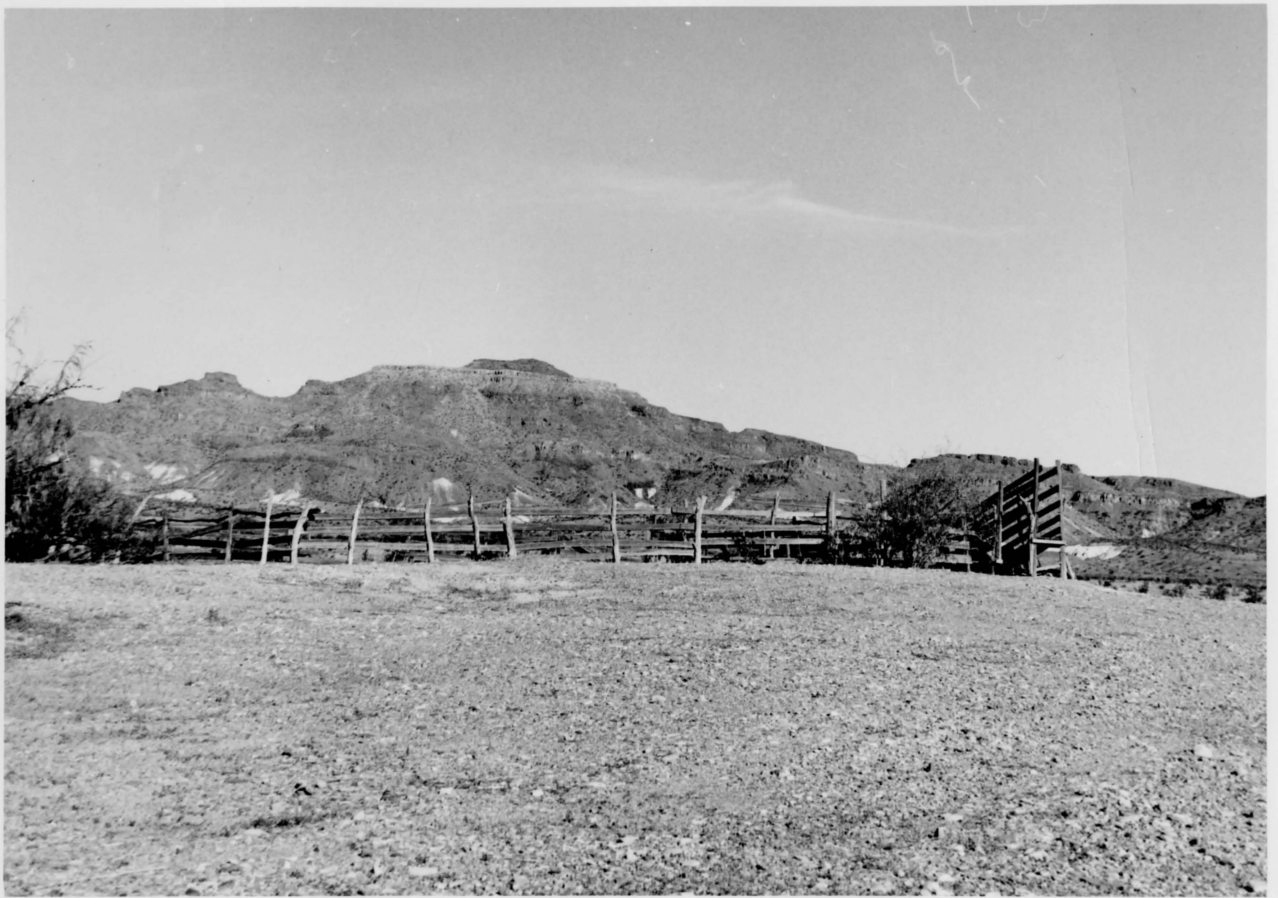
Castolon Historic Compound: Loading Corral

Description: Post and rail construction, about 50' x 50'.
Preservation to illustrate cattle ranching in vicinity is proposed.

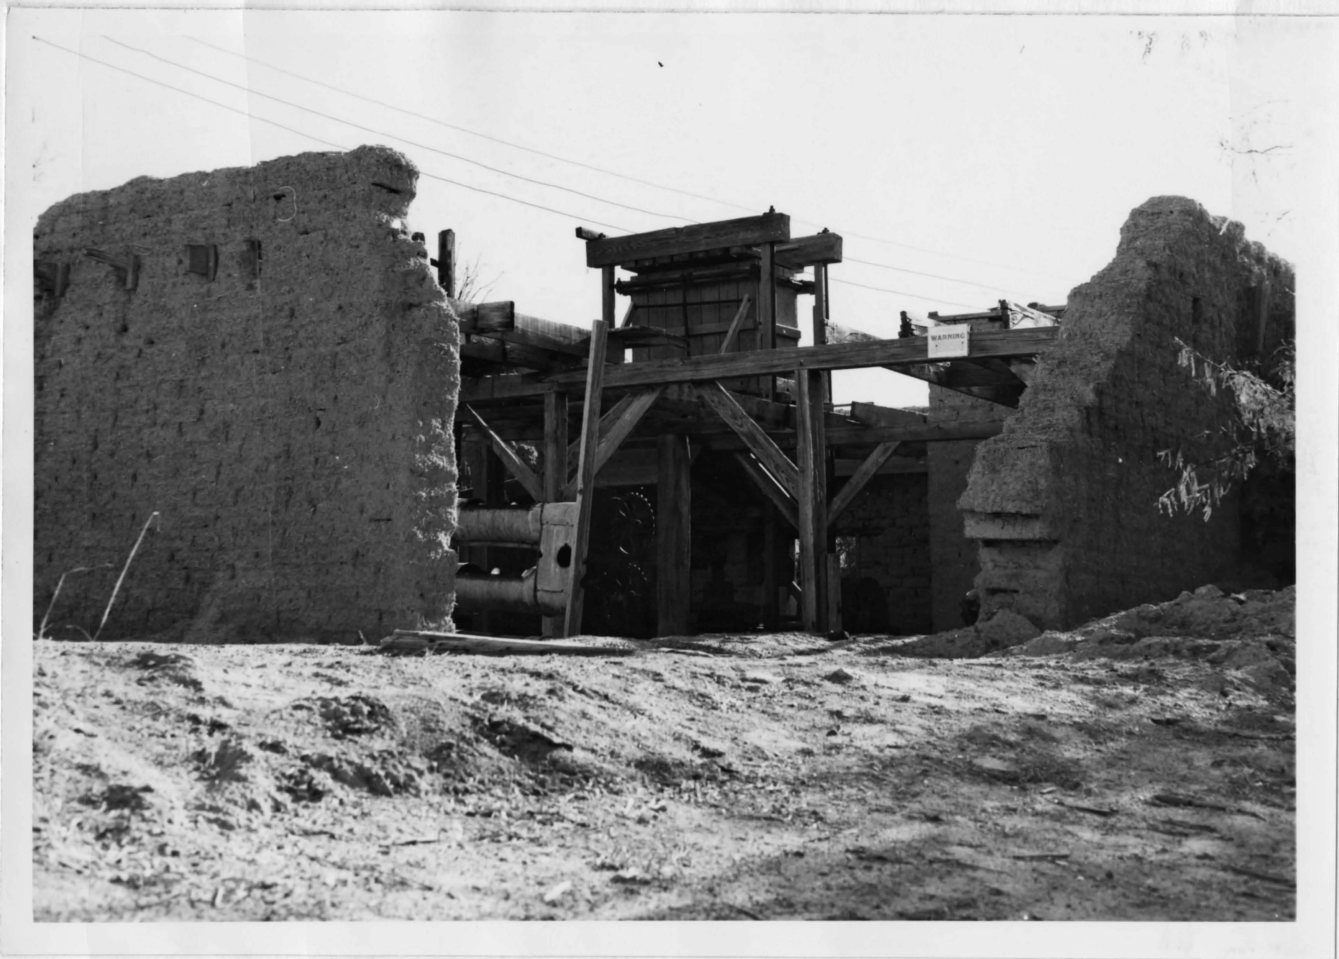
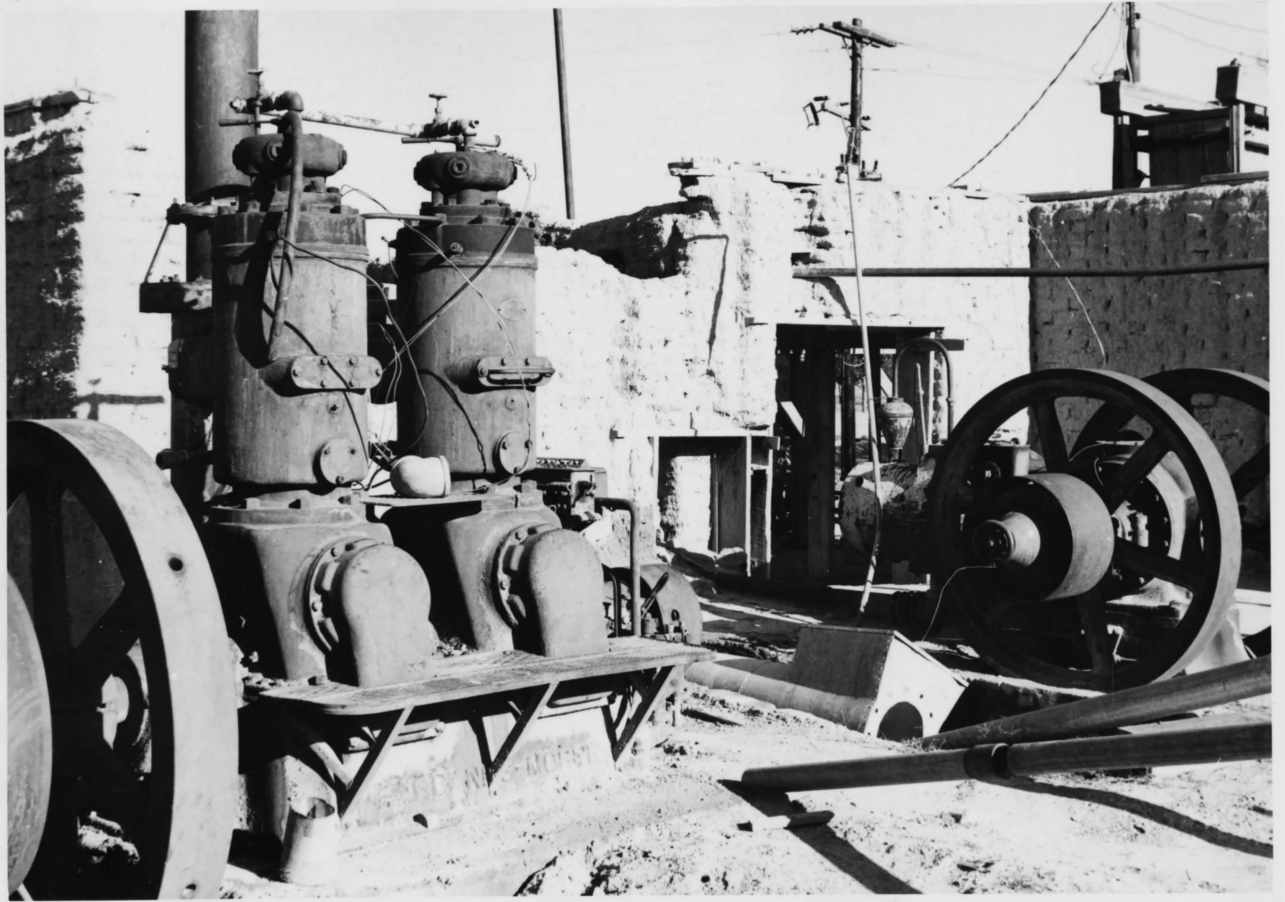
Cotton Gin (BBH-609)

4. NOTABLE FEATURES, HISTORICAL SIGNIFICANCE AND DESCRIPTION		OPEN TO PUBLIC Yes	
<p>Cartledge built the cotton gin and pumphouse in 1922. When the price of cotton dropped sharply in 1928, the cotton gin was permanently abandoned as an economic loss. The pumphouse was continued in use for furnishing irrigation water to the fields. Cotton grown after 1929 was processed at Fort Stockton. Park acquired building in 1961.</p> <p>The cotton gin, with its rusting machinery, would illustrate the marginal nature of farming activities in the remote sections of the Big Bend.</p> <p><u>Description:</u> Combined cotton gin and irrigation pumphouse on the north bank of the Rio Grande and strategically located with respect to the arable land. Two stories high, walls on both exterior and interior are of adobe block. Foundations are concrete while the floor is part wood and part earth. Former roof was corrugated metal. The second story has vanished with the exception of the south wall and two short adjacent stubs. Outside dimensions about 60' x 55'.</p> <p><u>Plan:</u> Stabilize and clean up so structure safe for visiting public.</p>

5. PHYSICAL CONDITION OF STRUCTURE			
Endangered	Yes	Interior	Ruins
		Exterior	Ruins
See interim historical base map accompanying this report.			
6. LOCATION MAP (Plan Optional)		7. PHOTOGRAPH Attached

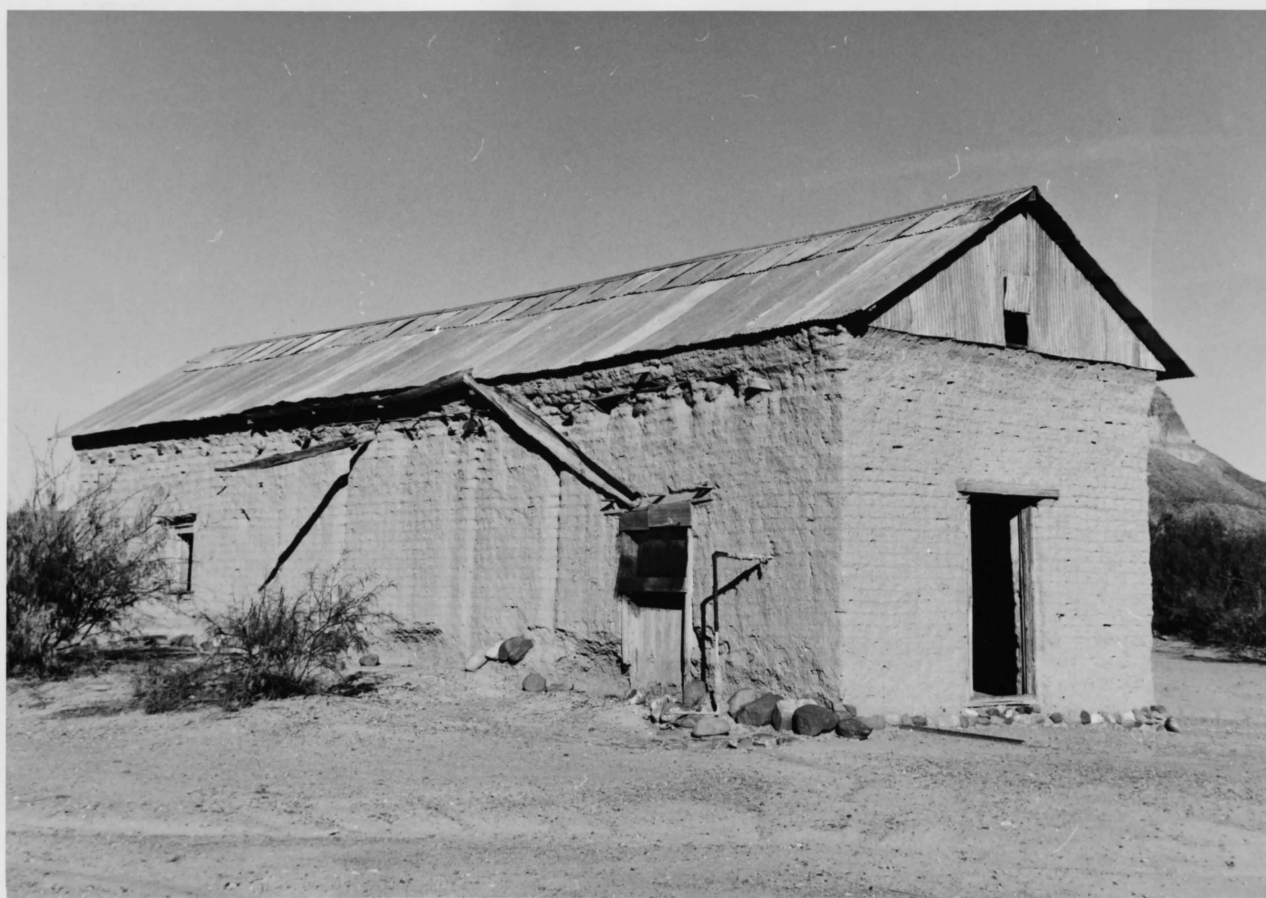
Castolon Old Store Compound:
Old Castolon Store (BBH-618)

3. FOR LIBRARY OF CONGRESS USE HSI Classification: CC	
4. NOTABLE FEATURES, HISTORICAL SIGNIFICANCE AND DESCRIPTION OPEN TO PUBLIC Yes			
<p>These three structures--Old Store (618), Cafe (617), and Shed (616)--formed the original nucleus of commercial settlement at Castolon. The trading establishment, serving farmers, ranchers, and miners in the area, was probably founded by Cipriano Hernandez about 1900. Later Sublett bought him out and ran the store until 1916 when Wayne Cartledge undertook the operation. Cartledge did business here until he bought the Army post in the present Castolon Historic Compound in 1925.</p> <p>The interpretive significance of this old compound would be in its role as the supply and social center for the isolated lower Big Bend country.</p> <p><u>Description:</u> Old Store (618): A large adobe one-story structure with attic, on river cobble foundation, floor of wood, roof of corrugated metal, though original adobe roof indicated. The reed or cane ceiling is of special interest. Erosion of adobe walls and some undercutting on north and west sides is being checked by emergency stabilization procedures. Outside dimensions: ca. 53' x 16'. Cafe (617): One-story adobe throughout except for concrete floor. Probably used as combination cafe-residence. Walls eroded, roof and ceiling intact, but roof leakage is leading to interior adobe erosion. Outside dimensions: ca. 34' x 14'. Shed (616): Single room shed of adobe construction throughout. Roof missing.</p> <p>Plans call for stabilization and preservation as an exhibit for visitors traveling Park Route 9.</p>

5. PHYSICAL CONDITION OF STRUCTURE		fair to ruins condition Endangered Yes Interior / Exterior	
<p>See interim historical base map attached to this report.</p>

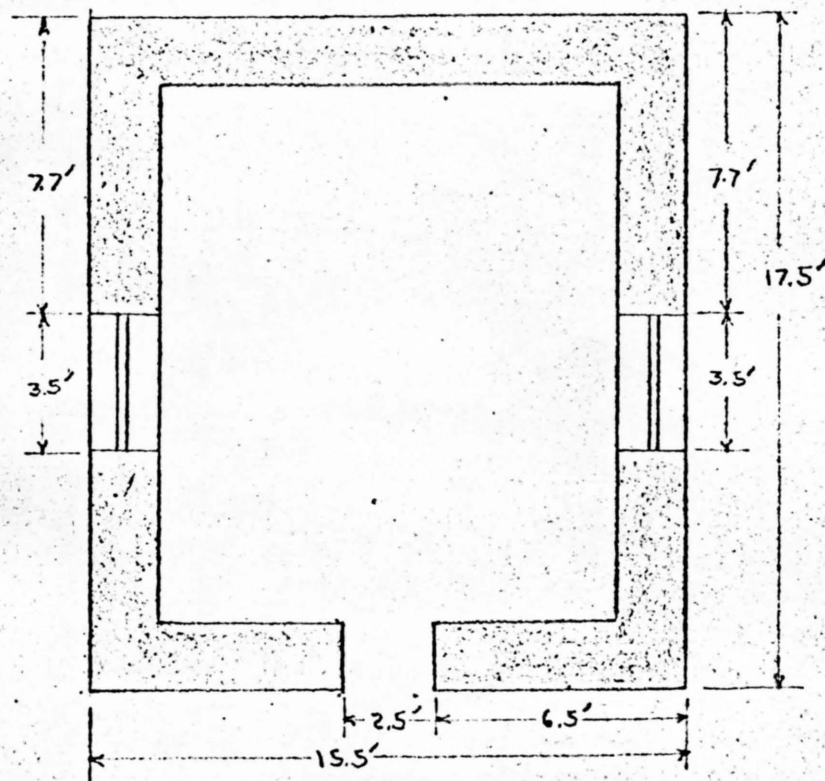
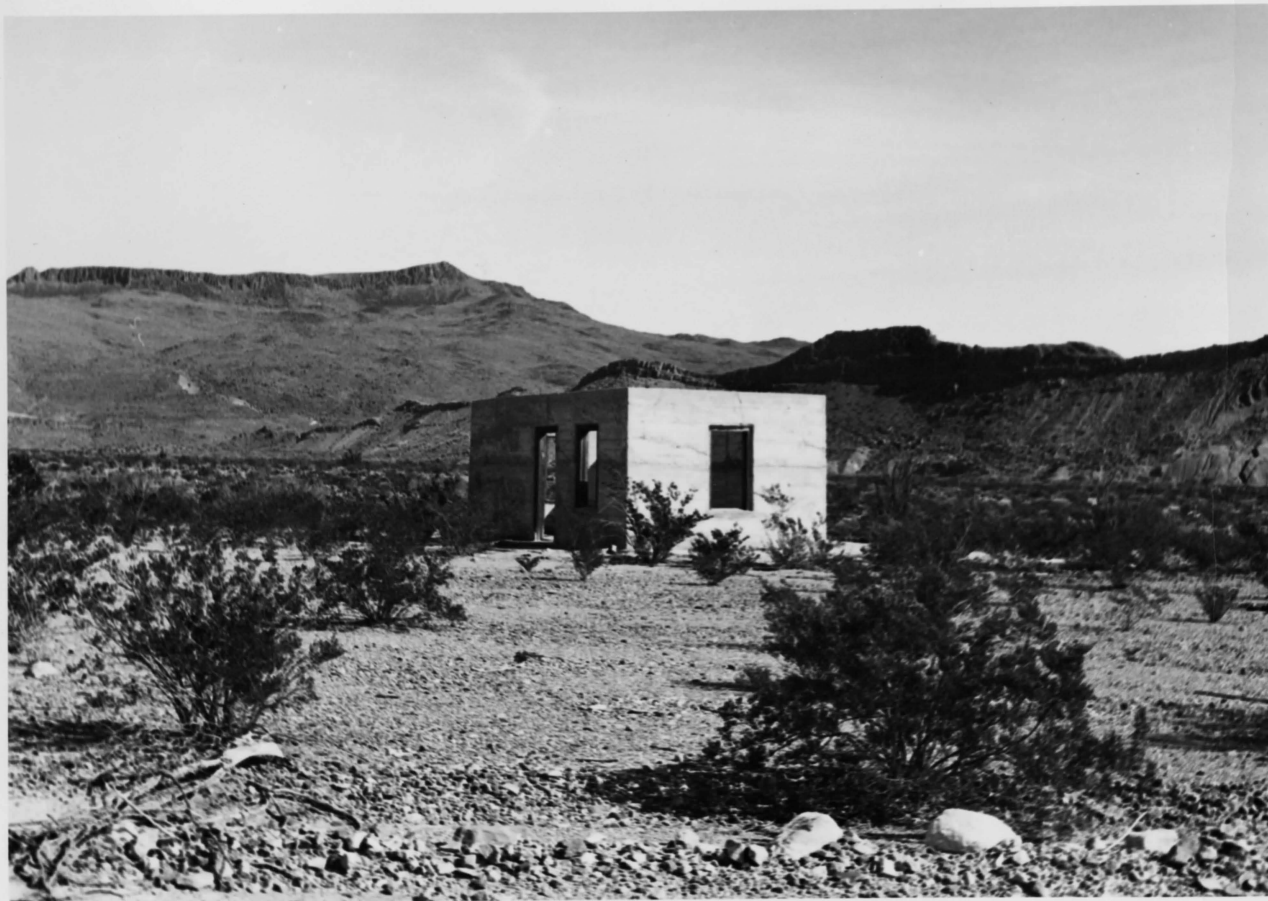
Nariscal Mine: Concrete Residence

Concrete Employee Residences: Seven of these one-room, concrete wall, floor, and foundation structures are grouped in the valley below the main mine complex. They are roofless. Dimensions are about 15' x 20'. They have been thoroughly stripped of all structural elements aside from the concrete fabric. Minor clean-up is all that is necessary to put them in condition for indefinite, maintenance-free exhibition.

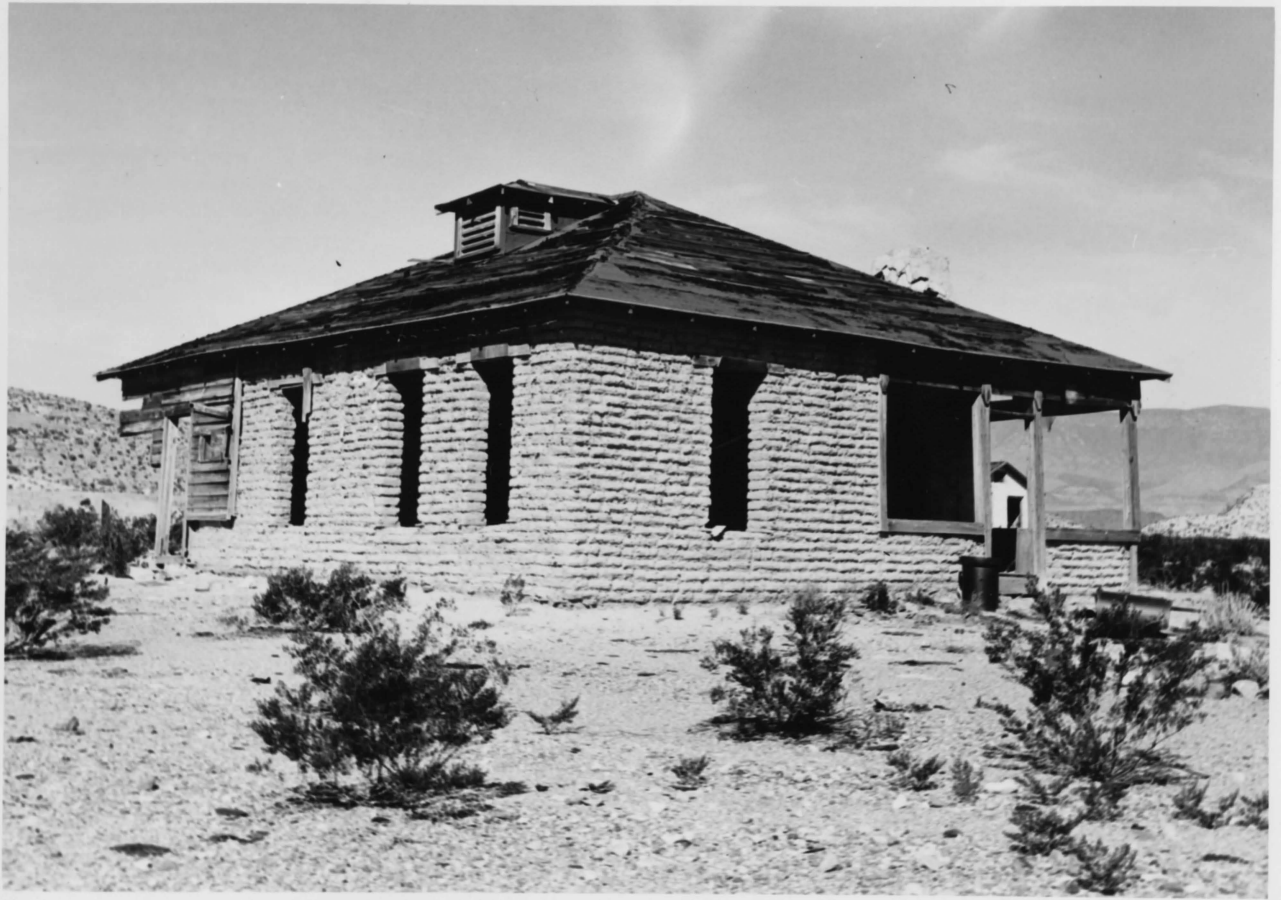
Mariscal Mine: Mine Superintendent's Residence

Mine Superintendent's House: A four-room adobe structure, wood floor and ceiling, rolled-roofing cover of hipped rafter-and-plank roof. Stone-veneered adobe chimney. Outside dimensions about 30' x 30'. This structure should be stabilized, cleaned up, and damaged roof sections repaired. In the event of future intensive interpretation of the mining story in the Big Bend, this structure would be the logical place for a small exhibit display and starting point for a self-guiding trail through the mine complex.

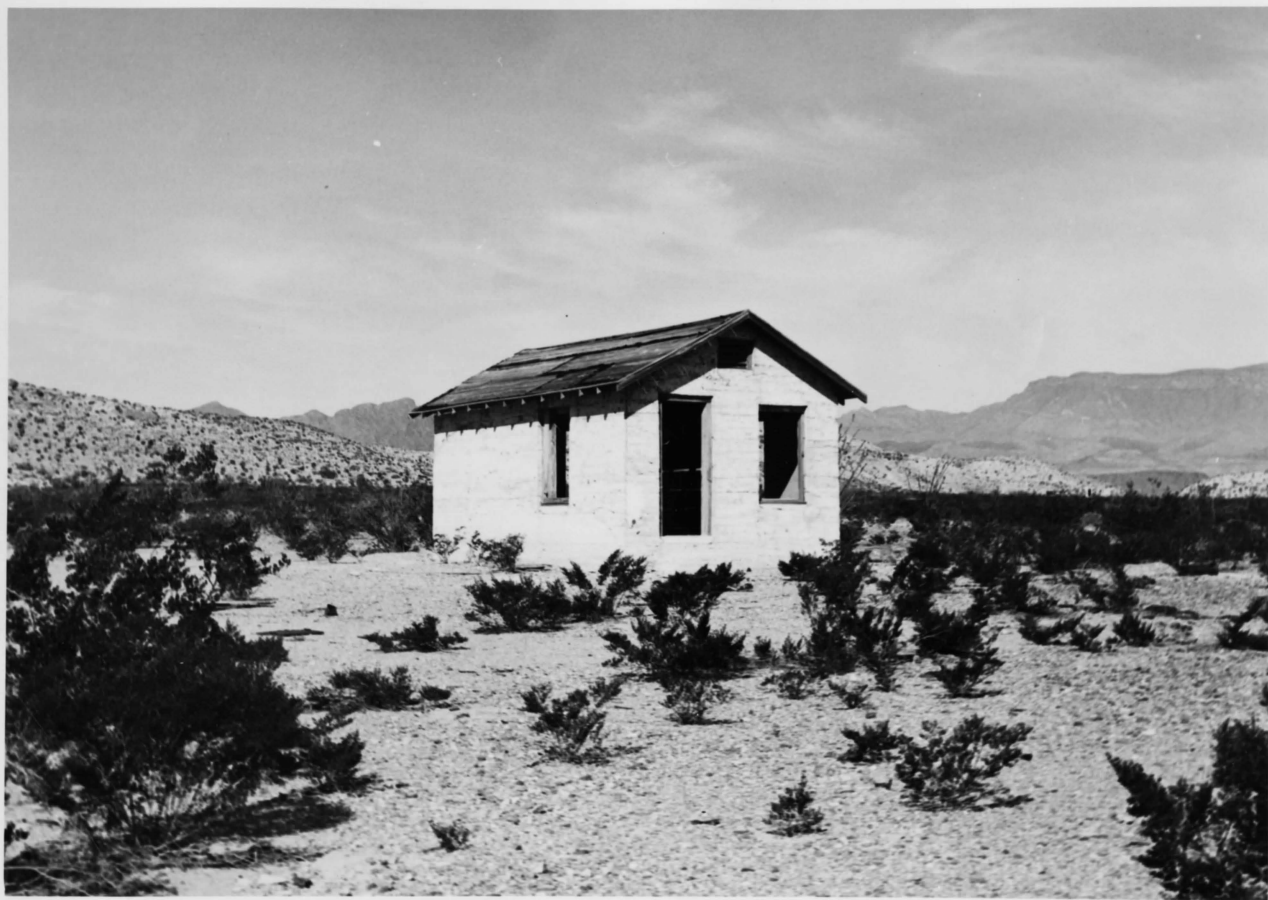
Mariscal Mine: Company Store

Company Store: A one-room concrete structure with a rafter-plank roof covered with rolled roofing paper. Clean-up and recovering of roof would hold this building indefinitely. Interpretation of the role of a company store in a company settlement such as this would be an interesting exhibit.

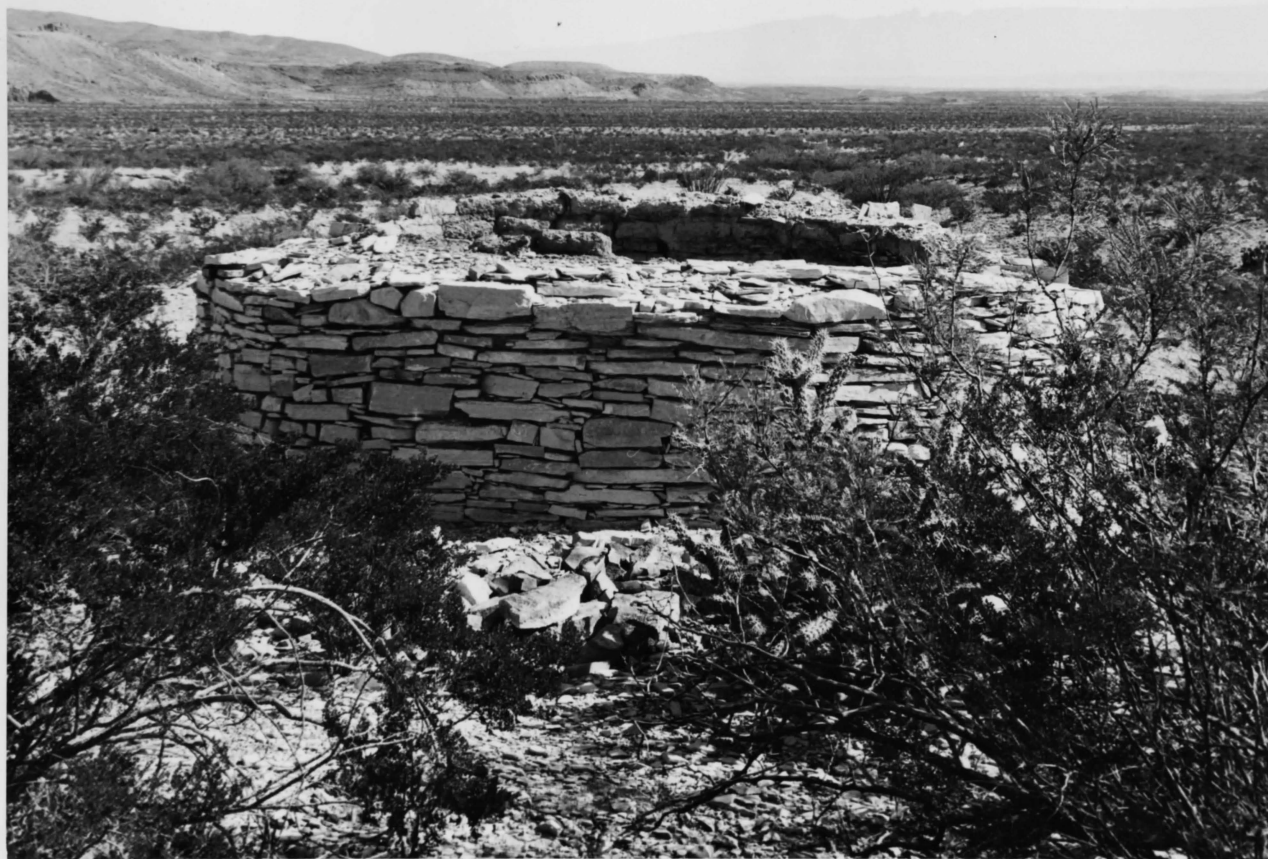
Mariscal Mine: Brick Kiln

Brick Kiln: Of limestone construction; 15' across, 8' inside diameter, 10' deep, circular wall 3' thick, with fire-brick lining.

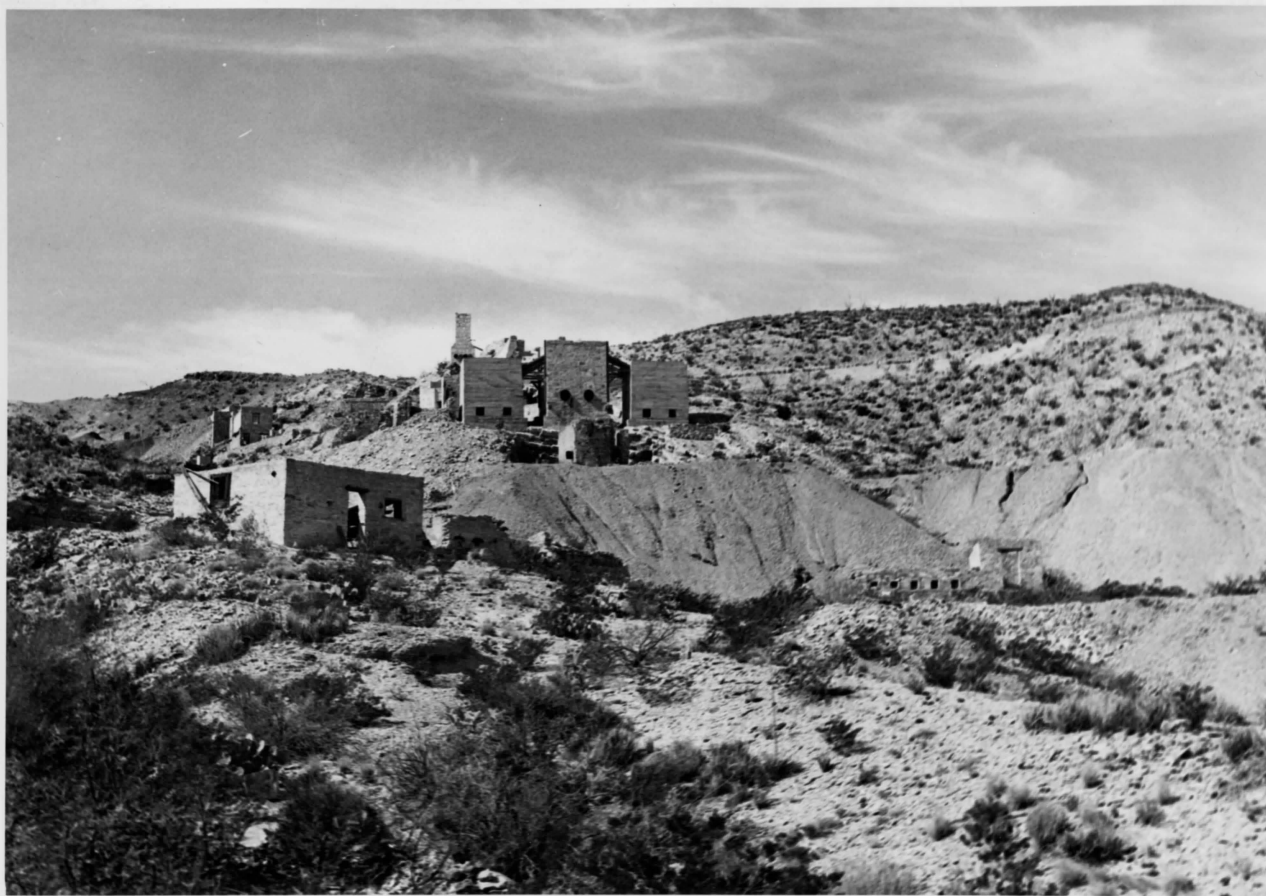
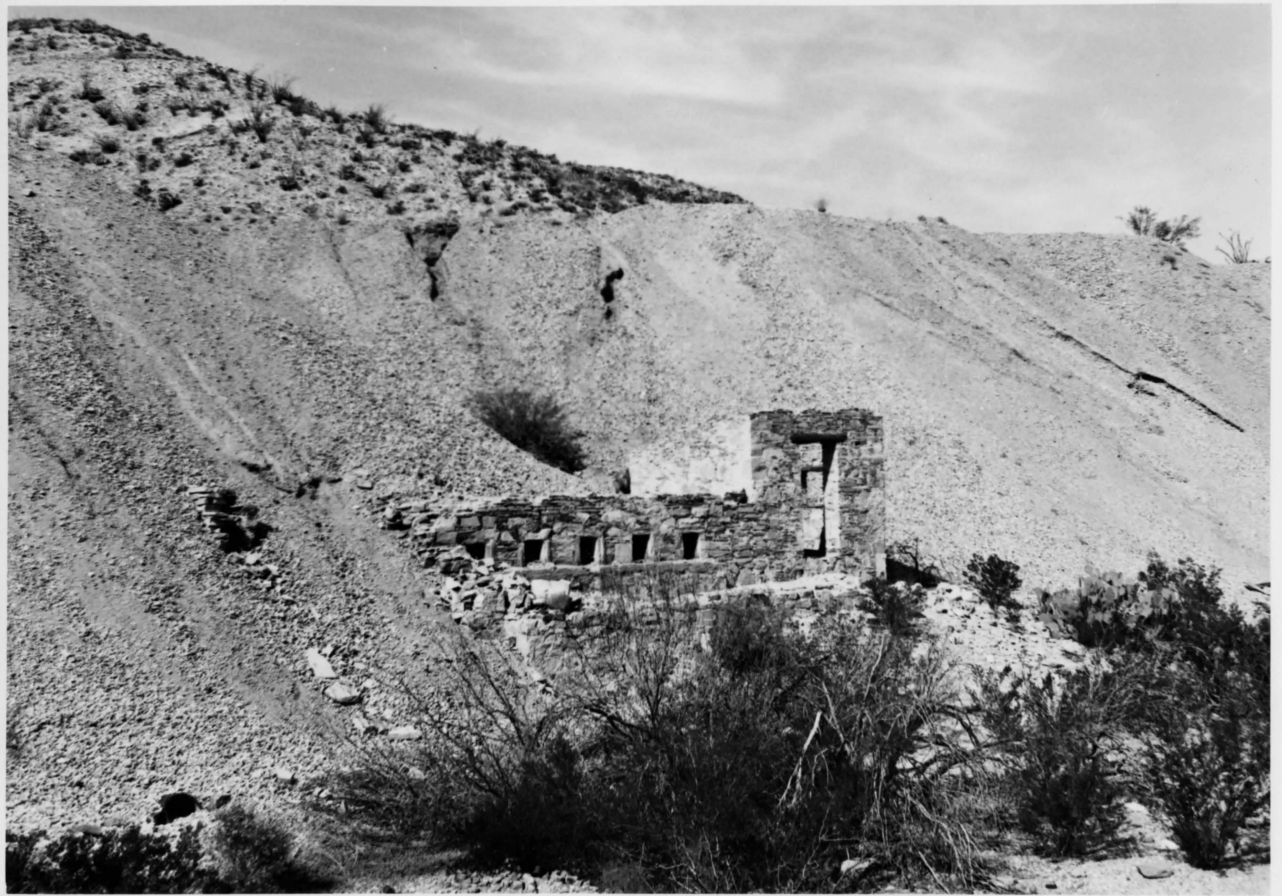
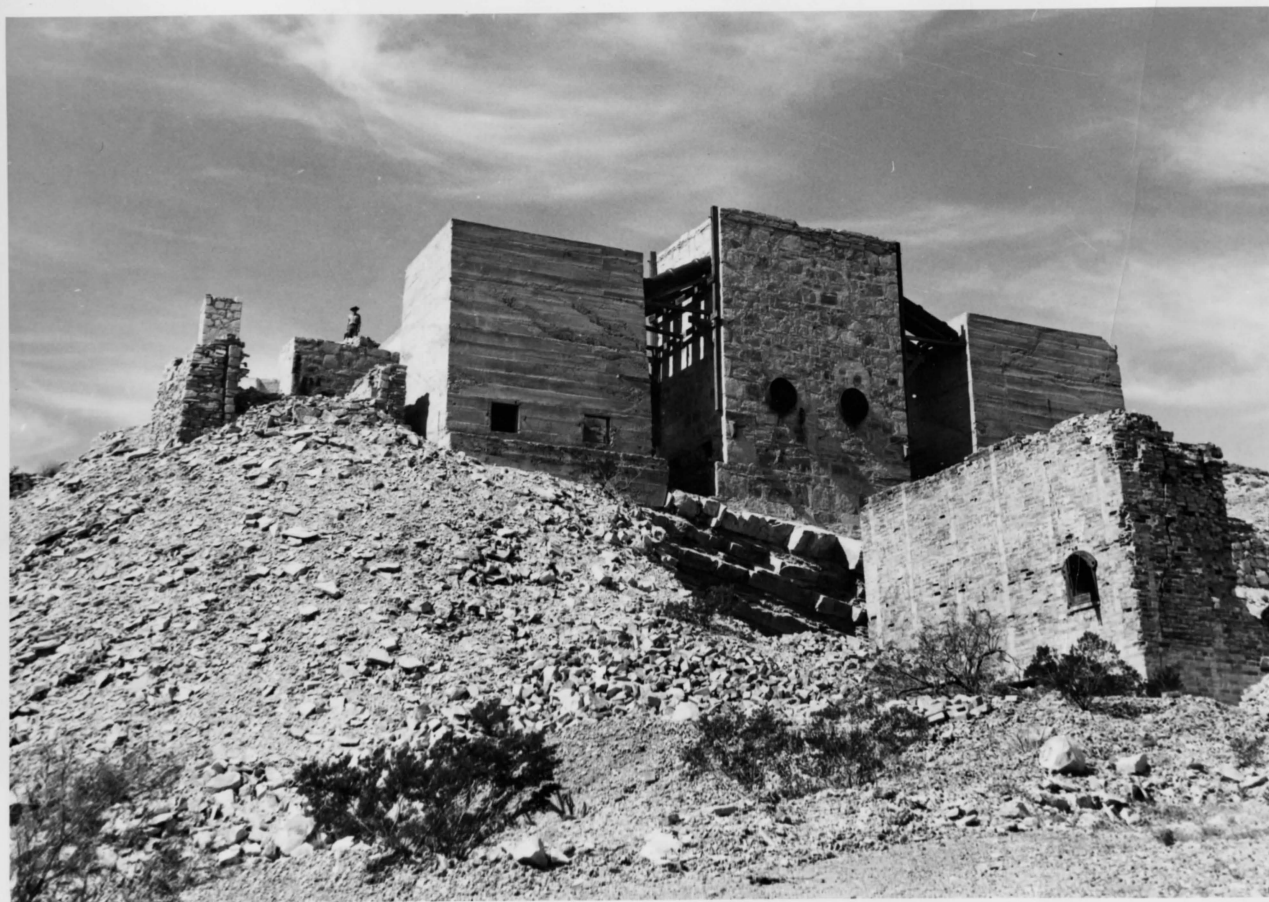
Mariscal Mine: Overall view of Main
Processing Plant

The Main Processing Plant and its satellite structures are all of sound stone, concrete, or brick construction. Clean up and removal of obvious hazards would appear to be the limit of NPS resources at this extensive site. The rugged terrain and the heights involved with some of these structures (assuming that all mine shafts are closed) would still dictate stringent warnings to all visitors, especially those accompanied by children.

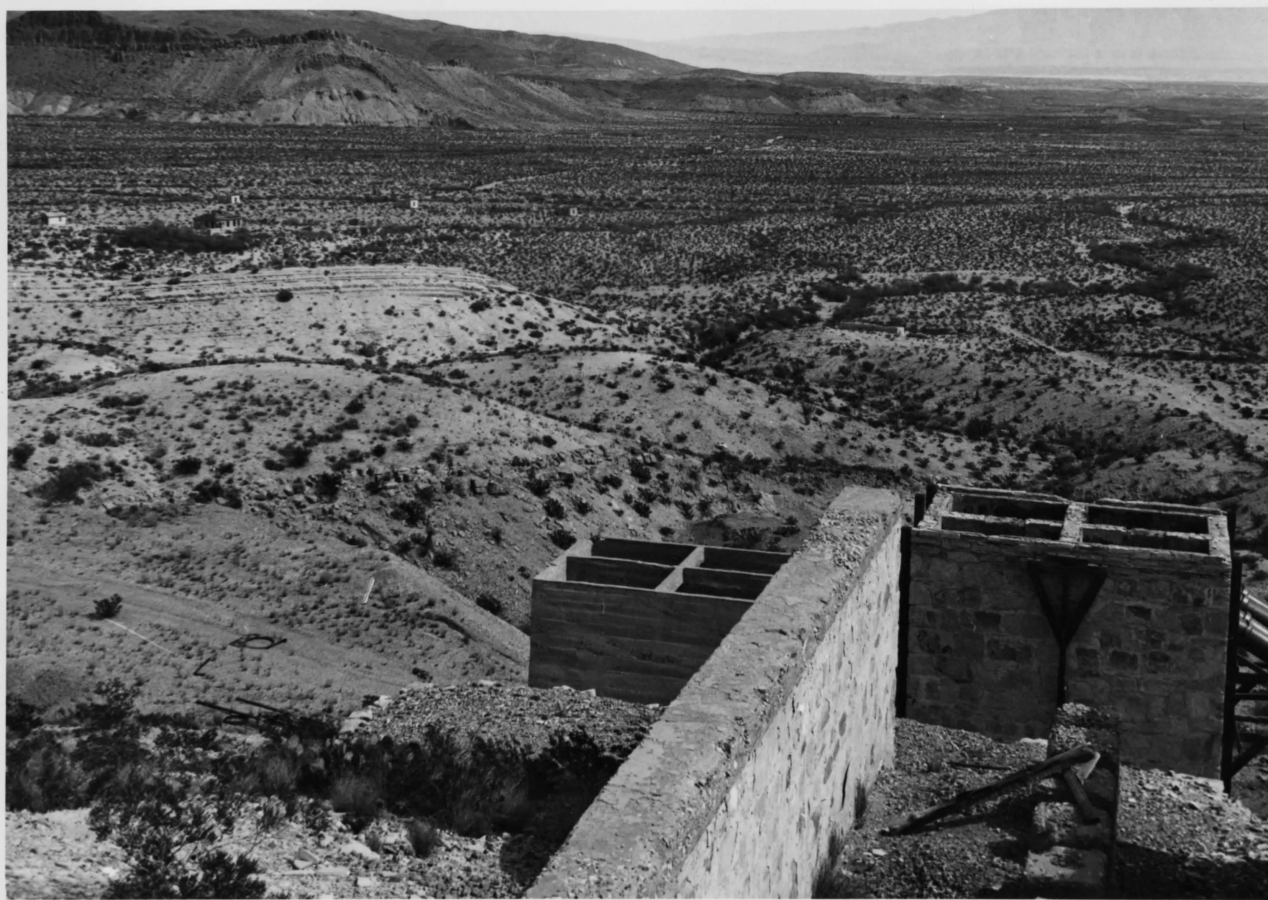
Mariscal Mine: View northeast from top of Main
Processing Plant showing Mine
Superintendent's House and other
structures in valley
