HISTORIC STRUCTURES REPORT 010076

HOT SPRINGS COMPLEX
Big Bend National Park
Texas

Koue, 1969
U.S. Dept. of the Interior-National Park Service

**Prepared by
A. Lewis Koue
April 1969**

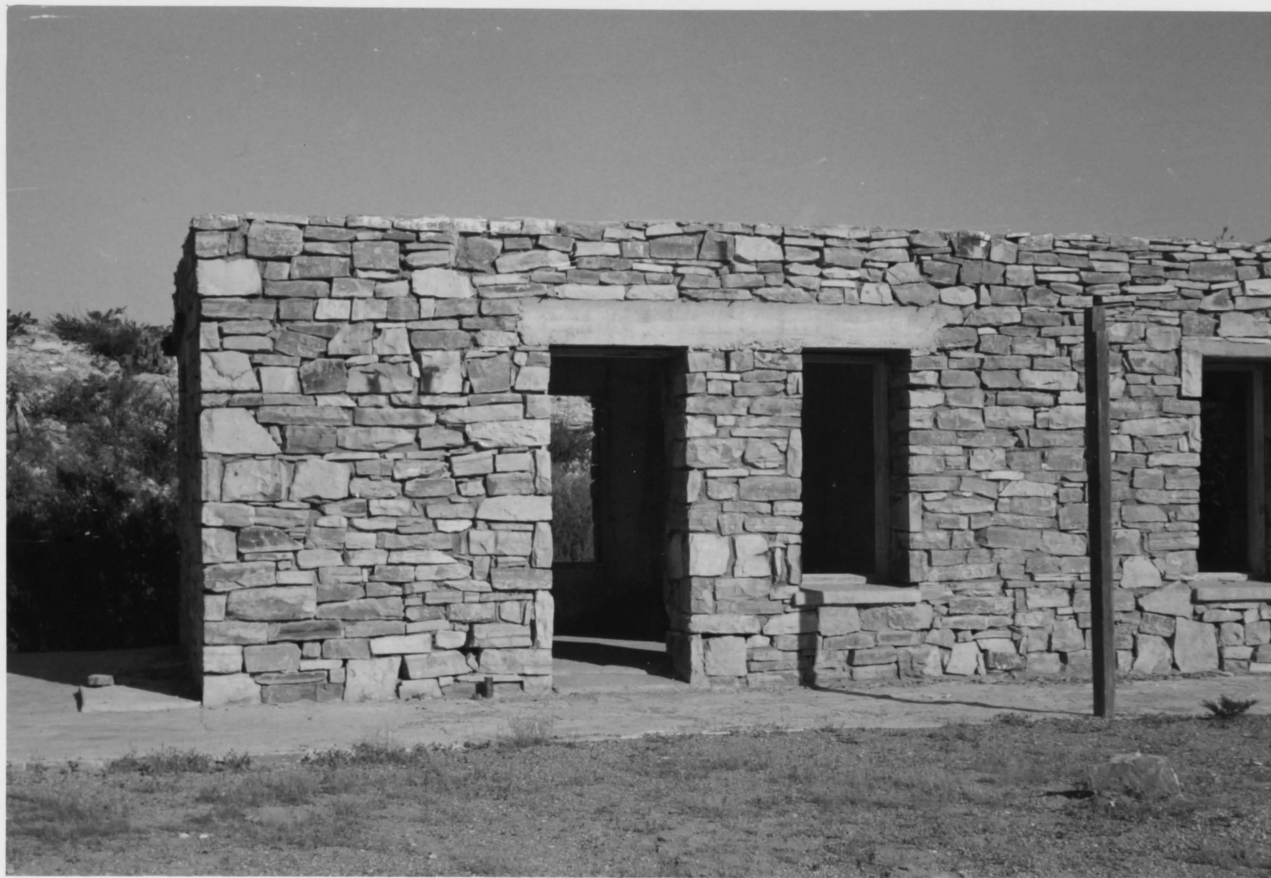
ILLUSTRATION NO. 1

The cabins consist of a one-story row of 7 attached one-room units with overall dimensions of approximately 15' x 117'. Rooms are approximately 11' x 15' inside dimensions, with a ceiling height of 8'-6" at high side and 6'-10" at low side. Each unit has one door and window opening to the terrace at the south and one door and window opening to the rear or north, except end units which have doors in end walls. Units 6 and 7 have an interconnecting doorway.

The exterior bearing walls are 9' high of random native stratified stone set in earth mortar and pointed up with cement mortar. The roof is supported by 1-1/2" x 7-1/4" surfaced wood joists at 23 inches on center exposed in rooms. The roof deck is of 1" plank exposed in the rooms over which is applied 1" of soil and 1" of cement mortar, except for a 36" strip of mineral surface roll roofing applied horizontally at the lower edge of the roof. The roll roofing is torn and peeled back in places and the mortar is veined with cracks. A hole has broken through the roof in unit 7, which indicates some decay of the roof sheathing.

Special features are hand-painted murals in four of the rooms, which have been vandalized and damaged by roof leaks. These murals should be protected by a sound roof and closed off from the public, but left observable through screened openings.

Hot Springs Cabins, BBH-80, South Elevation (West extremity)

Remove present sod and plaster roof, replace all defective roof sheathing, install new sound roof membrane, and replace sod roof material.

Repoint all defective stone pointing with a mortar mix as follows by volume:

Install 1" x 2" wire mesh screens at all openings of 4 units with murals on walls. One door to each unit to have screen mounted on a hinged frame.

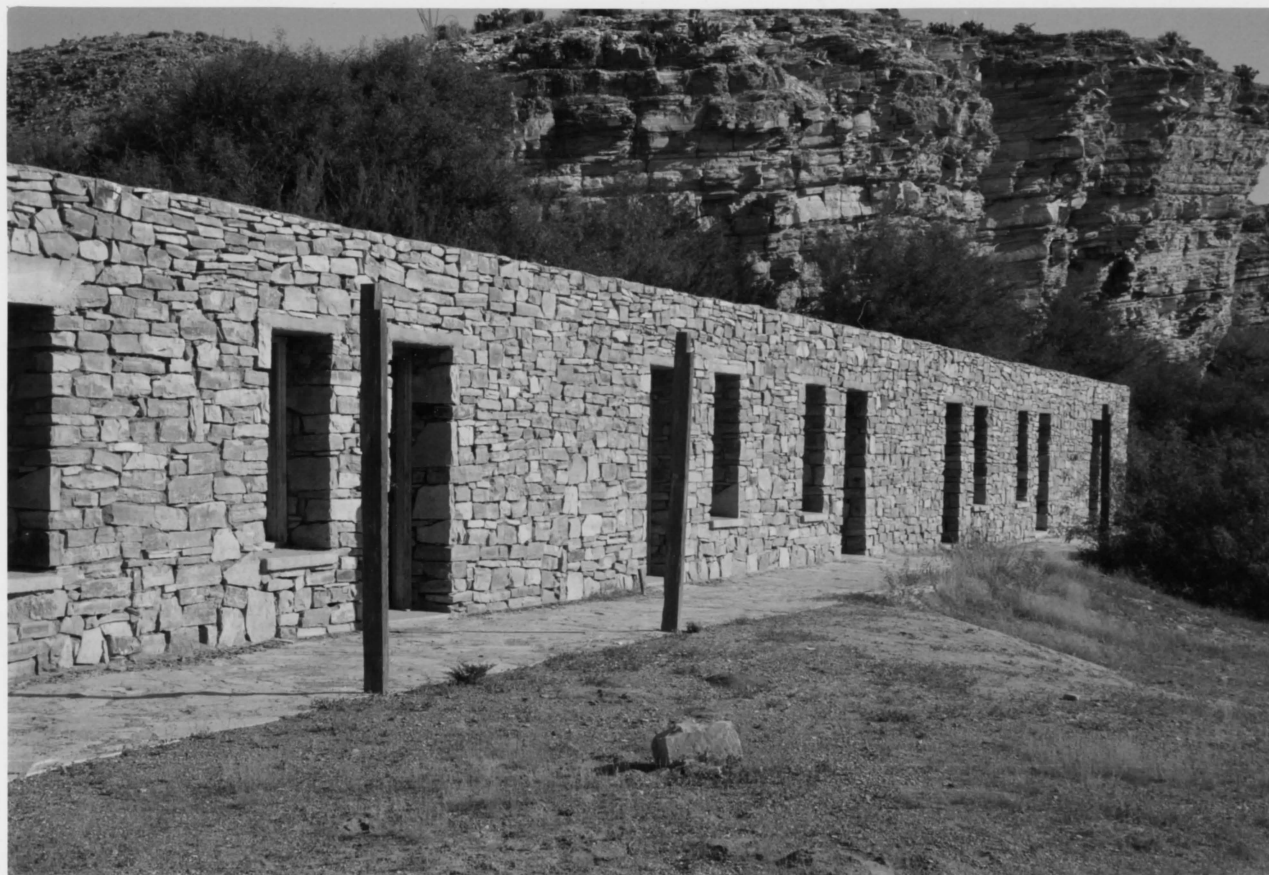
ILLUSTRATION NO. 2

A flagstone terrace extends along the south side and the east and west ends over which there originally was a covering or ramada as evidenced by a few remaining 4 x 6 posts and remnants of construction at the walls over openings.

Hot Springs Cabins, BBH-80, South Elevation (Center
and East extremity)

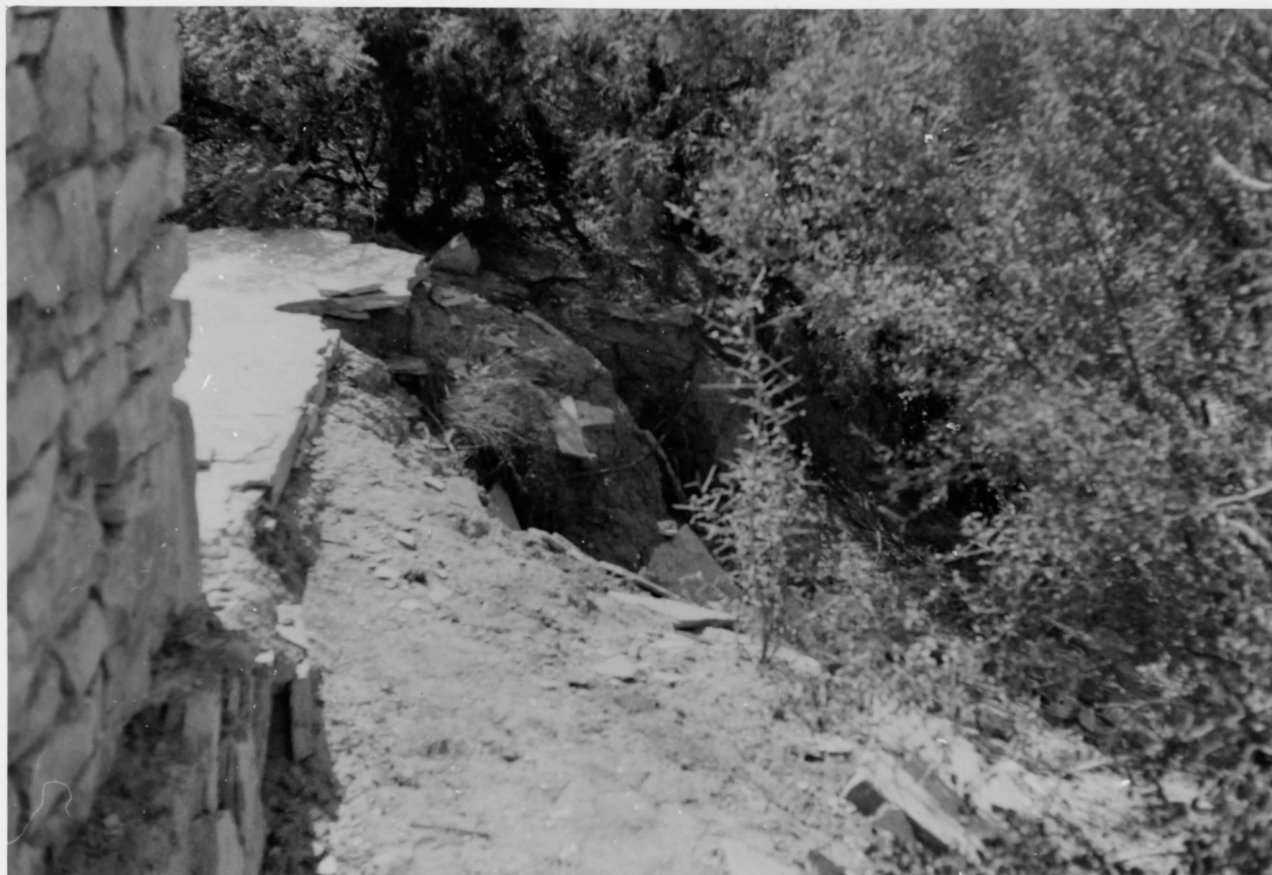
ILLUSTRATION NO. 3

A wash traces past the west end of the cabins and is undermining the terrace. Measures should be taken to arrest this erosion and protect the structure by placement of some fill protected by rip-rap. The embankment immediately at the rear of the cabins should be selectively cleared of overgrowth and graded to direct the flow of water.

Hot Springs Cabins, BBH-80, Erosion at West Terrace

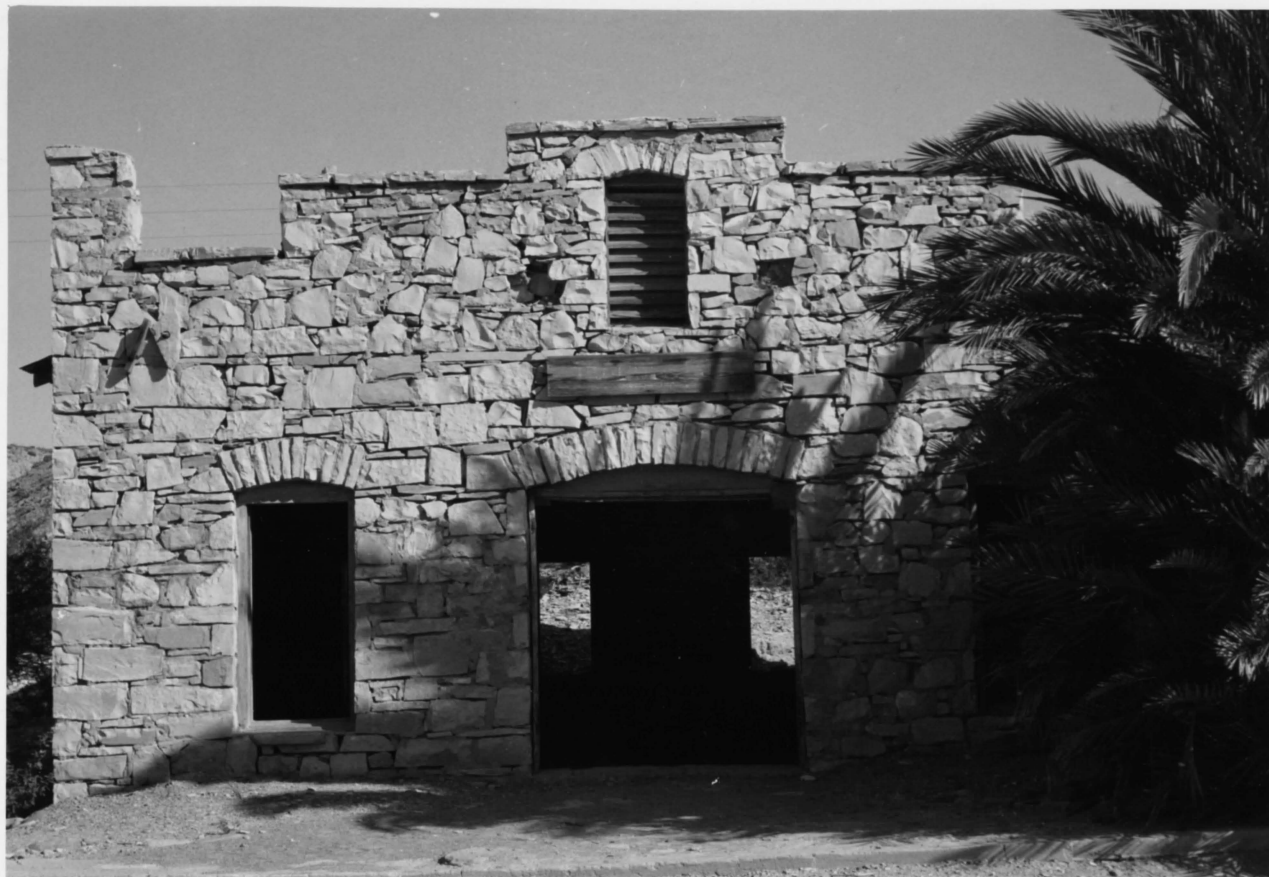
ILLUSTRATION NO. 4

The exterior bearing walls are 14" thick native stratified stone set in earth mortar pointed up with a lime or a natural limestone mortar, which has eroded away considerably. The roof construction consists of trussed rafters at 24" on center over which are spaced sheathing, celotex for insulation and corrugated iron. The interior walls are plastered and painted.

The stone work of the front or south elevation of the building has been more carefully laid up with selected stones than have the other walls. The openings are spanned by segmental arches with stone voussoirs. The top of the front and rear walls are stepped up to conform to the trussed roof, and the front wall has a louvered vent centered over the center entrance.

Store and Post Office, BBH-82, Front (South) Elevation

Replace all missing stone work and repair unsound walls.

Replace all defective corrugated iron roofing.

Point up all stone work with mortar as specified above for cabins.

Paint all wood window and door frames, and trim.

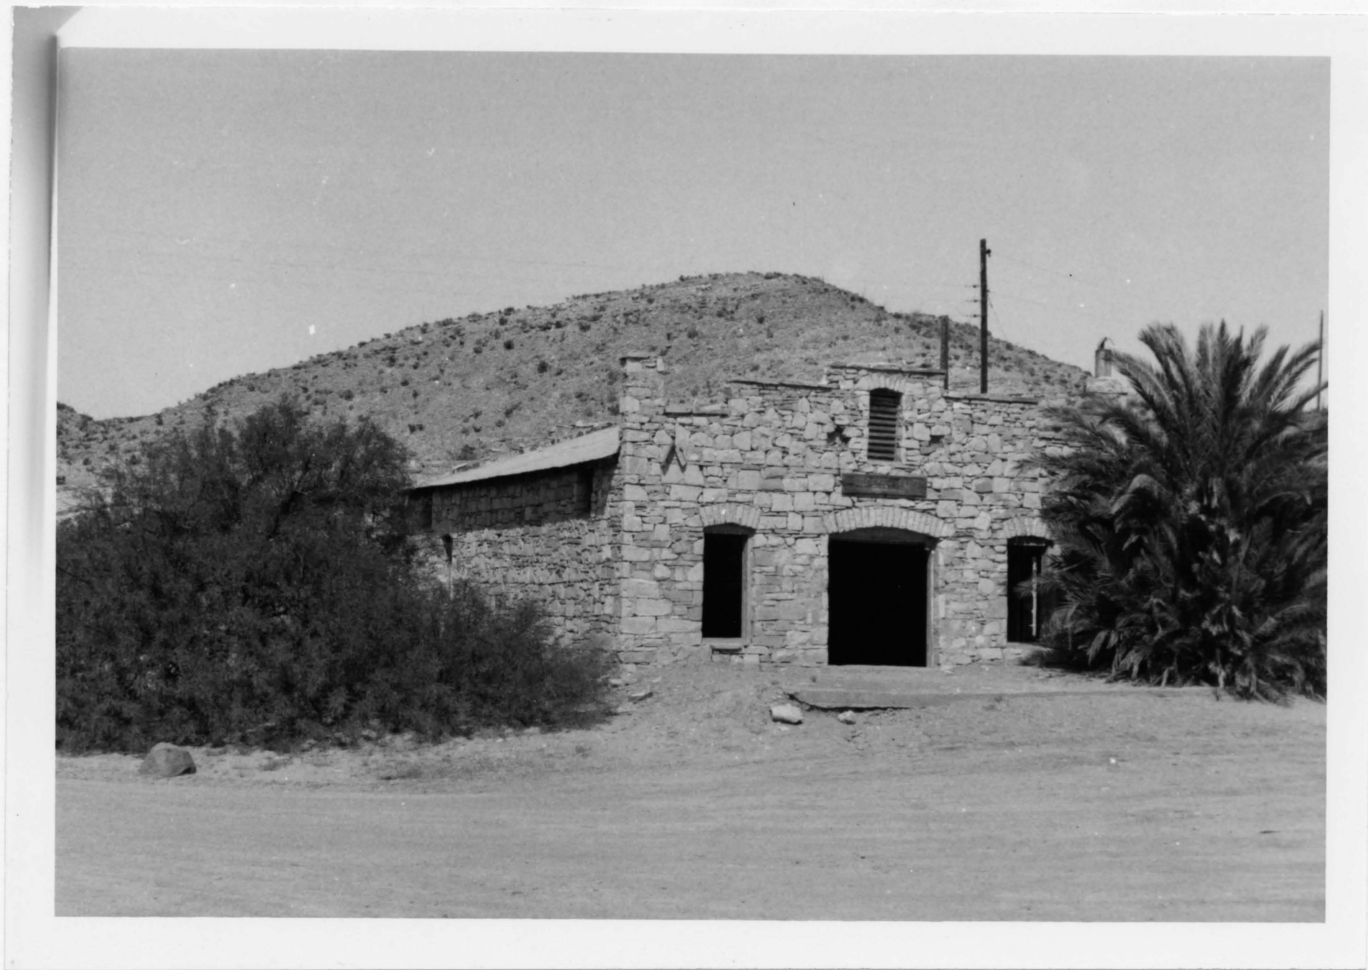
ILLUSTRATION NO. 5

A fireplace is built into the southeast corner and the stone chimney extends approximately 2' above the wall. This chimney is echoed by a similar buttress at the southwest corner.

Store and Post Office, BBH-82, South and West Elevations

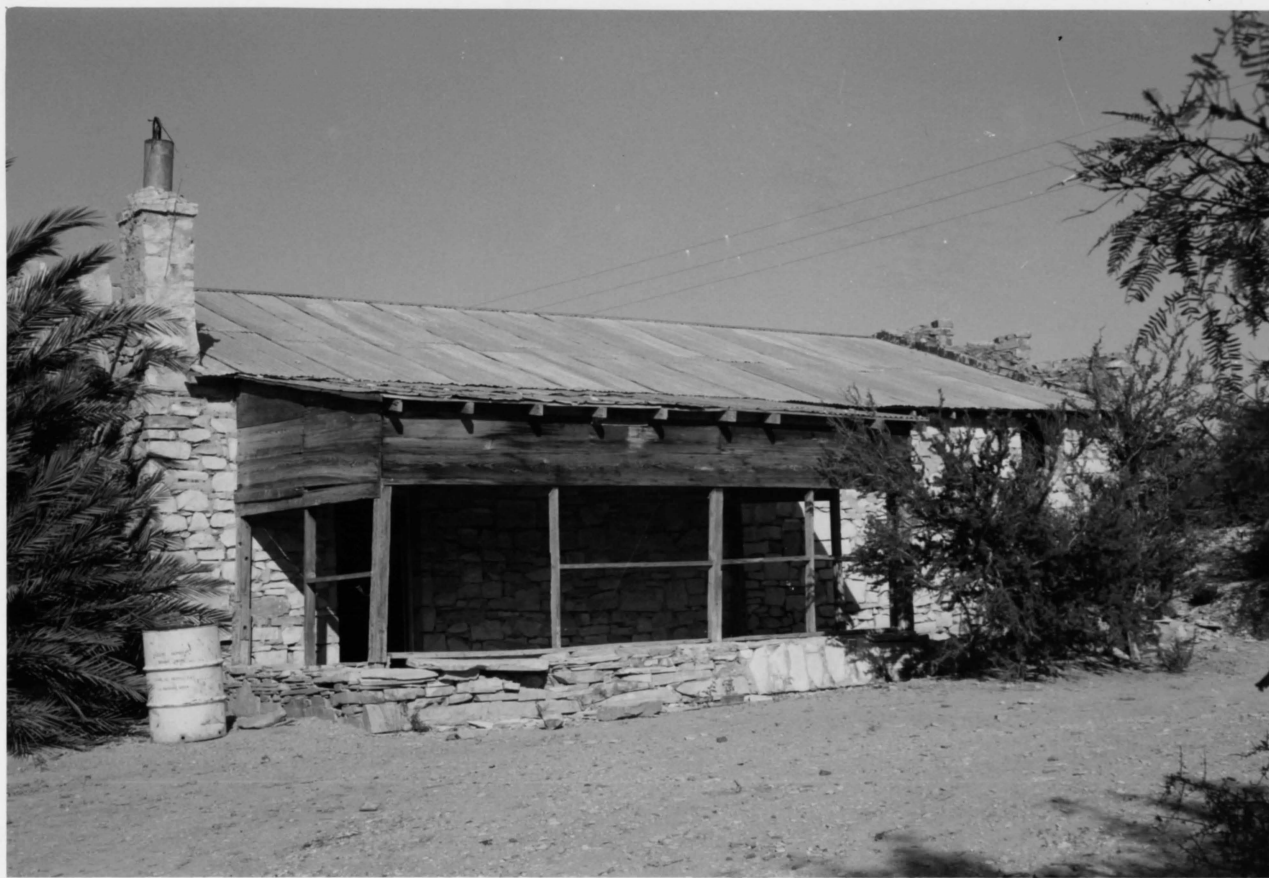
ILLUSTRATION NO. 6

A lean-to addition approximately 9' wide by 18' long, which is not considered significant, was constructed along the east side, consisting of a stone wall approximately 2' high surmounted with a screened wood structure. The wood construction of this addition is in bad repair and removal is suggested.

Store and Post Office, BBH-82, East Elevation

Remove wood construction of lean-to at east side of building. Stone curb walls to remain.

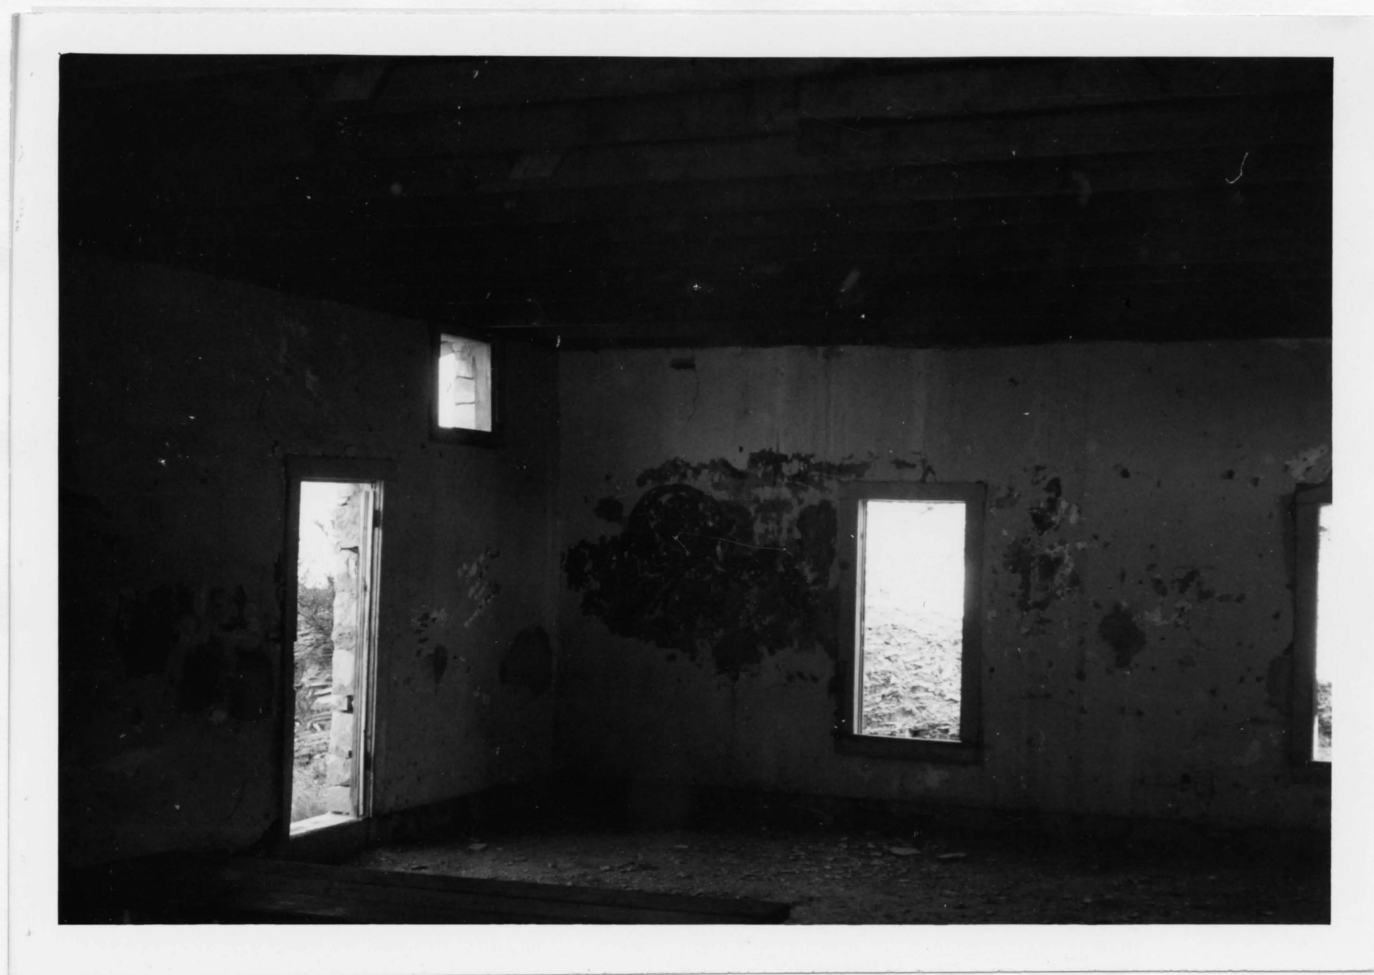
ILLUSTRATION NO. 7

The Store and Post Office is a one-story stone structure approximately 28' x 42', presently consisting of a single space devoid of doors and windows and without a finished floor. Presently the earth floor is covered with gravel and a picnic table permits visitors to lunch in the shade.

Store and Post Office, BBH-82, Interior View
