HISTORIC STRUCTURES REPORT

OLD CASTOLON
Big Bend National Park
Texas

A. Lewis Koue

November 1969

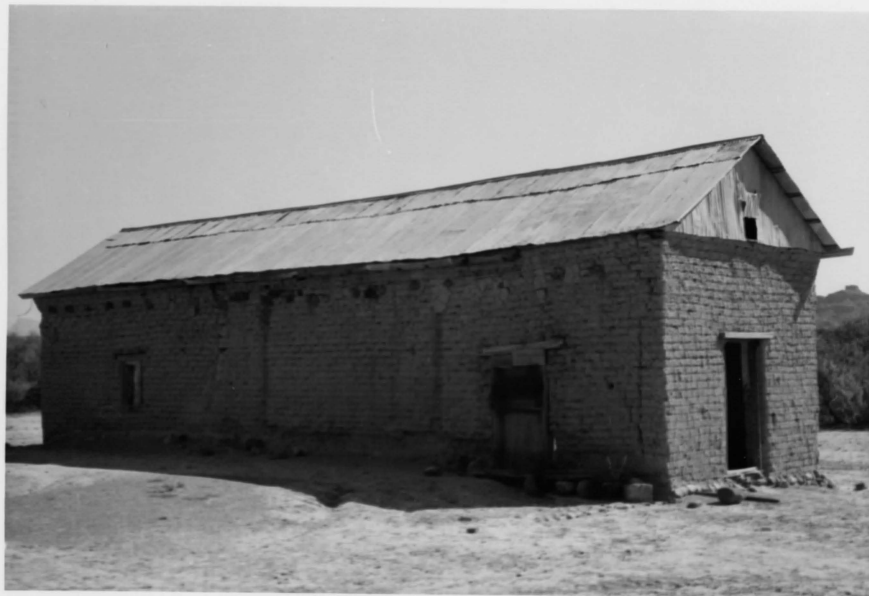
SOUTHWEST VIEW OF OLD CASTOLON STORE, BBH-618
Note erosion and failure of adobe wall.

Restore foundations, particularly of the West Wall.

Repair unsound or cracked adobe walls, including stabilizing ruin of wing wall.

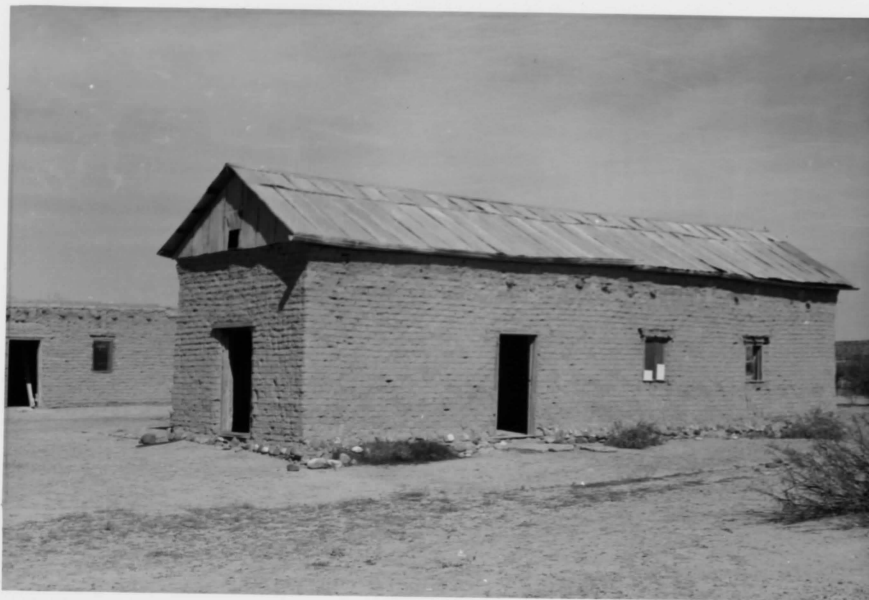
SOUTHEAST VIEW OF OLD CASTOLON STORE, BBH-618
Note stones imbedded in adobe walls at base.

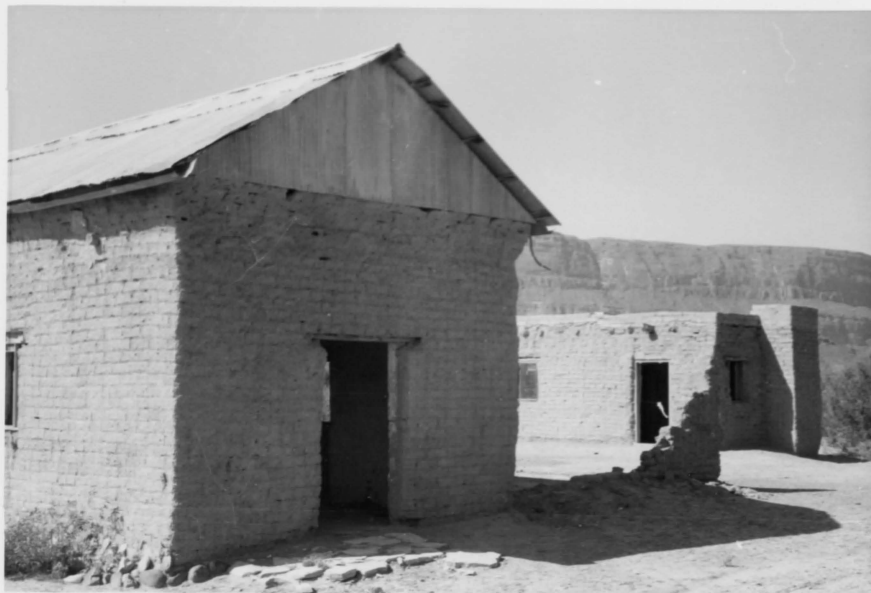
REAR VIEW OLD CASTOLON STORE, BBH-618
 Note ruins of addition and CAFE, BBH-617
 in background.

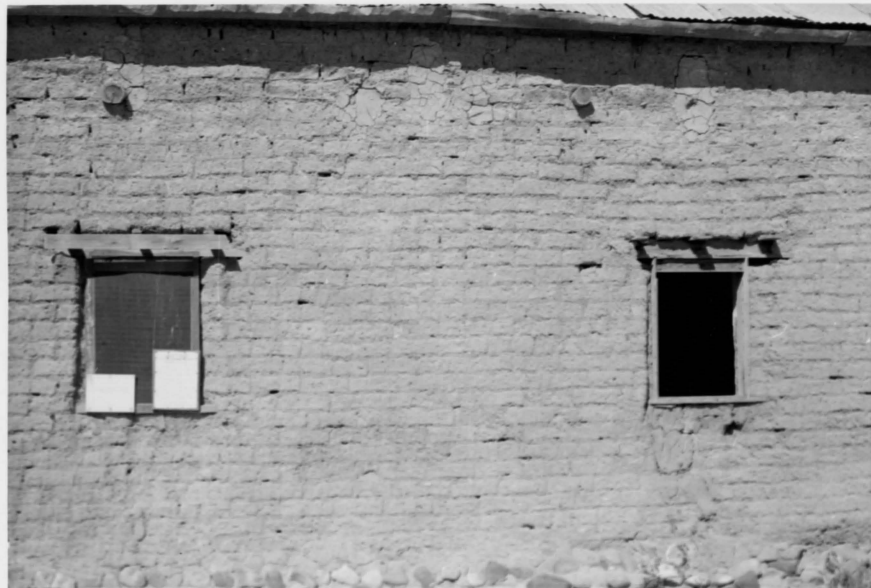
WALL DETAIL OLD STORE, BBH-618
 Note remnants of window caps and condition
 of corrugated iron roof and gutter.

Secure all corrugated iron roofing in acceptable condition; replace all defective roofing. Replace gutters.

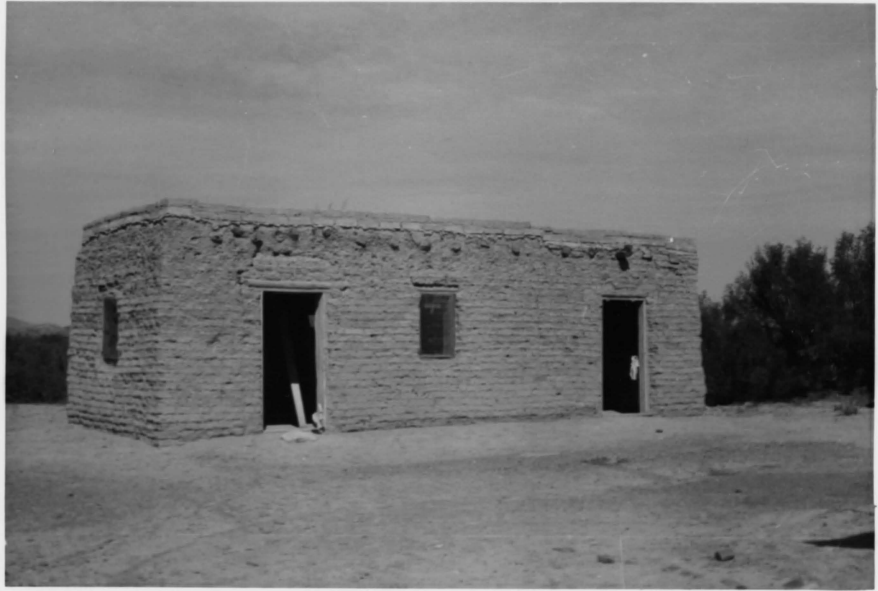
SOUTHEAST VIEW OLD CAFE, BBH-617
 Note addition of soil cement blocks at parapet.

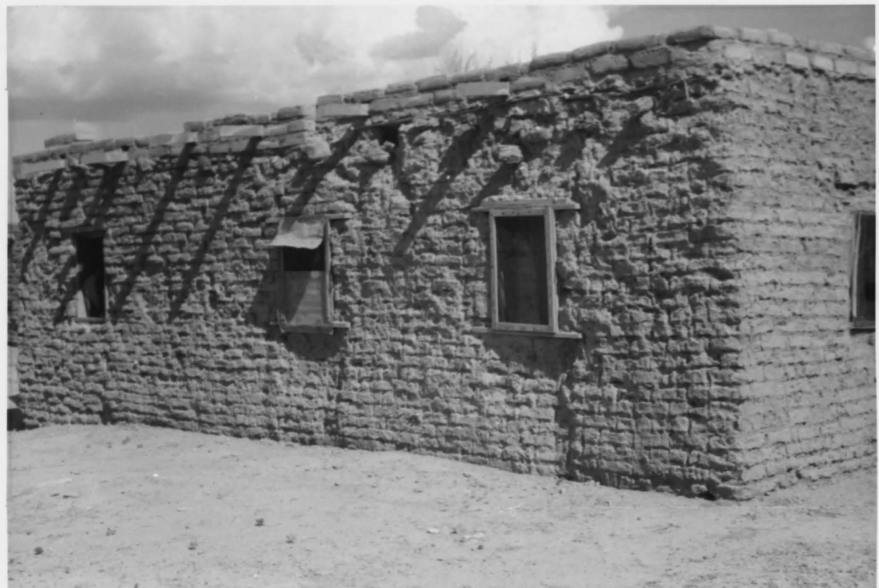
The Old Cafe is a two-room adobe block structure 14'- 0" x 33'- 4" (plus an exterior chimney) overall. The larger room, 11'- 9" x 19'- 9", has a doorway and a window in the South wall; one window in the West wall; two windows in the North wall; and an interior doorway to the kitchen on the East wall. The kitchen is 11'- 9" x 9'- 10" with the above mentioned interior doorway in its West wall; a window in the North wall; a fireplace and window in the East wall; and an exterior doorway in the South wall. The floors are concrete. The sloping roof is sod on cane latia supported by vigas. The latias are 9'- 7" above finish floor at the South wall and 8'- 10"[±] at the North wall. Six recent galvanized iron canale provide water drainage away from the North wall. There are several courses of recent adobe block replacements topping the structure. The adobe walls have some serious erosion and cracks. Some vigas are broken.

WESTERLY SIDE OF OLD CAFE, BBH-617
 Note excessive erosion of old adobe block walls.

Repair or replace badly eroded adobe blocks and point wherever necessary; repair cracks in wall.

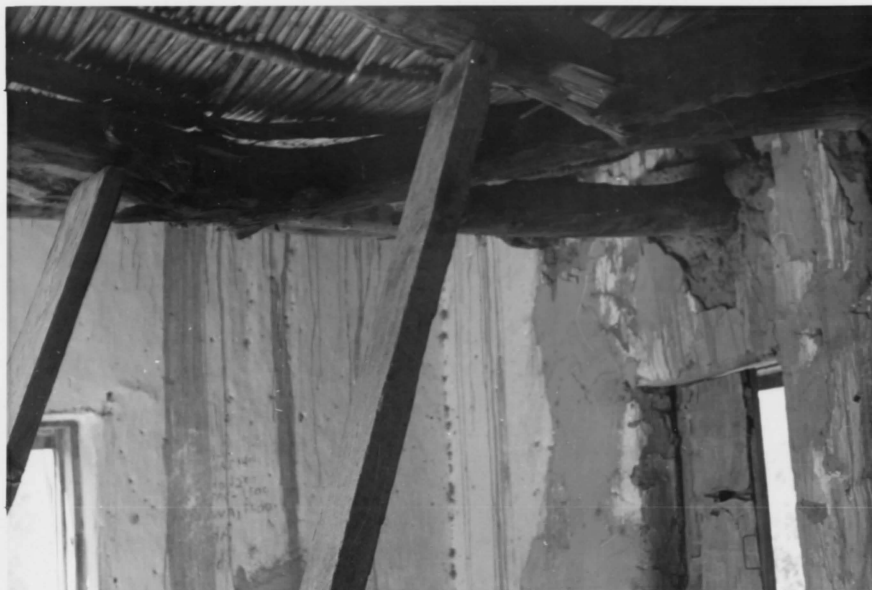
INTERIOR OLD CAFE, BBH-617
Note failure of vigas.

Remove and dispose of present sod roof. Replace or repair any broken or seriously checked vigas. Replace any damaged cane latias. Install styrofoam insulation covered by a continuous plastic membrane; top with sod to create original condition but with reduced weight.

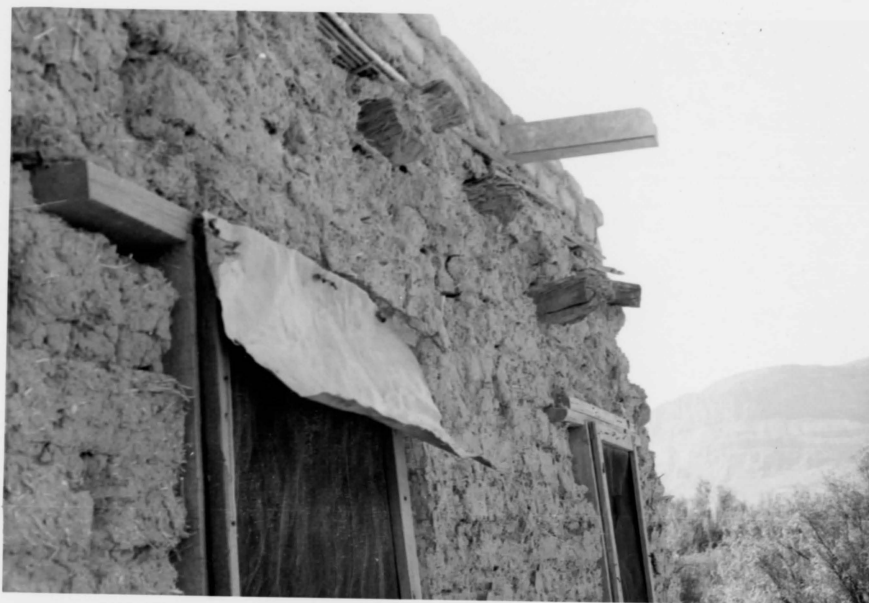
EXTERIOR OPPOSITE INTERIOR VIEW ABOVE
Note excessive erosion of adobe wall.

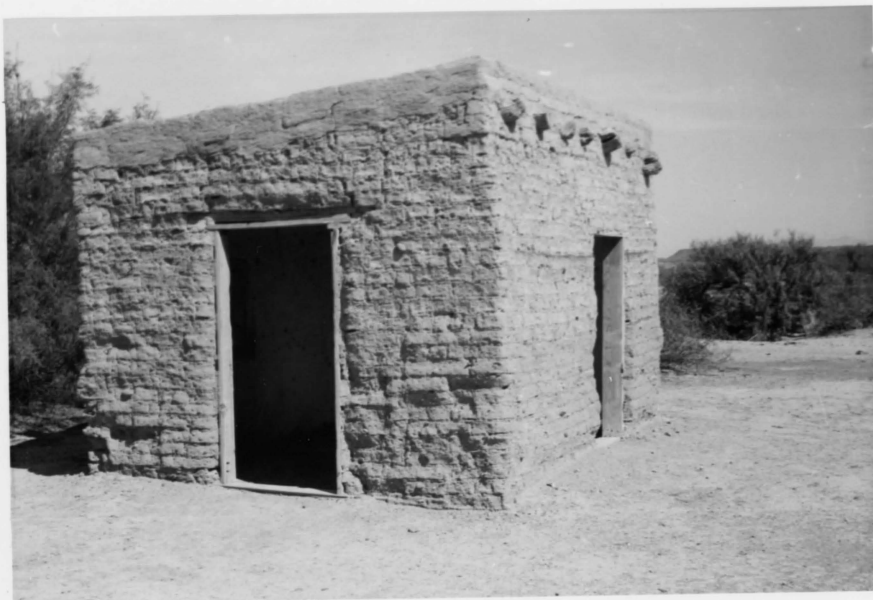
This structure is 11'- 8"[±] by 15'- 6"[±], consisting of one room with a doorway in the South and West walls and a window in the North wall. It has a concrete floor and a sloping sod roof. The cane latias are 8'- 9"[±] from the finished floor at the South wall and 7'- 10"[±] at the North wall. Two recent galvanized iron canale project this drainage away from the North wall. The latias were recently replaced, but laid in the wrong direction. There are several courses of recent adobe blocks topping the building.

ONE-ROOM SHED, BBH-616
Note repairs to parapet.

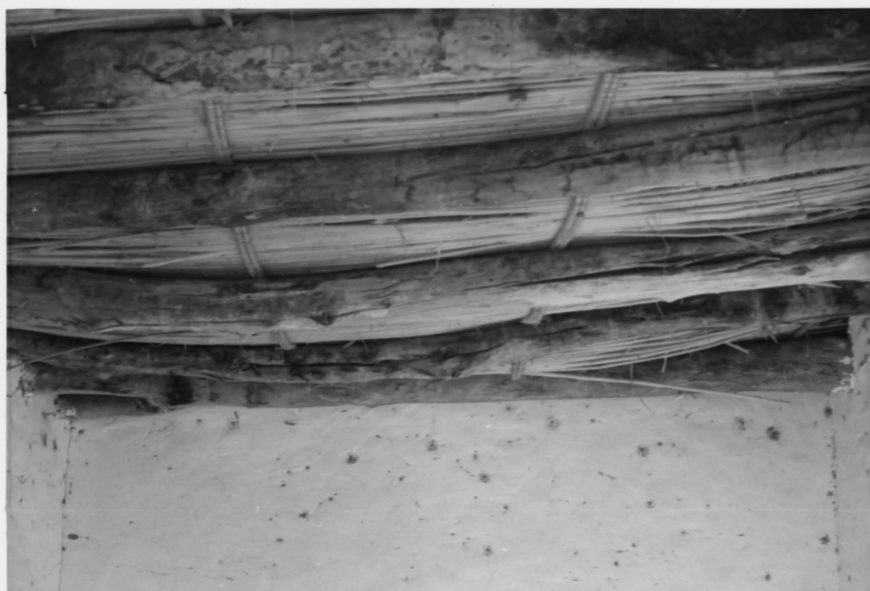
INTERIOR OF ONE-ROOM SHED, BBH-616
Note wrong placing of latia.

Remove and dispose of present sod roof. Replace or repair any seriously defective vigas. Reverse direction of cane latias and replace if necessary. Install styrofoam insulation covered by a continuous plastic membrane; top with sod to create original condition, but with reduced weight.

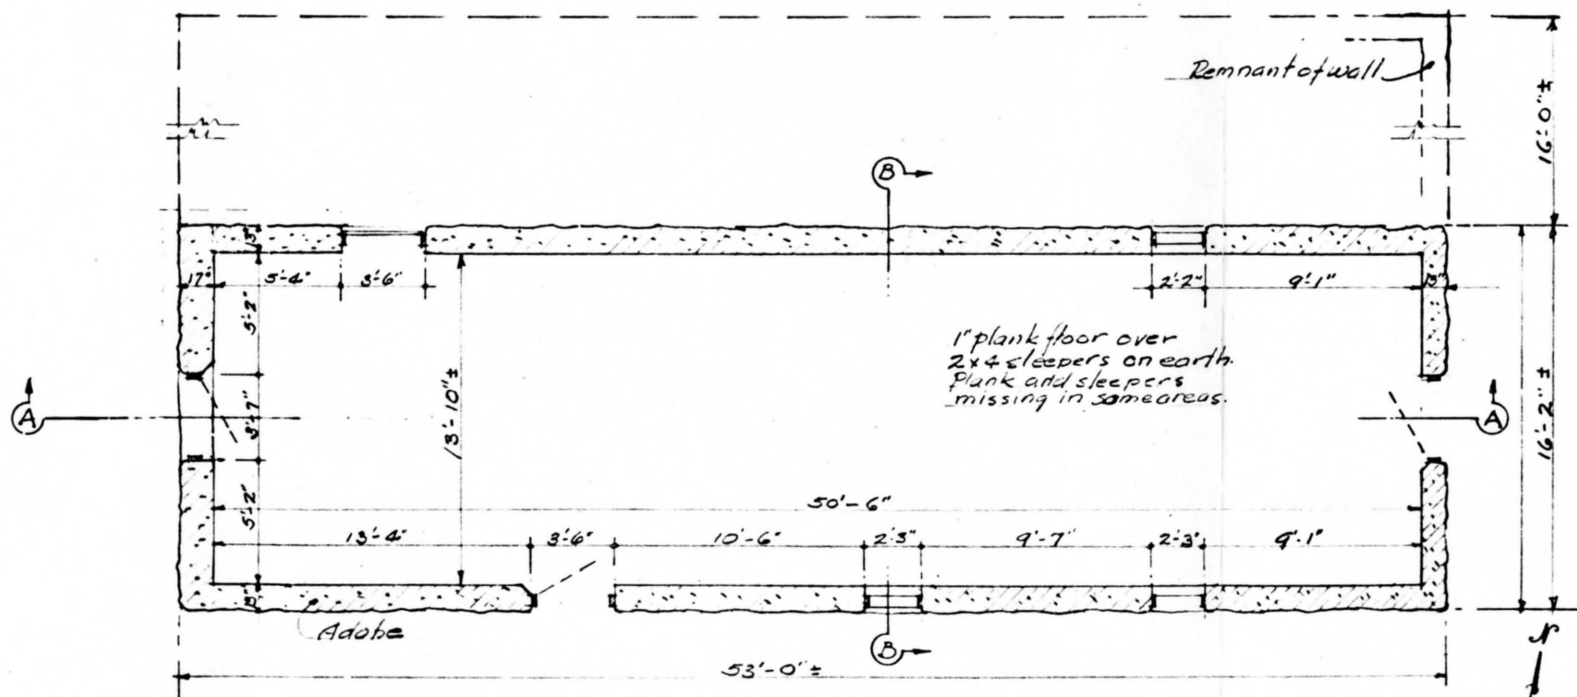
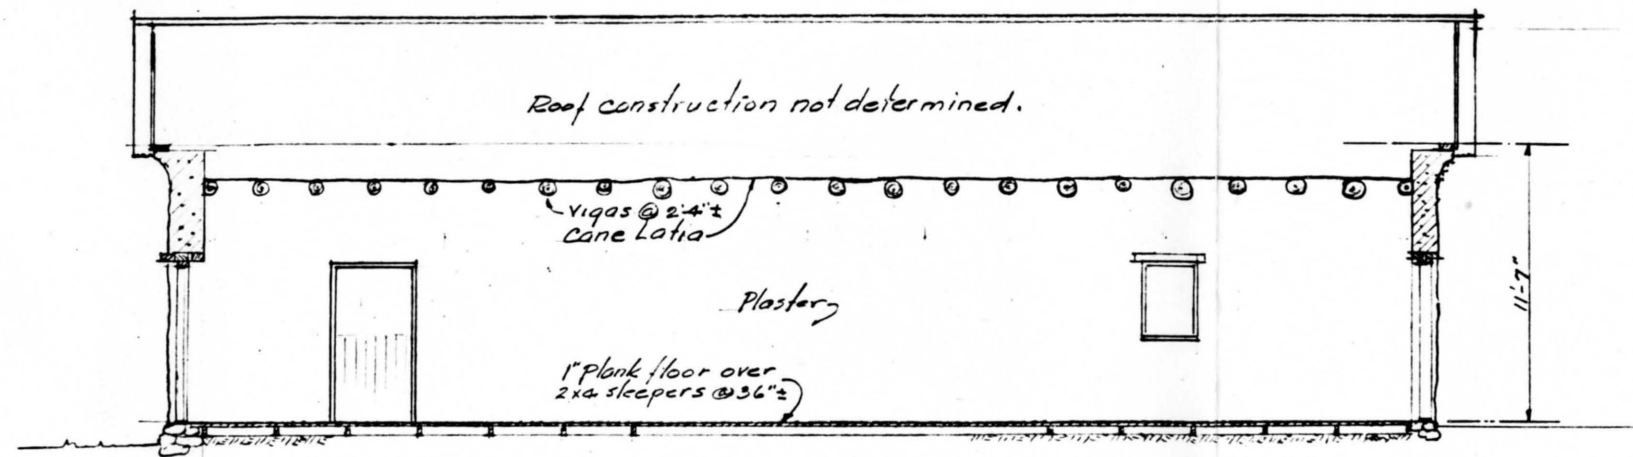
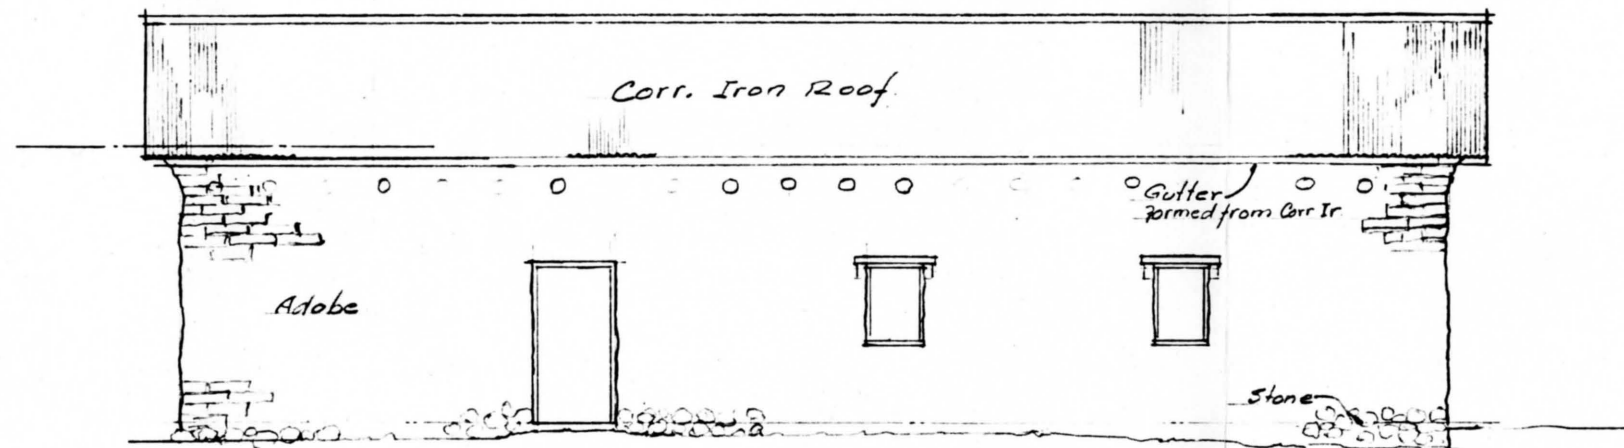
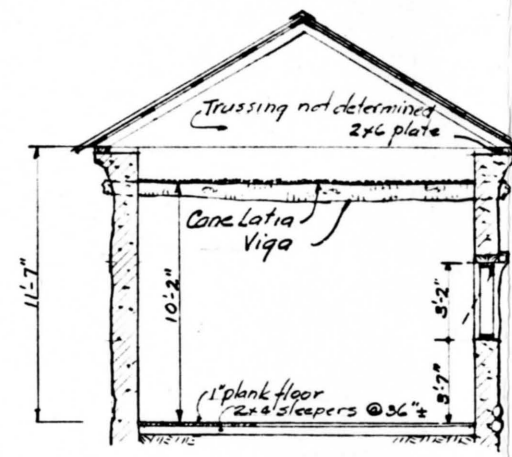
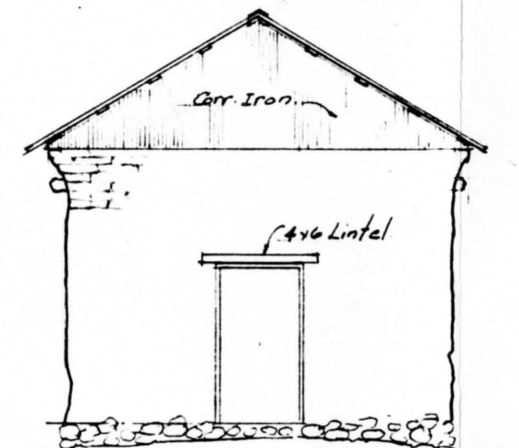
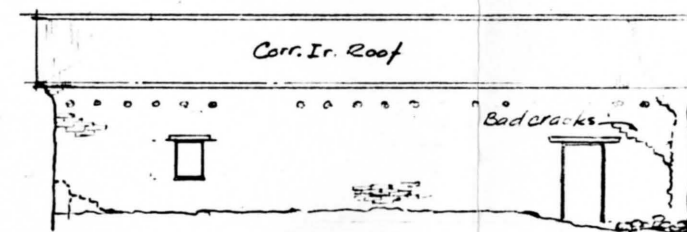
EXISTING CONDITIONS
UNITED STATES
DEPARTMENT OF THE INTERIOR
NATIONAL PARK SERVICE
OFFICE OF ARCHEOL. & HISTORIC PRESERVATION
BR. OF RESTORATION, SSC
OLD STORE, BBH618
OLD CASTOLON
BIG BEND N.P. TEXAS

This one room building is approximately 16'-2" x 53'-0" in size with 11'-7" high adobe block walls resting on a river cobble foundation. It has a doorway in each side with two windows in the South wall and one in the North wall. The lintels and frames are of wood. As there is a vigas and cane latia (the latter at 10'-2" above floor level) ceiling, it would appear that the corrugated metal gable roof was not original; but is known to have been in place prior to 1910. Its trussing is undetermined. The floor is of 1" planks over 2 x 4 sleepers at 36" on center. There are remnants of a wall forming an enclosure 16'-0"± by the full length of the building on its North side.
