Status of Climate and Water Resources at Big Bend National Park

Water Year 2019

Natural Resource Data Series NPS/CHDN/NRR—2022/2446

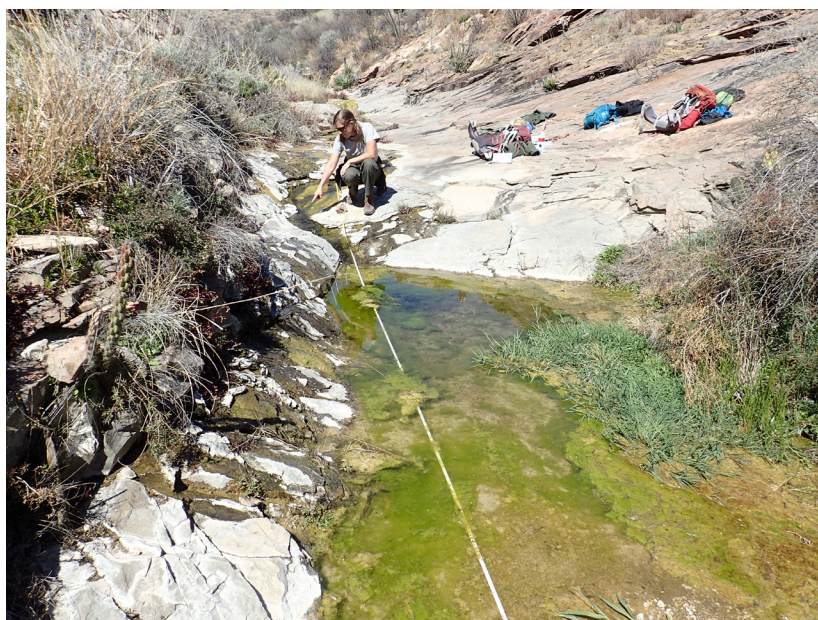
Figure 4-1. Bois D'Arc Spring, Orifice A (sampling location 1), Big Bend NP, February 2019.

Bois D’Arc Spring (Figure 4-1) is a rheoecrene spring (a spring that emerges as a flowing stream). In 2018, Orifice A emerged in a canyon as a small algae-filled pool which quickly disappeared under a gravel bar. Downstream, a monkeyflower-laden (*Mimulus* sp.) channel reemerged with nearly imperceptible flow and minimal surface water. The channel continued as intermittent pooled emergences, damp gravel and bedrock areas, and dried sections filled in with sand and vegetation such as whitebrush (*Aloysia gratissima*). In 2019, the crew found an additional pool about 40 m upstream of Orifice A. This new pool was designated Orifice B.

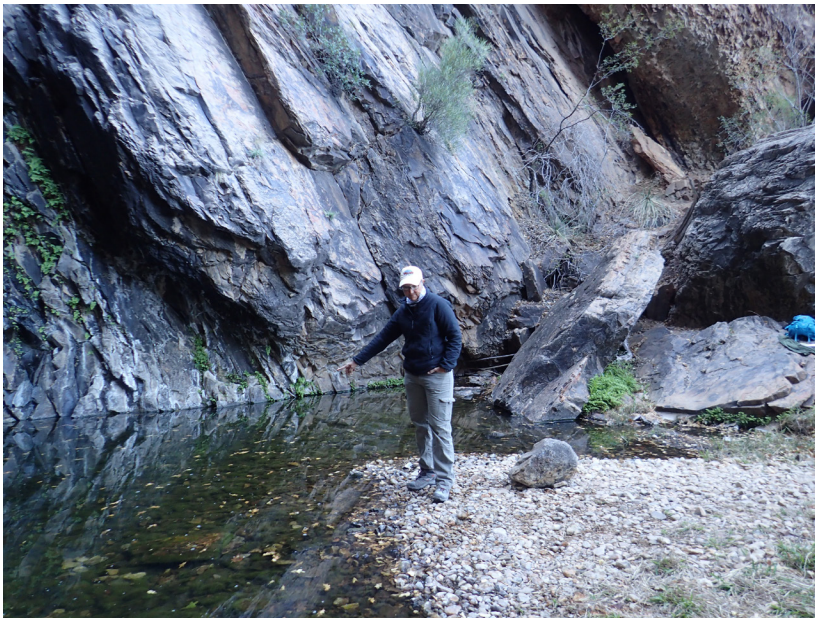
Figure 4-3. Cattail Falls, Orifice A (sampling location 1), Big Bend NP, February 2019.

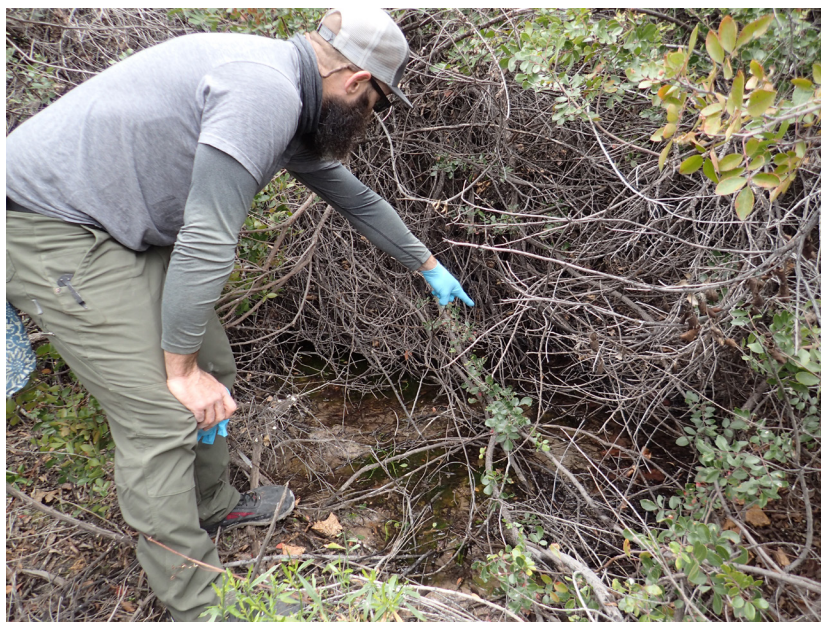
Chilicotal Spring Complex (Figure 4-5) is a rheochrene spring (a spring that emerges as a flowing stream). It likely originated near the large, lone cottonwood, flowing in an intermittently wet and unmeasurable channel. Orifice A emerged as cool, clear water under a dense sumac (*Rhus* sp.) community. The brook was covered with leaf litter and twigs and trickled into a wider marsh interlaced

The mean anthropogenic disturbance value was 1.0 (undisturbed) and the mean natural disturbance value was 1.3 (undisturbed). Median values for both disturbance categories were 1.0 (undisturbed). Salt crusts downstream of the orifice indicated drying. The crew also noted slight windthrow disturbance.

Figure 4-5. Chilicotal Spring Complex, Orifice A (sampling location 1), Big Bend NP, February 2019.

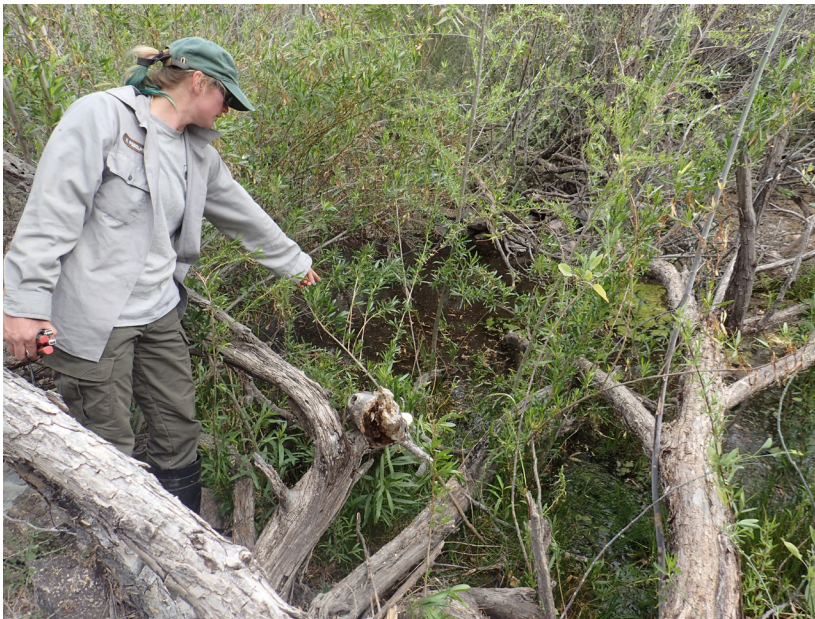
De La Ho Spring (Figure 4-7) emerged as a historically manufactured limnocrone spring (emerges as a pool) within a large, braided ephemeral wash. The orifice was situated on the upstream end of a densely vegetated pool of stagnant water. The pool was surrounded by significant amounts of woody debris with a perimeter thicket of mesquite (*Prosopis* sp.), desert-thorn (*Lycium* sp.), and acacia (*Acacia*, *Vachellia*, or *Senegalia* sp.). There was one outlet at a large willow (*Salix* sp.) that created a short channel with no discernable flow. The water was cool and clear; however, the upstream end of the pool had a soft silty substrate that was easily disturbed. The rest of the pool had a mixed substrate of silt, sand, and leaves.

Figure 4-7. De La Ho Spring, Orifice A (sampling location 1), Big Bend NP, March 2019.

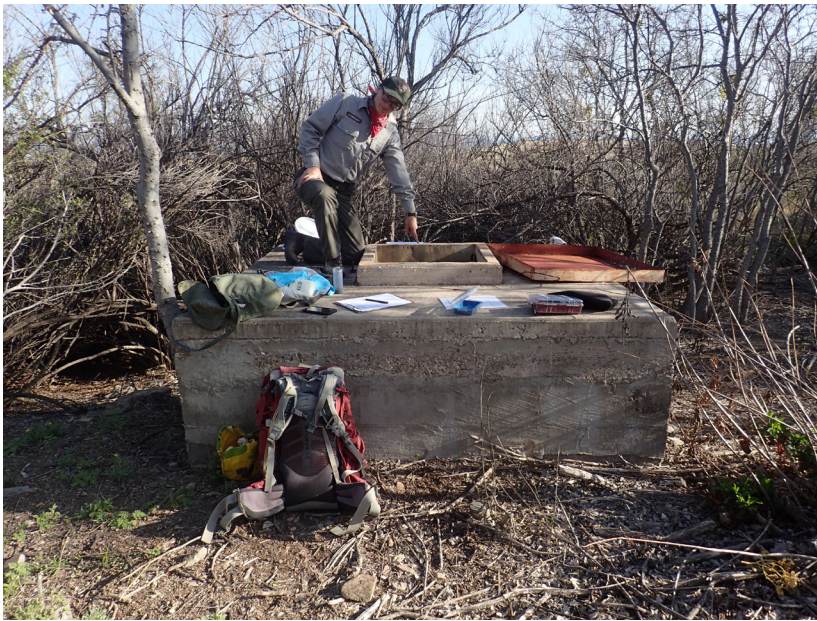
Figure 4-9. Government Spring springbox (sampling location 1), Big Bend NP, March 2019.

Government Spring (Figure 4-9) is a springbox that drains into a limnocrene pool. The water was warm and clear with no discharge from the springbox outflow piping. Downstream, a small pool contained cool and clear water with significant detritus over silt and gravel. There was no visible connection between the springbox and the pool.

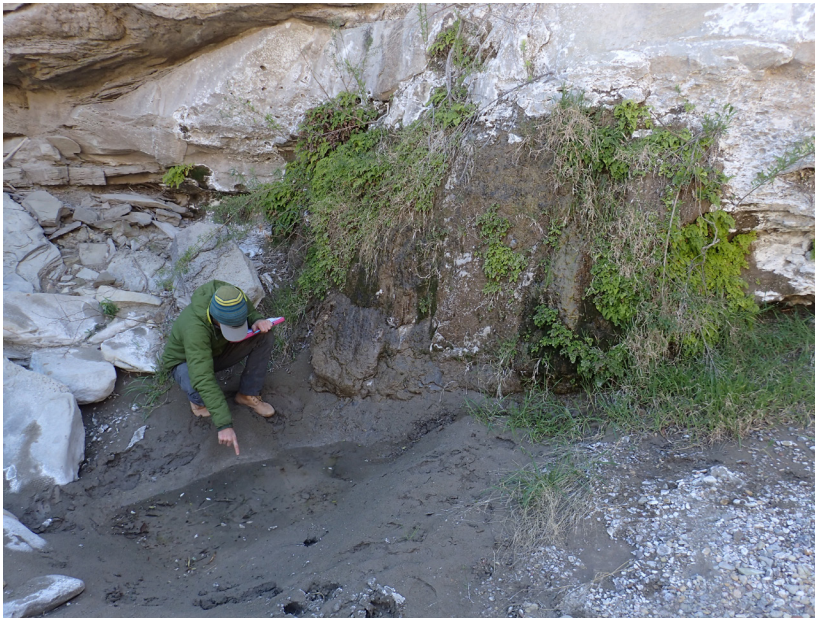
Figure 4-13. Lorn Spring, sampling location 1 (a pool below Orifice A), Big Bend NP, February 2019.

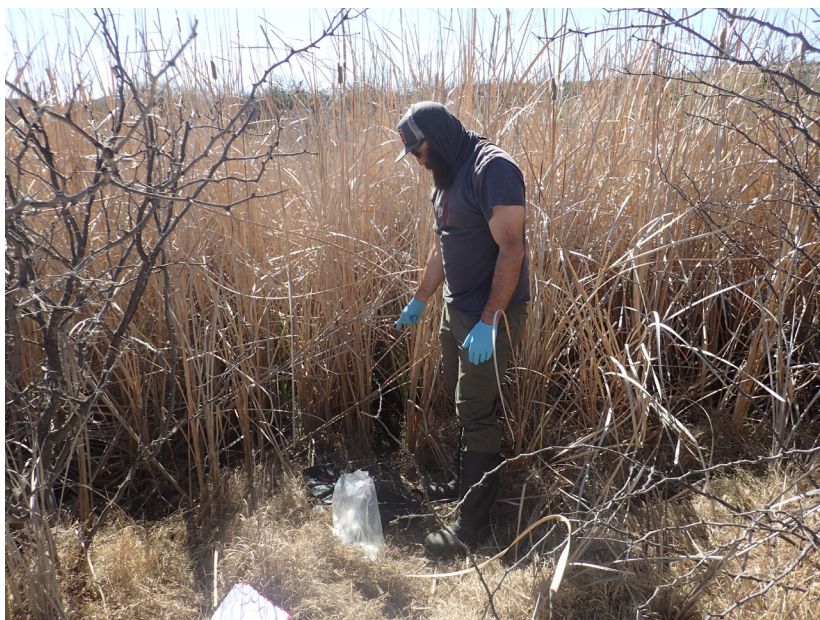
Figure 4-14. Lower Croton Spring, sampling location 1 (along the edge of the heleocrene pool), Big Bend NP, February 2019.

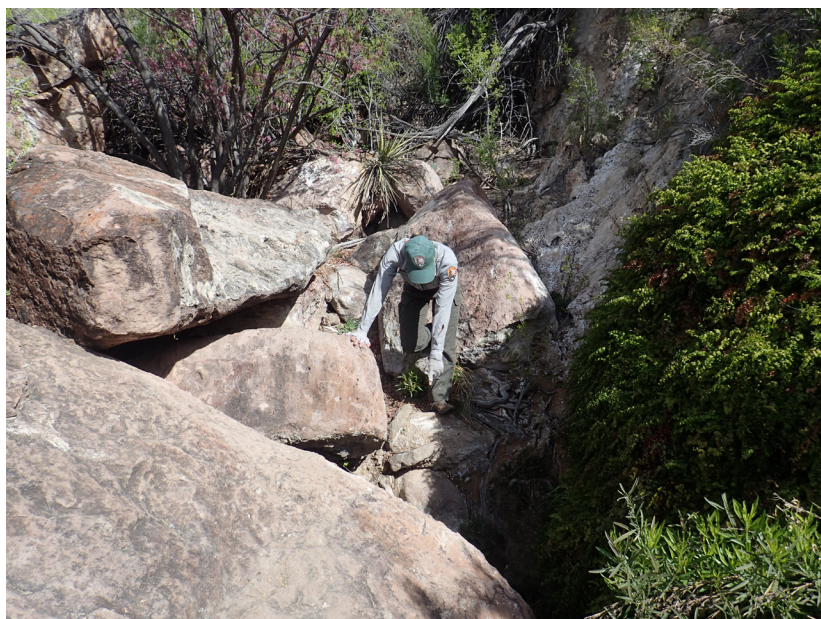
The mean anthropogenic disturbance value was 1.4 (slightly disturbed) and the mean natural disturbance value was 1.1 (undisturbed). Median values for both disturbance categories were 1.0 (undisturbed). Mule Ears trail is a high-traffic trail, which leads to the bottom half of the springbrook. There were various social trails and rock wear. Possible javelina tunnels were noted, though impossible to distinguish from wildlife use.

Figure 4-16. Mule Ears Spring, Orifice A (sampling location 1), Big Bend NP, March 2019.

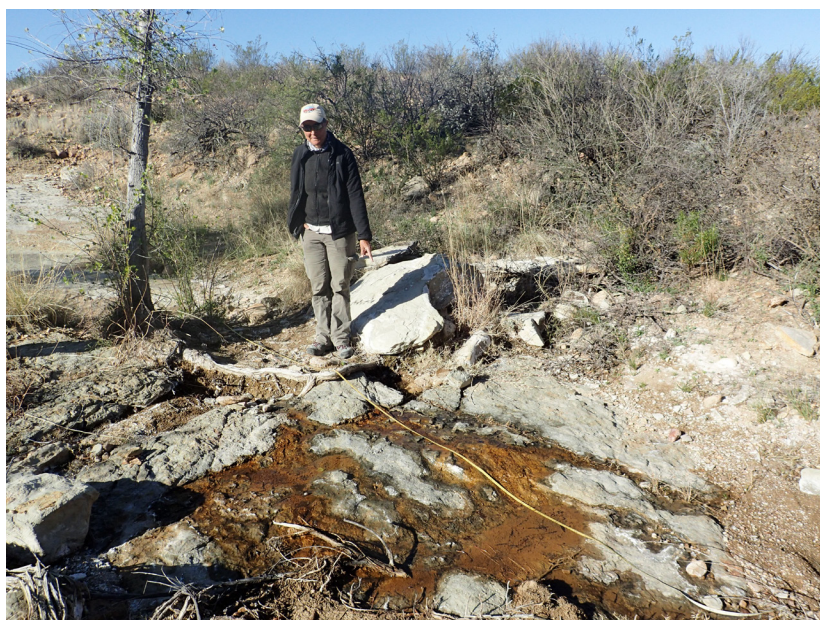
Painted Hills Spring (Figure 4-18) is a rheochrene spring (a spring that emerges as a flowing stream). The spring emerged from under a gravel bar and root. Water had collected in two small pools which did not appear to have any outflow. Water seeped from a seam just downstream and flowed over bedrock in a dispersed fashion. The channel was not well defined as most of the flow is on bedrock. There were several other instances where water or dampness was present within 200 m (656.2 ft).

Figure 4-18. Painted Hills Spring, sampling location 1 (a pool below Orifice A), Big Bend NP, February 2019.

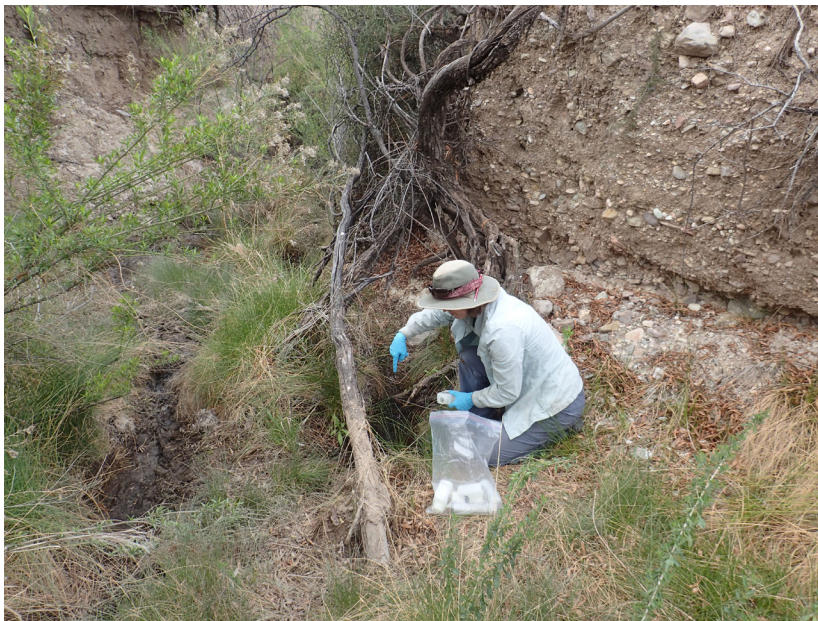
Peña Spring 1 (Figure 4-20) is a rheochrene spring (a spring that emerges as a flowing stream). Water emerged in a mat of spikerush (*Eleocharis* sp.) just downstream of several large willows (*Salix* sp.). Orifice A was a pool under a downed tree which flowed into a narrow channel of silt, organic matter, and pebbles. The water was cool and clear and filled with leaf litter. The channel curved with

Figure 4-20. Peña Spring 1, sampling location 1 (a pool below Orifice A), Big Bend NP, March 2019.

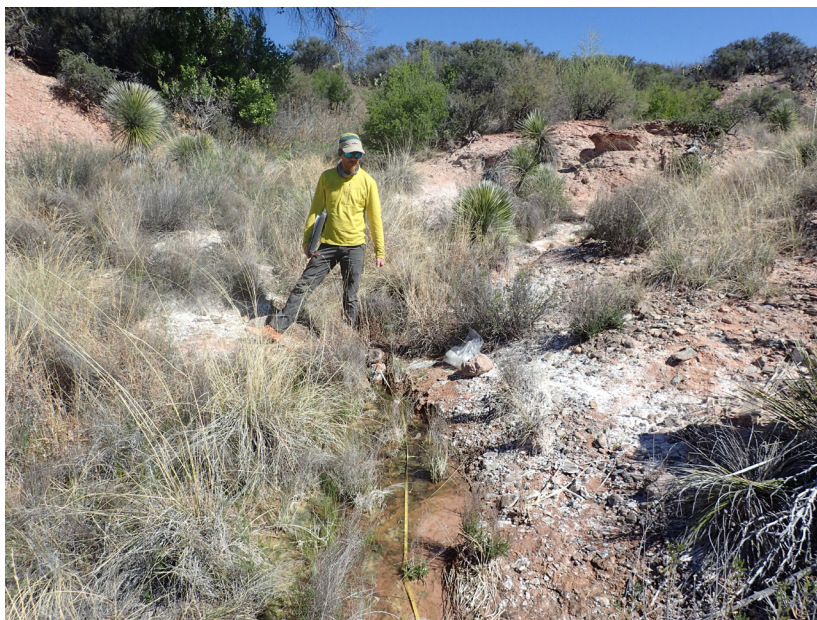
The mean anthropogenic disturbance value was 1.3 (undisturbed) and the mean natural disturbance value was 1.3 (undisturbed). Median values for both disturbance categories were 1.0 (undisturbed). Contemporary use was indicated with several sets of boot prints. The crew noted slight disturbance from drying and wildlife use.

Figure 4-22. Red Ass Spring, sampling location 1 (a pool below Orifice A), Big Bend NP, February 2019.

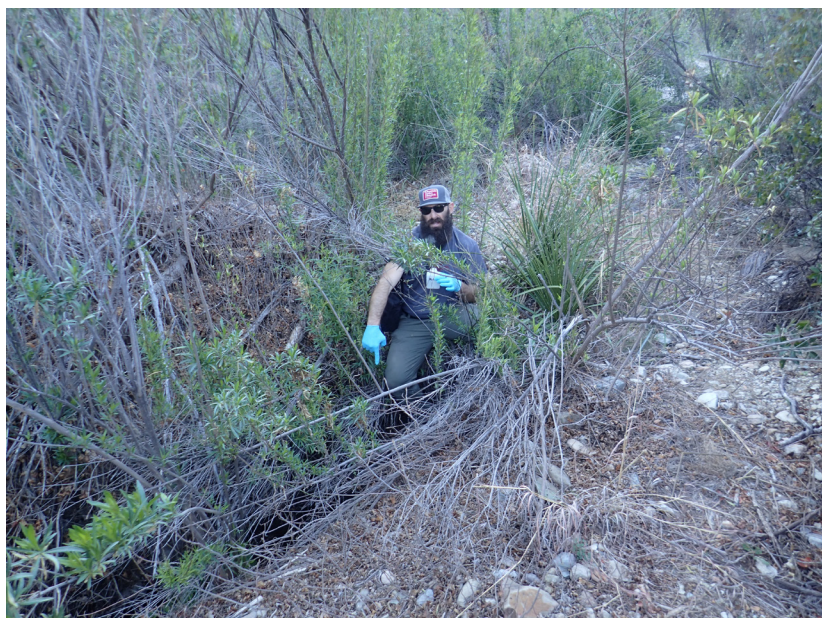
Figure 4-24. Rough Spring B, sampling location 1 (an incised channel below Orifice A), Big Bend NP, February 2019.

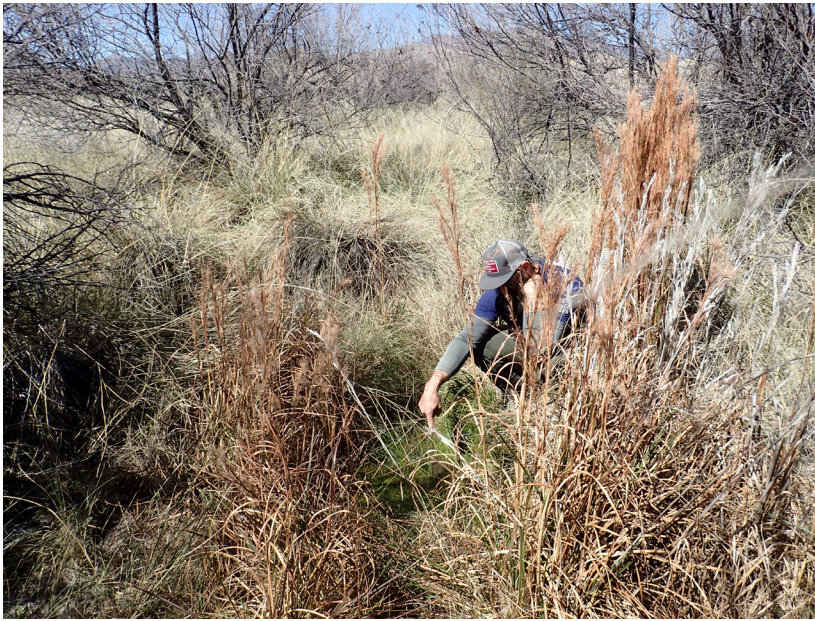
Figure 4-26. Screwbean Spring, sampling location 1 (a pool below Orifice A), Big Bend NP, February 2019.

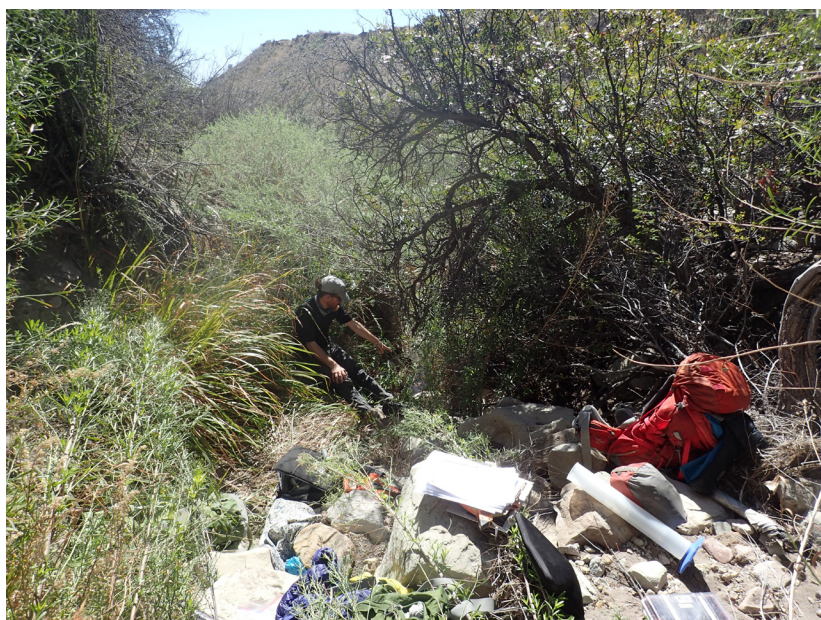
Figure 4-28. Shelf Spring, sampling location 1 (a pool below Orifice A), Big Bend NP, February 2019.

was slight disturbance from historical human use, drying, and wildlife. Recent flooding caused moderate disturbance.

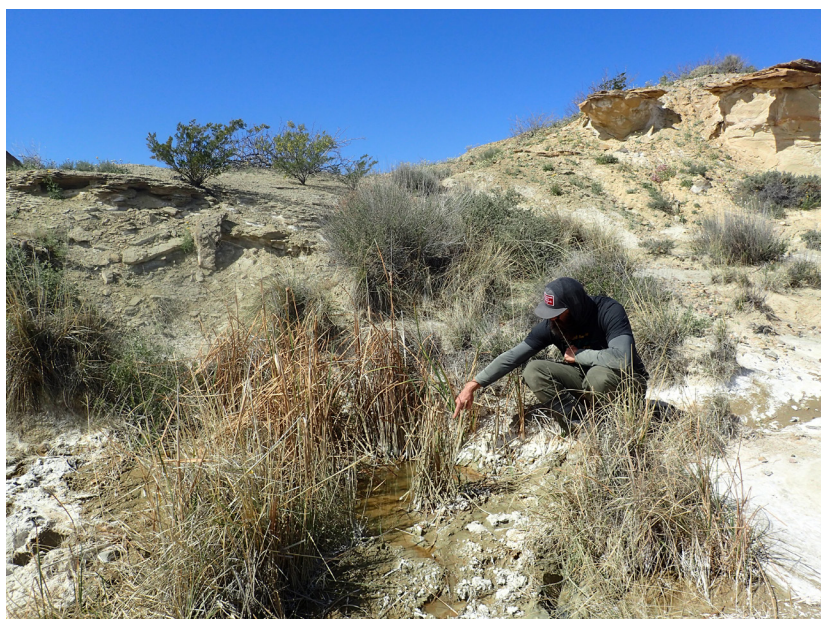
Solis Spring (Figure 4-30) is a rheochrene spring (a spring that emerges as a flowing stream). Orifice A, which supported several cattail (*Typha* sp.), emerged in a series of small stagnant pools. Orifice B emerged next to a small overhang, creating a small pool, which discharged a low flow into a narrow channel down the hillside. Orifice C emerged in a patch of dropseed (*Sporobolus* sp.) and flowed into a few small, silty puddles before terminating down the hill. The entire area surrounding Solis Spring showed a salty crust indicative of drying. Flow was so low it was nearly imperceptible in the silt-dominated channel. Water from all three orifices emerged clear though a deep silty substrate causing frequent murkiness in disturbed areas.

Figure 4-30. Solis Spring, sampling location 1 (a pool below Orifice A), Big Bend NP, February 2019.

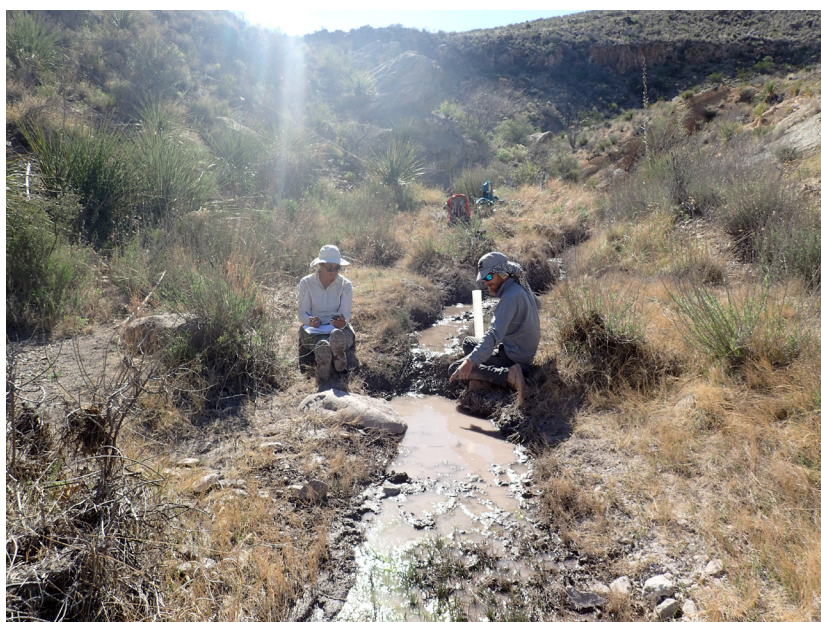
Tiptoe Spring (Figure 4-32) is a rheochrene spring (a spring that emerges as a flowing stream) in a small drainage. Orifice B emerged as stagnant water in a series of terraced pools with no apparent flow. Downstream from here was a steep drop containing the only discernable flow of the spring reach. After this drop, the water joined Orifice A, significantly increasing the water volume and widening the channel. Here the water was covered in a thick mat of algae. Downstream, the channel continued as a series of wetted patches with minimal standing water.

The mean anthropogenic disturbance value was 1.0 (undisturbed) and the mean natural disturbance value was 1.8 (slightly disturbed). Median values for both disturbance categories were 1.0 (undisturbed). Recent flooding caused significant disturbance to the site. The crew also noted slight disturbance due to drying and moderate disturbance caused by wildlife.

Figure 4-32. Tiptoe Spring, sampling location 5 (discharge sampling location), Big Bend NP, February 2019.

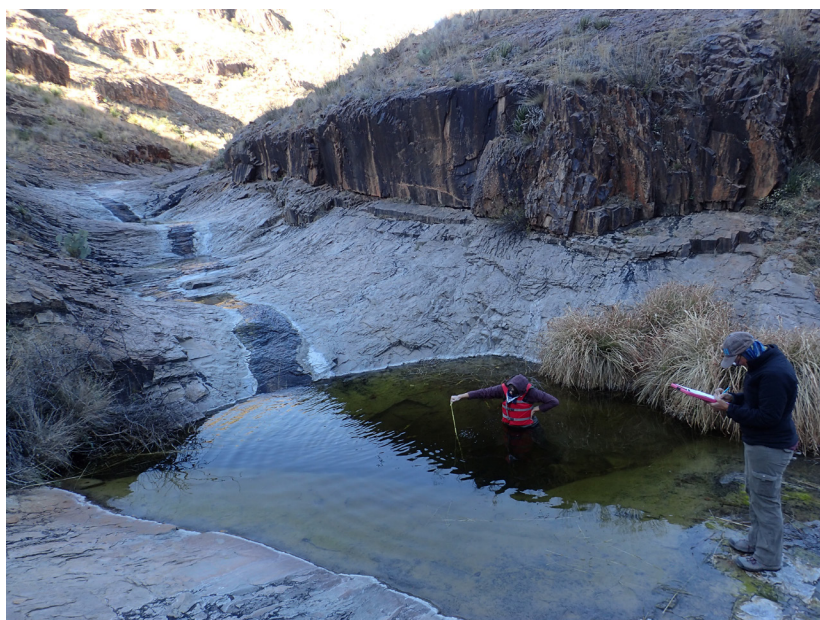
Water Boy Tinaja (Figure 4-34), a tinaja and a small pool, is in a rock basin of a bedrock canyon. Orifice A emerged from a narrow laminar flow on bedrock

Figure 4-34. Waterboy Tinaja, Orifice A (sampling location 1), Big Bend NP, February 2019.
