United States Department of the Interior  
National Park Service  
**National Register of Historic Places**  
**Registration Form**

**1. Name of Property**historic name North Rim Road, Black Canyon of the Gunnison National Parkother names/site number North Rim Road Historic District/ 5MN.3522**2. Location**street & number Black Canyon of the Gunnison National Park (BLCA) [N/A] not for publicationcity or town Crawford [X] vicinitystate Colorado code CO county Montrose code 085 zip code 81415**3. State/Federal Agency Certification**

**National Register of Historic Places  
Continuation Sheet****United States Department of the Interior  
National Park Service**North Rim Road  
Montrose County/ ColoradoSection number 7 Page 1  
Historic Park Landscapes in National and State Parks MPS**DESCRIPTION**

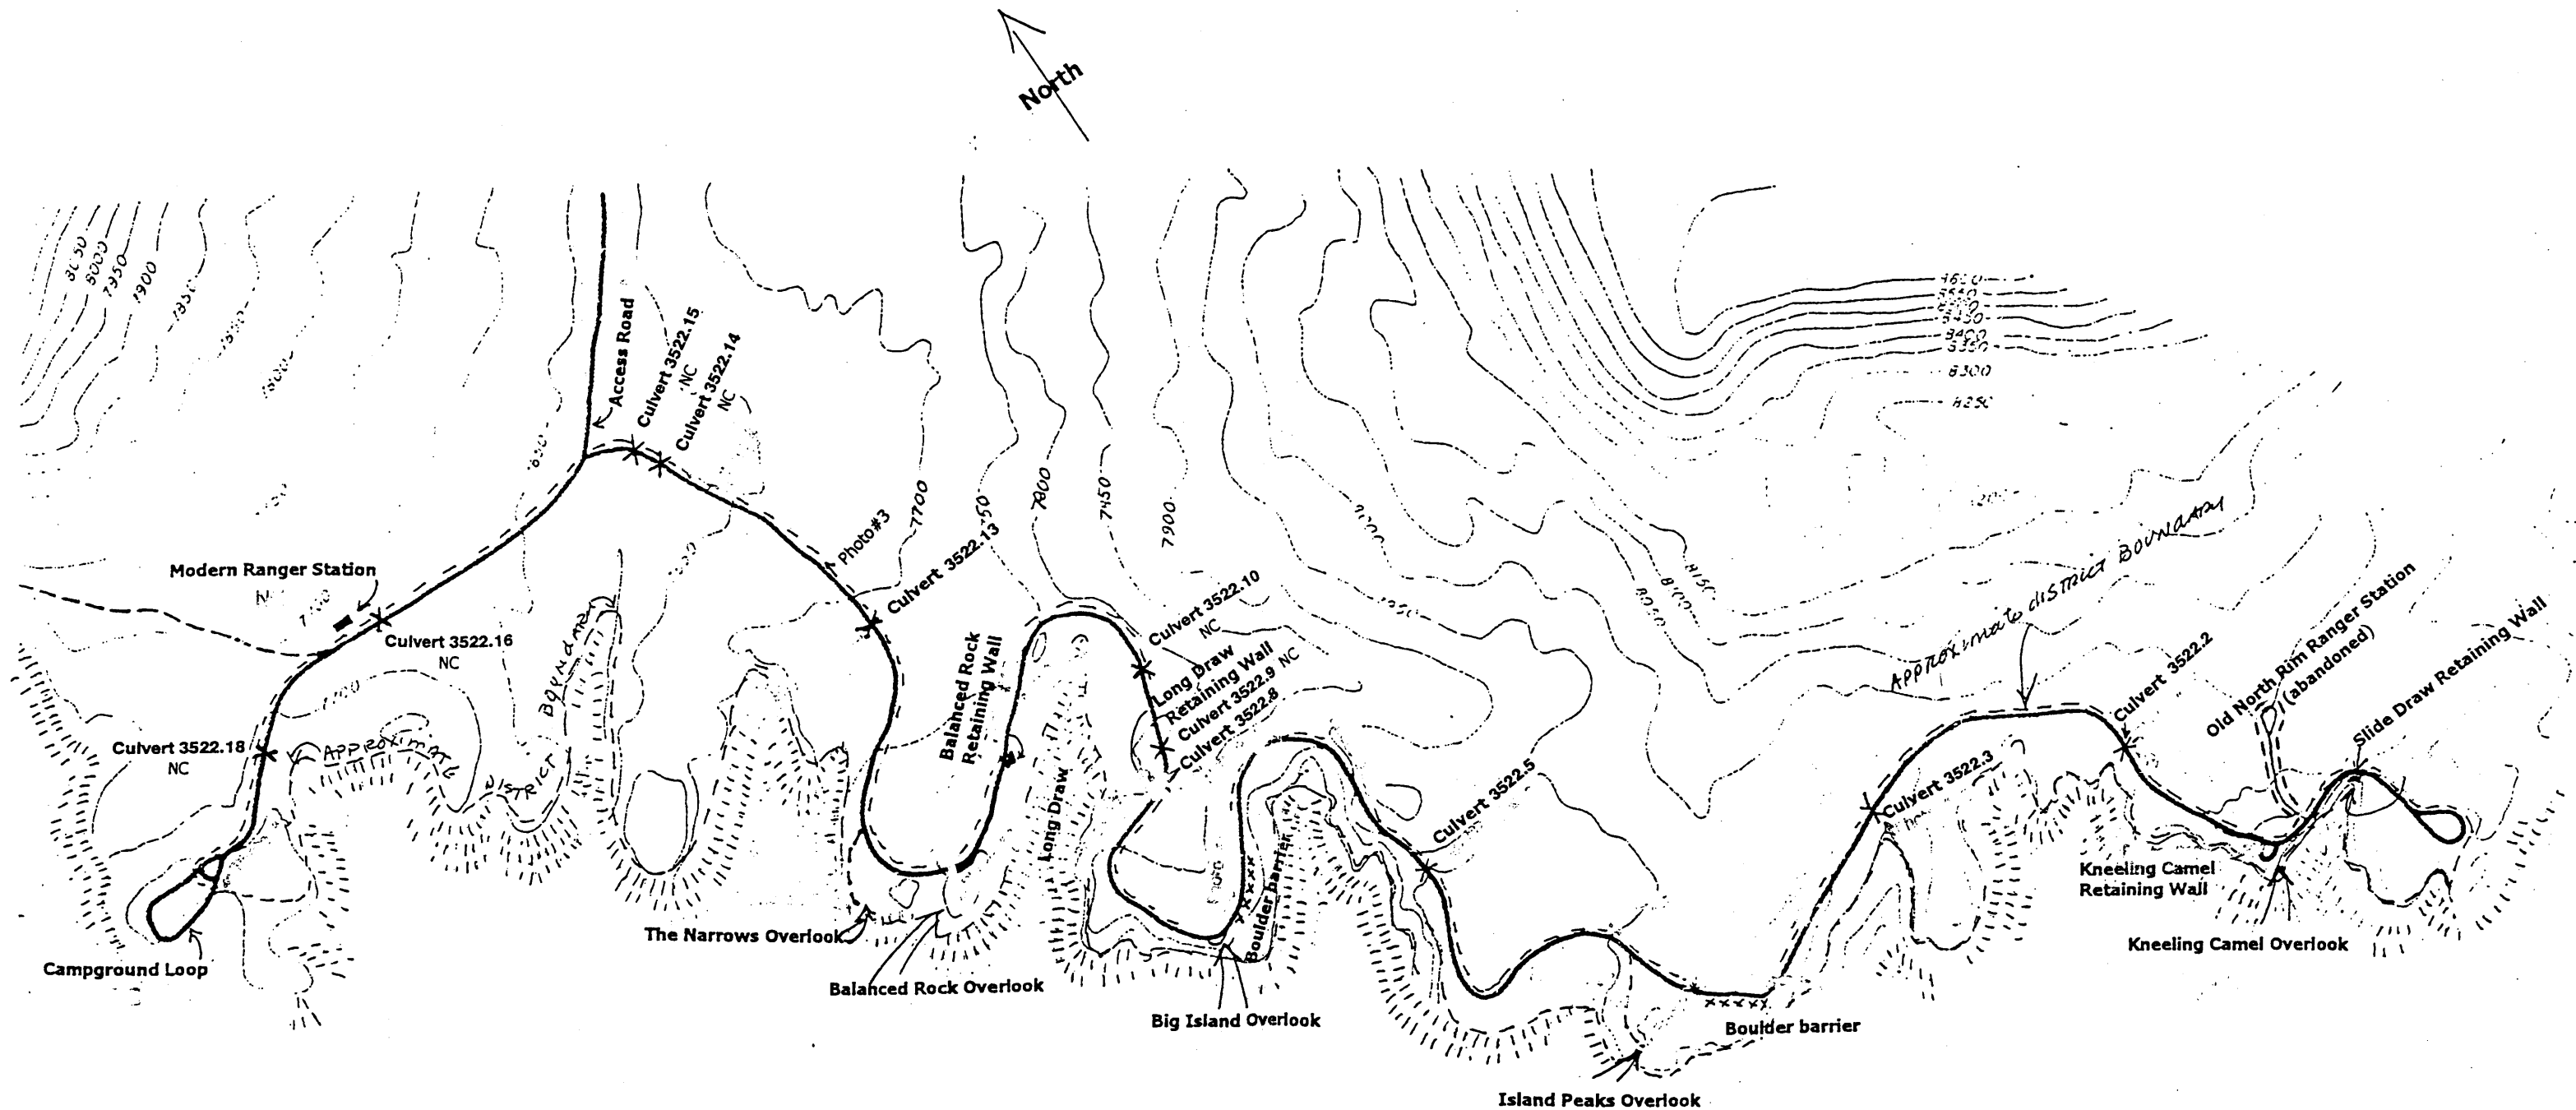
Schematic drawing showing alignment of North Rim Road and locations of associated overlooks, culverts, retaining walls and boulder barriers.

Noncontributing resources are marked with an "NC"

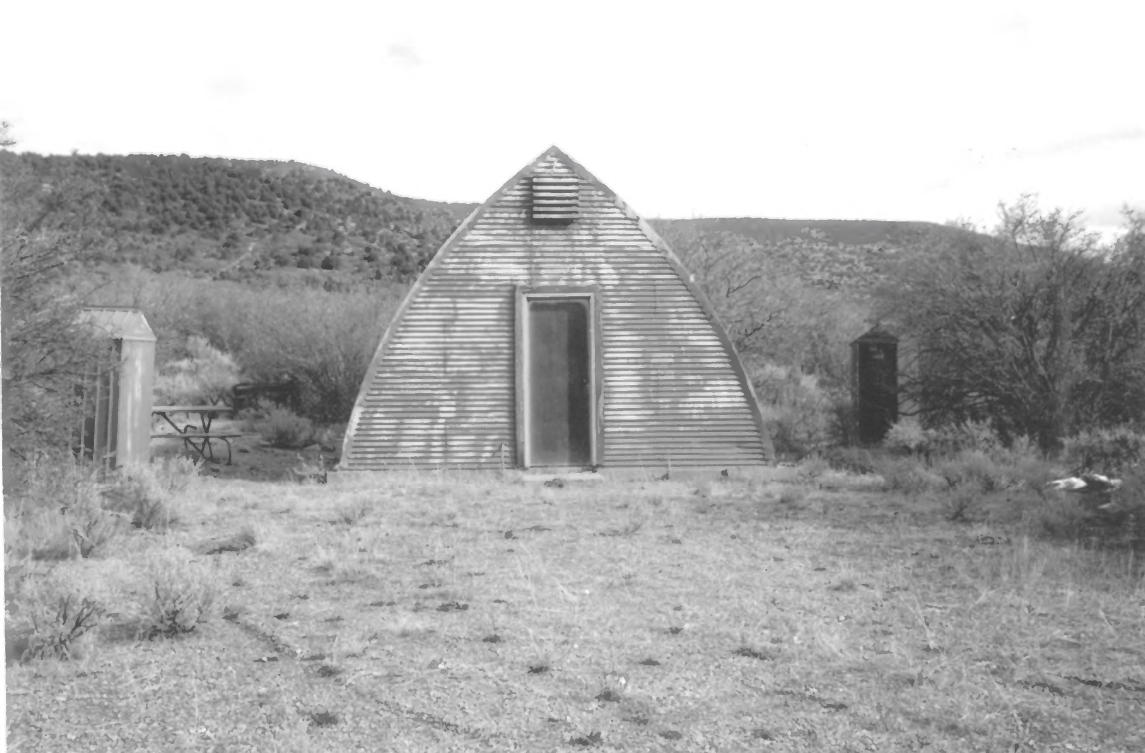
#8

South facade - Maintenance Shop

**Maintenance Shop (BCG-35):** This 1934 metal shed is quonset-like in appearance, but displays a pointed arch roof. A solid steel door provides access on the south façade. A four-light window is centrally placed on the east and west sides of the building. Corrugated metal walls rest atop a poured concrete foundation. A vent above the entry door also consists of metal. The building was designed by Howard Baker with the National Park Service and used for storage.

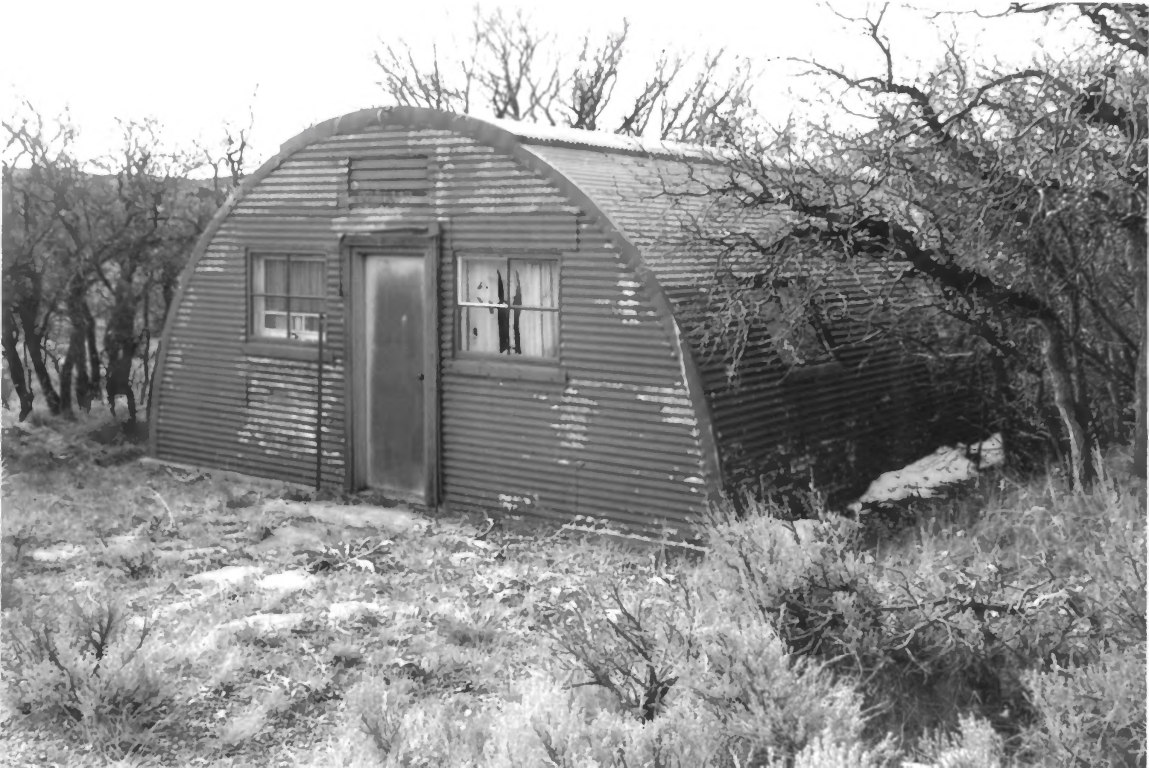
# 15

East side of Quonset Hut

**Quonset Hut (BCG-33):** Also known as the Ranger Residence, this 1934 building was constructed as a temporary shelter by the National Park Service. It is a typical Quonset Hut with a barrel arch roof, metal siding and roofing, and a poured concrete foundation. The west side has a centrally placed steel door flanked by four-light fixed awning windows. The east side is identical to the west. In addition, there are two of these same windows on the north and south walls, bringing the total window count to eight. Above each entry door is metal vent. The interior was remodeled by the National Park Service in 1953 and 1966 and was used as a seasonal dwelling for rangers until the early 1990s.

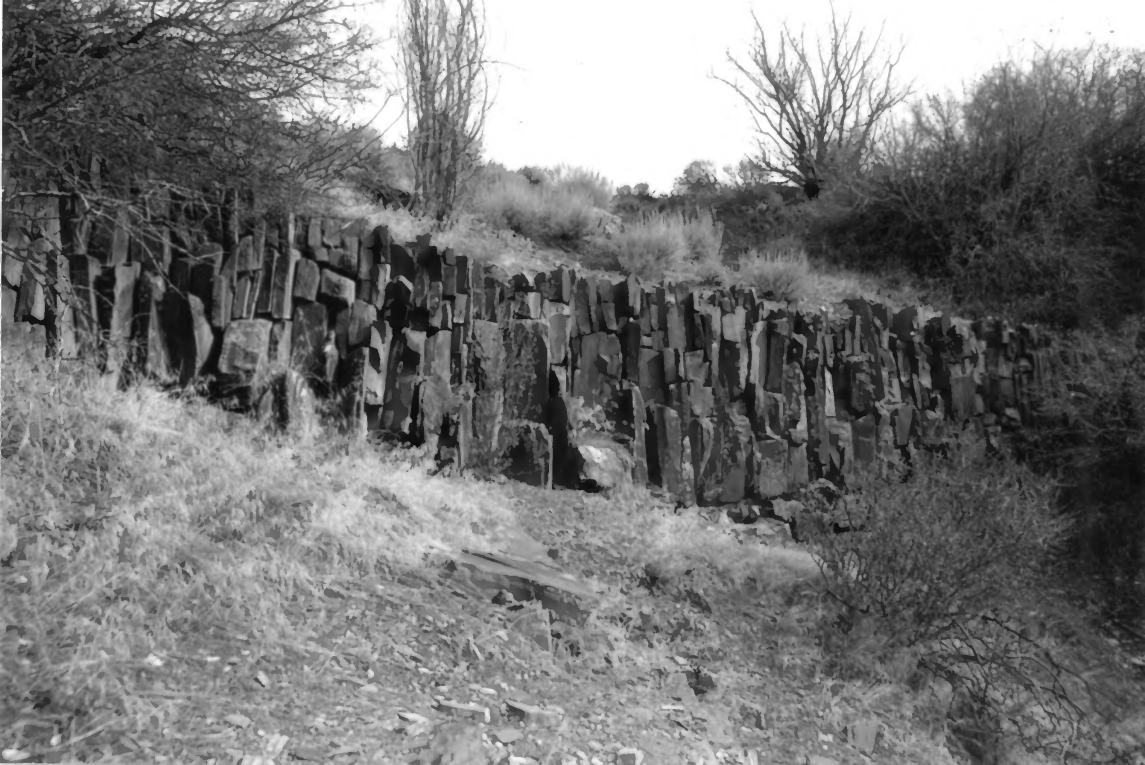
#24

Slide Draw retaining wall

Structures: Notable structures that occur along the North Rim Road, all of which represent original fabric, include the five stone culvert headwalls and the four stone retaining walls. As stated previously, the character of the stone headwalls conforms to contemporary guidance provided by the Branch of Engineering. The character of the four stone retaining walls is slightly more interesting due to the variation in their character--which appears to be dependent upon whether or not they were visible to travelers along the rim. As stated previously, the retaining wall located in Slide Draw and the wall adjacent to the west side of Kneeling Camel Overlook are "naturalistic," they are designed to mimic weathering patterns in adjacent bedrock outcrops.

An interesting component of Secrest's July 30, 1937 report, is a photograph of the Slide Draw retaining wall, with a caption that reads "Old dry wall in process of replacement by naturalistic grouted rock wall." The old dry wall is readily visible in the photograph, consisting of relatively small pieces of tabular stone set horizontally below a large fill segment of the roadway. In contrast the naturalistic grouted rock wall appears as large angular pieces of native bedrock, set vertically to approximate the natural weathering patterns of the local bedrock. The Slide Draw retaining wall, as well as the retaining wall adjacent to the east end of Kneeling Camel View, are both "naturalistic," both are substantial in size and located in areas that are visible from Kneeling Camel Overlook and likely visible from the south rim of the canyon. No doubt, the new naturalistic walls were used to mask the fill and make the roadway blend in with its surroundings. (Presumably, the "old dry wall" was removed after completion of the new wall- it is no longer visible today.) The two other retaining walls along the roadway, both located in the draw east of Balanced Rock Overlook, are not readily visible from either the south rim of the canyon or from other stopping points along the North Rim Road, and have simple dry-wall retaining walls.

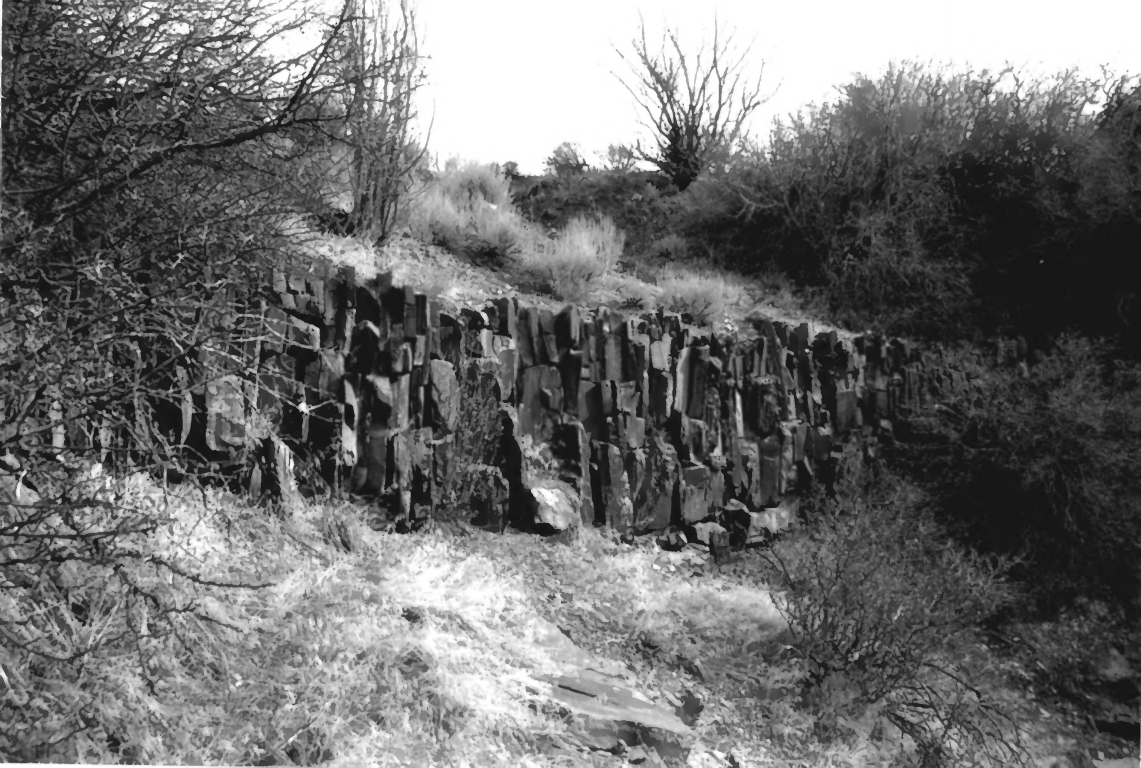
# 25

Slide Draw retaining wall

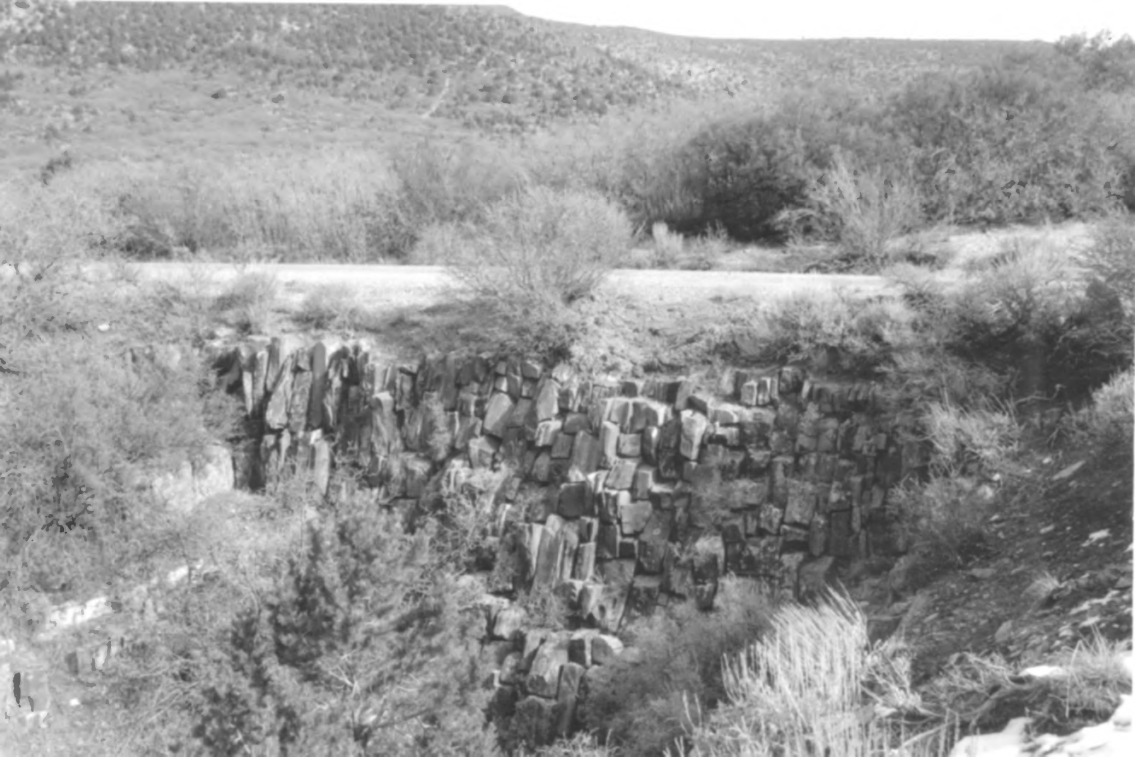
#3A

Kneeling Camel retaining wall

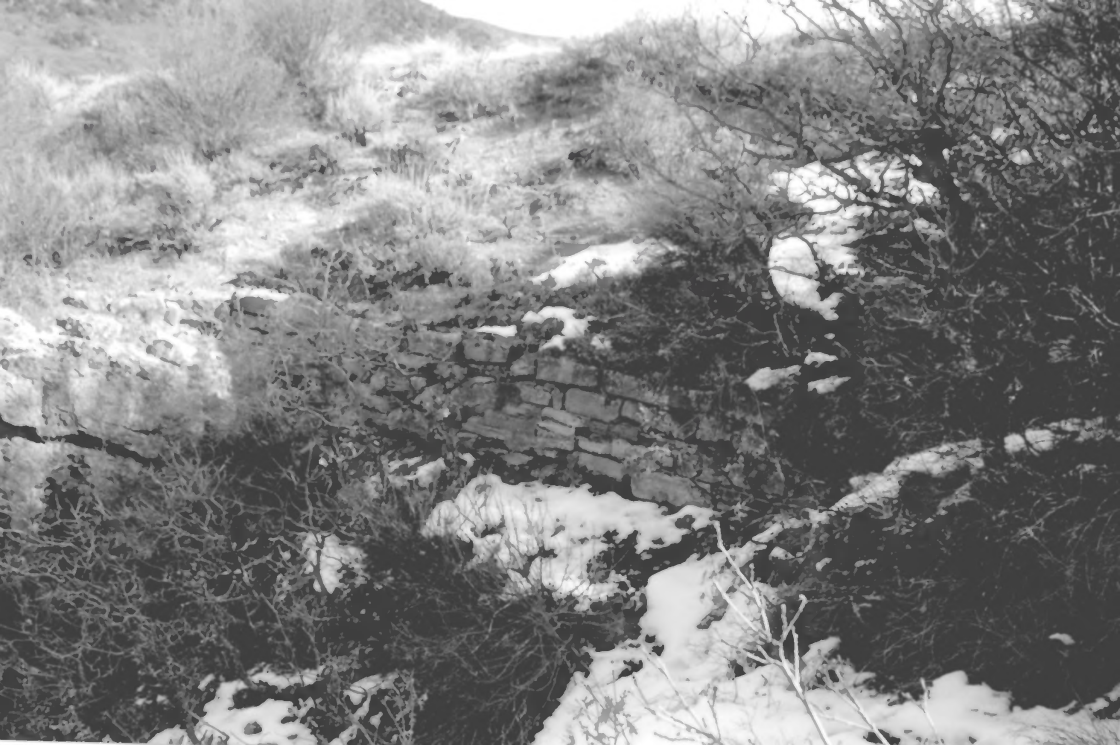
#4A 5MN3522

Unnamed retaining wall, near  
Kneeling Camel Overlook

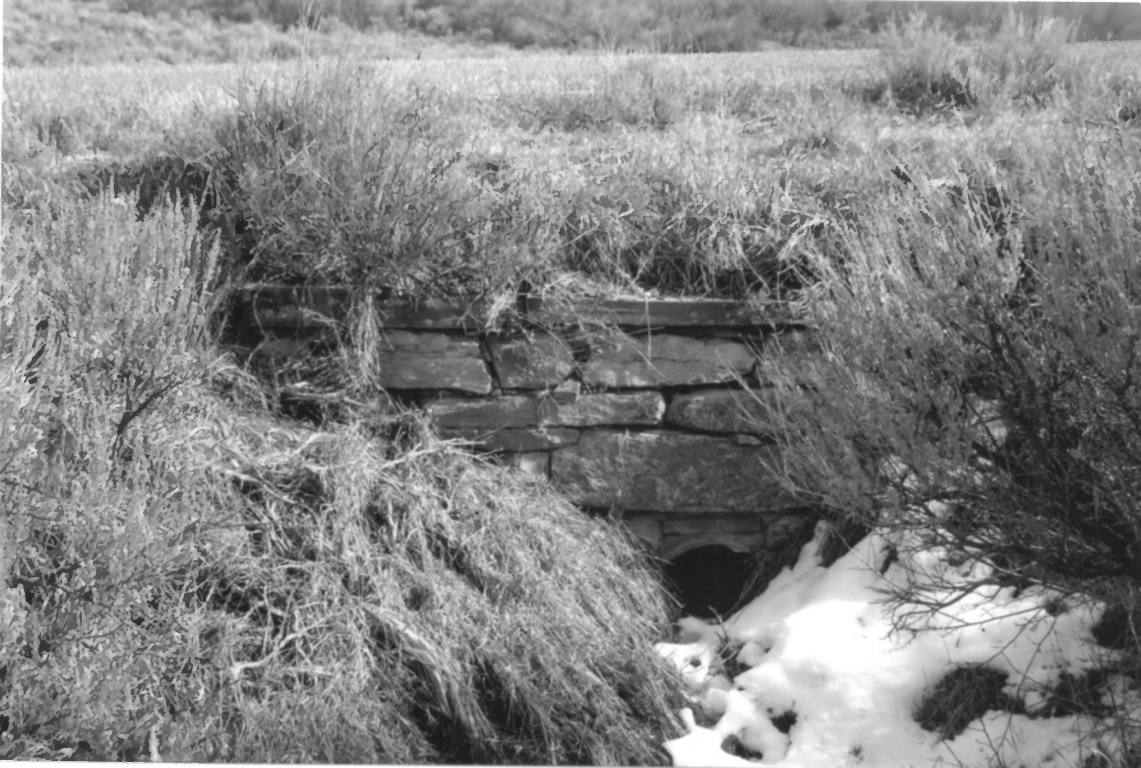
#6A

Culvert BCG-38

Where natural drainage courses were obstructed by road fill, Park Service engineers calculated the acres being drained by the natural channel and selected culverts of the appropriate size to handle the runoff. Five of the culverts on the road (5MN3522.2, 5MN3522.3, 5MN3522.5, 5MN3522.8 and 5MN3522.13, i.e. BCG-38, BCG-39, BCG-4 1, BCG-44 and BCG-49 respectively) retain their original stone headwalls on both side of the road. All of these headwalls are made with local stone and constructed according to the "Specifications and Instructions for Minor Roads and Appurtenant Structures." Six other culverts (5MN.3522.9, 5MN.3522.10, 5MN.3522.14, 5MN.3522.15, 5MN.3522.16, and 5MN.3522.18, i.e., BCG-45, BCG-46, BCG-50, BCG-51, BCG-52 and BCG-54 respectively) are primarily steel pipes with no headwalls, or crudely constructed headwalls that appear to be later constructions. These six culverts do not possess any architectural or engineering value.

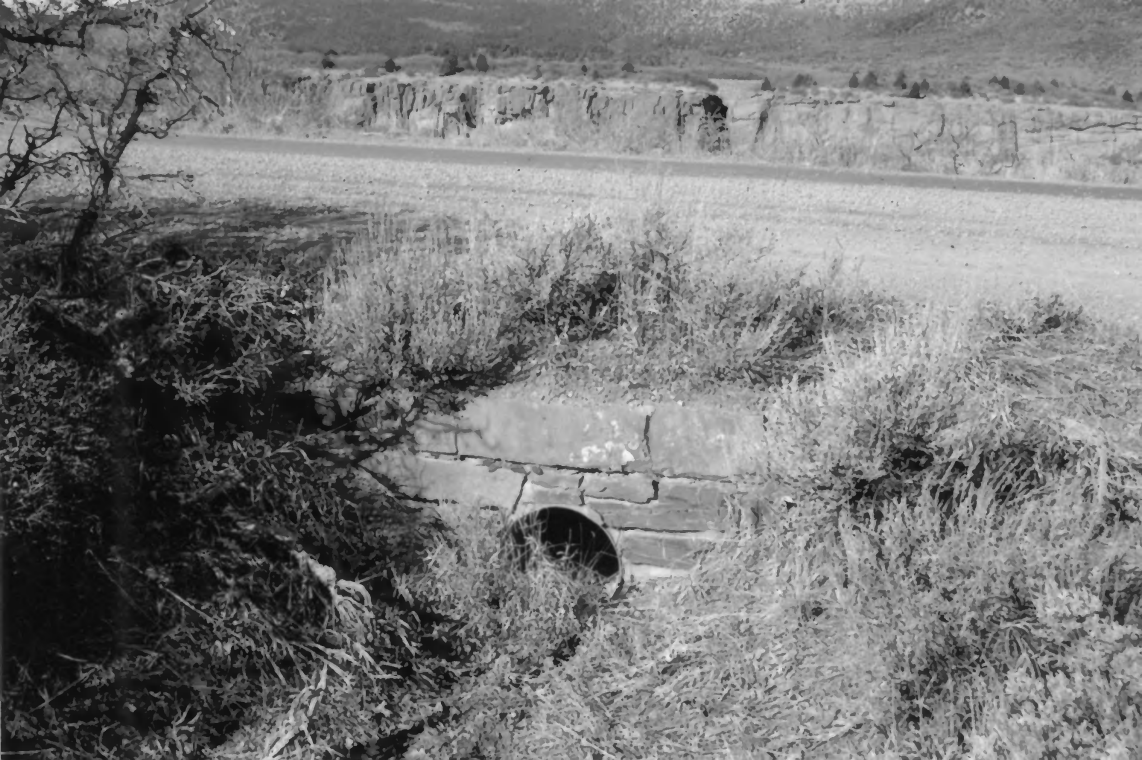
#11A

Culvert BCG-44

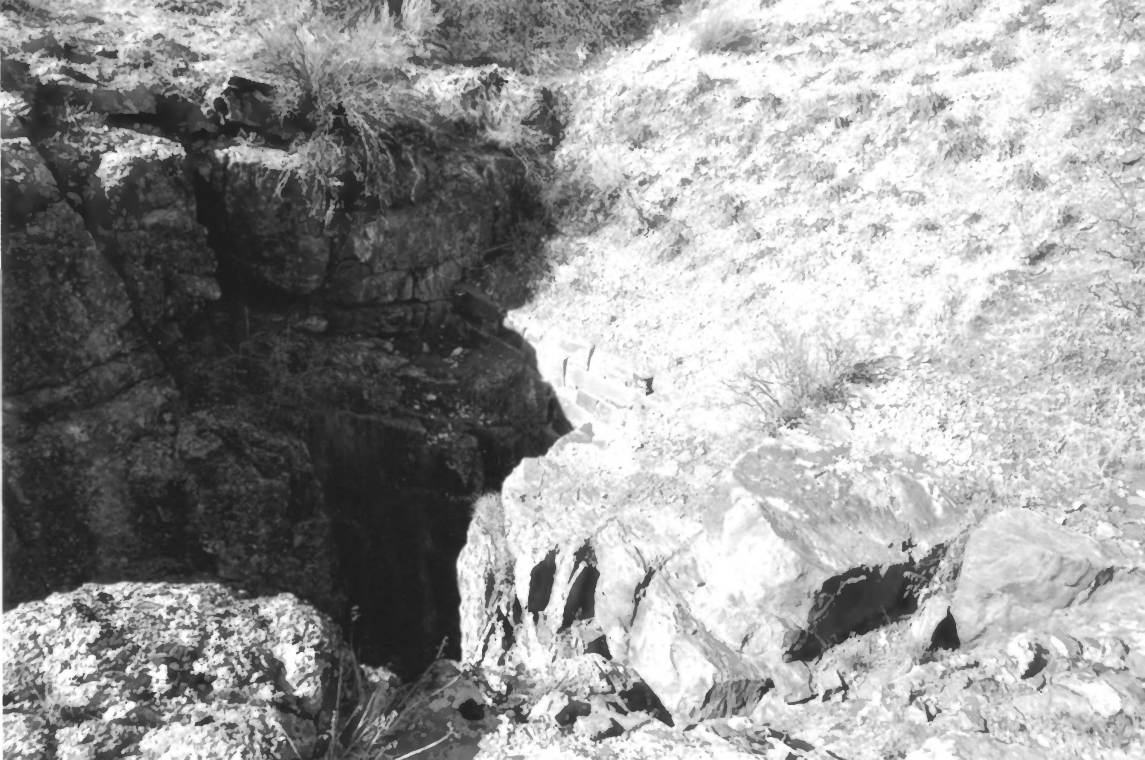
#12A

Balanced Rock retaining wall
